| <b>Inspector</b> | | Matthew Allen | | <b>MIT Date</b> | | 07/02/2024 | | <b>Time</b> | | 08:00 | |
| | | | | | | | | <b>Lease Name</b> | | BIG HEART | |
| | | | | | | | | <b>Well ID</b> | | 16 | |
| <b>Type of MIT</b> | | Ada Pressure Test | | | | | | <b>Test Reason</b> | | Routine | |

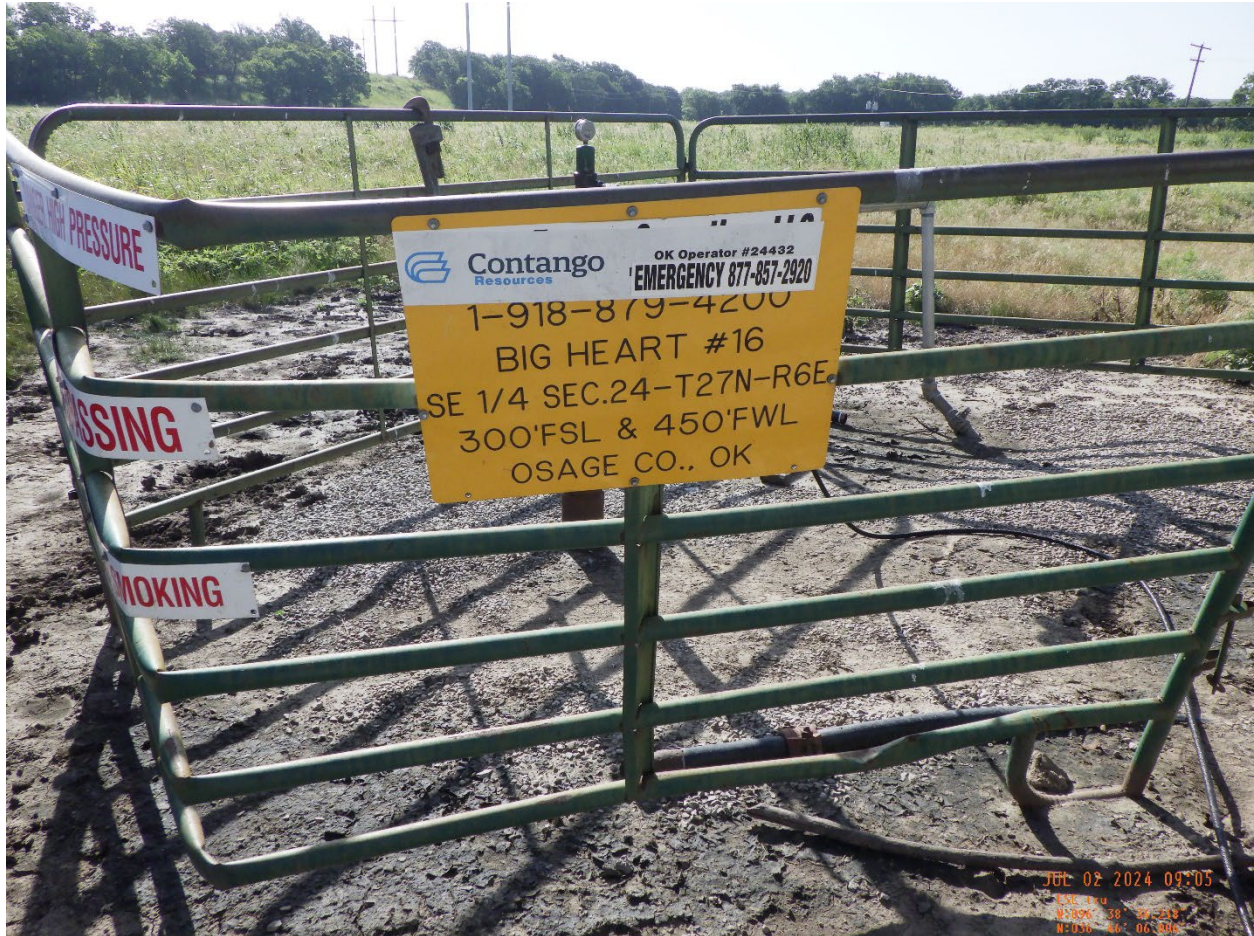
Photo No. 1

Description: This was the well sign for OS3063000.

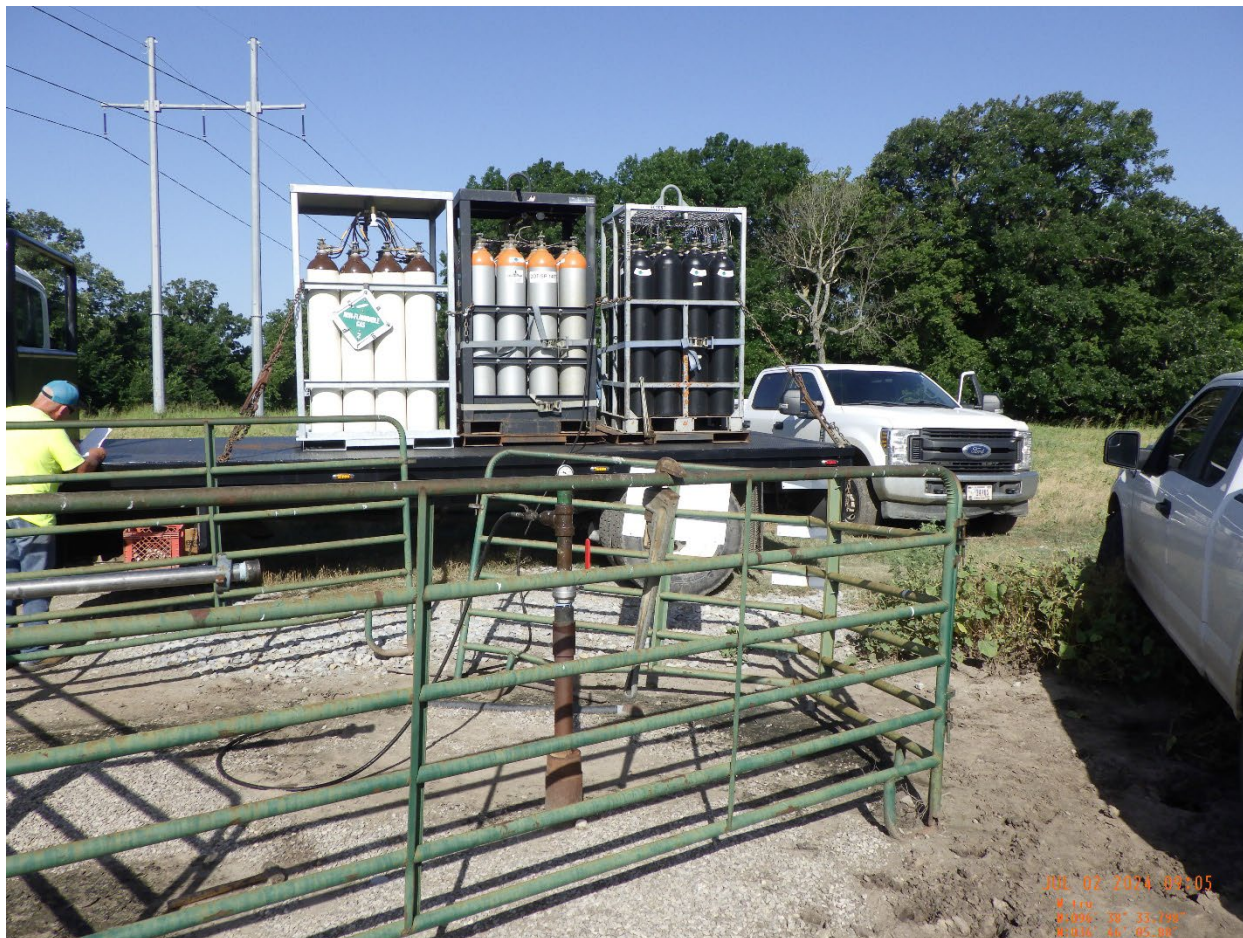
Photo No. 2

| <b>Inspection Comments</b> | | Well OS3036000 was observed with Opsig on the tubing prior to the inspection. The well reached and maintained the required test pressure for 30 minutes. | | | | | | | | | |

**Description:** This was well OS3063000 connected and pressured during the mechanical integrity test.
