6ENFORM-019-R6 (10/6/14)

### PURPOSE OF THE INSPECTION

The facility is known as the Lutex Oil Ltd. – Cora Malone Lease and is located in Luling, Caldwell County, Texas. The facility is located on an oil and gas lease at Latitude 29.686138N and Longitude -97.643579W. See Photo N°1 and Photo N°2 in Appendix 1. The lease consists of production wells, injection wells, vessels, flow lines, collection points, and other equipment used for the production of crude oil and natural gas. Production wells produce a mixture of produced water and crude oil (well fluids). Flow lines are used to transport well fluids from various locations on the leases. Collection points known as tank batteries consist of various tanks, vessels, and equipment used to separate and store the produced water, brine water, and crude oil. Produced water is typically high in salts and is commonly known as oil field brine. The crude oil is sold for profit and the produced water, and/or brine, is transported to and disposed of in various injection wells.

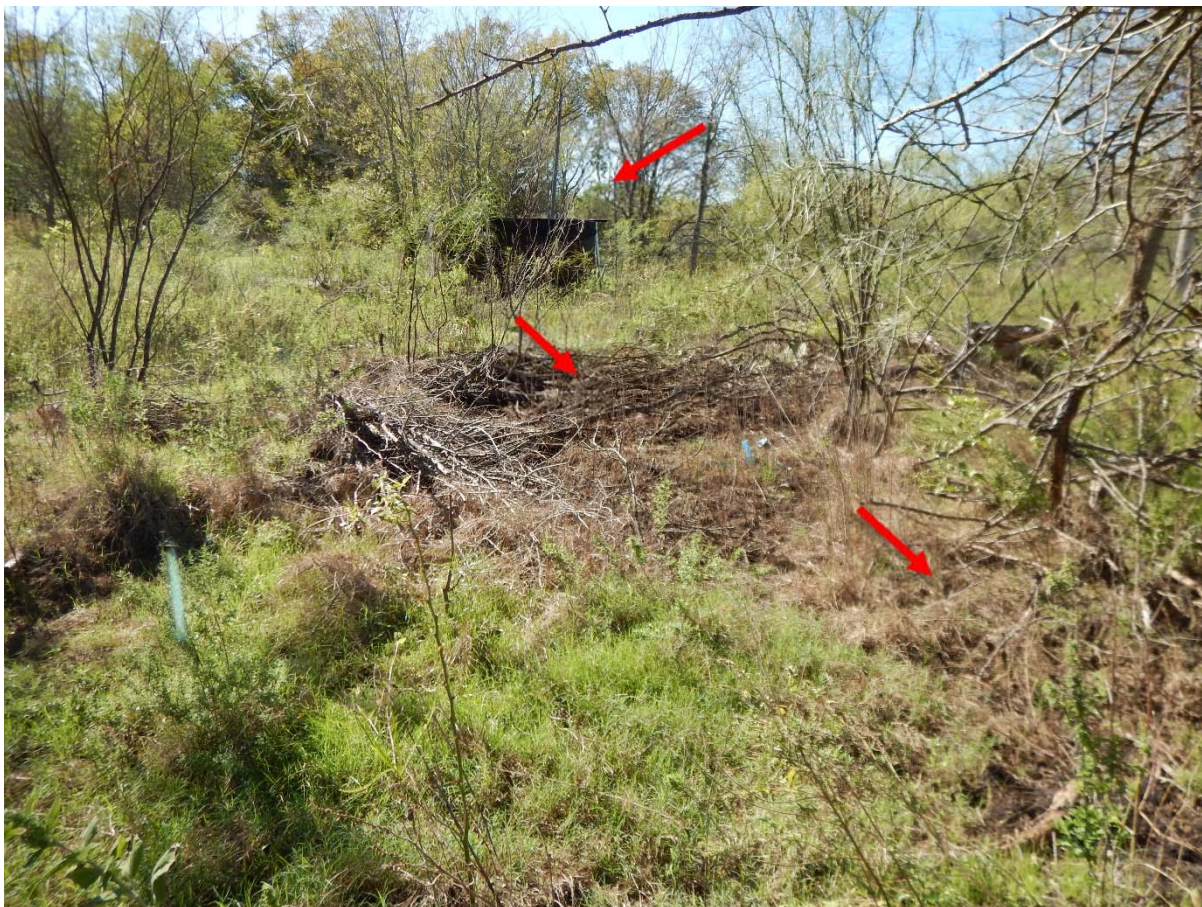
Photo No. 3

When we arrived at **Cora Malone Lease** on November 19, 2015, we observed that there was not a containment area around the tank, there was a standing pond of fluids, a flow path of fluids and dead vegetation away from the tank battery. See Photo N°3 in Appendix 1. The site showed one produced water (brine) storage tank. The tank was in-service and oil was visible on both the sides of the tank and the associated PVC flow line at the tank. There was dead vegetation around the tank. See Photo N°3 and photo N°4 in Appendix 1. The flow path of fluids was approximately 45 feet from the tank battery. It smelled strongly of hydrocarbons near the tank battery area at the time of the inspection. The tank battery is at approximately 373 feet elevation. Photo N°1 in Appendix 1

Description: This image shows the facility with one operational tank. There was not a containment area around the tank, a standing pond of fluids, a flow path of fluids and dead vegetation.

- EPA will send a copy of the inspection report to the facility and coordinate with the Rail Road Commission (RRC) or any other entity or representative that might become involved with actions at this facility about the areas of concern.
- EPA will continue to work with the facility to enable it to come into compliance with the requirements of the CWA.
- EPA will have a conference call with the facility to discuss the inspection report.
- EPA will discuss the inspection report with management to determine compliance and follow-up needs.
- EPA will refer the facility to the SPCC program.

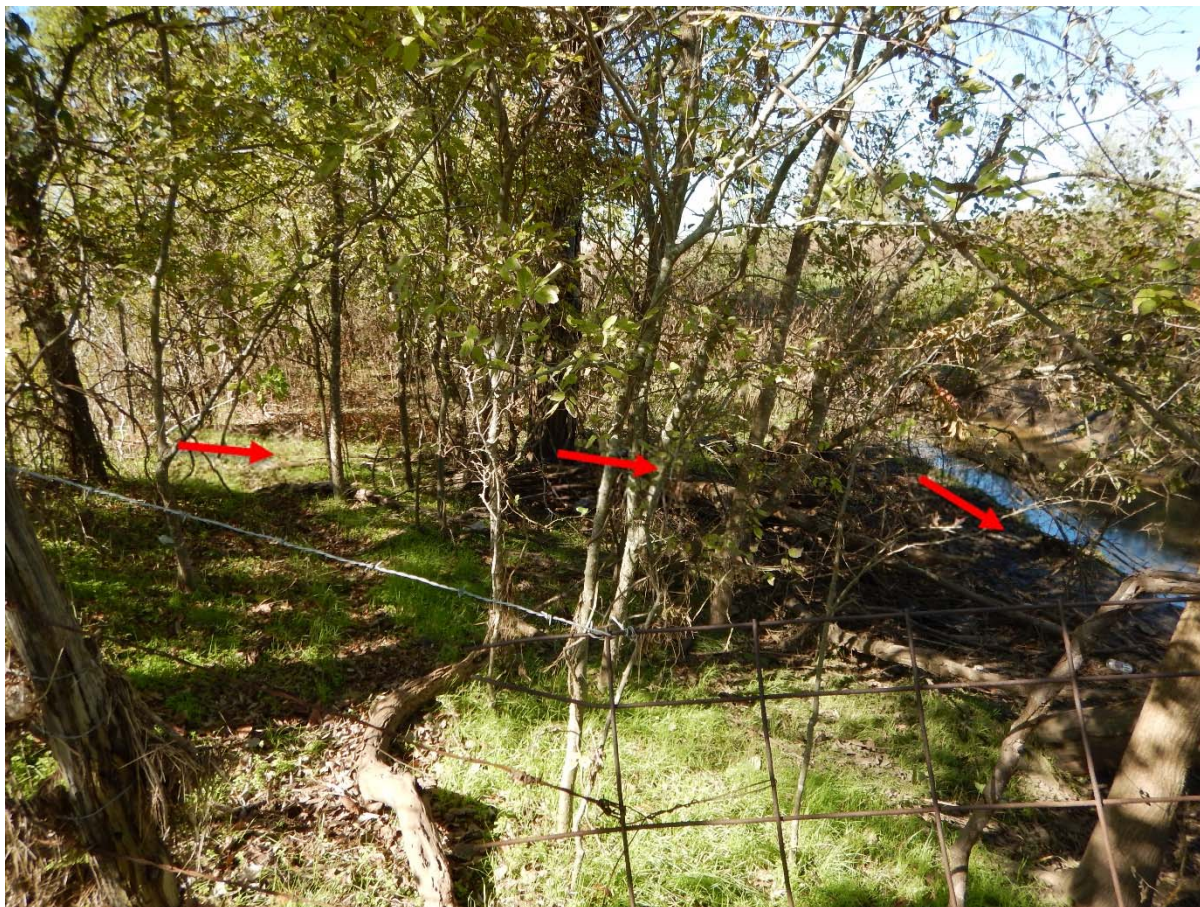
Photo No. 5

We followed the flow path southeast from the tank position, approximately 2.704 miles, to Salt Branch Creek, which is a tributary to Plum Creek, and performed different measurements to determine TSS concentrations. A calibrated YSI 30 Salinity Conductivity Meter was used to measure the Total Soluble Salts (TSS) and obtained a reading of 11,740 parts-per-million (ppm) at salt branch Creek. This is the first Point of Entry (POE) to Salt Branch Creek, approximately 427 feet from the tank, located at Latitude 29.687261 N and Longitude -97.642986 W at approximately 356 feet elevation. See Photo N°5 and

Description: This image shows the Point of Entry (POE) to Salt Branch Creek, approximately 497 feet from the tank.

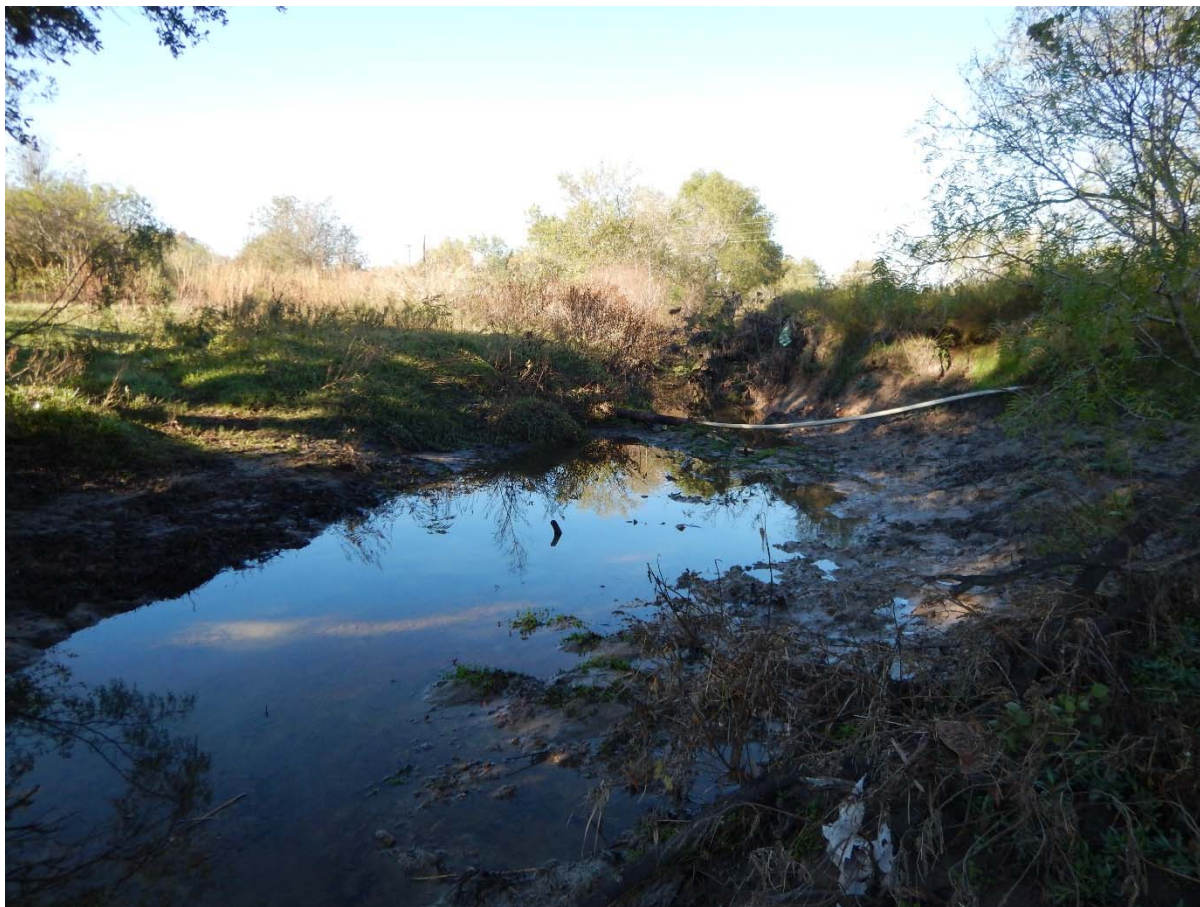
Photo No. 7

Description: This image shows Salt Branch Creek with defined bed and bank and evidence of plants growing along the tributary, evidence of sediments, debris, and plants growing along the creek.

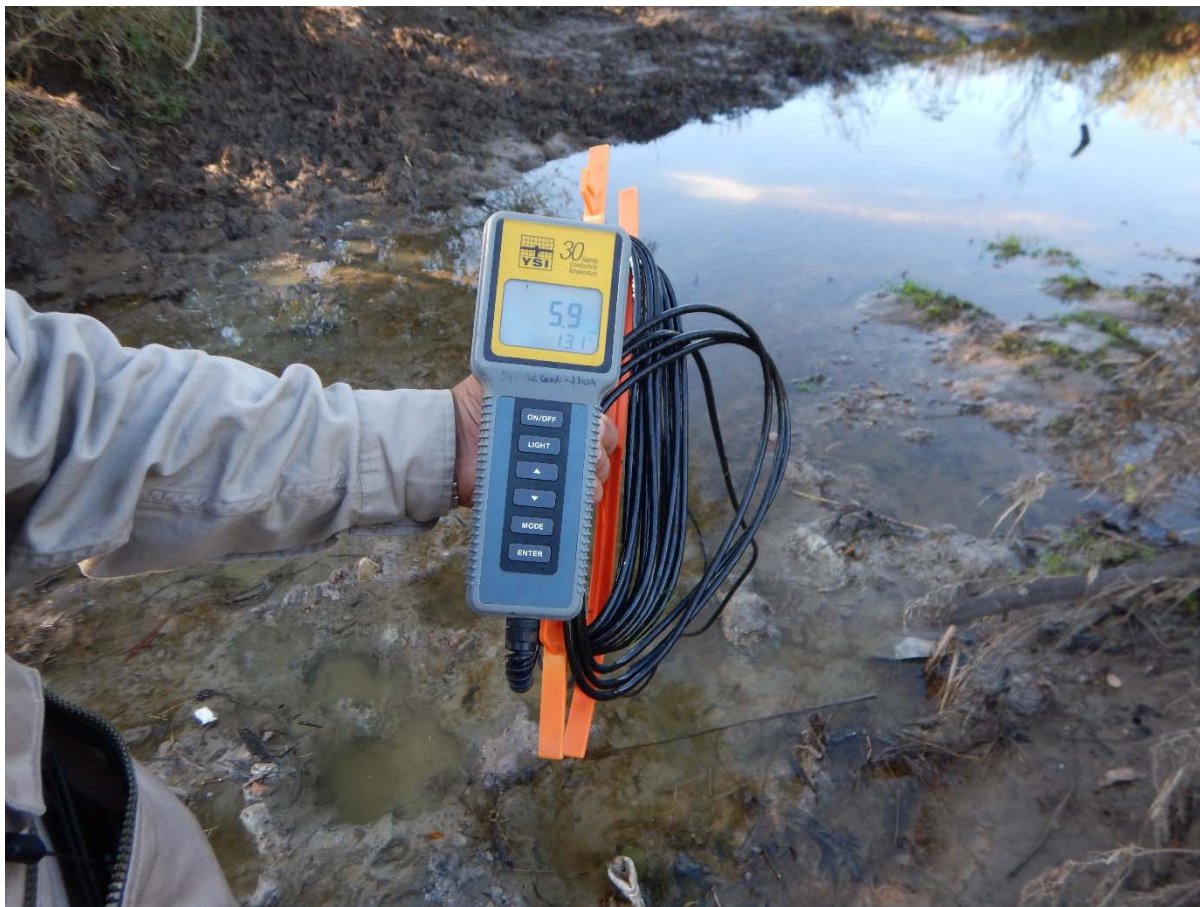
Photo No. 8

Photo N°6 in Appendix 1. Downstream, a second TSS reading of 5,900 ppm, approximately 630 feet from the tank, was obtained from Salt Branch Creek located at Latitude 29.687496 N and Longitude -97.642431 W. See Photo N°8 in Appendix 1. At this point, the creek shows a defined bed and bank and evidence of plants growing along the tributary, evidence of sediments, debris, and plants growing along the creek. Salt Branch Creek was approximately 4 feet deep and approximately 35 feet wide. See Photo N°7 and Photo N°9 in Appendix 1. At approximately 1.030 feet distance downstream from the first POE, we obtained a third TSS reading of 1,300 ppm at Latitude 29.687275 N and Longitude -97.639888 W at approximately 356 feet elevation. See Photo N°10 in Appendix 1. At approximately 1.26 miles distance downstream from the first POE, we obtained a fourth TSS reading of 900 ppm at Latitude 29.686192 N and -97.628506 W at approximately 338 feet elevation. See Photo N°11 in Appendix 1. At approximately 2.556 miles distance downstream from the first POE, we obtained a fifth TSS reading of 700 ppm at Latitude 29.676527 N and -97.624766 W at approximately 332 feet elevation. See Photo N°12 in Appendix 1. At this location Salt Branch Creek, which is a tributary of Plum Creek, was approximately 3 feet deep and approximately 55 feet wide. See Photo N° 12 in Appendix 1.

Description: This image shows a second TSS reading of 5,900 ppm, approximately 630 feet from the tank, obtained downstream from Salt Branch Creek.

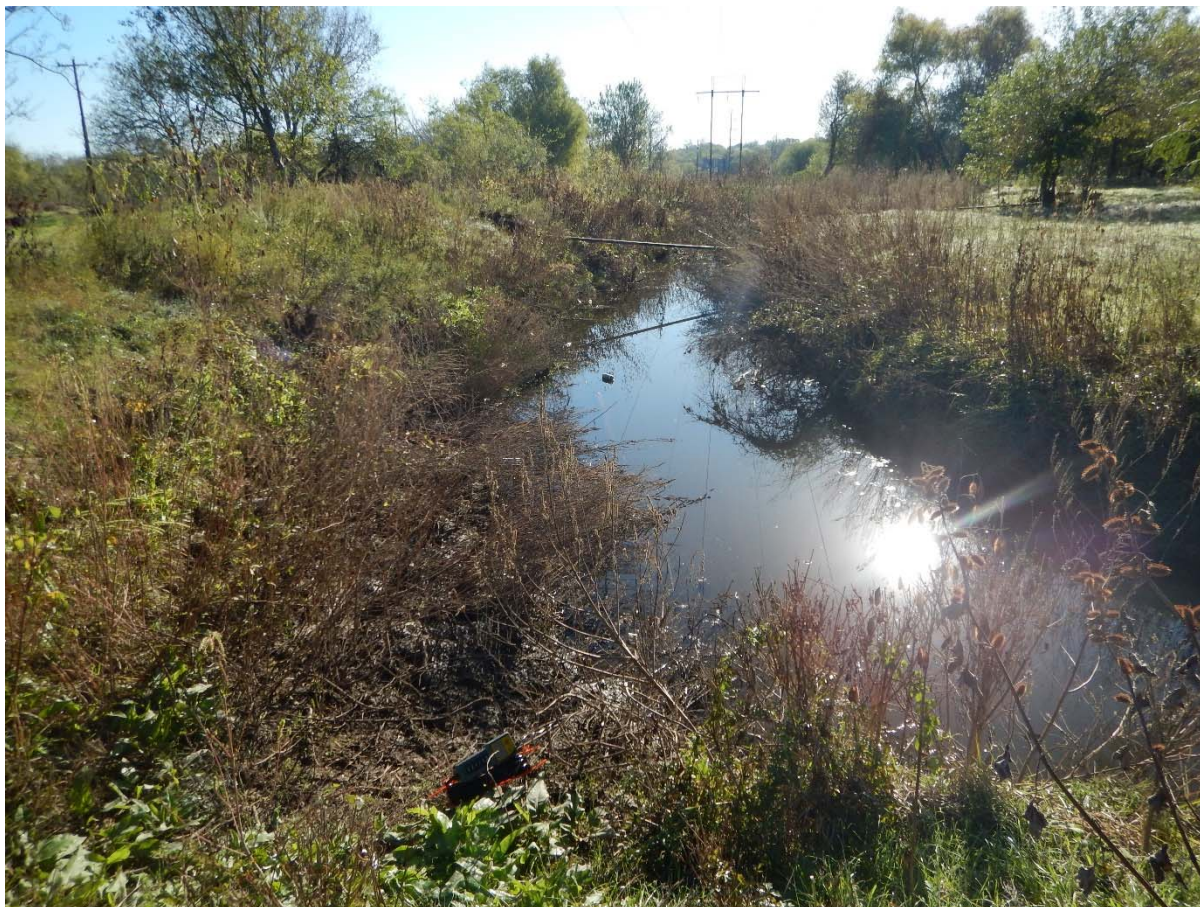
Photo No. 9

Description: This image shows the creek with a defined bed and bank, evidence of plants growing along the tributary, evidence of sediments, debris, and plants growing along the creek. The creek is approximately 35 feet wide by 4 feet deep.

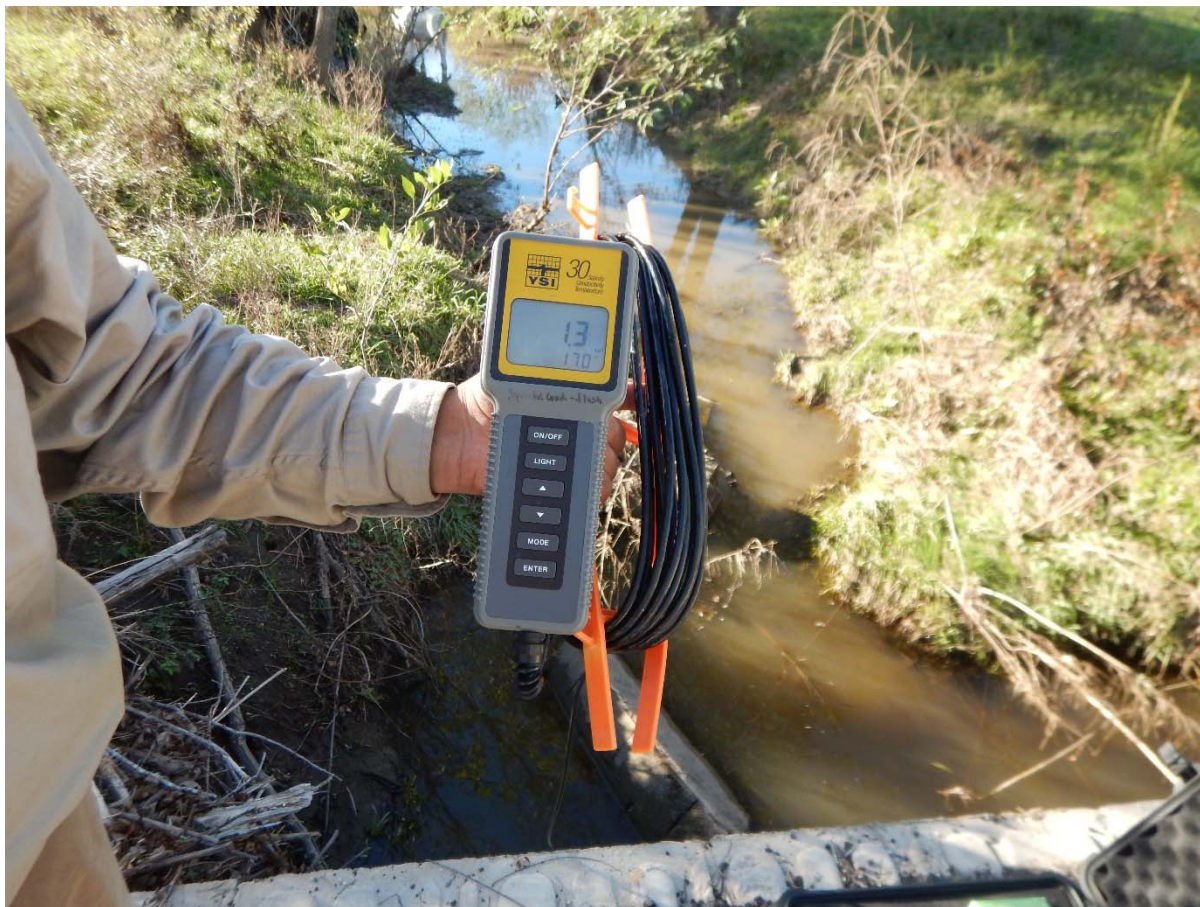
Photo No. 10

Description: This image shows, at approximately 1.030 feet downstream from the first POE, a third TSS reading of 1,300 ppm.

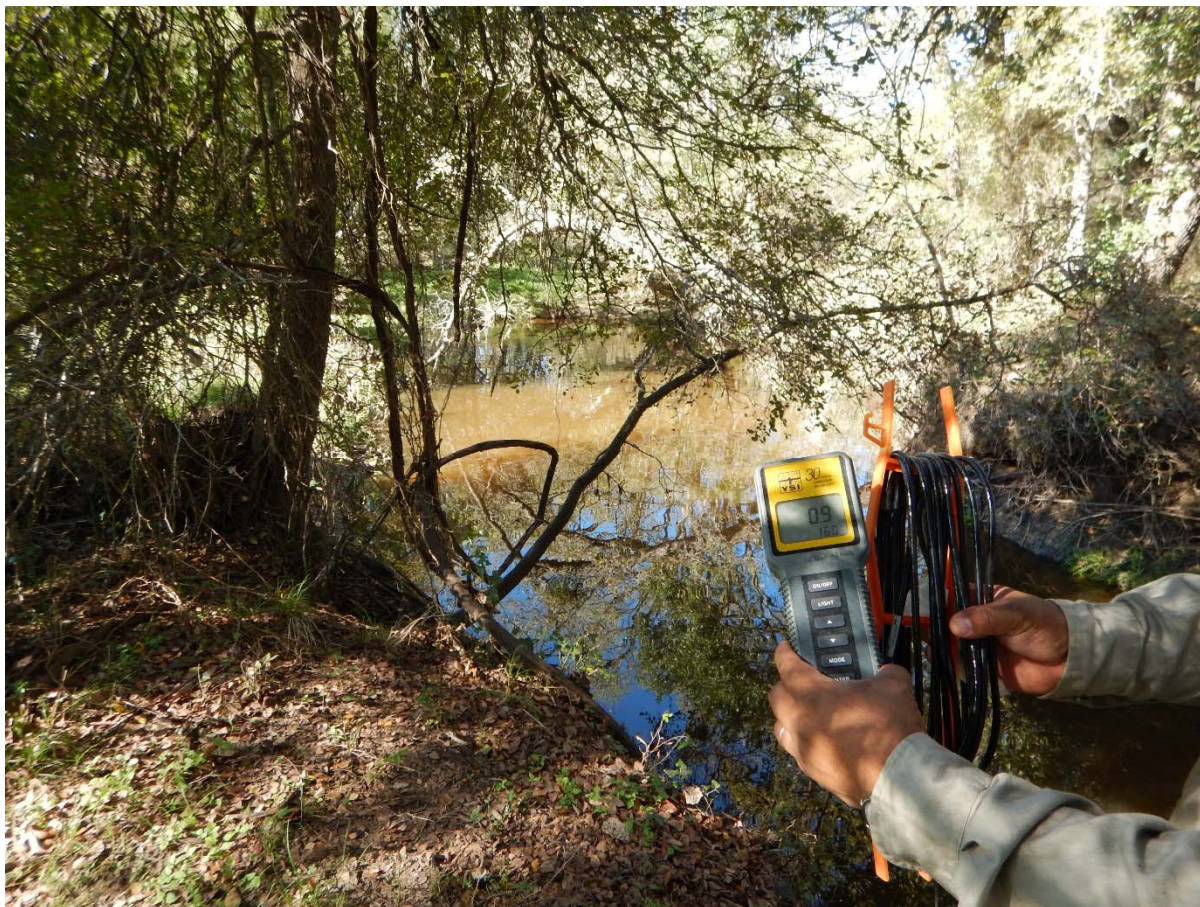
Photo No. 11

Description: This image shows a at approximately 1.26 miles downstream from the first POE, a fourth TSS reading of 900 ppm

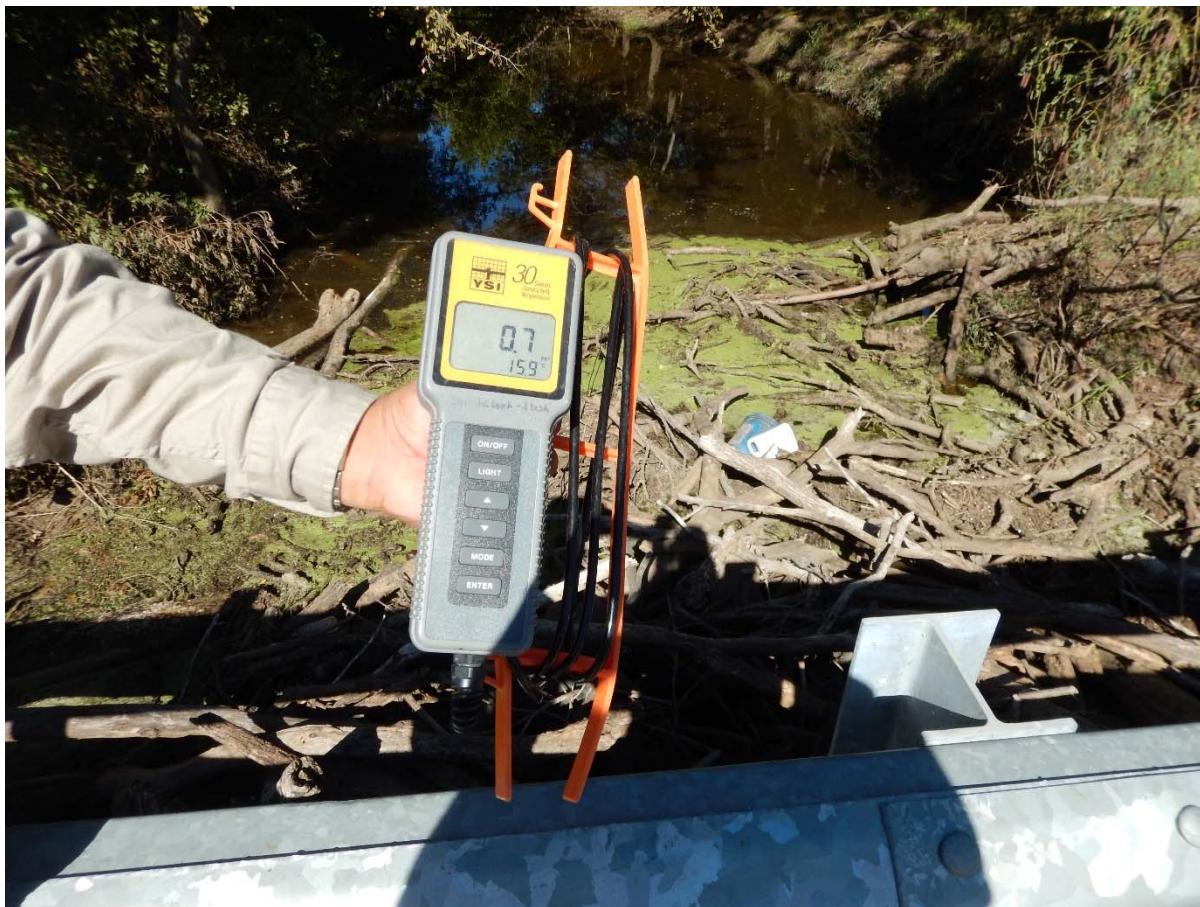
Photo No. 12

Description: This image shows, at approximately 2.556 miles downstream from the first POE, a fifth TSS reading of 700 ppm.

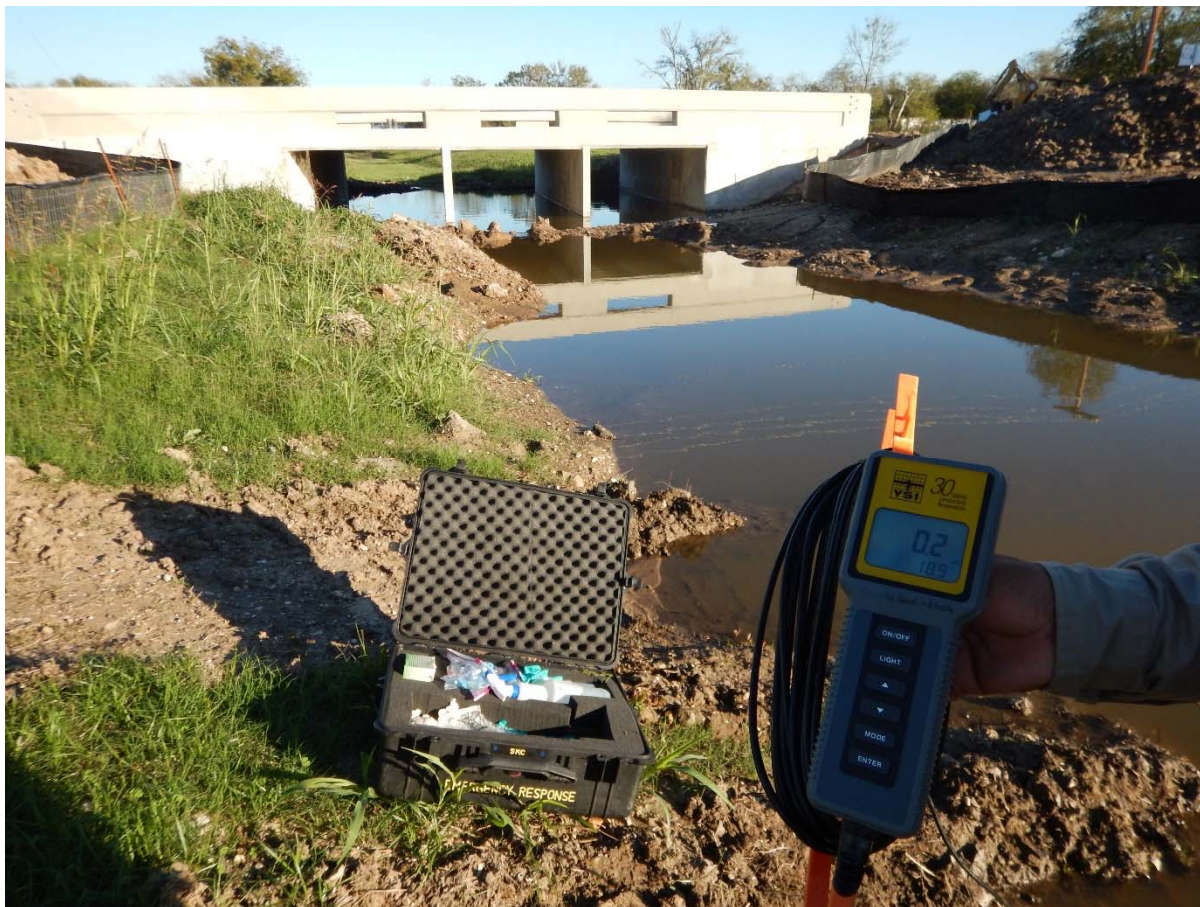
Photo No. 13

We measured the TSS to determine water quality data, such as water quality in the area. Therefore at approximately 0.49 miles upstream from the first POE, we measured the TSS and obtained a reading of 200 ppm at Latitude 29.687389 N and Longitude -97.650809 W. See Photo N°13 in Appendix 1.

Description: This image shows at approximately 0.49 miles upstream from the first POE, a TSS reading of 200 ppm. This is a background measurement upstream of Salt Branch Creek.
