Re: Reconnaissance Inspection Report, NPDES Permit No. NC0054992  
Cherokee Trout Farm at Morgan Mill

| | <p align="center"> <b>United States Environmental Protection Agency</b><br/> <b>Region 4</b><br/> <b>CV-NC0054992-5-10-2022</b> </p> | | | |
| | <p align="center"> <b>Reconnaissance Inspection Report</b> </p> | | | |

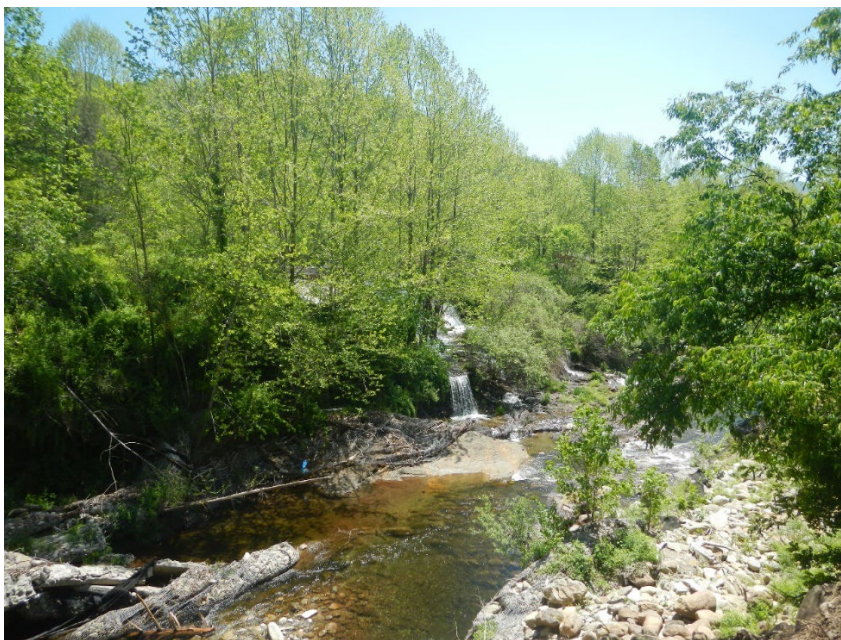
The discharge from the facility was from the intake structure as seen in Figures 1-4. EPA observed that the water had no contact with any trout ponds before being discharged to the Raven Fork River.

*Figure 1. Discharge from the facility as seen from upstream on opposite shore of the Raven Fork River (Receiving stream).*

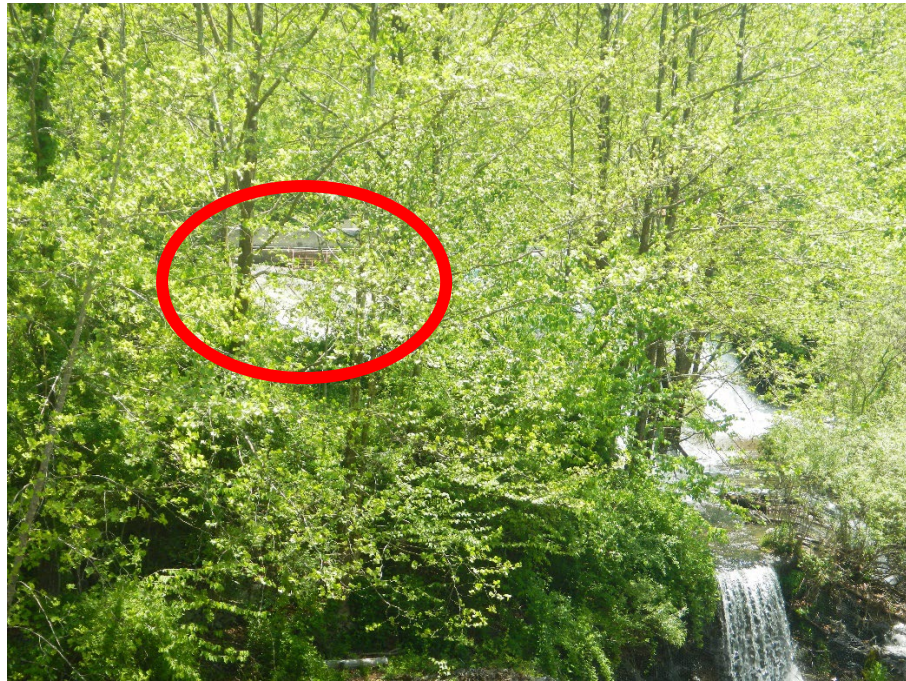
*Figure 2. Same view as Figure 1 but zoomed in. Facility structures visible behind trees (red circle).*

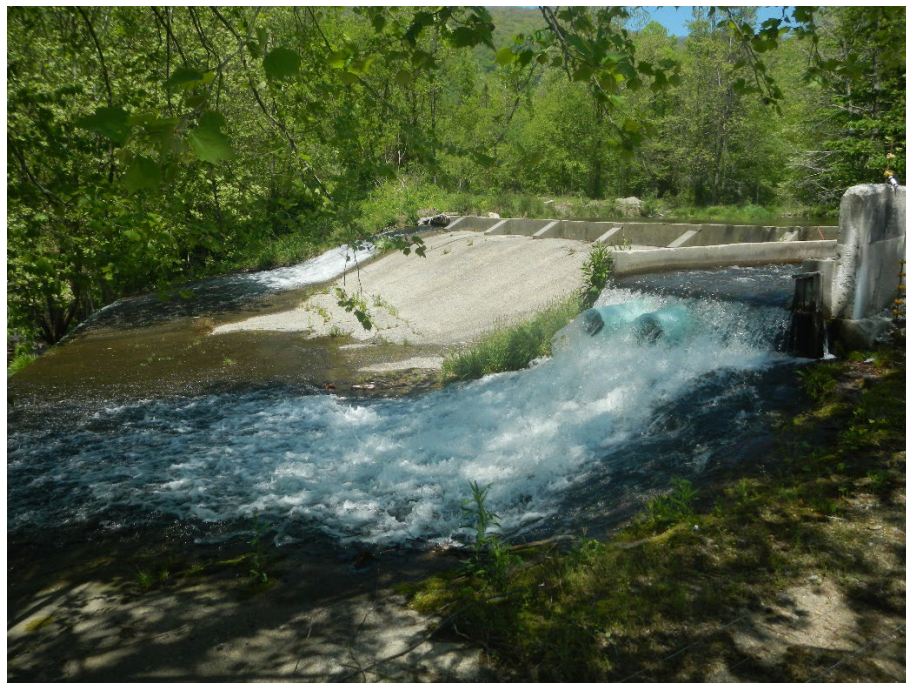
*Figure 3. Facility water intake structure. Overflow seen is source of new discharge. This water has no contact with any trout ponds.*

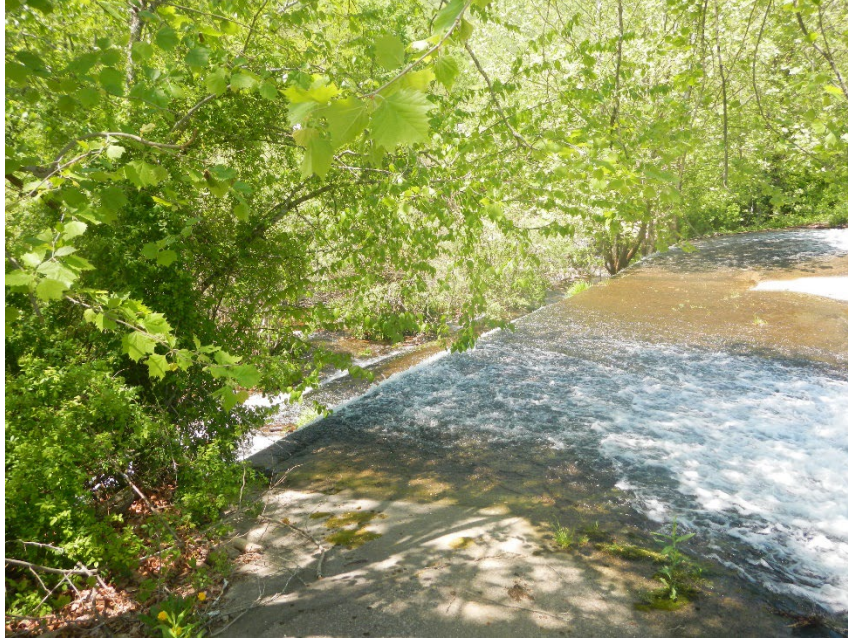
*Figure 4. View of discharge entering Raven Fork River from the facility. Cascades shown are the same as visible in Figure 1.*
