**Region 6 - Enforcement & Compliance Assurance Division**  
**INSPECTION REPORT**

| Company Name: | <b>Corley Trust, LLC</b> | |
| Facility Name: | <b>Wilson #7 SWD Tank Battery</b> | |

EPA Region 6 inspector Kerri McCabe (lead) arrived at the Corley Trust, LLC / Wilson #7 SWD Tank Battery (“facility”), at 0945 on 11/08/2024 for an unannounced follow-up inspection. The facility is located from Highway 7 N, then right onto Hwy 7B, right onto Gas Plant Rd, continuing left on Gas Plant Rd, and left onto an oil lease road at 33.353841, -92.692327. No facility representatives were present at the time of the inspection. The inspection was conducted by the authority of the Clean Water Act (CWA) to determine compliance with Environmental Protection Agency (EPA) regulations. There were no other federal, state, or local agency representatives present at the time of the inspection. The facility was originally inspected by Inspector Uma Lad on 10/07/2024.

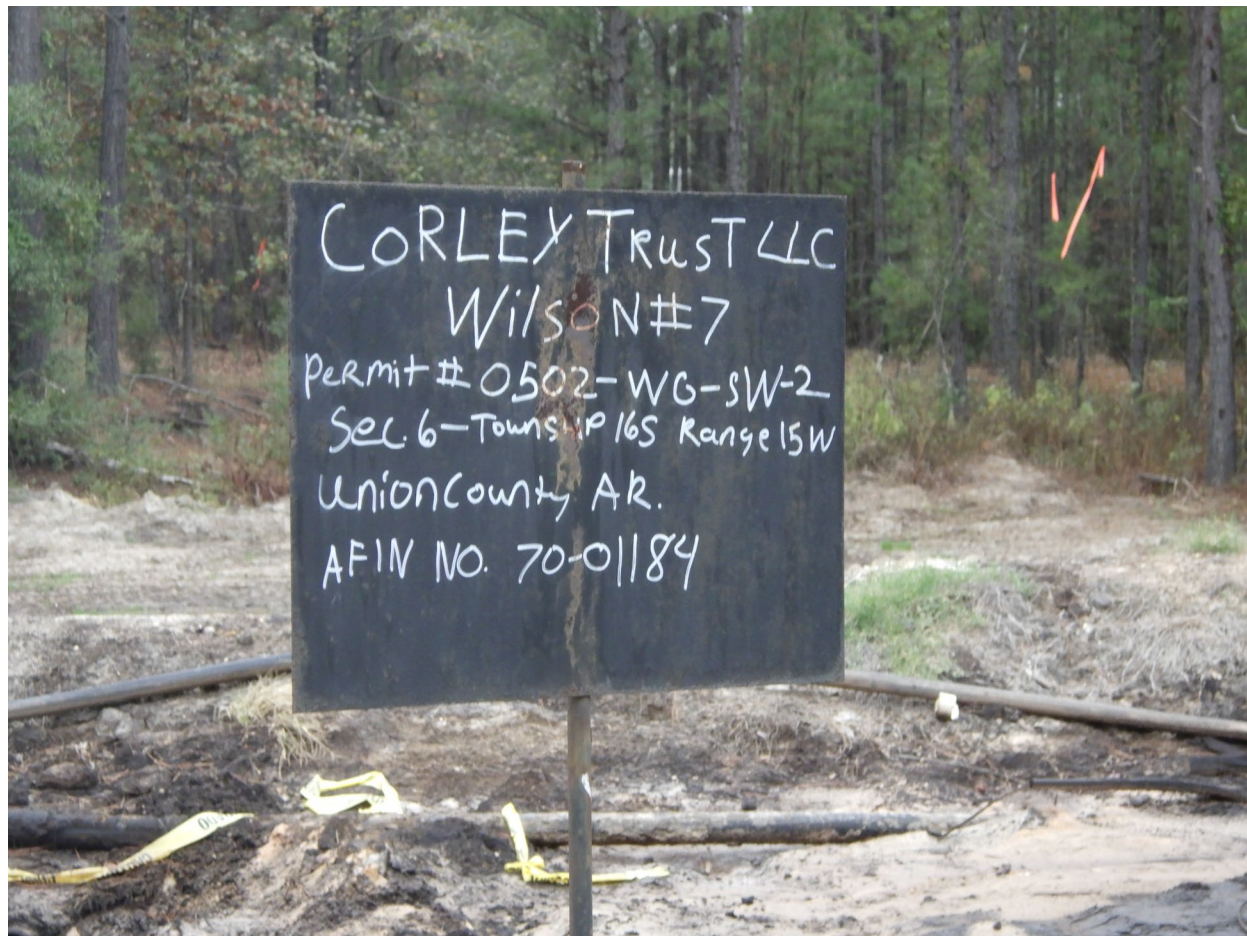
Photo No. 1

**Description:** Looking NNE, this photo shows the signage at the Wilson #7 Saltwater Disposal (SWD) well tank battery ("facility").

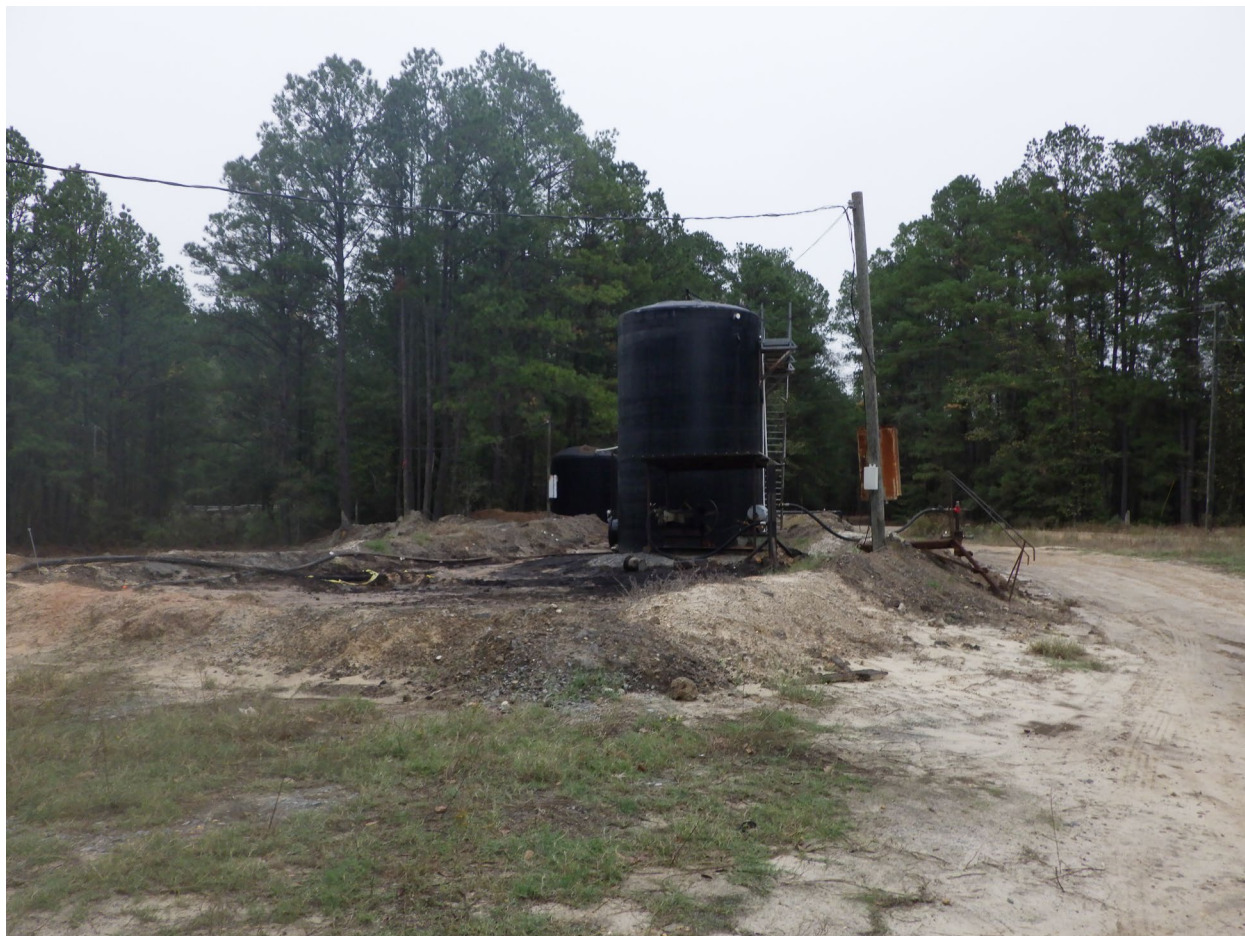
Photo No. 2

I observed the Corley Trust, LLC / Wilson #7 SWD Tank Battery facility, signage, and associated secondary containment, storage tanks, separators/treaters, production well, and saltwater disposal (SWD) well; see Appendix 1 (Photograph Log), Photo No. 1 and No. 2. For additional GPS location and photo metadata, see Appendix 1.

**Description:** Looking ENE, this photo shows an overview of the facility.

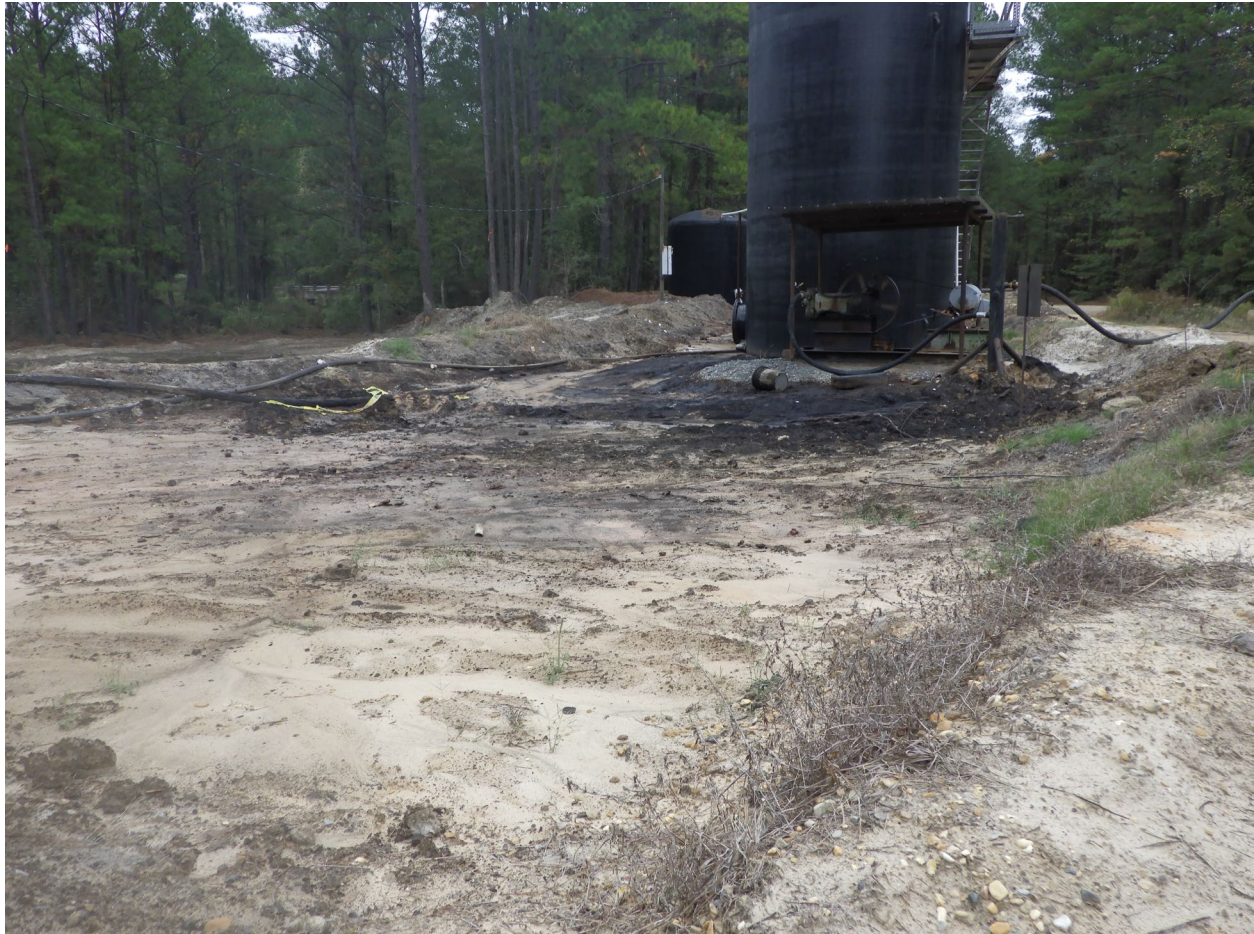
Photo No. 3

I observed loose oil inside secondary containment, see Photo No. 3, No. 4, and No. 12.

**Description:** Looking ENE, this photo shows loose oil inside secondary containment at the facility.

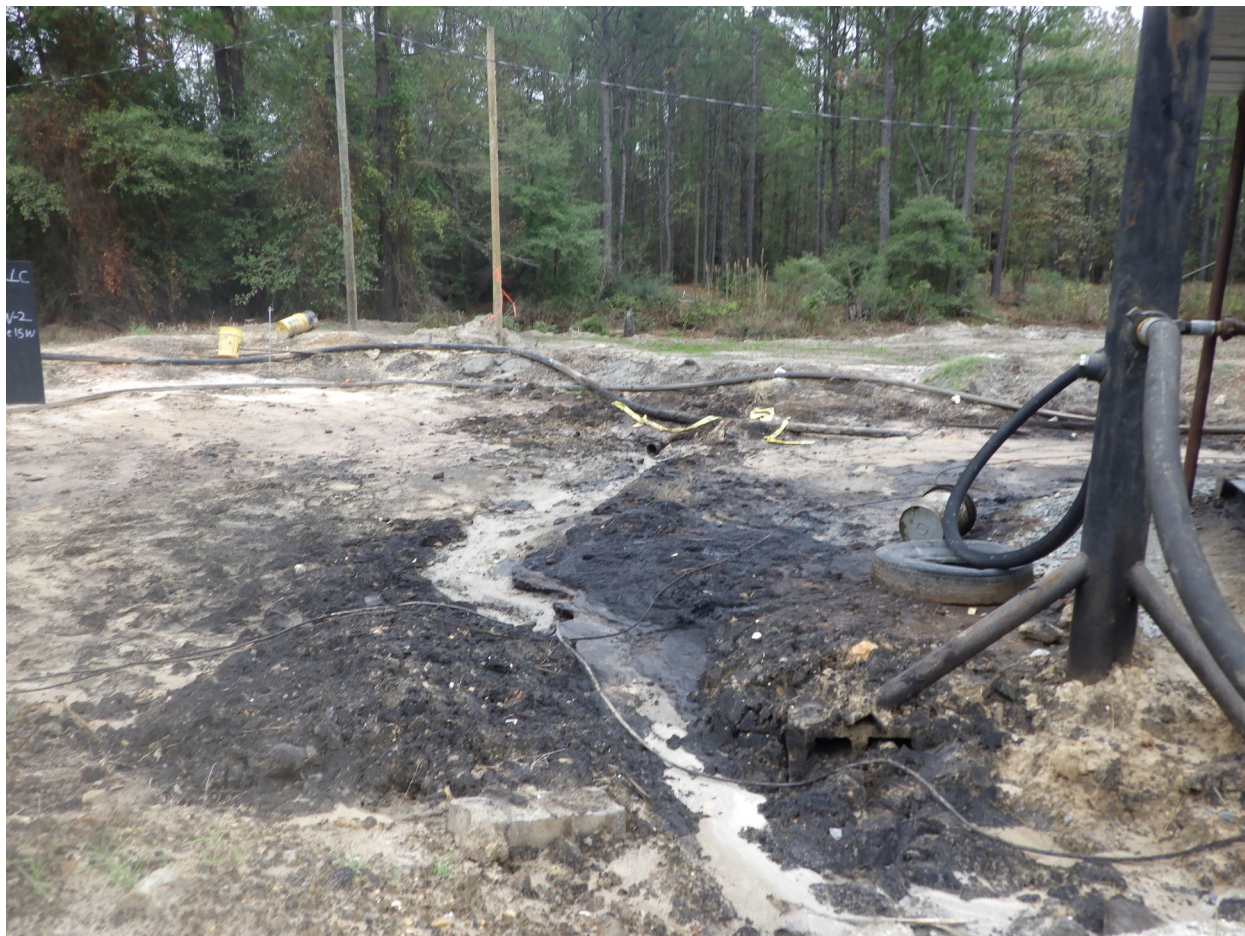
Photo No. 4

**Description:** Looking NNW, this photo shows the flowpath to the drainpipe inside secondary containment at the facility.

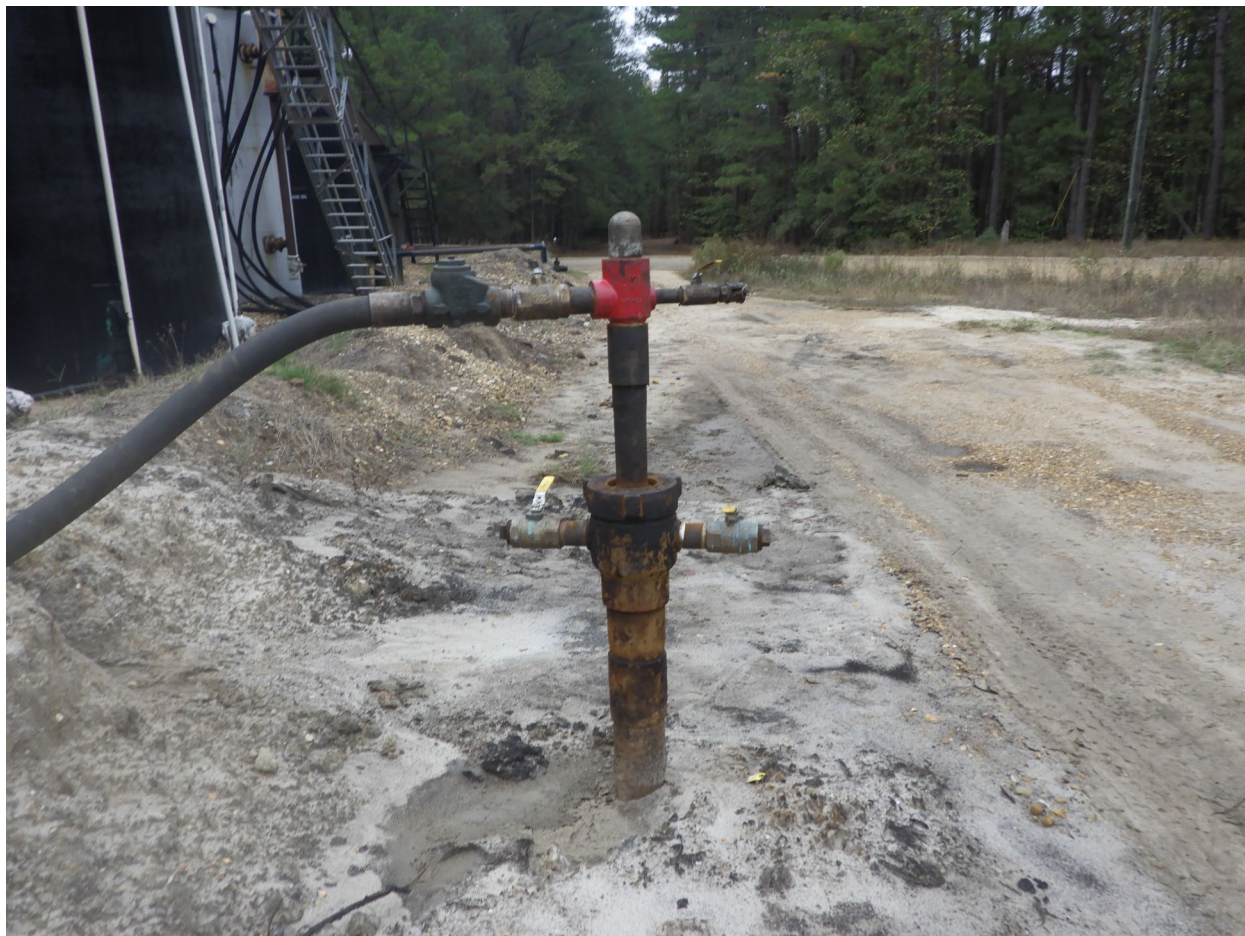
Photo No. 5

I observed the SWD well (Wilson #7), see Photo No. 5.

**Description:** Looking NE, this photo shows the Wilson #7 SWD well located at the facility.

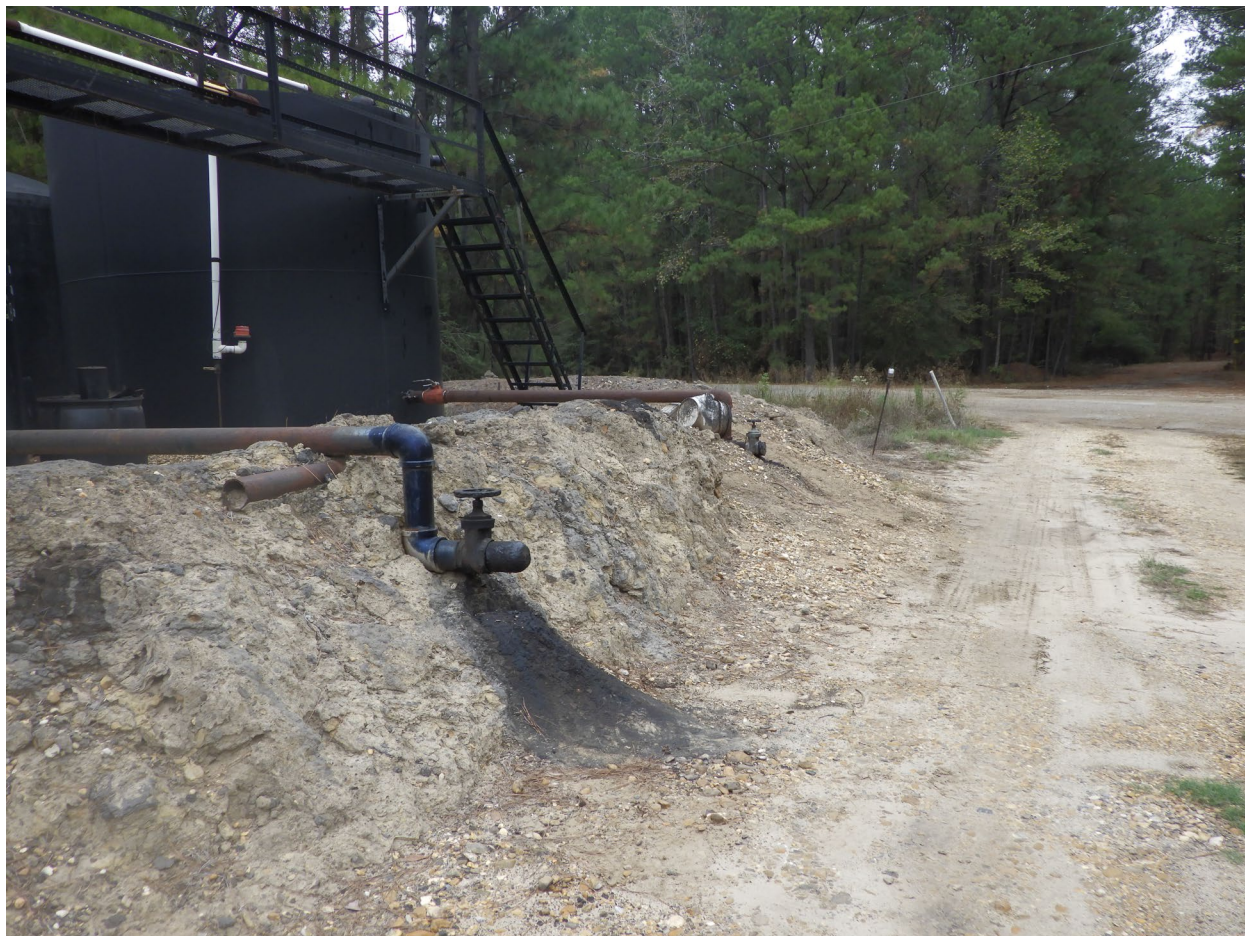
I observed transfer pipes outside secondary containment without catchment buckets and loose oil on the ground around the pipes, see Photo No. 6 through No. 8.

**Description:** Looking NE, this photo shows the front view of the facility with transfer pipes lacking catchment buckets and loose oil on the ground outside the secondary containment.

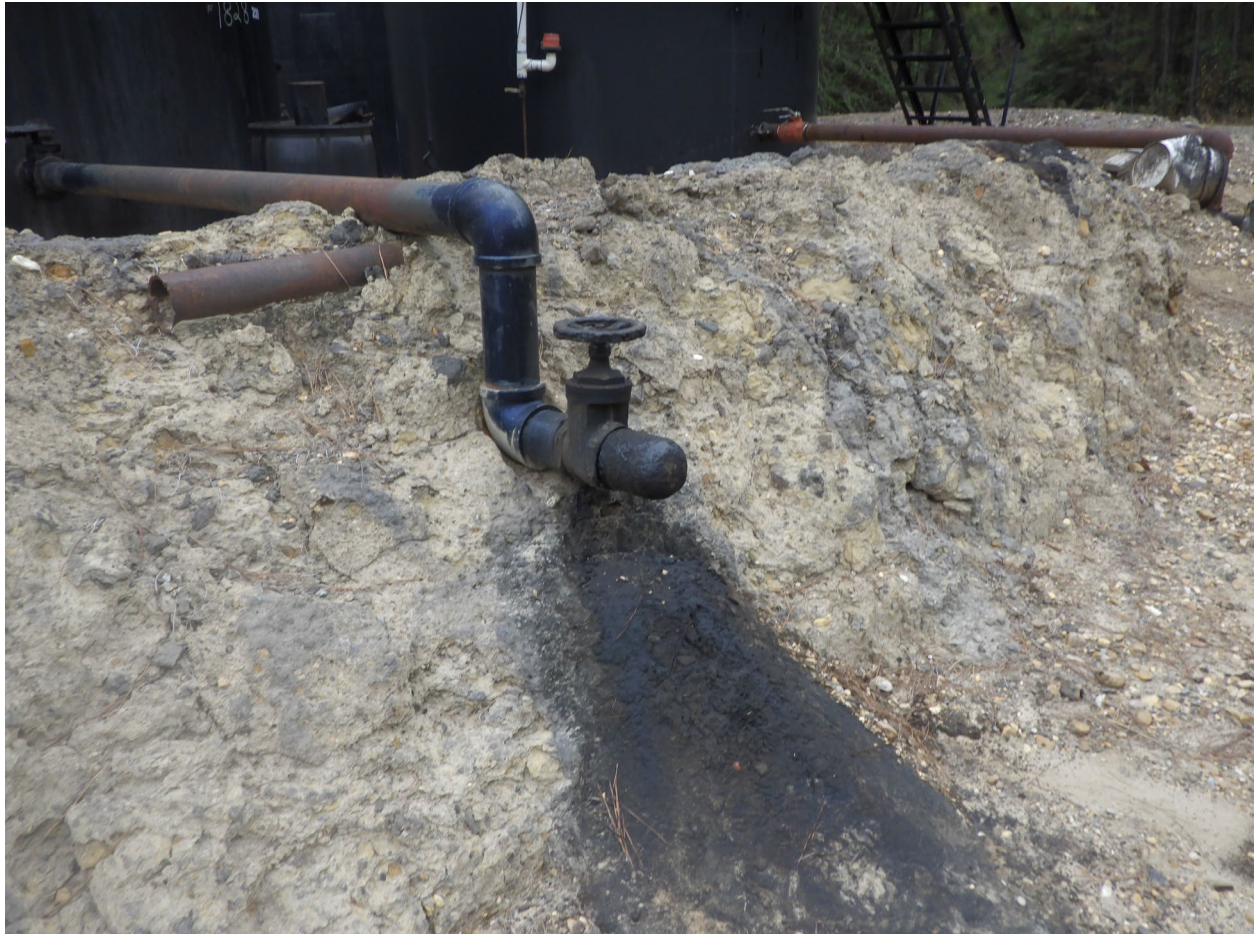
Photo No. 7

**Description:** Looking NNE, this photo shows one of two transfer pipes without catchment bucket and loose oil outside secondary containment.

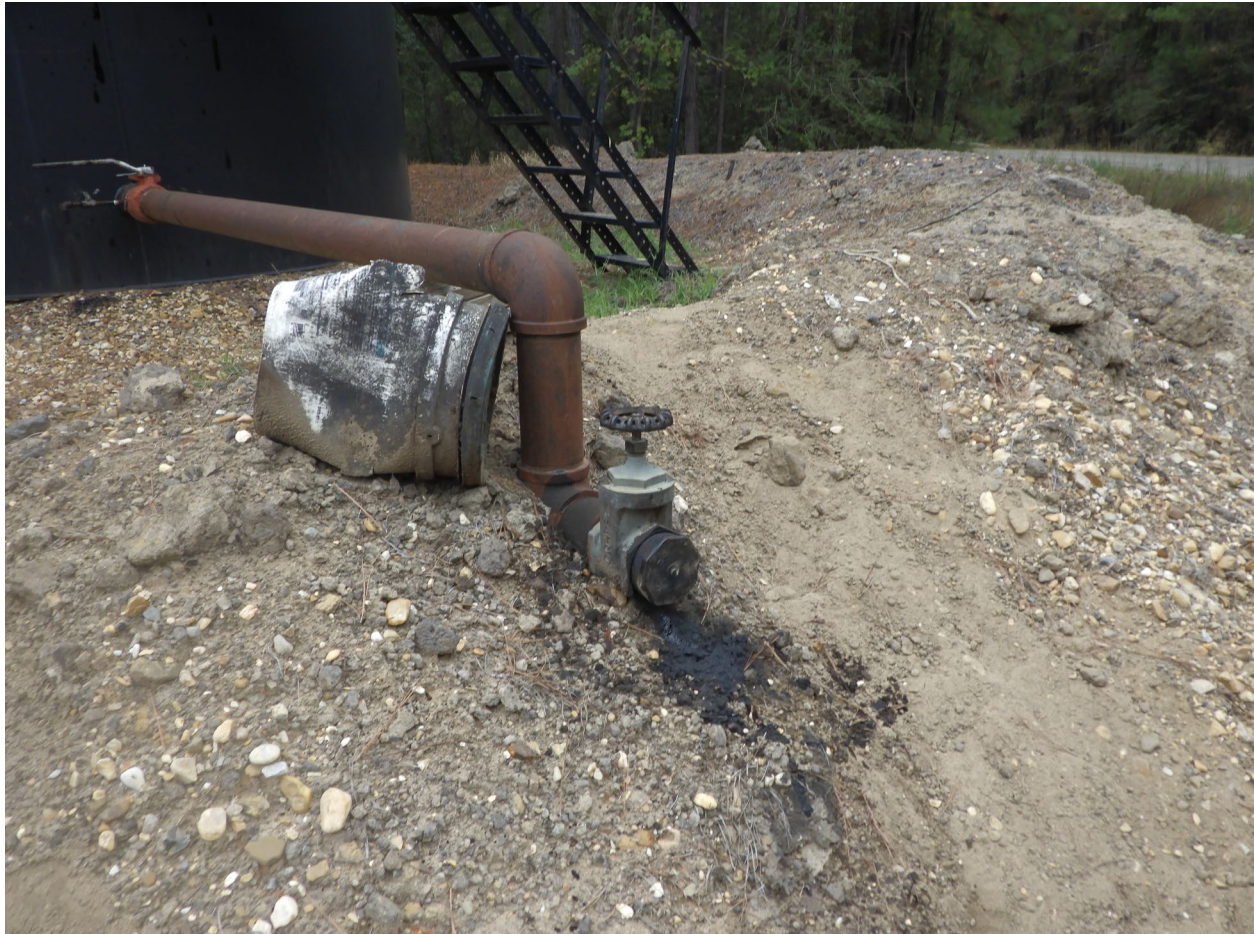
Photo No. 8

**Description:** Looking NNE, this photo shows two of two transfer pipes without catchment bucket and loose oil outside secondary containment.

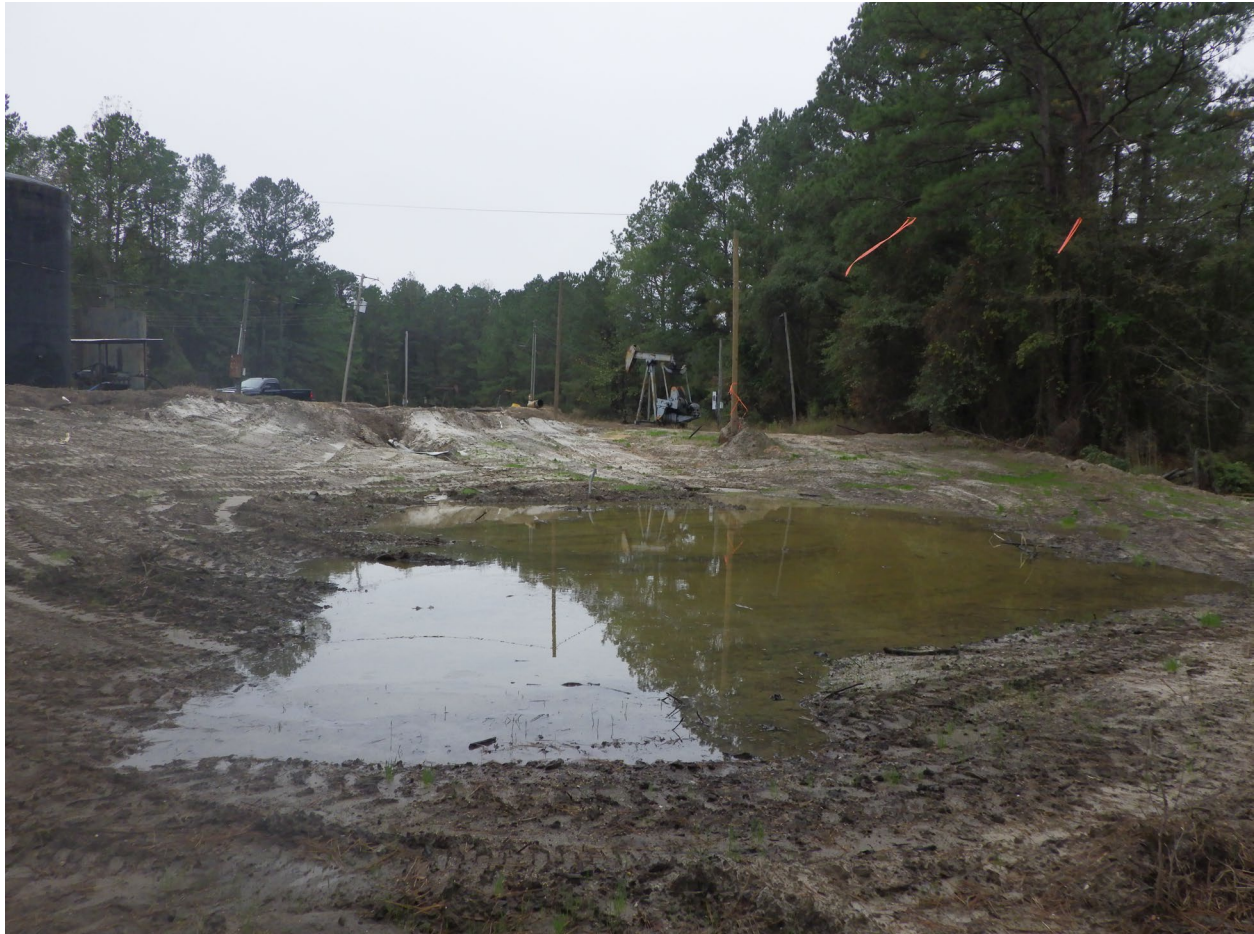
Photo No. 9

I observed the area of the workover pit that was identified from the 10/07/2024 inspection, see Photo No. 9, No. 10, No. 13, and No. 14.

**Description:** Looking S, this photo shows the closure of a workover pit that was identified at the facility during the 10/07/2024 inspection conducted by Inspector Uma Lad.

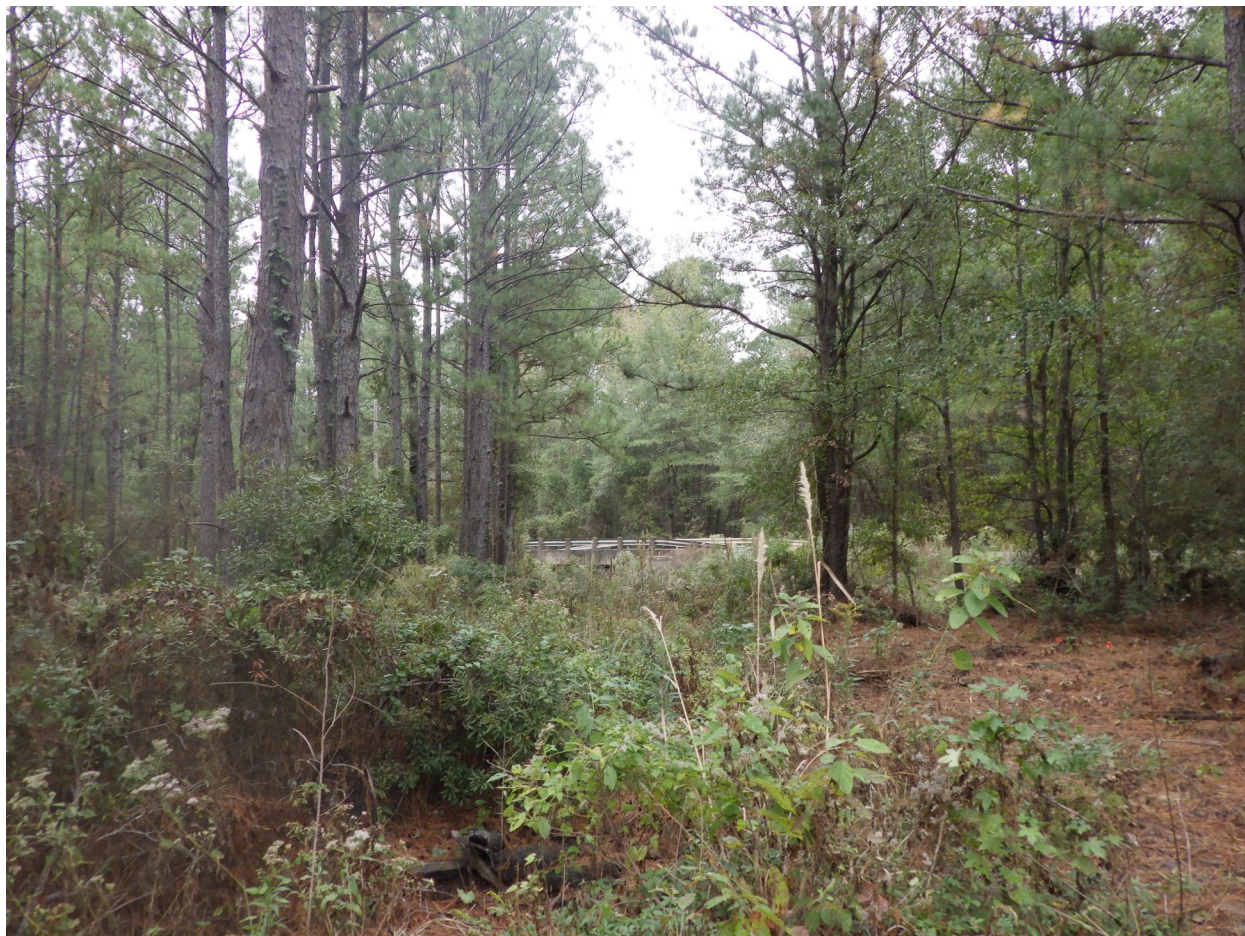
Photo No. 10

**Description:** Looking ENE, this photo shows the bridge (background) at Gas Plant Rd that crosses Holmes Creek, which is adjacent to the facility.

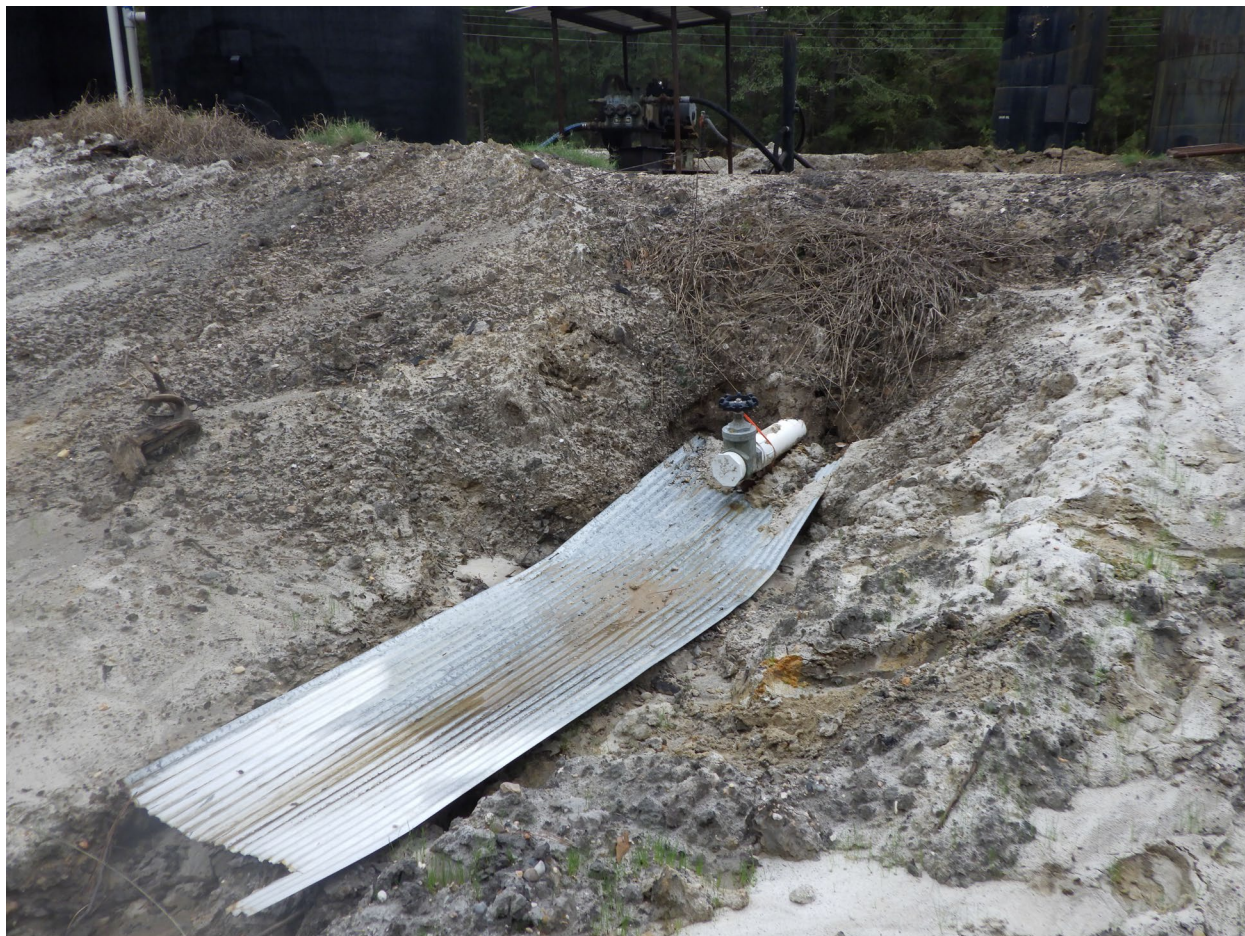
Photo No. 11

I observed the drainpipe for secondary containment with a cap and closed valve, see Photo No. 11.

**Description:** Looking ENE, this photo shows the drainpipe for secondary containment; the valve was closed and capped.

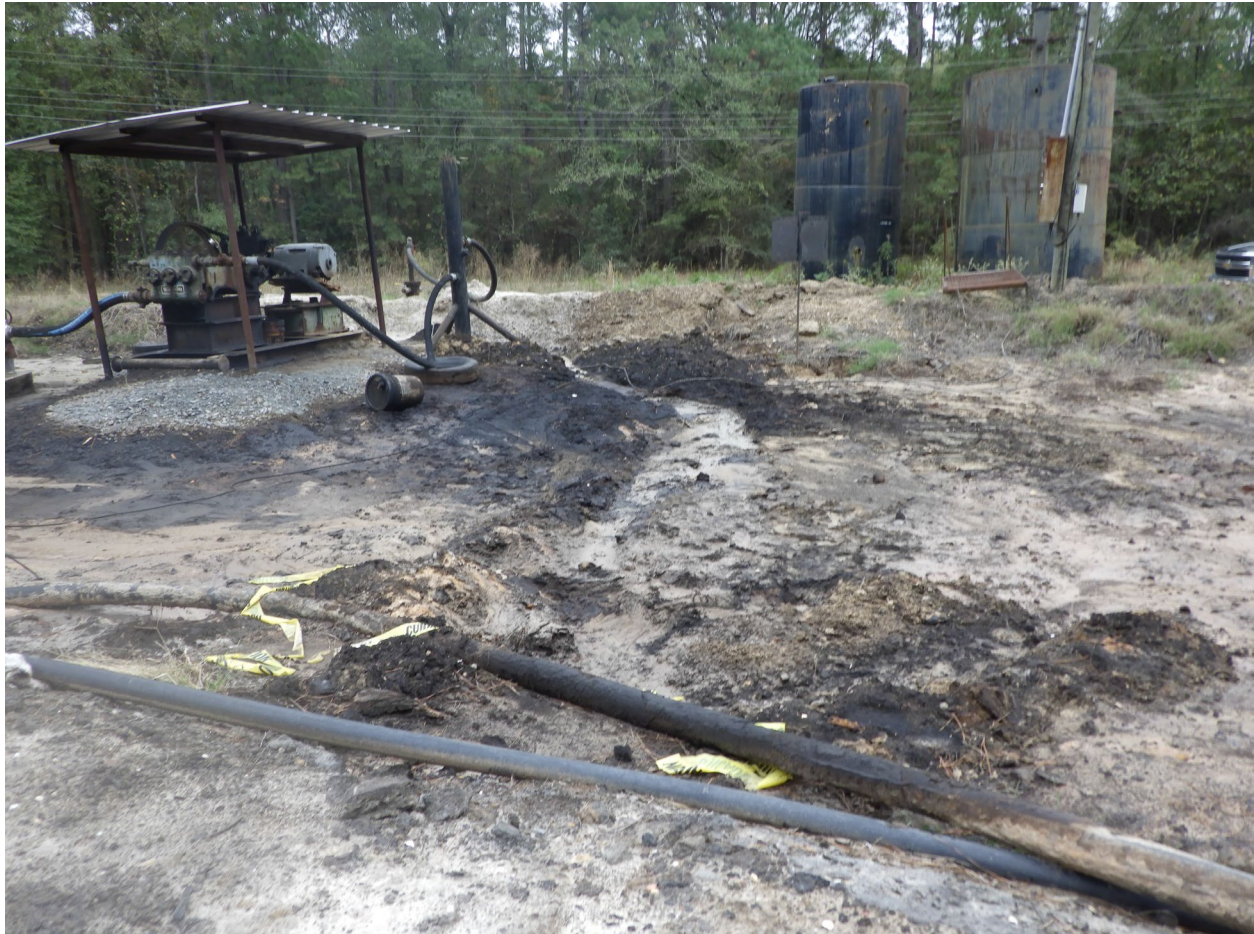
Photo No. 12

**Description:** Looking ESE, this photo shows the pump for the SWD, loose oil, and flow indicators inside secondary containment.

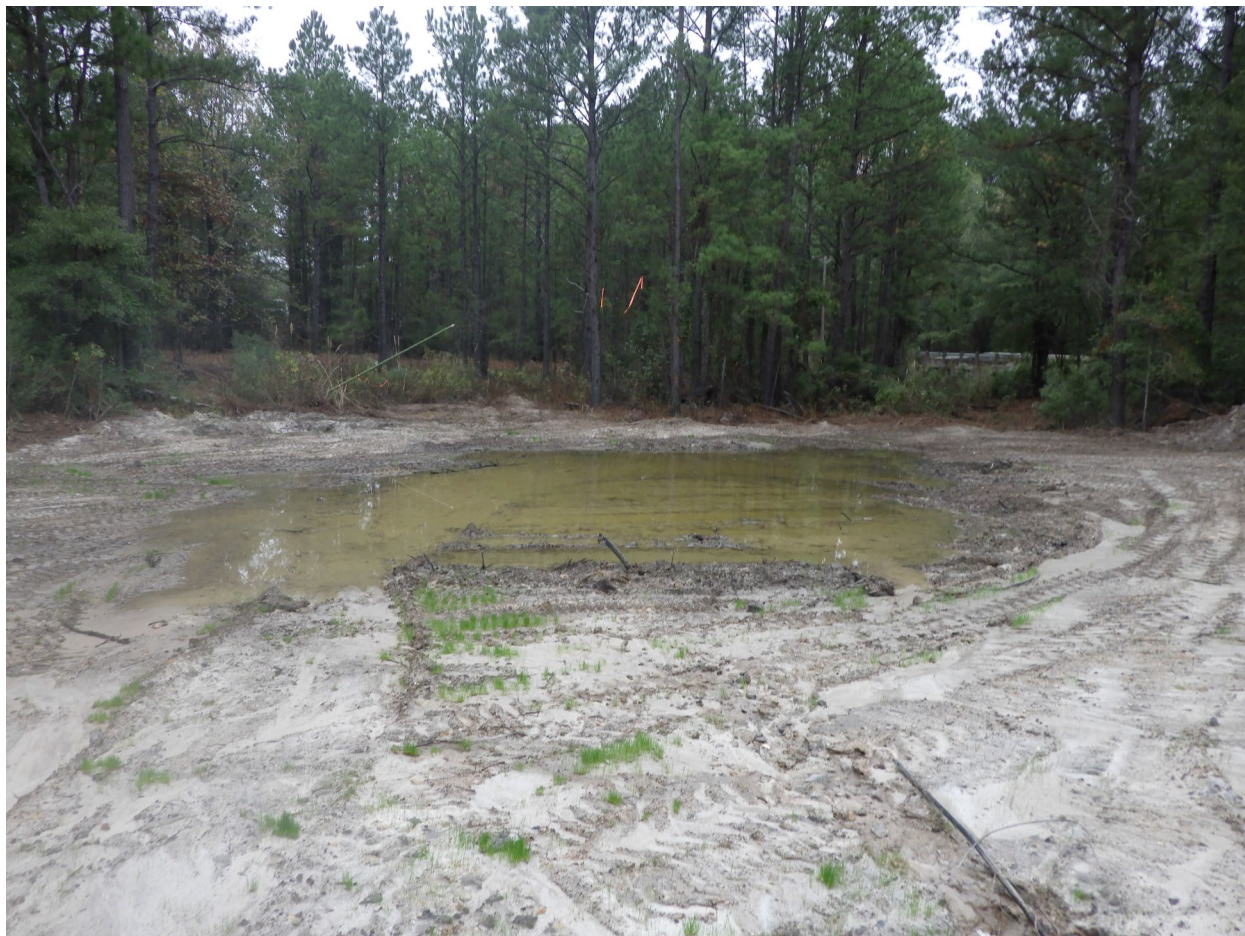
Photo No. 13

**Description:** Looking NE, this photo shows an additional view of the area where a workover pit was located during the 10/07/2024 inspection of the facility

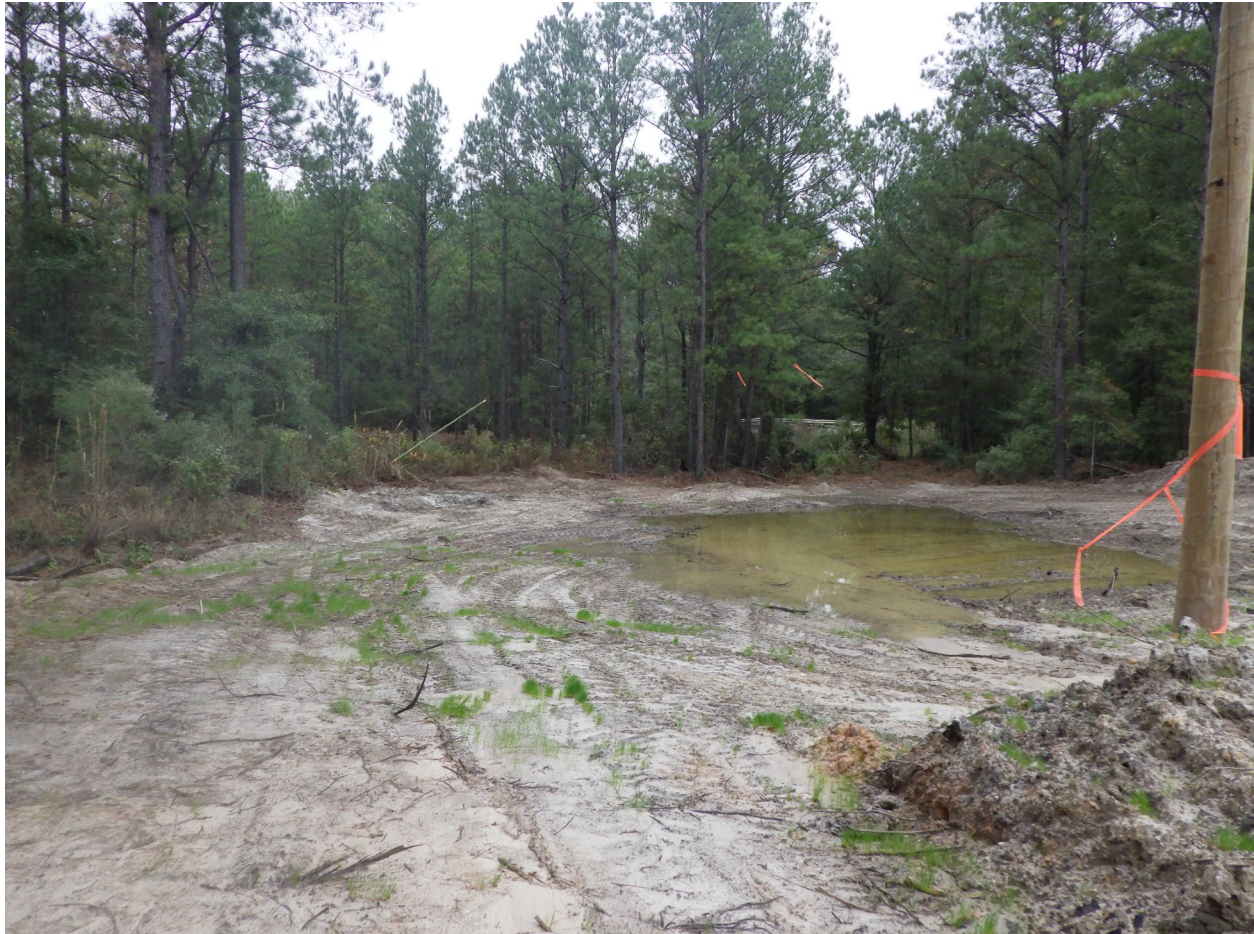
Photo No. 14

**Description:** Looking NE, this photo shows the area from Photo No. 13 that has been covered, grated, and seeded. Emerging seedlings were noted at the time of the inspection.

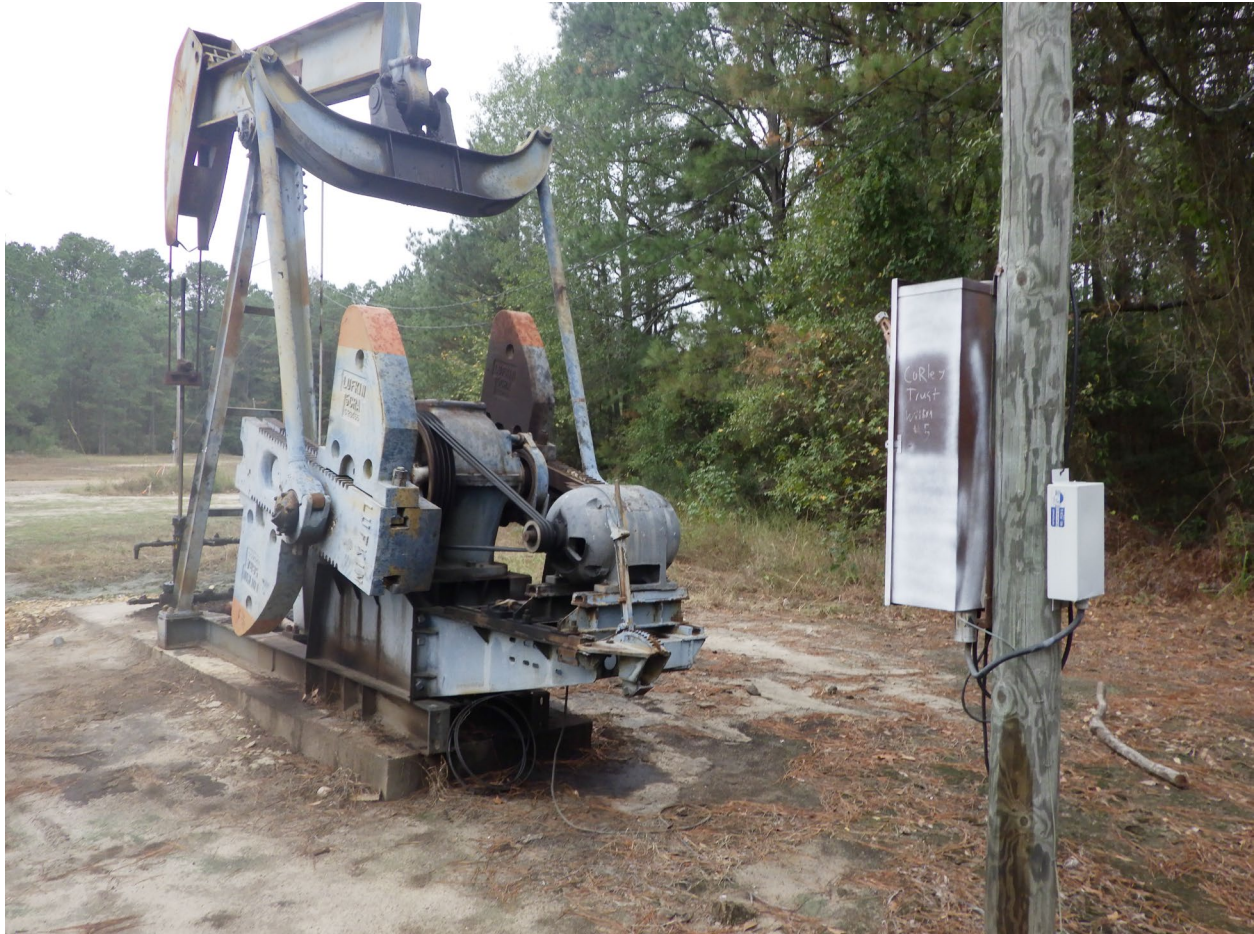
Photo No. 15

I observed a production well (Wilson #5) with minor residual oil staining on the ground, see Photo No. 15.

**Description:** Looking S, this photo shows the Wilson #5 production well located at the facility; residual oil staining noted during the inspection.

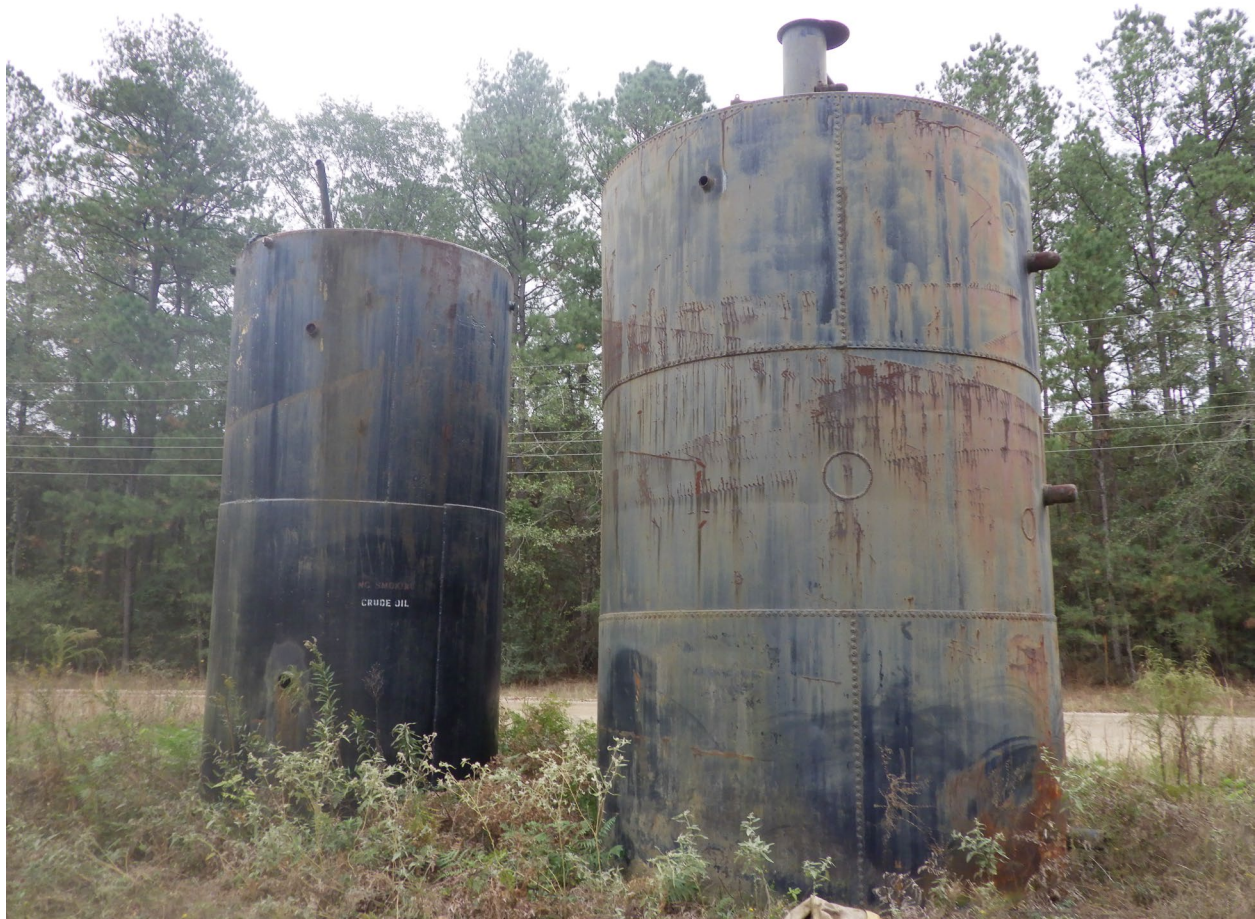
I observed two “out of service” storage tanks without proper labeling, see Photo No. 16 and No. 17.

**Description:** Looking SE, this photo shows two storage tanks outside secondary containment without "Out of Service" labeling; view from the tank battery.

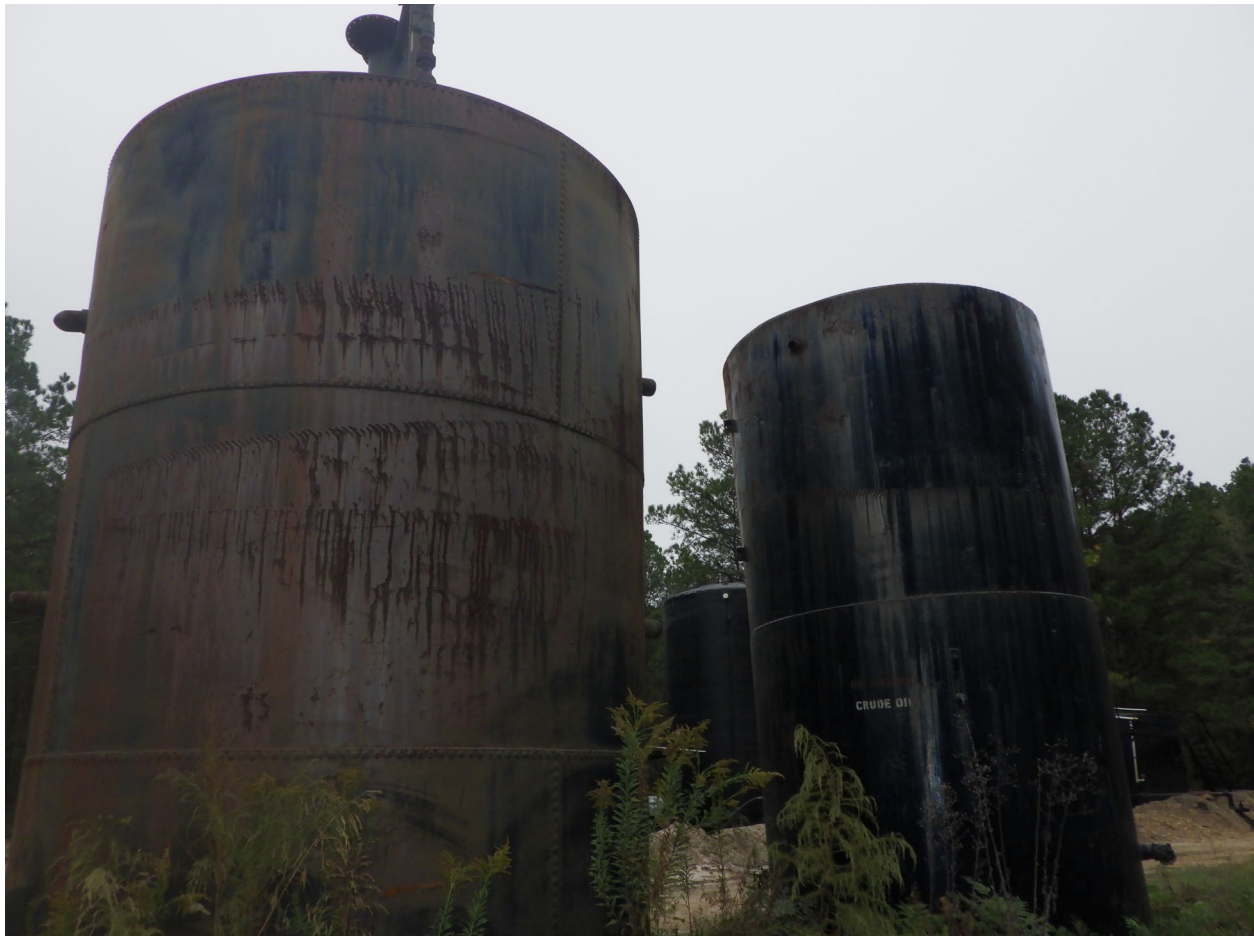
Photo No. 17

**Description:** Looking ENE, this photo shows two storage tanks outside secondary containment without "Out of Service" labeling; view from the road.
