## RCRA Compliance Evaluation Inspection Report

Peninsula Metal Finishing Inc.  
2550 Dinneen Avenue  
Orlando, FL 32804

July 14, 2021, 10:00 a.m.

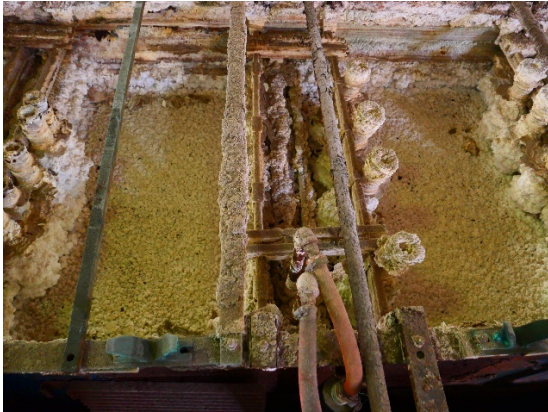
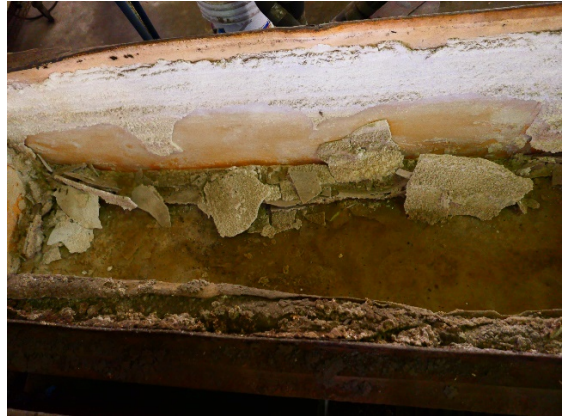
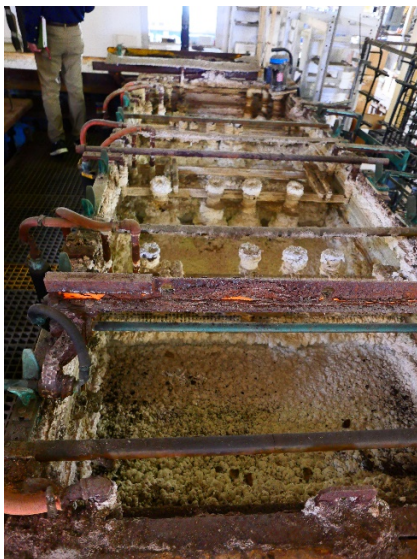
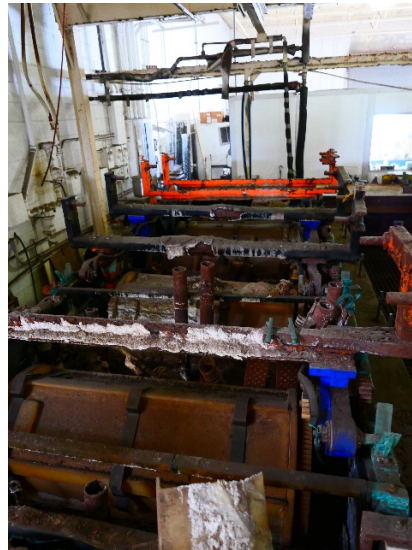
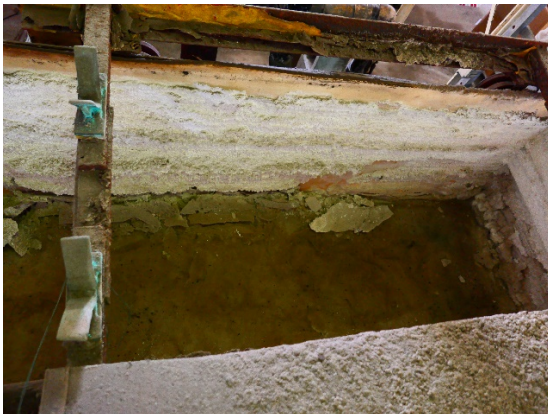
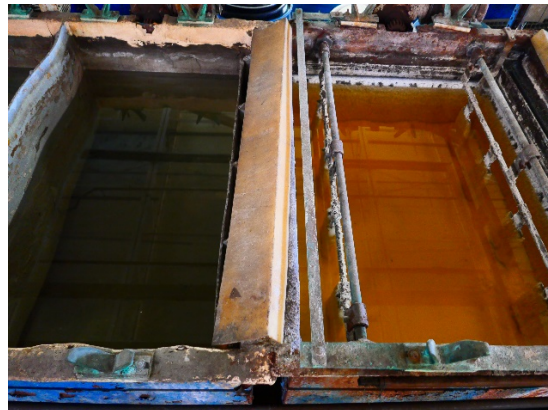
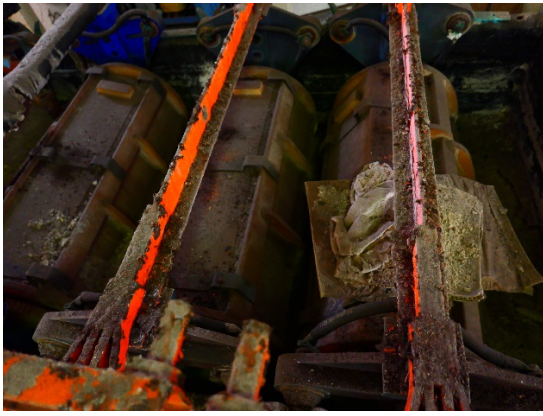
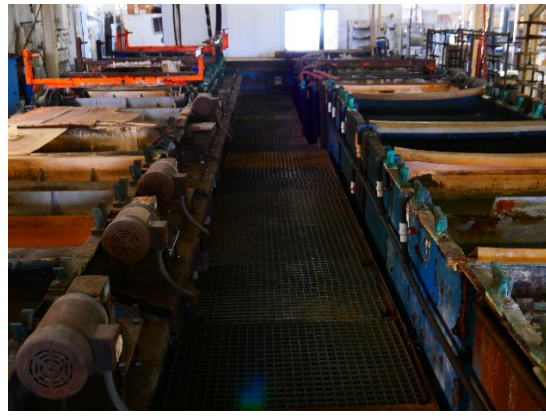
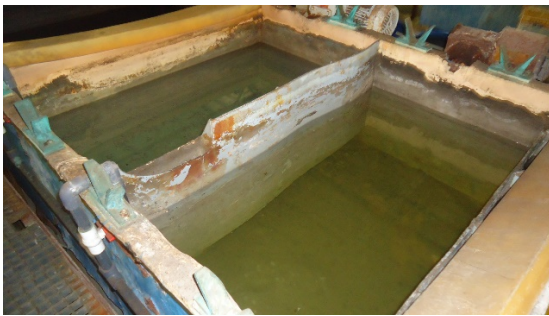
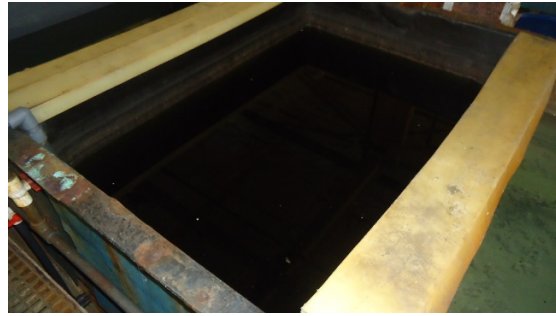
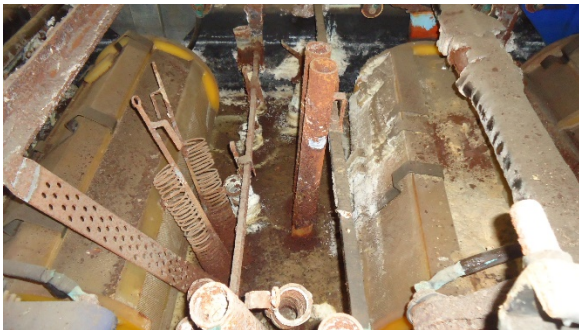
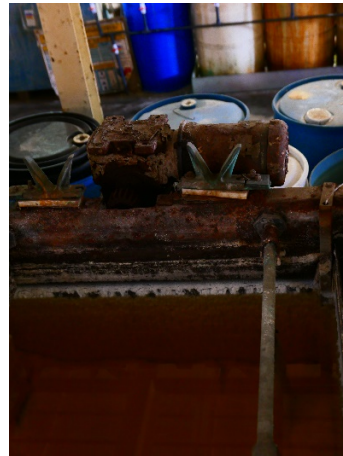
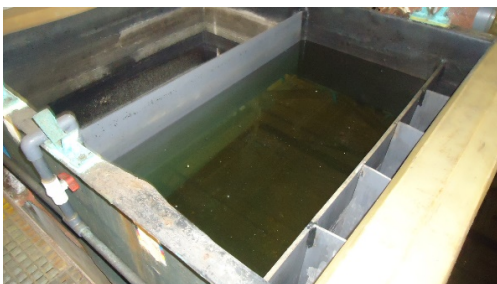
During the inspection, the small barrel line was in operation. According to Mr. Coachman, the large barrel line has been out of service for approximately two years. The inspectors observed rusted plating equipment and tanks in the large barrel line area. The equipment and open plating tanks contained plating solutions and dried up plating chemicals (Photos #1-13). The inspectors

Photo #1 – Out of service zinc plating large barrel line tanks.

Photo #2 – Out of service zinc plating large barrel line tank.

Photo #3 – Out of service zinc plating large barrel line tanks.

Photo #4 – Out of service/rusted zinc plating large barrel line tanks.

Photo #5 – Out of service zinc plating large barrel line tank.

Photo #6 – Out of service zinc plating solutions stored in the large barrel line tanks.

Photo #7 – Rusted out of service zinc plating large barrel line equipment.

Photo #8 – Out of service zinc plating large barrel line tanks.

Photo #9 – Out of service zinc plating solutions stored in the large barrel line tanks.

Photo #10 – Out of service zinc plating solutions stored in the large barrel line tank.

Photo #11 – Out of service zinc plating large barrel line tank.

Photo #12 – Out of service zinc plating large barrel line tank.

Photo #13 – Out of service zinc plating solutions stored in the large barrel line tanks.

informed Mr. Coachman to make waste determination of the plating solutions/materials left in the large barrel line tanks and dispose of the wastes accordingly.

**Pursuant to Fla. Admin. Code Ann. r. 62-730.160(1) [40 C.F.R. § 262.11], a person who generates a solid waste, as defined in Fla. Admin. Code Ann. r. 62-730.030(1) [40 C.F.R. § 261.2], must make an accurate determination as to whether that waste is a hazardous waste in order to ensure wastes are properly managed according to applicable RCRA regulations articulated in Fla. Admin. Code Ann. r. 62-730.160(1) [40 C.F.R. § 262.11].**

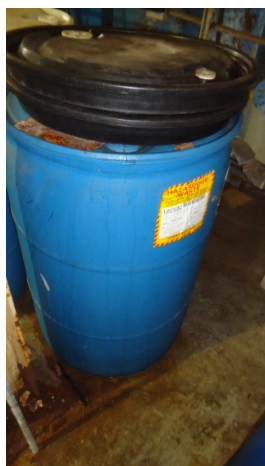
Next to the zinc strip line, there were six 55-gallon poly drums, one labeled “Hazardous Waste” (Photos #14-15), one labeled “Acid CAD Satellite Accumulation Drum,” one labeled “acid cad satellite accumulation,” one labeled “trace elements rinse water,” one labeled “bright acid cad,” and one labeled “satellite accumulation bright acid cad.” Mr. Coachman explained the three drums with “satellite accumulation” written on the label were mislabeled. The drums contain rinse water and will be reused in the process. The drum marked “Hazardous Waste” is used to collect wastes generated from the zinc plating area and was being managed in a satellite accumulation area (SAA) but was not marked with the hazards of the contents.

Photo #14 – Hazardous waste drum in SAA.

Photo #15 – Close-up of hazardous waste label.

**Pursuant to Fla. Admin. Code Ann. r. 62-730.160(1) [40 C.F.R. § 262.15(a)(5)(ii)], which is a condition of the SAA Permit Exemption, a generator must mark or label its containers with the following: (ii) an indication of the hazards of the contents (examples include, but are not limited to, the applicable hazardous waste characteristic(s) (i.e., ignitable, corrosive, reactive, toxic); hazard communication consistent with the Department of Transportation requirements at 49 C.F.R. part 172 subpart E (labeling) or subpart F (placarding); a hazard statement or pictogram consistent with the Occupational Safety and Health Administration Hazard Communication Standard at 29 C.F.R. 1910.1200; or a chemical hazard label consistent with the National Fire Protection Association code 704).**

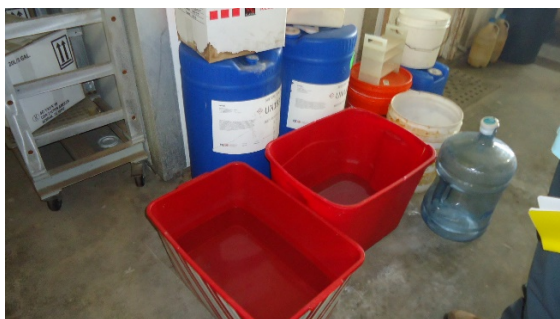
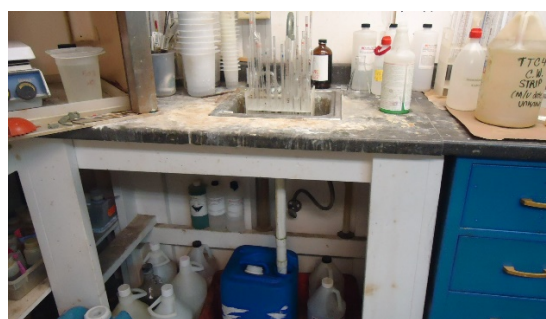
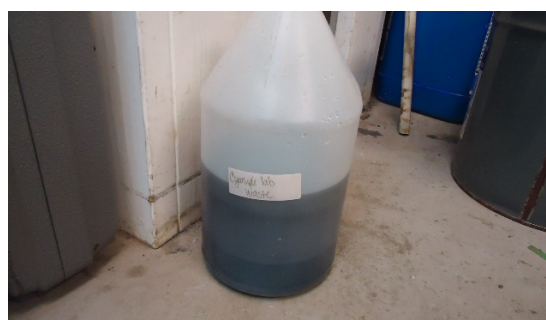
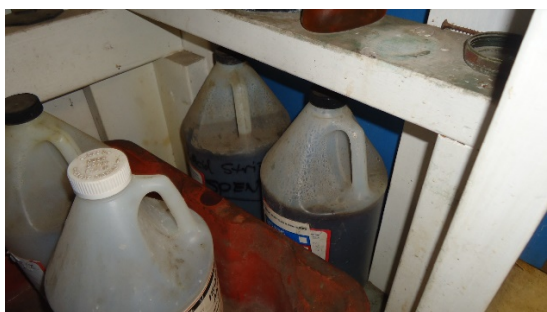
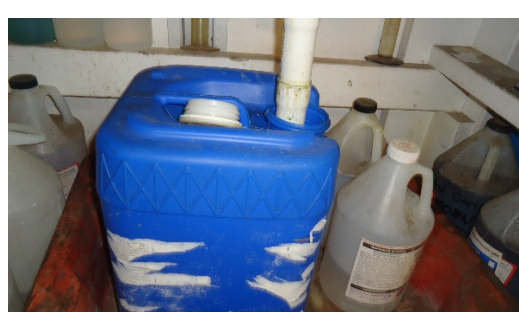
Next, the inspectors walked to the cadmium plating area. In the cadmium plating area, there are five process lines, one for cad and four for chromate (clear, yellow, black, and olive black). After plating, a compressor can be used to dry rinse water from the parts. In the chemistry laboratory, plating bath samples are tested for proper concentrations/constituents to ensure optimal plating performance of the processes and quality control. Outside the laboratory were two plastic totes and one 5-gallon bucket (Photo #16). The inspectors observed liquid in each of the containers. Mr. Coachman pH tested the liquid and the result was over 6 Standard Units. Laboratory waste is collected in a 5-gallon container below a sink (Photo #17). The container was not marked and Mr. Coachman could not verify how the wastes were being managed. One 1-gallon container labeled “cyanide lab waste” was staged on the floor in a corner (Photos #18-19). The container was not marked “Hazardous Waste” and not marked with the hazards of the contents. One 1-gallon container under the corner of the sink was marked “acid strip spent” (Photo #20). Under the sink were approximately nine other 1-gallon containers and on a shelf under and to the left of the sink were multiple small containers with unknown contents (Photos #17, and 20-21).

Photo #16 – Containers outside the chemistry laboratory.

Photo #17 – Laboratory sink and waste containers.

Photo #18 – Container of cyanide lab waste.

Photo #19 – Close up of container (Photo #18).

Photo #20 – Containers of spent acid strip.

Photo #21 – Container under the sink.

Pursuant to Fla. Admin. Code Ann. r. 62-730.160(1) [40 C.F.R. § 262.11], a person who generates a solid waste, as defined in Fla. Admin. Code Ann. r. 62-730.030(1) [40 C.F.R. § 261.2], must make an accurate determination as to whether that waste is a hazardous waste in order to ensure wastes are properly managed according to applicable RCRA regulations articulated in Fla. Admin. Code Ann. r. 62-730.160(1) [40 C.F.R. § 262.11]. The inspectors informed Mr. Coachman to make proper waste determination of the 1-gallon and 5-gallon containers stored in the laboratory and dispose of the wastes accordingly.

Pursuant to Fla. Admin. Code Ann. r. 62-730.160(1) [40 C.F.R. § 262.15(a)(5)(i-ii)], which is a condition of the SAA Permit Exemption, a generator must mark or label its containers with the following: (i) the words “Hazardous Waste;” (ii) an indication of the hazards of the contents (examples include, but are not limited to, the applicable hazardous waste characteristic(s) (i.e., ignitable, corrosive, reactive, toxic); hazard communication consistent with the Department of Transportation requirements at 49 C.F.R. part 172 subpart E (labeling) or subpart F (placarding); a hazard statement or pictogram consistent with the Occupational Safety and Health Administration Hazard Communication Standard at 29 C.F.R. 1910.1200; or a chemical hazard label consistent with the National Fire Protection Association code 704). The facility must mark the cyanide and acid strip waste containers with the words “Hazardous Waste” and an indication of the hazards of the contents.

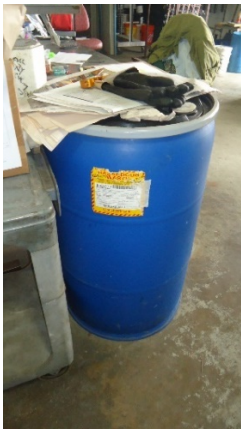
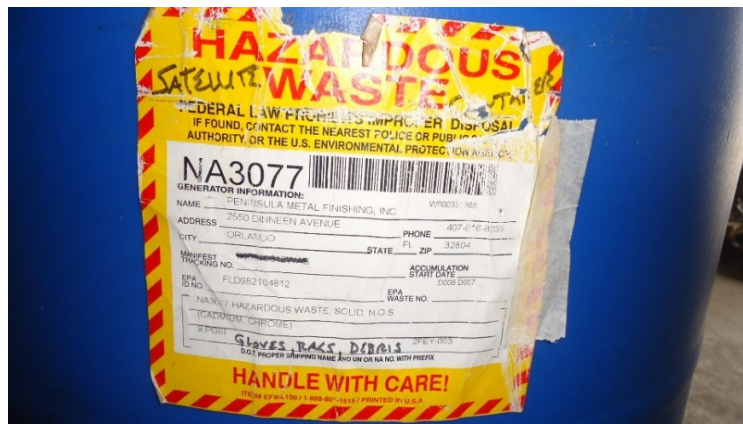
In the anodize plating area, aluminum is etched in order to insert the desired color into the parts. After color insertion a protective coating is applied to the part. The inspectors observed one 55-gallon poly container of hazardous waste gloves, rags, debris, located in a SAA. The drum was marked “Hazardous Waste” but was not marked with the hazards of the contents (Photos #22-23).

Photo #22 – Hazardous waste Container in SAA.

Photo #23 – Close up of SAA container (Photo #22).

Pursuant to Fla. Admin. Code Ann. r. 62-730.160(1) [40 C.F.R. § 262.15(a)(5)(ii)], which is a condition of the SAA Permit Exemption, a generator must mark or label its containers with the following: (ii) an indication of the hazards of the contents (examples include, but are not limited to, the applicable hazardous waste characteristic(s) (i.e., ignitable, corrosive, reactive, toxic); hazard communication consistent with the Department of Transportation requirements at 49 C.F.R. part 172 subpart E (labeling) or subpart F (placarding); a hazard statement or pictogram consistent with the Occupational Safety and Health Administration Hazard Communication Standard at 29 C.F.R. 1910.1200; or a chemical hazard label consistent with the National Fire Protection Association code 704).

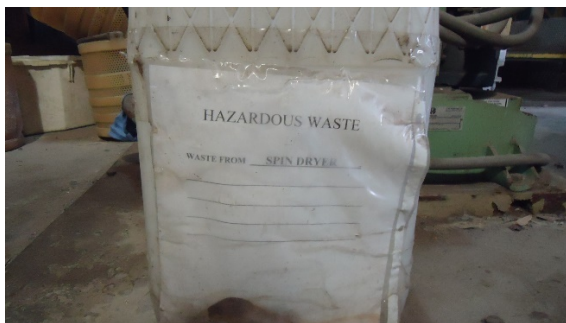
Back inside the building was a spin drier located at the end of the anodize line. The drier had a 5-gallon container attached collecting wastes from the drying process. The container was labeled “Hazardous Waste” but was not marked with hazards of the contents (Photo #24).

Photo #24 – Hazardous waste container in SAA.

**Pursuant to Fla. Admin. Code Ann. r. 62-730.160(1) [40 C.F.R. § 262.15(a)(5)(ii)], which is a condition of the SAA Permit Exemption, a generator must mark or label its containers with the following: (ii) an indication of the hazards of the contents (examples include, but are not limited to, the applicable hazardous waste characteristic(s) (i.e., ignitable, corrosive, reactive, toxic); hazard communication consistent with the Department of Transportation requirements at 49 C.F.R. part 172 subpart E (labeling) or subpart F (placarding); a hazard statement or pictogram consistent with the Occupational Safety and Health Administration Hazard Communication Standard at 29 C.F.R. 1910.1200; or a chemical hazard label consistent with the National Fire Protection Association code 704).**

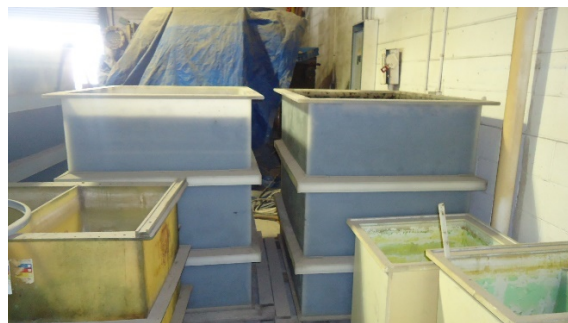
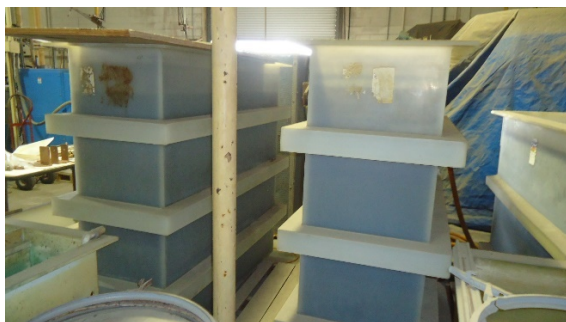
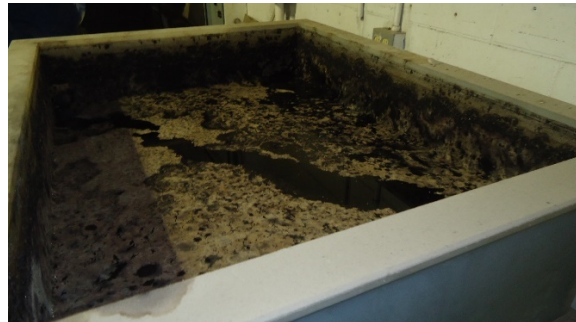
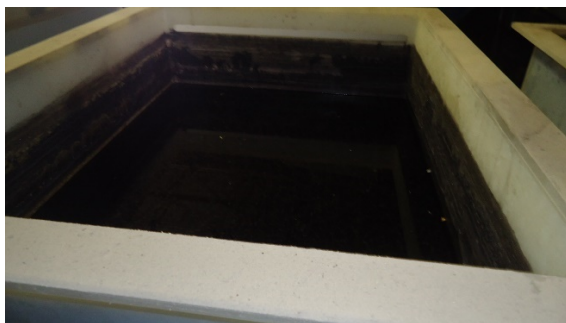
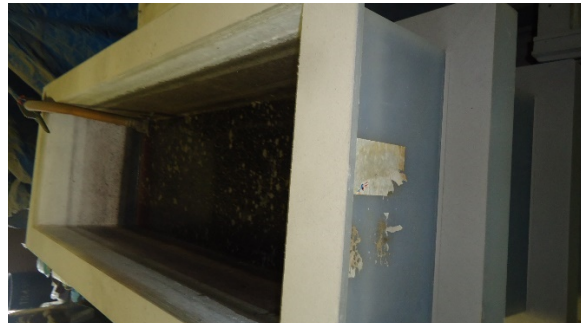
Near the central accumulation area (CAA) and the nickel strip plating area, four 250-gallon containers of anodize plating wastes were awaiting treatment in the wastewater treatment system (Photos #25-29). Mr. Coachman stated there was a backlog in the treatment process and the wastes have been accumulating in the containers for approximately six to eight weeks. The containers were not marked “Hazardous Waste,” were not marked with hazards of the contents, were not marked with an accumulation start date, and were open.

Photo #25 – Hazardous plating waste containers staged for wastewater treatment system.

Photo #26 – Hazardous plating waste containers staged for wastewater treatment system.

Photo #27 – One of the containers in Photo #25, contained dried up plating sludge.

Photo #28 – Contents of the containers (plating waste).

Photo #29 – Contents of the containers (plating waste).

**Pursuant to Fla. Admin. Code Ann. r. 62-730.160(1) [40 C.F.R. § 262.17(a)(5)(i)(A-C)], which is a condition of the LQG Permit Exemption, a generator must mark or label its containers with the following: (A) the words “Hazardous Waste;” (B) an indication of the hazards of the contents (examples include, but are not limited to, the applicable hazardous waste characteristic(s) (i.e., ignitable, corrosive, reactive, toxic); hazard communication consistent with the Department of Transportation requirements at 49 C.F.R. part 172 subpart E (labeling) or subpart F (placarding); a hazard statement or pictogram consistent with the Occupational Safety and Health Administration Hazard Communication Standard at 29 C.F.R. 1910.1200; or a chemical hazard label consistent with the National Fire Protection Association code 704); and (C) the date upon which each period of accumulation begins clearly visible for inspection on each container.**

**Pursuant to Fla. Admin. Code Ann. r. 62-730.160(1) [40 C.F.R. § 262.17(a)(1)(iv)(A)], which is a condition of the LQG Permit Exemption, if the hazardous waste is placed in containers, the large quantity generator must comply with the following: (A) a container holding hazardous waste must always be closed during accumulation, except when it is necessary to add or remove waste.**

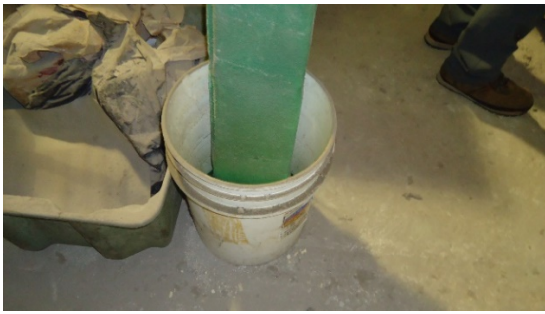
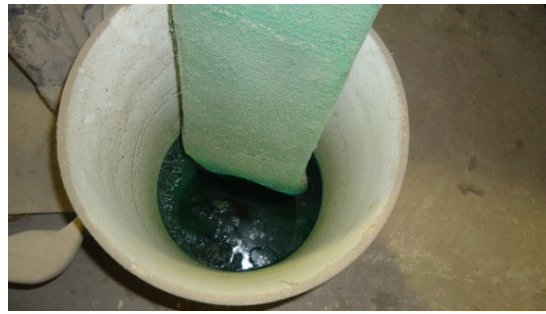
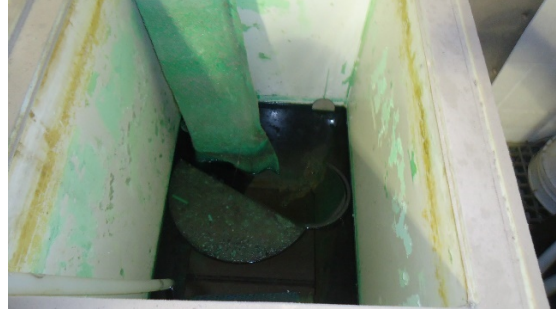
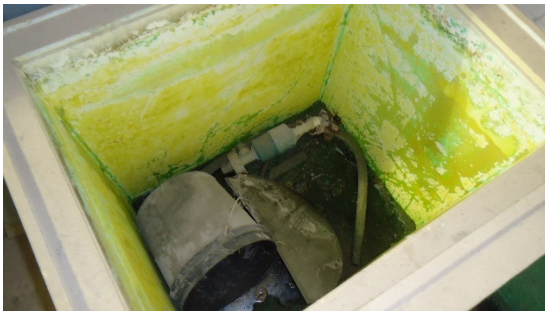
Also in this area were two unlabeled containers (appeared to be 50 gallons each) and one 5-gallon container with unknown contents (Photos #30-34). The inspectors requested that the facility conduct a waste determination of the unknown liquids and dispose of it accordingly.

Photo #30 – Spent sleeve/filter in 5-gallon container.

Photo #31 – Unknown contents of 5-gallon container (Photo #30).

Photo #32 – Two containers with unknown contents.

Photo #33 – Contents of the container (Photo #32).

Photo #34 – Contents of the container, (Photo #32).

**Pursuant to Fla. Admin. Code Ann. r. 62-730.160(1) [40 C.F.R. § 262.11], a person who generates a solid waste, as defined in Fla. Admin. Code Ann. r. 62-730.030(1) [40 C.F.R. § 261.2], must make an accurate determination as to whether that waste is a hazardous waste in order to ensure wastes are properly managed according to applicable RCRA regulations articulated in Fla. Admin. Code Ann. r. 62-730.160(1) [40 C.F.R. § 262.11].**

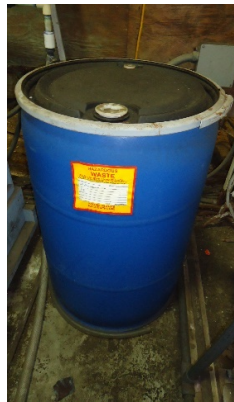
generated from the nickel black plating line cannot be treated in the waste treatment system. These wastes are manifested off-site as non-hazardous waste. There was a 55-gallon poly drum of hazardous waste filters in a SAA. The drum was marked "Hazardous Waste" but was not marked with the hazards of the contents (Photos #35-36).

Photo #35 – Hazardous waste container in SAA.

Photo #36 – Close up of Photo #35.

**Pursuant to Fla. Admin. Code Ann. r. 62-730.160(1) [40 C.F.R. § 262.15(a)(5)(ii)], which is a condition of the SAA Permit Exemption, a generator must mark or label its containers with the following: (ii) an indication of the hazards of the contents (examples include, but are not limited to, the applicable hazardous waste characteristic(s) (i.e., ignitable, corrosive, reactive, toxic); hazard communication consistent with the Department of Transportation requirements at 49 C.F.R. part 172 subpart E (labeling) or subpart F (placarding); a hazard statement or pictogram consistent with the Occupational Safety and Health Administration Hazard Communication Standard at 29 C.F.R. 1910.1200; or a chemical hazard label consistent with the National Fire Protection Association code 704).**

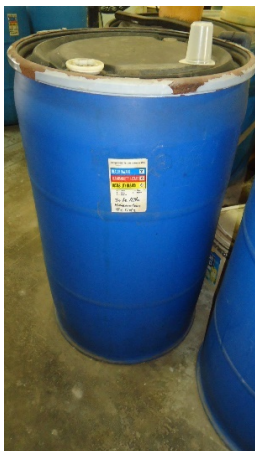
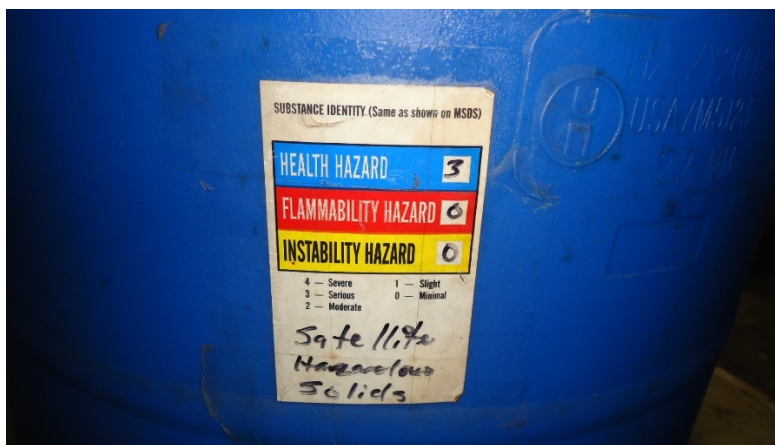
The inspectors observed one 55-gallon container of hazardous waste rags, gloves in the nickel plating line SAA. The drum was not marked "Hazardous Waste" and not marked with the hazards of the contents (Photos #37-38).

Photo #37 – Hazardous waste drum in SAA.

Photo #38 – Close up of Photo #37.

**Pursuant to Fla. Admin. Code Ann. r. 62-730.160(1) [40 C.F.R. § 262.15(a)(5)(i-ii)], which is a condition of the SAA Permit Exemption, a generator must mark or label its containers with the following: (i) the words "Hazardous Waste;" (ii) an indication of the hazards of the contents (examples include, but are not limited to, the applicable hazardous waste characteristic(s) (i.e., ignitable, corrosive, reactive, toxic); hazard communication consistent with the Department of Transportation requirements at 49 C.F.R. part 172 subpart E (labeling) or subpart F (placarding); a hazard statement or pictogram consistent with the Occupational Safety and Health Administration Hazard Communication Standard at 29 C.F.R. 1910.1200; or a chemical hazard label consistent with the National Fire Protection Association code 704).**

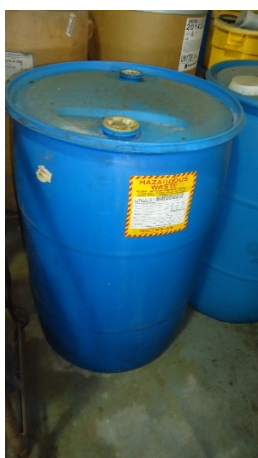
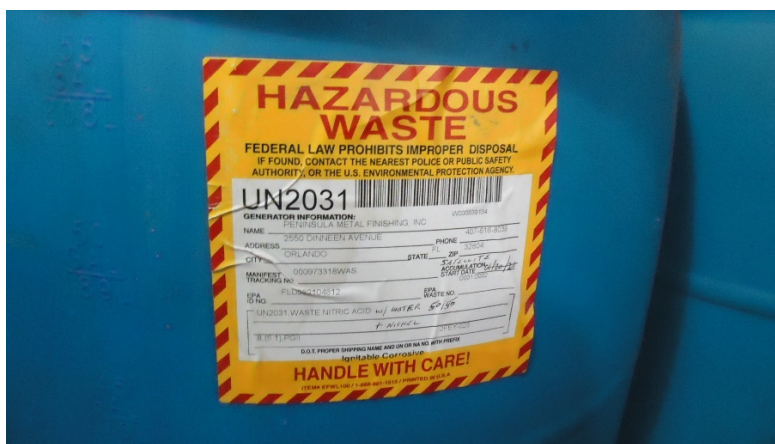
In the nickel strike plating line, there was one 55-gallon poly drum of hazardous nitric acid, located in a SAA. The drum was marked "Hazardous Waste" but was not marked with the hazards of the contents (Photos #39-40).

Photo #39 – Hazardous waste drum in SAA.

Photo #40 – Close up of Photo #39.

**Pursuant to Fla. Admin. Code Ann. r. 62-730.160(1) [40 C.F.R. § 262.15(a)(5)(ii)], which is a condition of the SAA Permit Exemption, a generator must mark or label its containers with the following: (ii) an indication of the hazards of the contents (examples include, but are not limited to, the applicable hazardous waste characteristic(s) (i.e., ignitable, corrosive, reactive, toxic); hazard communication consistent with the Department of Transportation requirements at 49 C.F.R. part 172 subpart E (labeling) or subpart F (placarding); a hazard statement or pictogram consistent with the Occupational Safety and Health Administration Hazard Communication Standard at 29 C.F.R. 1910.1200; or a chemical hazard label consistent with the National Fire Protection Association code 704).**

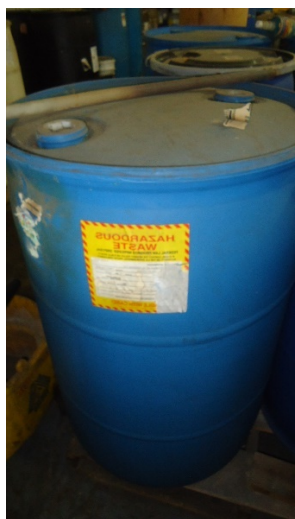
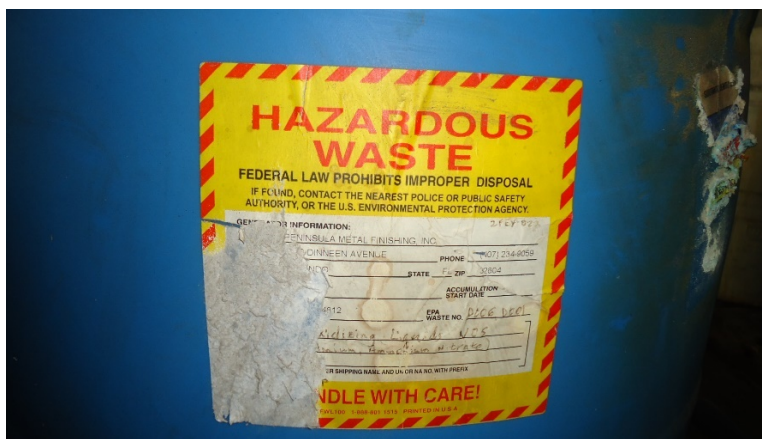
The chemical inventory area was located near the smaller plating lines. There were several rusty containers noted in this area. The inspector informed Mr. Coachman to assess the containers for usability and make a proper waste determination. There was one 55-gallon drum of hazardous waste ammonium nitrate waste. The drum was closed, labeled "Hazardous Waste" but was not marked with the hazards of the contents and not marked with an accumulation start date (Photos

Photo #41 – Hazardous waste drum in SAA.

Photo #42 – Close up of Photo #41.

**Pursuant to Fla. Admin. Code Ann. r. 62-730.160(1) [40 C.F.R. § 262.17(a)(5)(i)(B-C)], which is a condition of the LQG Permit Exemption, a generator must mark or label its containers with the following: (B) an indication of the hazards of the contents (examples include, but are not limited to, the applicable hazardous waste characteristic(s) (i.e., ignitable, corrosive, reactive, toxic); hazard communication consistent with the Department of Transportation requirements at 49 C.F.R. part 172 subpart E (labeling) or subpart F (placarding); a hazard statement or pictogram consistent with the Occupational Safety and Health Administration Hazard Communication Standard at 29 C.F.R. 1910.1200; or a chemical hazard label consistent with the National Fire Protection Association code 704); and (C) the date upon which each period of accumulation begins clearly visible for inspection on each container.**

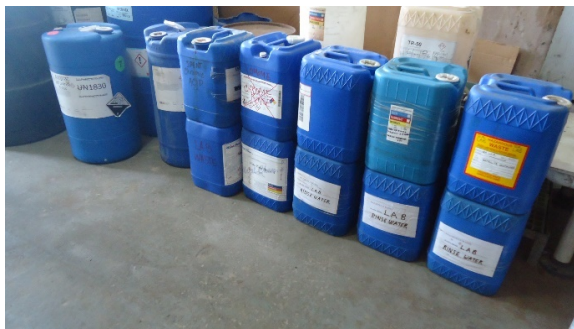
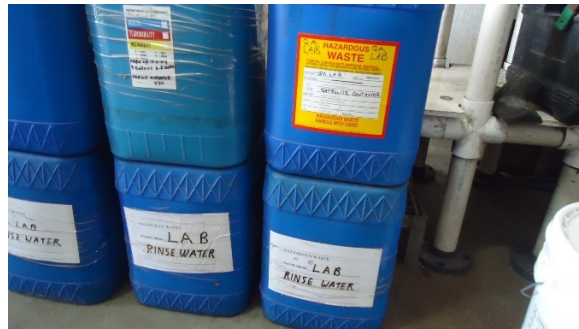
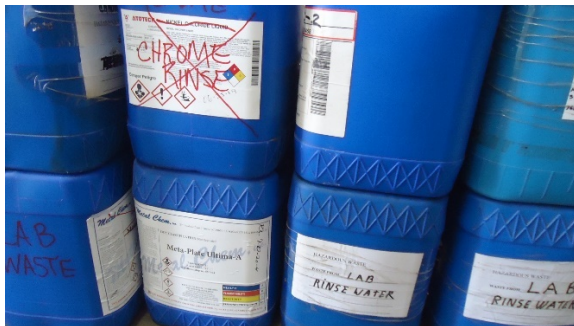
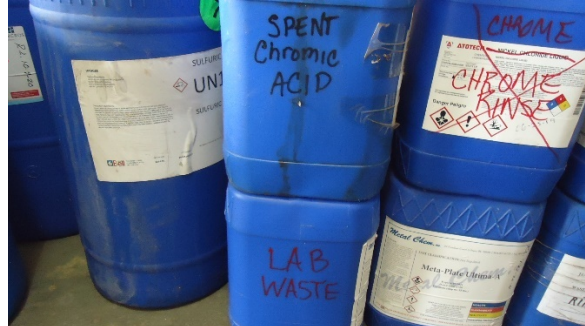
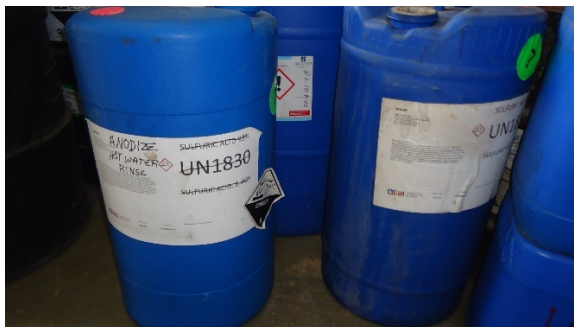
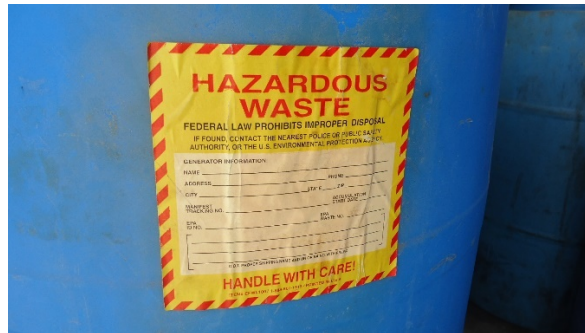
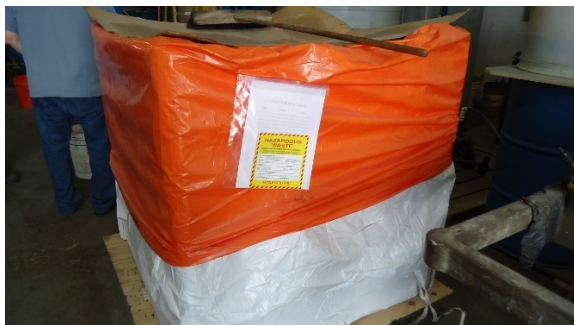
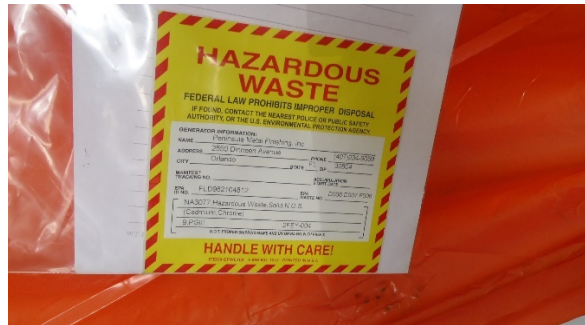
- There were ten 5-gallon containers, two 15-gallon containers, and three 55-gallon poly drums (Photos #43-48). Four of ten 5-gallon containers, two 15-gallon containers, and two of three 55-gallon poly drums were not marked with the words “Hazardous Waste.” Ten 5-gallon containers, one of two 15-gallon container, and three 55-gallon poly drums were not marked with the hazards of the contents. Ten 5-gallon containers, two 15-gallon containers, and three 55-gallon poly drums were not marked with an accumulation start date; and
- One cubic yard box of plating filter cake/sludge marked “Hazardous Waste” but was not marked with the hazards of the contents and not marked with an accumulation start date (Photos #49-50).

Photo #43 – Hazardous plating waste containers in the wastewater treatment system area.

Photo #44 – Close up of containers Photo #43.

Photo #45 – Close up of containers Photo #43.

Photo #46 – Close up of containers Photo #43.

Photo #47 – Close up of containers Photo #43.

Photo #48 – Hazardous waste label of one of the containers in Photo #43.

Photo #49 – F006 filter cake sludge stored in a 250-gallon tote.

Photo #50 – Close up label of Photo #49.

**Pursuant to Fla. Admin. Code Ann. r. 62-730.160(1) [40 C.F.R. § 262.17(a)(5)(i)(A-C)], which is a condition of the LQG Permit Exemption, a generator must mark or label its containers with the following: (A) the words “Hazardous Waste;” (B) an indication of the hazards of the contents (examples include, but are not limited to, the applicable hazardous waste characteristic(s) (i.e., ignitable, corrosive, reactive, toxic); hazard communication consistent with the Department of Transportation requirements at 49 C.F.R. part 172 subpart E (labeling) or subpart F (placarding); a hazard statement or pictogram consistent with the Occupational Safety and Health Administration Hazard Communication Standard at 29 C.F.R. 1910.1200; or a chemical hazard label consistent with the National Fire Protection Association code 704); and (C) the date upon which each period of accumulation begins clearly visible for inspection on each container.**

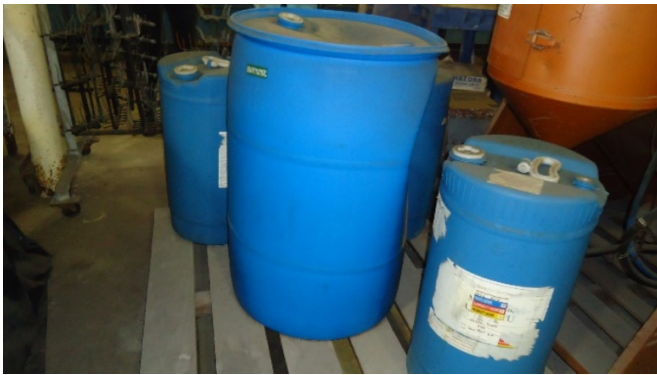
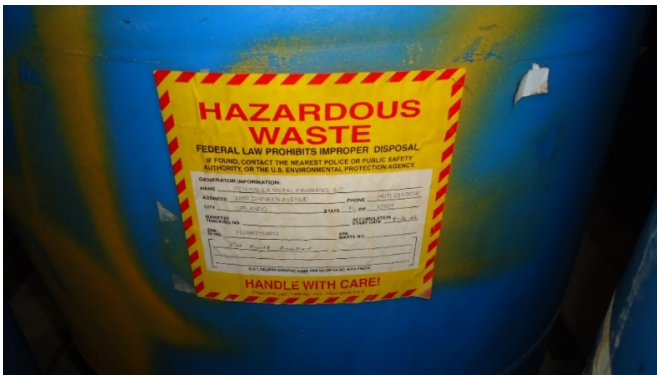
The inspectors observed one 55-gallon of “PM Rinse Solution” (Photos #51-52) near the main CAA and the chromate plating line. The container was marked “Hazardous Waste” and marked with an accumulation start date of 9/16/2016. Mr. Coachman stated that the container contained precious metal bearing electroplating wastewater for precious metal recovery. The facility could

not provide start accumulation date of PM Rinse Solutions or any documents that indicate percentage of solutions were reclaimed.

Photo #51 – Hazardous waste containers.

Photo #52 – Hazardous waste label from one of the containers in Photo #51.

**Pursuant to Fla. Admin. Code Ann. r. 62-730.181(1) [40 C.F.R. § 266.70(c)], persons who store recycled materials that are regulated under Subpart F - Recyclable Materials Utilized for Precious Metal Recovery, must keep the following records to document that they are not accumulating these materials speculatively (as defined in Fla. Admin. Code Ann. r. 62-730.030(1) [40 C.F.R. § 261.1(c)] of this chapter): (1) records showing the volume of these materials stored at the beginning of the calendar year; (2) the amount of these materials generated or received during the calendar year; and (3) the amount of materials remaining at the end of the calendar year.**

Precious metals recovery is regulated under 40 C.F.R. Part 266 Subpart F. In order to claim that a material is not accumulated speculatively, the generator must document that 75% of that material was reclaimed in the calendar year. In this case, the calendar year would have been January 1, 2016 to December 31, 2016. It appears that the container of PM rinse solution is being accumulated speculatively and as referenced in 40 C.F.R. § 266.70(d), is subject to all applicable provisions of 40 C.F.R. Parts 262 through 265, 267, 270, and 124. *The 55-gallon container has been in storage at the facility for greater than 90 days without a permit.*
