**Well Inspection**  
**Osage DNR / Environmental Protection Agency**  
**1201 Elm Street, Suite 500**  
**Dallas, Texas 75270**

| <b>Operator Info</b> | 2020 Harris Partners, LLC<br>P.O. Box 628<br>Barnsdall, OK 74002<br>Phone: 918-847-2531 | <b>Inventory ID</b> | OS2326000 | | |
| | | <b>Well ID</b> | W-11 | | |
| <b>Inspection Comments</b> | Inspector observed well OS2326000 (Jumas W-11). The casing was open to the atmosphere, and the tubing was closed by a gate valve. The tubing was bent over, it appeared to have been hit by a vehicle. Inspector was unable to obtain a fluid level at the time of the inspection due to poor and improper well maintenance. | | | | |

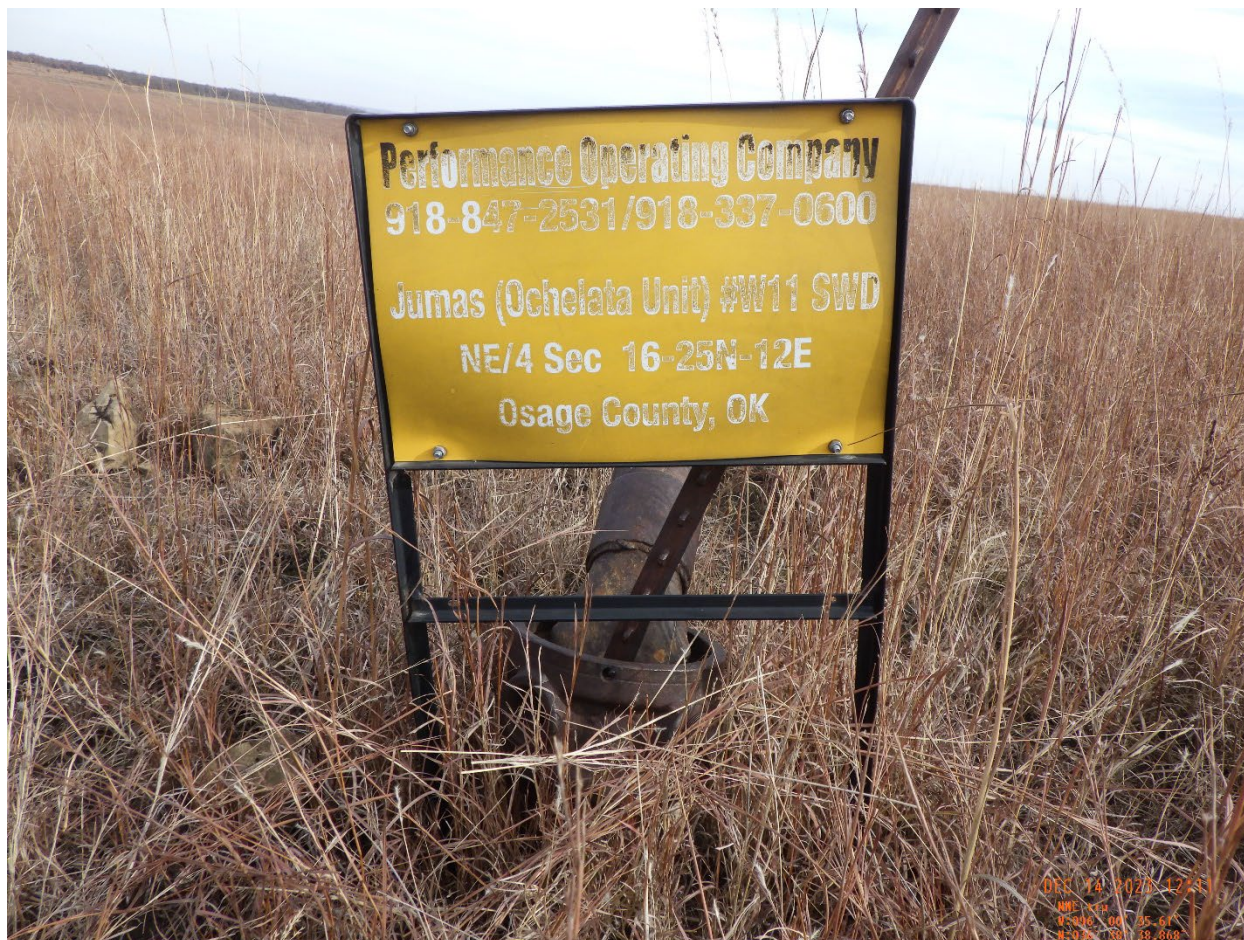
Photo No. 1

**Description:** This was well OS2326000 and its well sign at the time of the inspection.

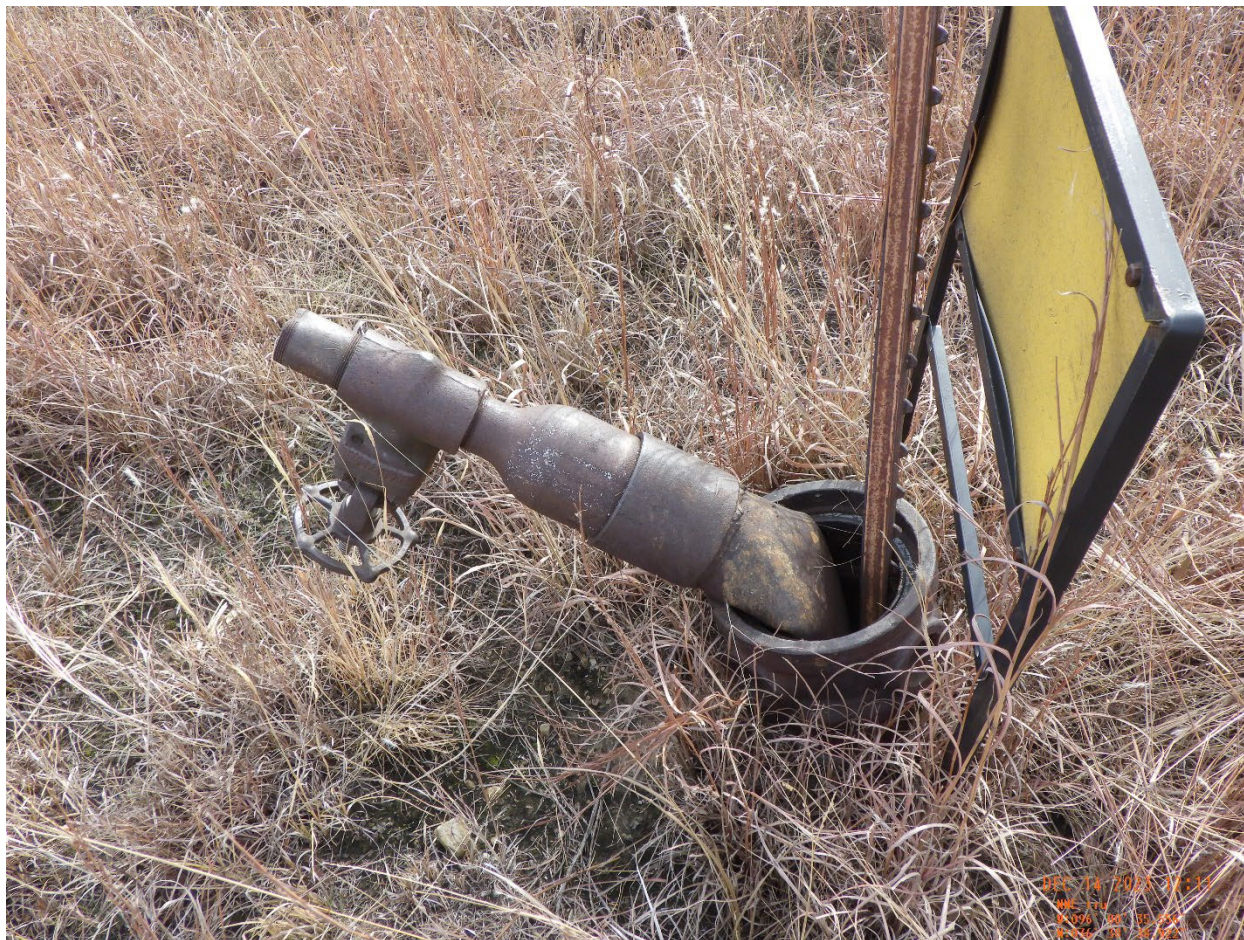
Photo No. 2

**Description:** This was well OS2326000 at the time of the inspection. The casing was open to the atmosphere and the tubing was damaged.
