## **Appendix C**

### **Figures**

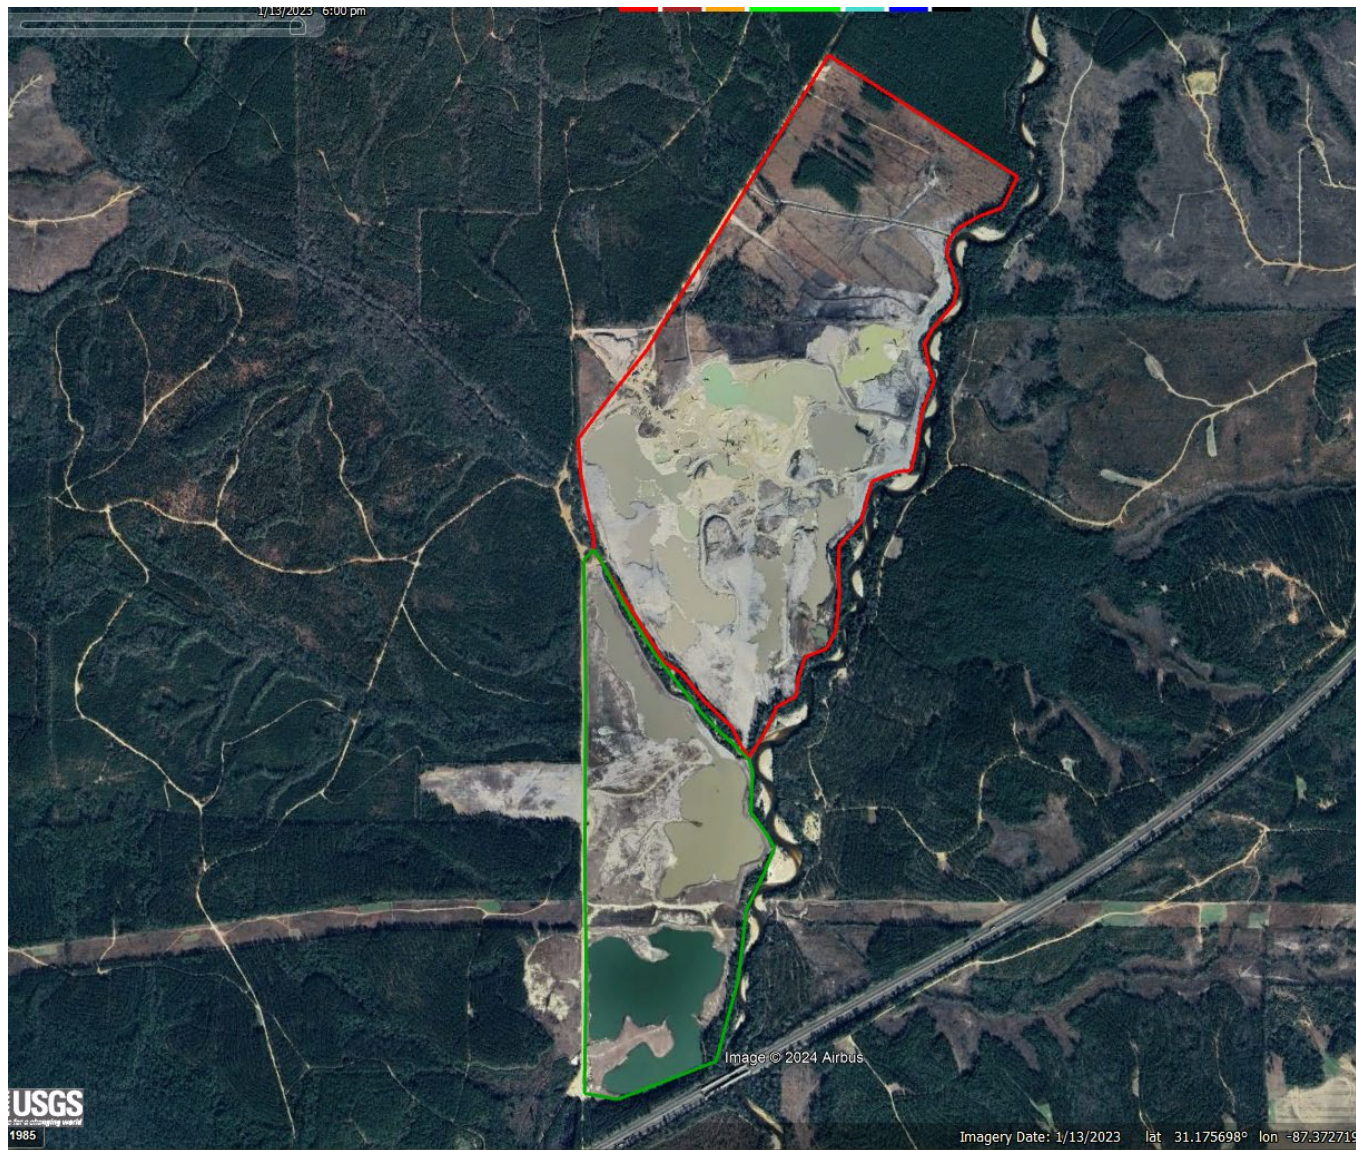
**Figure 1.** *GoogleEarth* aerial image of the Sardine Pit area, imagery dated January 13, 2023. The green line indicates the approximate property boundary of the previously permitted Sardine Pit South; the red line indicates the approximate property boundary of the Facility.

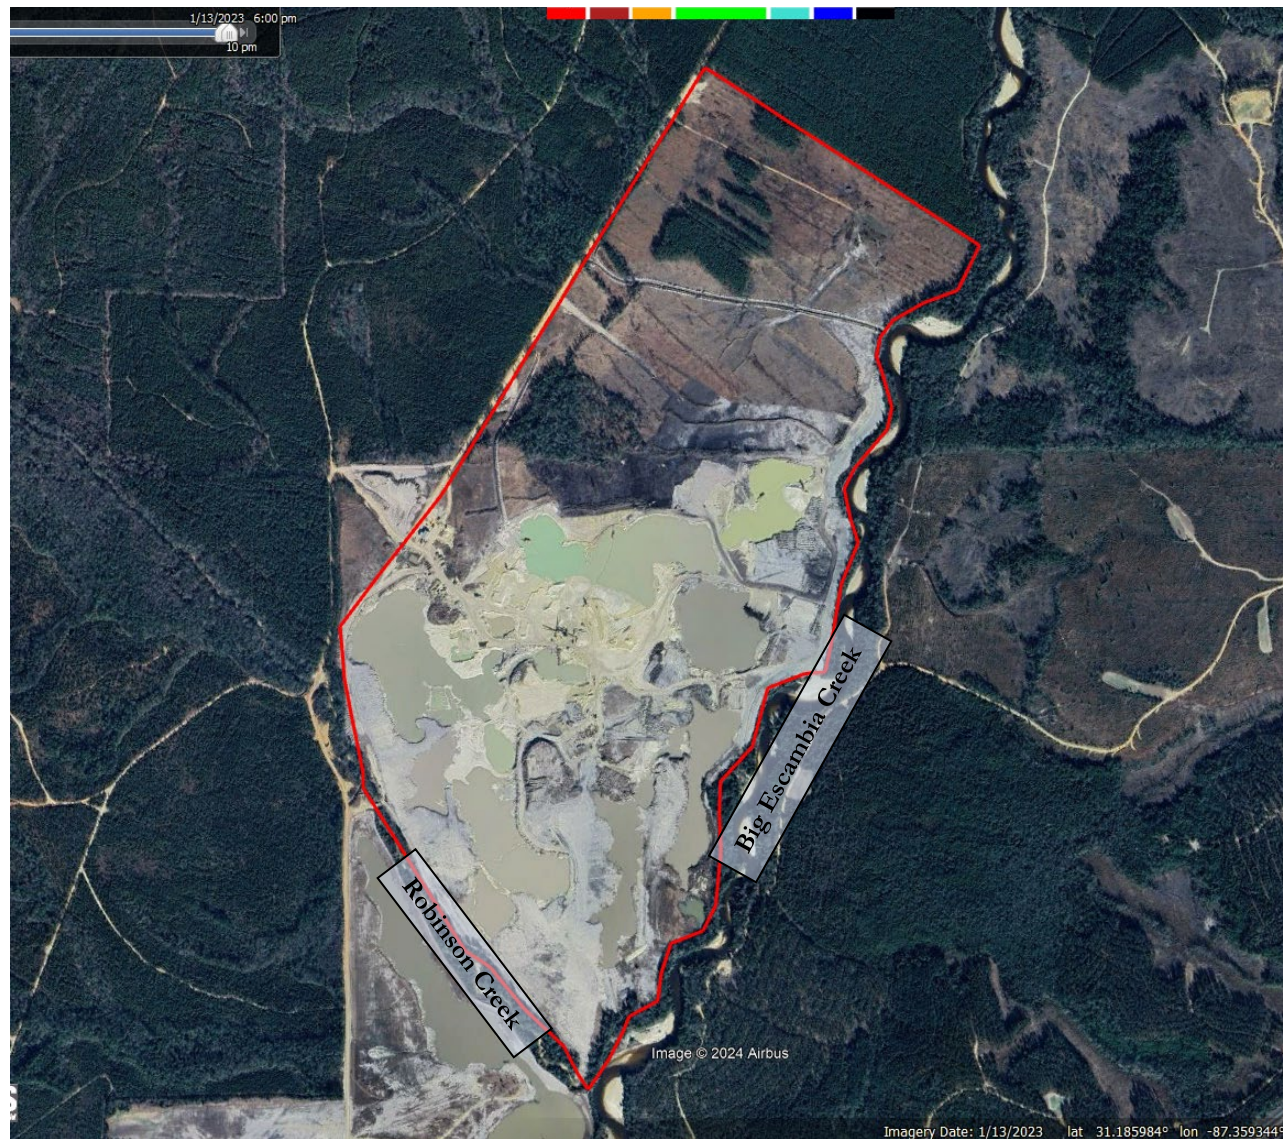
**Figure 2.** *GoogleEarth* aerial image of the Facility and locations of Robinson Creek and Big Escambia Creek, imagery dated January 13, 2023. The red lines indicate the approximate Facility boundary.

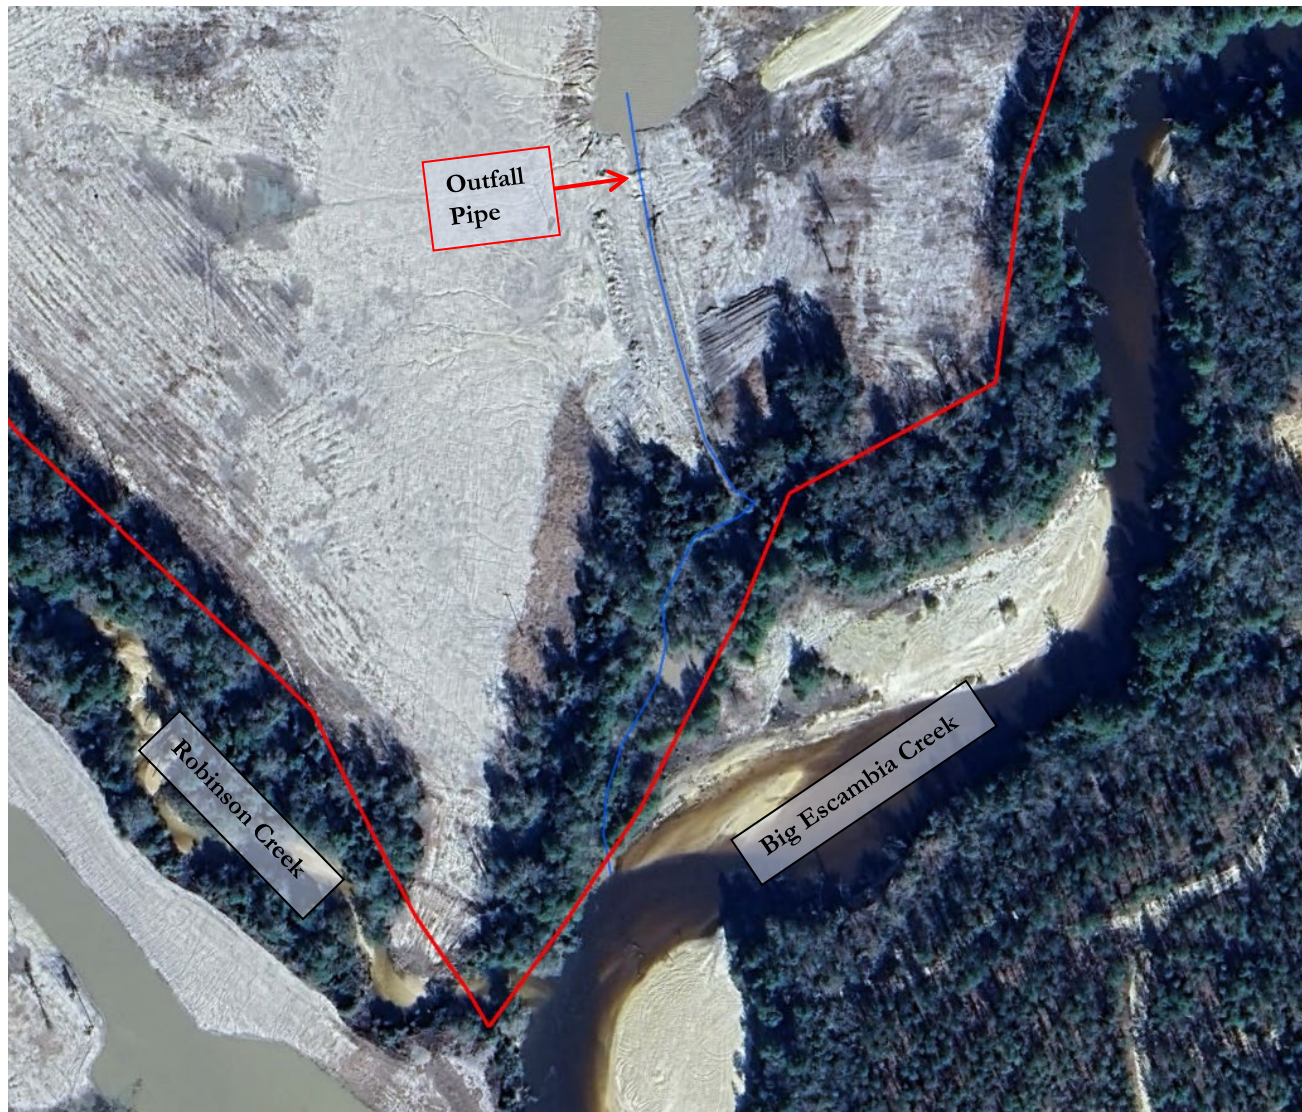
**Figure 3.** *GoogleEarth* aerial image of the southeast corner of the Facility, imagery dated January 13, 2023. The light blue line indicates the approximate surface water flow path from the process water pond to Big Escambia Creek. The red lines indicate the approximate Facility boundary.

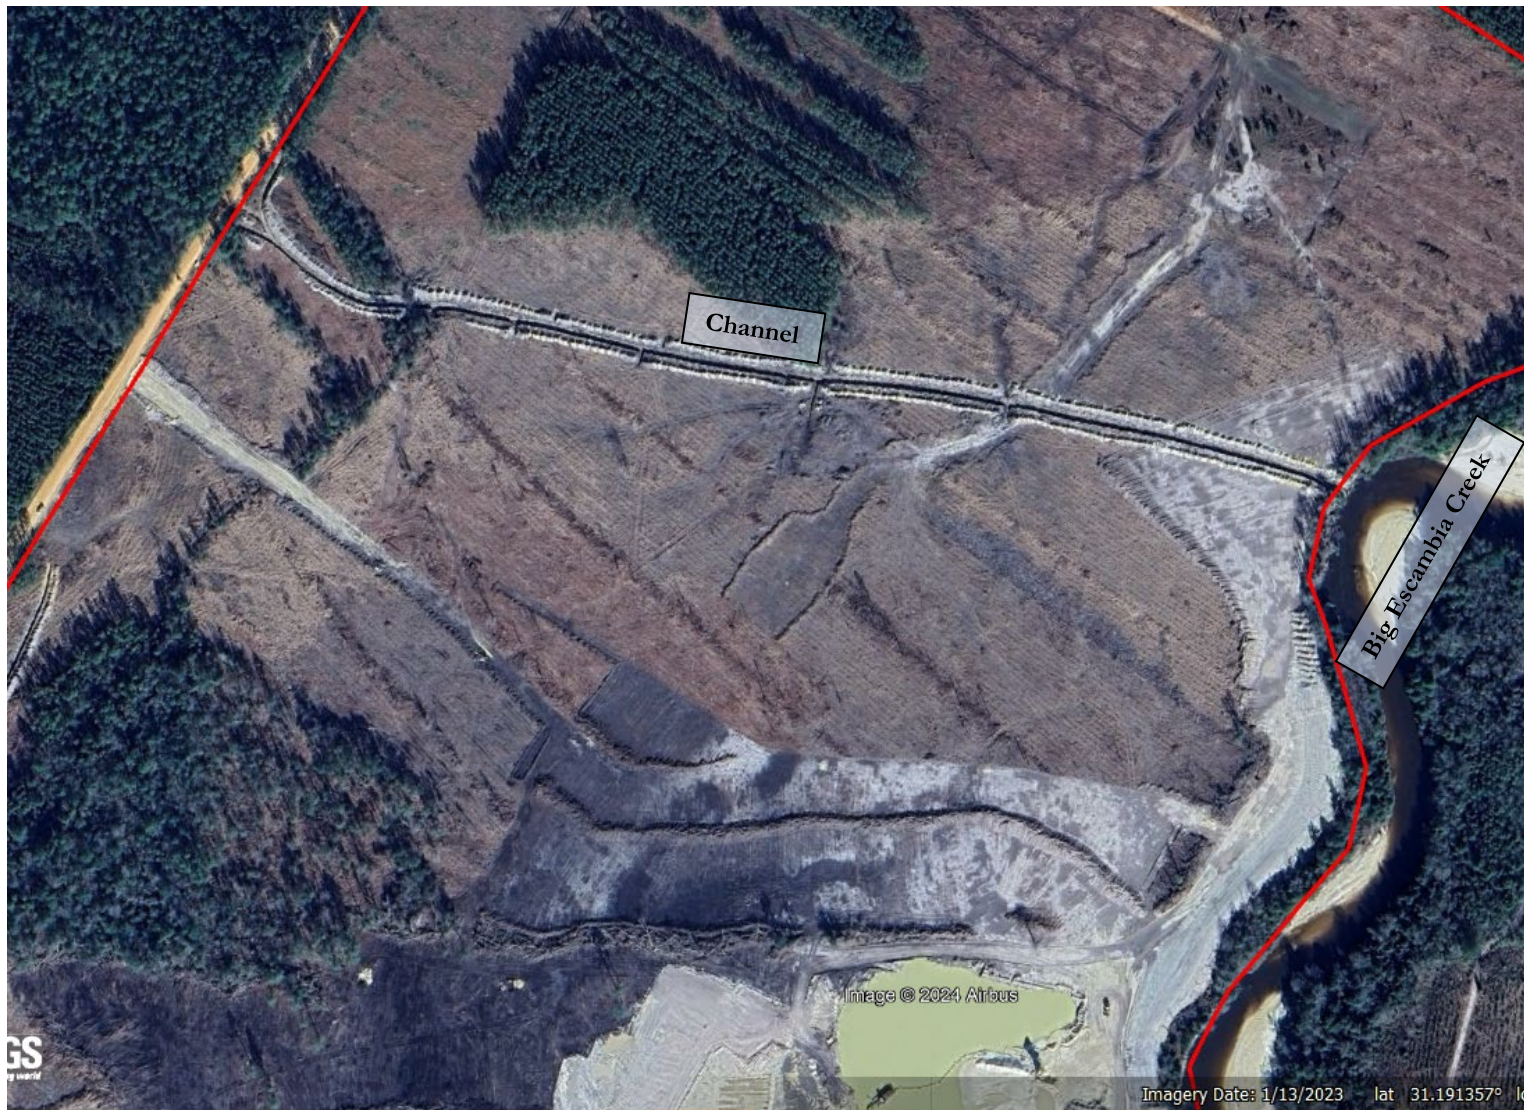
**Figure 4.** *GoogleEarth* aerial image of an excavated channel leading across the northern area of the Facility, imagery dated January 13, 2023. The channel flow path leads from west to east and to Big Escambia Creek. The red lines indicate the approximate Facility boundary.

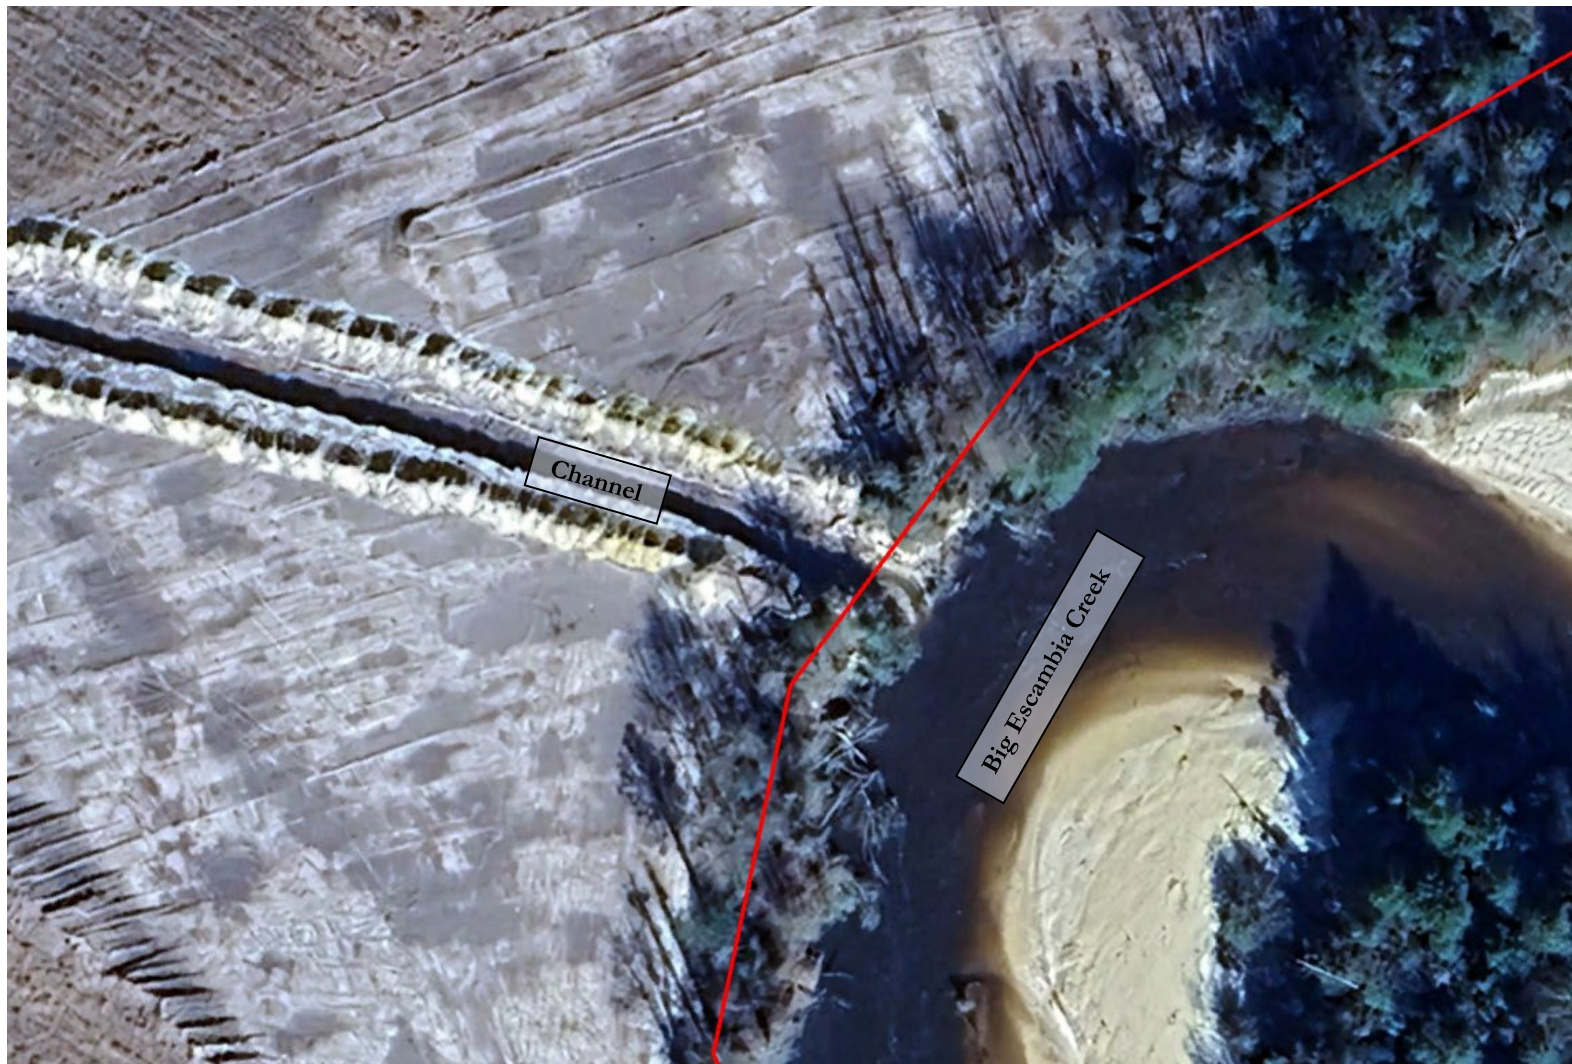
**Figure 5.** *GoogleEarth* aerial image showing close-up of excavated channel from Figure 4 and its confluence with Big Escambia Creek, imagery dated January 13, 2023. The red lines indicate the approximate Facility boundary. Also refer to Appendix B, Photographs 8 through 11.

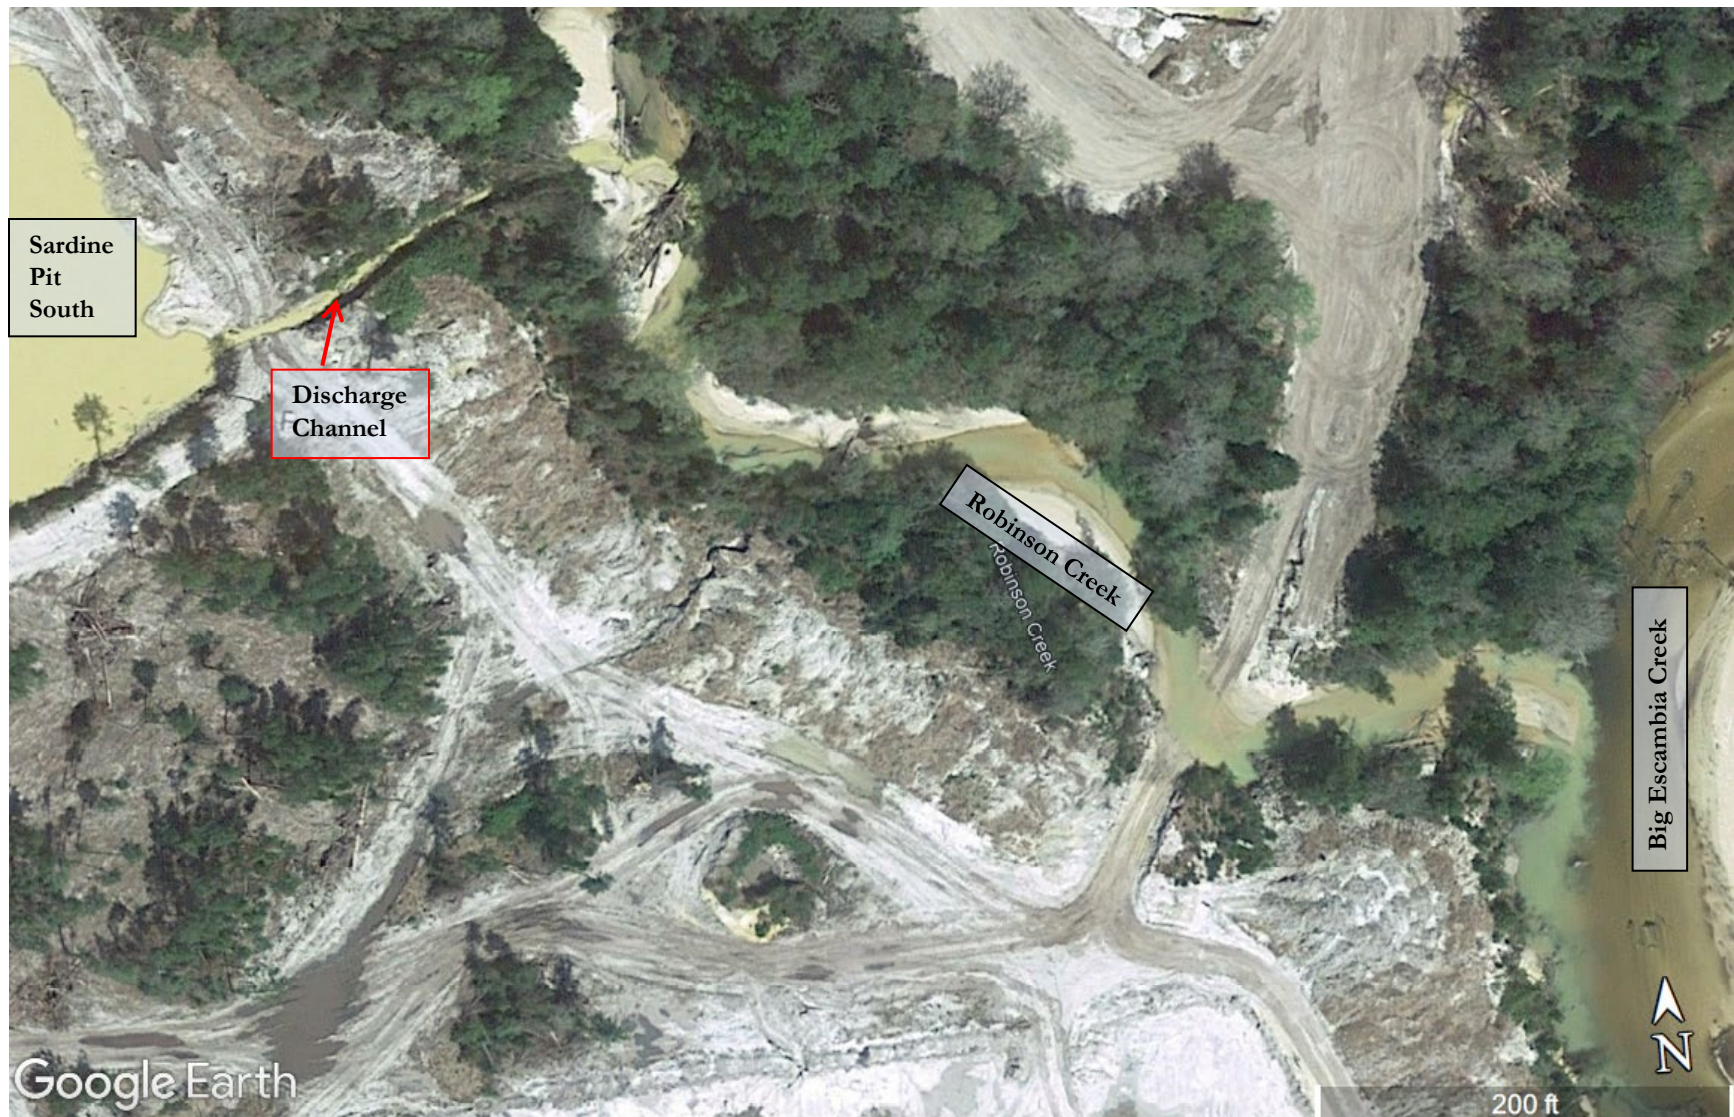
**Figure 6.** *GoogleEarth* aerial image of the Sardine Pit South and a surface water discharge channel leading from the Pit to Robinson Creek and ultimately to Big Escambia Creek. Approximate imagery date 2016. Note the change in water clarity of both Robinson Creek and Big Escambia Creek upstream and downstream of the discharge channel.

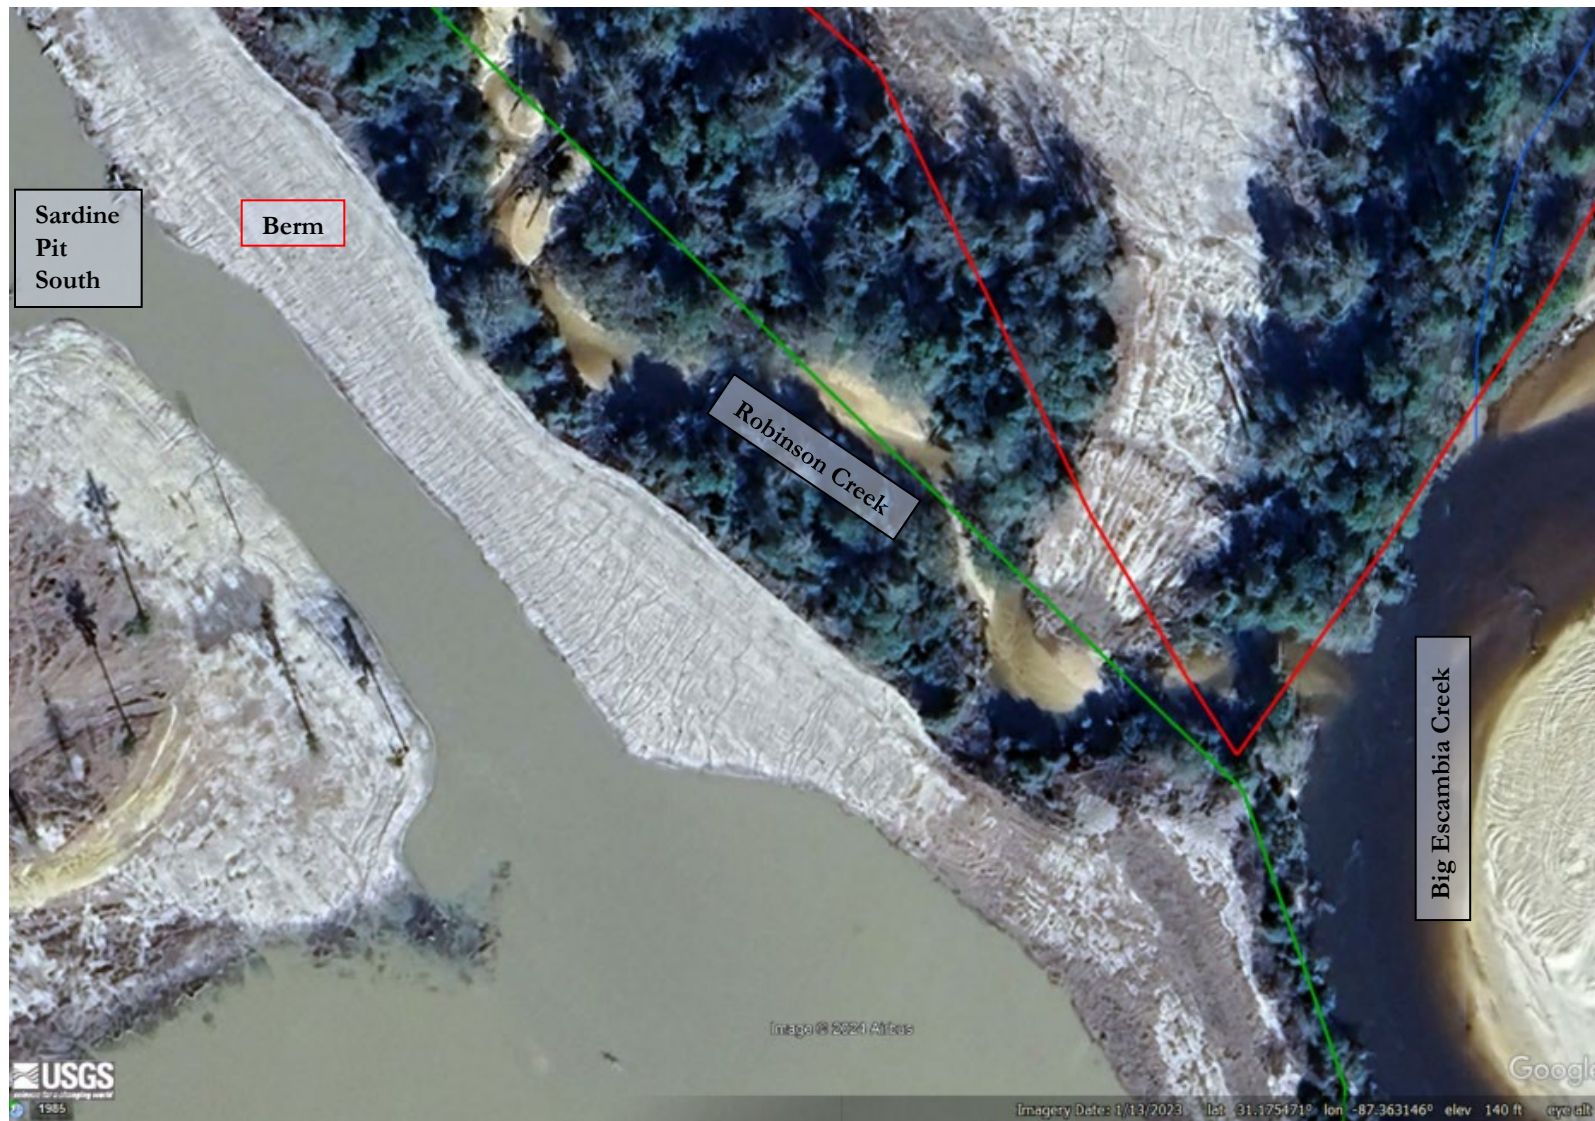
**Figure 7.** *GoogleEarth* aerial image of the reclaimed Sardine Pit South, imagery dated January 13, 2023. The green line indicates the approximate property boundary of the previously permitted Sardine Pit South; the red line indicates the approximate property boundary of the Facility.
