## **RCRA Inspection Report**

Purecoat International, LLC  
3301 Electronics Way  
West Palm Beach, FL 33407

EPA ID # FLD980839013  
NAICS # 332813 – Electroplating,  
Plating, Polishing, Anodizing, and  
Coloring

January 23, 2024

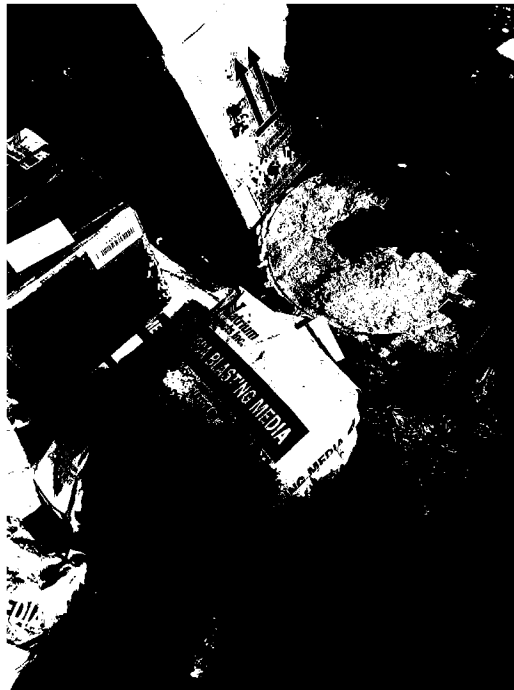
The inspectors observed one 58-pound torn bag which was spilling “soda blasting” on the floor. In addition, waste from a damaged container was also observed in this area. This material had not yet been determined as waste or if it could be used as product. Photo #2. Per the email received from Johnny Keohan on February 3, 2024, the spill was addressed and processed by their waste treatment system.

Photo #2 – one bag of 58-pounds broken and spilling “soda blasting” on the floor

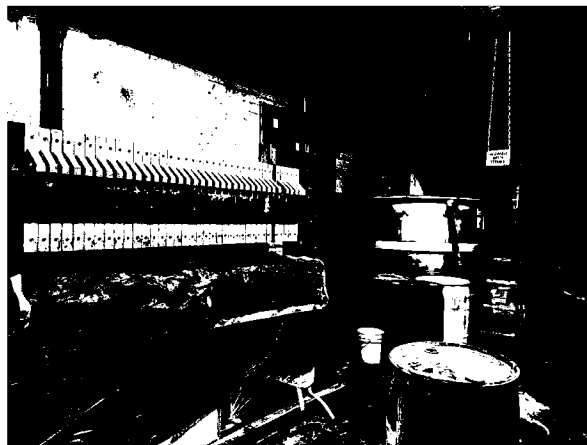
- Wastewater Treatment Unit #1 - The sludge removed from the filter press, is accumulated in two (1)-cubic yard bags/totes located underneath the filter press. The bags/totes were closed; however, were not labeled with the words “hazardous waste”, dated, or with the indication of the hazard of the contents. Due to the capacity of the bags/totes (1 cubic yard), this area shall be considered and inspected as a central accumulation area. Photo #4.

Photo #4 – Wastewater Treatment Unit #1: two (1)-cubic yard bag/tote located underneath the filter press

Photo with new label was received by email on February 3, 2024; however, the container was not labeled or marked with the appropriate hazard indicator. Instead, it

was labeled with the Class 9 (miscellaneous) Department of Transportation (DOT) label. Recent guidance from the EPA (February 2023), states that the Class 9 DOT label, by itself, does not adequately indicate the hazard associated with the container's content. Per an email dated, March 1, 2024 – a new toxic label was attached.

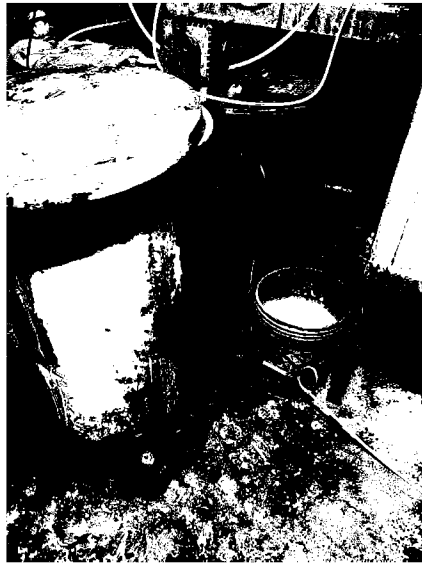
One (55)-gallon container, one (5)-gallon container (with liquid), and a small bucket (less than 5 gallons with sludge) were observed opened, not labeled with the words "hazardous waste", or with the indication of the hazard of the contents. Photos #5 and #6.

Photo #5 – 55-gallon container and 5-gallon container opened and without marking

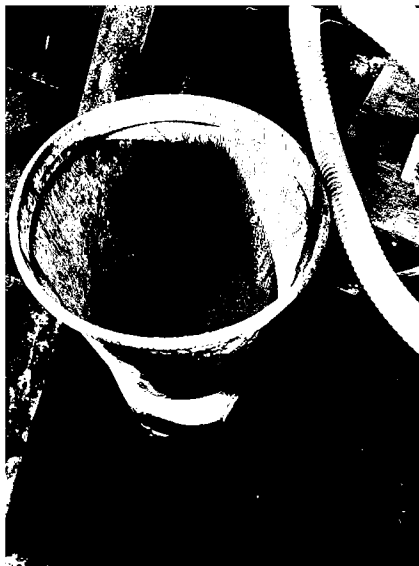
Photo #6 – small bucket (less than 5 gallons with sludge)

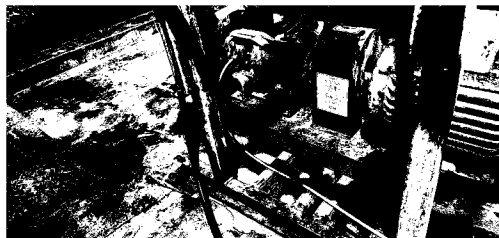
Photo #10 – Wastewater Treatment Unit #2

Leaking pump

Pump repaired

A photo with new label was received by email (from Johnny Keohan) on February 3, 2024; however, the bag/tote was not labeled or marked with the appropriate hazard indicator. Instead, it was labeled with the Class 9 (miscellaneous) Department of Transportation (DOT) label. Recent guidance from the EPA (February 2023), states that the Class 9 DOT label, by itself, does not adequately indicate the hazard associated with the container’s content. On March 3, 2024, a photo with a “toxic label” to mark the container was received by email. The leak on the pump was repaired.

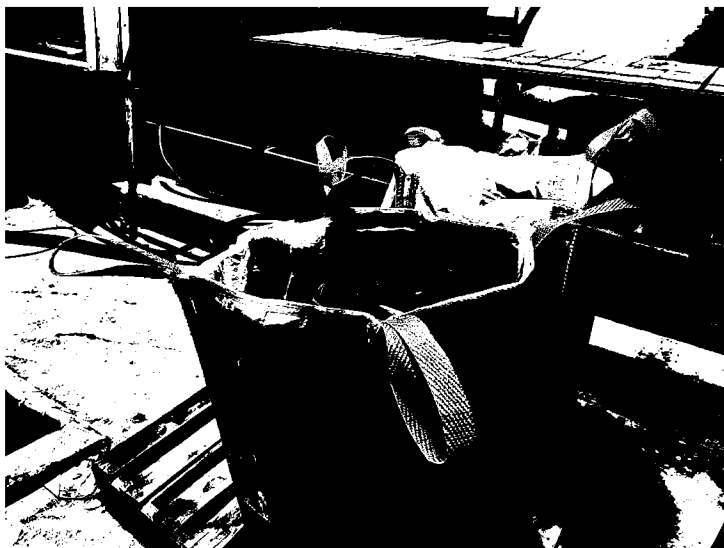
- SAA-Two quarter-bags/totes (approximately 43 dry gallons), from the “nibron” plating were observed to be opened, labeled as “hazardous waste (“nibron” cleanup solids and hazardous chromate waste). The bags/totes were not labeled with the indication of the hazard of the contents (Photo #11). Furthermore, one 5-gallon shop vacuum container was observed to be closed and labeled with the words “for nitric holding tank cleaning”. The vacuum was not labeled with the words “hazardous waste” and with an indication of the hazards of the contents (Photo #12).

Photo #11 – SAA in the Cyanide Room: Two quarter-bag/tote (approximately 43 dry gallons), from the “nibron” plating

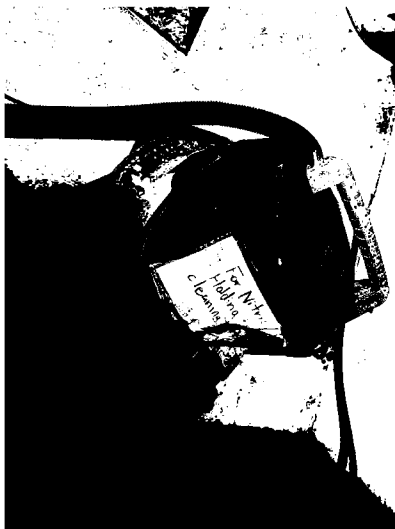
Photo #12 – A 5-gallon shop vacuum container in the Cyanide Room

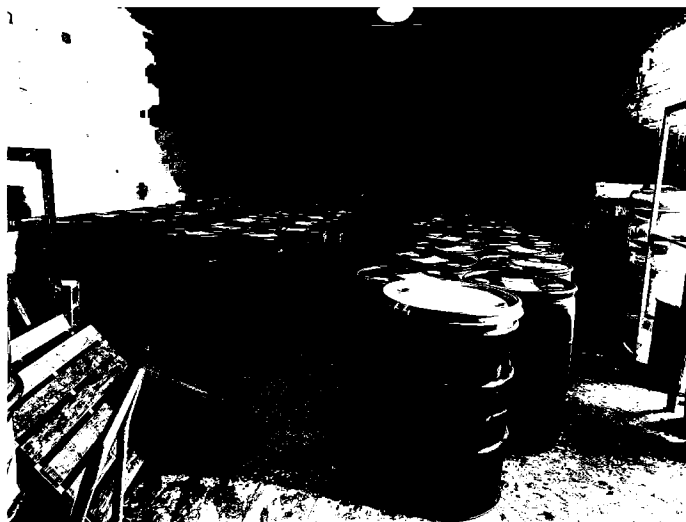
Line #1 (left side) – Approximately, sixteen (55) -gallon containers were observed in this line. Three containers were empty, five were labeled as non-hazardous, and one was dated April 25, 2023, exceeding the 90 accumulation days. Photo #14.

Line #2 (middle) – Approximately, twenty-five (55)-gallon containers were observed in this line. Twelve containers were pending of analysis, and one was marked as non-hazardous (electroless nickel). Photo #14.

Line #3 (right side) – Approximately, thirty-five (55)-gallon containers were observed in this line. Photo #14.

Photo #14 – 90 days CAA

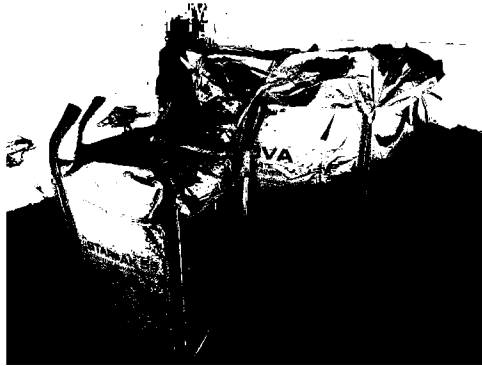
On the back wall to the left – one quarter bag/tote (material from spills) was not labeled with the words “hazardous waste”, not marked with the indication of the hazard of the contents and

not dated. One (1)- cubic yard bag/tote was observed with a label that read “waste pending characterization” and dated May 20, 2022. Photo #15.

Photo #15 – CAA: one quarter bag/tote and one (1)- cubic yard bag/tote

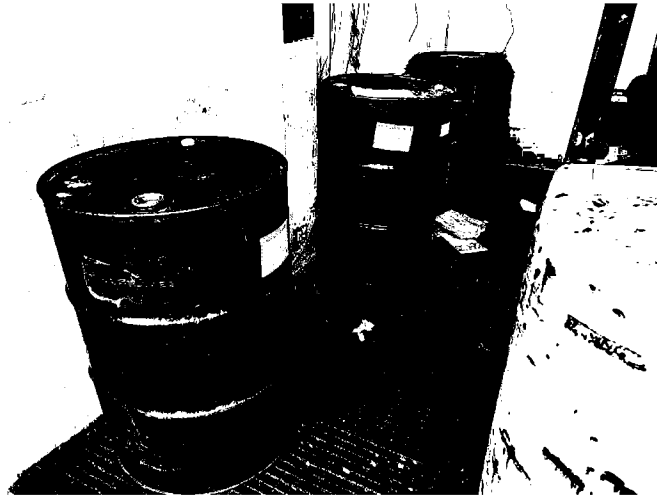
The flammable liquid waste is stored outside of the facility next to the outdoor holding tank (Photo #17). This area is covered and has three low walls with a fence between the walls and overhead covering and is surrounded by a secondary containment. The fourth wall is open facing to the parking lot to add or remove waste from the area. The area had a wall in the center separating flammable product on the right from the flammable waste on the left. Signage of “No Smoking”, “Hazardous Waste Containment Area” posted at the gate. The following was observed in this area:

Photo #17 – CAA: Flammable Waste Storage Area

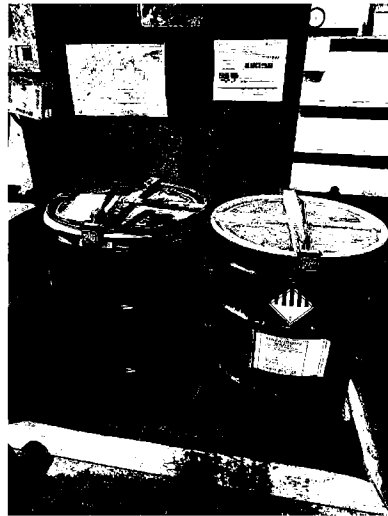
Photo #18 – SAA Nibron Plating Area: container not labeled or marked with the appropriate hazard indicator

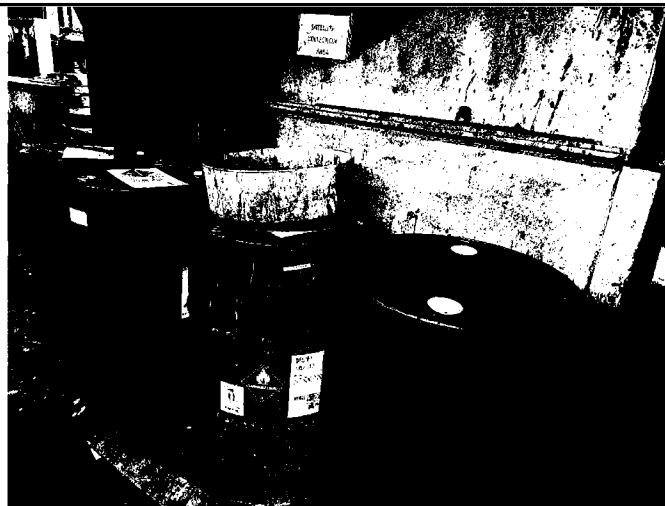
Products are brought to this area after plating to clean and localize plating. Secondary containment around the degreasing area appeared unmaintained and contained oil spills filling over half of the containment. Four (55)-gallon containers were observed in this area as follows:

Two closed (55)-gallon containers not labeled with the words “hazardous waste” and one of them was not marked with the indication of the hazards of the contents. Photo #20.

Two closed (55)-gallon containers (one with funnel on top) with methyl ethyl ketone (MEK) were not labeled with the words “hazardous waste” and one of them was not marked with the indication of the hazards of the contents. Photo #20.

Photo #20 – Degreasing Area

A photo was received by email (from Johnny Keohan) on February 3, 2024; with containers labeled or marked with the with the indication of the hazards of the contents.

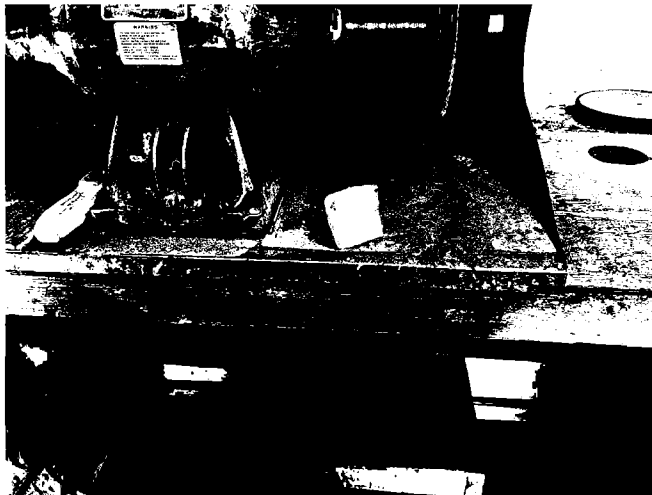
The Polishing Area is the finishing process for military aviation parts after plating. Some debris or residues from the polishing process were observed in this area. According to Mr. Johnny Keohan, this material is disposed of as regular trash. Photo #21.

Photo #21 – Polishing Area

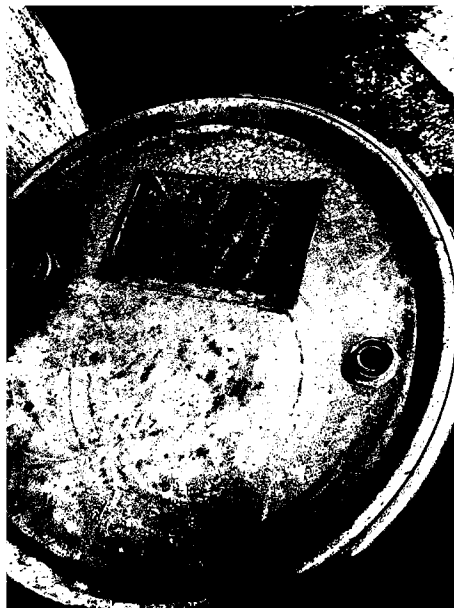
Photo #22– Dry Paint

One (55)-gallon container labeled as “dry paint” was observed closed in this area. The container was closed; however, it was not labeled with the words “hazardous waste” and with the indication of the hazards of the contents. Photo #22.

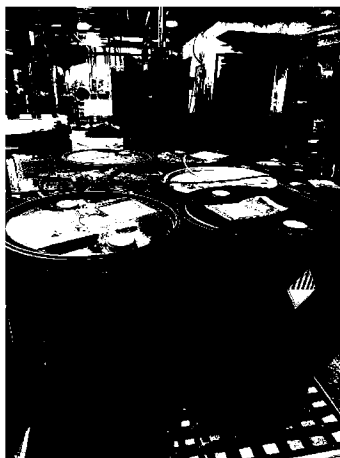
Photo #24 – SAA: Main Plating Area

Six (55)-gallon containers with silver, stripper, nitric acid 50%, tarni ban filters, nitric bifluoride, tarni ban liquid, and cadmium filters, were observed closed, labeled with the words hazardous waste”, and with the indication of the hazard of the contents. One of these containers was not labeled or marked with the appropriate hazard indicator. Instead, it was labeled with the Class 9 (miscellaneous) Department of Transportation (DOT) label. Recent guidance from the EPA (February 2023), states that the Class 9 DOT label, by itself, does not adequately indicate the hazard associated with the container’s content. This waste stream comes from the precious metal aluminum line. Photo #24.

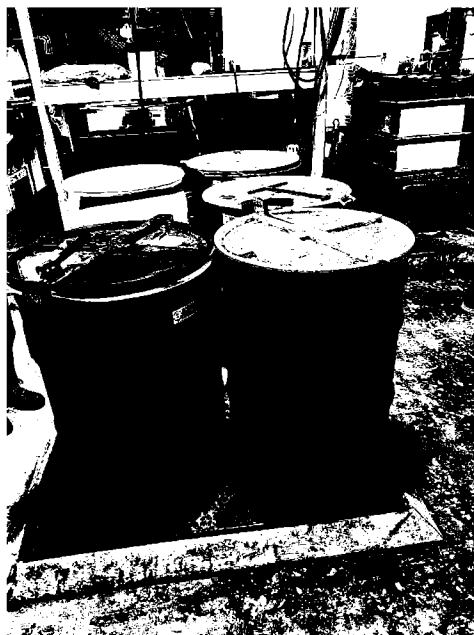
Photo #25 – SAA: New Precious Metals Line

waste”, and with the indication of hazard of the contents (toxic). One container was labeled as non-hazardous (pyro cooper bath filters). Photo #25.

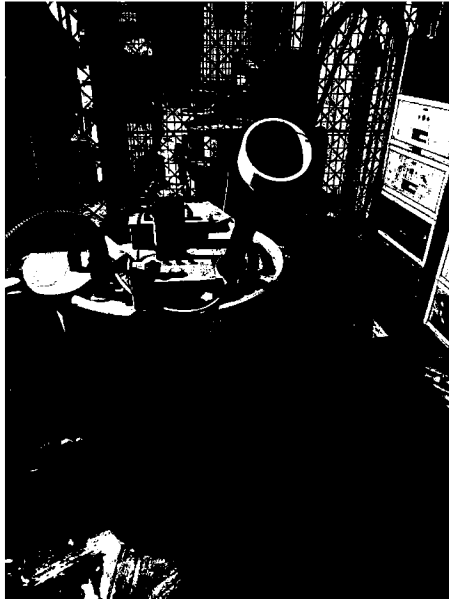
Photo #28– Universal Waste Lamps

The facility generates universal waste lamps that are stored in the Maintenance Shop Area. The facility crushed the lamps (Light-Emitting Diodes (LED)) using a 55-gallon container. LED lamps do not contain mercury; however, is recommended to label the container with the words "Universal Waste—Lamp(s)," "Waste Lamp(s)," or "Used Lamp(s)" on the box (non-crushed) and "Crushed Non-Mercury Lamps" on the container used to crush the lamps. Photo #28.
