Tittabawasse River and Floodplain Cleanup: **A Model for Success**

JUNE 15, 2017

Tittabawasse River and Floodplain Cleanup

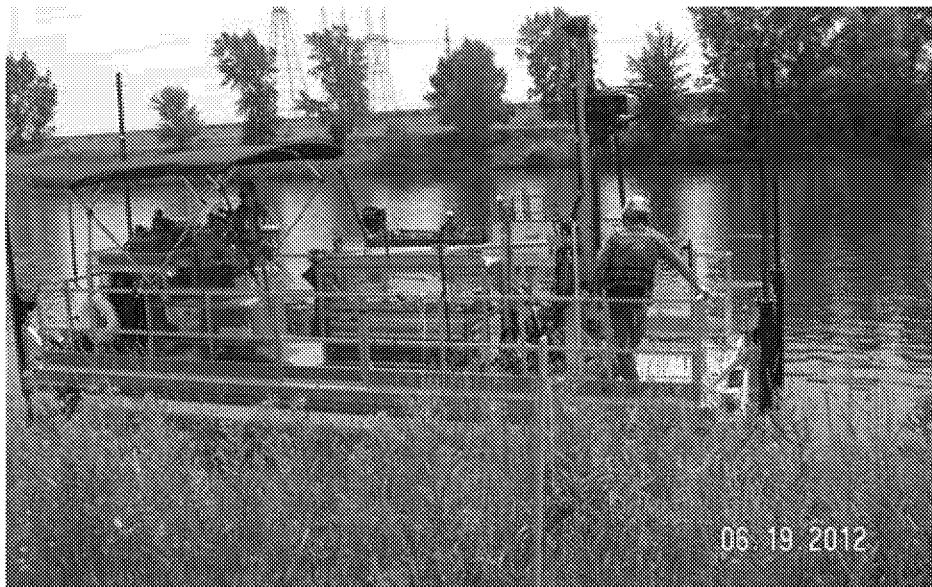
Sonic rig used to install sampling wells

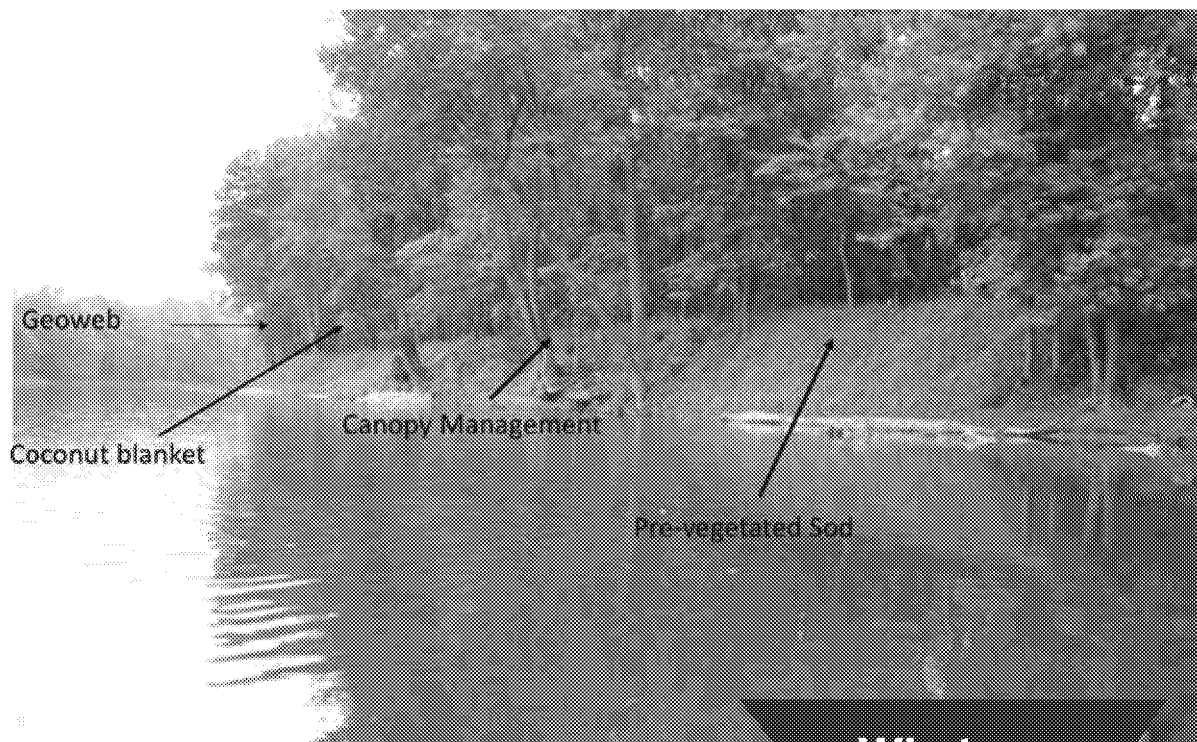
Pilot bank stabilization technologies were installed in 2008 through 2011 along the Tittabawasse River. The pilots provided EPA and Dow information to select and design effective, bioengineered and sustainable technologies for banks.
