**CWA COMPLIANCE EVALUATION INSPECTION REPORT  
U.S. ENVIRONMENTAL PROTECTION AGENCY, REGION 5**

**Facility:** Village of Kingston Wastewater Treatment Plant  
1050 S. South Street  
Kingston, Wisconsin 53939

**WPDES Permit Number:** WI0036421

**Date of Inspection:** May 1, 2025

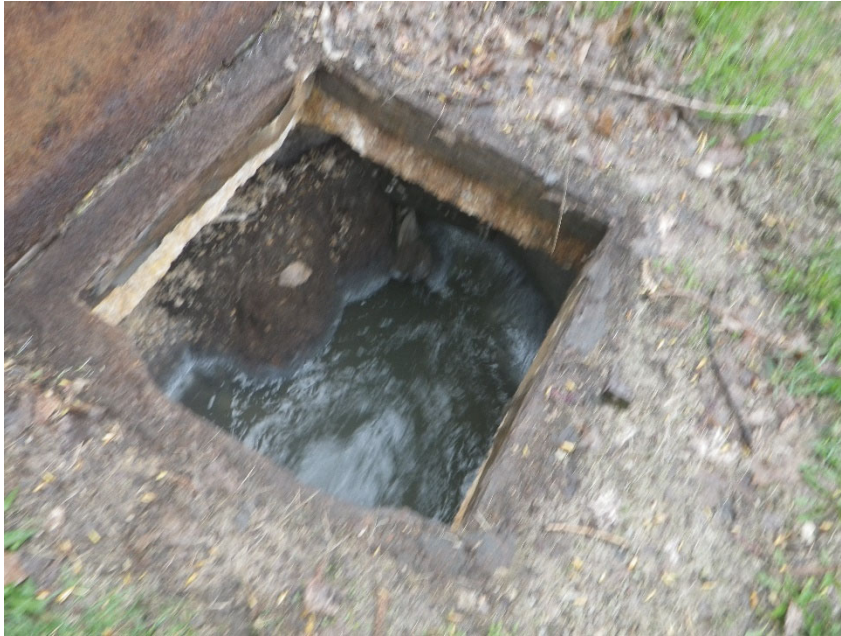
1: IMGP0001

At 10:18 am, EPA and Mr. Dolgner viewed the influent pit that flowed into the Kingston WWTP from the septic tank. This wastewater then flowed into Lagoon Pond #1 (Photograph 1 in Attachment A). At this time, Mr. Dolgner and EPA followed the influent to Lagoon Pond #1 (Photograph 2 in Attachment A). EPA observed that the surface aeration setup on both lagoon ponds, which consisted of an air hose that was attached to two perforated pipes in the center of the pond (Photograph 4 in Attachment A). This perforated pipe appeared to be in places not making contact with the surface of the pond. Mr. Dolgner did mention later in the inspection that there had been some consideration for a different aeration setup than the current WWTP setup. EPA also noticed riprap along the water surface level to restrict vegetation growth and erosion. EPA and Mr. Dolgner went back inside to the WWTP building to continue discussing the WWTP operation.

Description: Influent into Kingston WWTP from Septic Tank

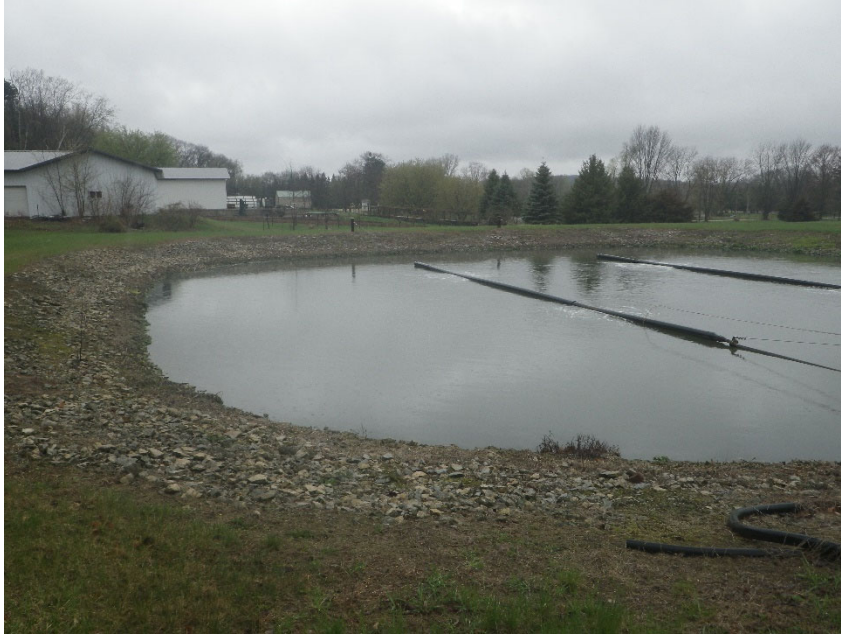
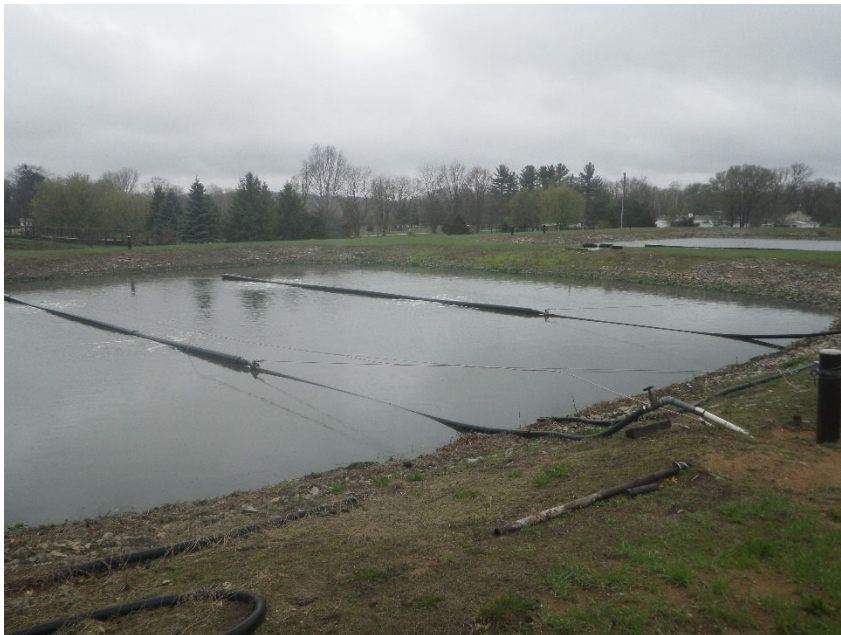
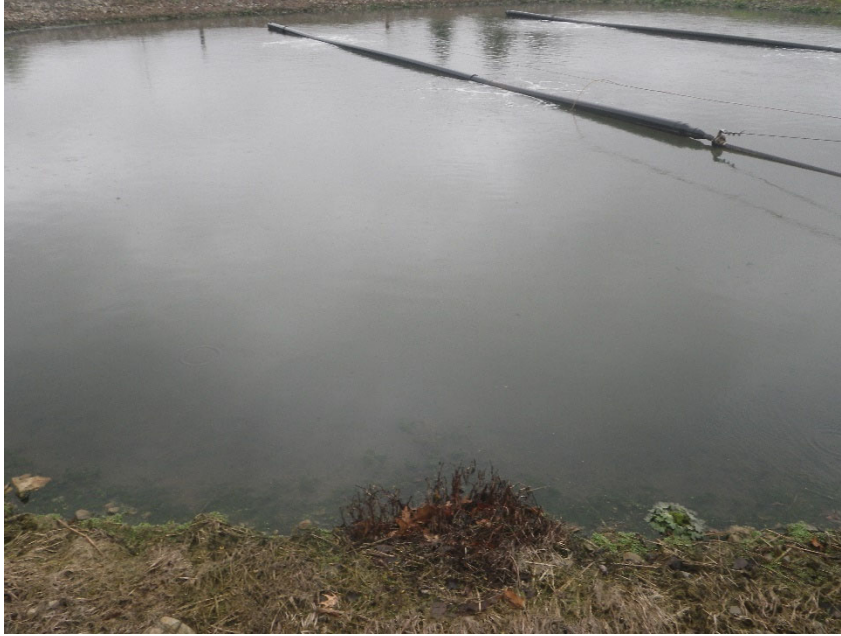
2: IMGP0002

Description: Lagoon Pond #1 with Aerators

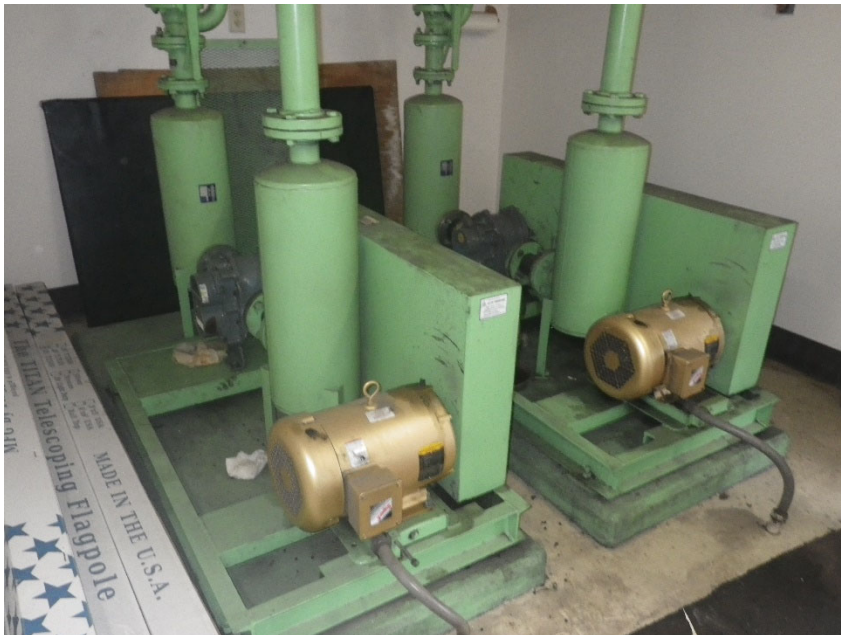
5: IMGP0005

At approximately 10:27 am, Mr. Dolgner then showed EPA a room within the WWTP building that housed the aeration blower motors (Photograph 5 in Attachment A). Mr. Dolgner explained to EPA that the blower motors are rotated in and out of service every 3-4 months. In addition, Mr. Dolgner performs the routine maintenance on this equipment. While in this room, EPA observed the ferric acid (Photograph 6 in Attachment A) and the sulfuric acid dosing setup. Mr. Dolgner estimated that the Kingston WWTP uses approximately one 55-gallon drum of ferric acid each month. Mr. Dolgner indicated to EPA that the WWTP uses much less sulfuric acid, which is added to the effluent to achieve a constant pH of about 7.5. Mr. Dolgner told EPA that the ferric acid and sulfuric acid are supplied by Hawkins, a wastewater treatment chemical supply company. EPA and Mr. Dolgner then went back to the main room in the WWTP building to continue discussing EPA's questions related to the Kingston WWTP.

Description: Aeration Blower Motors

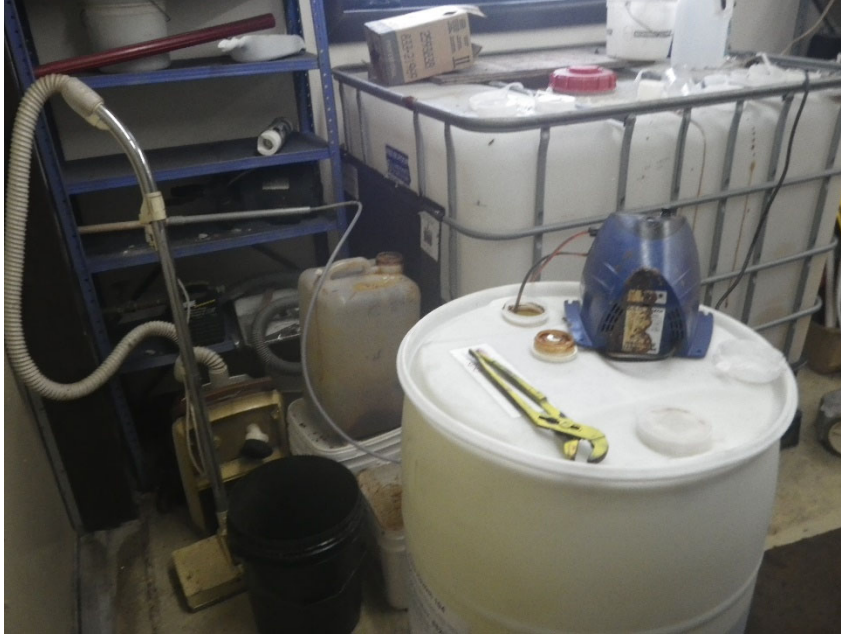
6: IMGP0006

Description: WWTP Ferric Acid Dosing Setup

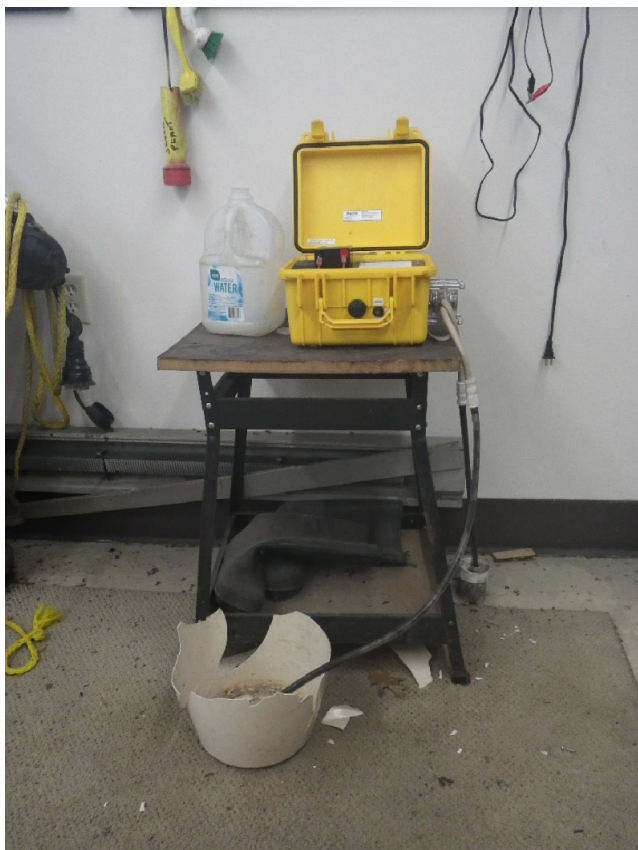
7: IMGP0007

While EPA and Mr. Dolgner discussed the Kingston WWTP's WPDES permit compliance sampling, Mr. Dolgner showed EPA the pump used to obtain compliance samples from the Kingston WWTP effluent sampling point (Photograph 7 in Attachment A). Mr. Dolgner then used the pump to obtain an effluent sample (Photograph 8 in Attachment A). The sample obtained at this time appeared clear.

Description: Effluent Compliance Sampling Location

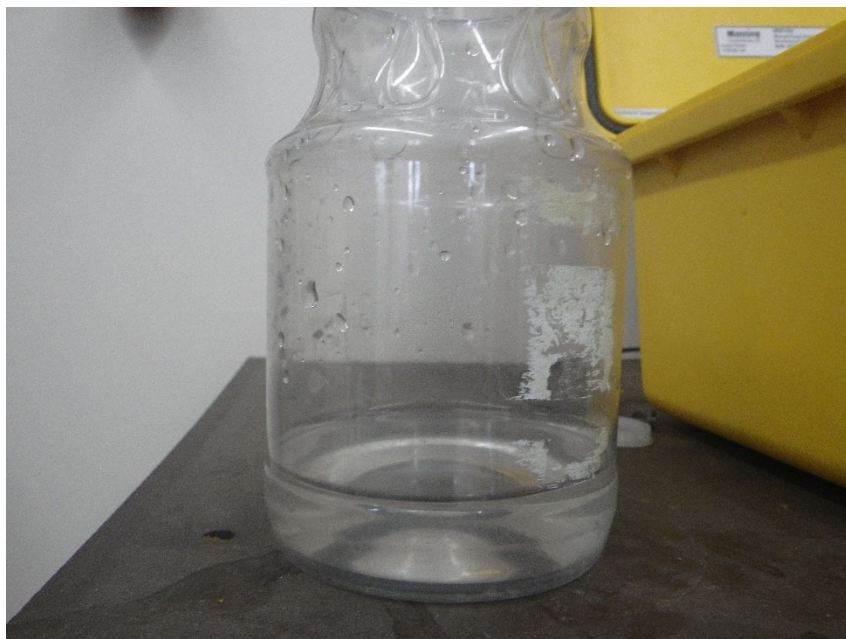
8: IMGP0008

Description: WWTP Sample Effluent

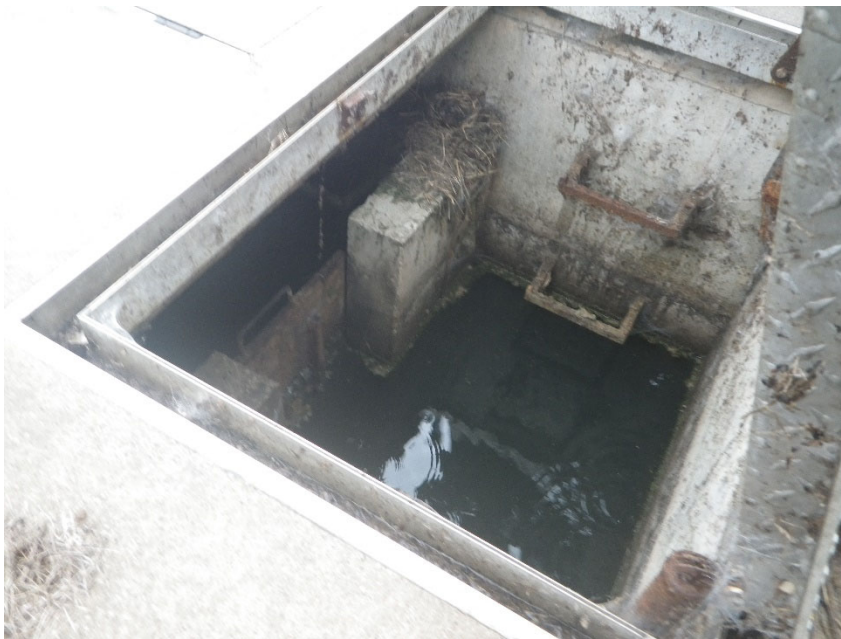
11: IMGP0011

Description: Control Structure Between Lagoon Pond #1 and Lagoon Pond #2

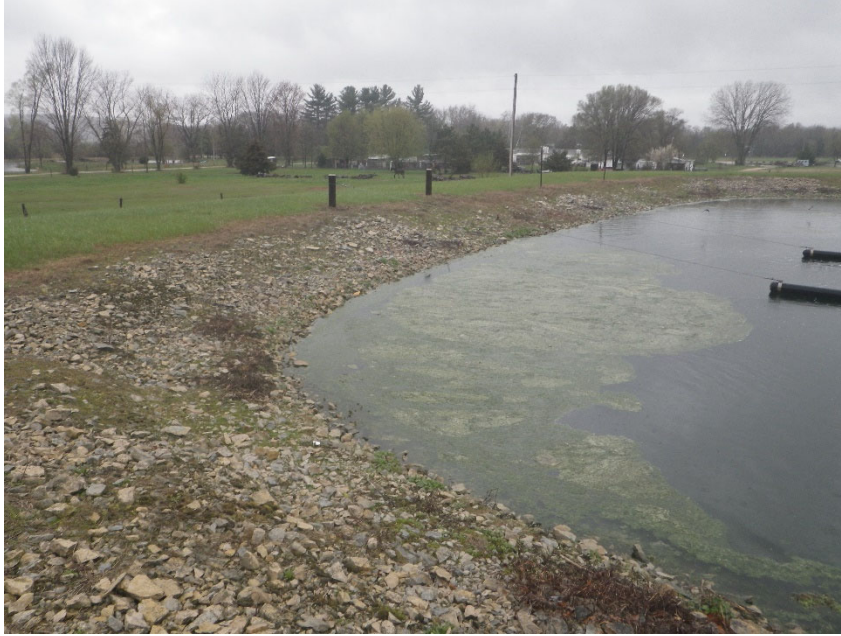
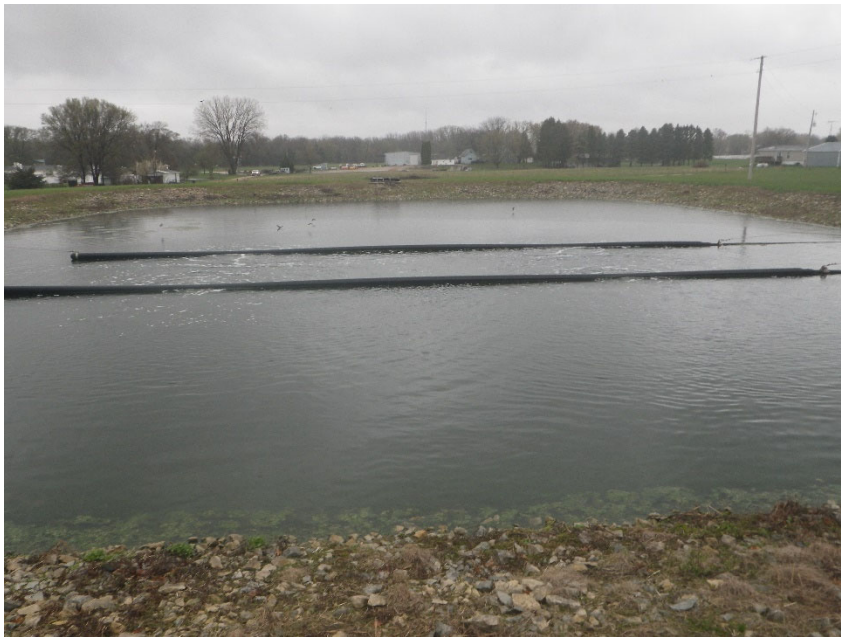
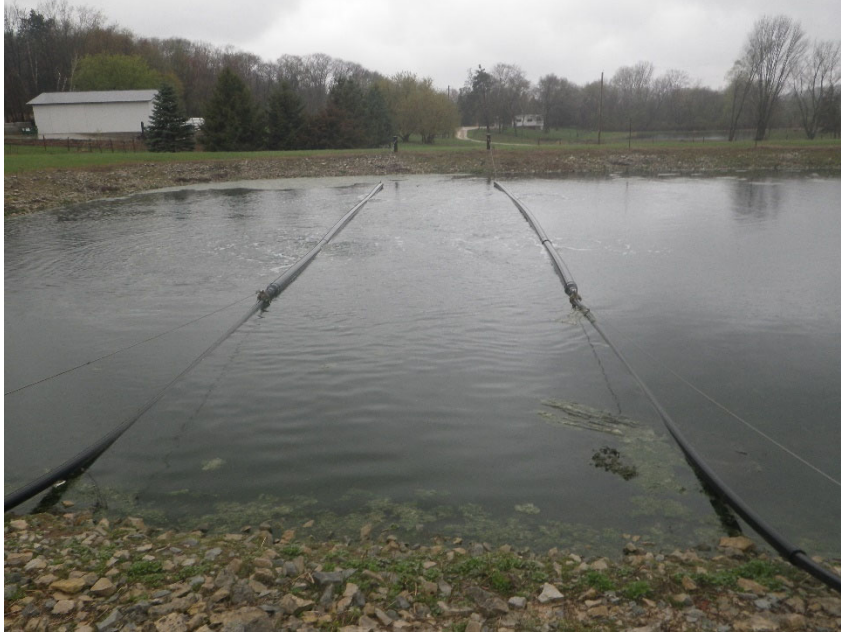
12: IMGP0012

In addition, EPA observed some algae build-up in the southwest corner of Lagoon Pond #2. Aerated lagoons should not have a build-up of algae. Since algae can raise the amount of TSS and BOD5 levels, especially when it begins to die, EPA is concerned about its presence in the Kingston WWTP. EPA is unclear if the Kingston WWTP has employed any measure, such as copper sulfate, to control the build-up of algae.

Description: Lagoon Pond #2

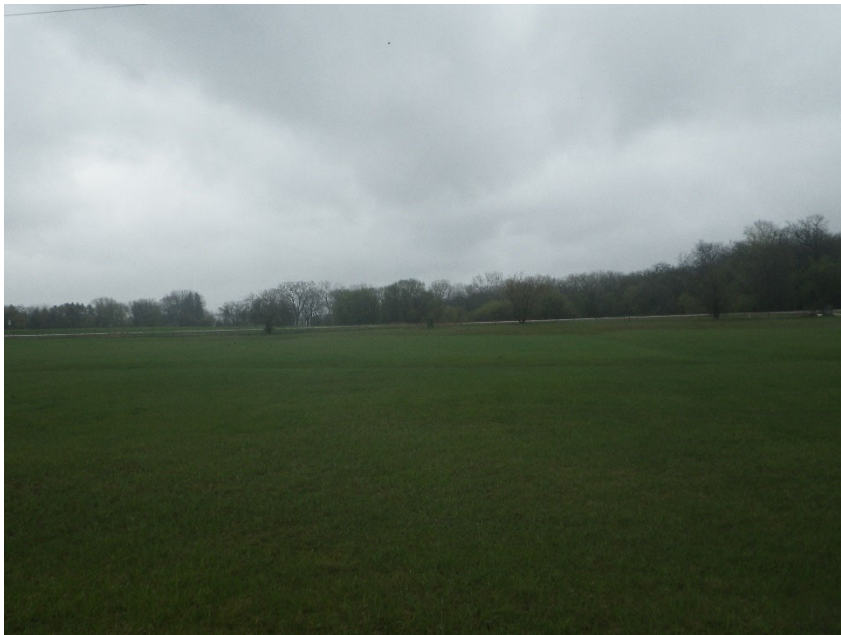
15: IMGP0015

weir that controls the water surface elevation in the lagoon ponds, unless there is a large precipitation event that has occurred. EPA and Mr. Dolgner then turned to the north to observe lagoon pond #2. The aeration setup for Lagoon Pond #2 was similar to Lagoon Pond #1, with the same perforated aeration pipe setup (Photograph 13 in Attachment A). EPA did notice that there was some algae buildup on the southwest corner of Lagoon Pond #2 (Photograph 14 in Attachment A). There was also some buildup of material in Lagoon Pond #2 along the northern aeration hose (Photograph 15 in Attachment A).

Description: Leach Field

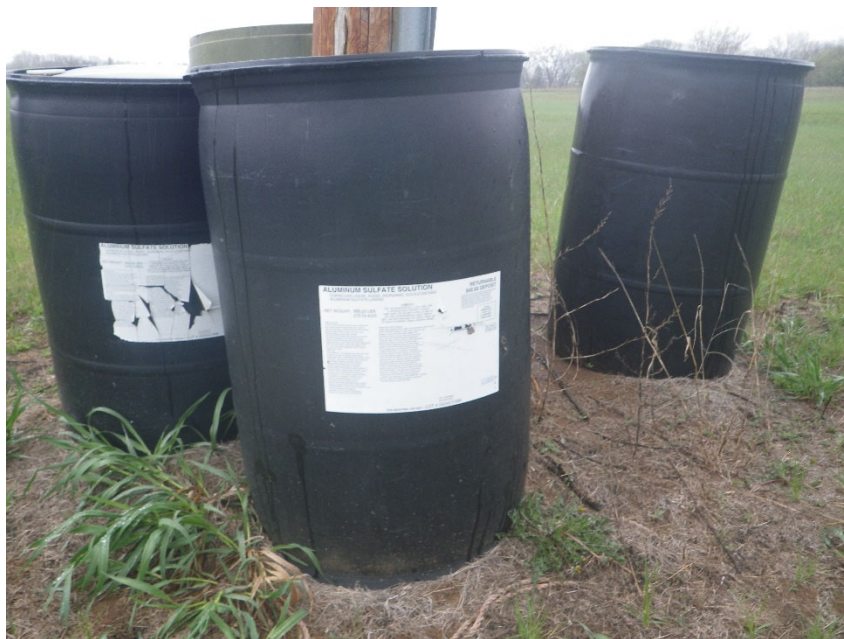
16: IMGP0016

10. Chemical Drum Storage Outside: During the inspection, EPA observed chemical drums/storage containers oriented around a power pole in between the Kingston WWTP and the leach field (Photograph 16 in Attachment A). The drums were labeled to contain aluminium sulfate and EPA confirmed that there was still liquid in the drums. Mr. Dolgner was not sure what was in these drums. If the drums still did contain aluminium sulfate, EPA would be concerned about the spill potential associated with the drums stored in this manner.

Description: Assorted Chemical Drums

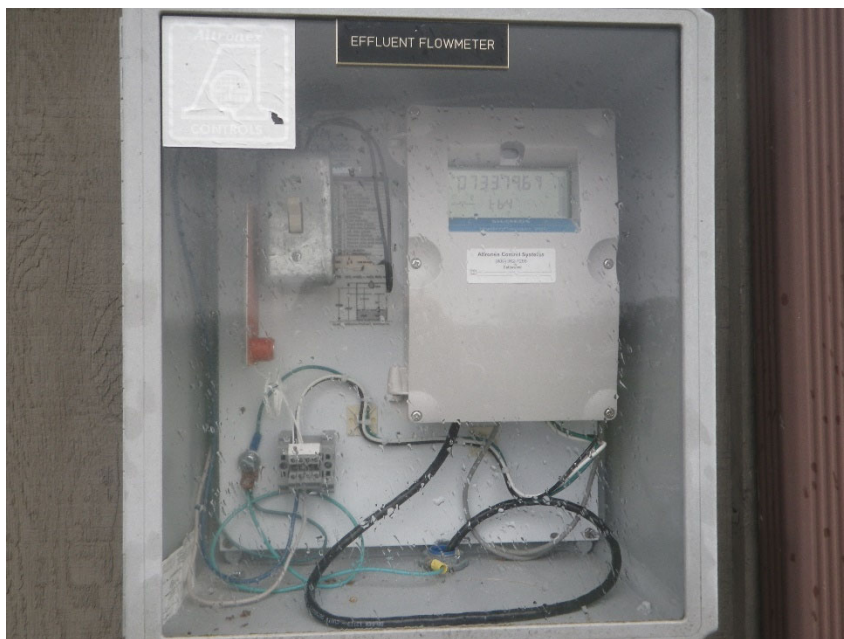
17: IMGP0017

Description: Effluent Flow Meter Read-Out

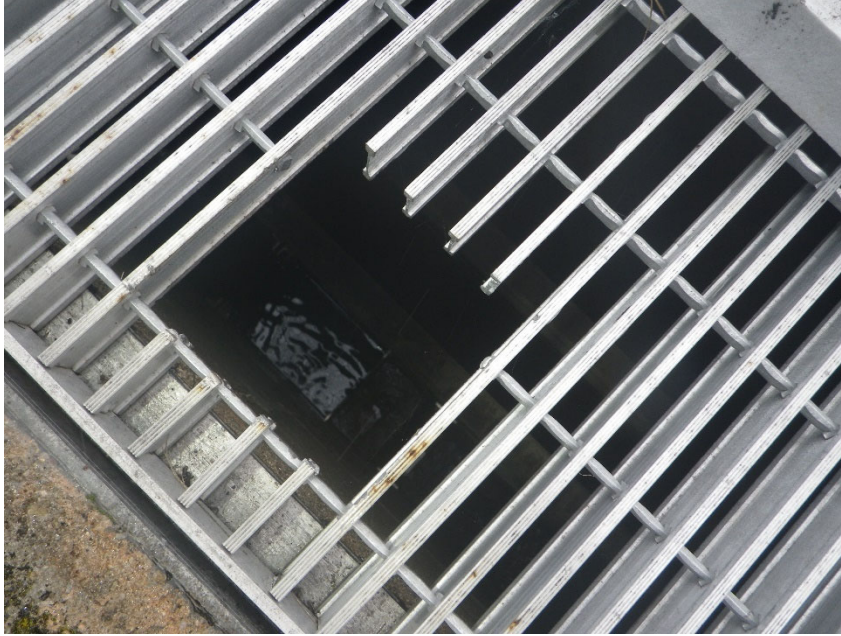
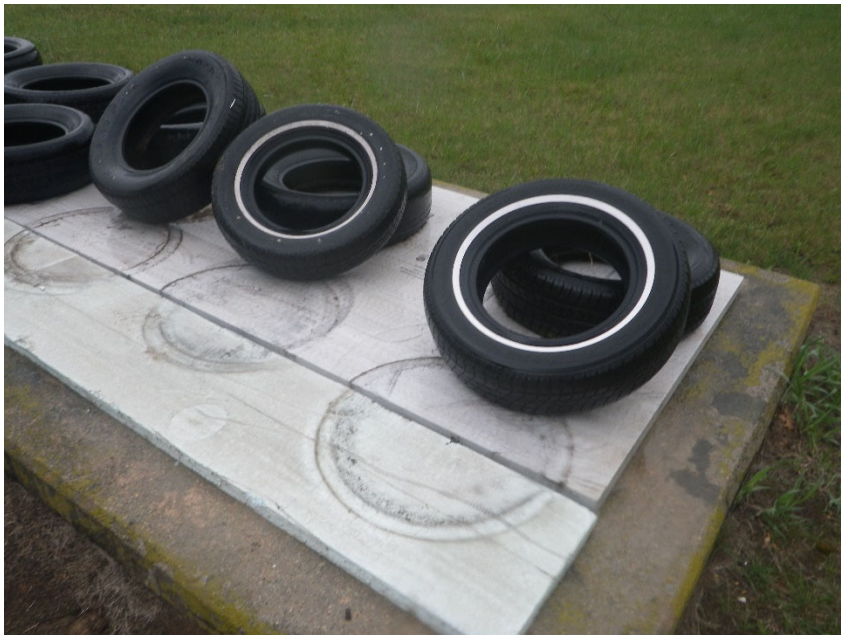
18: IMGP0018

Next, EPA and Mr. Dolgner walked to the effluent pit. At the effluent pit, Mr. Dolgner removed the cover to allow EPA to look in at the pit (Photograph 18 and 19 in Attachment A). Mr. Dolgner explained that he covers the effluent pit because the pit can freeze in the winter and cause a disruption that would not allow the WWTP to discharge effluent. EPA also observed the effluent flow meter readout screen on the west wall of the WWTP building (Photograph 17 in Attachment A). EPA and Mr. Dolgner then walked to the effluent wet well that was located south of the WWTP building. Mr. Dolgner removed the effluent wet well manhole cover to allow EPA to observe the wet well (Photograph 20 in Attachment A).

Description: Effluent Pit

Description: Covered Effluent Pit

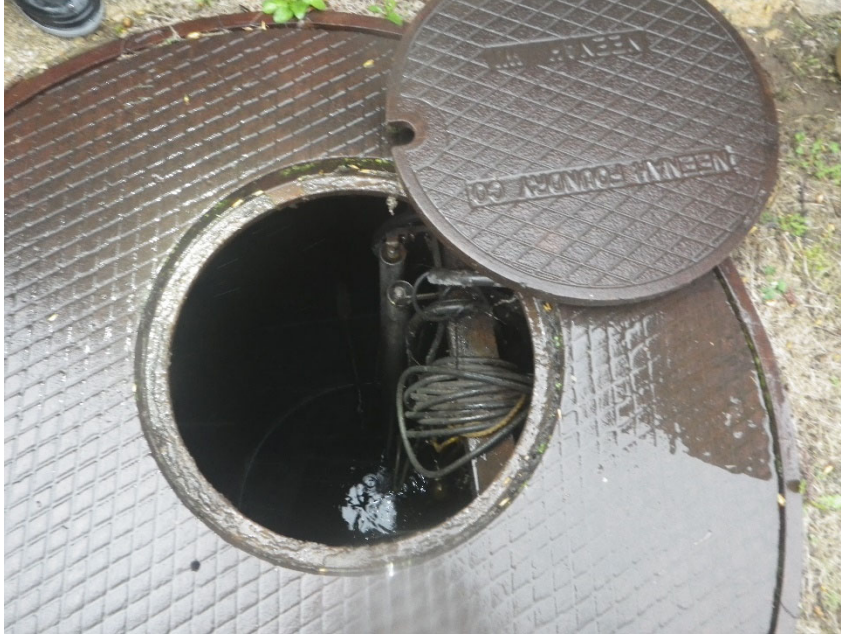
20: IMGP0020

Description: Effluent Wet Well

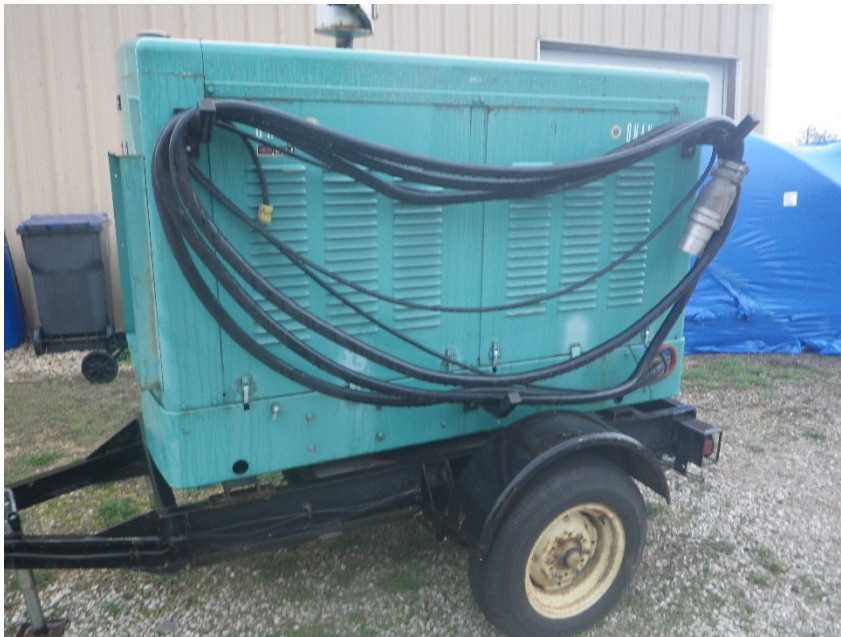
21: IMGP0021

EPA and Mr. Dolgner then left this portion of the Kingston WWTP and drove 5 minutes to the north to the Kingston village hall building to view the WWTP backup generator (Photograph 21 in Attachment A). Mr. Dolgner informed EPA that this backup diesel generator that can power the WWTP and the three lift stations located within the Kingston sewer collection system. Next, EPA and Mr. Dolgner drove to the east to observe the lift station (Photograph 22 and 23 in Attachment A) and the septic tank (Photograph 24 in Attachment A). EPA learned from Mr. Dolgner that the lift station at this location could pump about 2,200 gallons per minute to the Kingston WWTP. Mr. Dolgner also explained to EPA how the three septic tanks were arranged and how United would pump solids out of the septic tank.

Description: Backup WWTP Diesel Generator

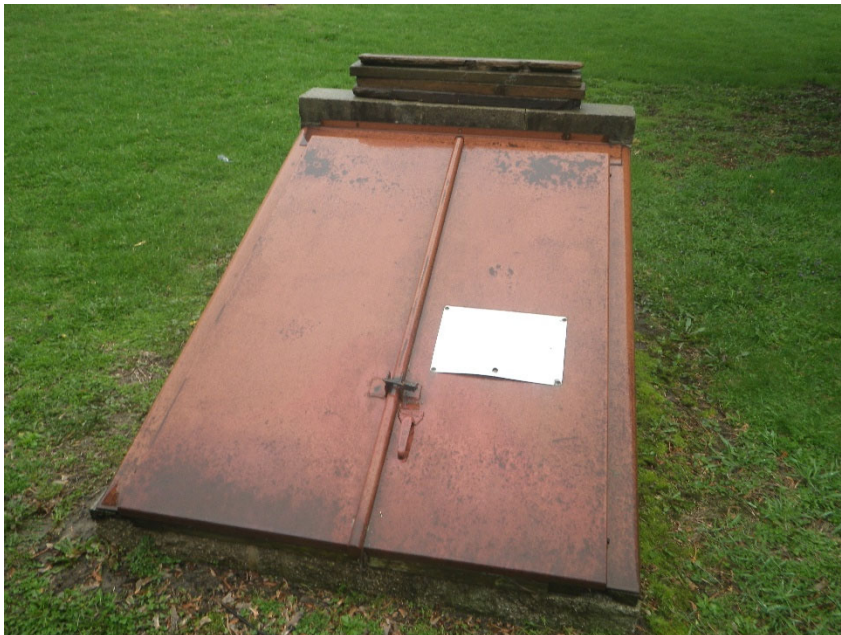
25: IMGP0025

Then, EPA and Mr. Dolgner drove a short distance north to view one of the Kingston sewer collection system lift station locations. In Doc Meyers Community Park, EPA observed the lift station location (Photograph 25 in Attachment A). Next, EPA and Mr. Dolgner drove west to 550 Main Street to view the last lift station within Kingston (Photographs 26 and 27 in Attachment A). At both of these locations, EPA did not notice or observe any evidence of a

Description: Doc Meyers Community Park Lift Station

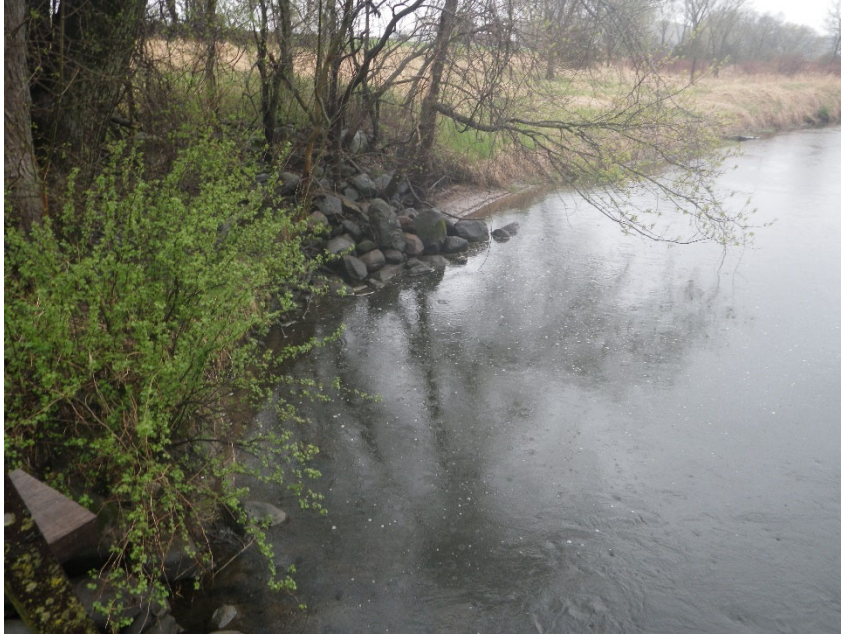
28: IMGP0028

15. WWTP Effluent Discharge in Grand River: At Outfall 001 (Kingston WWTP treated effluent discharge to the Grand River), EPA observed numerous small white bubbles around the submerged discharge pipe (Photograph 28 in Attachment A). It was unclear if the presence of these white bubbles was because of the composition of the discharge or because of the submerged discharge being discharged to the Grand River under pressure. Section 6.4.4 of Kingston WWTP's WPDES permit indicates that "there shall be no discharge of floating solids or visible foam other than trace amounts."

Description: Outfall 001 Effluent Location

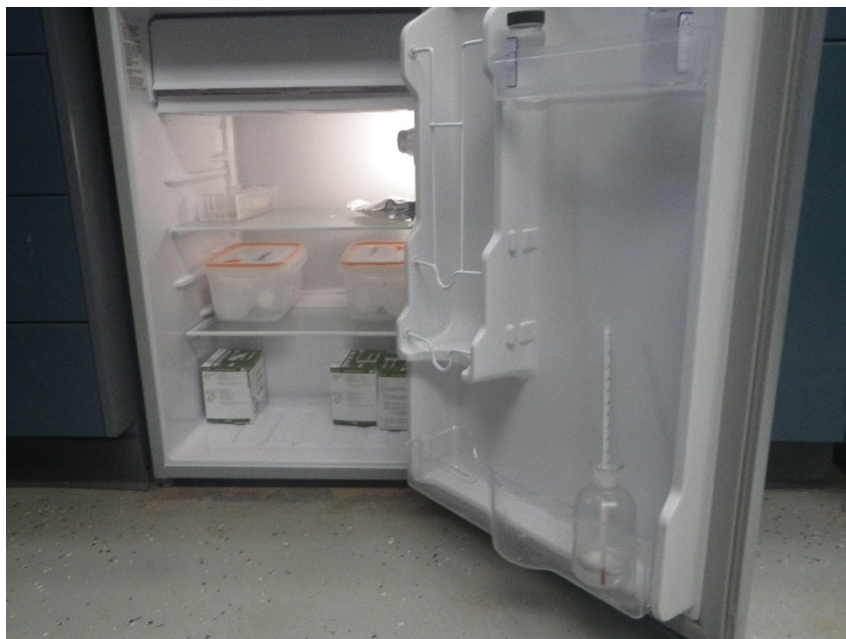
30: IMGP0030

Description: Sampling Refrigerator with Thermometer

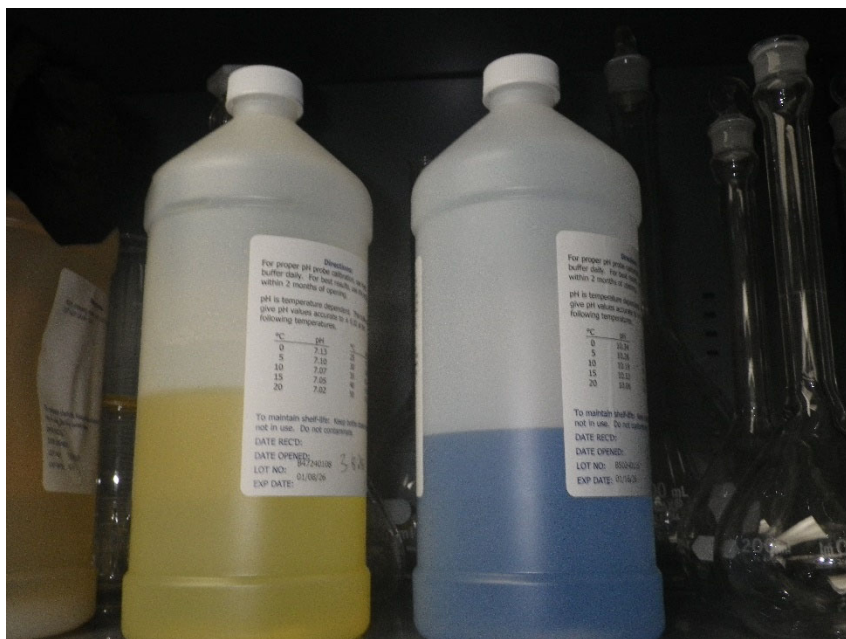
31: IMGP0031

Description: Bottles Used for Two-Point pH Calibration
