## **RCRA Inspection Report**

| Kewaunee Scientific Corporation | Physical Address: |

September 8, 2020

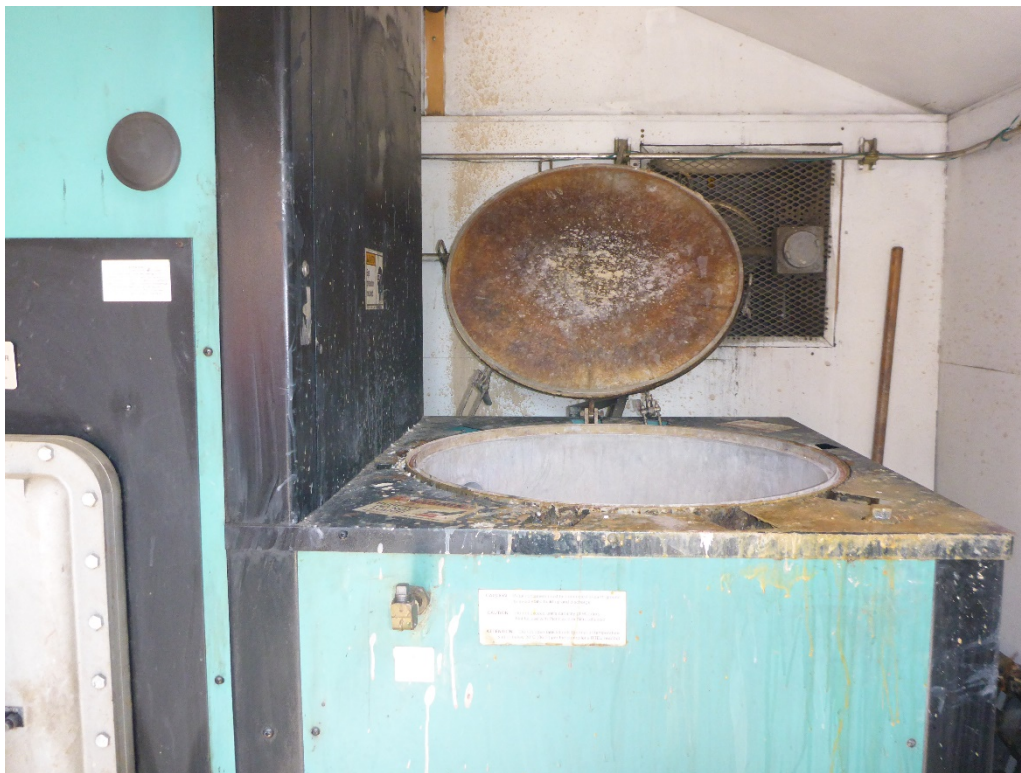
**Photo 1:** Open distillation unit inside the distillery.

**Wood Plant - Distillery:** The inspection participants visited the small outbuilding located next to the stain pump room at the Wood Plant. The building houses the facility's distillation system, and it is kept secure with a padlock on the door. The inspectors observed signs reading "Caution," "Hazardous Waste Satellite Accumulation Point," "Unauthorized Personnel Keep Out," "No Smoking," "Danger," and "Keep Out" on the door to the outbuilding. The inspectors observed an emergency eyewash station next to the SAA inside the building. The distillation unit was not in use at the time of the inspection, and the lid to the unit was open. The inspectors observed liquids inside the unit (Photos 1 and 2) and recommend that the facility review standard operating procedures to prevent potential release of hazardous wastes or waste constituents to the atmosphere.

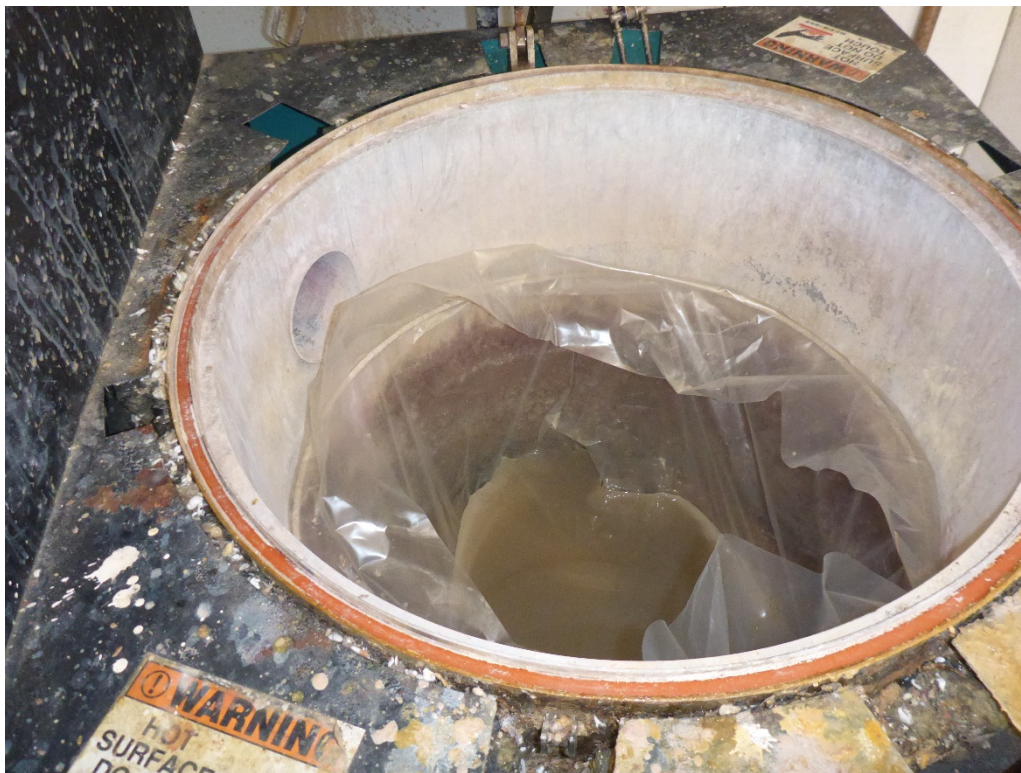
**Photo 2:** Spent solvent liquids inside the open distillation unit.

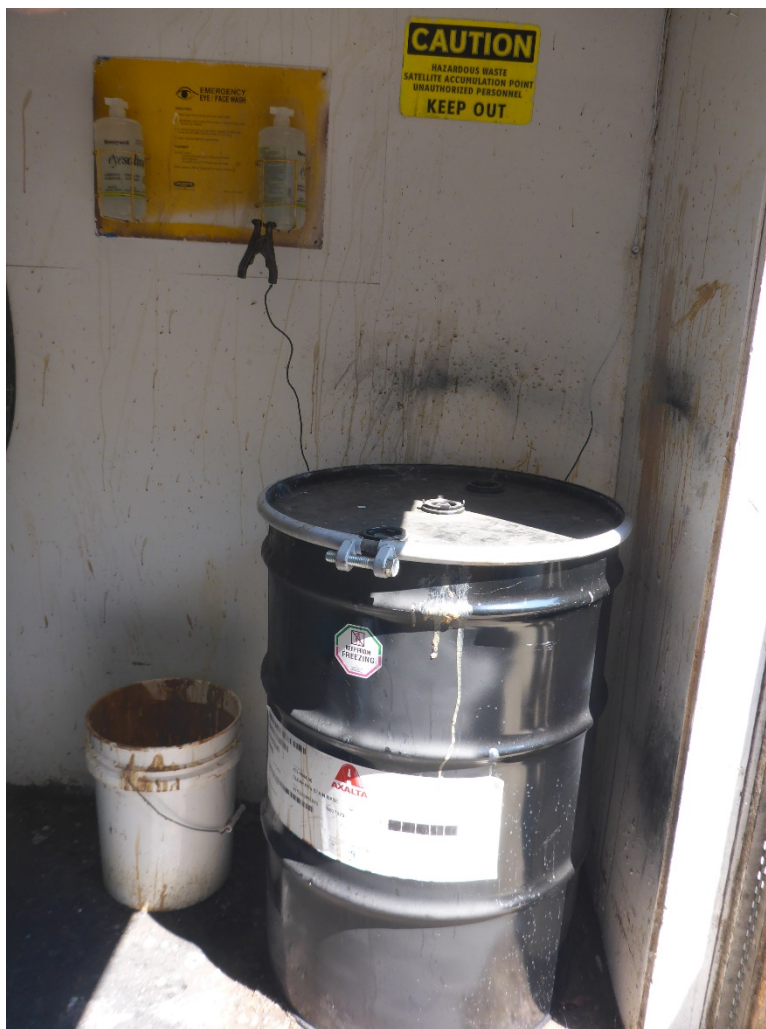
**Photo 3:** Wood Plant SAA for accumulating hazardous waste silt bottoms in the distillery. 55-gallon drum was grounded and closed, and reported to be empty.

Ms. Reavis stated that personnel working in the Finishing Room are responsible for running the system, and those personnel only work during the first shift. Mr. Will Gaillard, an employee familiar with the distillation system, stated that spent solvents are pumped directly from the tank near the process lines into the distillation unit, and recovered solvent is pumped into a 55-gallon drum for re-use at the facility. Mr. Gaillard explained that the unit is typically operated only once each day, because it takes too long to cool down for a second cycle. Once cooled, leftover solids and paint are removed from the unit and accumulated in the SAA located in the corner of the building by the door (Photo 3). The inspectors observed one 55-gallon drum at this SAA. The drum was grounded and closed, but it was not labeled with the words "hazardous waste" or an indication of the hazards for solvent still bottoms (Photo 4). In an email from Scott Hager to Andrew Martin on 09/11/2020, Mr. Hager indicated that the drum was empty at the time of the

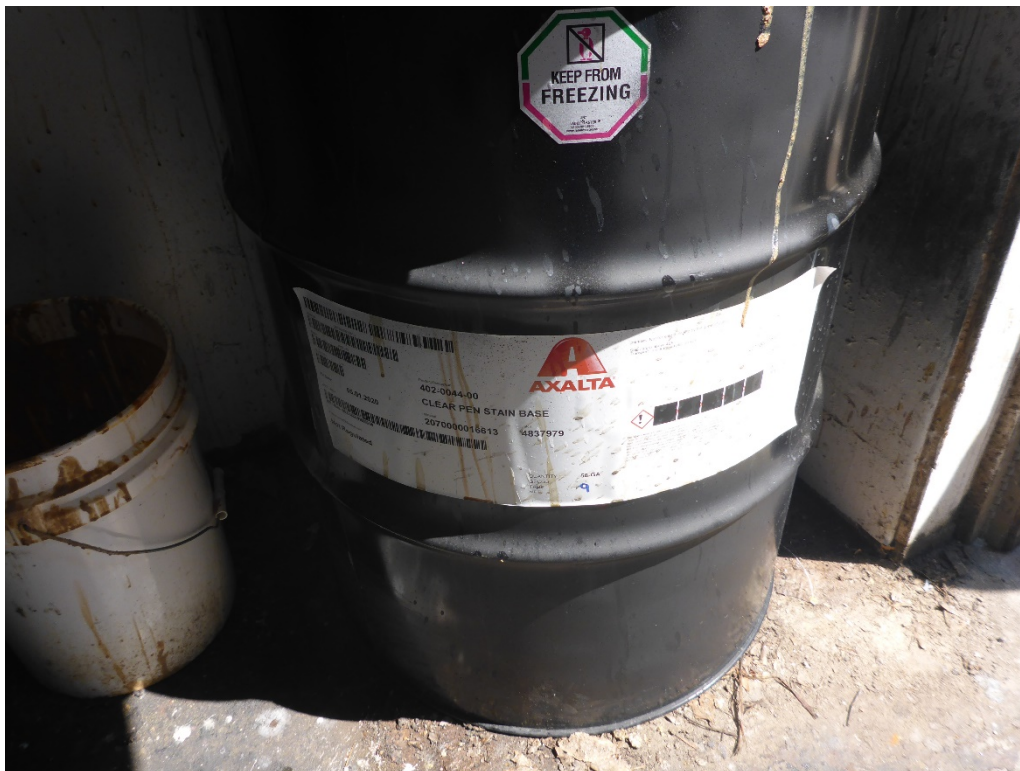
**Photo 4:** 55-gallon drum in the distillery SAA. Drum to be used for accumulating hazardous waste still bottoms, but it was not labeled with the words “hazardous waste” or with an indication of the hazards. Drum reported to be empty.

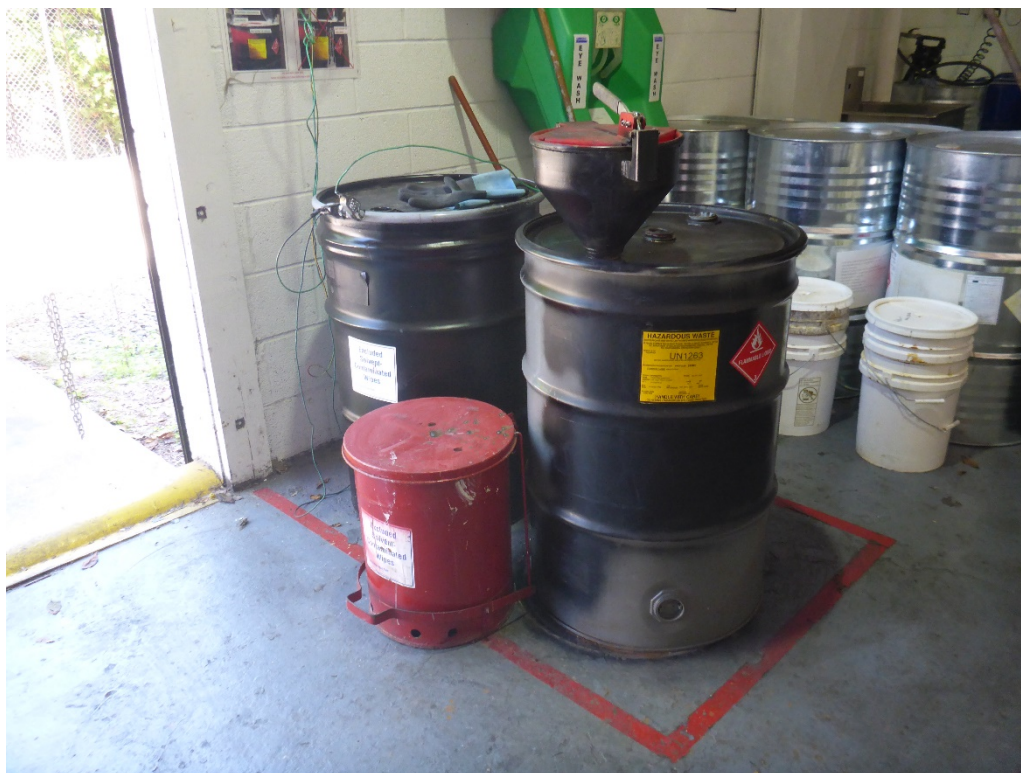
Hazardous waste paint related material generated when mixing colors or performing quality assurance testing is accumulated in a SAA located near the door leading to the distillation outbuilding (Photo 5). The inspectors observed one 55-gallon drum with a latched funnel lid in this SAA. The drum was labeled as D001 / F003 / F005 hazardous waste paint related material and identified with a flammable liquid hazard placard. The inspectors also observed a second 55-gallon drum labeled excluded solvent contaminated wipes in this area.

**Photo 5:** Wood Plant SAA for accumulating waste in the stain pump room. One 55-gallon drum and one red flip-top flammable can each labeled excluded solvent contaminated wipes located on the left, and one 55-gallon drum for accumulating waste paint related material located on the right. Drum on the right labeled D001 / F003 / F005 hazardous waste paint related material and identified with a flammable liquid hazard placard.

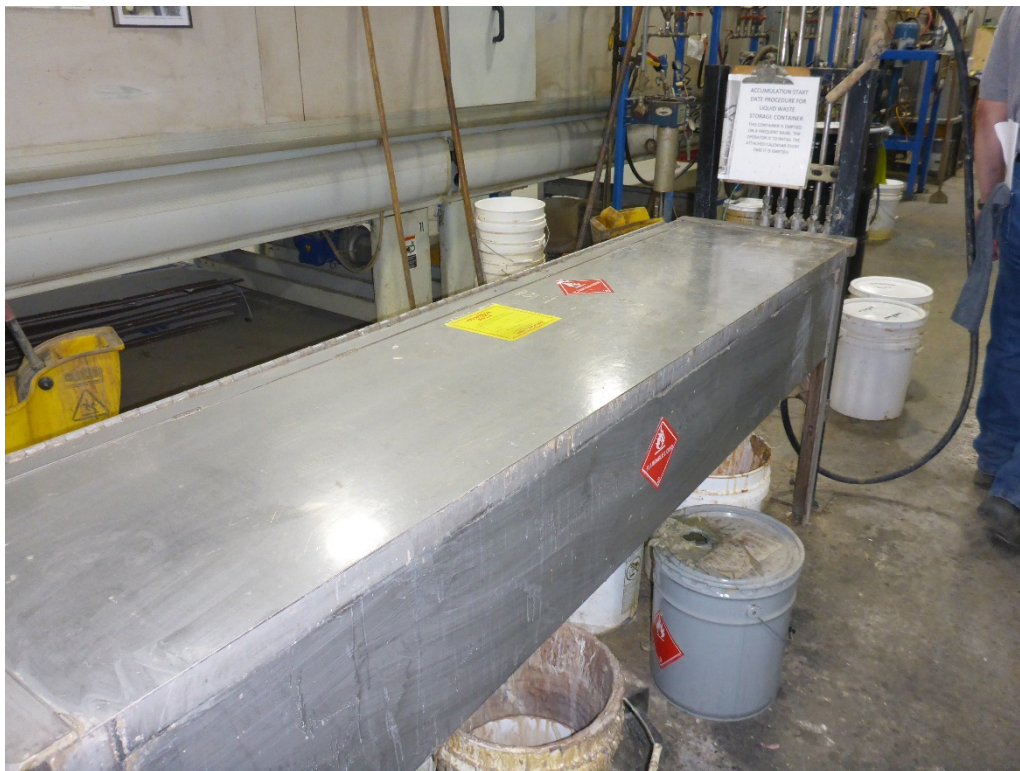
Wood Plant - Spray Coat Line and Roll Coat Line: The inspectors observed a small tank between the spray coat line and the roll coat line (Photo 6). The tank was labeled D001 / F003 / F005 hazardous waste acetone and it was identified with a flammable liquid hazard placard. The tank is used to store spent solvents generated from cleaning machines used in the “flat-line finishing / painting process” and the roll-coating operation, from mopping the floors in the Wood Plant, and from cleaning the UV coater in the Resin Plant. The inspectors observed signs reading “hazardous waste storage area” and “no smoking” on the roll-coating process unit near the tank. The inspectors also observed an emergency eyewash station and fire extinguisher in this area.

Although the tank is equipped with piping to feed waste solvents from the process units into the tank, Mr. Gaillard explained that most of these lines are no longer in use. Instead, employees accumulate spent solvents in a bucket while they clean the machines and then dump the contents of the bucket into the tank. Employees use a foot pedal to open the tank lid, and the lid automatically closes when pressure is removed from the pedal. The area also has a manual pump for employees to pump waste from an accumulation container into the tank, if preferred. According to the standard operating procedures posted near the tank, up to 10.5 gallons of spent solvents can be accumulated in the tank and sent to the distillery each day (Photo 7). Employees remove spent solvents from the tank by pumping it directly from the tank into the distillation unit using a dedicated pump and piping line (Photo 8). The inspectors observed a calendar hanging next to the waste storage tank. Facility personnel use this calendar to track when the tank is emptied, and written standard operating procedures describing this tracking system were observed with the calendar.

**Photo 6:** Small tank located between the spray coat line and the roll coat line in the Wood Plant. Tank is labeled D001 / F003 / F005 hazardous waste acetone and identified with a flammable liquid hazard placard.

Inspection Records: The inspectors reviewed available records of inspections of hazardous and universal waste management areas. No records were available of daily inspections of the hazardous waste storage tank located in the Wood Plant. Inspections are recorded for weekly inspections of the universal waste accumulation areas, the hazardous waste SAAs, and the hazardous waste CAAs. The records include the date and time of the inspection and the signature of the employee conducting the inspection. Each week, the employee records notations of observations and necessary follow-up actions for the inspected areas.

**Pursuant to 15A NCAC 13A .0107 [40 C.F.R. § 262.16(b)(3)(iii)(A)-(C)], which is a condition of the SQG Permit Exemption, a small quantity generator that accumulates hazardous waste in tanks must, at least once each operating day, inspect, where present: discharge control equipment to ensure that it is in good working order; data gathered from monitoring equipment to ensure that the tank is being operated according to its design; and the level of waste in the tank.**

- **Pursuant to 15A NCAC 13A .0107 [40 C.F.R. § 262.16(b)(3)(iii)(A)-(C)], which is a condition of the SQG Permit Exemption, a small quantity generator that accumulates hazardous waste in tanks must, at least once each operating day, inspect, where present: discharge control equipment to ensure that it is in good working order; data gathered from monitoring equipment to ensure that the tank is being operated according to its design; and the level of waste in the tank.**

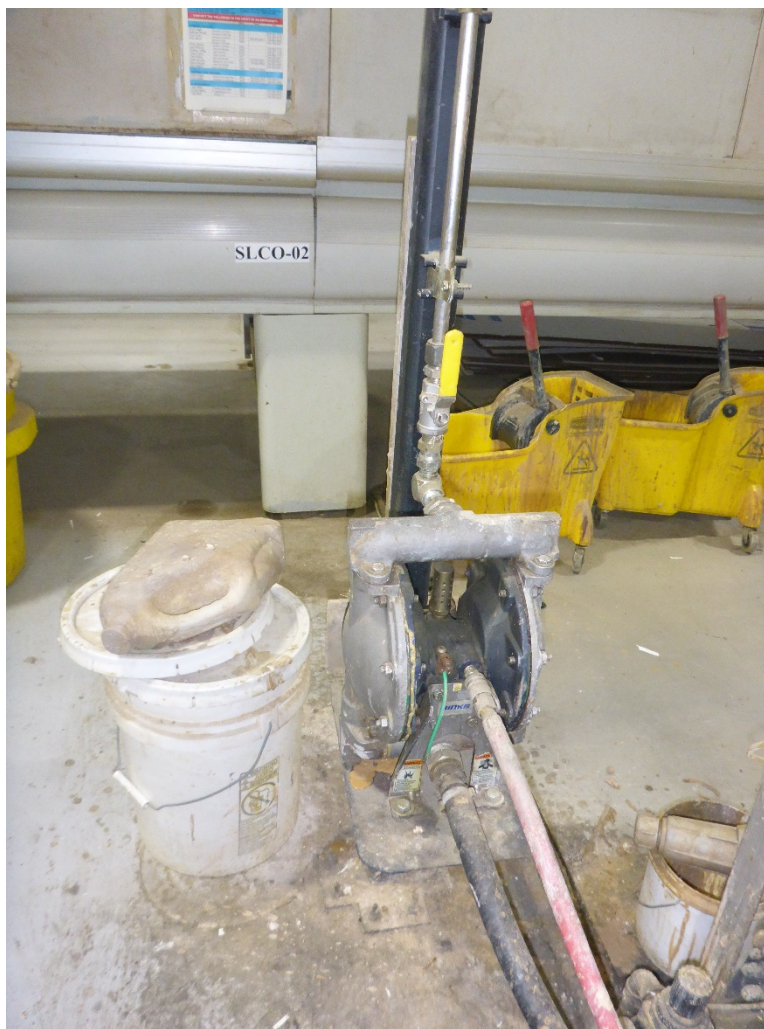
**Photo 8:** Dedicated pump and piping line to transfer spent solvents from the storage tank into the distillation unit.

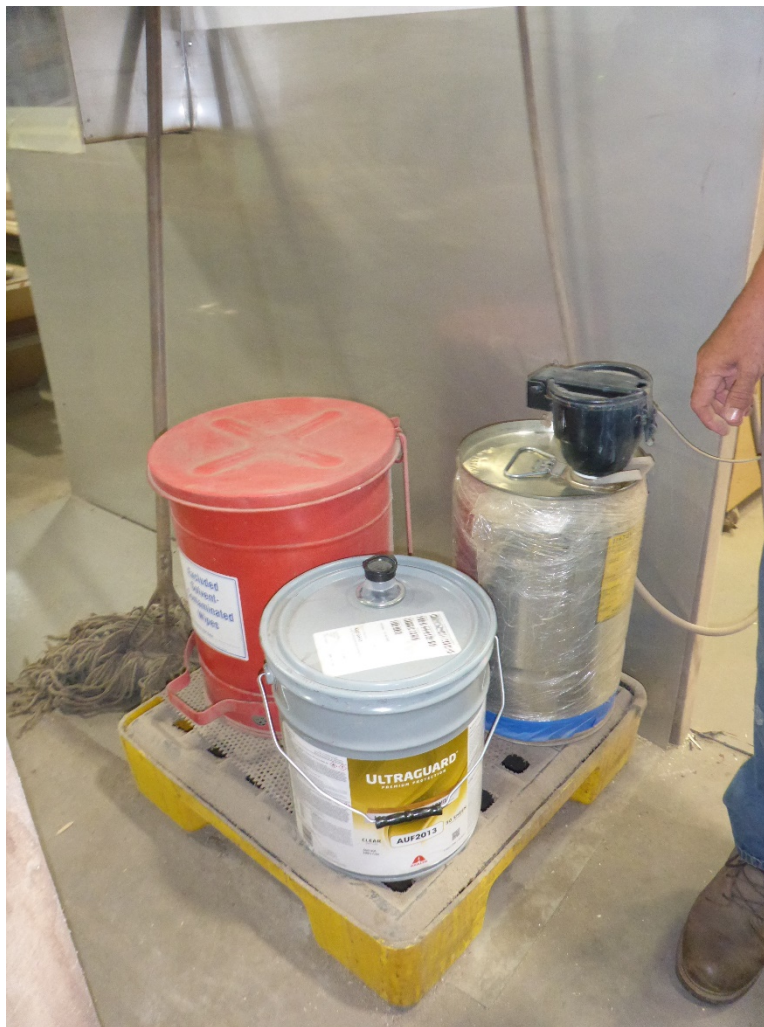
Wood Plant - Manual Spray Booth: Spent solvents generated from cleaning the paint gun in the manual spray booth are accumulated in a SAA next to the booth (Photo 9). The inspectors observed one 10-gallon container with a latched funnel in this SAA. The container was labeled as D001 / F003 / F005 hazardous waste paint and identified with a flammable liquid hazard placard. An employee working at the spray booth explained that the process would take approximately two-and-one-half weeks to fill the container, so the contents of the container are

poured into the 55-gallon drum at the stain pump room at the end of each day. The inspectors explained that hazardous waste cannot be transferred from one SAA to another, because that waste would no longer be at or near the point of generation where wastes initially accumulate. In an email from Scott Hager to Andrew Martin on 09/11/2020, Mr. Hager indicated that the contents of the 10-gallon container are actually emptied into the holding tank between the spray coat line and roll coat line, which is managed as a hazardous waste central accumulation area.

**Photo 9:** Wood Plant SAA for accumulating waste near the manual spraybooth. One red flip-top flammable can for accumulating excluded solvent contaminated wipes. One 10-gallon container of product material. 10-gallon container with latched funnel for accumulating D001 / F003 / F005 hazardous waste paint related materials.

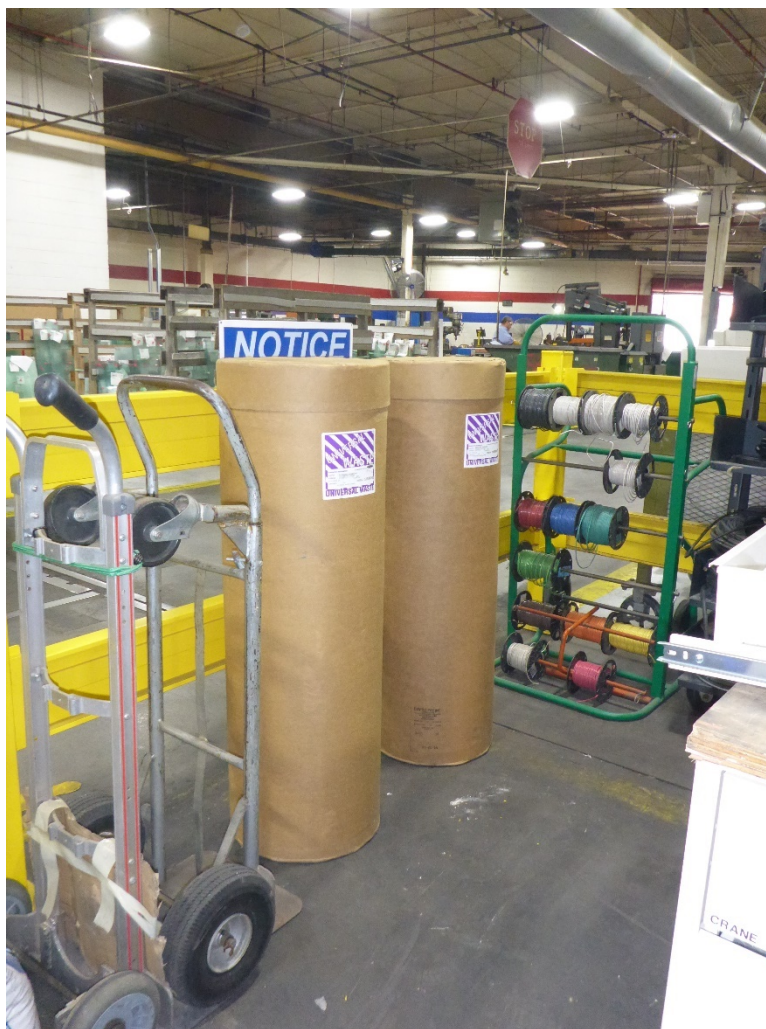
Wood Plant - Maintenance Shop: Used oil and universal wastes are accumulated in the facility's maintenance shop. The inspectors observed one 55-gallon drum labeled used oil on a portable secondary containment and one 55-gallon drum labeled oil clean-up on another portable secondary containment unit in this area. The used oil drum was equipped with a funnel. The inspectors also observed two 4-foot cylinders labeled universal waste lamps in this area (Photo 10). One cylinder was dated 08/04/20, and the other was dated 06/01/20.

**Photo 10:** Two 4-foot cylinders for accumulating universal waste lamps in the maintenance shop. Containers labeled universal waste lamps and dated 08/04/20 and 06/01/20.

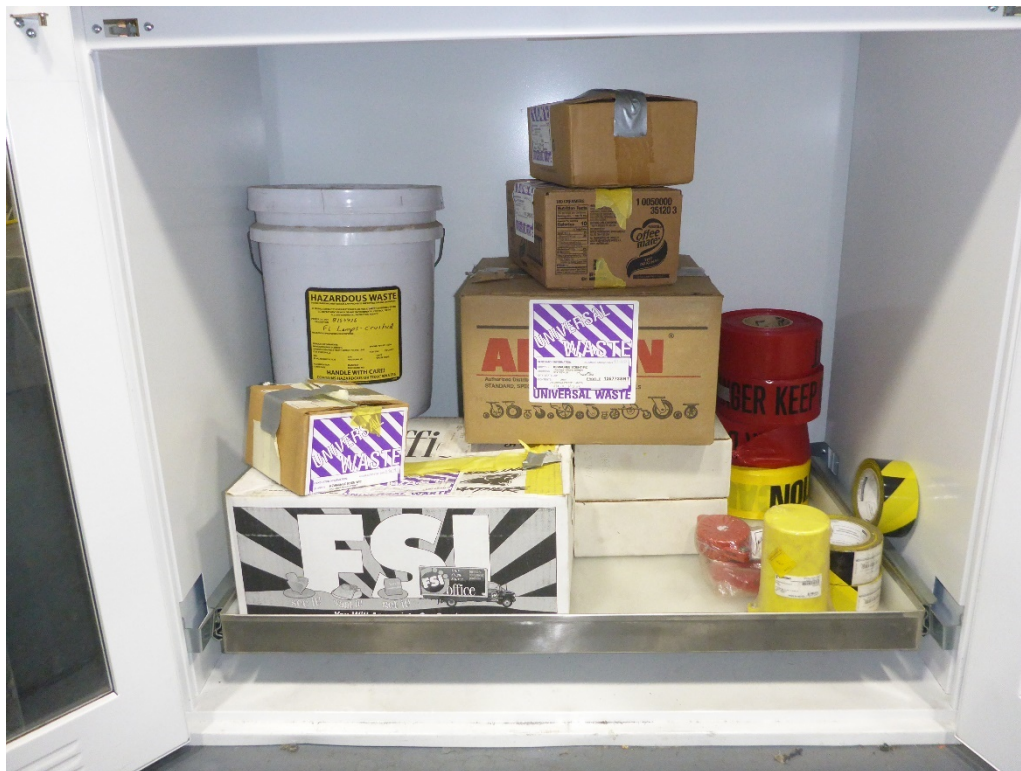
Hazardous and universal wastes are accumulated in a SAA cabinet in the maintenance area (Photo 11). The inspectors observed one 5-gallon bucket for accumulating broken fluorescent lamps as hazardous waste. The bucket was closed and labeled hazardous waste crushed fluorescent lamps, and it was identified with an indication of the hazards. According to the labels, the contents of the other containers included universal waste lamps (metal halide), nonregulated non-PCB ballast, universal waste lithium ion batteries, universal waste nickel metal hydride batteries, and universal waste alkaline batteries. Each universal waste container was labeled and marked with an accumulation start date, and the oldest date observed on any container was 11/12/19.

**Photo 11:** SAA cabinet in the maintenance area. One 5-gallon white bucket for accumulating broken fluorescent lamps as hazardous waste, and several other universal waste containers.

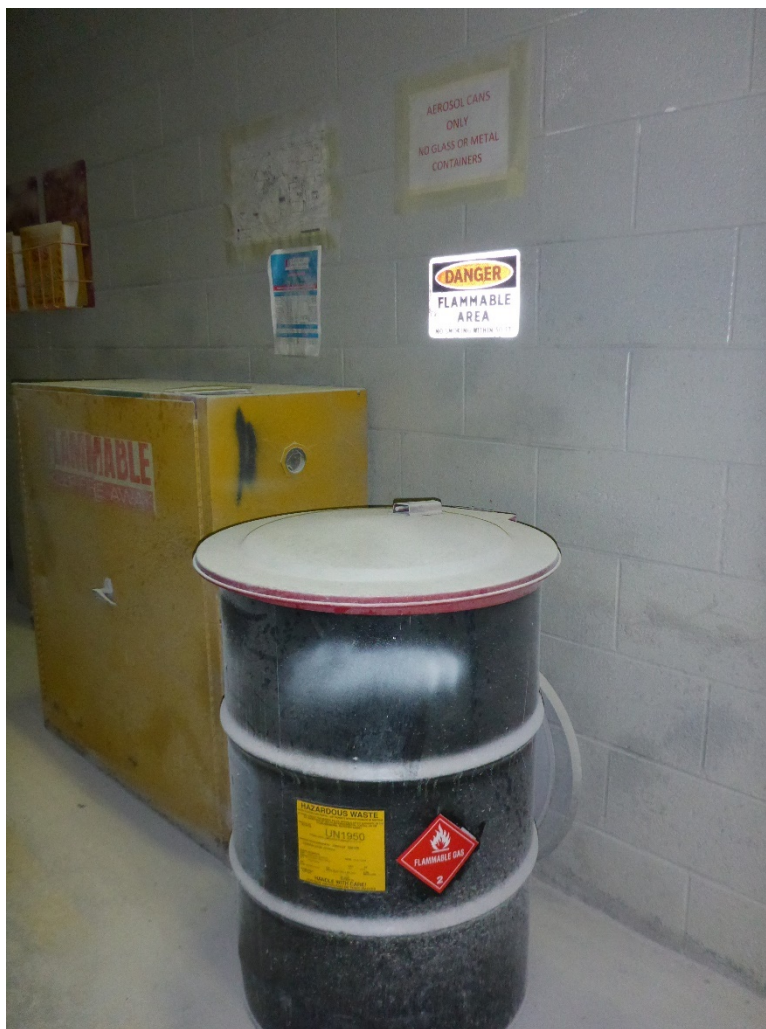
Metal Plant – Metal Paint Area: Kewaunee manages a SAA for accumulating waste aerosol cans in the metal paint area (Photo 12). The inspectors observed one 55-gallon drum with a flip-top lid in this SAA. The drum was labeled D001 / F003 / F005 hazardous waste aerosols, and it was identified with a flammable gas hazard placard.

**Photo 12:** SAA for accumulating waste aerosol cans in the Metal Plant. 55-gallon drum with flip-top lid labeled D001 / F003 / F005 hazardous waste aerosols.

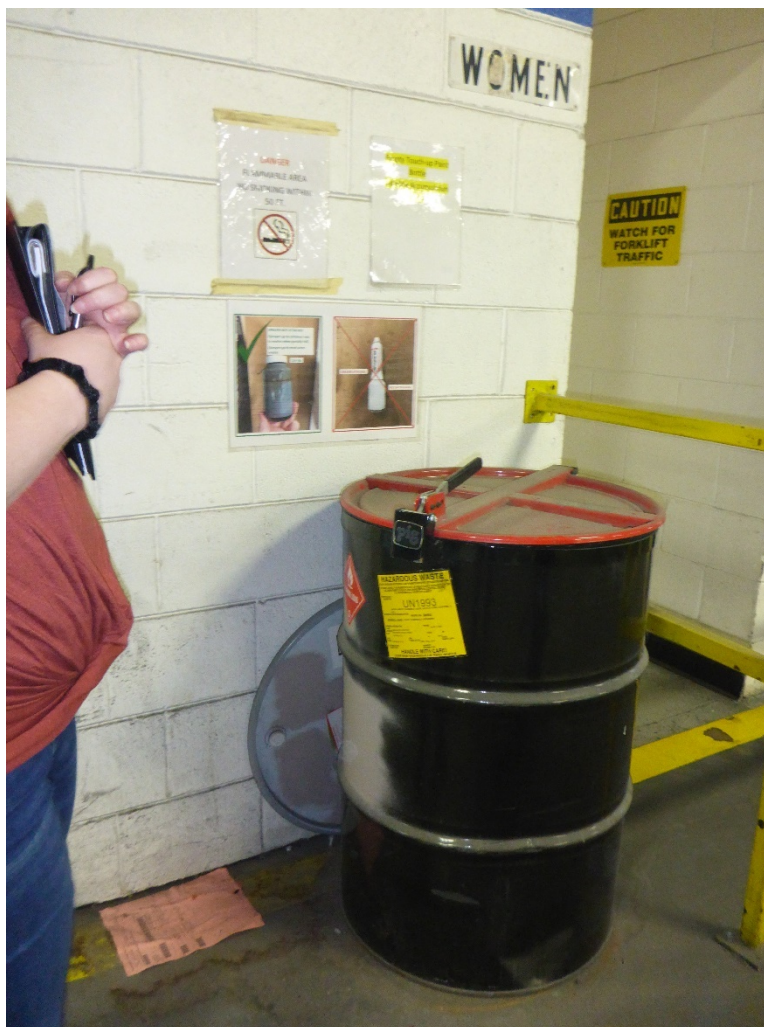
Metal Plant – Hoods Area: Kewaunee manages a SAA for accumulating waste touch-up paint bottles in the hoods area (Photo 13). The inspectors observed one 55-gallon drum with a latched flip-top lid in this SAA. The drum was labeled D001 / F003 / F005 hazardous waste loose flammable containers, and it was identified with a flammable liquid hazard placard.

**Photo 13:** SAA for accumulating waste touch-up paint bottles in the Metal Plant. 55-gallon drum with latched flip-top lid labeled D001 / F003 / F005 hazardous waste loose flammable containers.

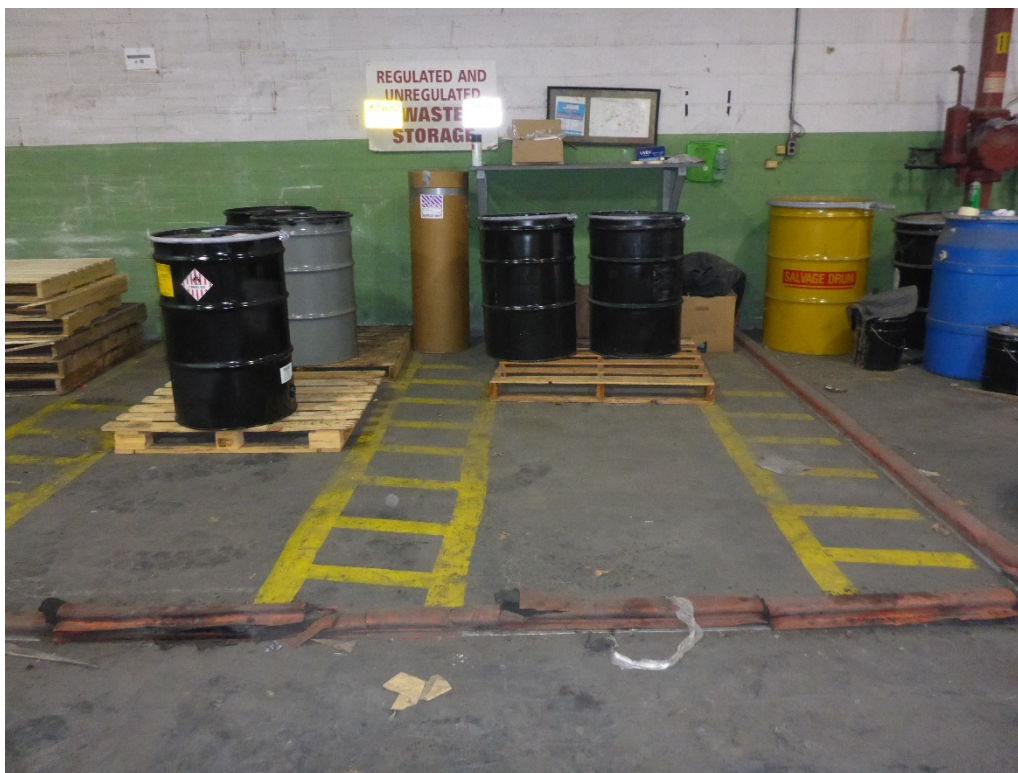
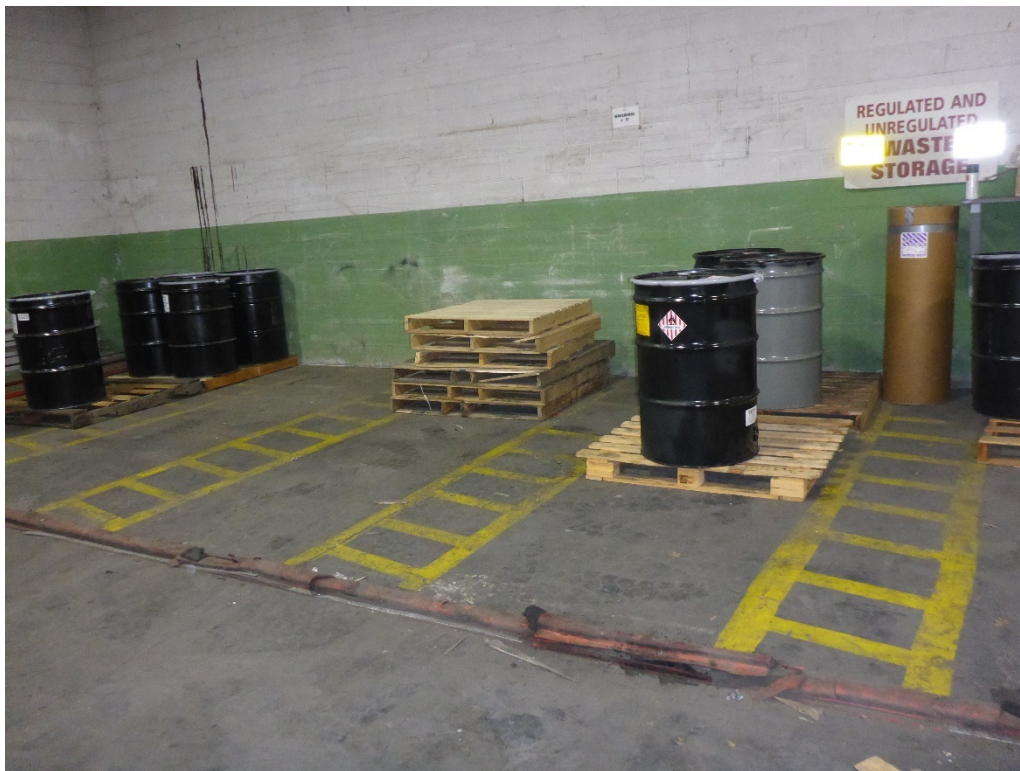
Resin Plant - Regulated and Unregulated Waste Storage Central Accumulation Area: The facility's main hazardous waste central accumulation area (CAA) is in the upstairs resin warehouse (Photos 14 and 15). The area is identified with signs reading "regulated and unregulated waste storage" and "no smoking" and it is equipped with a fire extinguisher and emergency eyewash station. The inspectors observed several gaps in the secondary containment berm around the perimeter of this area. Ms. Reavis stated that Personnel carry cell phones or walkie talkies to alert a team leader in the event of an incident in this area. She also explained that personnel generally work in pairs when working in this area. The inspectors observed yellow lines painted on the cement floor in this area to define space to create aisle spacing and five rows for staging waste containers.

**Photo 14:** Main hazardous waste central accumulation area. Several gaps in the secondary containment berm around the perimeter of the area.

**Photo 15:** Main hazardous waste central accumulation area. Several gaps in the secondary containment berm around the perimeter of the area.

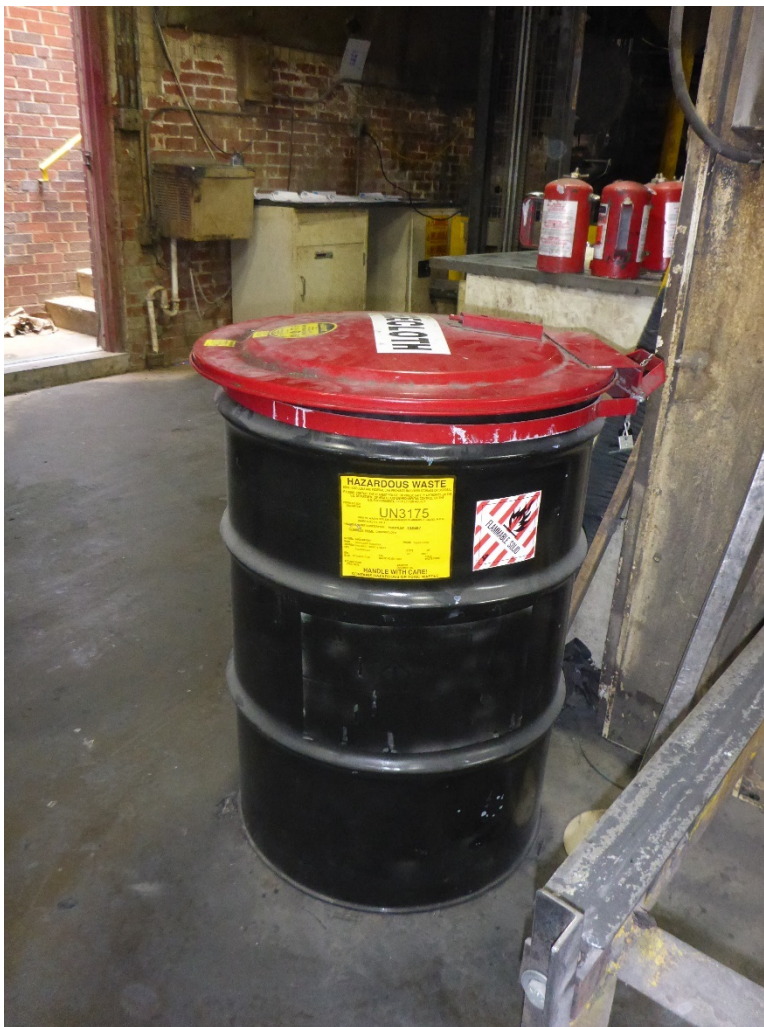
Resin Plant - Sinks Area: Kewaunee manages a SAA for accumulating contaminated cheesecloth used for cleanup activities in the sinks area. The inspectors observed one 55-gallon drum with a latched flip-top lid in this SAA. The drum was labeled D001 hazardous waste cheesecloth, and it was identified with a flammable solid hazard placard.

**Photo 16:** Resin Plant SAA for accumulating contaminated cheesecloth in the sinks area. 55-gallon drum with flip-top lid labeled D001 hazardous waste cheesecloth.

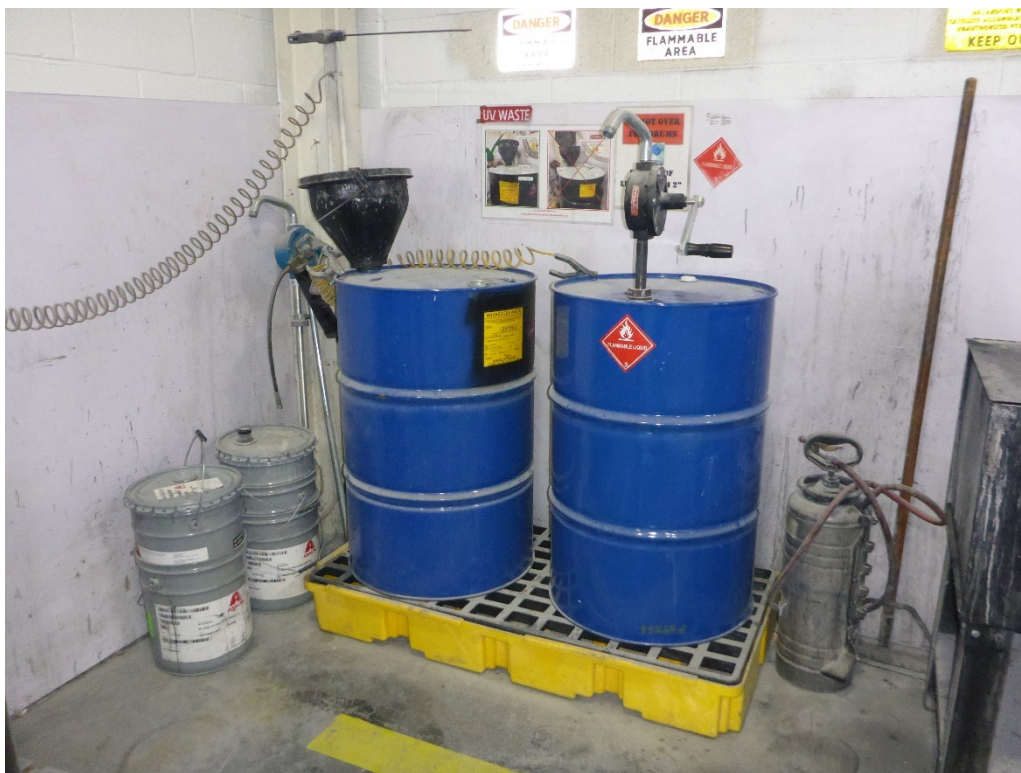
Resin Plant - UV Area: Kewaunee manages a SAA for accumulating spent solvent generated during cleanup activities in the UV area (Photo 17). The inspectors observed one 55-gallon drum with a latched flip-top lid in this SAA. The drum was labeled D001 / F003 hazardous waste recycled solvent, and it was identified with a flammable liquid hazard placard. The inspectors also observed a 30-gallon flammable can labeled excluded solvent contaminated wipes near this area.

**Photo 17:** Resin Plant SAA for accumulating contaminated spent solvent generated during cleanup activities in the UV area. 55-gallon drum with flip-top funnel lid labeled D001 / F003 hazardous waste recycled solvent.
