## **RCRA Inspection Report**

SI Group, Inc.  
725 Cannon Bridge Road  
Orangeburg, South Carolina 29115-  
7221

EPA ID# SCD043384072

December 1, 2022, at 9:15 a.m. EDT

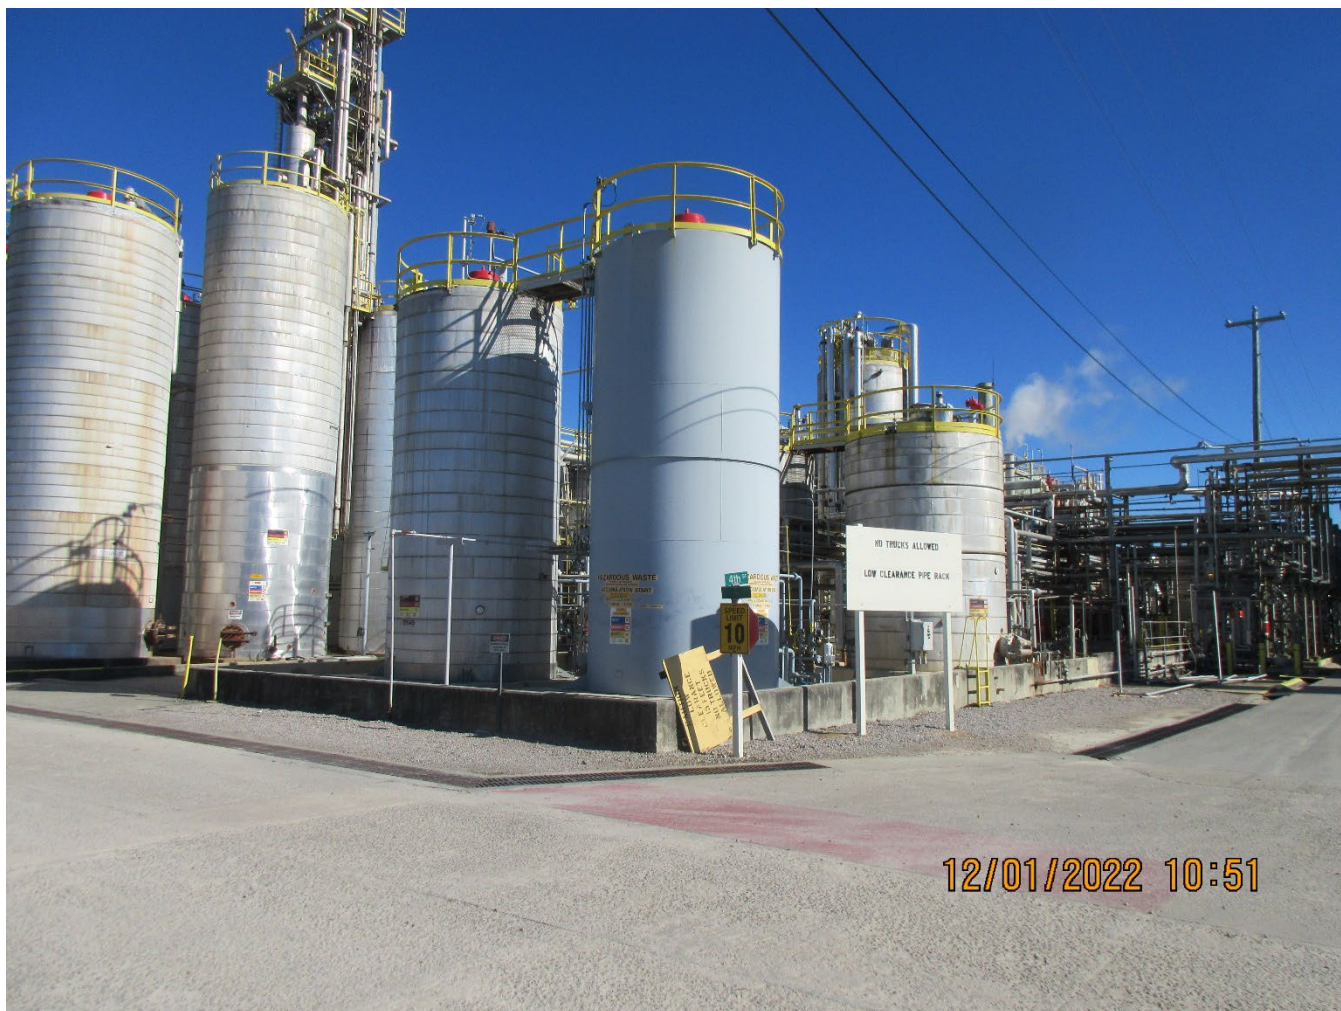
Hazardous waste is accumulated in Tank T8155 (T-15M-42) in this area. Tank 8155 (Photographs 1-4) is a 15,000-gallon, less than 90-day hazardous waste accumulation tank for hazardous waste solvents. Tank T-8155 manages spent solvent wastes having the EPA Waste Codes D001, F003 and F005 which are generated in Area 2. The contents of the tank are pumped into tanker trucks and transferred to the permitted tank farm in the area of Boiler #4. The tank had secondary containment which exceeded the 15,000-gallon volume of the tank (Photograph 3). The secondary containment was free of cracks and gaps and was coated at the time of the inspection. The top of the tank was inspected and found to have all openings equipped with proper closure devices. Ancillary equipment associated with the tank was properly marked and all pumps, flanges and valves were tagged for air monitoring purposes (Photograph 4).

Photograph 1 – Tank 8155 (center foreground)

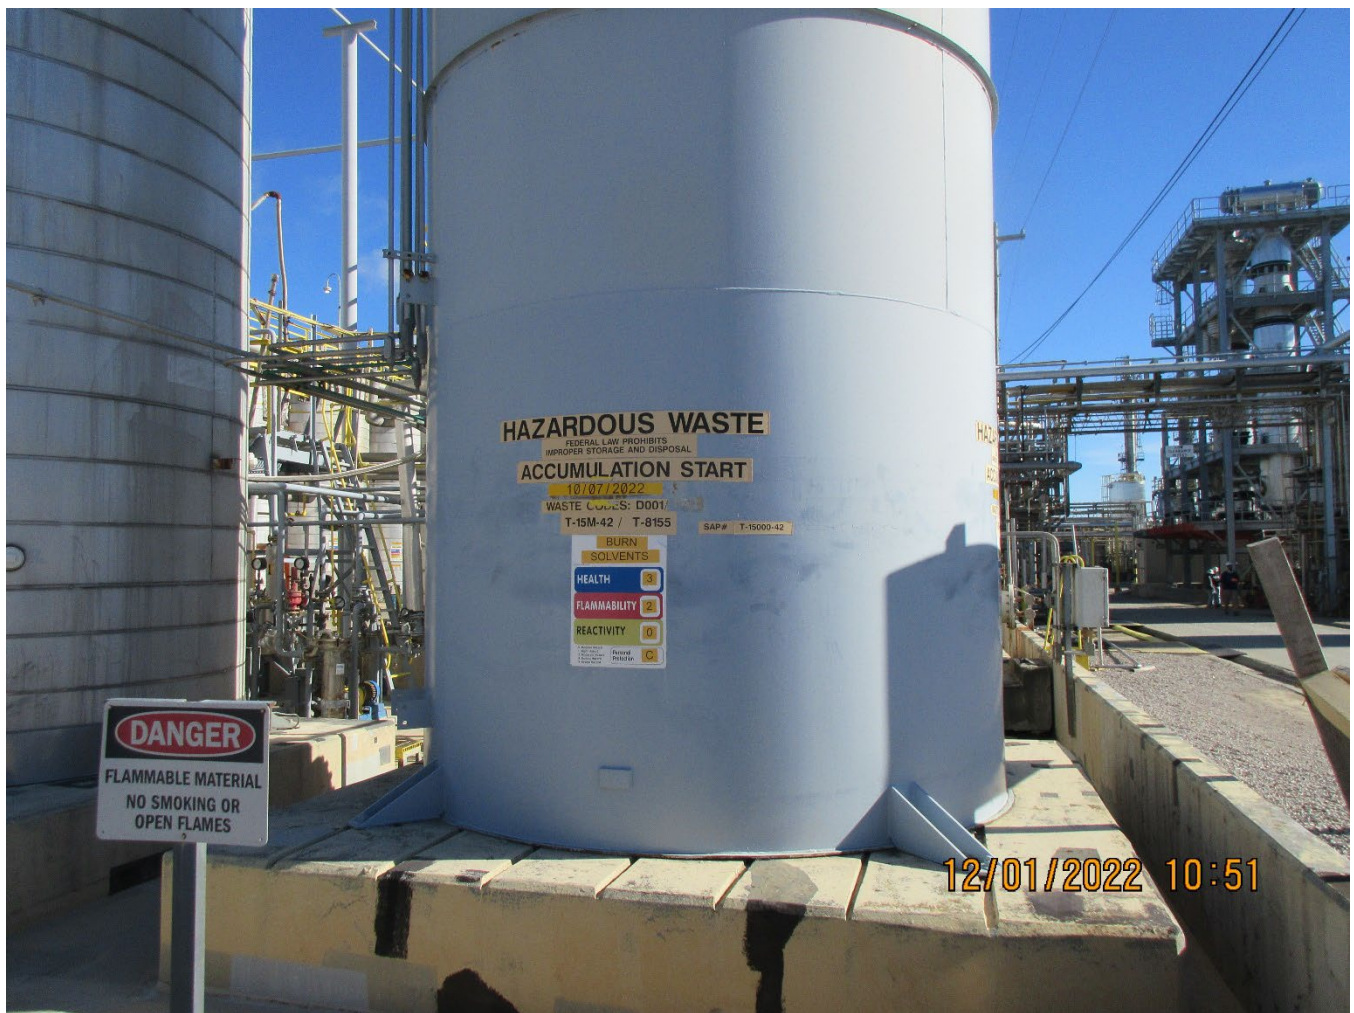
Photograph 2 – Labeling on Tank 8155

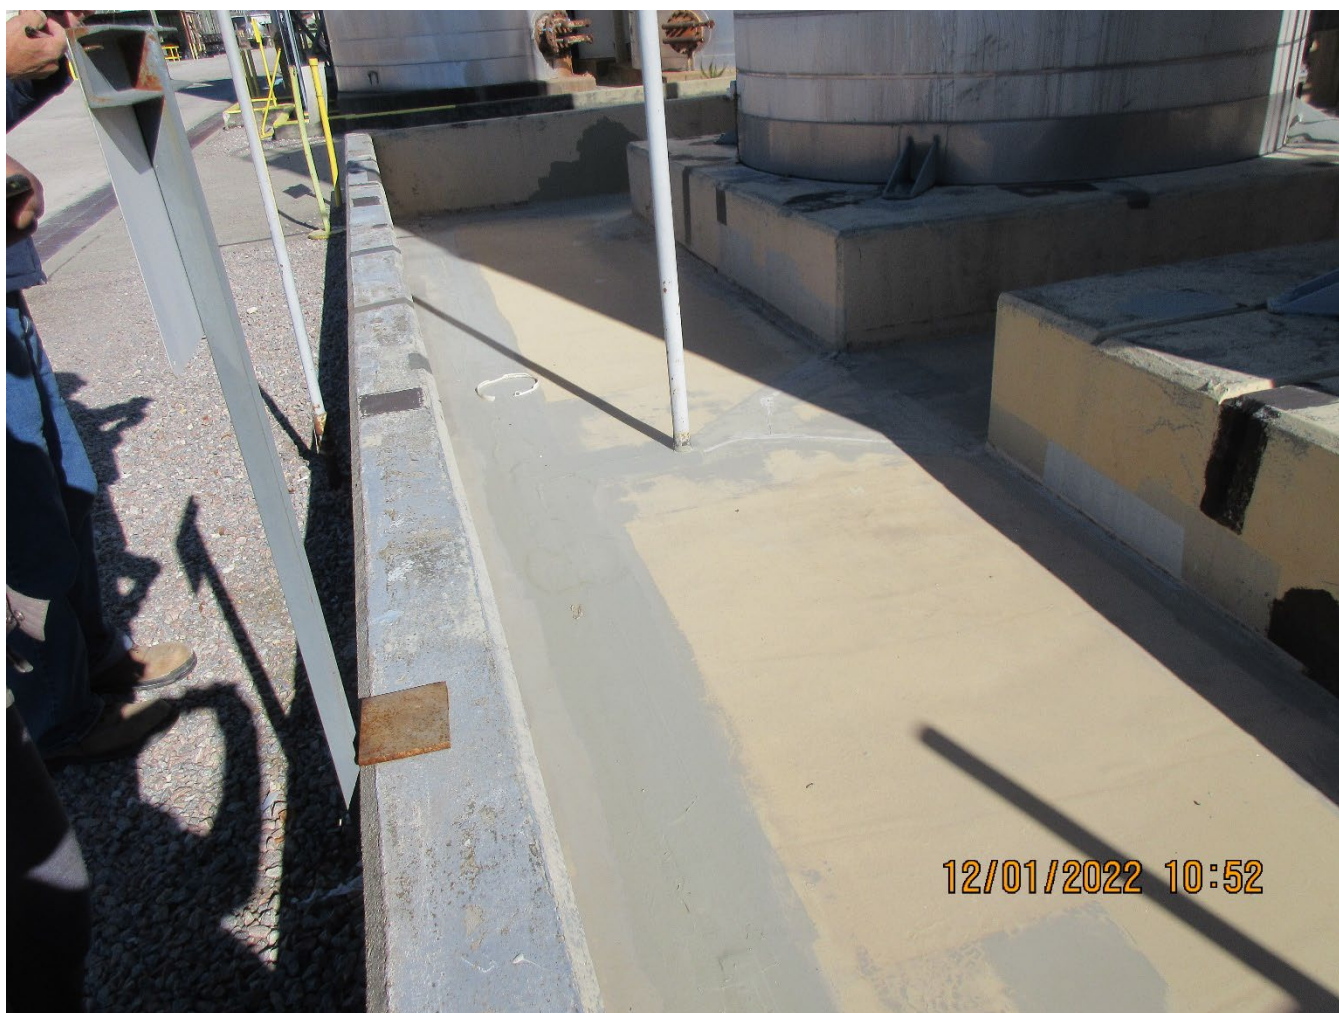
Photograph 3 – Secondary Containment for Tank 8155

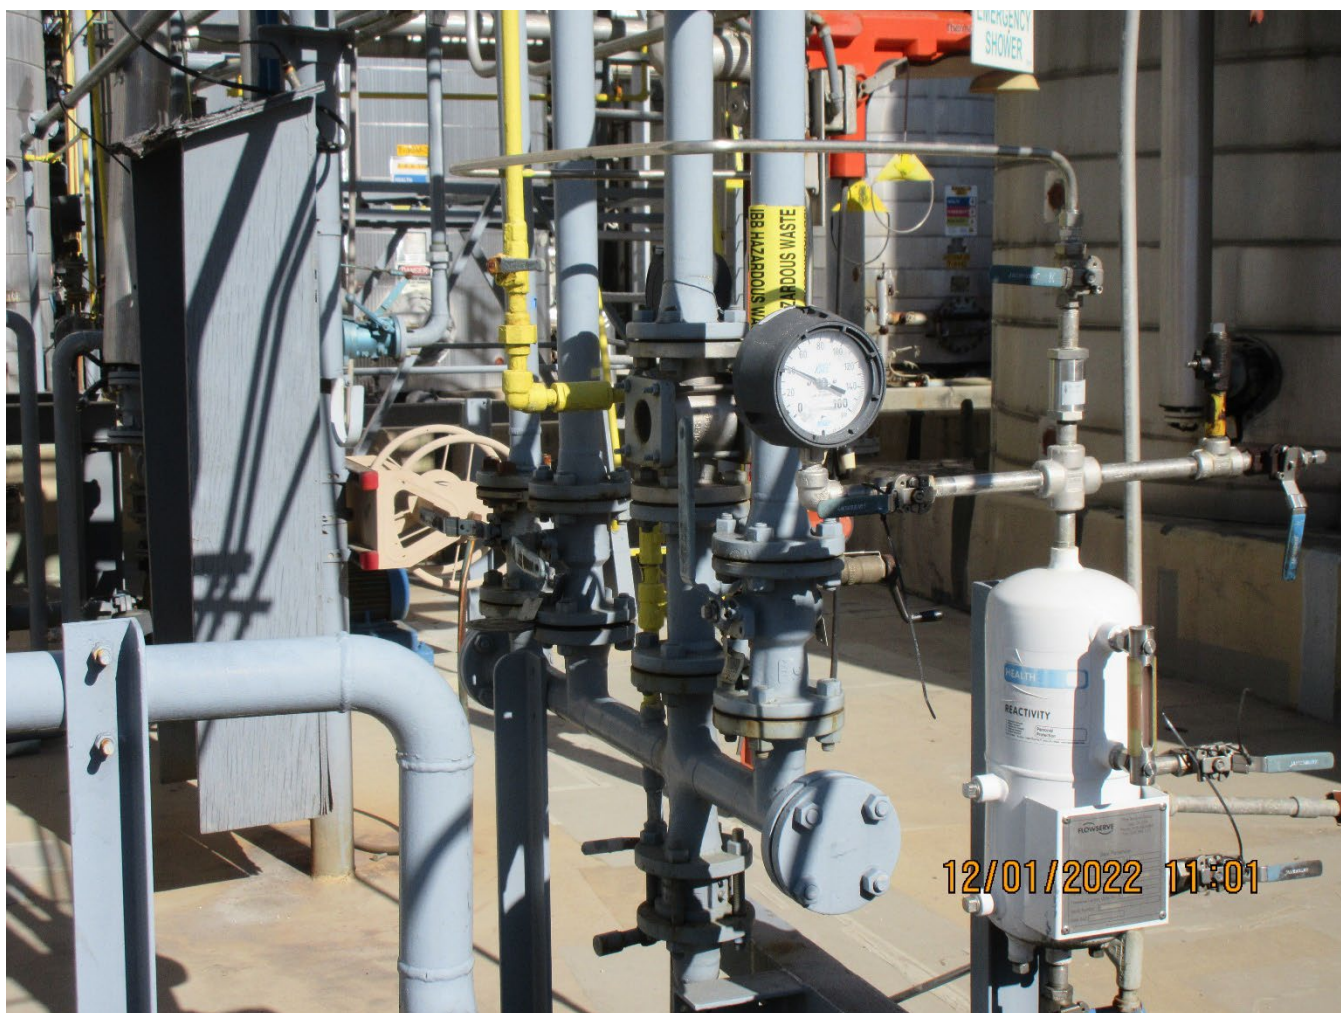
Photograph 4 – Ancillary equipment to Tank T8155

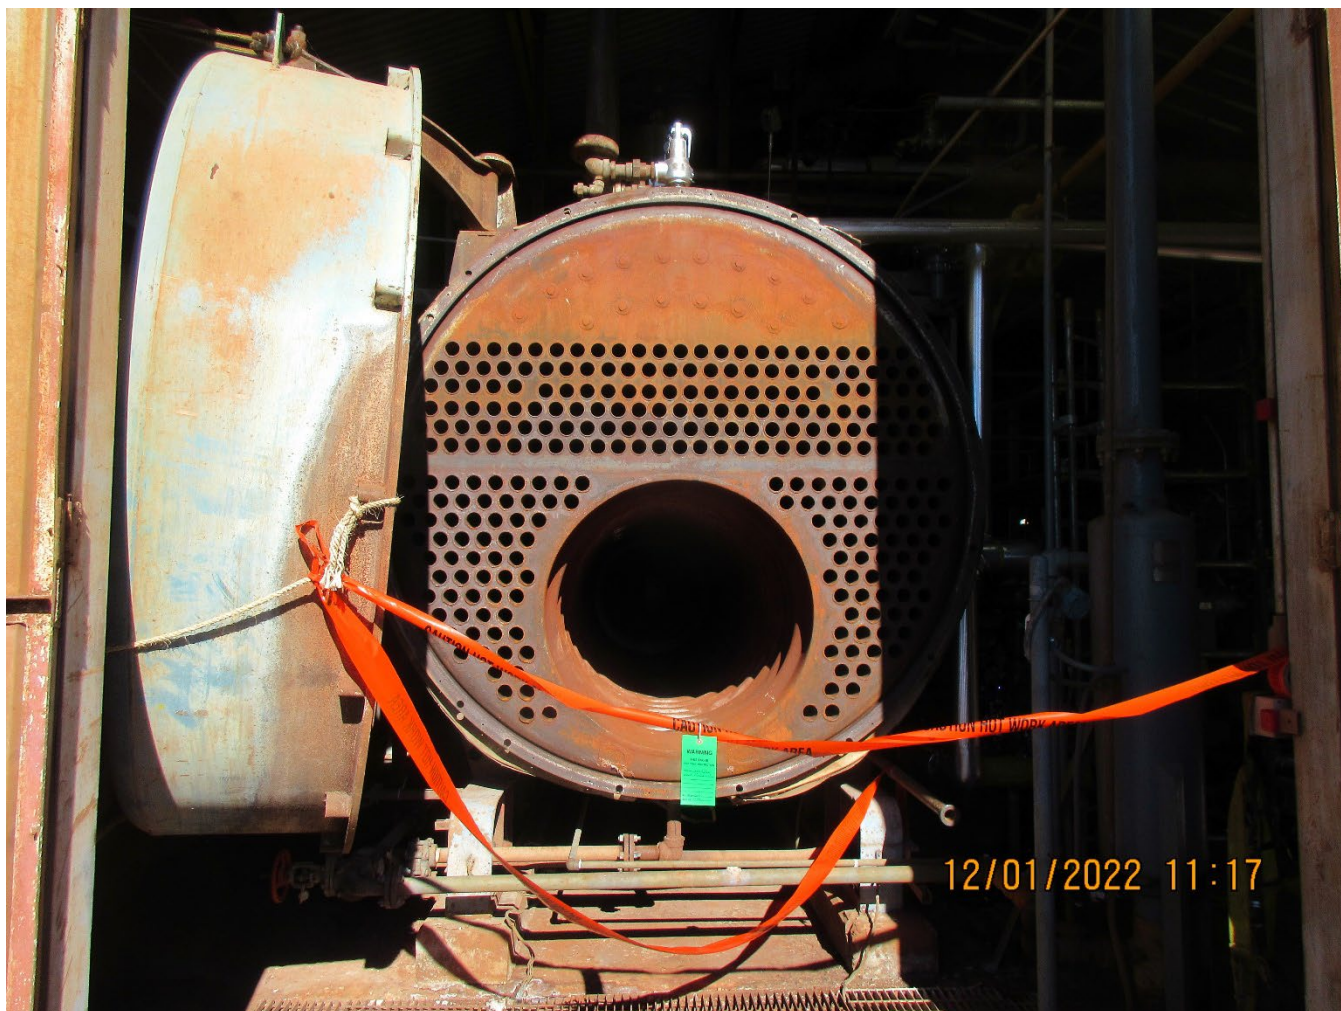
At the time of the inspection, Boiler #4 was shut down for maintenance. Both ends of the permitted hazardous waste treatment device were disassembled at the time of the inspection (Photograph 5). Facility personnel indicated that Boiler #4 would be operational in the next several weeks.

Photograph 5 – Boiler #4

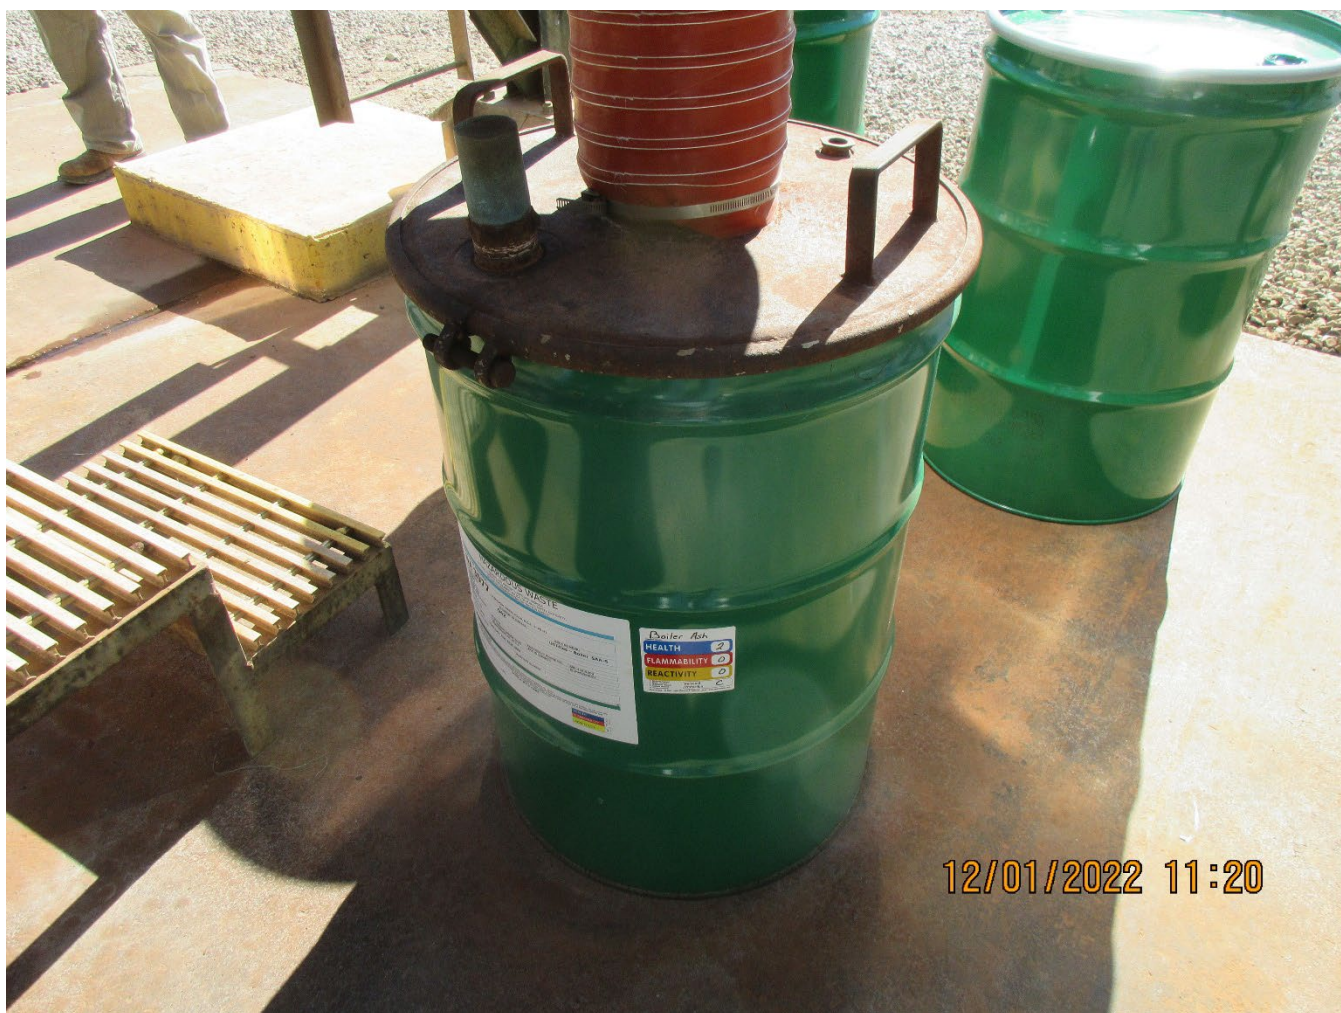
A 55-gallon container was connected to a baghouse silo connected to the emission stack for Boiler #4 for the collection of hazardous waste ash. The container was identified as SAA “S” (Photograph 6).

Photograph 6 – Container for ash from Boiler #4's Baghouse

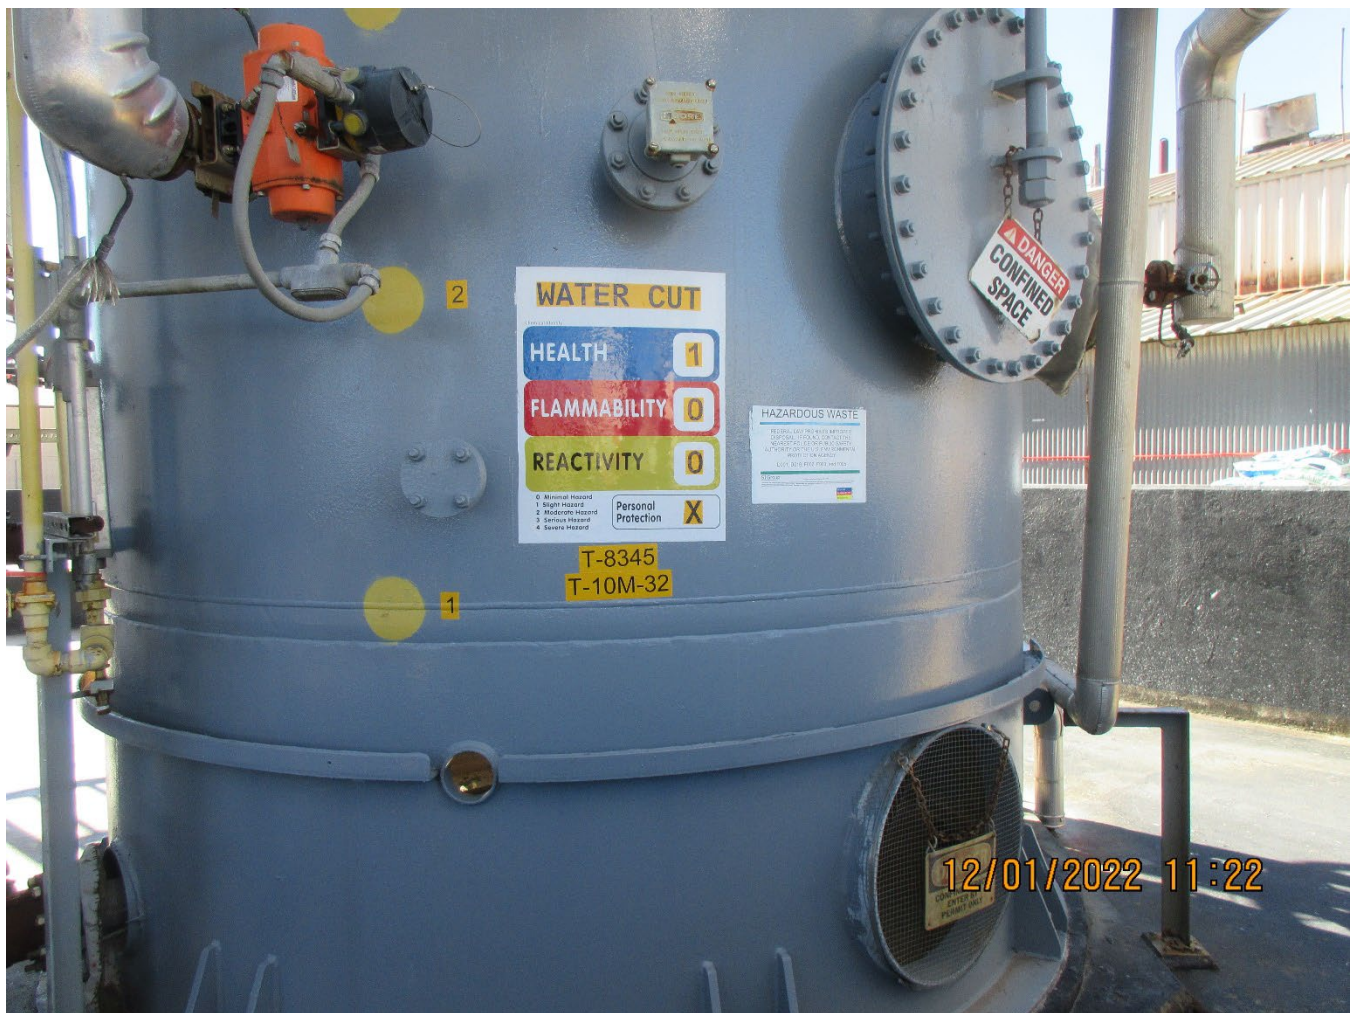
The tank farm in the area of Boiler #4 has four permitted hazardous waste tanks (Photographs 4 - 6) The tanks (T-8332, T-8333, T-8331 and T-8345 (Photograph 7)) receive distillation heels from the facility’s production areas. When a tank is full, the valves are shut off and a sample of the tank contents are sent for analysis. Once the analysis is returned, the tank’s contents are fed to the Boiler #4, generally from the 100,000-gallon tank to be used as fuel. As stated above, Boiler #4 was not operating at the time of the inspection.

Photograph 7 – Hazardous Waste Tank T-8345

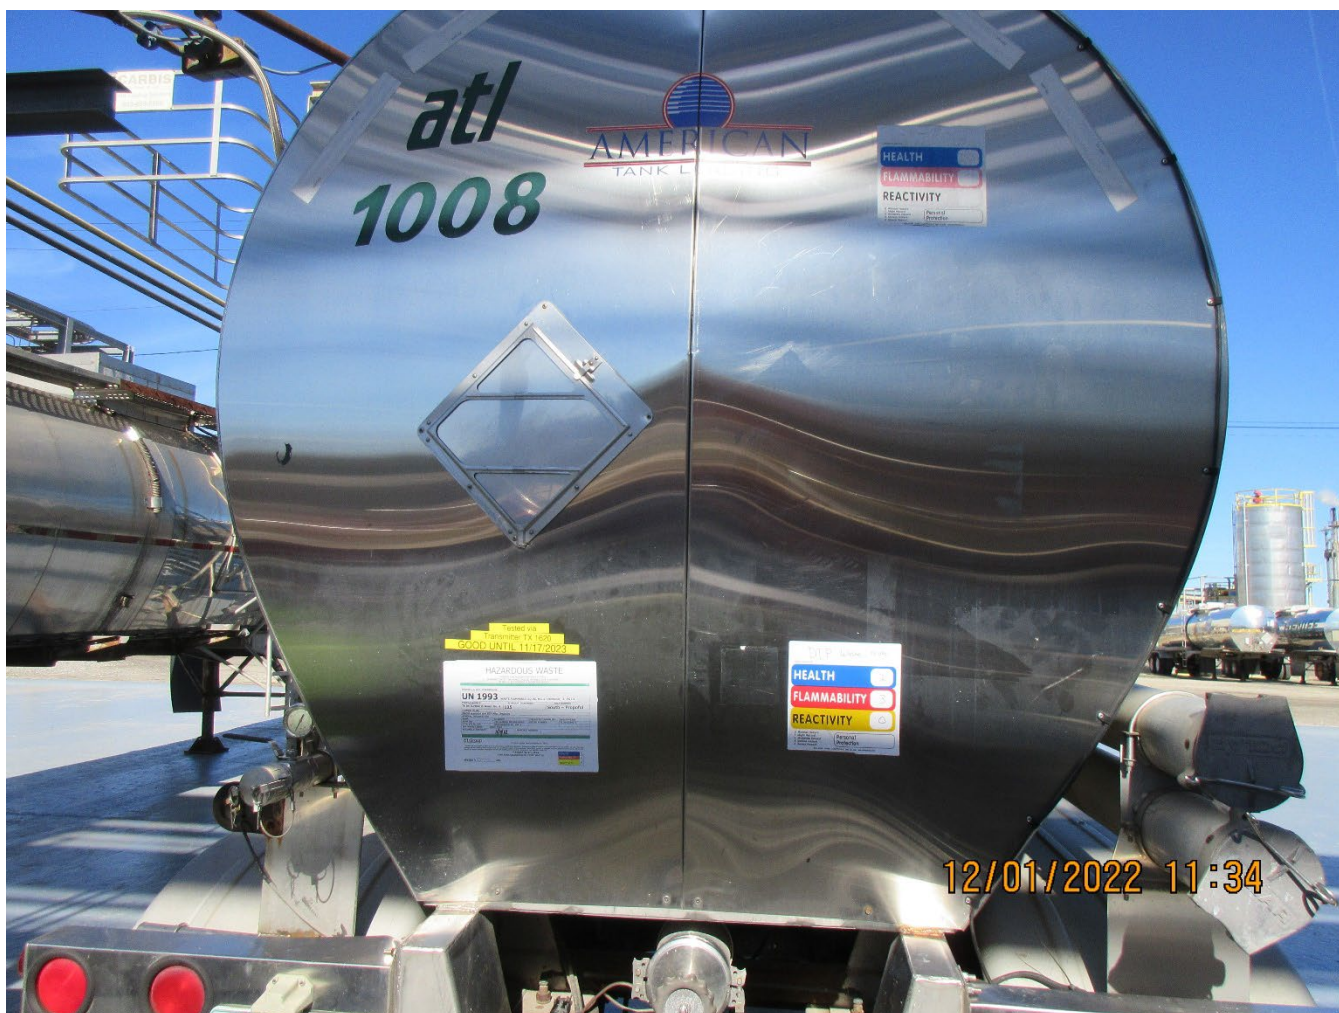
The facility also operates a concrete pad for the accumulation of hazardous waste solvents generated on-site in 6,000-gallon tanker trucks (Photograph 9). The pad is sloped and coated. At the time of the inspection, one tanker (Photograph 8) was observed on the pad which contained approximately 4,800 gallons of hazardous waste. The tanker truck was closed, labeled with the words "Hazardous Waste" and was marked with an indication of the hazard of the waste contained. The trailer was marked with an accumulation start date of November 17, 2022.

Photograph 8 – Tanker truck on Tanker Pad

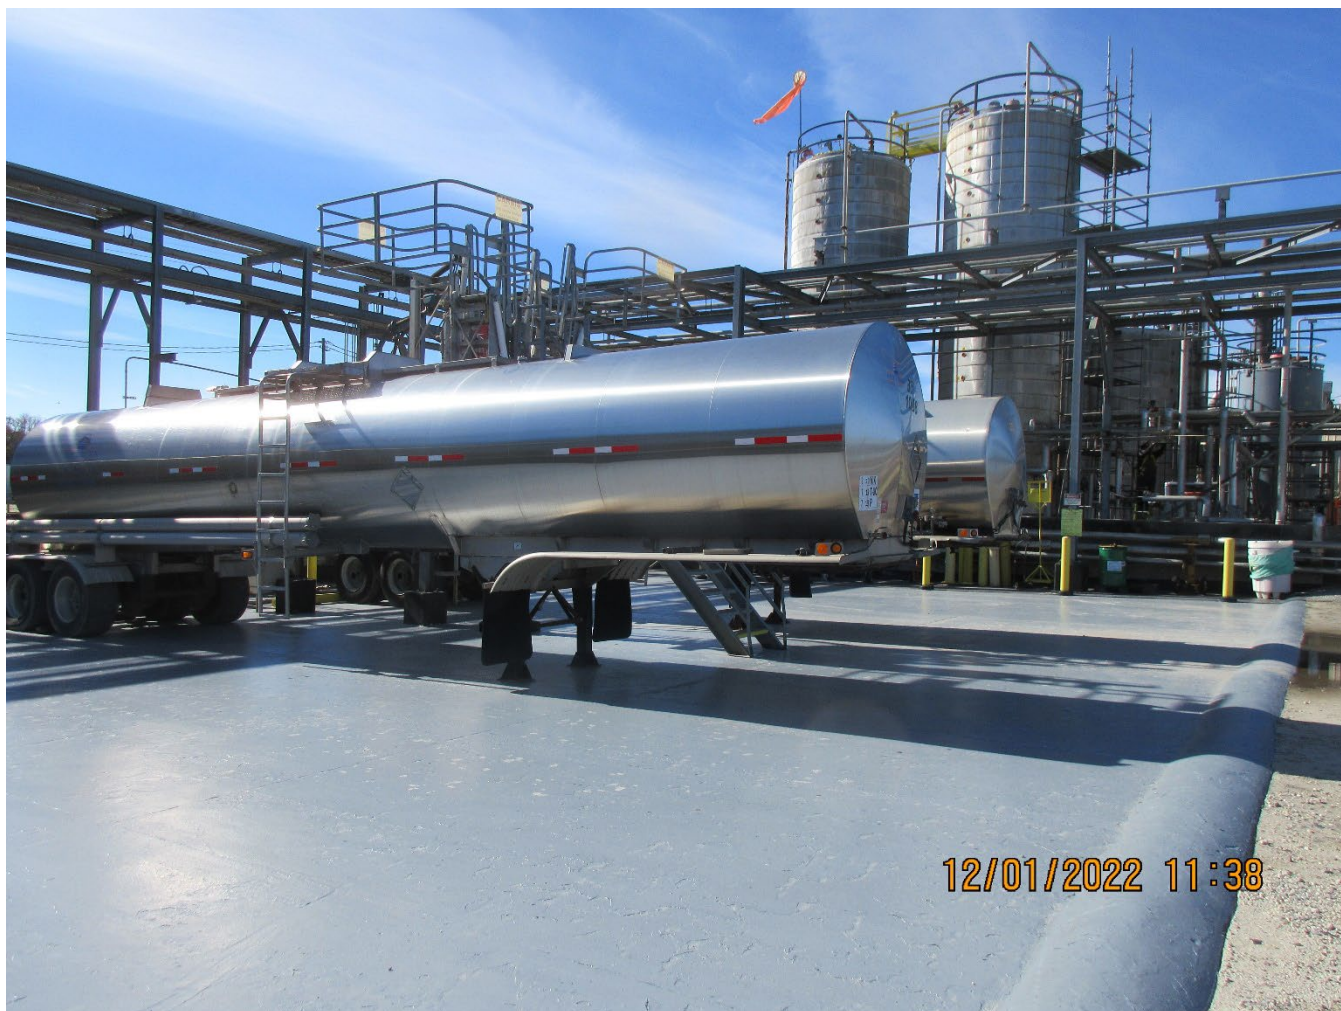
Photograph 9 – Tanker Trailer Pad

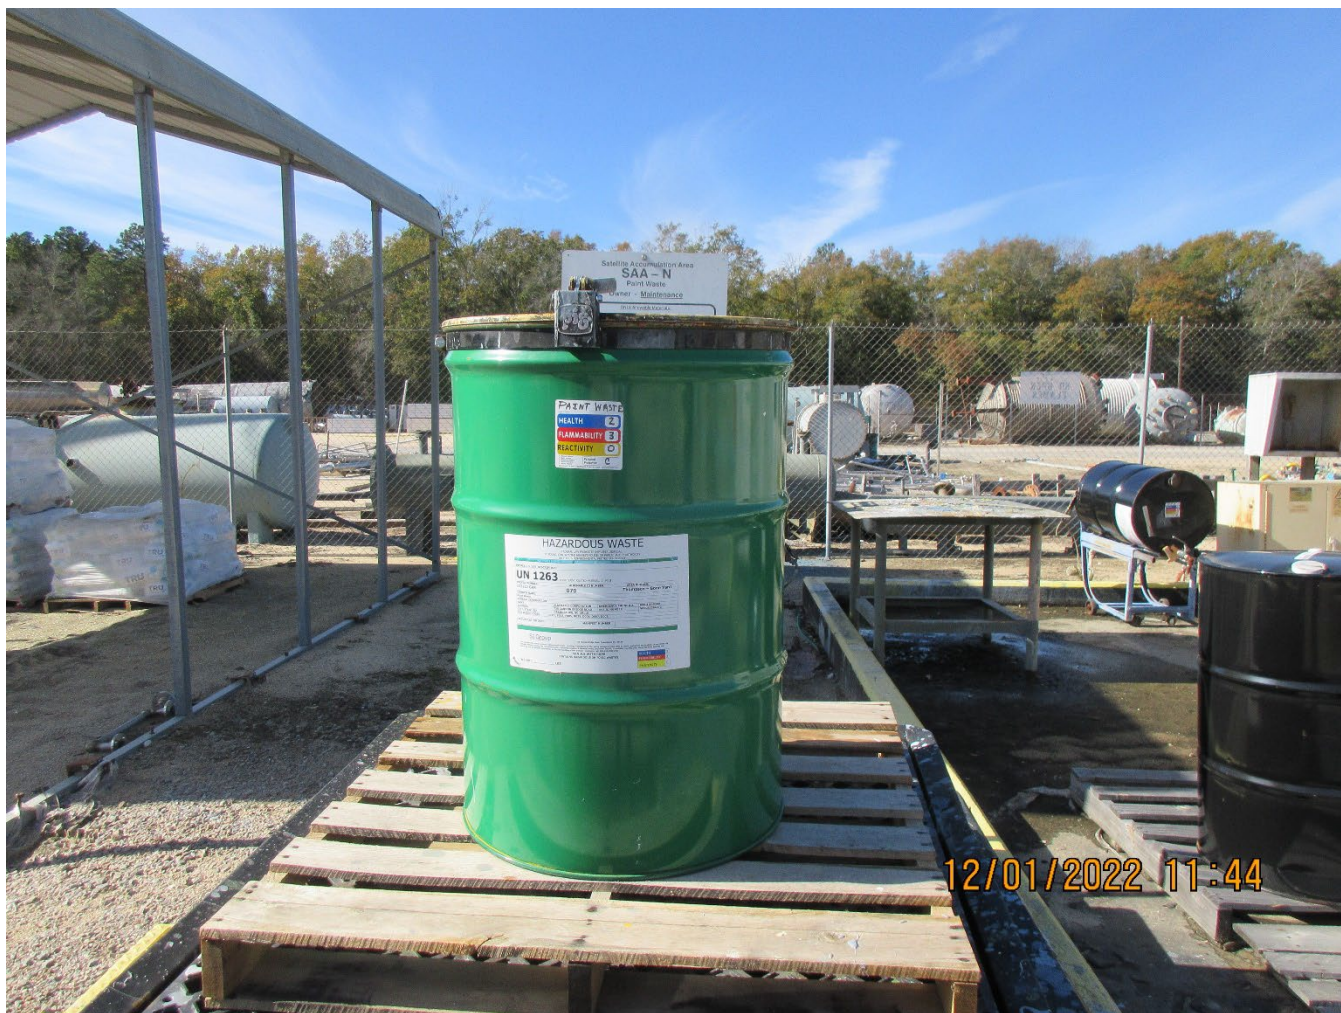
In a paint shed, the inspectors observed one 55-gallon container (Photograph 10) of hazardous waste within (SAA "N") that contained spent solvent hazardous wastes from painting activities (D006/D007/D008/D035 characteristic hazardous wastes and F003/F005 listed hazardous waste).

Photograph 10 – 55-gallon container in SAA in the Contractor’s Work Area and Bone Yard

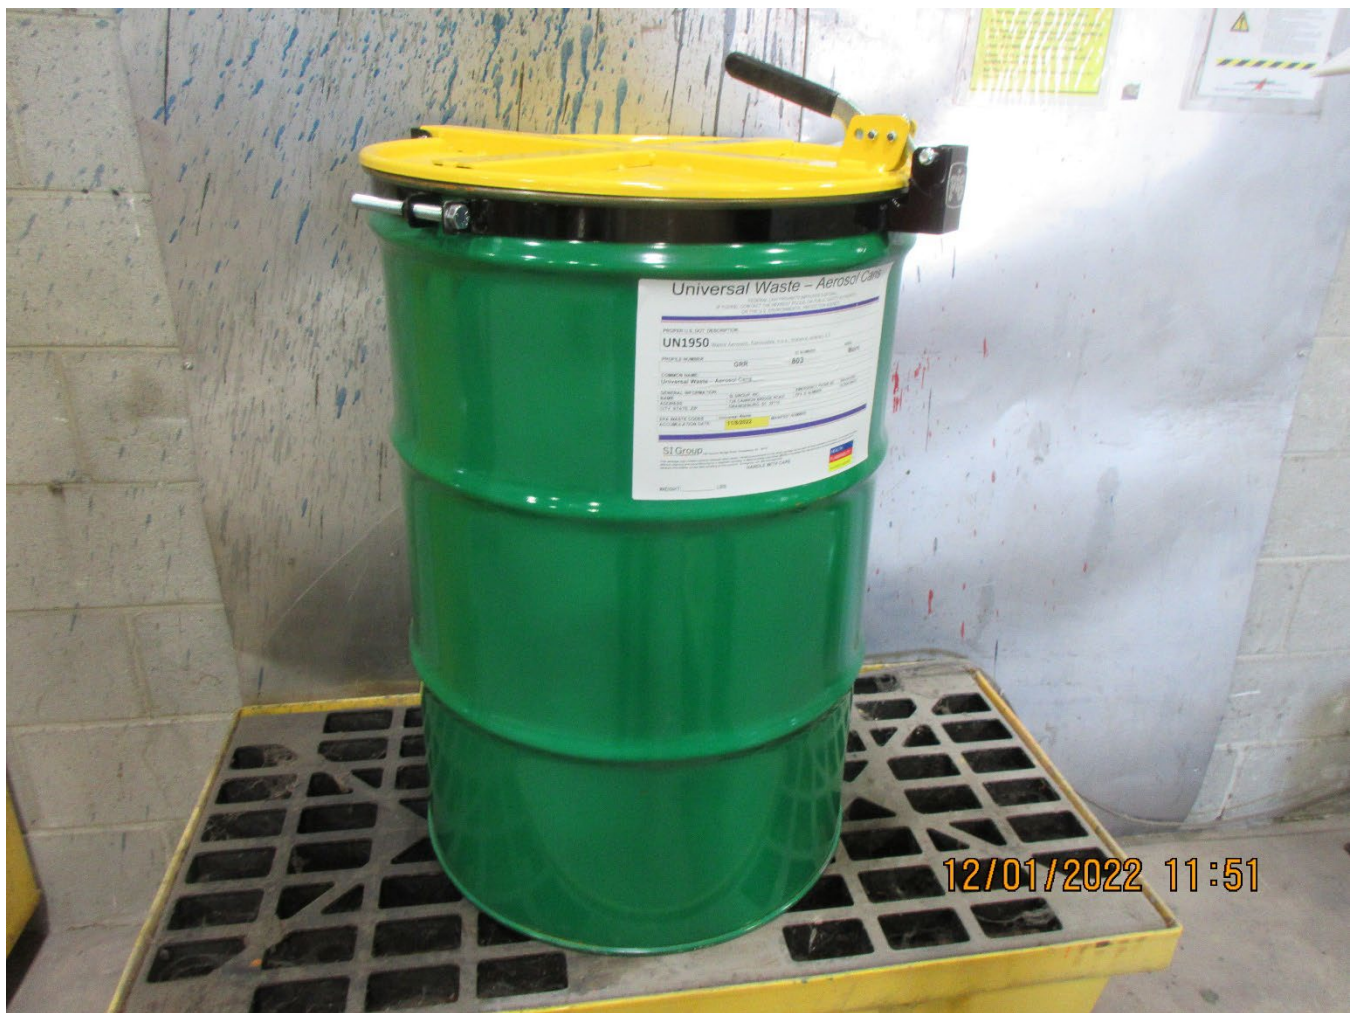
In the South Maintenance Shop, the inspectors observed one 55-gallon container (Photograph 11) that contained Universal Waste aerosol containers. The container was labeled with appropriate universal waste language and was dated with an accumulation start date of less than one year. One container of hazardous waste spent solvents (D002/D035 F003/F005) was also observed in a SAA in this area.

Photograph 11 – 55-gallon drum in SAA in South Maintenance Area for the collection of Universal Waste Aerosols.

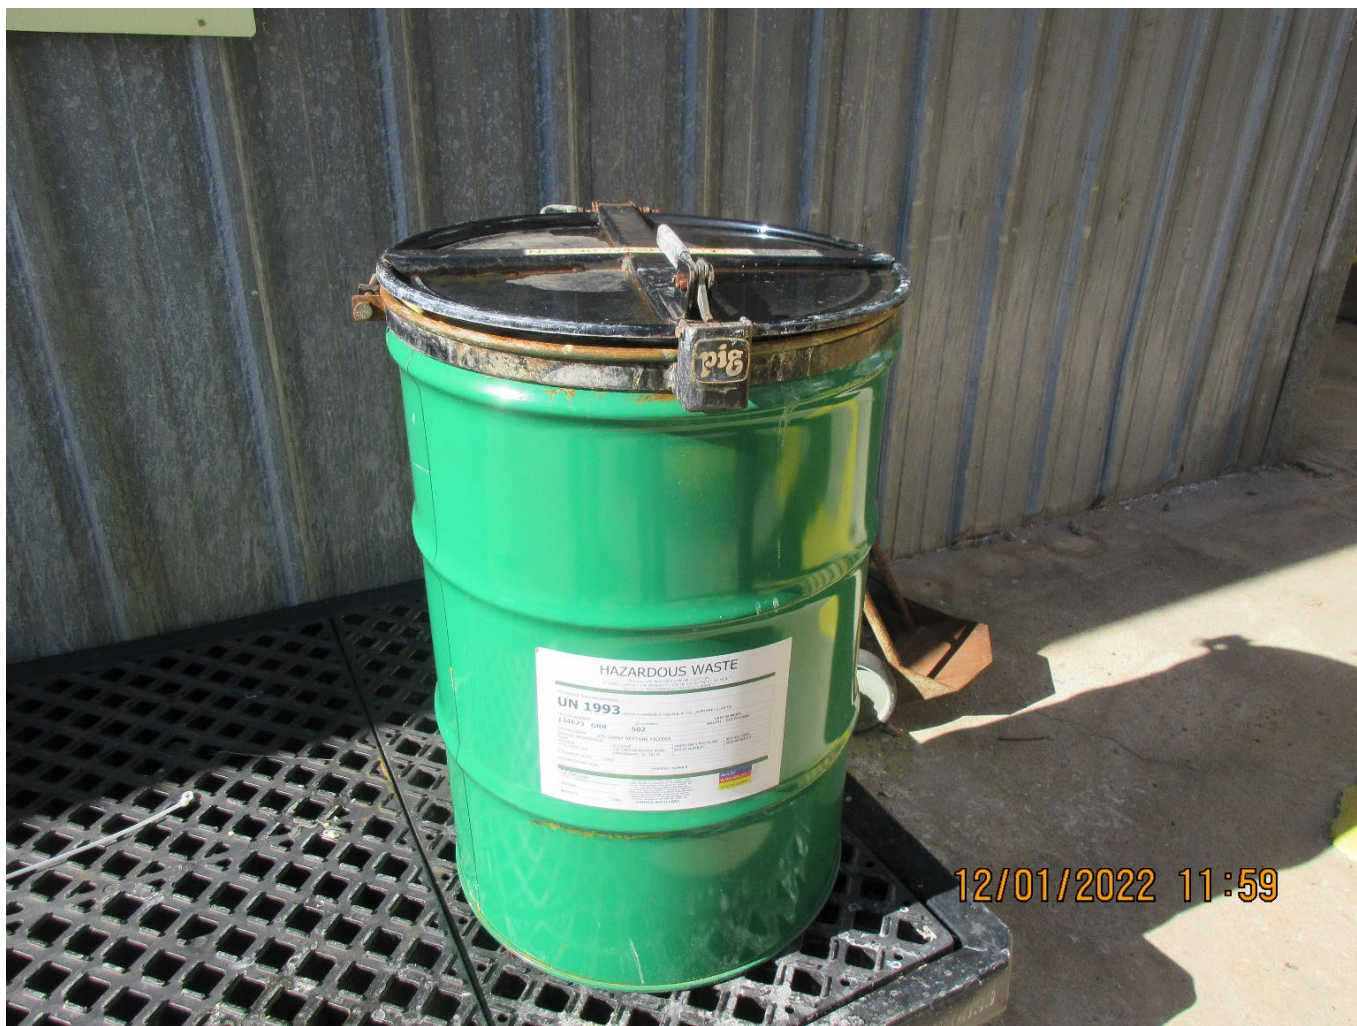
One 55-gallon container of hazardous waste spent heptane filters was observed in SAA "R" in this area. The container was open at the time of the inspection. (Photograph 12)

**Pursuant to S.C. Code Ann. Regs. 61-79.262.15(a)(4) [40 C.F.R. § 262.15(a)(4)], which is a condition of the SAA Permit Exemption, a generator is required to keep containers of hazardous waste closed at all times during accumulation, except when adding, removing, or consolidating waste; or when temporary venting of a container is necessary for the proper operation of equipment, or to prevent dangerous situations, such as build-up of extreme pressure.**

Photograph 12 – 55-gallon drum in SAA in South 330 Process Area collection of hazardous waste filters

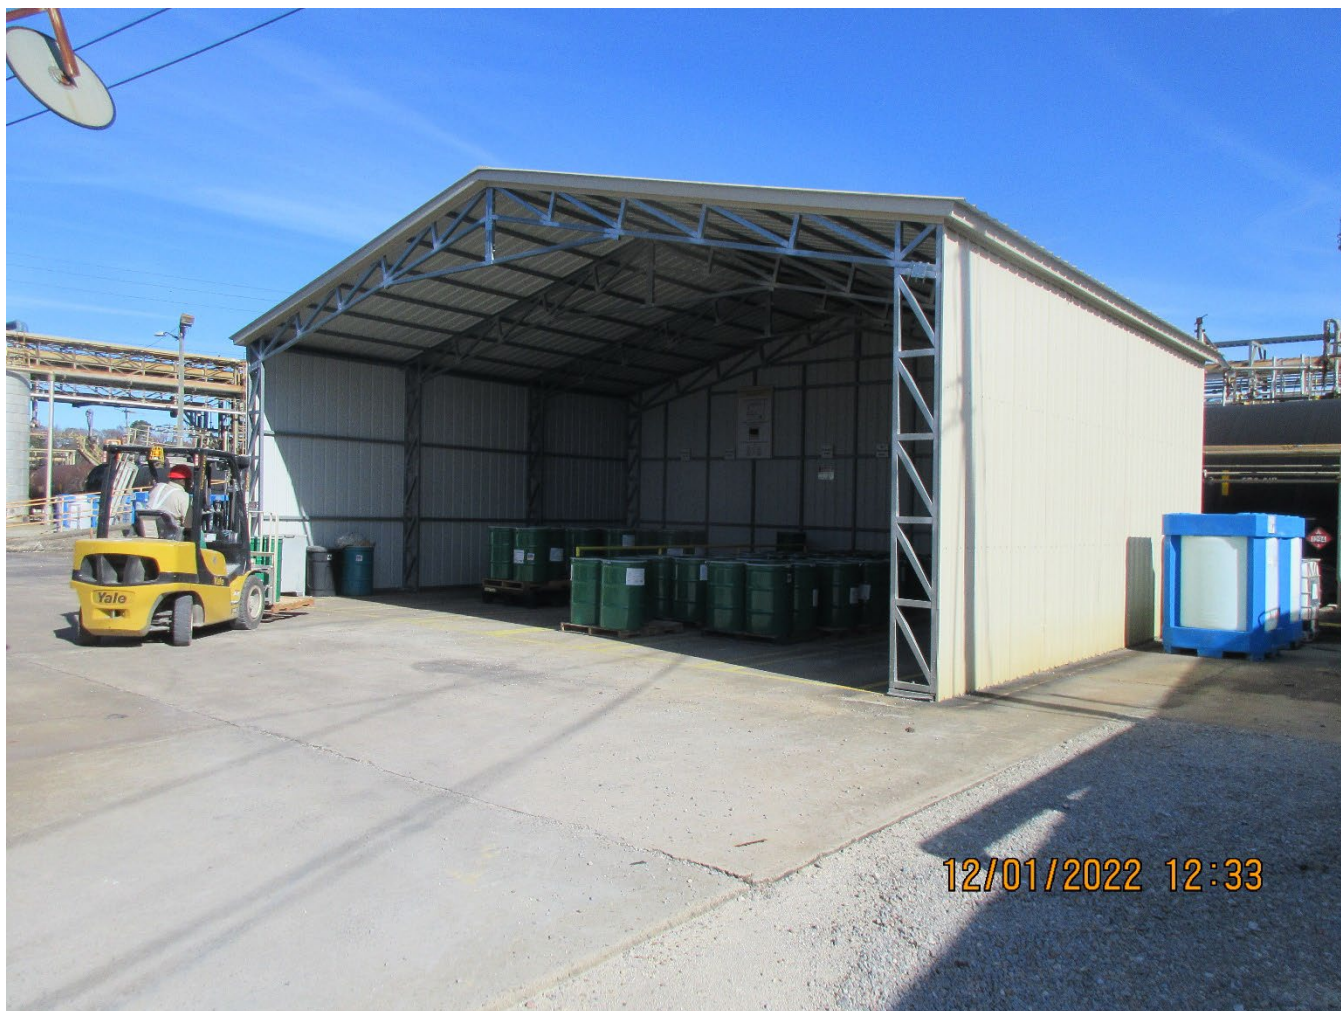
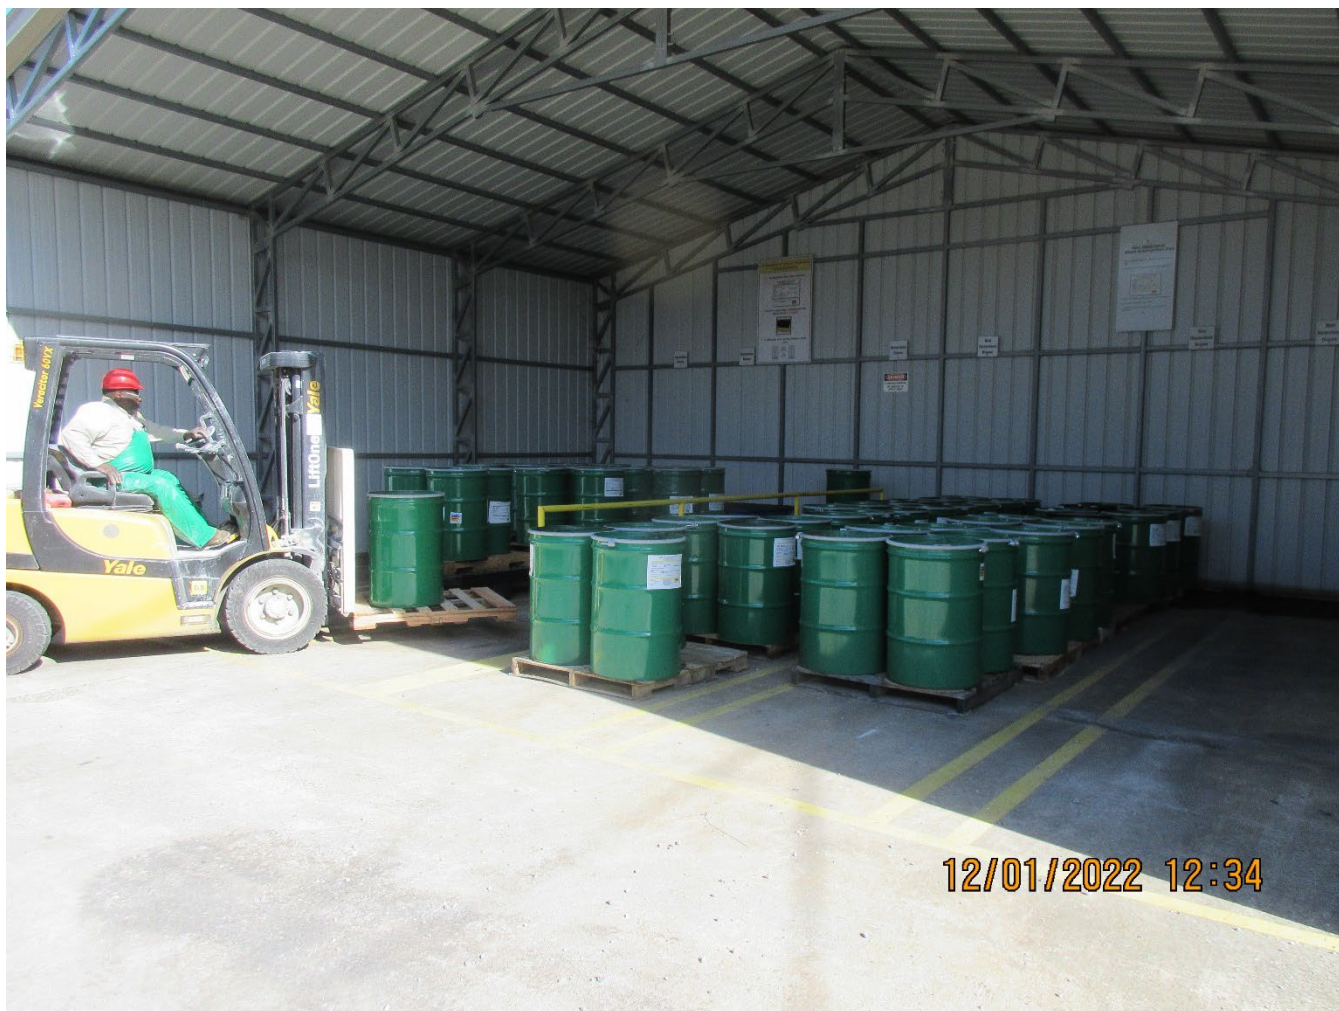
This area contained a CAA for the 90-day accumulation of hazardous waste in containers (Photographs 13 and 14). Eighteen 55-gallon containers of hazardous waste were observed in this area. At the time of the inspection, the area was not equipped with a fire extinguisher.

**Pursuant to Ga. Comp. R. and Regs. 391-3-11-.08(1) [40 C.F.R. § 262.17(a)(6)], which incorporates Ga. Comp. R. and Regs. 391-3-11-.08(1) [40 C.F.R. § 262.252], and is a condition of the LQG Permit Exemption, a generator is required must equip container accumulation areas with fire extinguishers the actual hazardous waste generation or accumulation area does not lend itself for safety reasons to have a such equipment.**

Photograph 13 – CAA Area

Photograph 14 – CAA Area
