## **RCRA Inspection Report**

InChem – Rock Hill, LLC EPA ID# SCD981014780  
800 Cel-River Road  
Rock Hill, South Carolina 29730

April 13, 2021

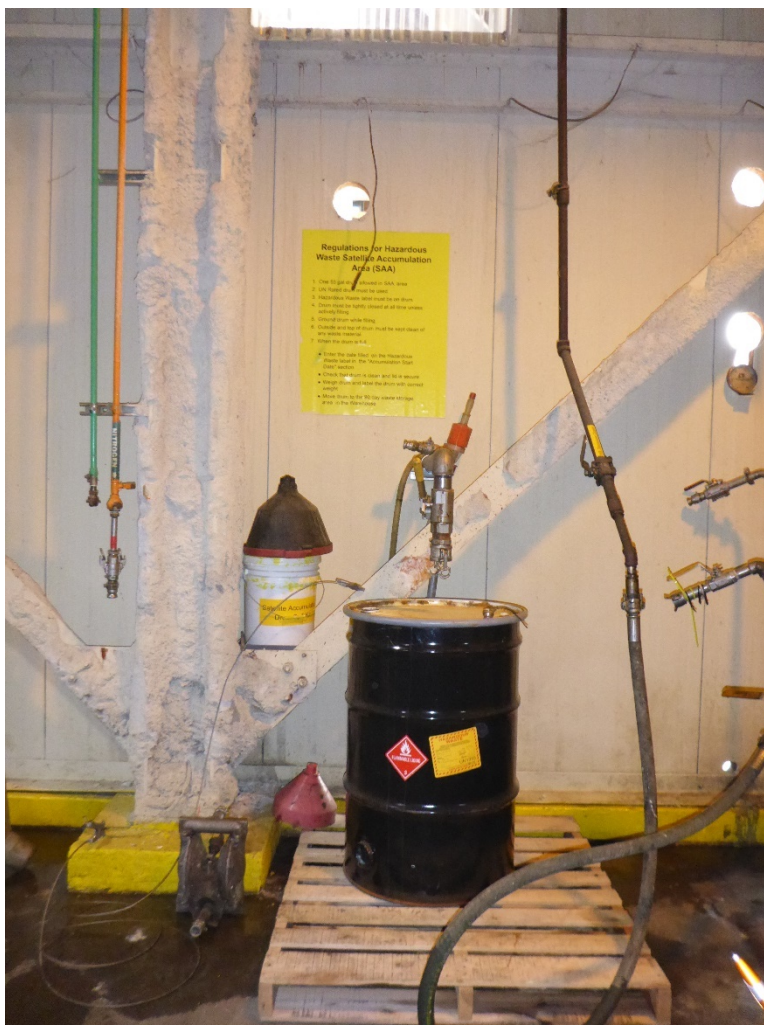
West Plant SAA: InChem manages one SAA in the West Plant K5/K6 area for managing hazardous waste flammable solvents generated in the West Plant. The waste is generated from draining process lines, and sampling material in the process units. The inspectors observed one 55-gallon drum in this SAA (Photo 2). The drum was located on a wooden pallet next to the wall beneath a pipe and valve, which can drain material from the upper level of the West Plant. The drum was closed, labeled D001 / F003 hazardous waste flammable liquid (methanol / ethanol) cleaning alcohols, and identified with a flammable liquid DOT hazard placard. The inspectors observed a fire extinguisher in the West Plant.

**Photo 2:** One 55-gallon drum located in the West Plant SAA. The drum was closed, labeled D001 / F003 hazardous waste flammable liquid (methanol / ethanol) cleaning alcohols, and identified with a flammable liquid DOT hazard placard.
