**Class I and II Well Inspection Form**  
**US Environmental Protection Agency – Region 4**  
**Underground Injection Control Program**  
61 Forsyth Street SW, MC 9T25, Atlanta, Georgia, 30303  
Phone: (404)562-9424

Well Name & #: *W.W. Foskett #24-3* \_\_\_\_\_  
Well Type (see table): *Enhanced Recovery (EOR)* \_\_\_\_\_ State Permit: API # *0911320097* \_\_\_\_\_  
Latitude (°N): *30.841148 °N* \_\_\_\_\_ Longitude (°W): *-87.101548 °W* \_\_\_\_\_ Elevation (ft): *NA* \_\_\_\_\_  
Injection Method (check applicable): ☐ Casing Injector; ☒ Tubing & Packer; ☐ Cemented Injection Tubing

W.W. Foscett #24-3

September 13, 2022

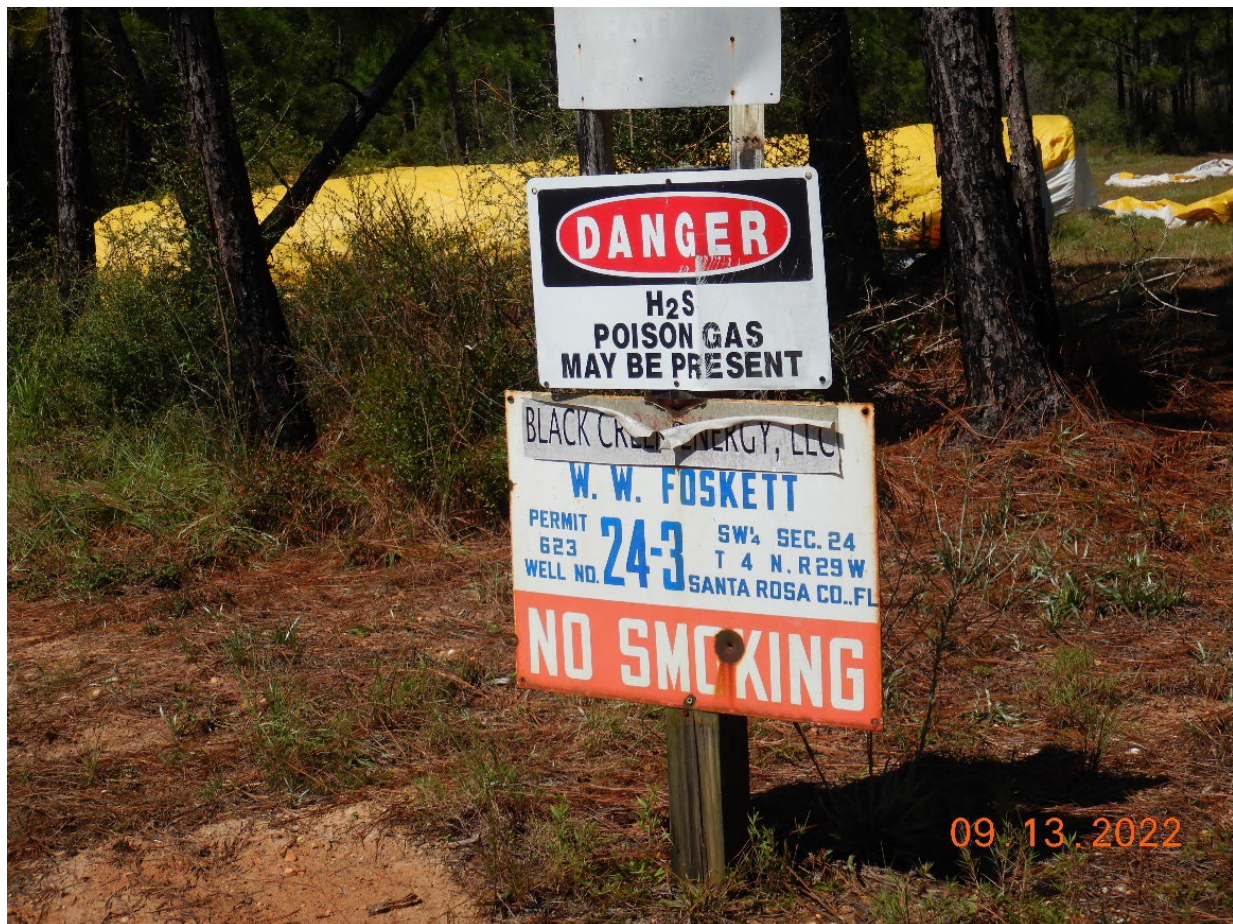
Description: *Looking west, W.W. Foskett #24-3 sign alongside access road.* \_\_\_\_\_

**Photograph 1:** Looking west, W.W. Foscett #24-3 sign alongside access road.

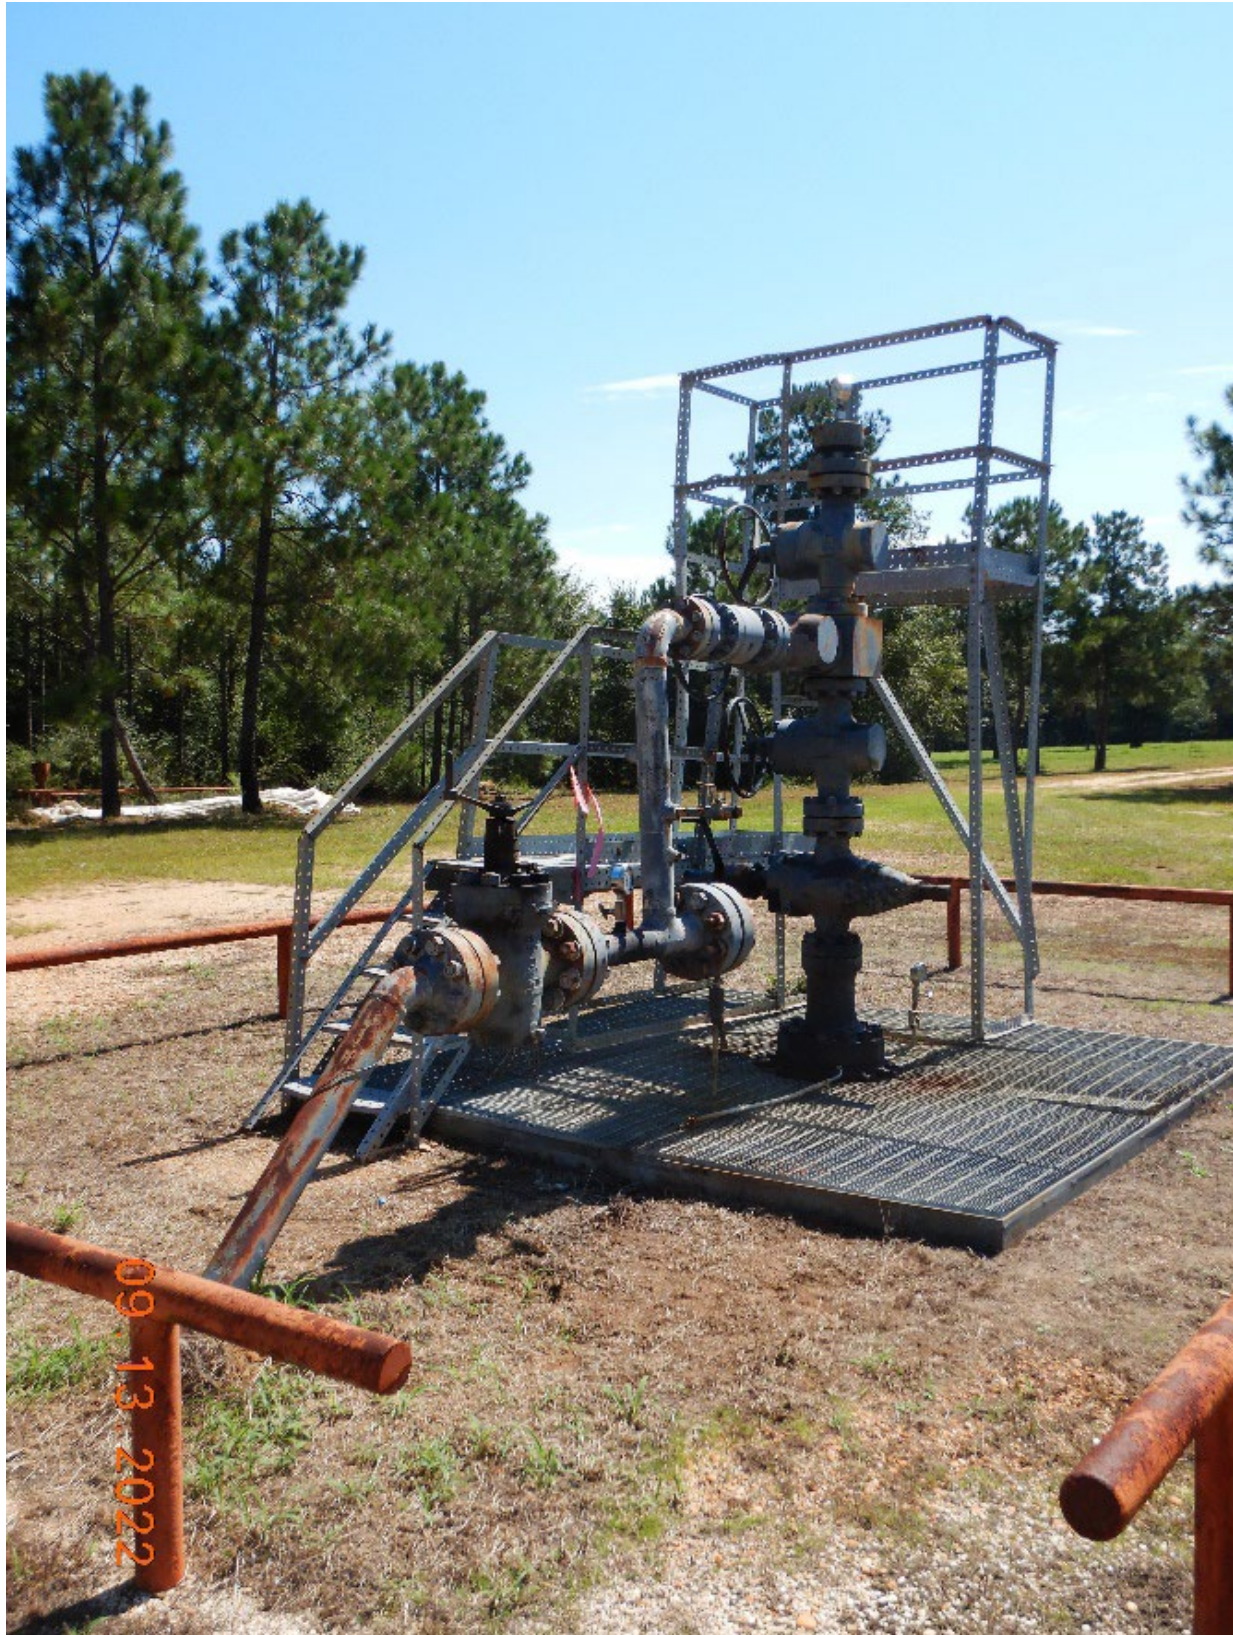
*The internal pressure gauge reading was 1,700 psi. The site was clean and well-maintained. There was no evidence of leaks or excessive corrosion.*  
*Perfs (see well schematics):*  
*Re-perfed: 15,890'-940' GR 2SPF (11/'80)*  
*Re-perfed: 15859' – 889' GR 4SPF (11/26/'77)*  
*Perfs: 15865'-935' GR (08/19/'74)*

Description: *Looking east, site overview, showing well head, pressure gauges, valves, and access stairs.* \_\_\_\_\_

**Photograph 2:** Looking east, site overview, showing well head, pressure gauges, valves, and access stairs.

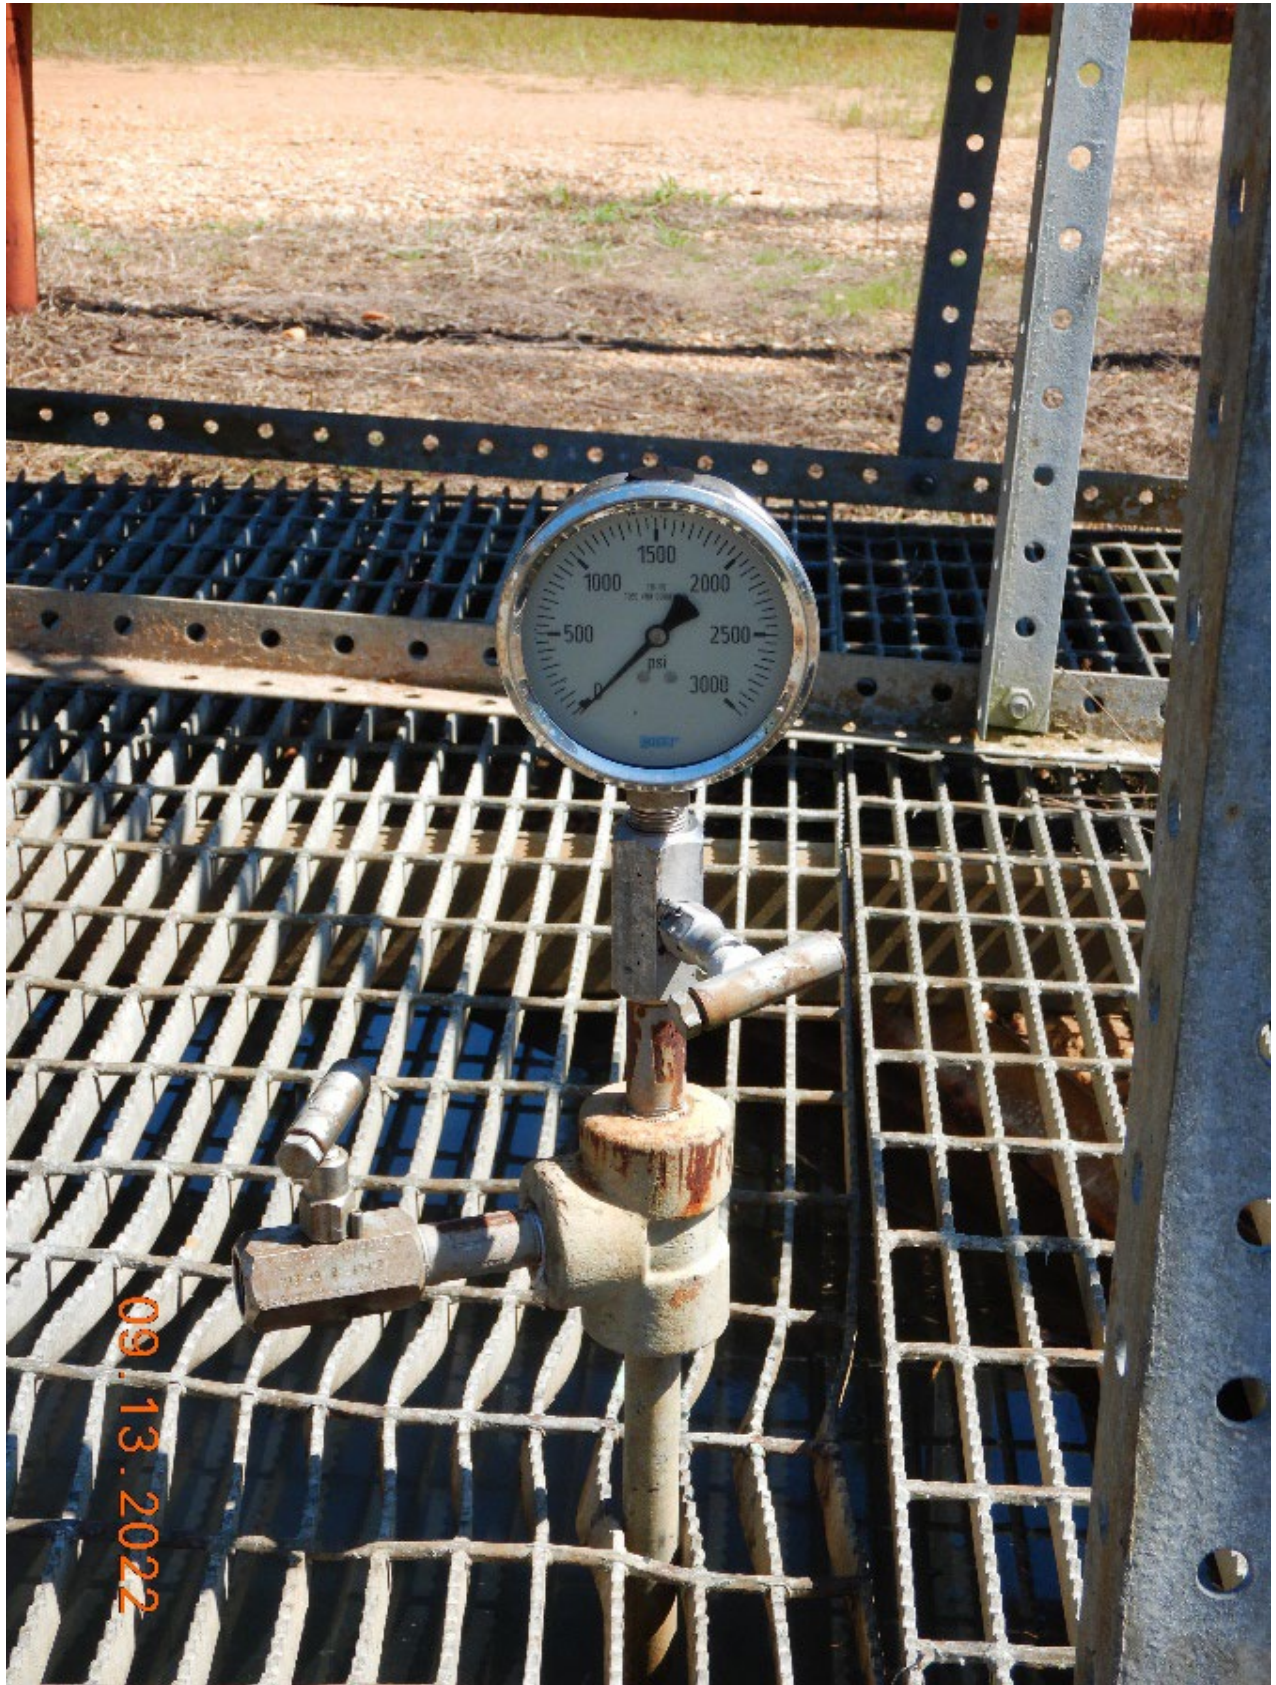
Description: *Looking north, closeup view of surface pressure gauge reading 0 psi.* \_\_\_\_\_

**Photograph 3:** Looking north, closeup view of surface pressure gauge reading 0 psi.

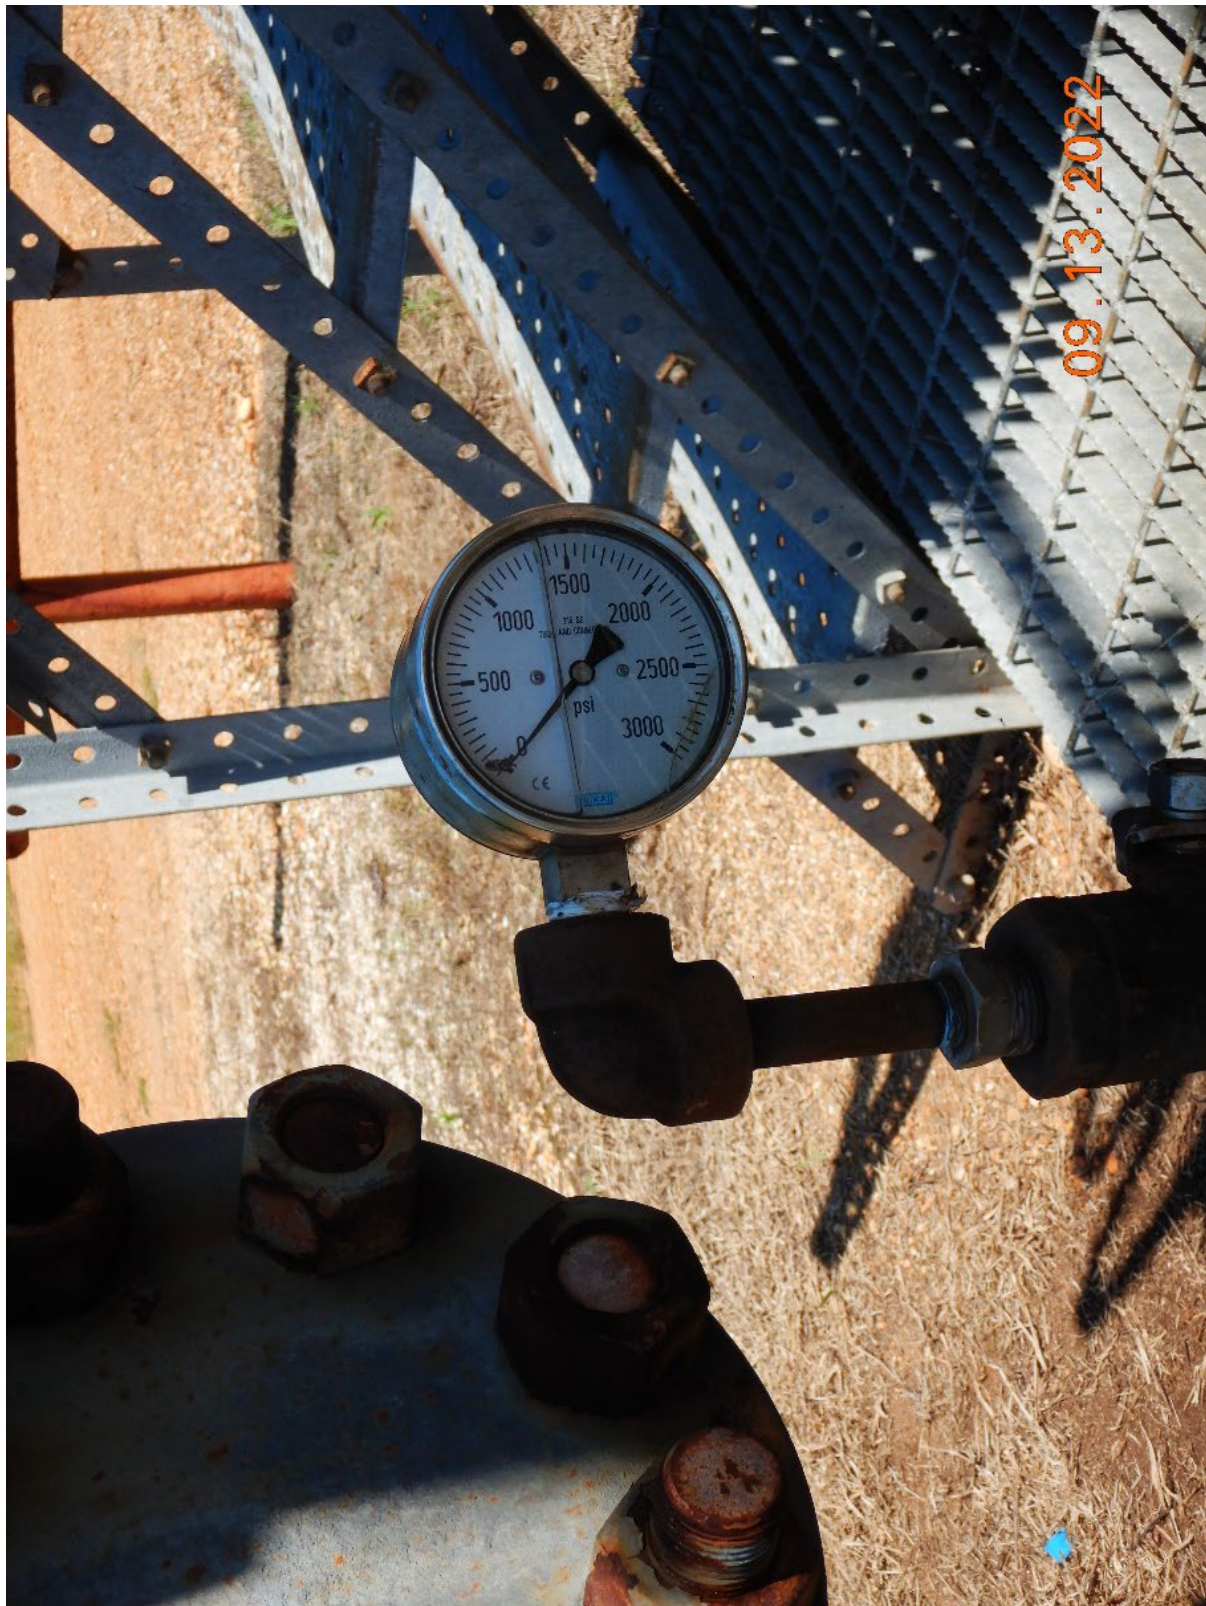
Description: *Looking north, closeup view of production casing pressure gauge reading 0 psi.* \_\_\_\_\_

**Photograph 4:** Looking north, closeup view of production casing pressure gauge reading 0 psi.

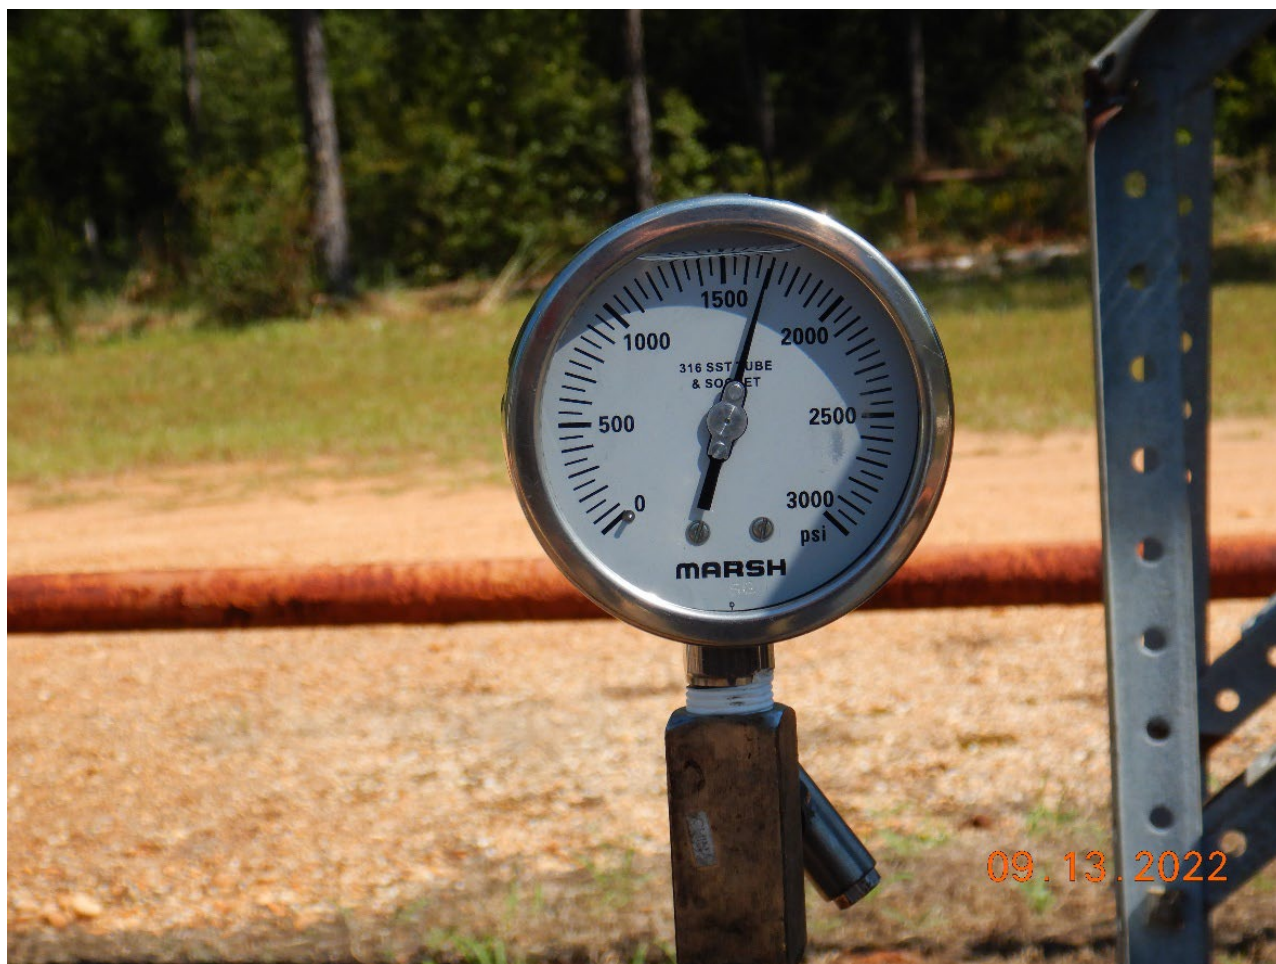
Description: *Looking north, view of incoming line pressure gauge reading 1,700 psi.* \_\_\_\_\_

**Photograph 5:** Looking north, view of incoming line pressure gauge reading 1,700 psi.

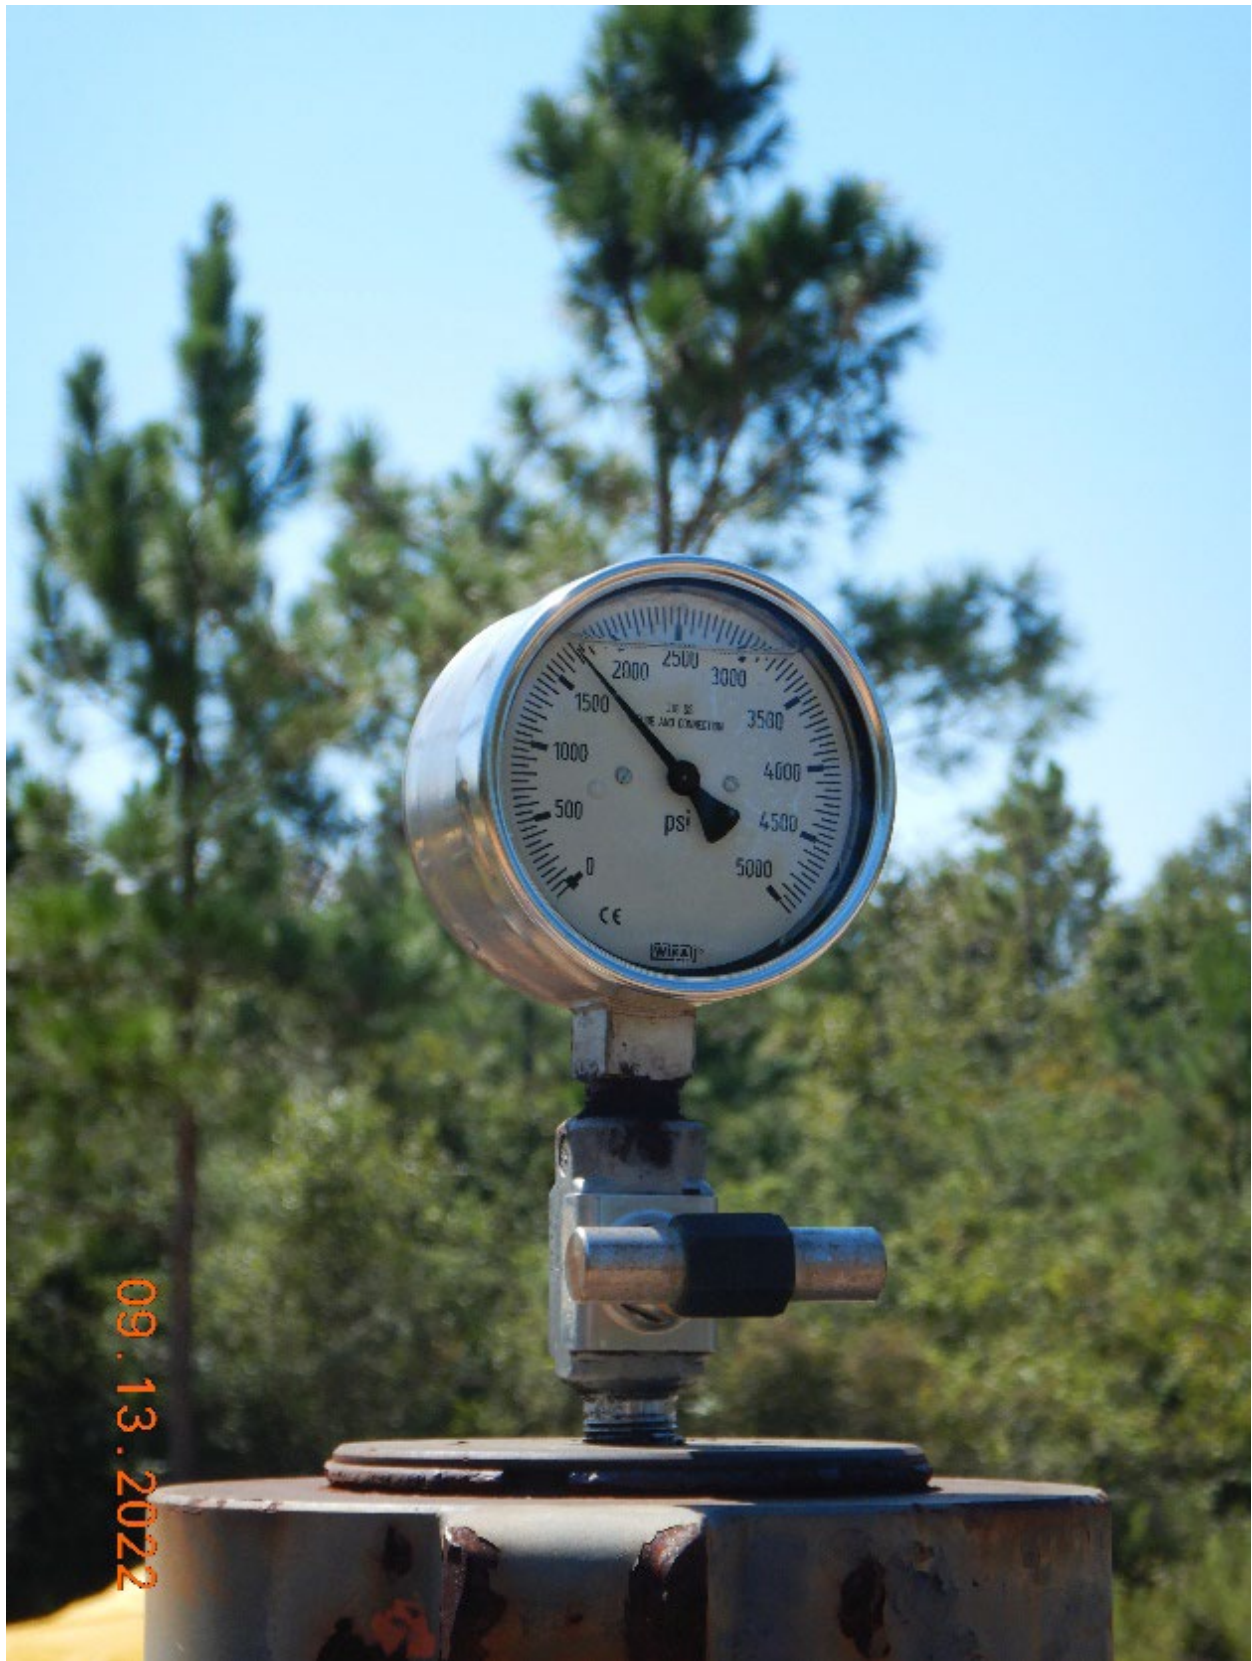
Description: *Looking east, view of internal pressure gauge reading 1,700 psi.* \_\_\_\_\_

**Photograph 6:** Looking east, view of internal pressure gauge reading 1,700 psi.
