INSPECTION REPORT

Media:	Water
Statute(s)/Program(s):	Clean Water Act, NPDES, Stormwater – Industrial
Type of inspection:	ISI - Industrial Stormwater Inspection
Access:	Granted

Permittee Name:	Columbia Quarry Company
Facility or Site Name:	Columbia Quarry Company – Dupo Quarry Plant #9
Facility/Site Physical Address:	100 Industrial Drive
(City, state, zip code)	Dupo, IL 62239
County/Parish:	
Facility GPS Coordinates:	38.505978, -90.200772
Mailing address: (If different)	
(City, state, zip code)	
Facility/Site Identifier:	110001686355
Permit Number:	ILG840213
SIC or NAICS:

ILG840213 - Columbia Plant #9 - Dupo Quarry

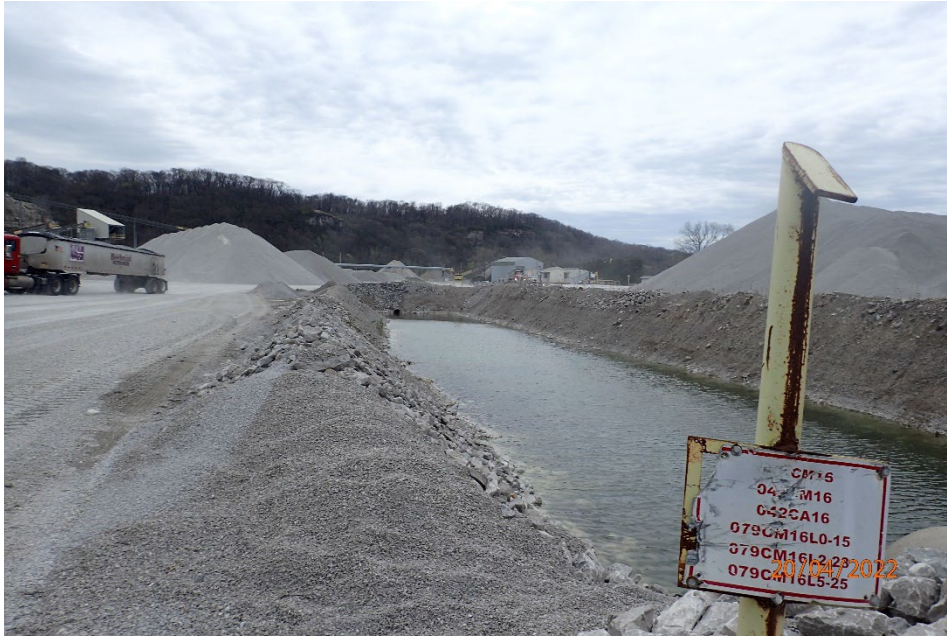
1: P4200029

Description: A sedimentation pond at the Dupo Quarry allows sedimentation to fall out before flowing via gravity to Outfall 002. Approximately 22 acres of storm water flow to Outfall 002.

Location: West side of the Dupo Quarry.

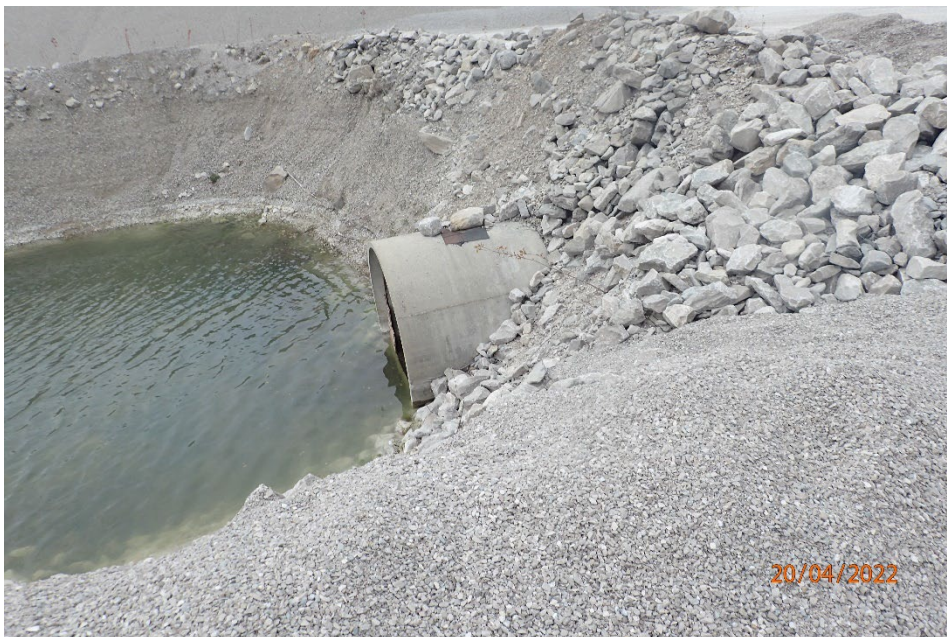
2: P4200030

Description: The pipe for flow to exit via gravity from the sedimentation pond to Outfall 002.

Location: West side of the Dupo Quarry.

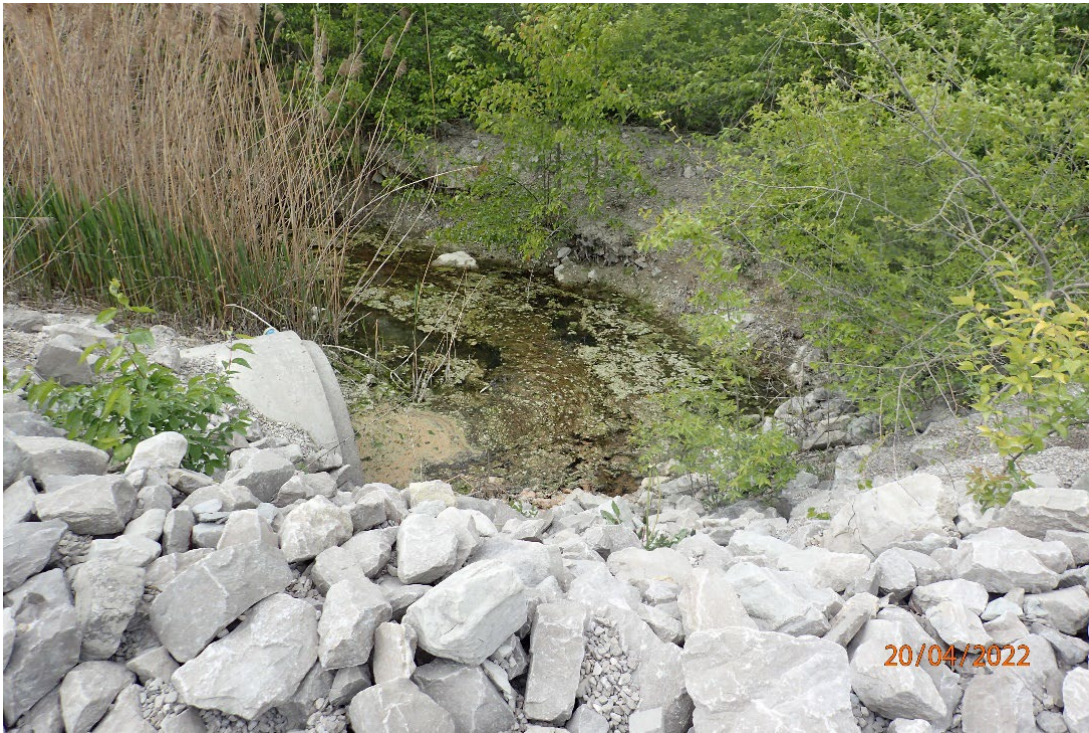
3: P4200031

Description: Flow from the sedimentation pond goes north to a swamp/wetland area before flowing via gravity to Outfall 002.

Location: West side of the Dupo Quarry.

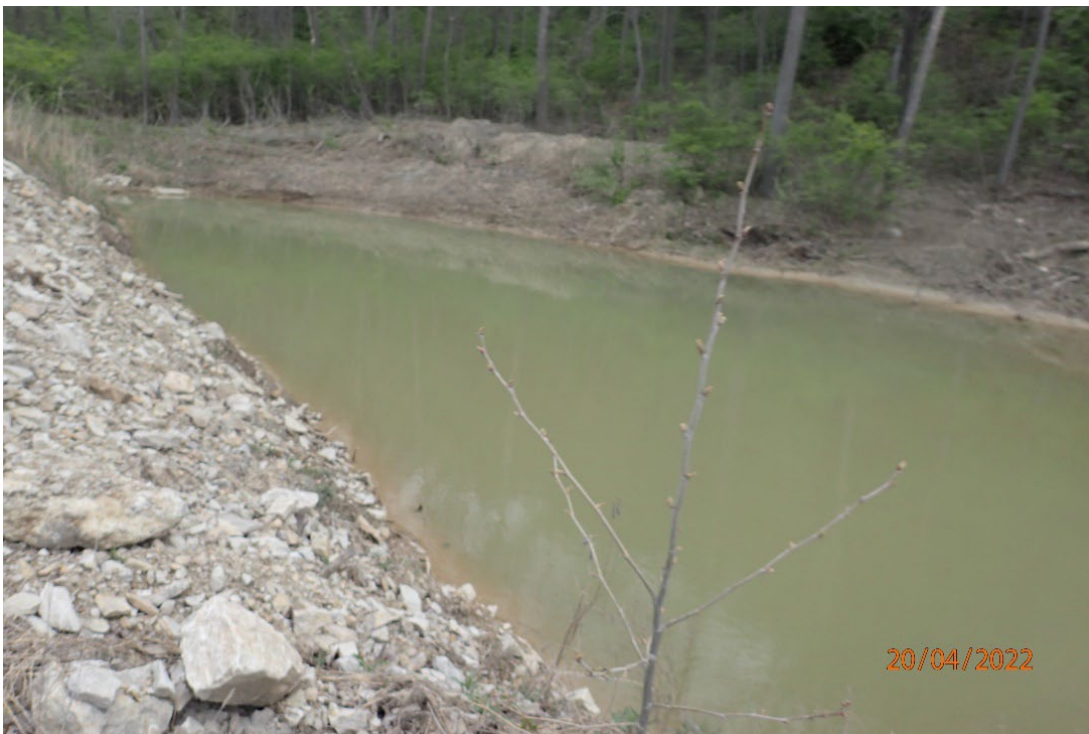
4: P4200032

Description: The Primary Settling Pond accepts storm water from surface flow and from the pumped pit water.

Location: Primary Settling Pond.

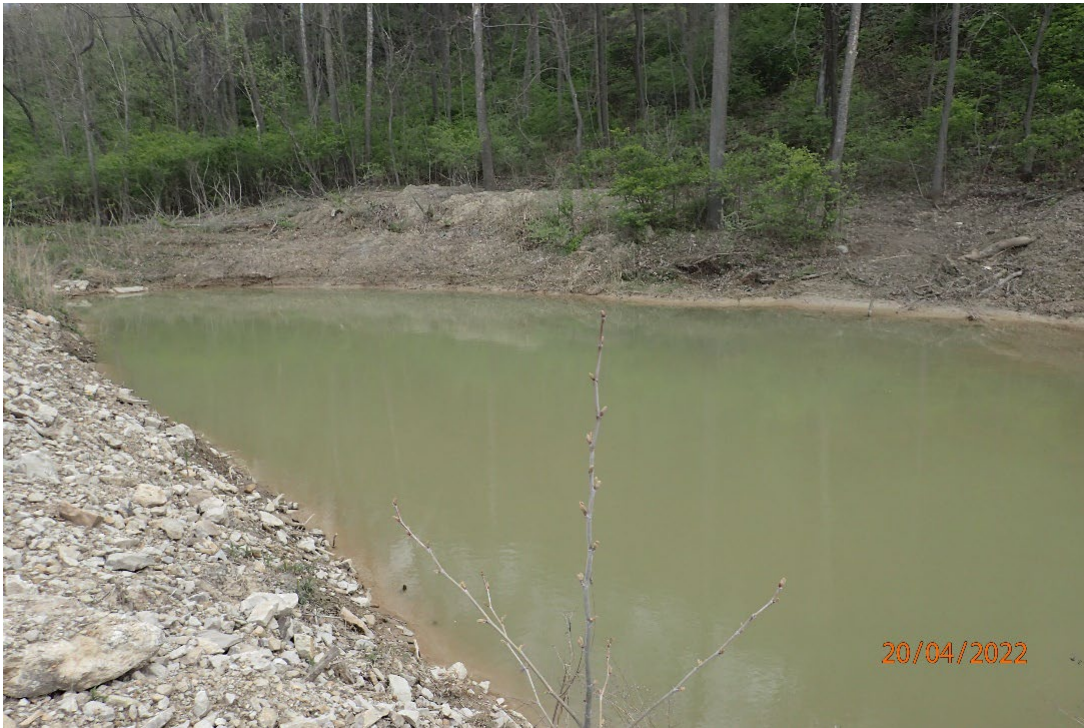
5: P4200033

Description: The Primary Settling Pond accepts storm water from surface flow and from the pumped pit water.

Location: Primary Settling Pond.

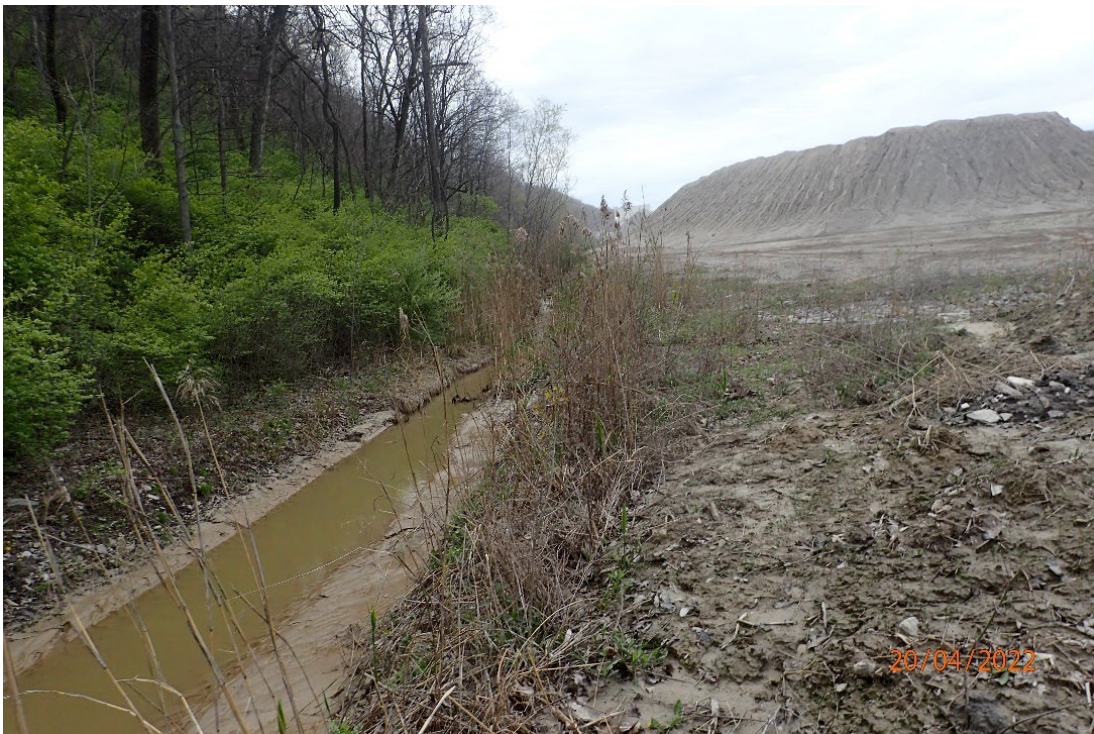
6: P4200034

Description: Looking upstream along a storm water ditch flows to the Primary Settling Pond.

Location: Southeast of the Primary Settling Pond.

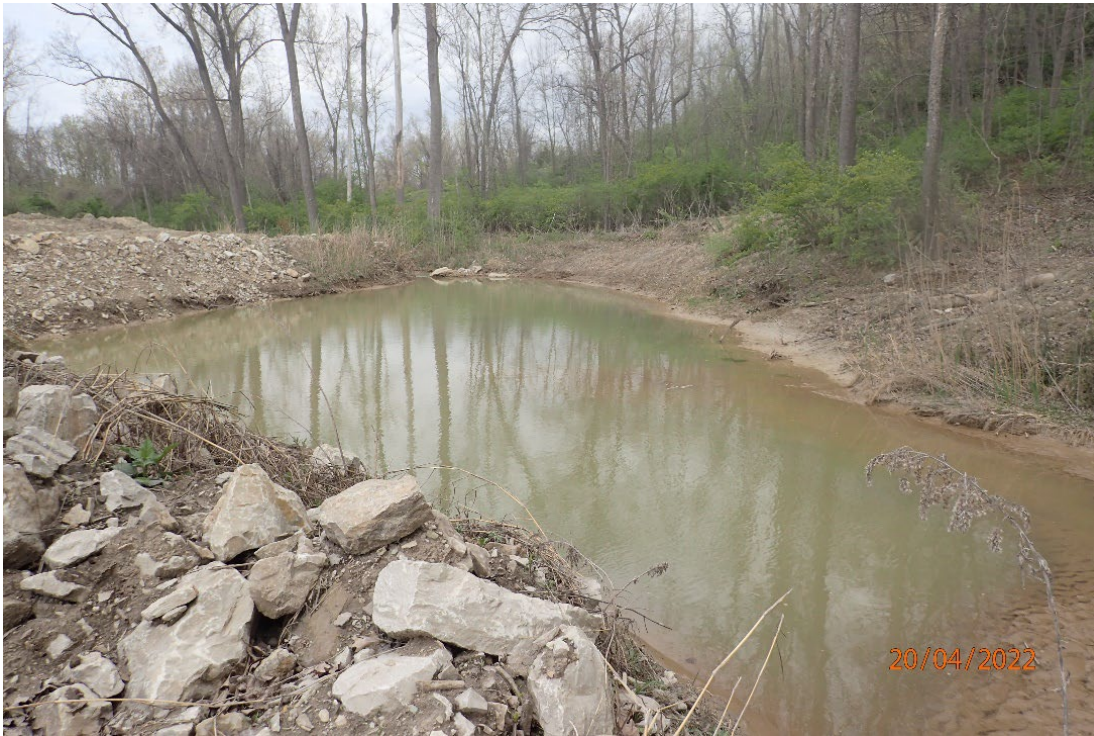
7: P4200035

Description: Downstream in the storm water ditch to the Primary Settling Pond.

Location: Southeast of the Primary Settling Pond.

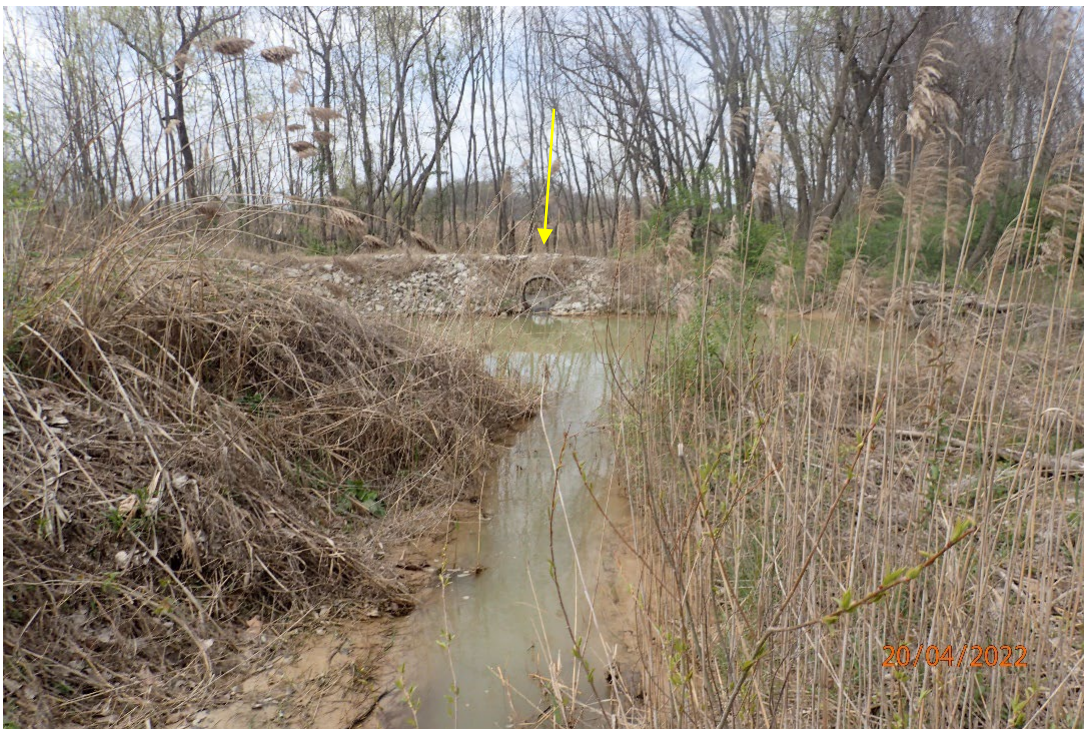
8: P4200036

Description: The outfall pipe is denoted with a yellow arrow. The pipe allows water to flow via gravity from the Primary Settling Pond to the swamp to the west.

Location: Primary Settling Pond.

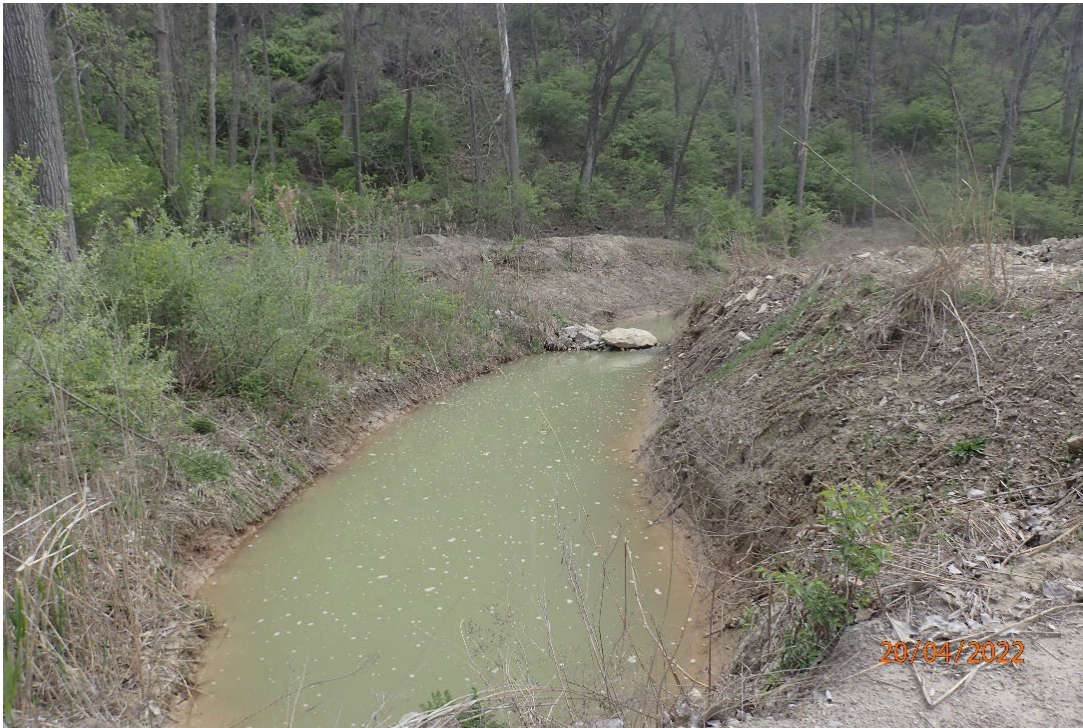
9: P4200037

Description: There is a rock check dam on the ditch upstream of the Primary Settling Pond to slow the flow of the water and allow sedimentation to settle out.

Location: Primary Settling Pond.

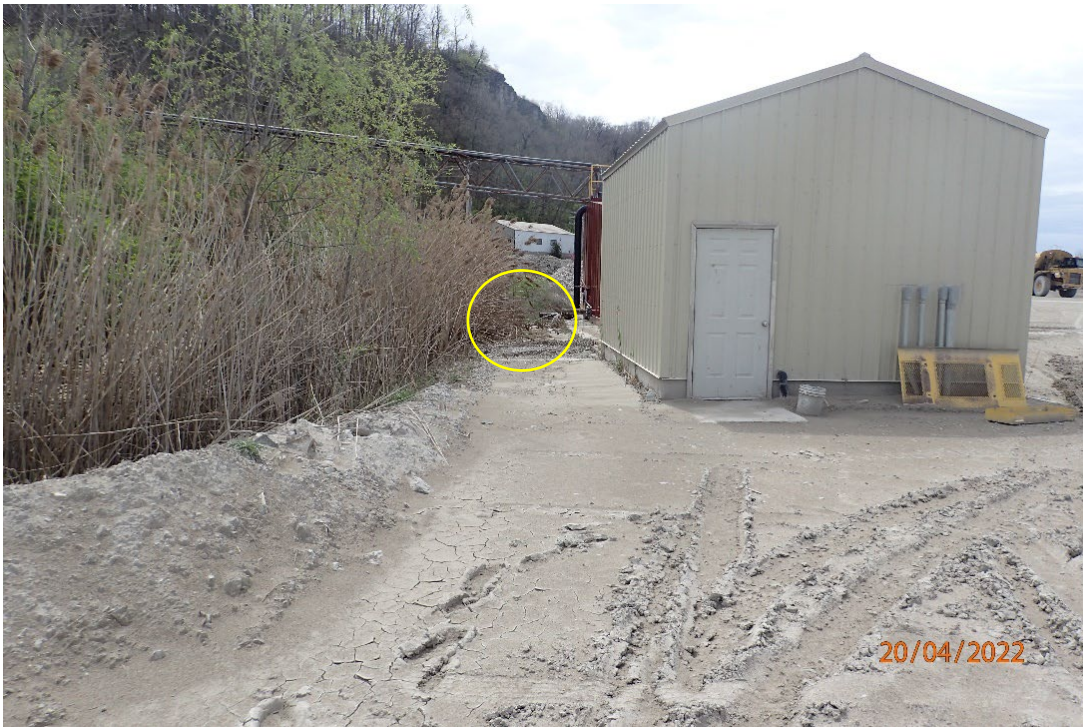
10: P4200038

Description: Pit water is pumped up from the quarry pit and used on the conveyor belts in the quarry. Excess water can be directed to the ditch. The end of the pipe from the pit water to the ditch is circled with a yellow circle.

Location: East of the quarry pit.

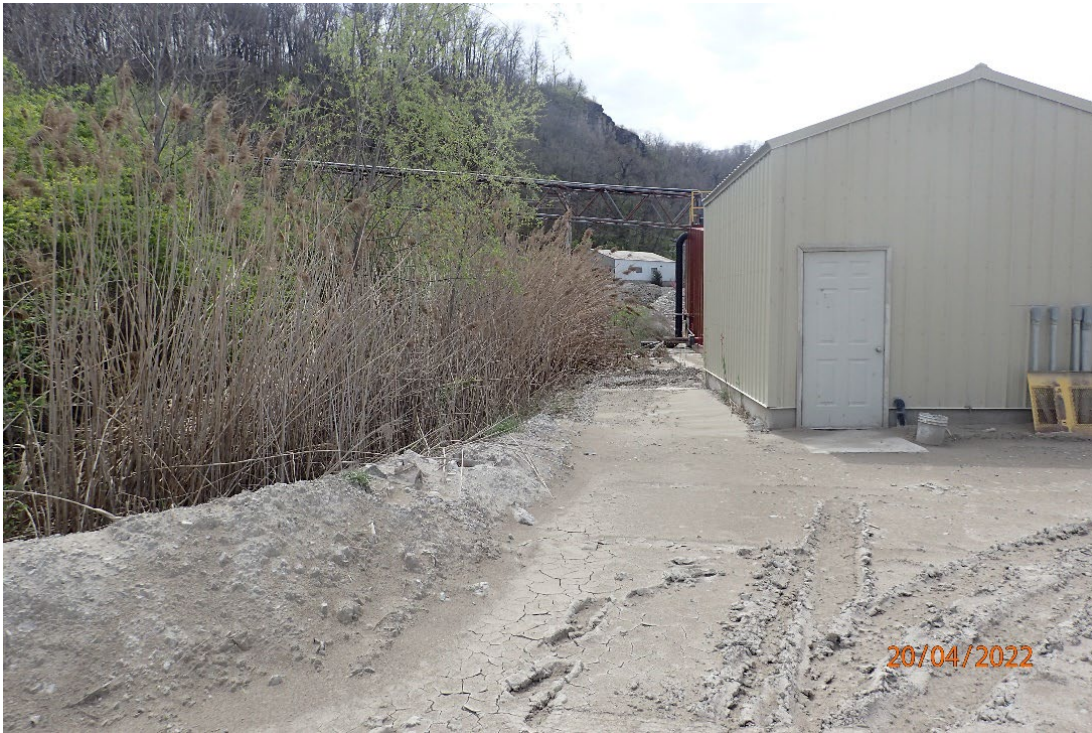
11: P4200039

Description: Pit water is pumped up to the ditch.

Location: East of the quarry pit.

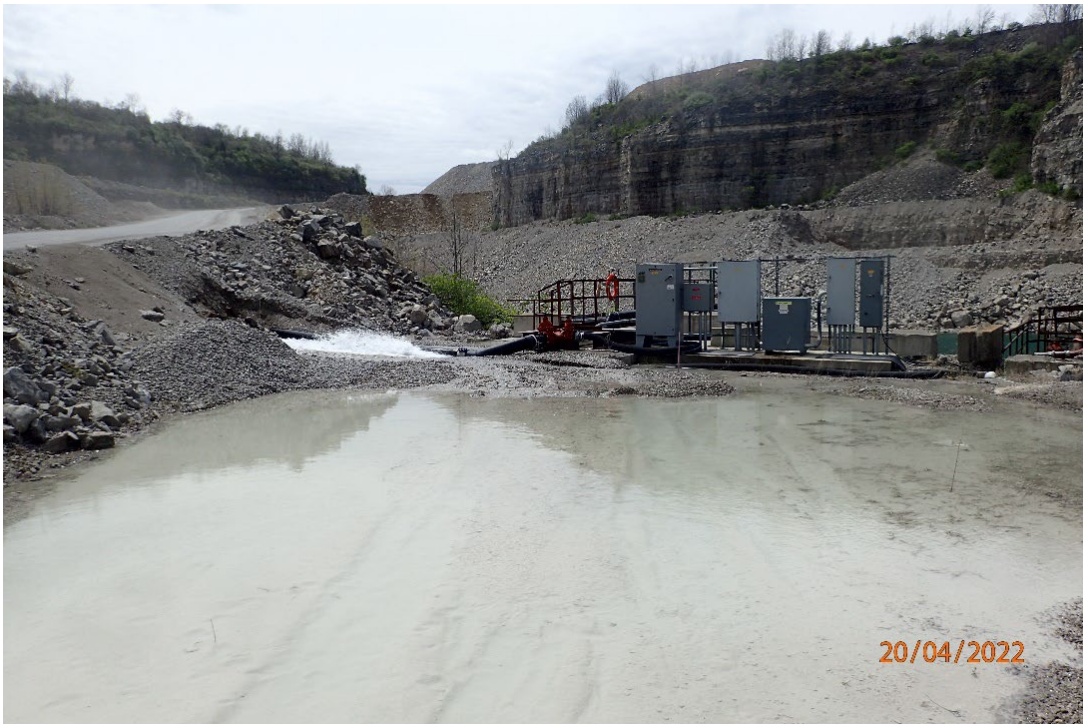
12: P4200040

Location: Quarry Pit and Quarry Pit Pump	Contains CBI: No
Observation #: JR4-OB-004	Date: 06/17/2022
<p>EPA arrived at the quarry pit and observed the scaffolding that held the piping for the pump in the quarry pit. The pump and piping were on the east side of the quarry pit. EPA observed that the pipe from the pit was leaking, and water collected on the ground around the scaffolding. Eventually, the water would flow back into the pit.</p> <p>Near the scaffolding, EPA observed the piping that allowed pumped water to be pumped into trucks for dust suppression.</p>

Description: The pump and pipe to dewater the pit is on the east side of the pit. There was a leak in the pipe from the pit but water would flow back into the pit.

Location: East side of the quarry pit.

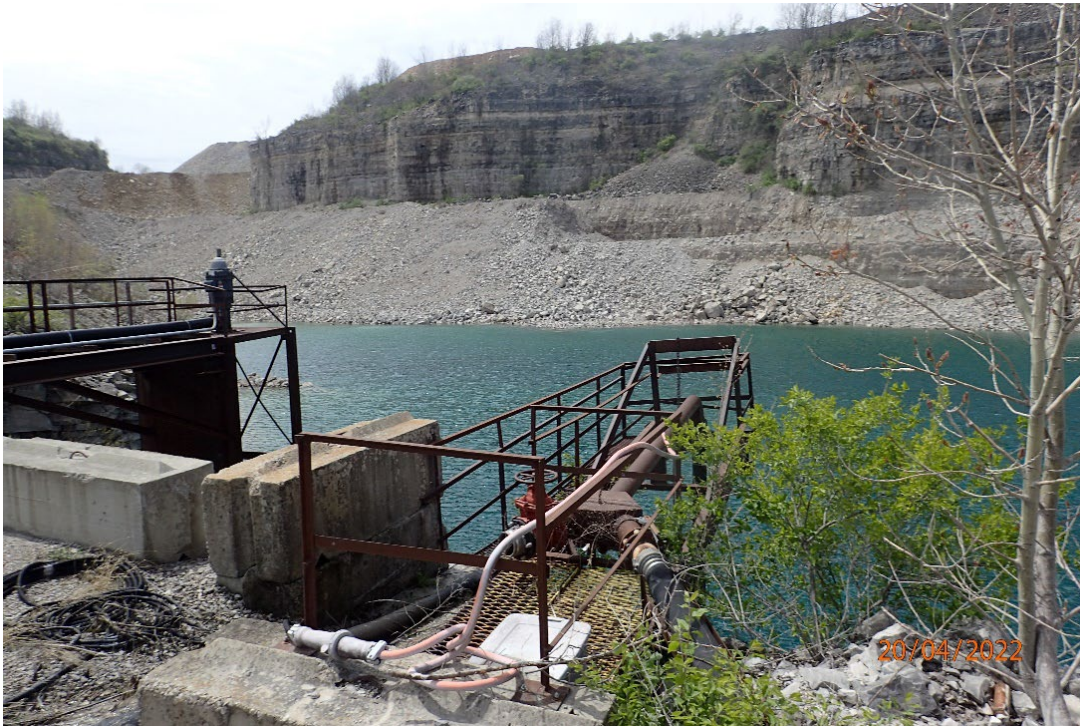
13: P4200041

Description: Scaffolding for the pump and piping from the quarry pit.

Location: East side of the quarry pit.

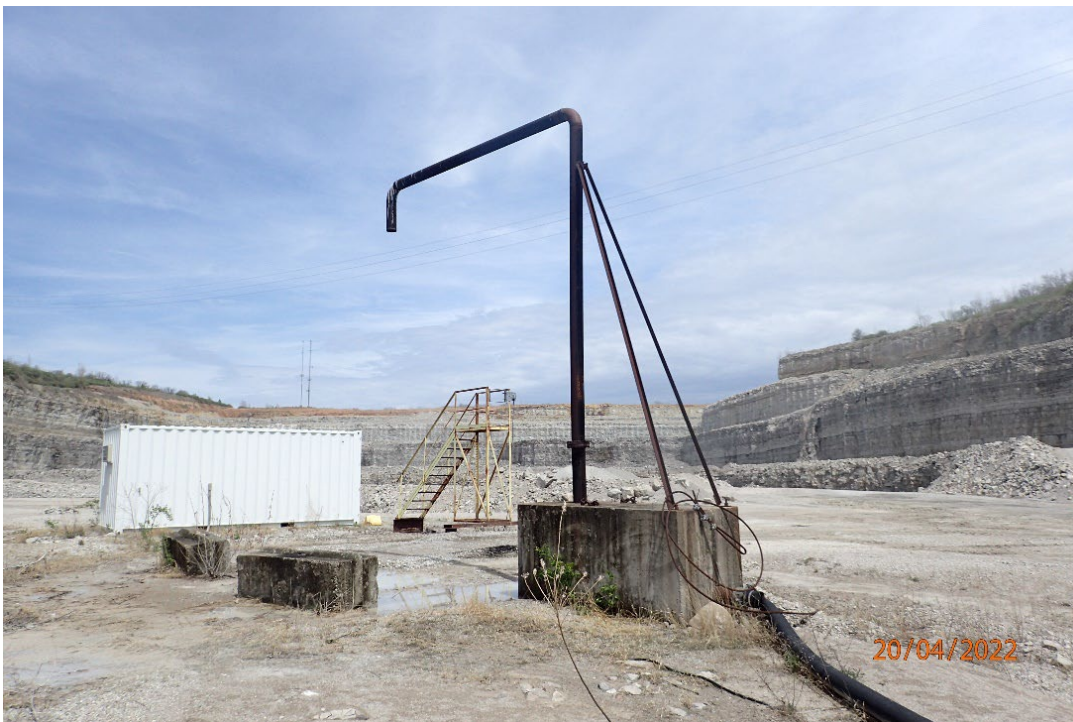
14: P4200042

Description: Piped water from the quarry pit can be pumped into trucks for dust suppression.

Location: East side of the quarry pit.

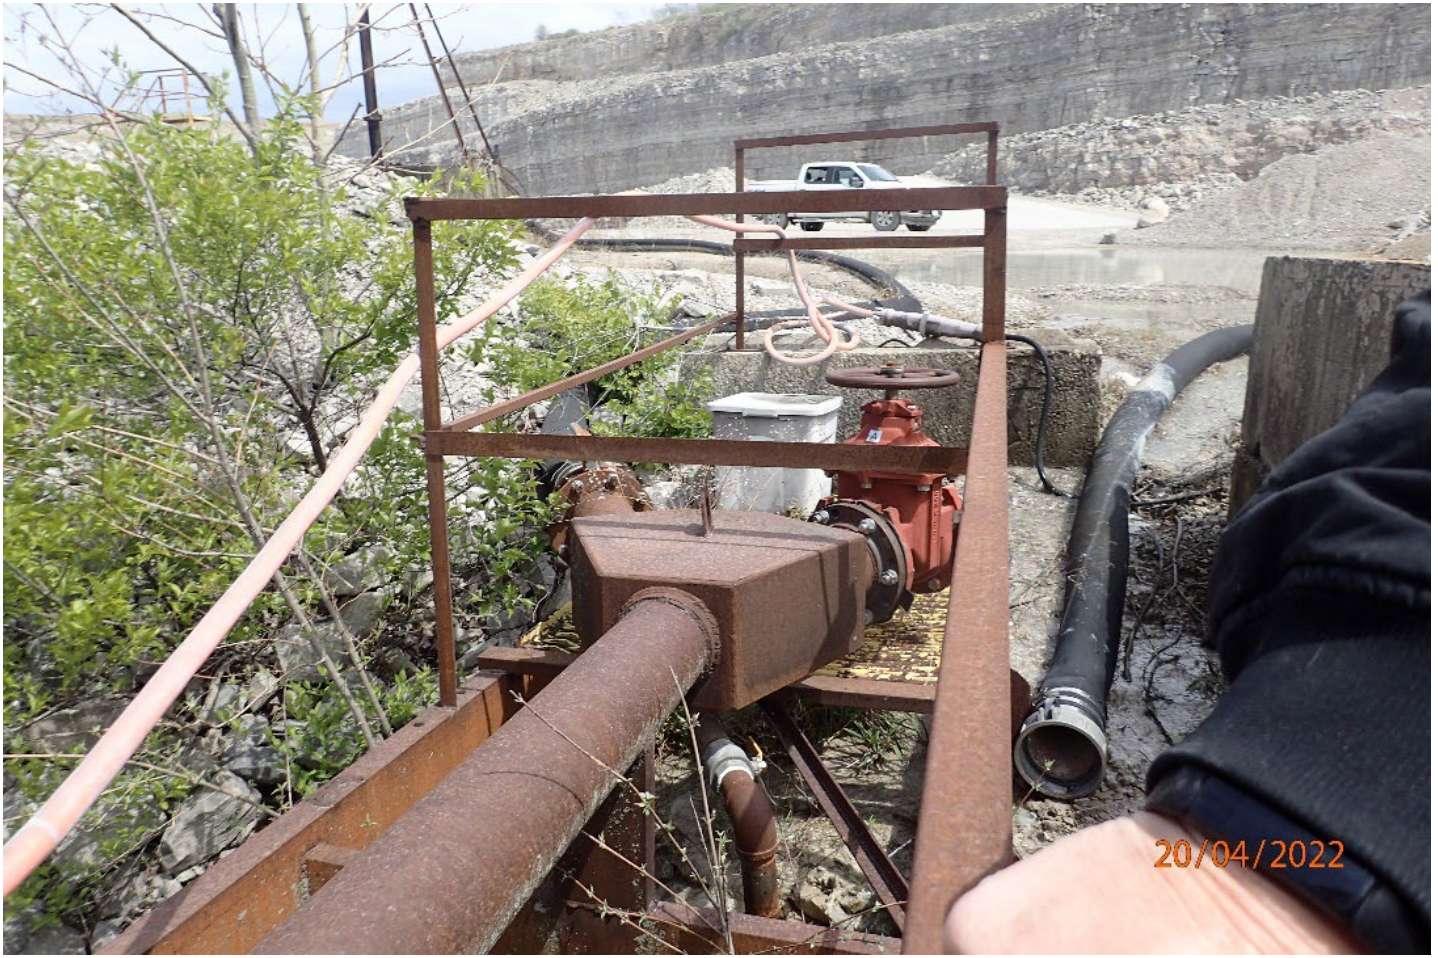
15: P4200043

Description: The pump and piping for dewatering the quarry pit.

Location: East side of the quarry pit.
