## **RCRA Inspection Report**

Century Aluminum of Kentucky  
1627 State Route 3543  
Hawesville, Kentucky 42348  
Hancock County

May 2, 2023; 8:30 am – 4:00 pm

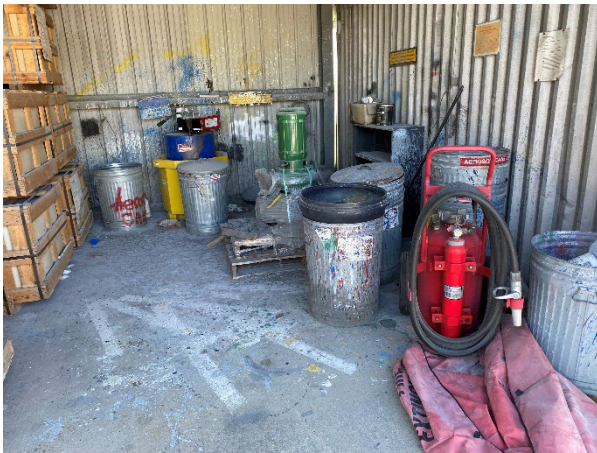
The inspection team noted a one-gallon container of paint material at the aerosol can piercing station (Photographs 2-3). This container appeared to have been stored outside in the weather in this area for some time, but Century Aluminum had not made a hazardous waste determination on the contents of this container. An active can puncturing device was affixed to the top of a blue 55-gallon container which was marked as hazardous waste (Photograph 2). This container was not labeled with an indication of the hazards of its contents. The “Danger Flammable Material” sign among others in this area were faded or partially painted over. The walls of this location showed signs of previous spills of paint likely associated with the puncturing operations (Photograph 2). Century Aluminum should ensure all relevant signs are clearly legible.

Photograph 2: Aerosol Can Piercing Station.

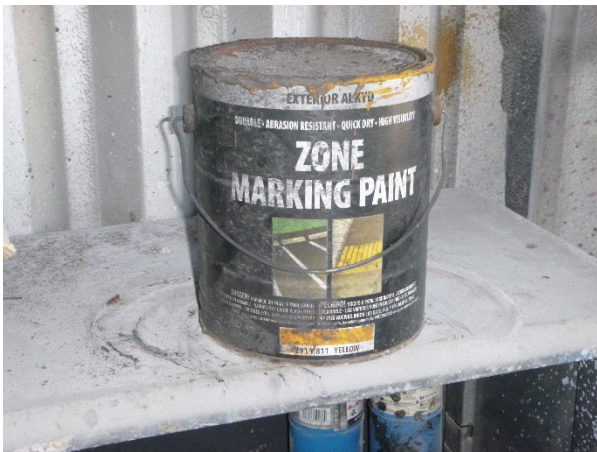
Photograph 3: Container of waste paint with no hazardous waste determination at Aerosol Can piercing Station.

**Pursuant to 401 KAR 39:080 Section 1 [40 C.F.R. § 262.11], a person who generates a solid waste, as defined in 401 KAR 39:080 Section 1 [40 C.F.R. § 261.2], must make an accurate determination as to whether that waste is a hazardous waste in order to ensure wastes are properly managed according to applicable RCRA regulations articulated in 401 KAR 39:080 Section 1 [40 C.F.R. § 262.11].**

**Pursuant to 401 KAR 39:080 Section 1 [40 C.F.R. § 262.15(a)(5)], which is a condition of the SAA Permit Exemption, a generator is required to mark or label its containers (ii) with an indication of the hazards of the contents.**

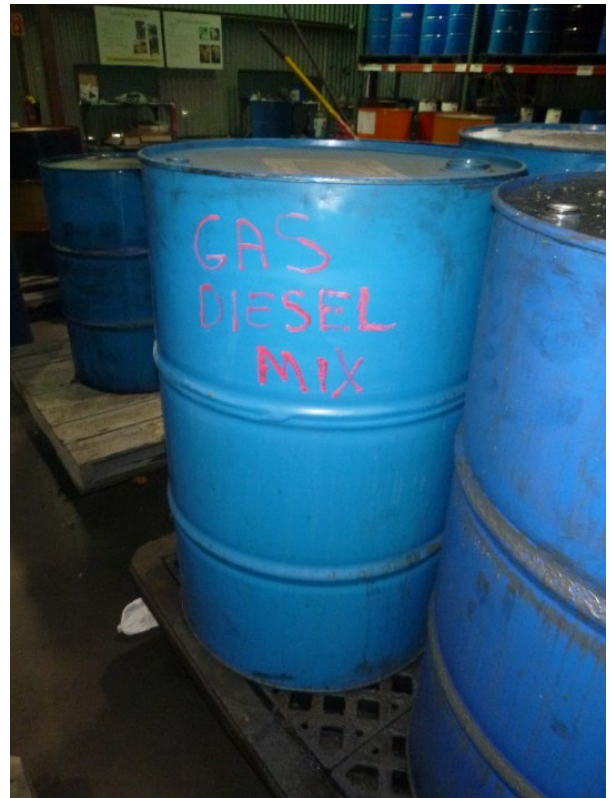
Century Aluminum was storing a 55-gallon container of gas diesel mix in the Oil Building. (Photograph 4). Century Aluminum has determined that this waste is a hazardous waste, but this container was not labeled as hazardous waste or with an indication of the hazards.

Photograph 4: Oil Building – Container without hazardous waste label and indication of the hazard.

**Pursuant to 401 KAR 39:080 Section 1 [40 C.F.R. § 262.15(a)(5)], which is a condition of the SAA Permit Exemption, a generator is required to mark or label its containers (i) with the words “Hazardous Waste” and (ii) with an indication of the hazards of the contents.**

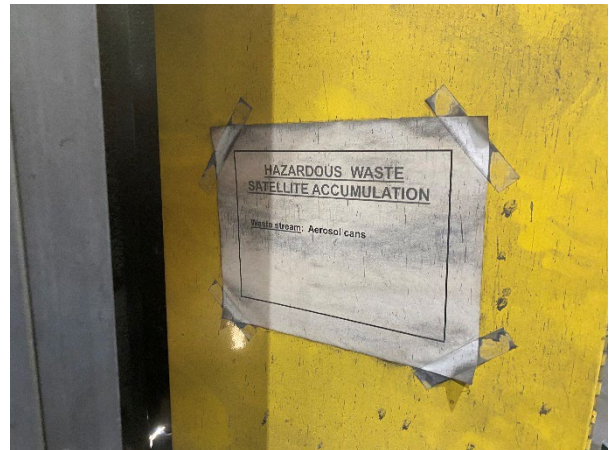
The inspection team noted a 30-gallon metal trash can labeled “Aerosol Can” in the rodding area next to a flammable cabinet. Although Century Aluminum has determined that this waste stream is a hazardous waste, this container was not labeled as “Hazardous Waste” or with the indication of the hazard (Photograph 5-7). Additionally, inside the adjacent flammable cabinet, there was a small container and a jug of unknown material that appeared to be discarded (Photograph 8).

Photograph 5: Rodding Department SAA for spent aerosol cans.

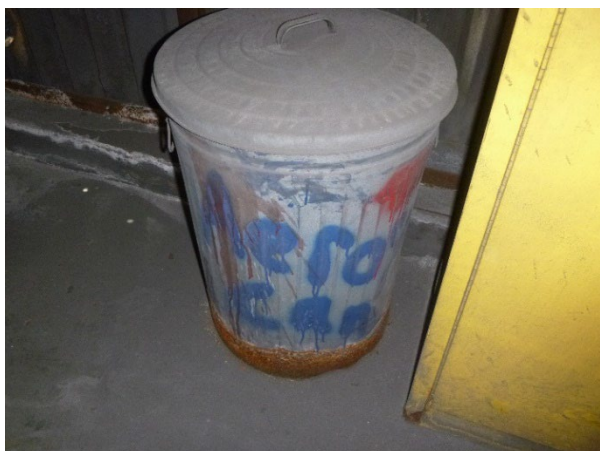
Photograph 6: Rodding Department SAA for spent aerosol cans – no hazardous waste liable or indication of hazard.

**Pursuant to 401 KAR 39:080 Section 1 [40 C.F.R. § 262.15(a)(5)], which is a condition of the SAA Permit Exemption, a generator is required to mark or label its containers (i) with the words “Hazardous Waste” and (ii) with an indication of the hazards of the contents.**

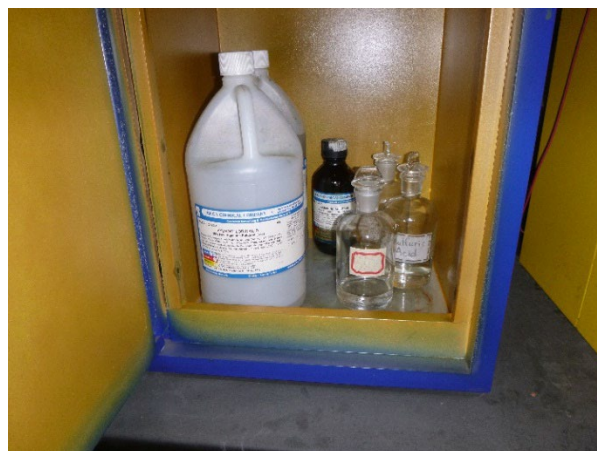
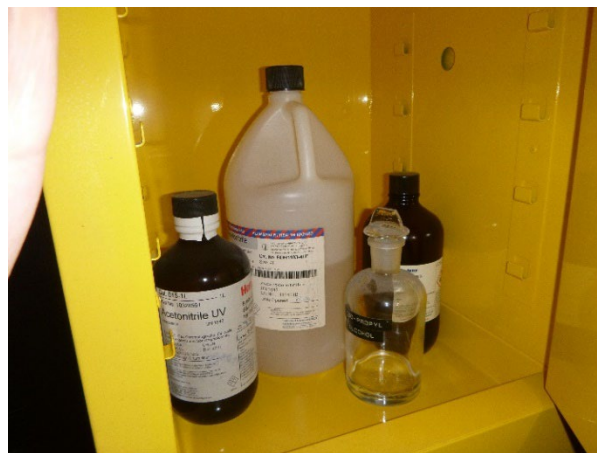
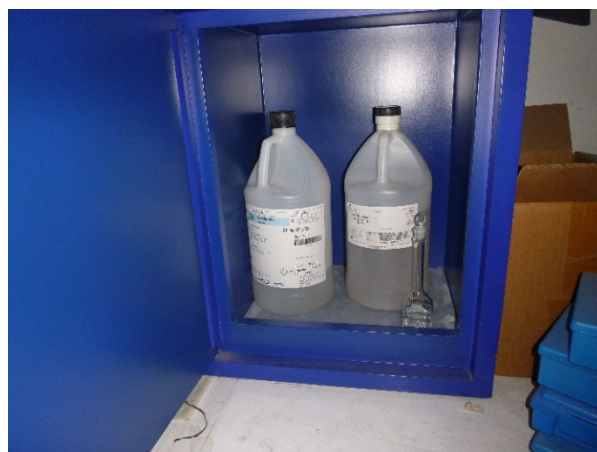
Century Aluminum formerly operated a laboratory facility where laboratory technicians conducted analytical testing to determine quality of the material and determine levels of alumina/cryolite/fluoride. The inspection team noted three storage cabinets with small containers of chemicals. Facility representatives stated that the laboratory was closed in 2015. Some of these containers were expired (Photographs 9-11). A container of sulfuric acid was labeled with an expiration date of November 2017. Century Aluminum had not conducted hazardous waste determinations on these chemicals.

Photograph 9: Former Environmental Office and Laboratory – unknown waste material.

Photograph 10: Former Environmental Office and Laboratory – unknown waste material.

Photograph 11: Former Environmental Office and Laboratory – unknown waste material.

**Pursuant to 401 KAR 39:080 Section 1 [40 C.F.R. § 262.11], a person who generates a solid waste, as defined in 401 KAR 39:080 Section 1 [40 C.F.R. § 261.2], must make an accurate determination as to whether that waste is a hazardous waste in order to ensure wastes are properly managed according to applicable RCRA regulations articulated in 401 KAR 39:080 Section 1 [40 C.F.R. § 262.11].**

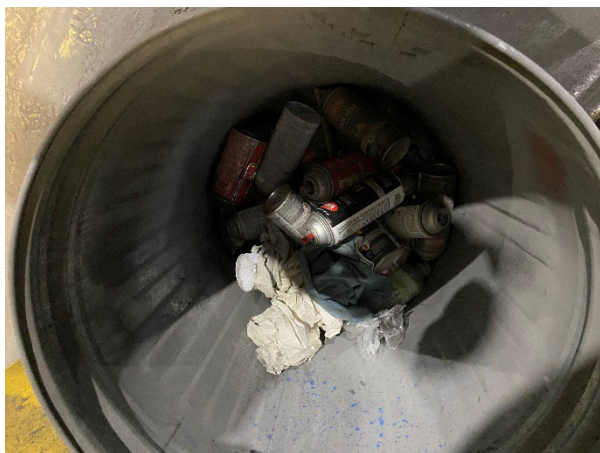
Photograph 7: Rodding Department SAA for spent aerosol cans.

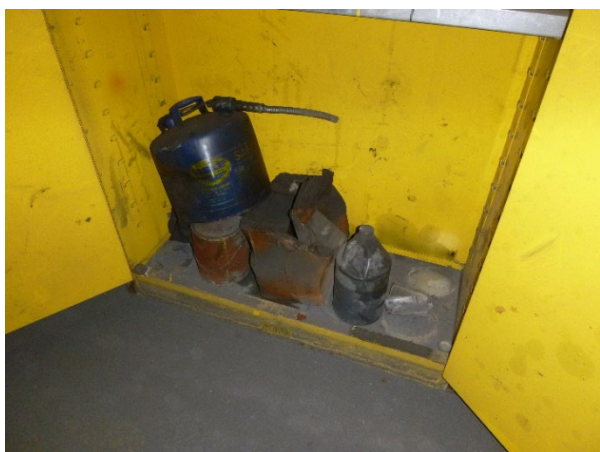
Century Aluminum had not made a hazardous waste determination on the contents of the small container or the jug.

Photograph 8: Rodding Department - unknown container and jug was waste material.

**Pursuant to 401 KAR 39:080 Section 1 [40 C.F.R. § 262.11], a person who generates a solid waste, as defined in 401 KAR 39:080 Section 1 [40 C.F.R. § 261.2], must make an accurate determination as to whether that waste is a hazardous waste in order to ensure wastes are properly managed according to applicable RCRA regulations articulated in 401 KAR 39:080 Section 1 [40 C.F.R. § 262.11].**

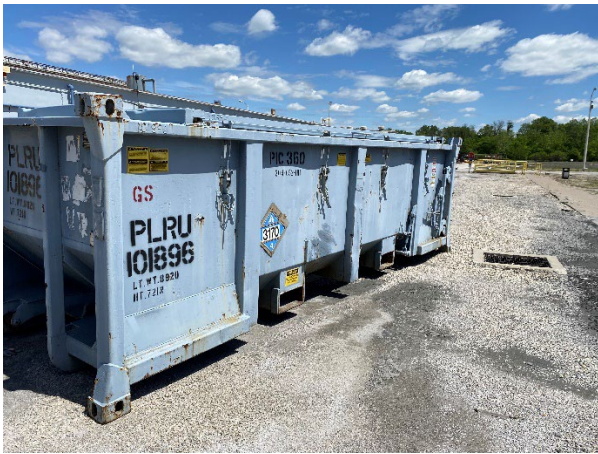
The designated CAA is comprised of a concrete pad which is used to store K088 waste in 30-cubic yard metal roll-offs. At the time of the inspection, the area was storing one empty roll-off (Photograph 12). There was no other hazardous waste stored in this area on the day of the inspection.

Photograph 12: Spent Pot Liner (K088) Central Accumulation Area Container.

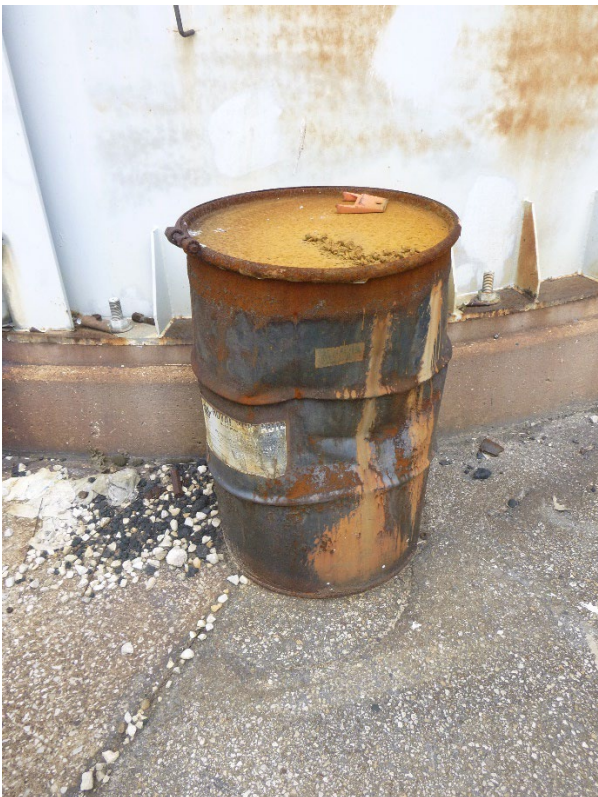
Century Aluminum generates waste liquids in the scrubber tower. On the day of the inspection there was a tote with about 5-10 gallons of clear liquid (Photograph 14). Facility personnel had not made a hazardous waste determination on this liquid. Additionally, adjacent to the scrubber tower, Century Aluminum was storing a 55-gallon container of paint. The paint container appeared to be in poor condition (rusted and dented) and weathered (Photograph 13). The inspection team determined that a waste determination was necessary for this container.

Photograph 13: Unknown contents in container at base of scrubber tower.

**Pursuant to 401 KAR 39:080 Section 1 [40 C.F.R. § 262.11], a person who generates a solid waste, as defined in 401 KAR 39:080 Section 1 [40 C.F.R. § 261.2], must make an accurate determination as to whether that waste is a hazardous waste in order to ensure wastes are**

**properly managed according to applicable RCRA regulations articulated in 401 KAR 39:080 Section 1 [40 C.F.R. § 262.11].**

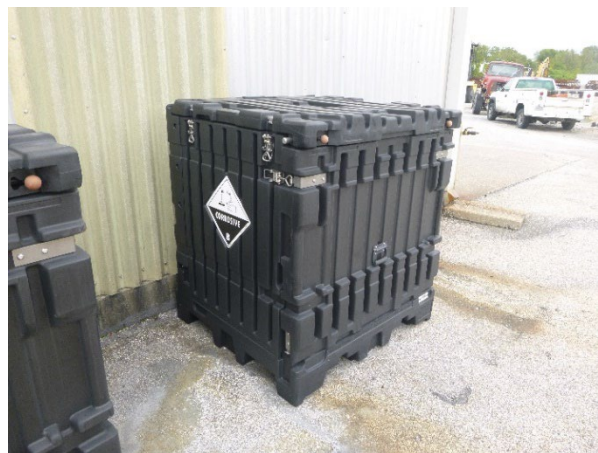
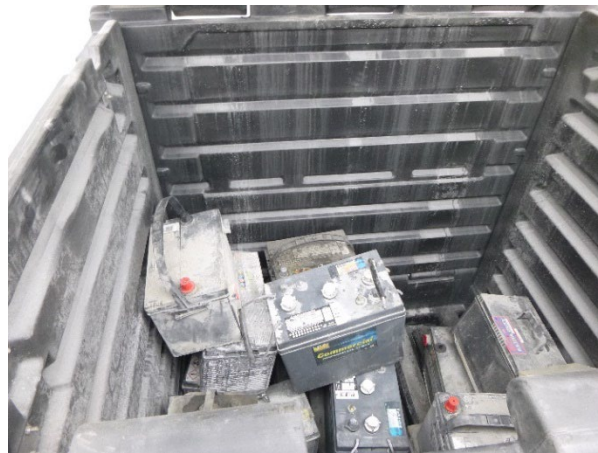
The inspection team noted two black plastic containers storing lead acid batteries outside of the Mobile Garage building (Photographs 20-22). These two containers were storing multiple lead acid batteries destined for reclamation under 40 CFR 266 Subpart G.

Photograph 20: Mobile Garage lead acid exchange accumulation totes.

Photograph 21: Mobile Garage lead acid exchange accumulation tote.

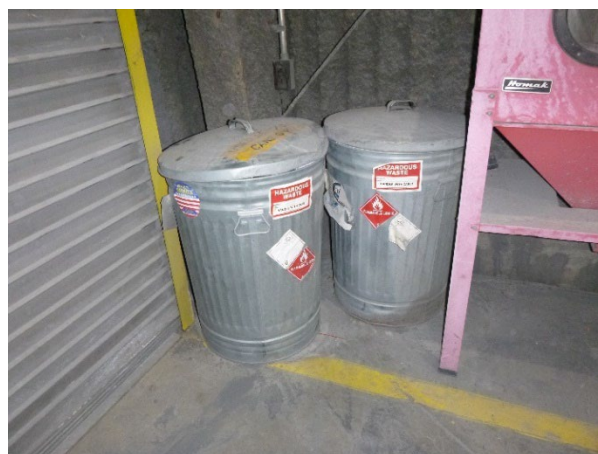
Century Aluminum utilizes the Mobile Garage to conduct maintenance on vehicles. The inspection team noted two 30-gallon metal trash cans that were accumulating hazardous waste spent aerosol cans (Photograph 22). Both containers were full. Century Aluminum was storing greater than 55 gallons of hazardous waste at this SAA.

Photograph 22: Spent Aerosol Can SAAs – exceeds 55 gallons.

**Pursuant to 401 KAR 39:080 Section 1 [40 C.F.R. § 262.15(a)(6)], a generator who accumulates hazardous waste in excess of 55 gallons must, with respect to that amount of excess waste, comply with 401 KAR 39:080 Section 1 [40 C.F.R. § 262.17(a)] or remove the excess waste from the SAA within three consecutive calendar days.**

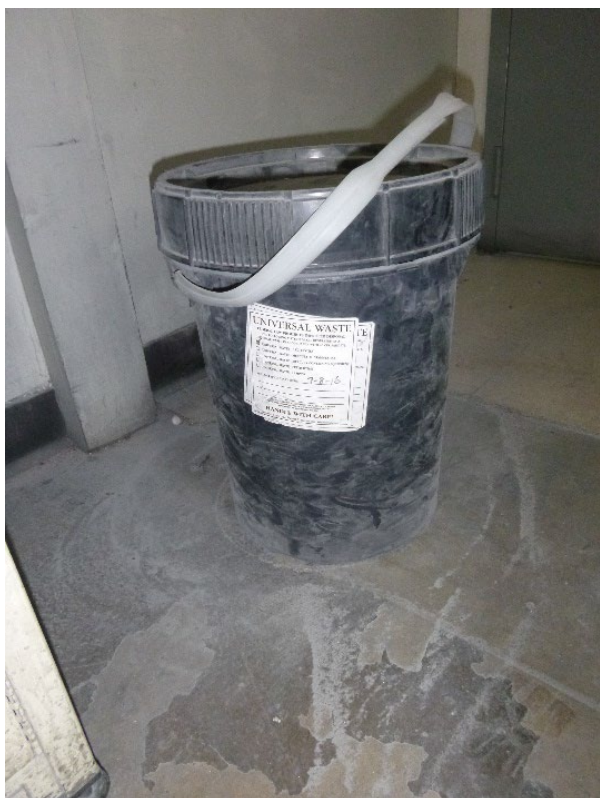
Century Aluminum was accumulating universal waste batteries in a 5-gallon black plastic container (Photograph 23-24). This container was in good condition and labeled as universal waste batteries. The accumulation start date on the label of this container was September 8, 2016. This date well exceeds a year for storage. Facility representatives stated that this will be gathered with other waste onsite and shipped off site for disposal and or reclamation.

Photograph 23: Stores Area – universal waste batteries that exceeded one year.

Photograph 24: Stores Area – universal waste batteries that exceeded one year.

**Pursuant to 401 KAR 39:080, Section 3(1) [40 C.F.R. § 273.15(a) and (c)], a SQHUW may accumulate universal waste no longer than one year and must be able to demonstrate the length of time that the universal waste has accumulated from the date that it became a waste or was received.**

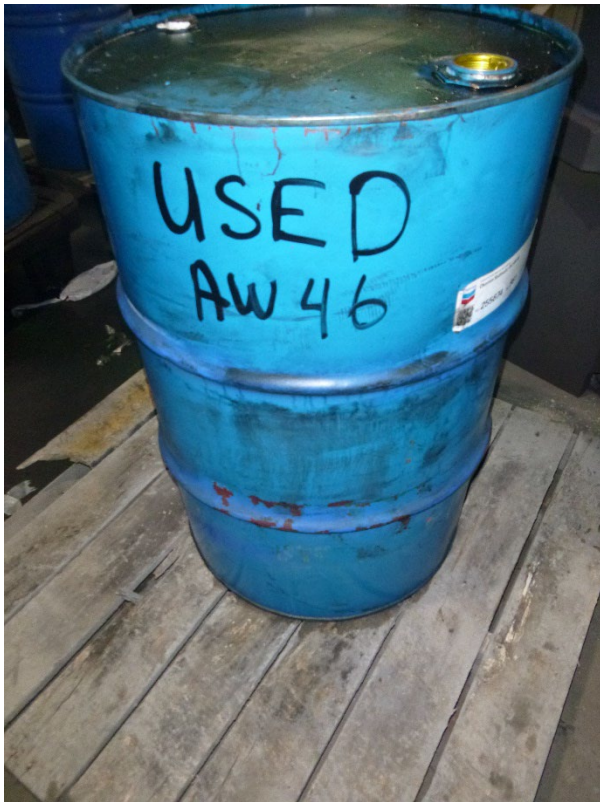
Century Aluminum was accumulating used oil in multiple locations across the site (Photographs 25-33). The Oil building housed containers of product oil and used oil. The inspection team noted one 55-gallon blue container labeled as “Used AW46” (Photograph 28) in the Oil Building. This container was not labeled with the words “Used Oil.” The inspection team noted trays and secondary containment pallets used to collect oil drippage from product containers (Photograph 30). At the time of the inspection these trays and one secondary containment pallet were full of used oil. Subsequent to the inspection, Facility representatives stated that the used oil had been pumped into a used oil accumulation container.

Photograph 28: Oil Building – Container of used oil without Used Oil label.

**Pursuant to 401 KAR 39:080 Section 4(1) [40 C.F.R. § 279.22(c)(1)], containers and aboveground tanks used to store used oil at generator facilities must be labeled or marked clearly with the words “Used Oil.”**

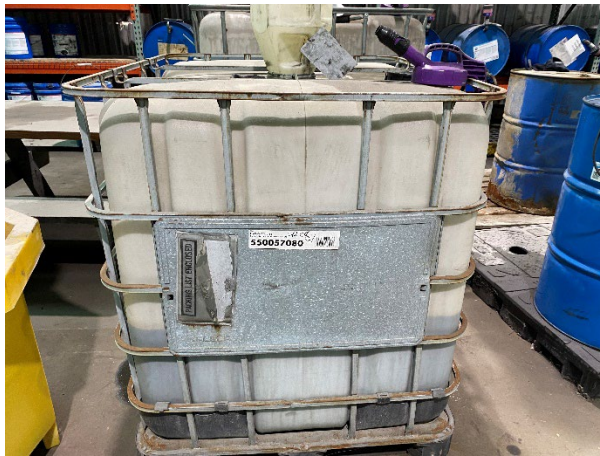
Photograph 29: Oil Building – Tote of Used Oil.

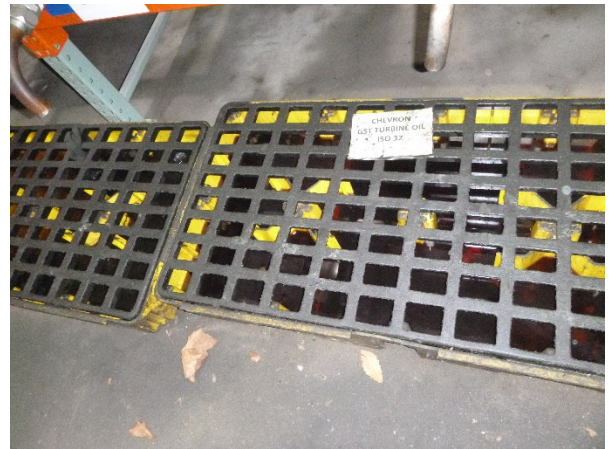
Photograph 30: Oil Building with oil accumulated in floor drains.

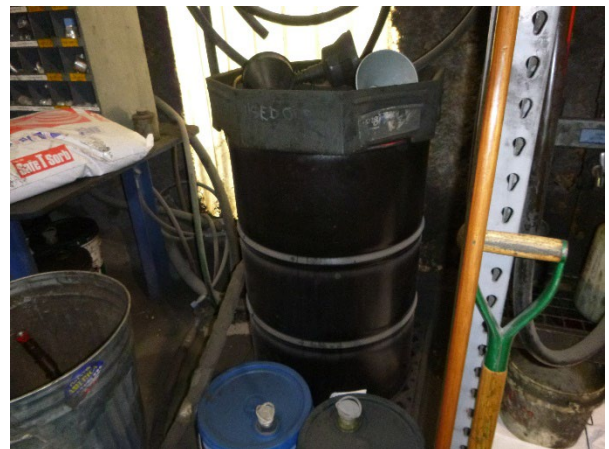
Century Aluminum was storing used oil in a large tank at the Mobile Garage area (Photograph 33). This tank was in good condition and labeled with the words “Used Oil.” At the Mobile Garage, Century Aluminum was also storing used oil in a 55-gallon black metal container that was not labeled as to its contents (Photograph 32). This container was used to accumulate drained used oil from the funnel on top of the container.

Photograph 32: Mobile Garage – container of used oil without Used Oil label.

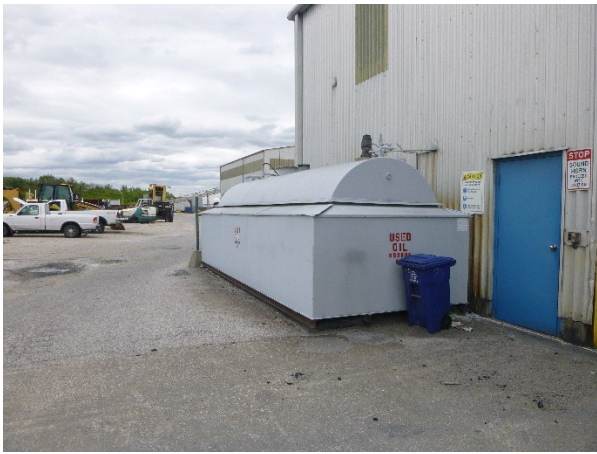
Photograph 33: Mobile Garage Used Oil Tank.
