# **NPDES Compliance Inspection Report**

## **Town of Odessa Sewer Treatment Plant Odessa, Washington**

**Permit #: WA0045560**

**Inspection Date: May 5, 2021**

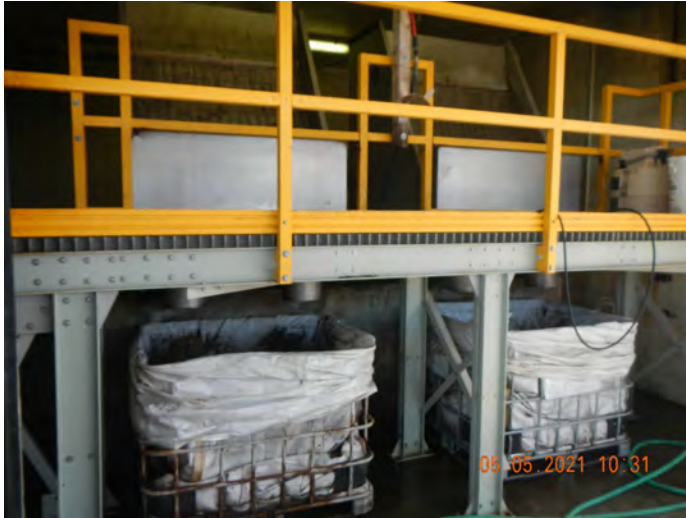
Photo #:01 (DSCN2127)  
Description: Facing northeast, photo of the two hydrasieve screens

We continued the walk-through to the headworks; a new influent flow meter was installed/calibrated in November of 2020. The Facility has two hydrasieve screens to remove larger material and grit. Removed screenings from the influent are bagged, dewatered, and sent to the landfill. The hydrasieve screens (**Photo 1**), are located within the southern end of the operations/maintenance building. Influent composite samples required monthly by the permit are taken by a SIGMA 900 composite sampler located near the screens, inside of the operations/maintenance building.

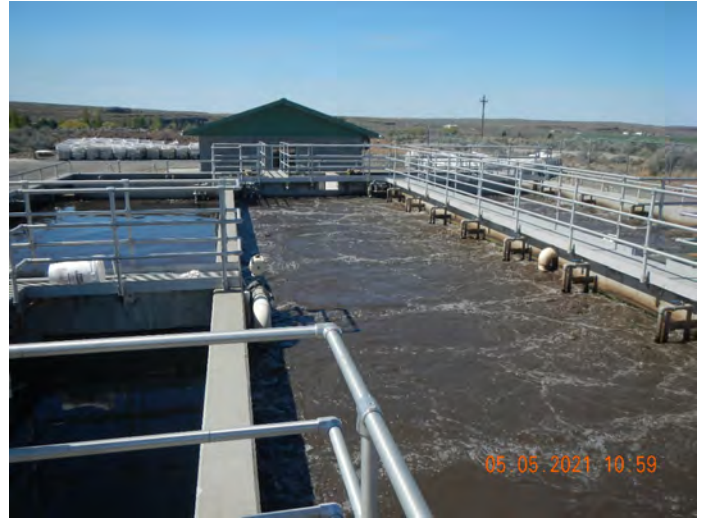
Photo #:02 (DSCN2134)  
Description: Facing southwest, photo of the first stage aeration basin.

We continued the walk-through to the Aero-Mod WWTP, effluent flow from the screens combine with return activated sludge (RAS) and discharges to the primary aeration basin (**Photo 2**), which flows by gravity to the secondary aeration/anoxic basin (**Photo 3**). The effluent flows into the clarifier and then is discharged to the UV disinfection system (**Photo 4**). The underflow returns to the aeration basin as RAS or is wasted into the aerated digester tank. Waste solids go into the bagging system. According to Mr. Webster the Facility changed their bagging system from small bags to large totes approximately 18 months ago. Dewatering from the solids area is captured by a drain on the concrete slab (**Photo 5 & 6**) and returned to in the influent of the WWTP. Solids are hauled as needed to Barr-Tech Composting near Fishtrap, WA.

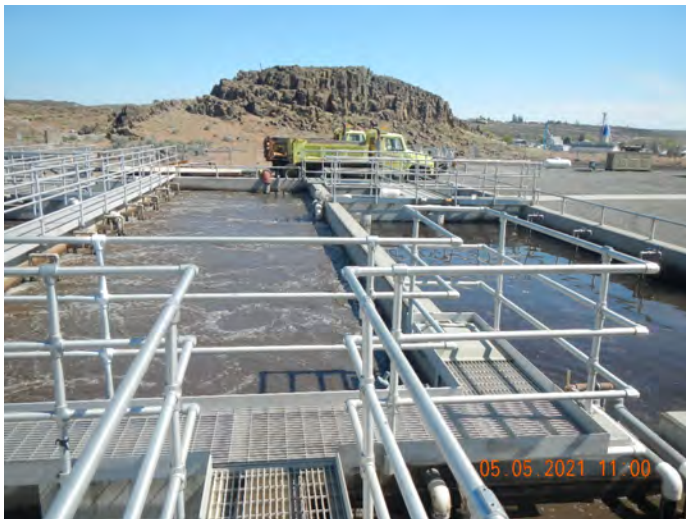
Photo #:03 (DSCN2135)  
Description: Facing northeast, photo of the first and second aeration basins from above the surge tank.

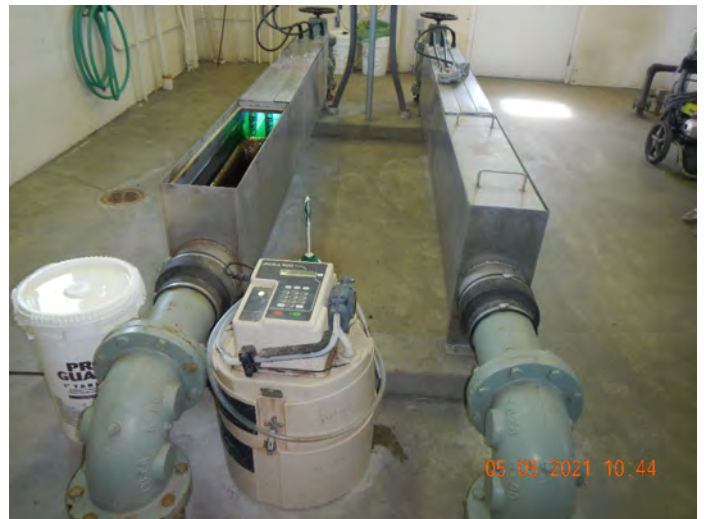
Photo #:04 (DSCN2128)  
Description: Photo of the UV disinfection system.

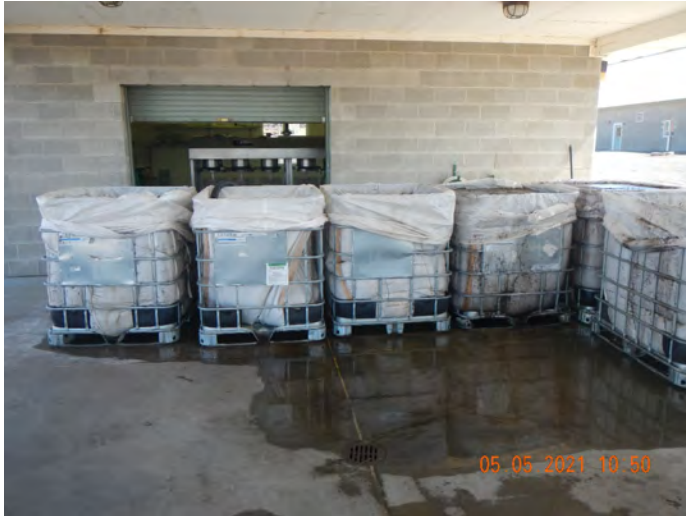
Photo #:05 (DSCN2129)

Description: Facing northeast, photo of the covered solids area used for dewatering.

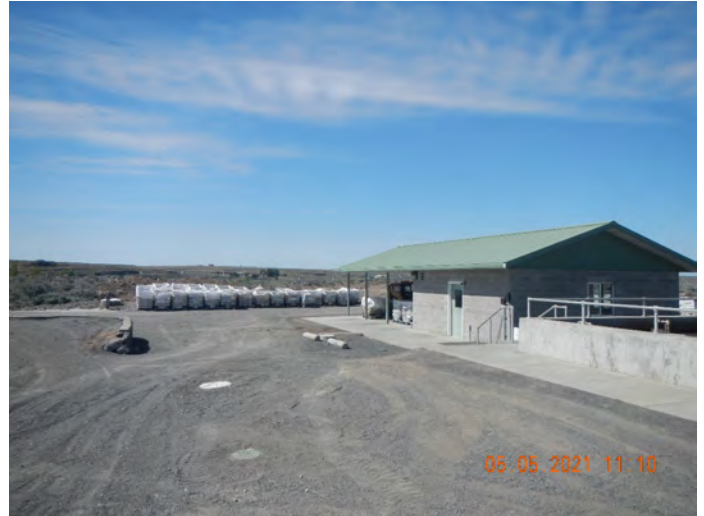
Photo #:06 (DSCN2136)

Description: Facing southwest, photo of the solids handling area and dewatered totes set for removal.

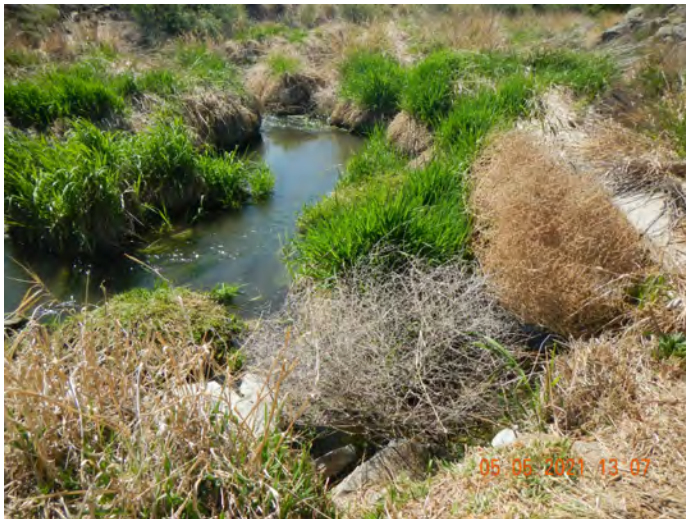
Photo #:07 (DSCN2146)

Effluent from the UV system discharges to a Parshall Flume and this is routed downhill via underground pipe the outfall within Crab Creek (**Photo 7**). Effluent composite samples required by the permit are taken by a SIGMA 900 sampler located near the UV system.

Description: Photo of the outfall to Crab Creek.
