## NPDES Inspection Report – Industrial User

| Nature Soy, LLC<br>6123 Arapahoe Rd<br>Boulder, CO 80303 | City of Boulder<br>Permit No. SIU 2024-1<br>NPDES ID: COPU00175<br>Inspection ID: 202412_COPU00175<br>NAICS Code: 311991 – Perishable Prepared Food Manufacturing<br>Latitude: 40.0151145 °N, Longitude: -105.210832°W | |

## Photographs for Boulder PCI: Nature Soy IU Inspection

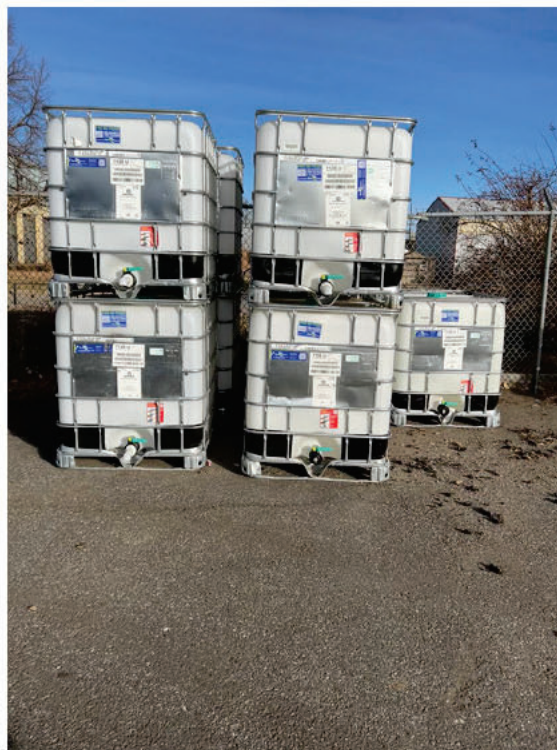
Photo number 2 taken by Jennifer Ferrando on 12/19/2024.\*

Empty soy sauce totes stored in the northeast corner of the paved parking area.

The Facility also stores soy sauce, canola oil, and vinegar. Soy sauce is kept in 250-gallon totes, while the canola oil and vinegar are kept in 55-gallon drums. These products are all housed in the Facility's production area and were observed to be both with and without secondary containment (Photos 10-14). Empty soy sauce totes are stored outside in the northeast corner of the paved parking area (Photo 2). Facility representatives communicated that no totes of soy sauce are rinsed or washed onsite. The totes that were seen in the parking area were scheduled to be removed.

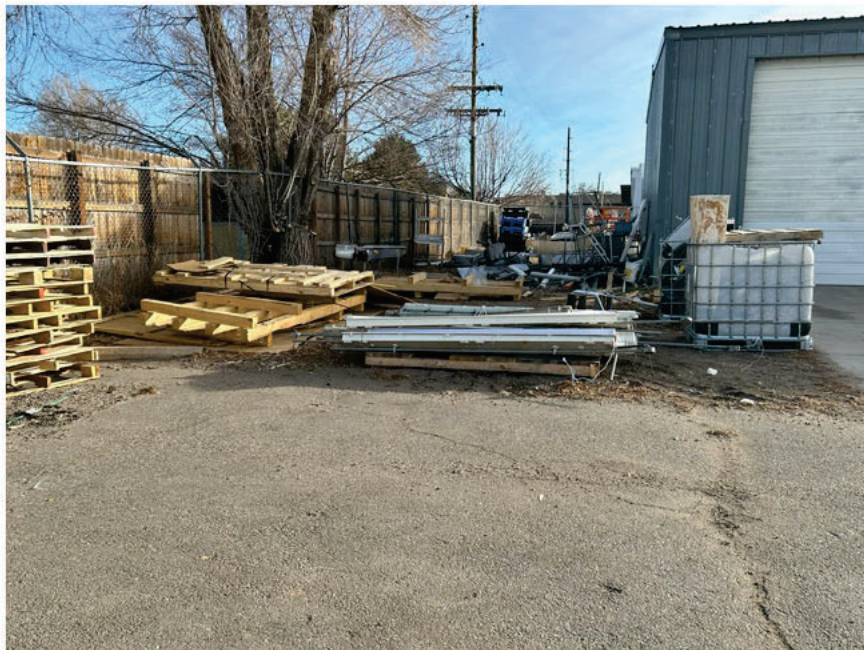
Photo number 3 taken by Jennifer Ferrando on 12/19/2024.

Pallets, disused equipment, and other debris were stored outdoors in the northeast corner of the lot. The area pictured is immediately east of the area shown in Photo 2.

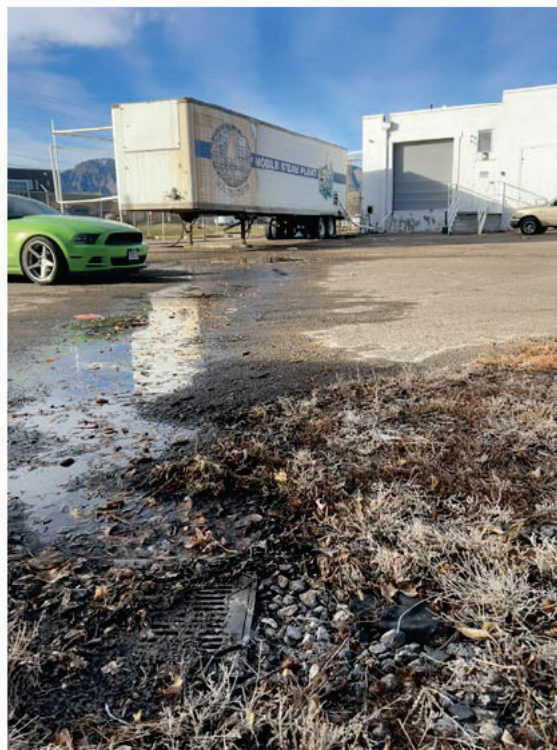
Photo number 6 taken by Jennifer Ferrando on 12/19/2024.

The inspectors observed condensate from the mobile steam plant, located at the southeast corner of the building, dripping onto a metal plate below the steam plant before flowing northeast across the paved parking area and entering a storm drain (Photo 6).

Condensate from the mobile steam plant, located at the southeast corner of the building, was observed dripping onto a metal plate below the steam plant before flowing northeast across the paved parking area and entering the drain shown in the foreground of the photo.

To prevent stormwater contamination, it is recommended that the Facility evaluate the water quality of the mobile steam plant condensate that enters the storm drain or avoid discharging condensate to the storm drain.

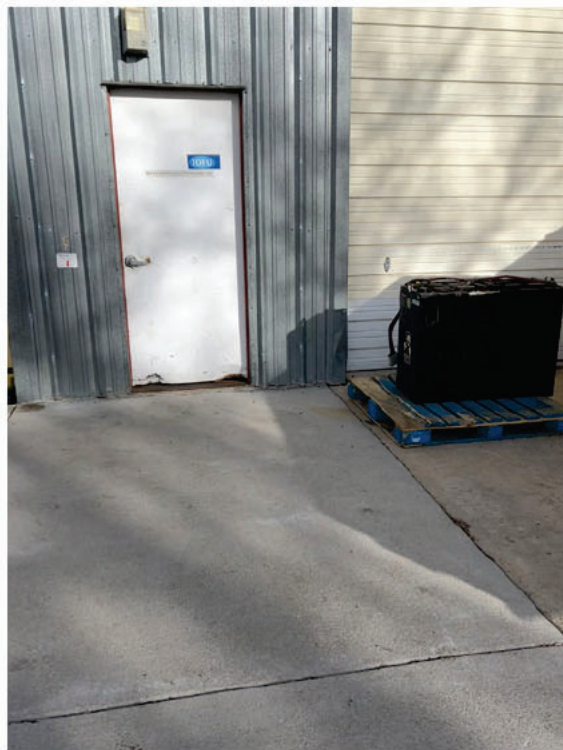
Photo number 7 taken by Jennifer Ferrando on 12/19/2024.

At the time of the inspection, a battery was stored outside without cover or secondary containment (Photo 7).

A battery was stored without cover or secondary containment at the south end of the maintenance/storage barn, located at the northeast corner of the site.

To prevent stormwater contamination, it is recommended that all batteries stored outside be stored under cover.

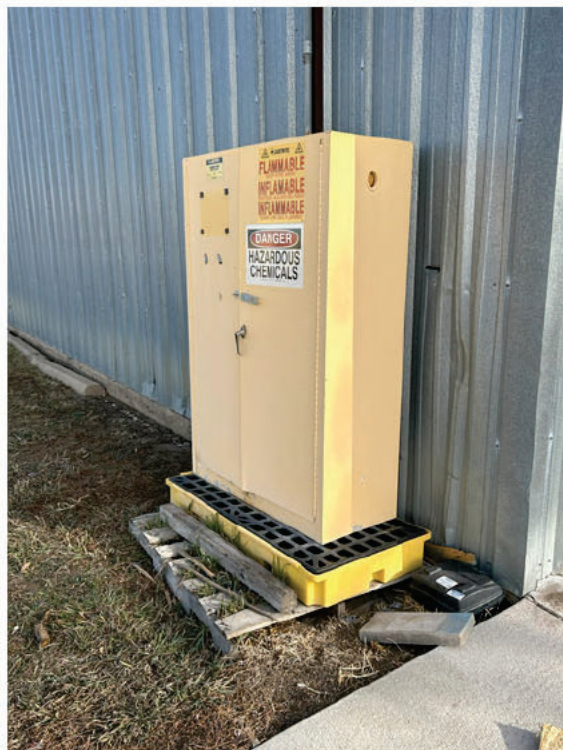
Photo number 8 taken by Jennifer Ferrando on 12/19/2024.

A hazardous chemicals locker located at the southwest corner of the maintenance/storage barn contained small containers of propane and flammable gas.

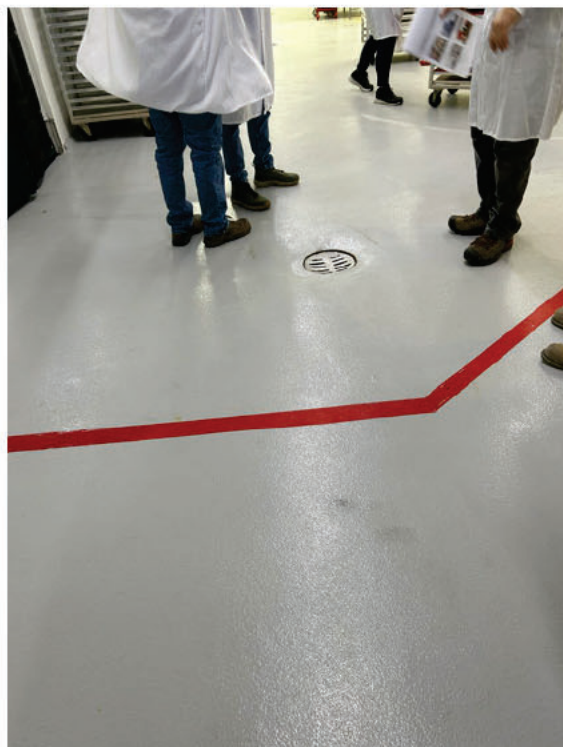
Photo number 9 taken by Jennifer Ferrando on 12/19/2024.

Floor drains in the production area capture all cleaning water and process wastewater and send it to a solids settling tank ("Tank 1") in the Facility's wastewater treatment room (Photos 9 and 21). Solids are transferred to a truck for disposal off-site. Supernatant from the solids settling tank is pumped into a decanting tank ("Tank 2"), where solids further settle out (Photo 19). Like Tank 1, any solids collected from Tank 2 are

A floor drain located near the grain processing area for the seitan line. According to the facility and City representatives, all floor drains in the process building drain to the pretreatment system.

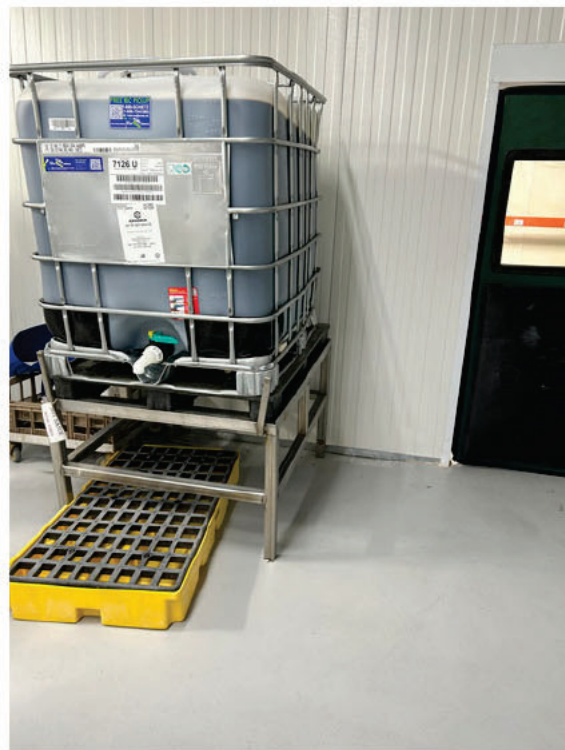
Photo number 10 taken by Jennifer Ferrando on 12/19/2024.

A soy sauce tote in use in the seitan line included a tray to catch drips or leaks.

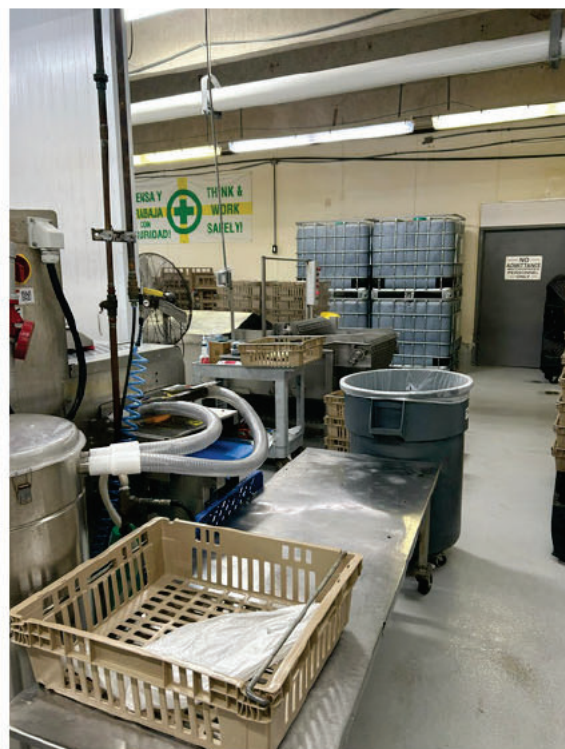
Photo number 11 taken by Jennifer Ferrando on 12/19/2024.

At the time of the inspection, totes of soy sauce, and drums of [REDACTED] and canola oil were observed to be without secondary containment (Photos 11, 12, 14, and 17-20). The drums of [REDACTED] that were observed in the pretreatment room were near sewer drains (Photo 23). The totes of soy sauce and drums of canola oil that were in the production area were located near floor drains.

Additional full soy sauce totes (against the wall in the background of the photo) did not have secondary containment. Photo taken from approximately the same location as Photo 10.

Ensure that the Facility's slug discharge control plan includes all chemicals and ingredients that are stored and handled at the Facility and that the City and Facility have determined what should have secondary containment to avoid contamination from spills and/or leaks.

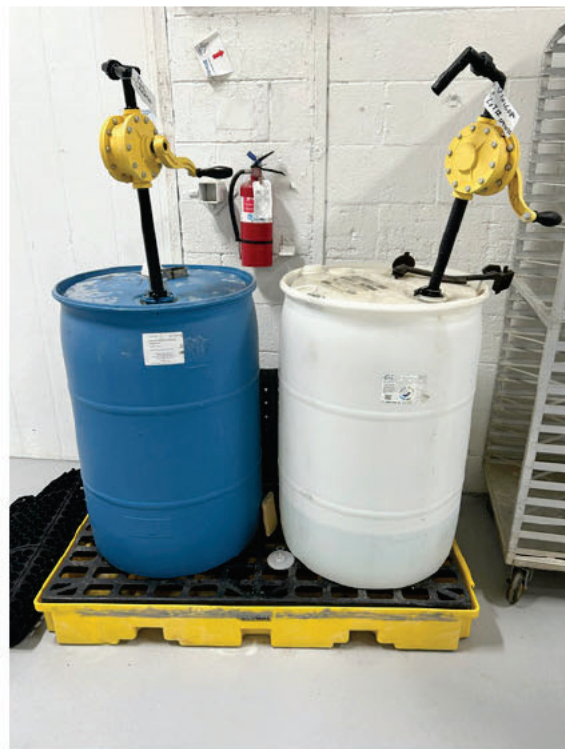
Photo number 13 taken by Jennifer Ferrando on 12/19/2024.

Canola oil and vinegar drums in active use were stored on a secondary containment pallet.

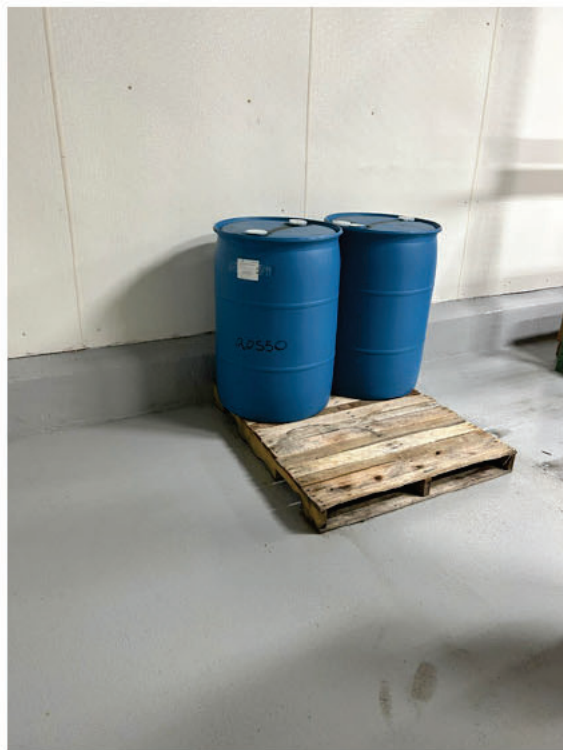
Photo number 14 taken by Jennifer Ferrando on 12/19/2024.

Full canola oil drums were stored without secondary containment; Mr. Gothmann stated that these drums were subsequently placed on a secondary pallet during the site visit.

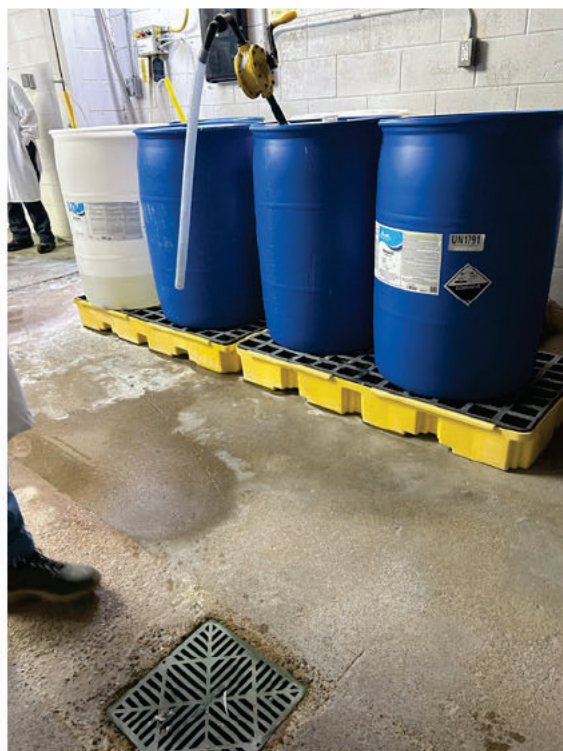
Photo number 15 taken by Jennifer Ferrando on 12/19/2024.

Cleaning chemicals in the chemical storage area, including [REDACTED] and [REDACTED] were stored on secondary containment; however, the filling device in one of the drums appeared to be dripping onto the concrete near a floor drain.

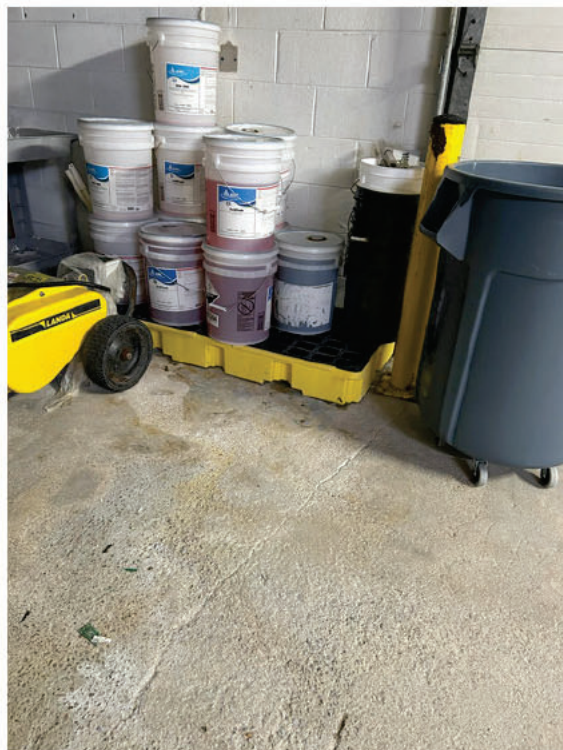
Photo number 16 taken by Jennifer Ferrando on 12/19/2024.

Buckets of cleaning chemicals, including [REDACTED] and [REDACTED], were stored on secondary containment pallets in the chemical storage area.

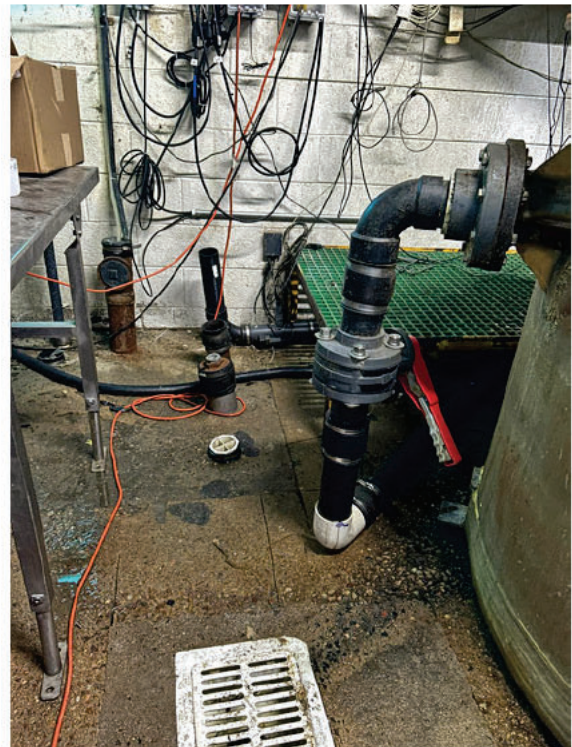
Photo number 23 taken by Jennifer Ferrando on 12/19/2024.

transferred to a truck for off-site disposal. Solids are pumped from Tanks 1 and 2 every 2-3 months. The clarified water is then gravity-fed into Tank 3 (Photo 22). Tank 3 is used for pH neutralization, where it is treated with [REDACTED] and [REDACTED] (Photos 17 – 20). Treated wastewater passes a flow meter and discharges to the City's collection system (Photo 23).

The flow meter and discharge point, located behind the pH neutralization tank.
