**SUBJECT:** CLEAN AIR ACT INSPECTION REPORT  
Kensington Processing Plant

**Facility Name:** Kensington Processing Plant

## **Flare VISR Test Report**

**Facility: Kensington Process Plant**

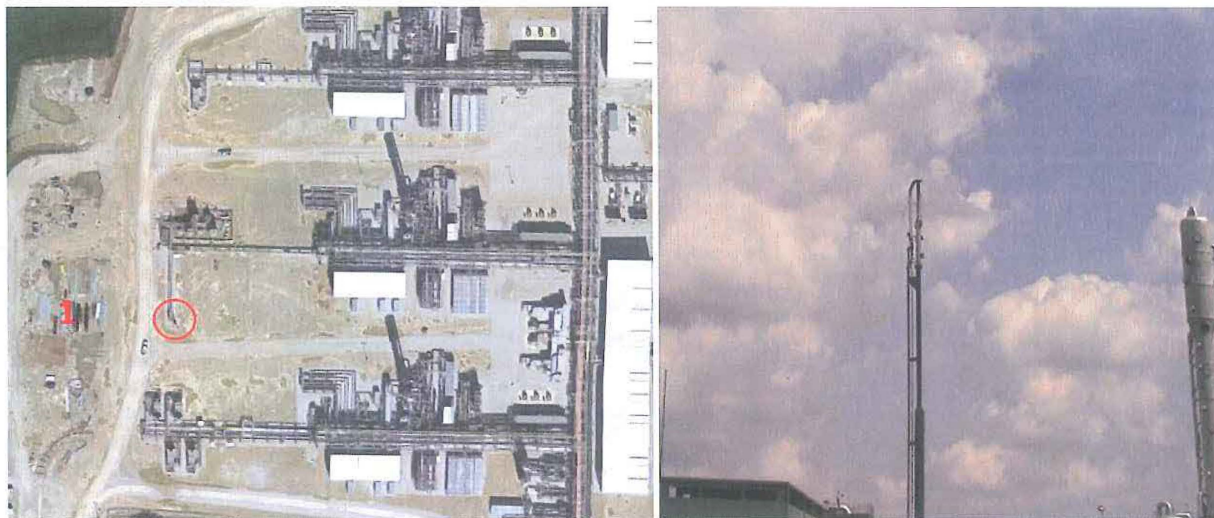
**Figure 1. Tank Flare.**  
Left: Google map with a red circle indicating the location of the flare and a red number "1" indicating the location of the VISR instrument. Distance: 150 ft.  
Right: A photo of the flare taken during the test.

Tank flare (associated with T001) – Very little flaring was observed from this unassisted flare during the inspection. Several short events of venting lasting a few seconds each were seen. One of these short events had noticeable visible emissions, although they all burned bright orange. VISR data showed the CE for these short events was between 90 and 99%.

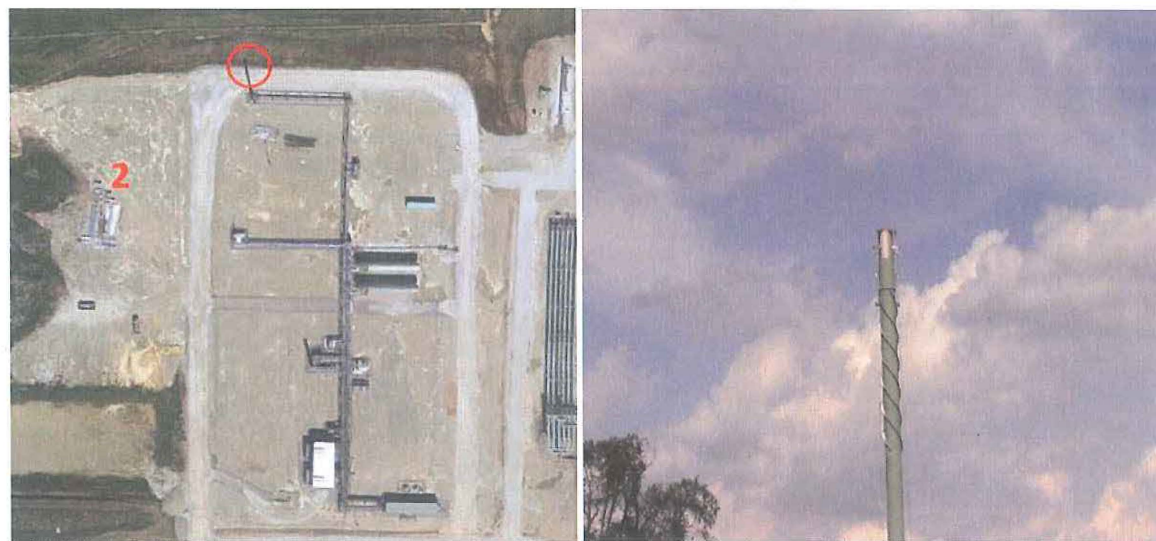
**Figure 2. Emergency Flare.**  
Left: Google map with a red circle indicating the location of the flare and a red number "2" indicating the location of the VISR instrument. Distance: 213 ft.  
Right: A photo of the flare taken during the test.

Emergency flare (associated with HP stabilizer) – Only the pilot lights were visible with the FLIR, and therefore only CE readings for the pilots were collected with the VISR. This flare is air-assisted and the headers leading to it are swept with natural gas from the Kensington natural gas product delivery line.

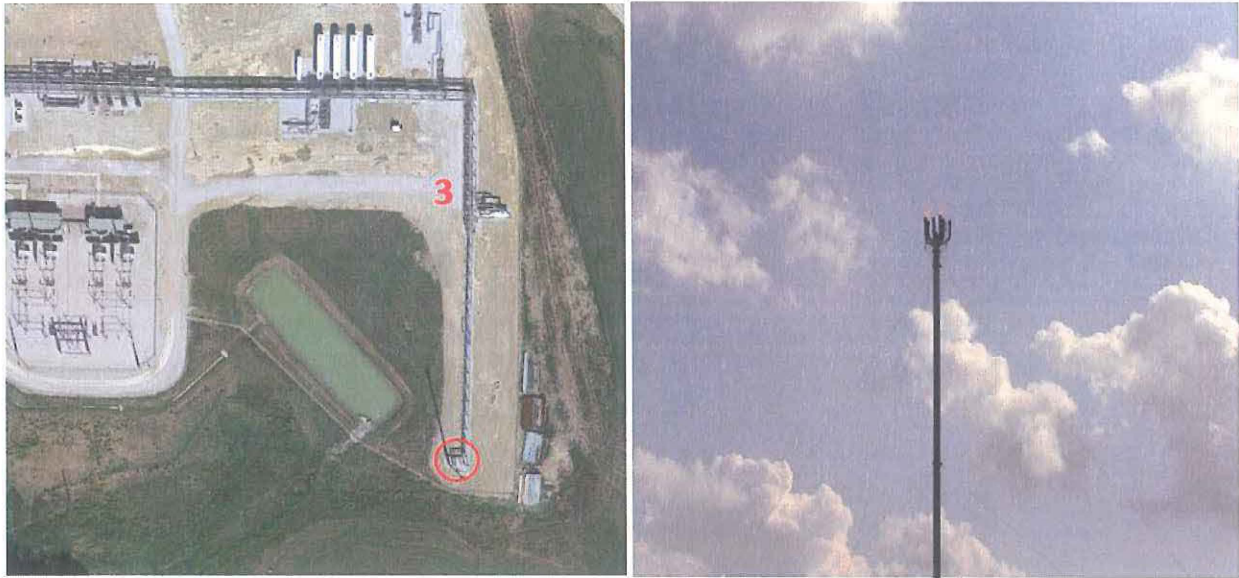
**Figure 3. High Pressure (HP) Flare.**  
Left: Google map with a red circle indicating the location of the flare and a red number “3” indicating the location of the VISR instrument. Distance: 369 ft.  
Right: A photo of the flare taken during the test.

High Pressure (HP) flare – Control room data showed a rather steady vent gas (VG) flow rate of approx. 275 lb/hr to this unassisted flare. VISR observations indicated CE of approx. 99% on average.

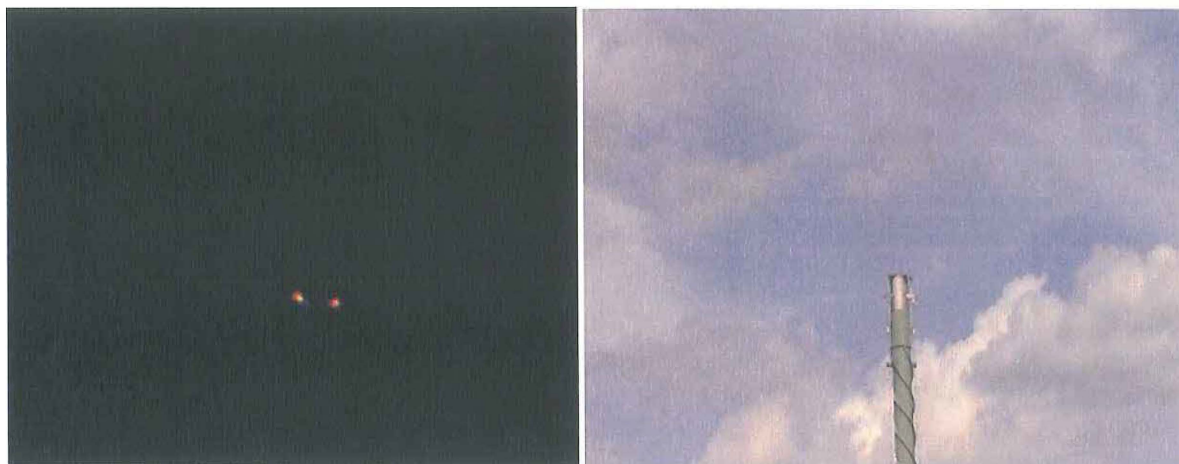
Figure 12. Emergency Flare.

Test results for the Emergency Flare (North Flare) are summarized in Table 2. Variability (or trending) of the flare during the test can be seen in Figures 9-11. Figure 12 provides a snapshot of the spectral image and a visible image of the flare. During the test only the flare pilots were detected (see Figure 12).

Left: A representative composite spectral image generated by VISR instrument. Red color represents CO<sub>2</sub>; green color represents hydrocarbon; and blue or bluish white color represents aerosol (e.g., soot) or hot solid object (e.g., the shield for the pilots).

Right: A representative image in visible spectrum.
