**Class I and II Well Inspection Form**  
**US Environmental Protection Agency – Region 4**  
**Underground Injection Control Program**  
61 Forsyth Street SW, MC 9T25, Atlanta, Georgia, 30303  
Phone: (404)562-9424

Well Name & #: *W.W. Foskett #25-N* \_\_\_\_\_  
Well Type (see table): *Enhanced Recovery (EOR)* \_\_\_\_\_ State Permit: API # *0911320136* \_\_\_\_\_  
Latitude (°N): *30.833716°N* \_\_\_\_\_ Longitude (°W): *-87.0953°W* \_\_\_\_\_ Elevation (ft): *NA* \_\_\_\_\_  
Injection Method (check applicable): ☐ Casing Injector; ☒ Tubing & Packer; ☐ Cemented Injection Tubing

**Site Photographs**  
**W.W. Foskett #25-N:**  
September 13, 2022

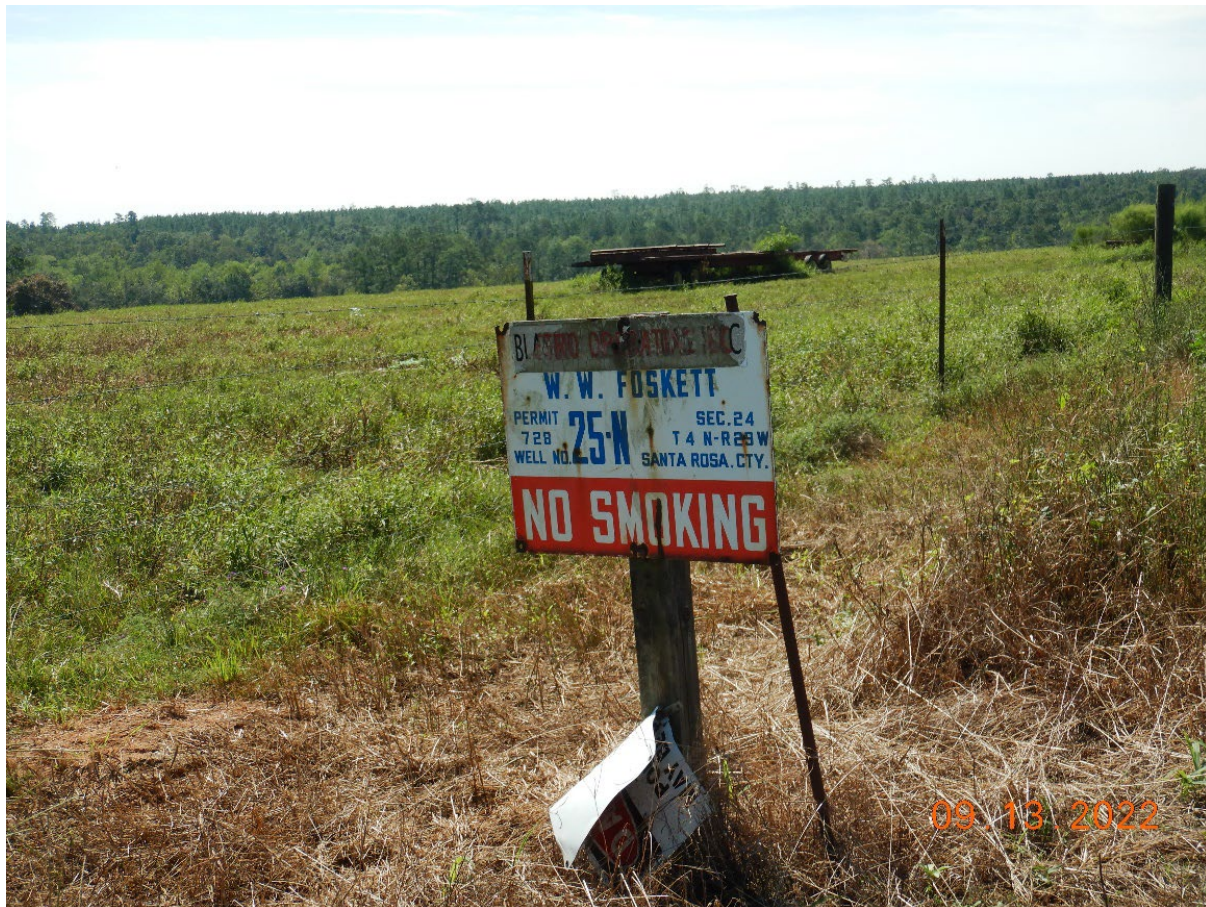
Description: *Looking south, W.W. Foskett #25-N sign alongside access road.* \_\_\_\_\_

**Photograph 1:** Looking south, W.W. Foskett #25-N sign alongside access road.

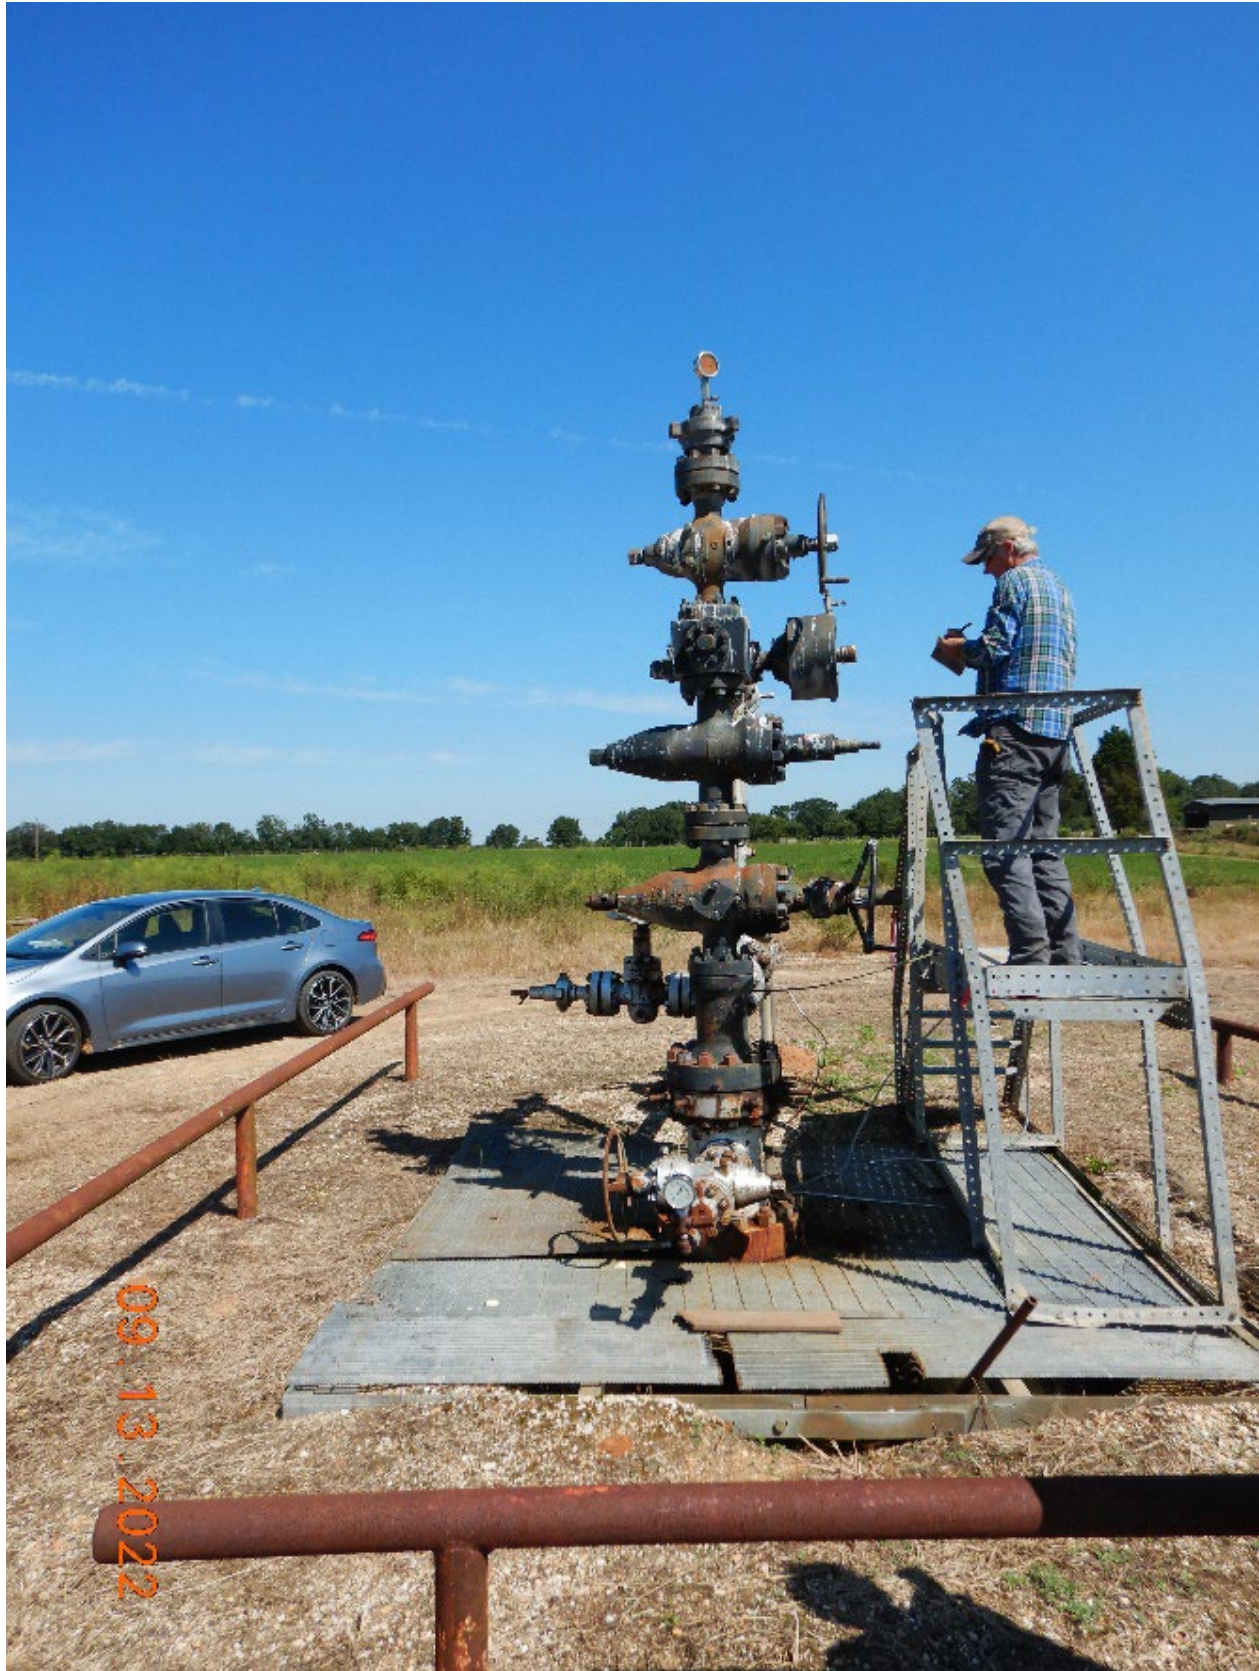
Description: *Looking north, site overview, showing well head, pressure gauges, valves, and access stairs.* \_\_\_\_\_

**Photograph 2:** Looking north, site overview, showing well head, pressure gauges, valves, and access stairs.

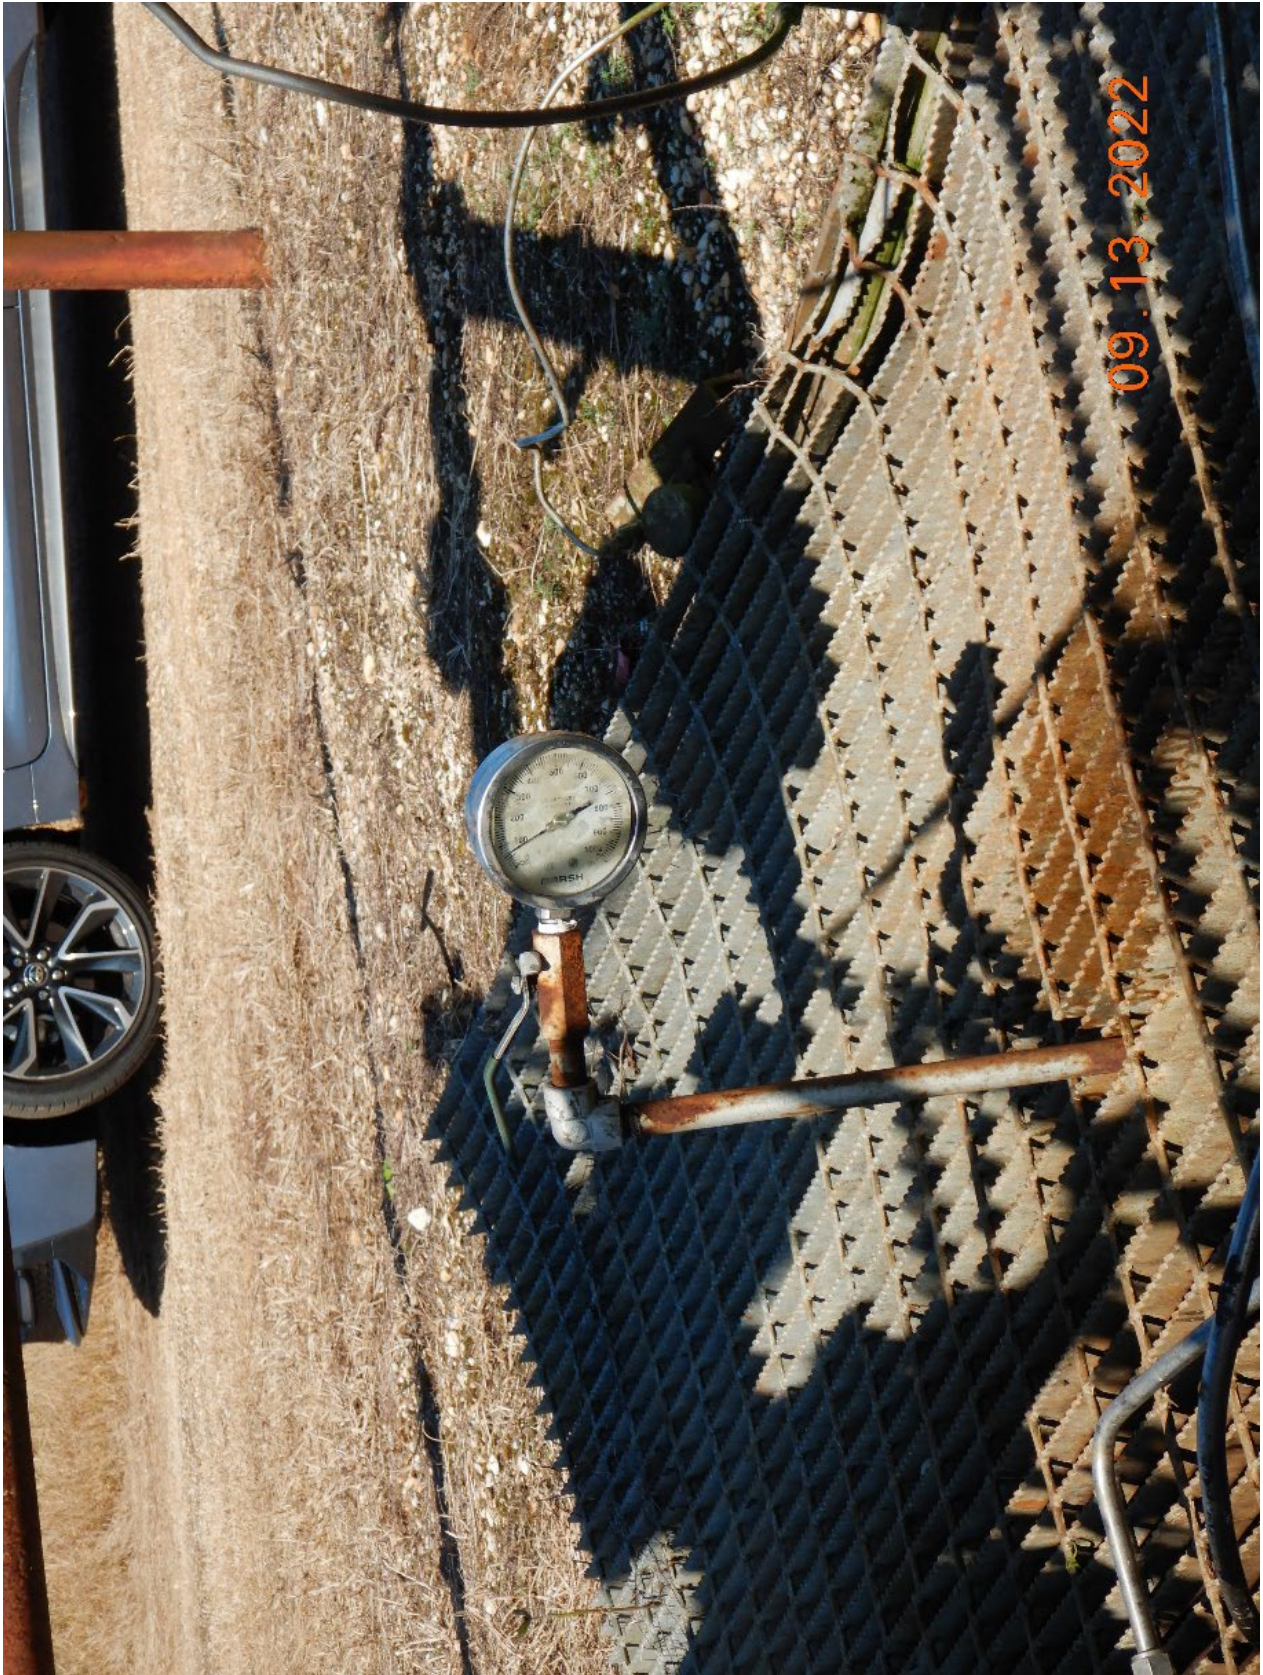
Description: *Looking west, closeup view of surface pressure gauge reading 0 psi.* \_\_\_\_\_

**Photograph 3:** Looking west, closeup view of surface pressure gauge reading 80 psi.

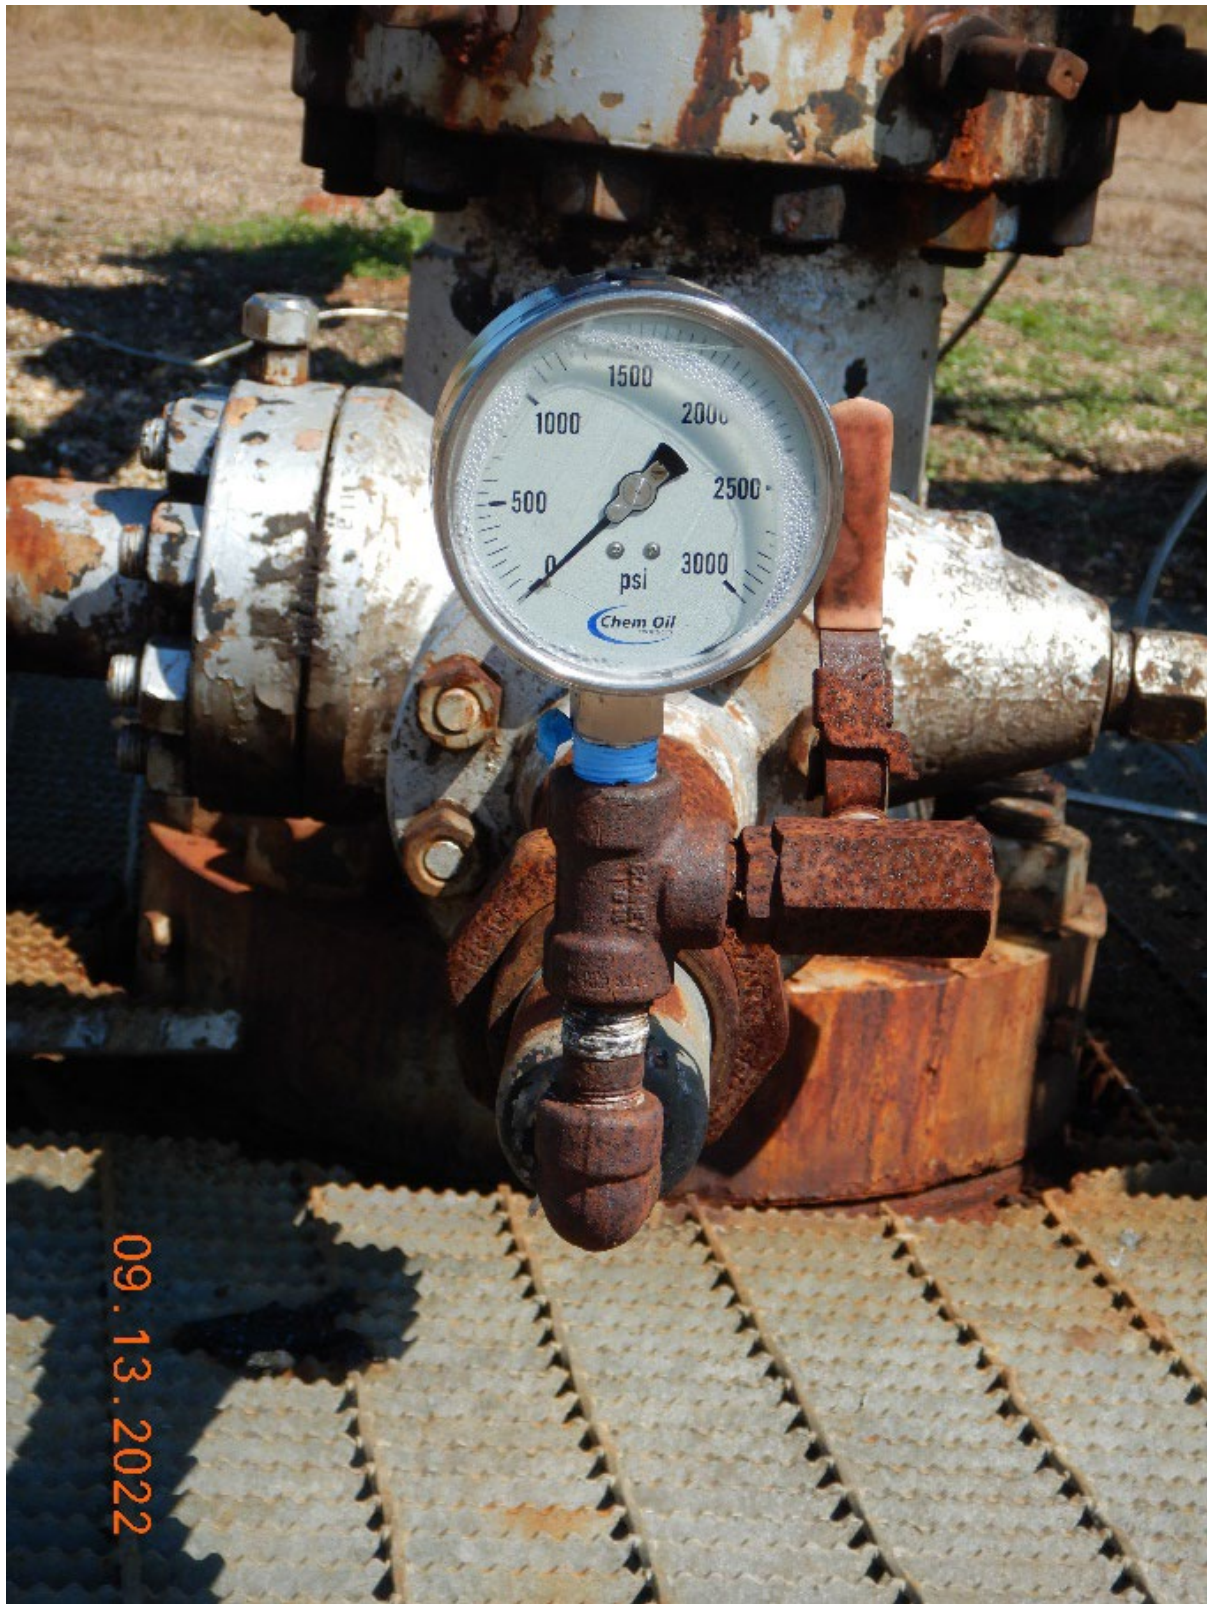
Latitude (°N): *30.833734°N* \_\_\_\_\_ Longitude (°W): *-87.095360°W* \_\_\_\_\_ Elevation (ft): *NA* \_\_\_\_\_  
EPA GPS ID: PG No. *3358766066* \_\_\_\_\_ Well Status (see table): *AC* \_\_\_\_\_ If not Active, Reported Date Last Active: \_\_\_\_\_  
Nature of Injected Fluid(s) if any: \_\_\_\_\_  
General Condition of the Well Site: The site is clean and well maintained. There was no evidence of leaks or excessive \_\_\_\_\_  
corrosion. The access stairs are not stable, could use some repairs/upgrades to ensure safety of personnel. \_\_\_\_\_  
Notes & Comments (include discrepancies from database values): \_\_\_\_\_  
*The internal pressure gauge was reading 1,750 psi. The surface casing pressure gauge was reading 80 psi. The operator suggested that this is likely due to the thermal expansion of the fluids above the top of cement due to having been shut in for a long period, then being recently reactivated. The operator indicated this is not indicative of an MI issue, because the production casing pressure still reads 0 psi.*

Description: *Looking north, closeup view of production casing pressure gauge reading 0 psi.* \_\_\_\_\_

**Photograph 4:** Looking north, closeup view of production casing pressure gauge reading 0 psi.

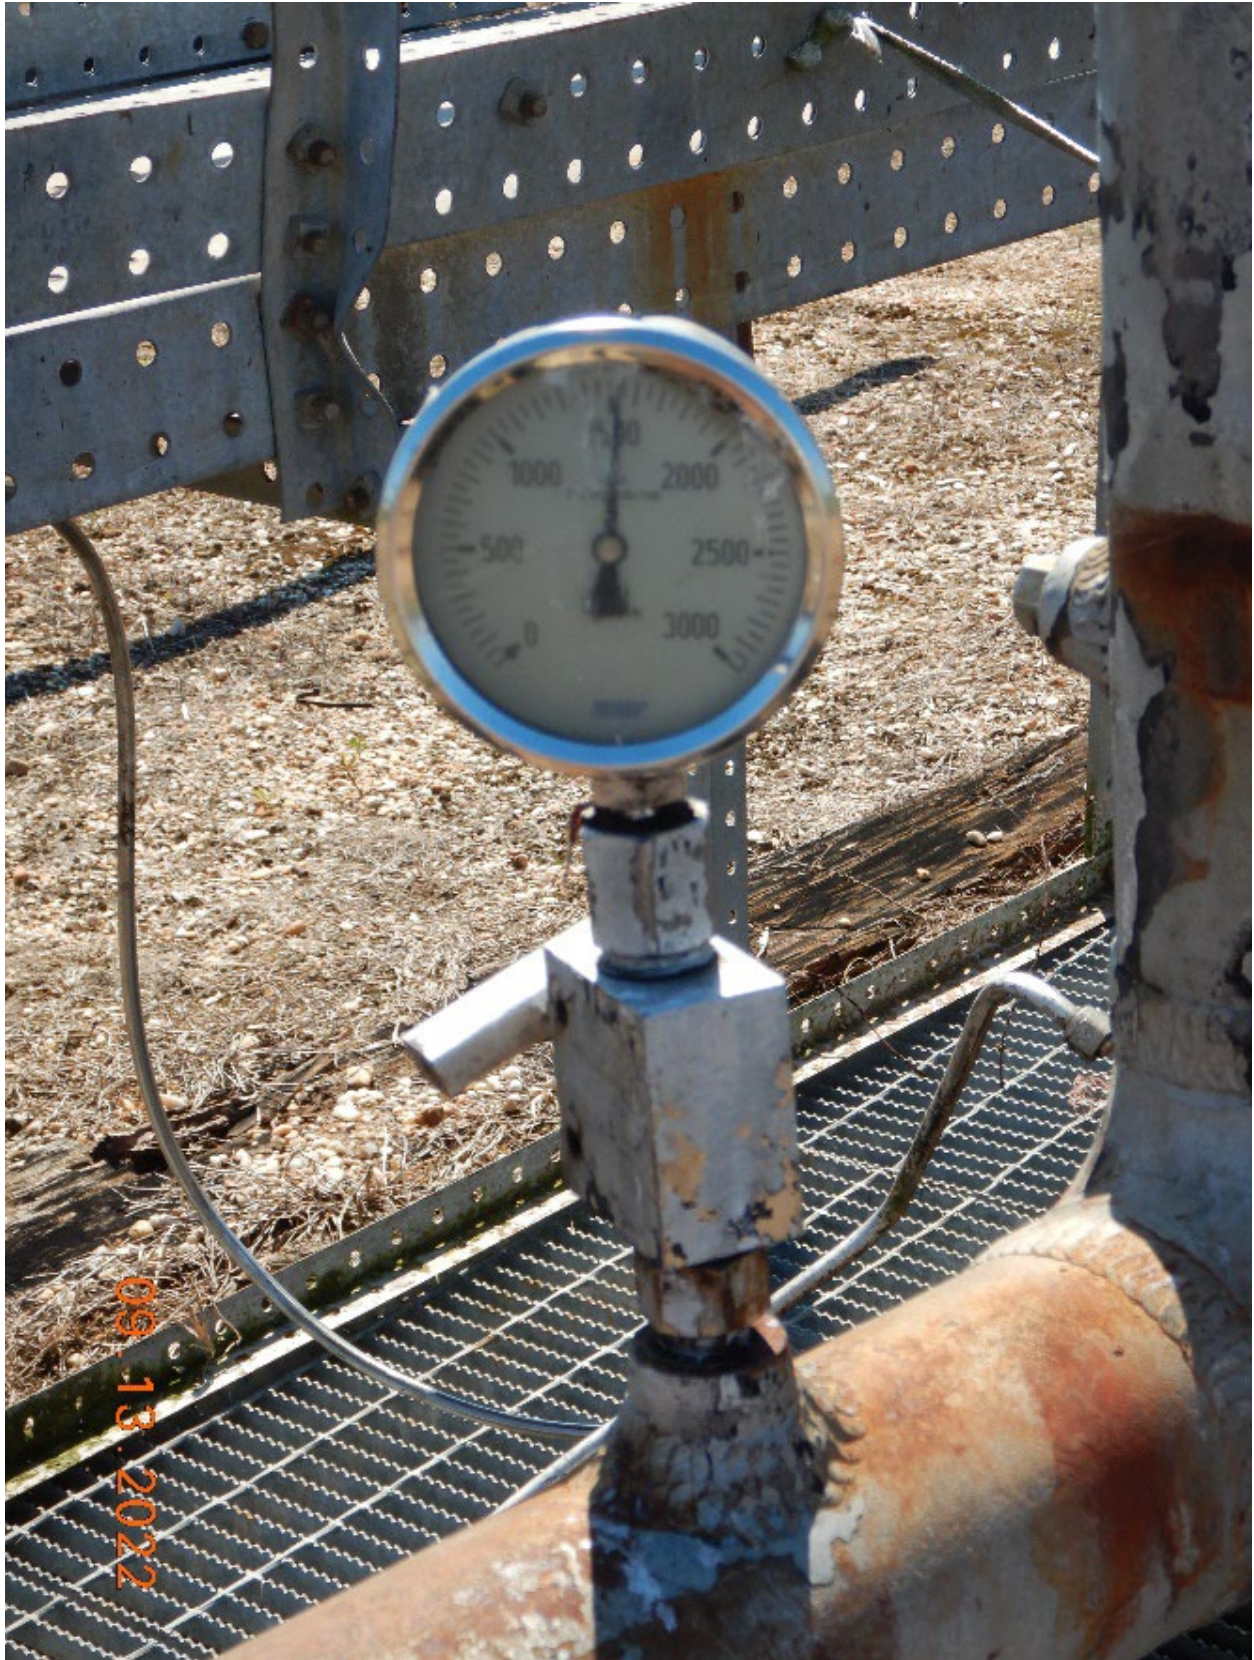
Description: *Looking south, view of incoming line pressure gauge reading 1,520 psi.* \_\_\_\_\_

**Photograph 5:** Looking south, view of incoming line pressure gauge reading 1,520 psi.

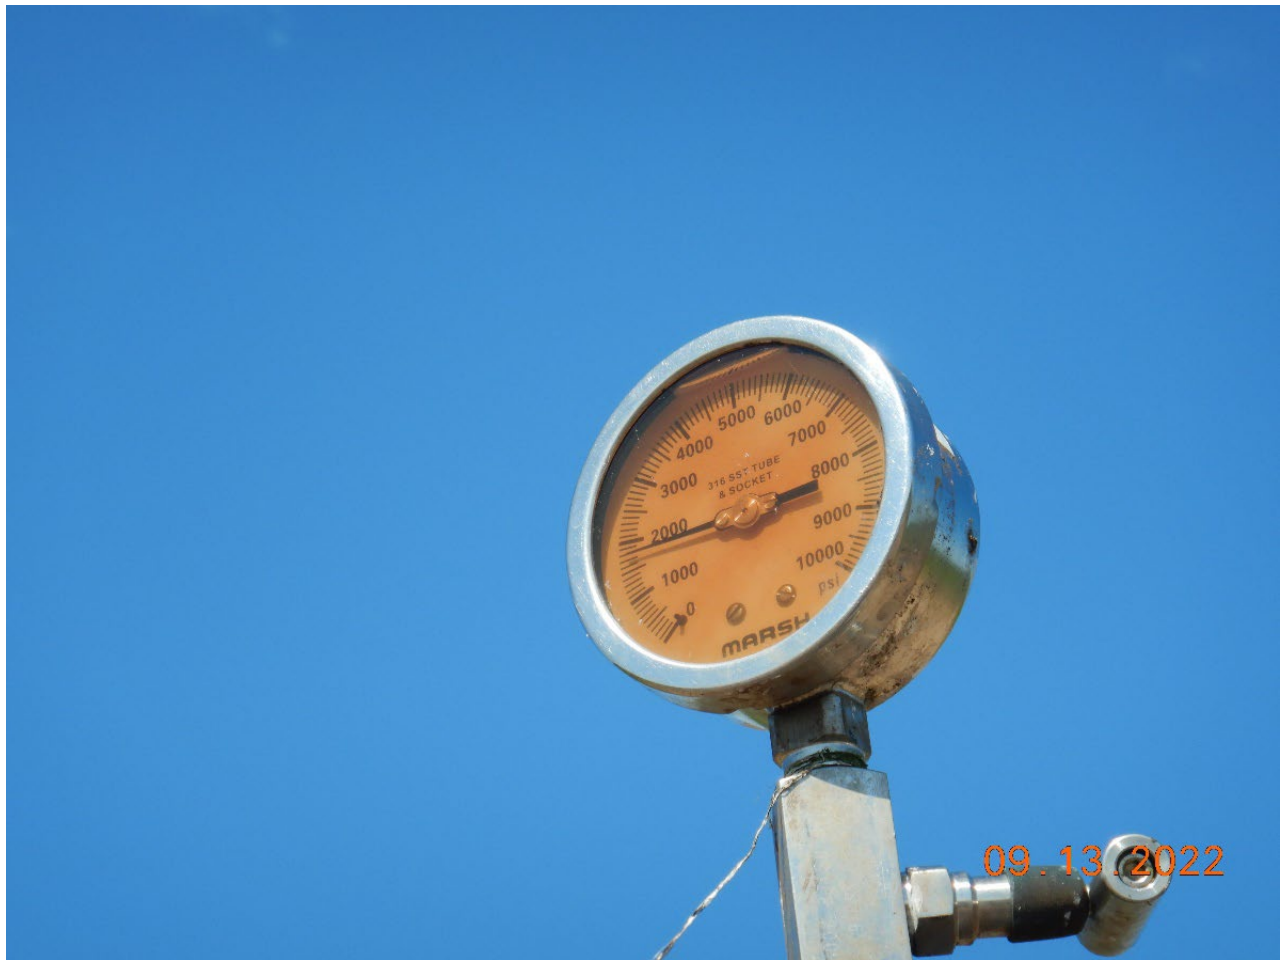
Description: *Looking west, view of internal presure gauge reading 1,750 psi.* \_\_\_\_\_

**Photograph 6:** Looking west, view of internal pressure gauge reading 1,750 psi.
