## **RCRA Inspection Report**

SAATI Americas, Inc.  
201 Fairview Street, Ext  
Fountain Inn, Greenville County, South Carolina 29644

SAATI Americas, Inc.  
SCD980841944  
RCRA CEI Report  
June 17, 2021

SAATI Americas, Inc.  
SCD980841944  
June 17, 2021  
RCRA CEI Photographs  
Photographs by William Kappler  
Camera Model: Samsung WB250F  
Property Tag #: S75917

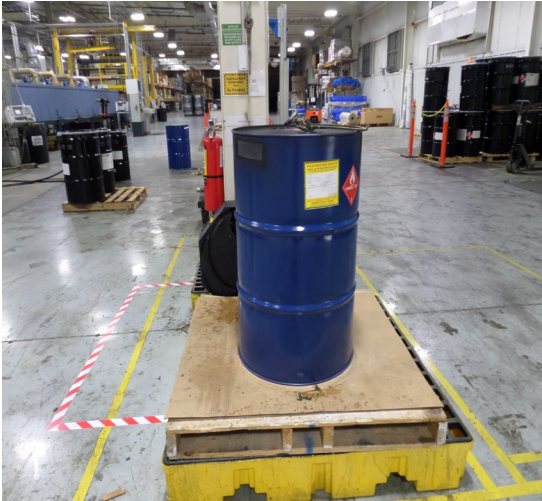
The inspectors observed a 55-gallon container on a wooden pallet on a containment pallet in the first SAA next to the column. The inspectors observed the container was closed, labeled with the words hazardous waste (waste flammable liquids D001, D035, F005) and labeled with a flammable hazard indicator (Photograph 1). The profile number for this waste stream is 193220232. The inspectors observed a 55-gallon container on a containment pallet in the second SAA next to the column. The inspectors observed the container was closed, labeled with the words hazardous waste (waste flammable solids D001, D035), and labeled with a flammable hazard indicator (Photograph 2). The profile number for this waste stream is 193221580.

SAATI Americas, Inc., (SAATI). Coating Line. Inspectors observed one 55-gallon container accumulating hazardous waste next to the column. Photograph 1 taken at 10:45 a.m.

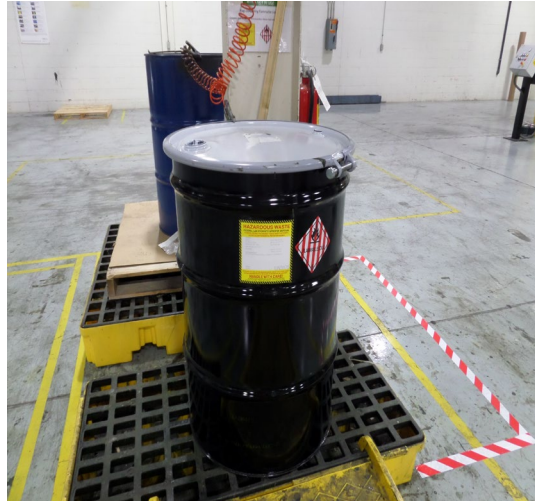
SAATI. Coating Line. Inspectors observed a second 55-gallon container accumulating hazardous waste next to the column. Photograph 2 taken at 10:47 a.m.

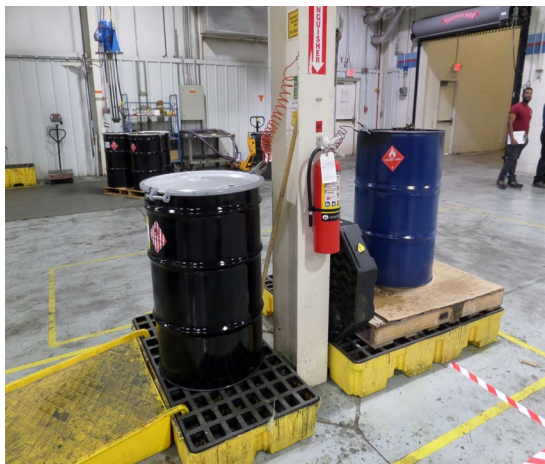
In this area a resin is coated on the fabric by dipping and/or placing a thin film of resin on the fabric. The Isotex machine coats the fabric with a resin for use in protective helmets and other ballistic items. The inspectors observed two satellite accumulation areas (SAA) located next to a structural column (Photograph 3).

SAATI. Coating Line. The two 55-gallon containers observed by inspectors in photographs 1 and 2. Photograph 3 taken at 10:47 a.m.

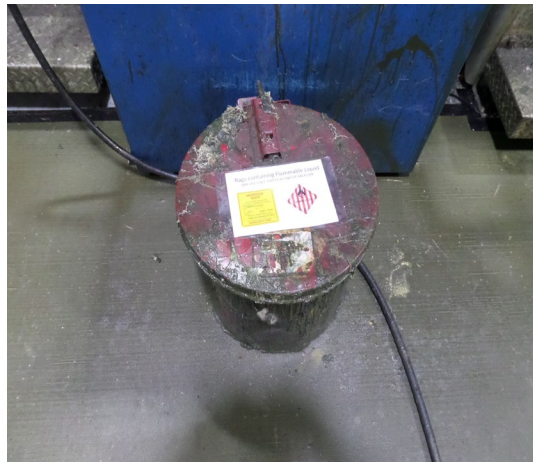
Located next to the Isotex machine inspectors observed an empty 5-gallon red safety container to accumulate hazardous waste rags during the day and transferred to a 55-gallon container in the SAA at the end of the shift. The container was labeled with the words hazardous waste (waste flammable solids D001, D035) and labeled with a flammable hazard indicator. The container's lid did not appear to be in good condition to keep the container closed when accumulating hazardous waste. The inspectors suggested the container not be used to accumulate hazardous waste (Photographs 4 and 5).

SAATI. Coating Line. Inspectors observed one 5-gallon empty container. The cover was not in good condition. Photograph 4 taken at 10:52 a.m.

On July 12, 2021, Ms. Kowalske emailed the EPA a photograph showing the facility replaced the 5-gallon container with a new container on June 23, 2021.

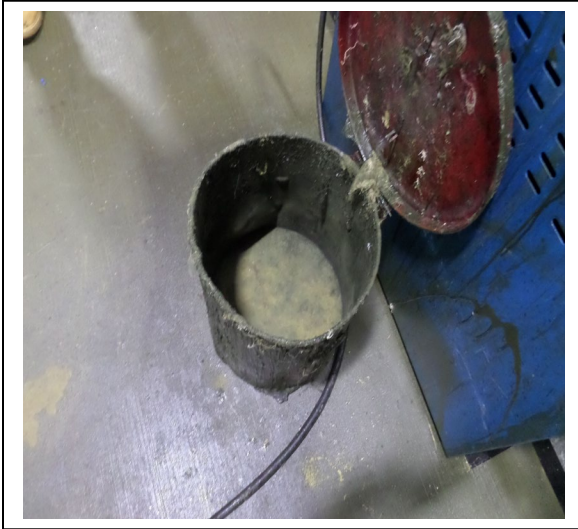
SAATI. Coating Line. Inspectors observed one 5-gallon empty container. Cover was not in good condition. Photograph 5 taken at 10:52 a.m.

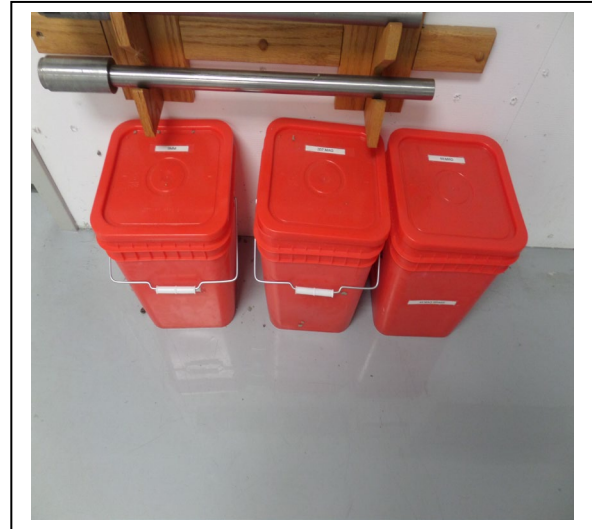
SAATI. Ballistics Laboratory. Inspectors observed three 5-gallon containers accumulating spent bullets. Photograph 6 taken at 11:08 a.m.

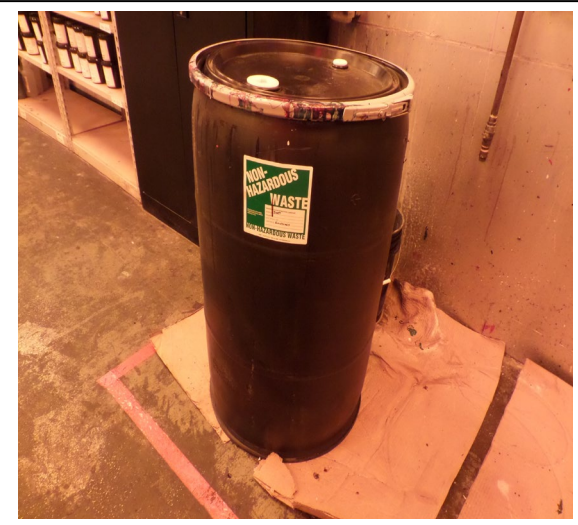
Ann Goodreaux is the QC Laboratory Technician in this area. After mixing the emulsion is transferred to this room to cool. Samples of the emulsion products are retained in this room for customer quality control. The samples are removed from their specified shelf space, based on a date procedure, and accumulated in a 55-gallon container as non-hazardous waste. The inspectors observed one 55-gallon container in this area accumulating waste emulsion samples.

The container was closed and labeled with the words non-hazardous waste (Photograph 7).

SAATI. Cool Room (Emulsions). The inspectors observed waste samples are accumulated in a 55-gallon container labeled with the words non-hazardous waste. Photograph 7 taken at 11:36 a.m.

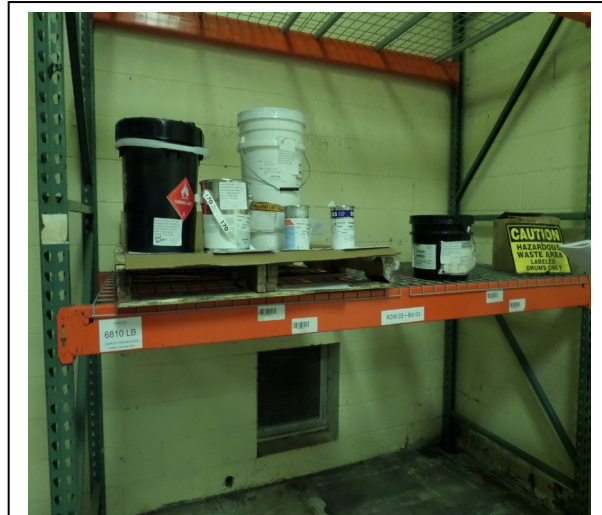
The inspectors observed a 0.5-gallon container of expired chemical (silver ink 191) labeled with the words hazardous waste. The hazard indicator (pictogram) was covered with other labeling partially concealing the hazard indicator (Photograph 8).

**Pursuant to 25 S.C. Code Ann. Regs. 61-79.262.17(a)(5)(i) [40 C.F.R. § 262.17(a)(5)(i)], which is a condition of the LQG Permit Exemption, a large quantity generator must mark or label its containers with the following: an indication of the hazards of the contents**

SAATI. 90-Day or Less Accumulation Area. The inspectors observed the hazardous waste label on a one-quart bottle appeared to cover the hazard indicator. Photograph 8 taken at 11:49 a.m.

On July 12, 2021, Ms. Kowalske emailed the EPA a photograph showing the facility re-labeled the container with a flammable hazard indicator on June 17, 2021.

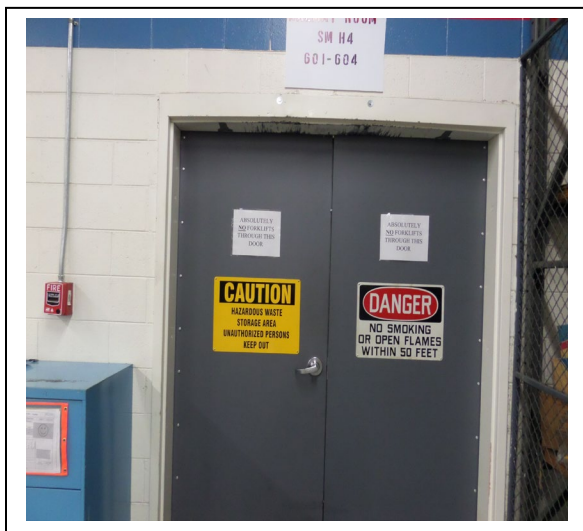
The 90-Day or Less Accumulation Area (90-Day) is constructed of cinder block walls, a concrete floor and secured by locked double metal doors. The inspectors observed signs posted on the exterior doors with the words “Caution Hazardous Waste Storage Area Unauthorized Persons Keep Out” and “Danger No Smoking or Open Flames Within 50 Feet” (Photograph 9). Chemical products and hazardous wastes are stored in the room. The accumulation area for hazardous waste is separated from the chemical products. The inspectors observed hazardous waste is accumulated on a shelf system constructed of metal scaffolding. The inspectors observed a sign on the shelf with the words “Caution Hazardous Waste Area”. Located on a wooden pallet the inspectors observed a five-gallon container accumulating waste acetone (D001, F003), a one-gallon container of ignitable waste (D001), a five-gallon container of ignitable waste (D001), two one-quart containers of ignitable waste (D001) and a 5-gallon container of corrosive waste (D002). The containers were closed, in good condition, accumulating with aisle space, labeled with the words hazardous waste, and labeled with a hazard indicator. The containers were marked with a date. The earliest date observed on a container was May 3, 2021.

SAATI. 90-Day or Less Accumulation Area. Inspectors observed signs identifying the storage area. Photograph 9 taken at 11:49 a.m.

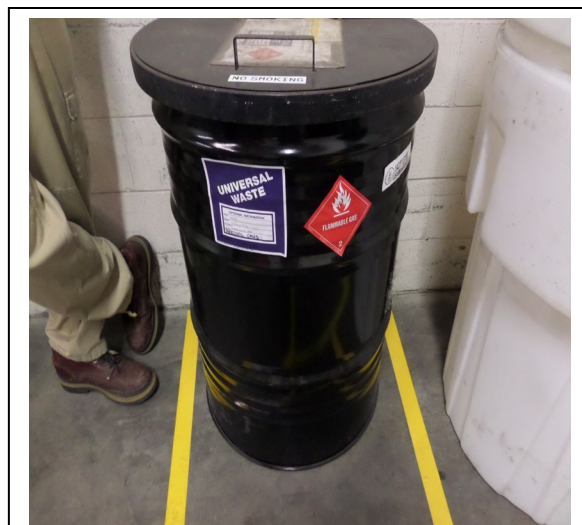
Spent aerosol cans are accumulated in this area as universal waste. The inspectors observed a 55-gallon container accumulating spent aerosol cans. The container was closed labeled with the words universal waste, marked with the date July 29, 2020, and marked with the word aerosol cans. The inspectors explained the effective date the universal waste aerosol rule was adopted by SCDHEC was May 28, 2021. The facility marked the container with the date May 28, 2021 (Photograph 10).

SAATI. Loading Dock Area. The inspectors observed a 55-gallon container accumulating aerosol cans not at atmospheric pressure. The facility corrected accumulation date on the container. Photograph 10 taken at 11:59 a.m.
