## **RCRA Inspection Report**

| Aalberts Integrated Piping Systems - Americas | dba Conbraco Industries, Inc. |
| Pageland, South Carolina 29728 | EPA ID SCR000006155 |

February 9, 2021

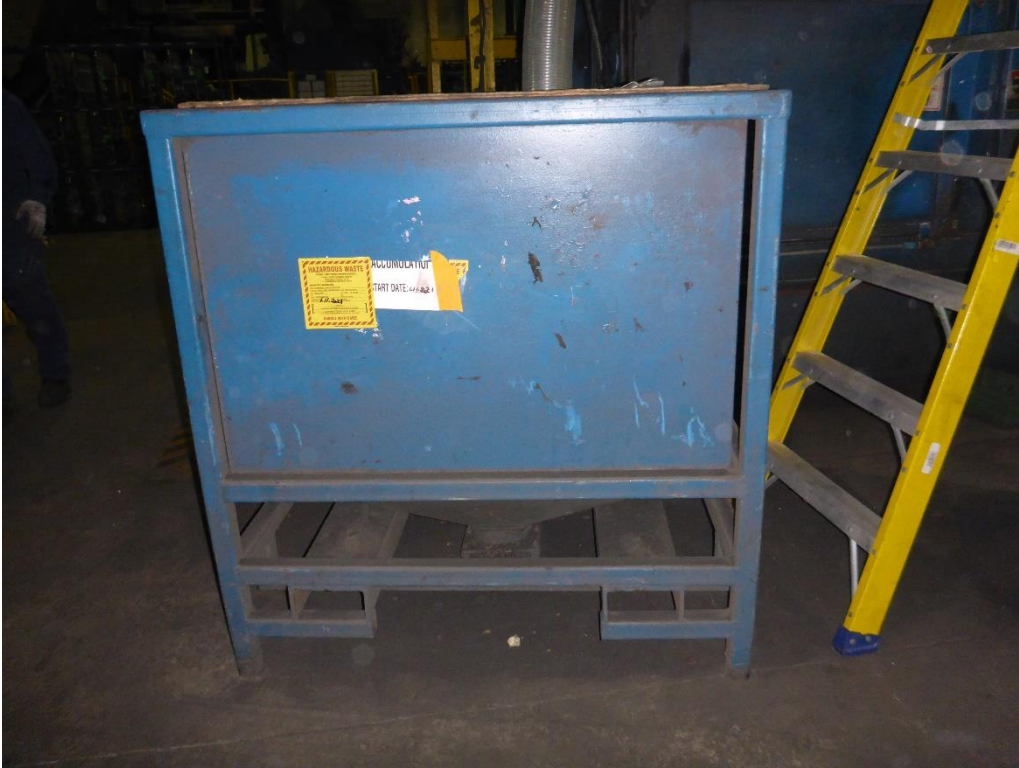
34 Wheelabrator CAA: The inspection tour began at the 34 Wheelabrator unit, where inspectors observed a blue box on one side of the unit, and a supersack on the other side of the unit. The box was labeled D008 hazardous waste solid containing copper, lead and zinc (Photo 1) and dated 01/11/2021. The lid on the box was not completely closed. The facility representatives explained that the box and the supersack both contain a mixture of foundry sand (mold sand and core molds) and brass parts that will be brought to the Reclaim Room for further processing.

**Photo 1:** Blue box for accumulating core mold pieces that will be sent for brass recovery on-site. Box is labeled hazardous waste solid D008 contains copper, lead and zinc and marked with an accumulation start date of 01/11/2021.

In an email dated 03/02/2021, Mr. Stewart provided photographs of this area which show that a supersack has been placed inside the metal hopper. This change allows employees to secure the supersack to the outfall duct and improve control over the transfer of the material from the process unit into the storage container. Mr. Stewart stated that each area has been identified as a hazardous waste CAA, the supersacks are each labeled and marked with an accumulation start date, and the facility has implemented the weekly inspection protocol at each location.

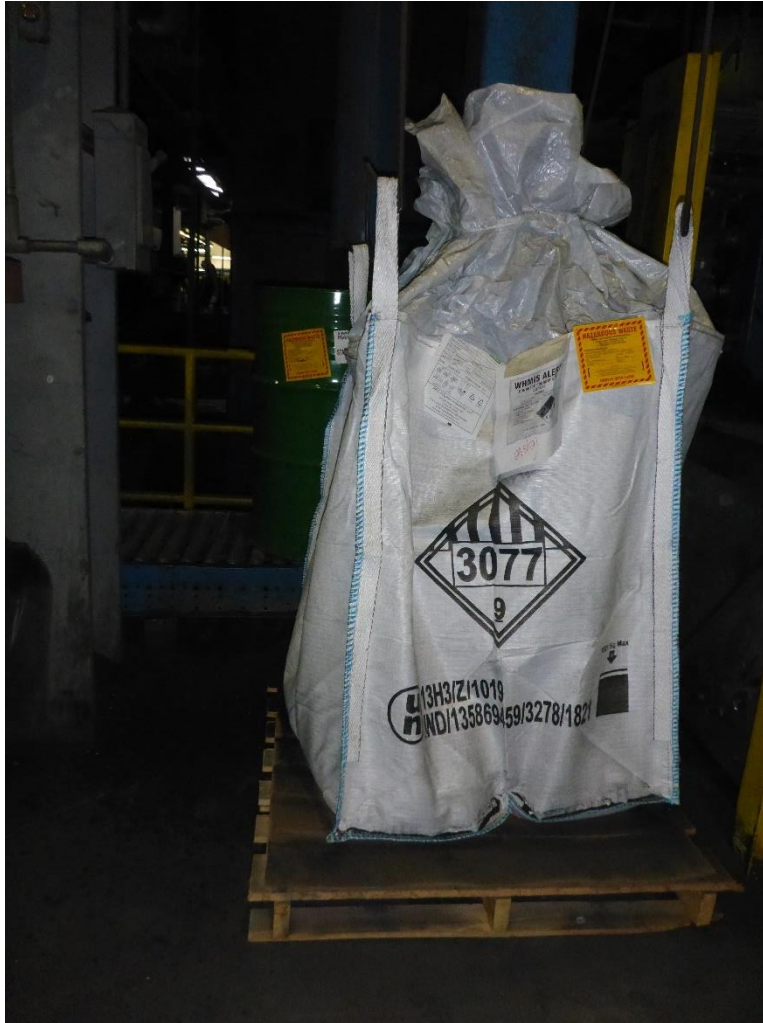
Excess System Sand / Bleed-out CAA: Next, the inspection participants visited the Bleed-out area, where used mold sand is removed from the storage unit in order to make room to replenish the supply with new sand. Representatives explained that the system operator will periodically push a button to remove used mold sand from the storage tank and send it through a chute where it is deposited into a collection container. The inspectors observed a supersack attached to one bleed-out chute (Photo 2), and a 55-gallon drum beneath another bleed-out chute (Photo 3). The supersack was labeled as D008 hazardous waste solid containing copper, lead and zinc, and it was dated 02/08/2021. The 55-gallon drum was labeled as D008 hazardous waste solid containing copper, lead and zinc, and it was dated 02/09/2021. The inspectors also observed a third 55-gallon drum in this area (Photo 4). The third 55-gallon drum was also labeled D008 hazardous waste solid containing copper, lead and zinc. All three of these containers held used mold sand that had been discharged from the storage tank so that the tank could be replenished with new sand. Neither drum had a lid, and the contents of the second drum were overflowing

**Photo 2:** Supersack under one of the bleed-out chutes used to accumulate mold sand that is discharged from the storage tank so that the tank can be replenished with new sand. Supersack is labeled D008 hazardous waste solid contains copper, lead and zinc, and marked with an accumulation start date of 02/08/2020.

In an email dated 03/02/2021, Mr. Stewart provided photographs of this area which show that each of the two bleed-out chutes had been fitted with a supersack for accumulating D008 hazardous waste bleed-out sand. The photograph also shows that the overflow bleed-out sand on the floor in this area has been cleaned up. Mr. Stewart stated that the area has been identified as a hazardous waste CAA, the supersacks are labeled and marked with an accumulation start date, and the facility has implemented the weekly inspection protocol here.

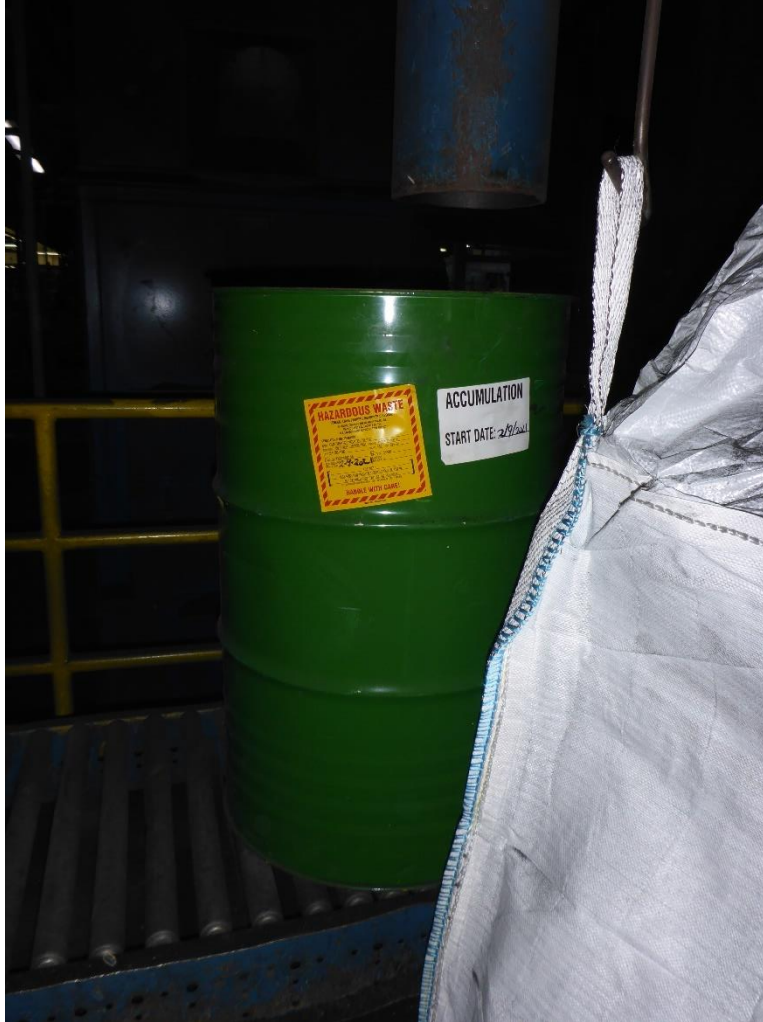
**Photo 3:** 55-gallon drum behind supersack shown in Photo 1. Drum is positioned under the other bleed-out chute and contains mold sand that was discharged from the storage tank so that the tank could be replenished with new sand. The drum has no lid. It is labeled D008 hazardous waste solid contains copper, lead and zinc, and marked with an accumulation start date of 02/09/2021.

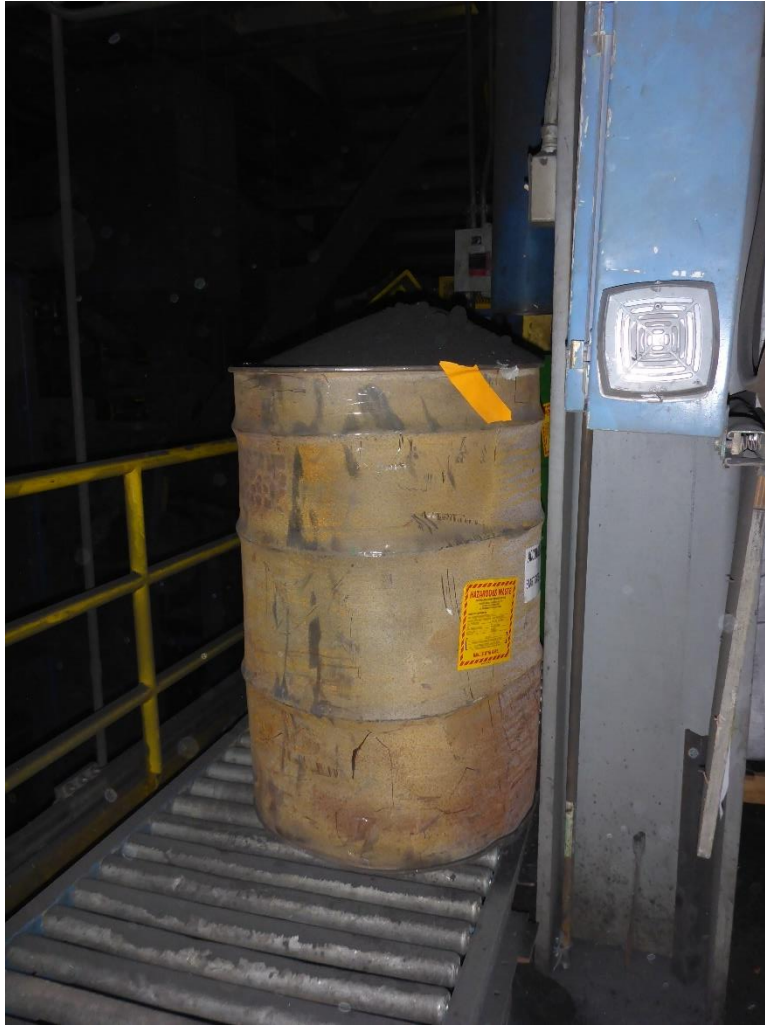
the top of the drum, resulting in a release. The inspectors observed more released overflow material on the ground near the supersack and first 55-gallon drum (Photo 5).

**Photo 4:** The third 55-gallon drum near Bleed-out area. The drum is labeled D008 hazardous waste containing copper, lead and zinc, and it is marked with an accumulation start date of 02/08/2021. The drum is overfilled, and it has no lid.

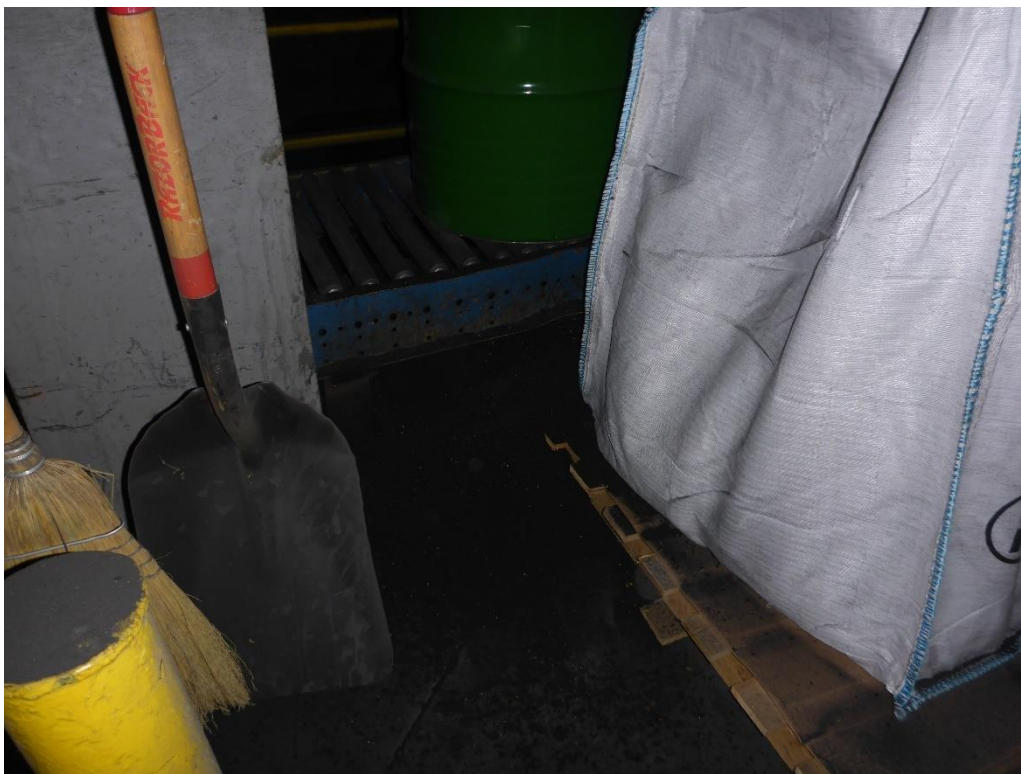
**Photo 5:** Pile of used mold sand on the floor next to the bleed-out bag and 55-gallon drum in the Bleed-out area.

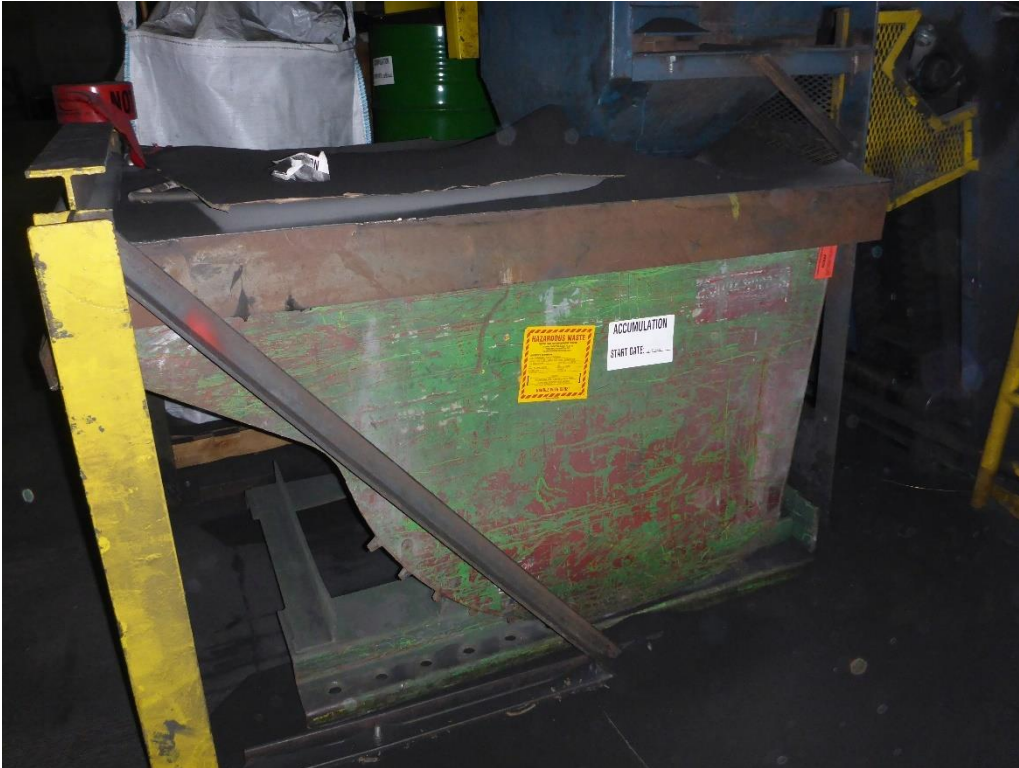
Conveyor Belt Sand CAA: The inspection participants observed a green hopper used to automatically accumulate excess used foundry sand from the conveyor belt (Photo 6). The hopper was labeled as D008 hazardous waste containing copper, lead and zinc, and it was dated 02/08/2021. However, facility representatives explained that this material is dumped back into the foundry sand storage tank for reuse in the process. The inspectors observed spilled sand on the floor surrounding the hopper and on top of the hopper lid, and the facility representatives stated that this material will be swept up and also placed back into the storage tank for reuse in the process.

**Photo 6:** Green hopper containing excess used mold sand coming off the conveyor belt. Facility personnel stated that this material is dumped back into the system for reuse on-site. The container was labeled D008 hazardous waste containing copper, lead and zinc, and it was marked with an accumulation start date of 02/08/2021.

In an email dated 03/02/2021, Mr. Stewart provided photographs of this area which show that the metal hopper has been replaced with a supersack. The photograph also shows that the overflow sand on the floor in this area has been cleaned up. Mr. Stewart stated that the area has been identified as a hazardous waste CAA, the supersack is labeled and marked with an accumulation start date, and the facility has implemented the weekly inspection protocol here.

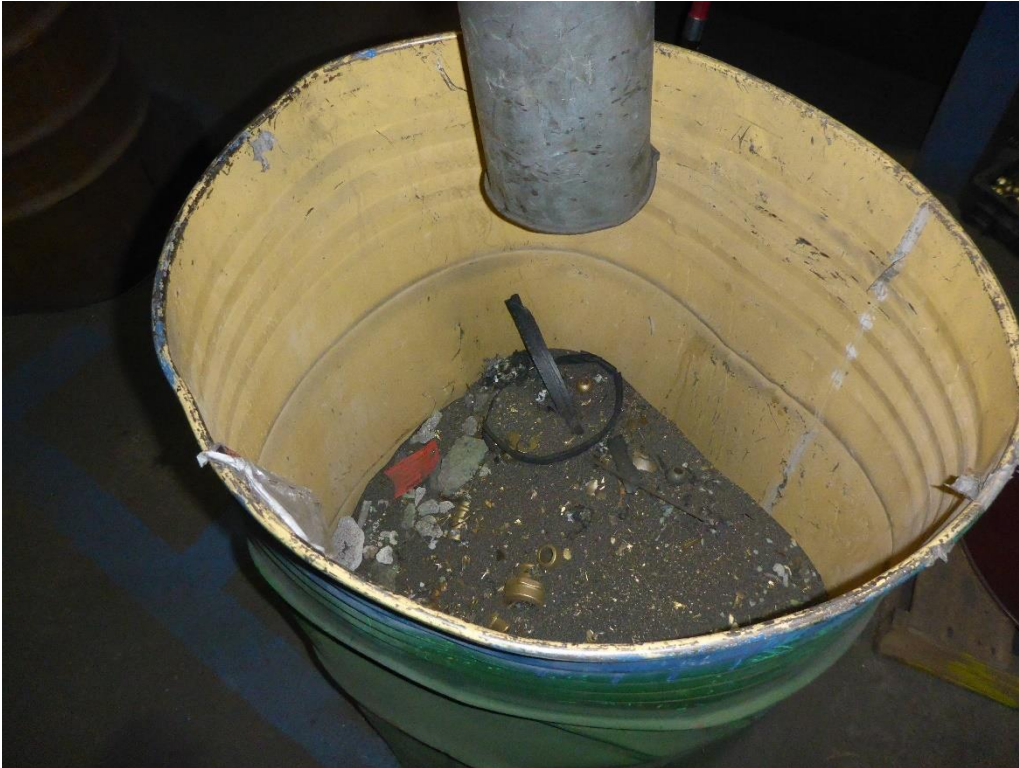
**Photo 7:** 55-gallon drum of used shot blast and debris generated by the Grinding Wheelabrator unit. Used shot blast and metals are reclaimed. Shot blast that is recovered in the Reclaim Room is reused on-site in the Wheelabrator; metals that are recovered in the Reclaim Room are remelted and reused in the casting process; foundry sand that is segregated in the Reclaim Room is disposed of as D008 hazardous waste. The container was open and it was not labeled.

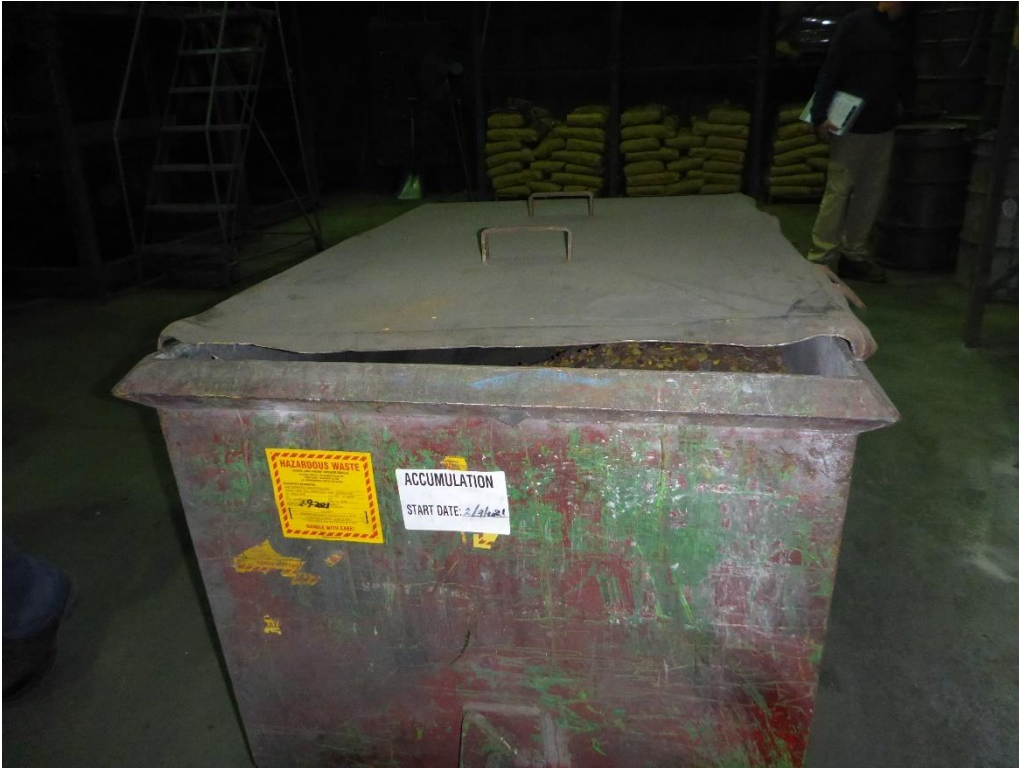
**Photo 8:** One hopper of on the floor in the middle of the Reclaim Room. Hopper was labeled as D008 hazardous waste containing copper, lead and zinc. It was dated 02/09/2021. The hopper appeared to contain cores and core sand for processing in the Reclaim Room. Shot blast that is recovered in the Reclaim Room is reused on-site in the Wheelabrator; metals that are recovered in the Reclaim Room are remelted and reused in the casting process; foundry sand that is segregated in the Reclaim Room is disposed of as D008 hazardous waste.

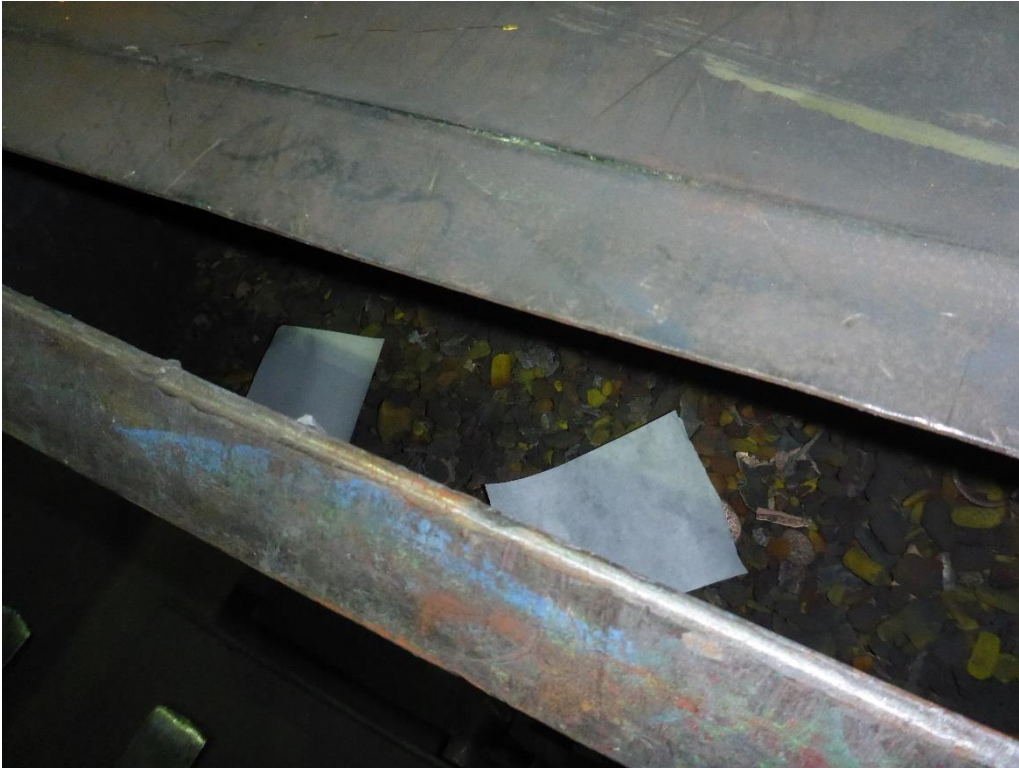
**Photo 9:** Close up of contents in hopper observed on the floor in the middle of the Reclaim Room shown in Photo 8. Hopper was labeled as D008 hazardous waste containing copper, lead and zinc. It was dated 02/09/2021. The hopper appeared to contain cores and core sand for processing in the Reclaim Room. Shot blast that is recovered in the Reclaim Room is reused on-site in the Wheelabrator; metals that are recovered in the Reclaim Room are remelted and reused in the casting process; foundry sand that is segregated in the Reclaim Room is disposed of as D008 hazardous waste.

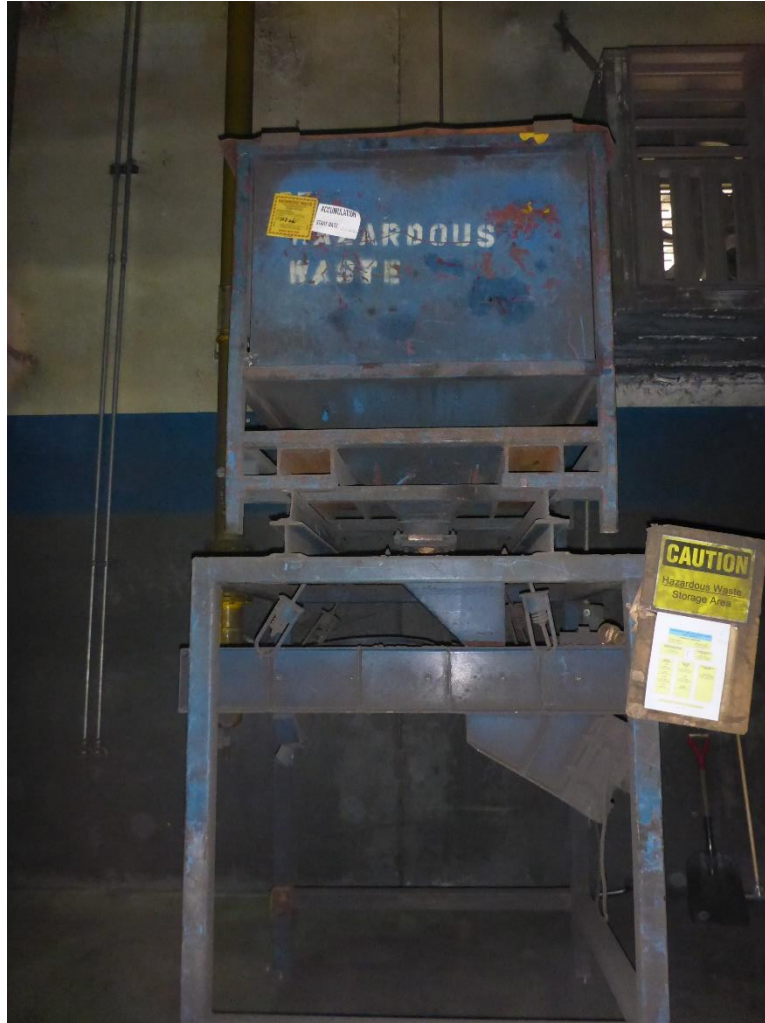
**Photo 10:** Metal hopper on elevated stand in the Reclaim Room. The hopper appears to be staged for processing. Shot blast that is recovered in the Reclaim Room is reused on-site in the Wheelabrator; metals that are recovered in the Reclaim Room are remelted and reused in the casting process; foundry sand that is segregated in the Reclaim Room is disposed of as D008 hazardous waste. The hopper was labeled as D008 hazardous waste containing copper, lead and zinc, and dated 12/08/2020.

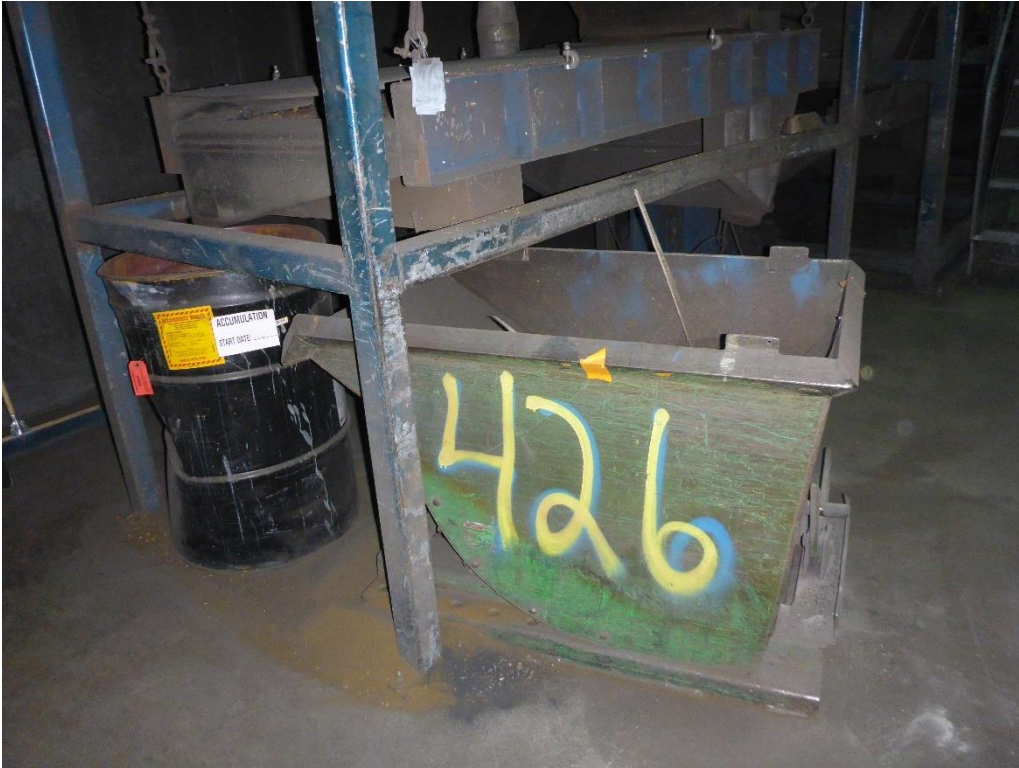
**Photo 11:** Metal hopper and 55-gallon drum for accumulating separated material that has been processed in the Reclaim Room. The hopper is labeled D008 hazardous waste 02/08/2021 and appears to contain used foundry sand. The 55-gallon drum is labeled D008 hazardous waste 02/08/2021 and appears to contain metal shavings.

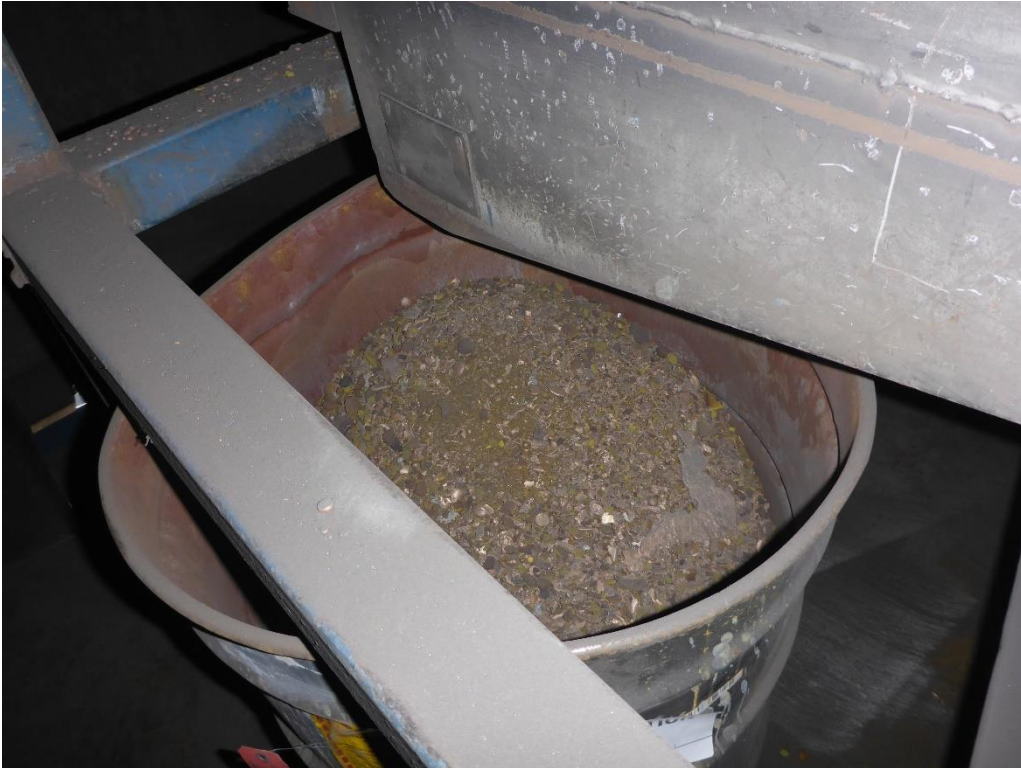
**Photo 13:** 55-gallon drum for accumulating separated material that has been processed in the Reclaim Room. The 55-gallon drum is labeled D008 hazardous waste 02/08/2021 and appears to contain metal shavings.

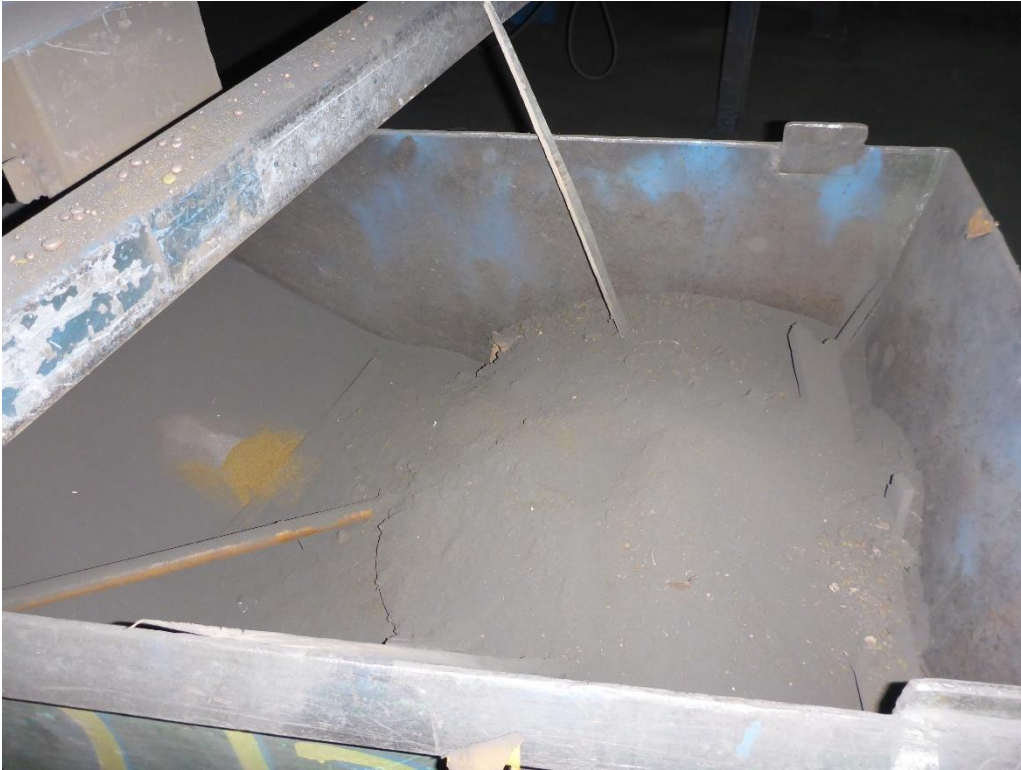
**Photo 14:** Metal hopper for accumulating separated material that has been processed in the Reclaim Room. The hopper is labeled D008 hazardous waste 02/08/2021 and appears to contain used foundry sand.

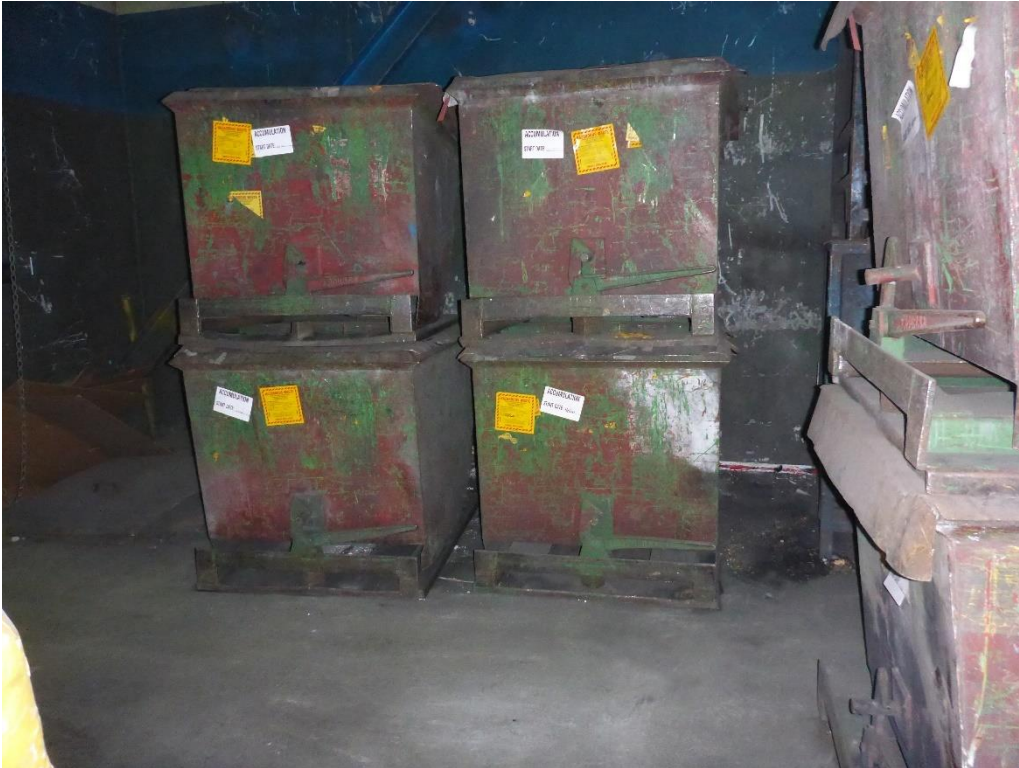
**Photo 15:** Metal hoppers near the door in the Reclaim Room. This area contained a total of ten metal hoppers. Eight of the hoppers were empty, and all were labeled D008 hazardous waste and marked with an accumulation start date. The oldest hopper was dated 02/01/2021. Personnel did not know if the hoppers contained material ready for reclamation or material that had already gone through the separation process.

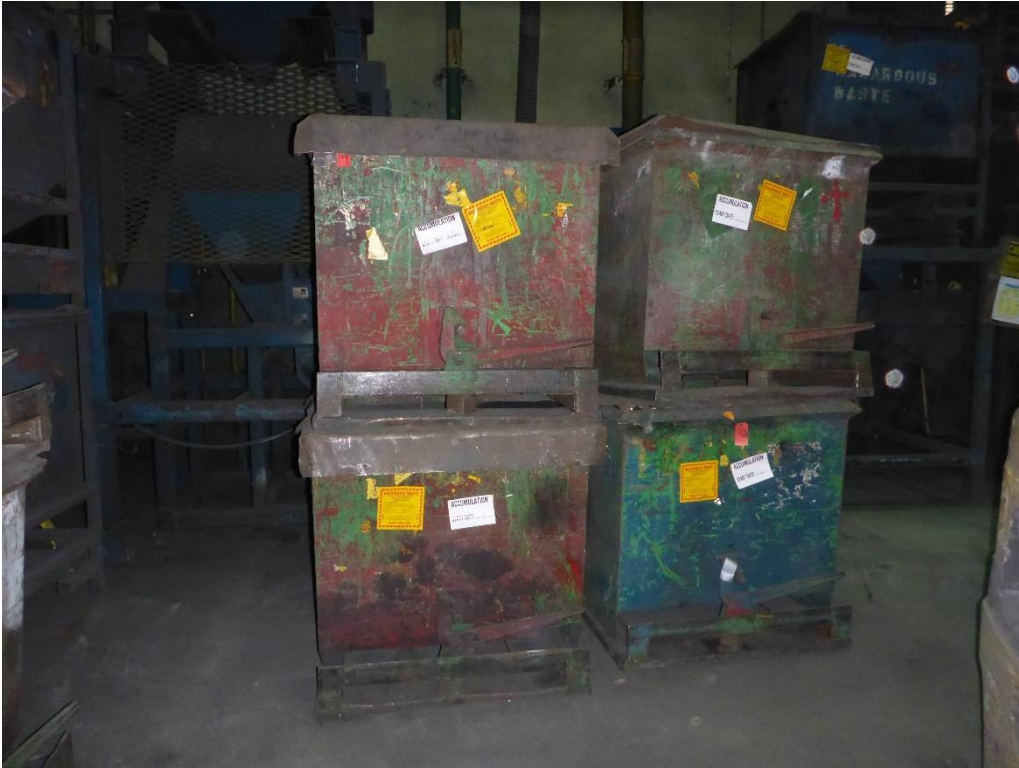
**Photo 16:** Metal hoppers near the door in the Reclaim Room. This area contained a total of ten metal hoppers. Eight of the hoppers were empty, and all were labeled D008 hazardous waste and marked with an accumulation start date. The oldest hopper was dated 02/01/2021. Personnel did not know if the hoppers contained material ready for reclamation or material that had already gone through the separation process.

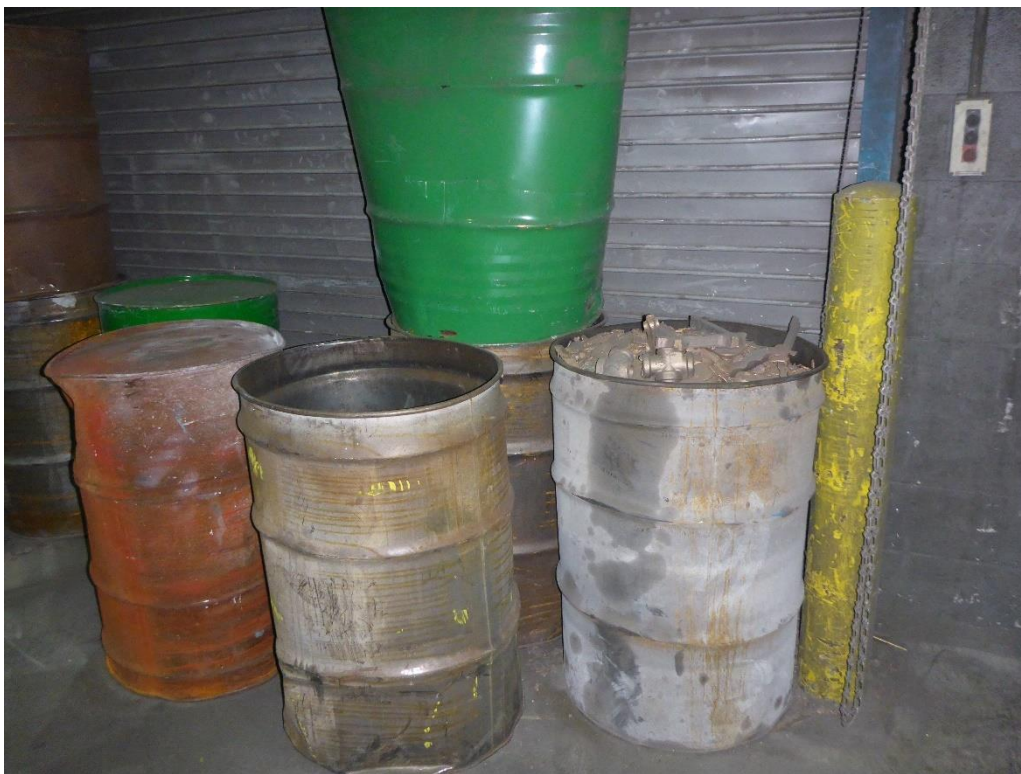
**Photo 17:** 55-gallon drums in the Reclaim Room. No labels, and could not determine if contents will be processed here or have already been processed.

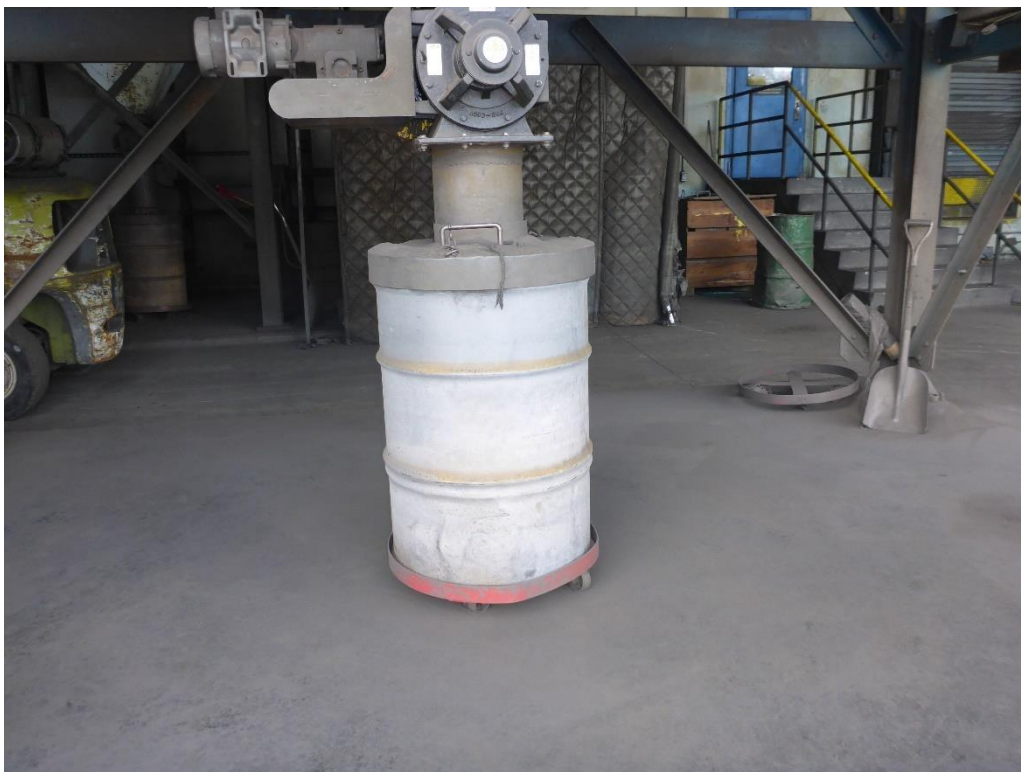
**Photo 18:** 55-gallon drum under Grinding Baghouse. The drum is not labeled.

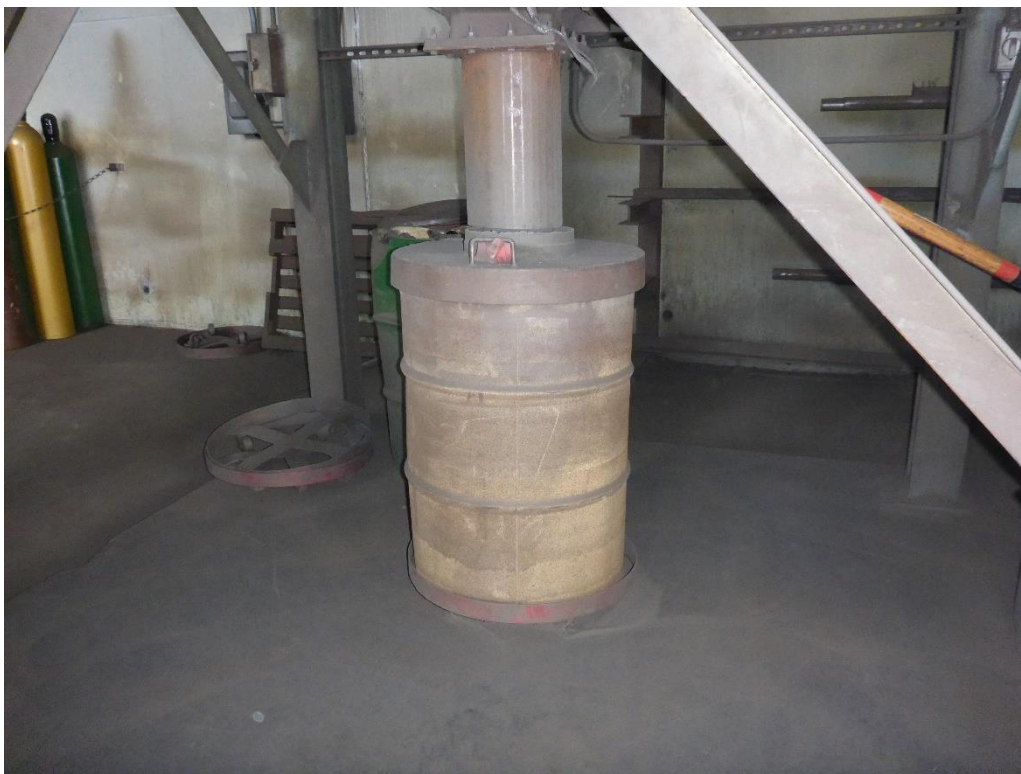
**Photo 19:** 55-gallon drum under Wheelabrator Baghouse. The drum is not labeled.

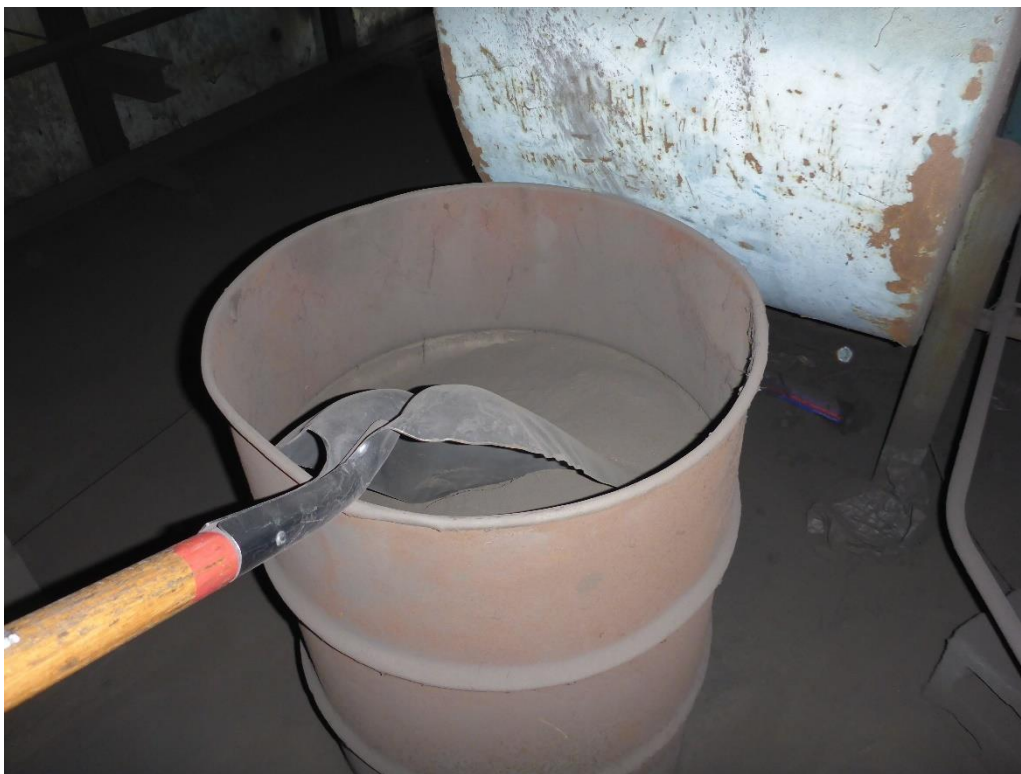
**Photo I:** 55-gallon drum under Wheelabrator Baghouse. The drum is not closed or labeled.

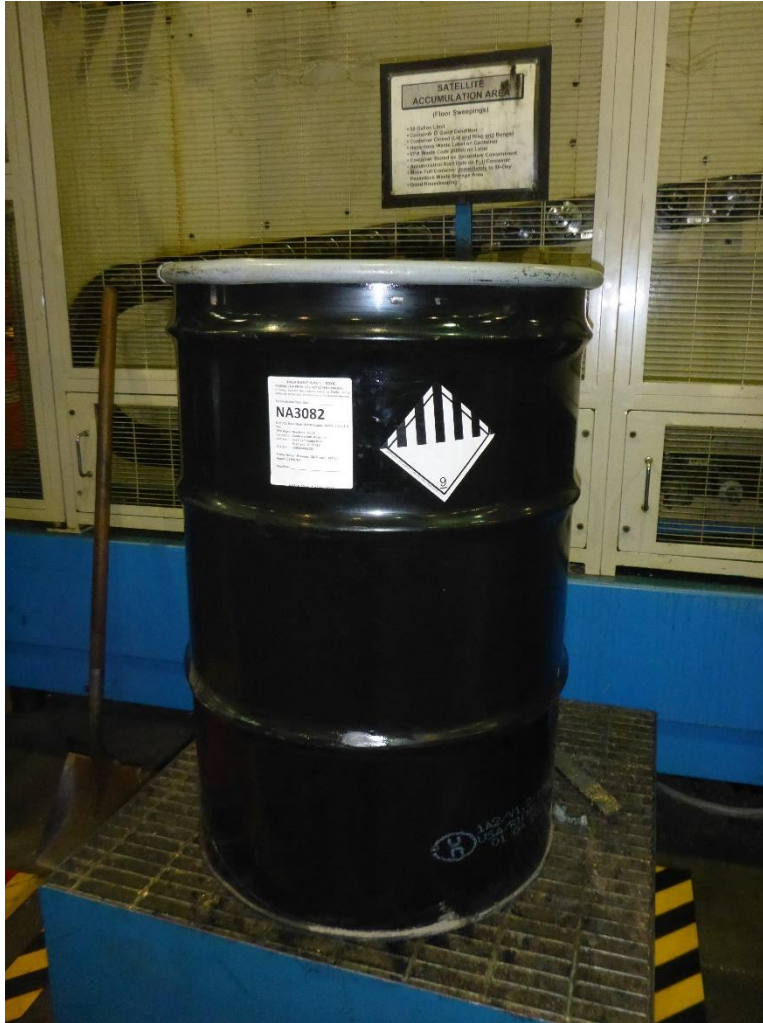
**Photo 21:** SAA for accumulating floor sweepings generated in part of the Machining area. 55-gallon drum labeled D008 hazardous waste liquid (lead shavings, oil/grease and water) and identified with a DOT class 9 hazard placard. Ring was not secured on the drum, so Mr. Peebles closed the drum by securing the lid with the ring.

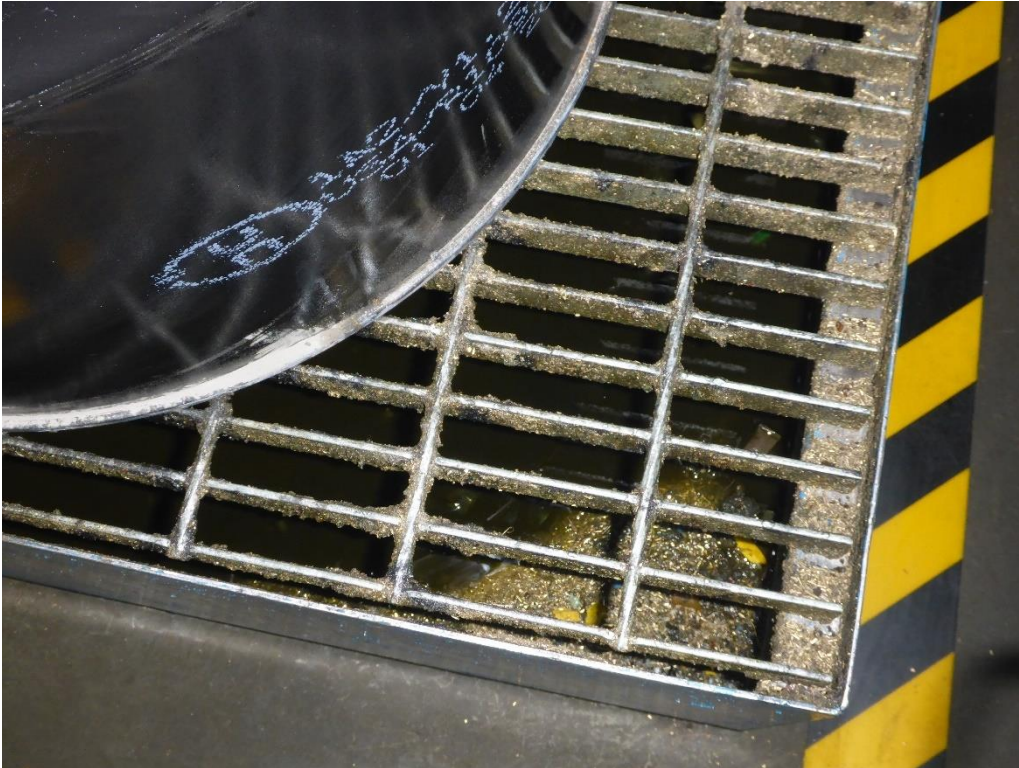
**Photo 22:** SAA for accumulating floor sweepings generated in part of the Machining area as D008 hazardous waste liquid (lead shavings, oil/grease and water). Material observed inside the secondary containment pallet.

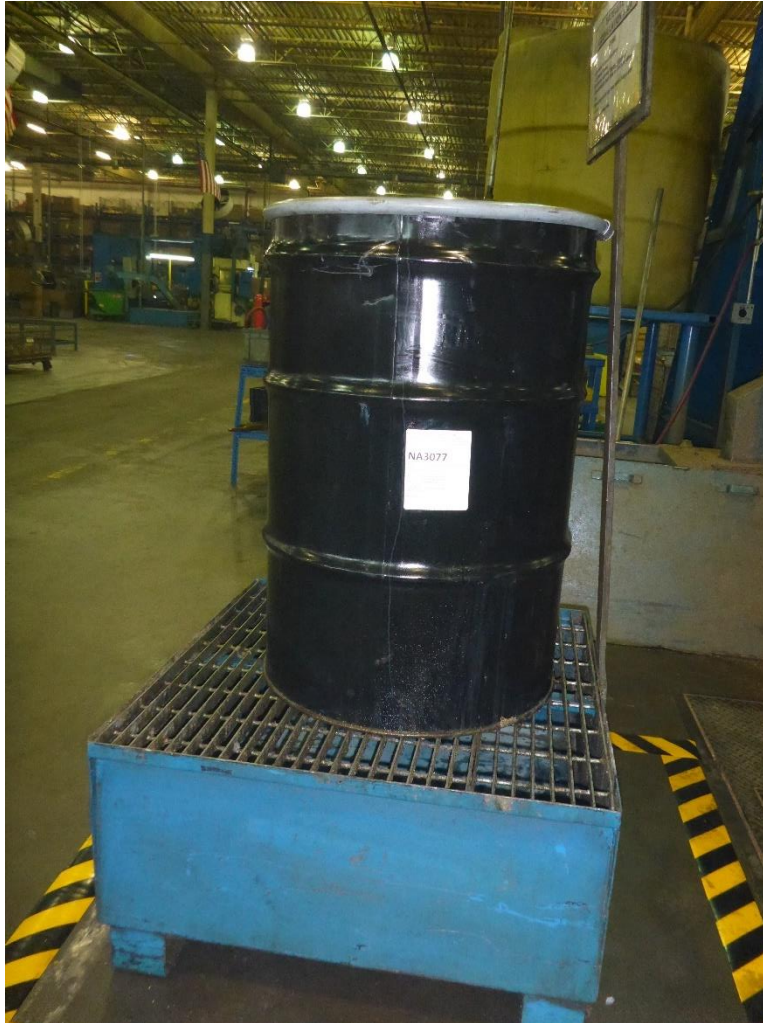
**Photo 23:** SAA for accumulating floor sweepings generated in part of the Machining area. 55-gallon drum labeled D008 hazardous waste air filters. Personnel immediately relabeled as D008 hazardous waste contaminated debris.

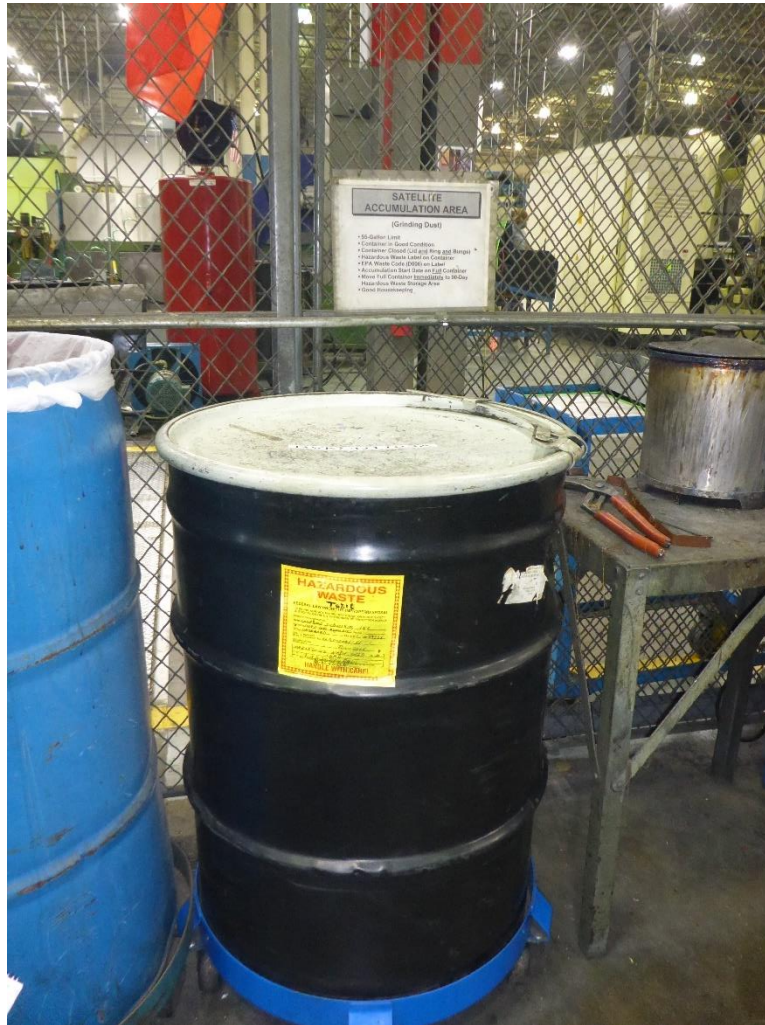
**Photo 24:** SAA for accumulating air filters generated in the air handling vacuum system in the Tool Crib area. The drum was labeled D006 hazardous waste solid led and identified with the word “toxic” on the hazardous waste label. Not that the D006 hazardous waste characteristic is toxic for elevated levels of cadmium, not lead.

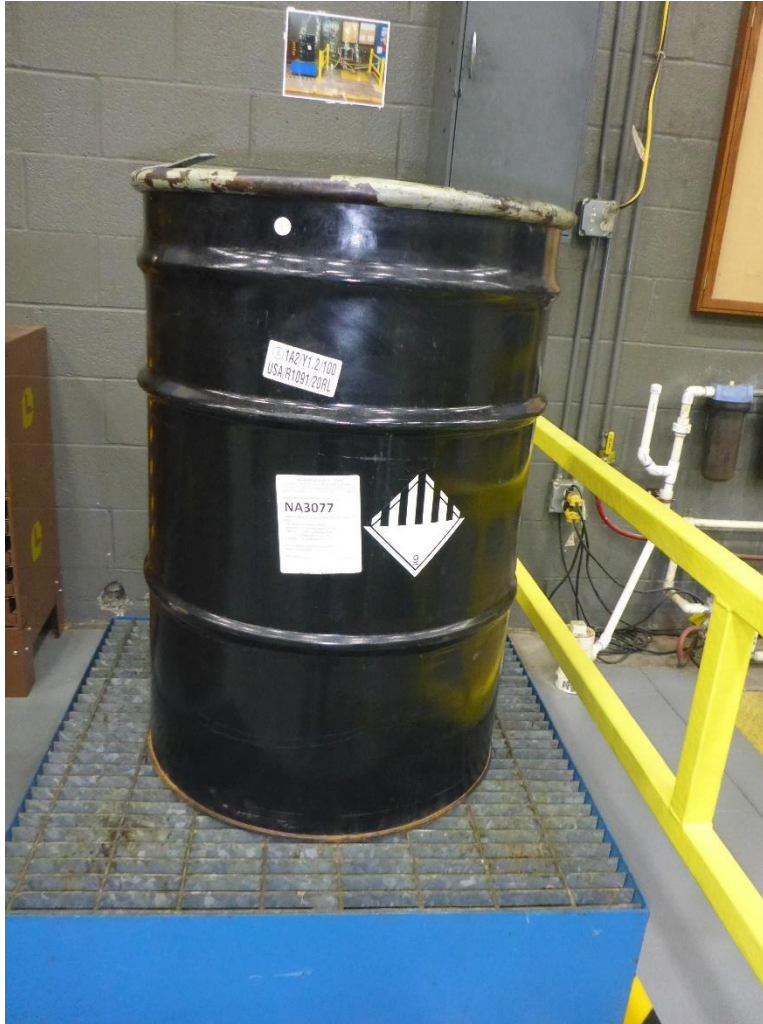
**Photo 25:** SAA for accumulating mop heads and used filters generated in the filter system for the hand sinks. 55-gallon drum labeled D008 hazardous waste contaminated debris and identified with a DOT class 9 hazard placard.

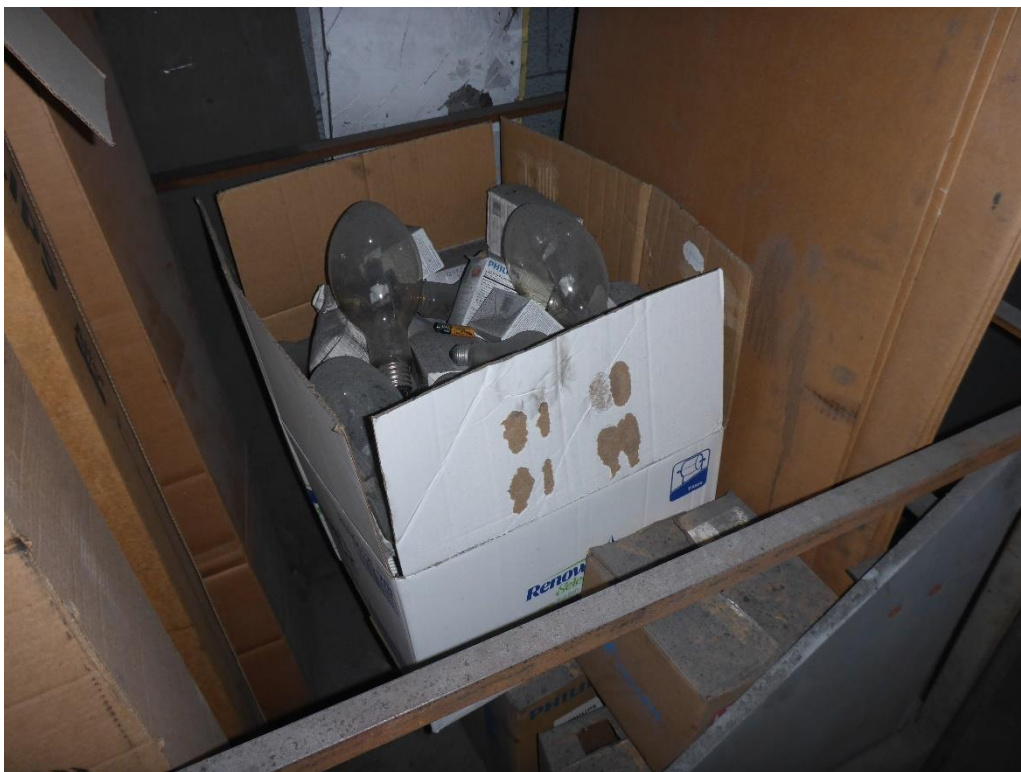
**Photo 26:** Box of used bulbs in the universal waste storage area. Box open and not labeled.
