## **RCRA Inspection Report**

| Aalberts Integrated Piping Systems - Americas | dba Conbraco Industries, Inc. |
| Pageland, South Carolina 29728 | EPA ID SCR000006155 |

February 9, 2021

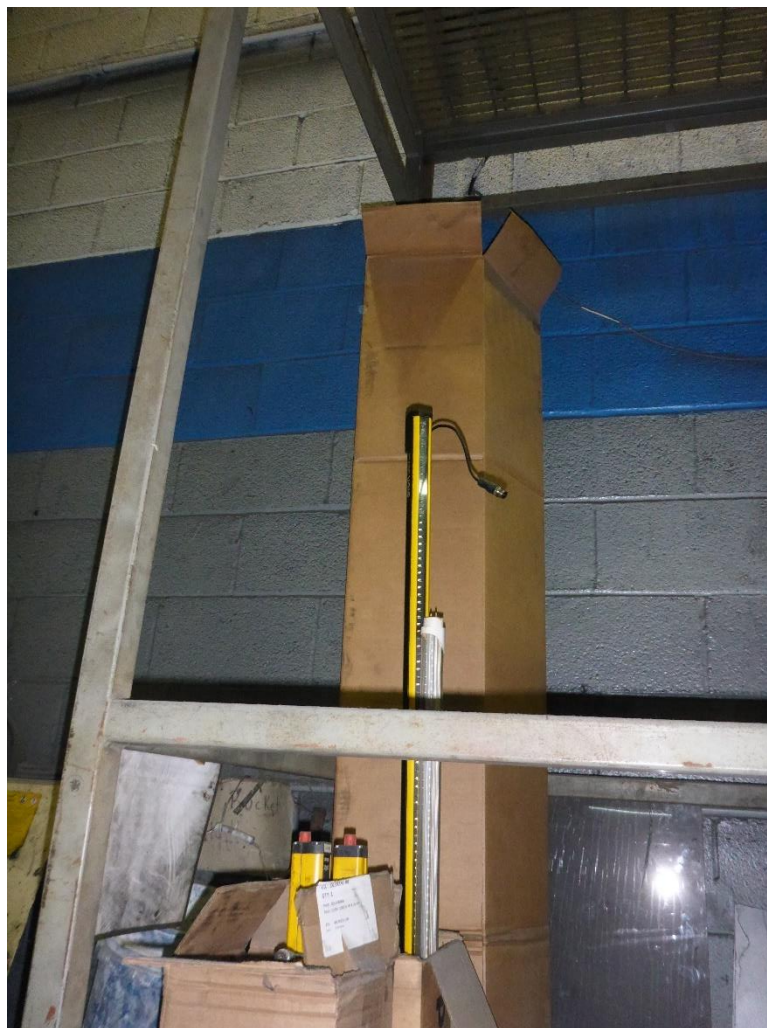
**Photo 28:** Boxes of used bulbs in the universal waste storage area. Boxes open and not labeled.

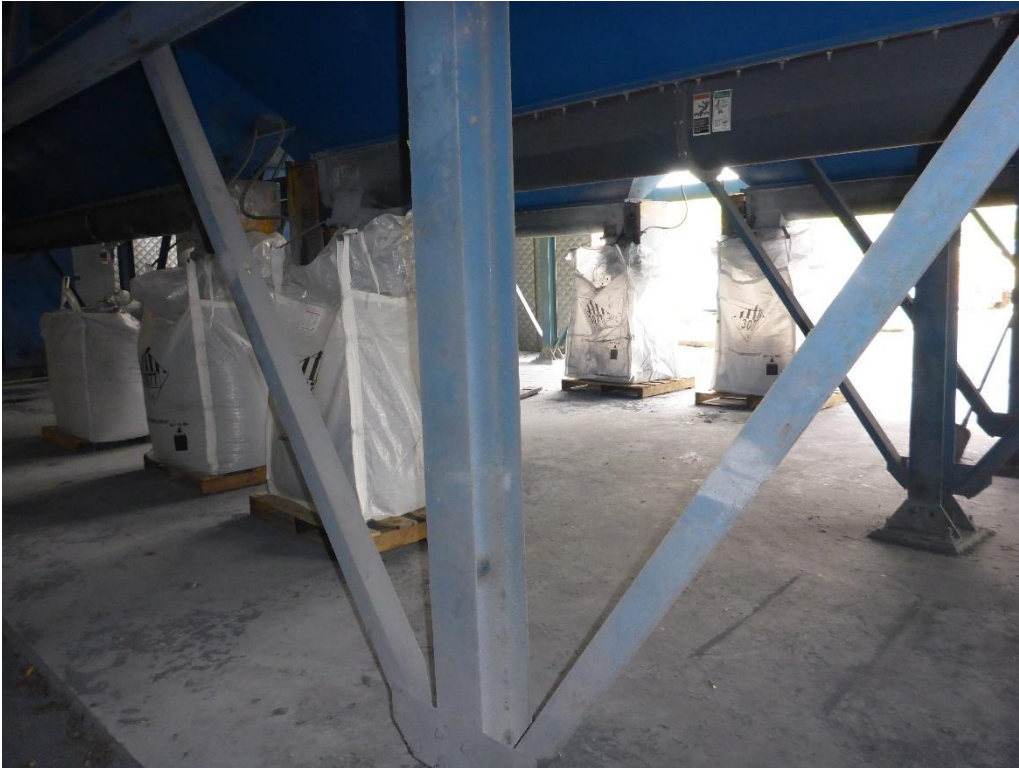
**Photo 29:** Four supersacks observed connected to the Furnace Baghouse. Additional supersacks stored in this area. Bags identified with DOT class 9 hazard placard, but not labeled. Personnel stated that the bags contain furnace ash, which is sold as zinc.

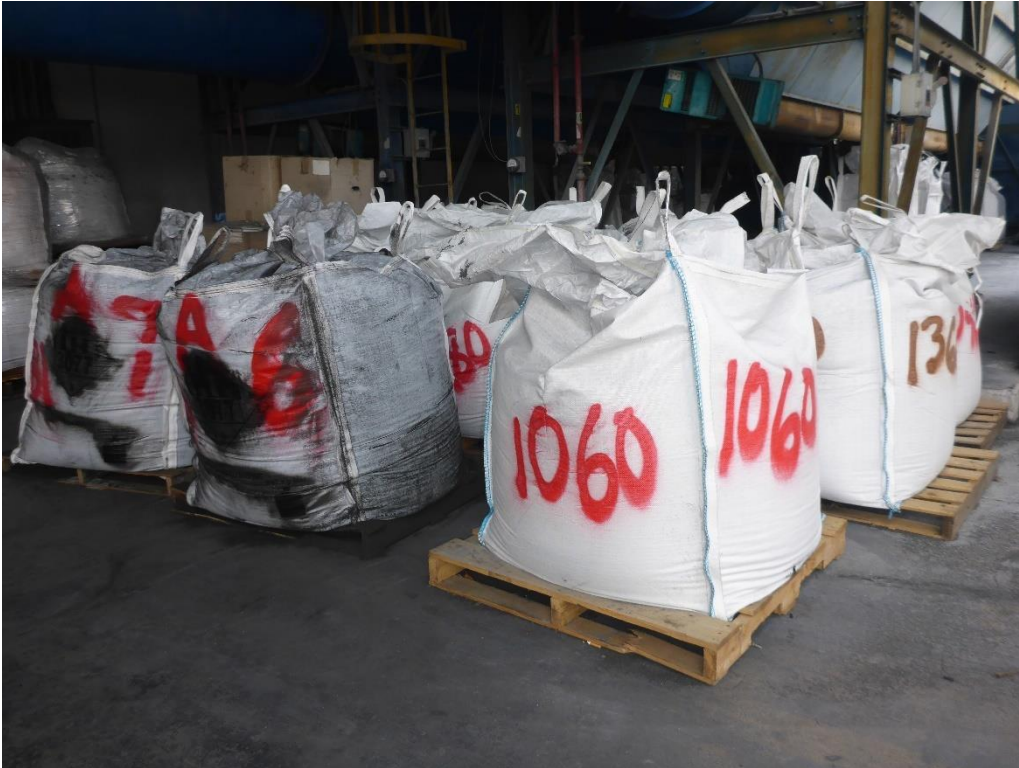
**Photo 30:** Supersacks observed in the Baghouse area. Bags were not labeled, but facility personnel stated they contain zinc material that will be sold for use off-site. Spray painted numbers indicate the weight of the bag.

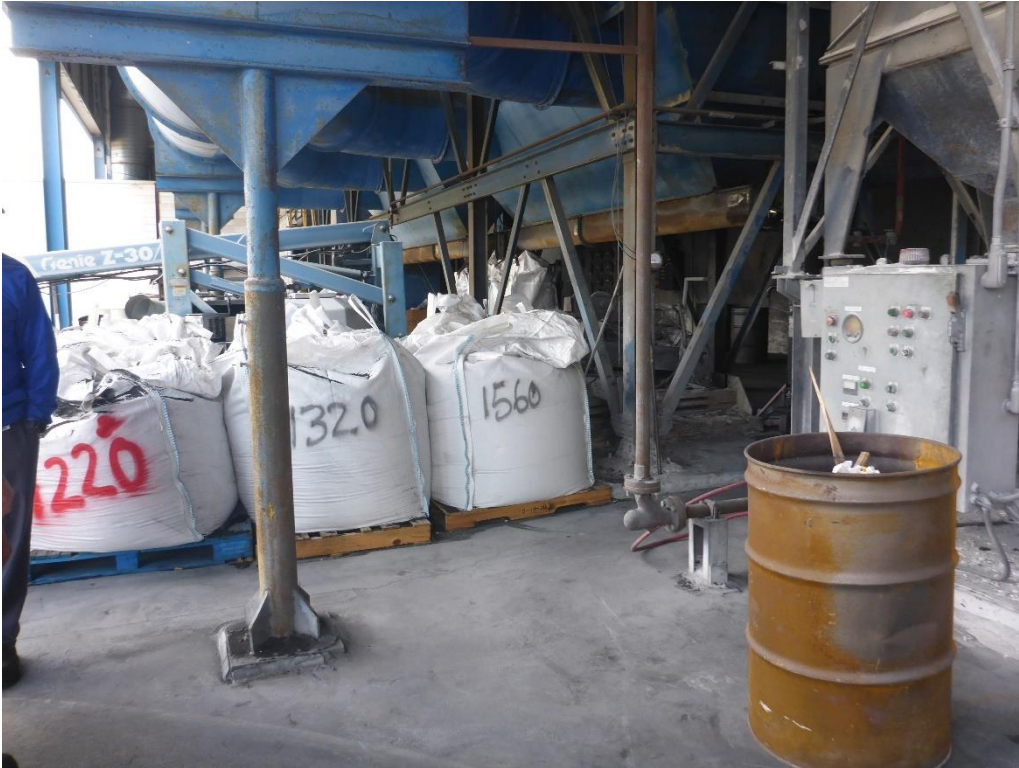
**Photo 31:** Supersacks observed in the Baghouse area. Bags were not labeled, but facility personnel stated they contain zinc material that will be sold for use off-site. Spray painted numbers indicate the weight of the bag.

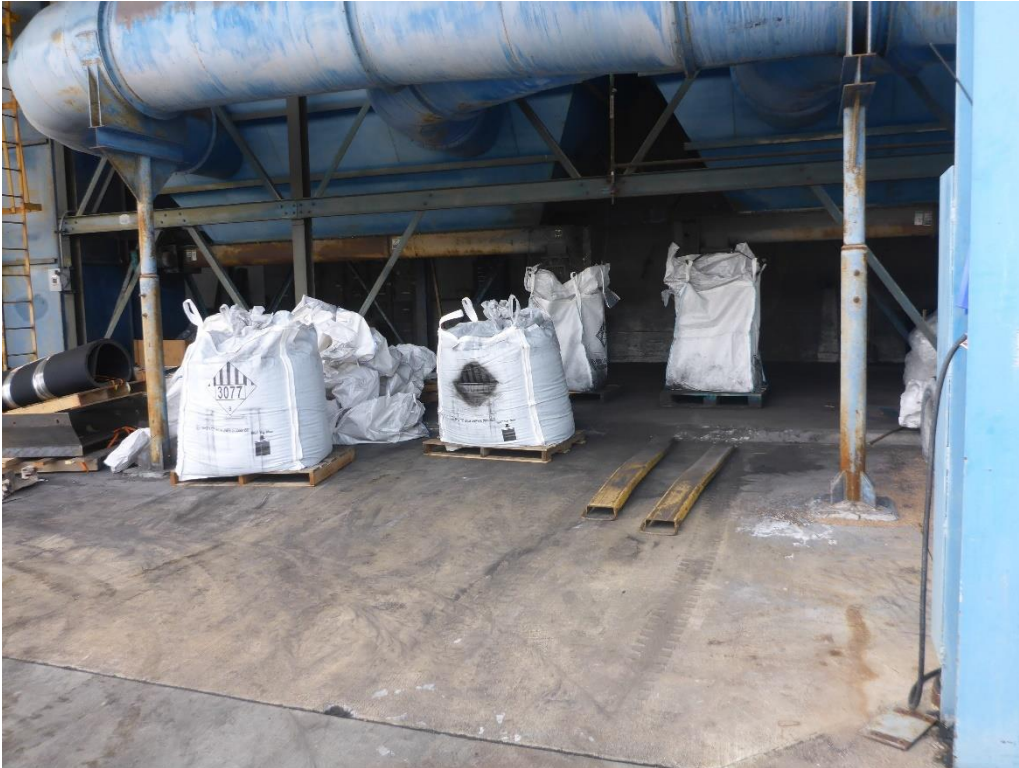
**Photo 32:** Two supersacks observed connected to the Sand System Baghouse. Bags are not closed, labeled as hazardous waste, or marked with an accumulation start date.

Additional supersacks are also stored in this area. These bags are also not labeled as hazardous waste or marked with an accumulation start date. Facility personnel explained that the full bags are staged here while they await analytical testing to determine if they exhibit the D008 hazardous waste characteristic of toxicity due to elevated levels of lead.

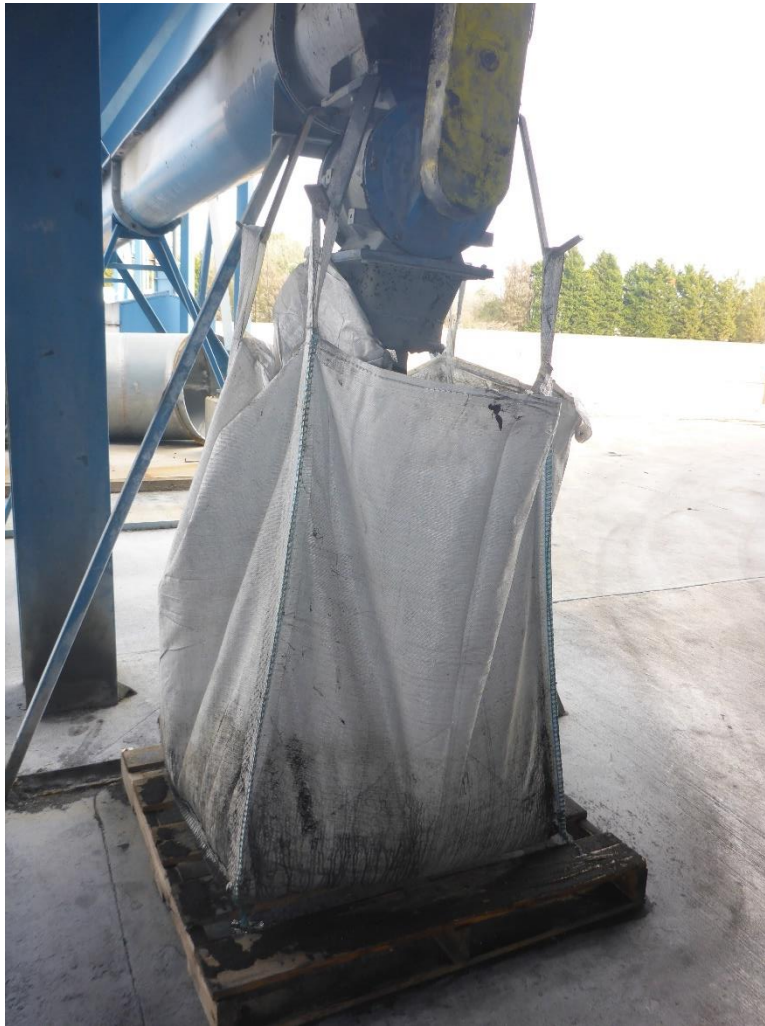
**Photo 33:** Supersack observed under the Travel Vent Baghouse. Bag is not closed, labeled as hazardous waste, or marked with an accumulation start date.

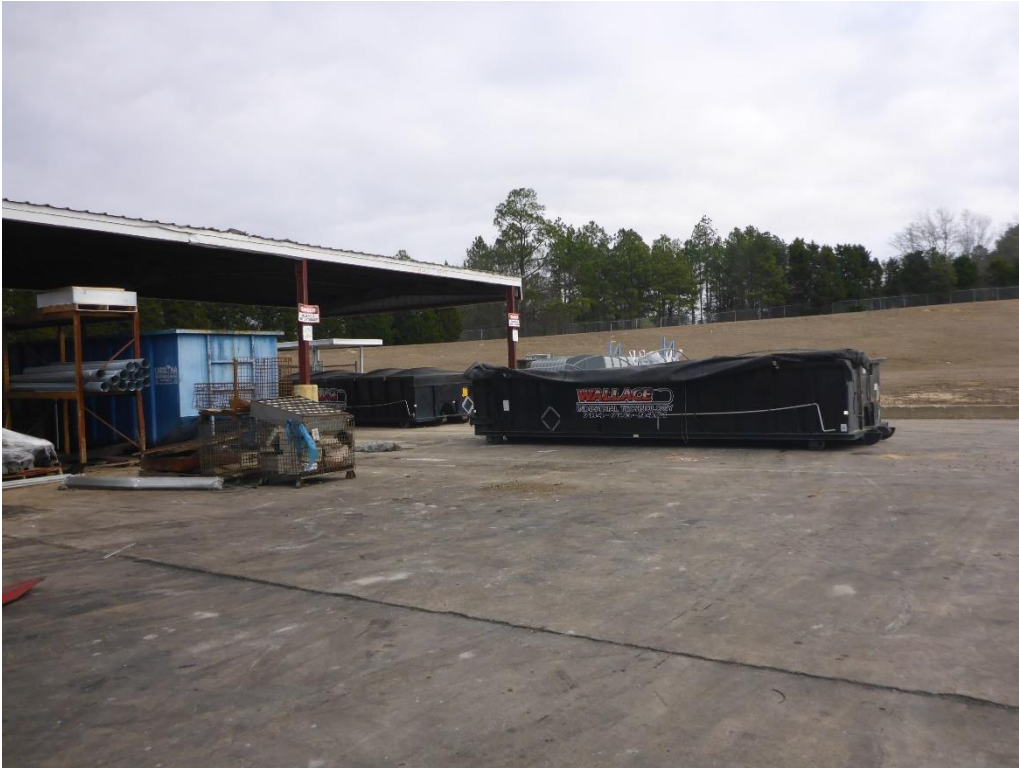
**Photo 34:** Two roll-off containers used to store and ship supersacks of D008 hazardous waste baghouse dust. One roll-off staged and open to receive supersacks, and the other stored under the metal roof. Both containers were labeled D008 hazardous waste solid (contains copper, lead and zinc) and identified with the UN3077. The open container was dated 02/09/2021, and the closed container was dated 02/08/2021.

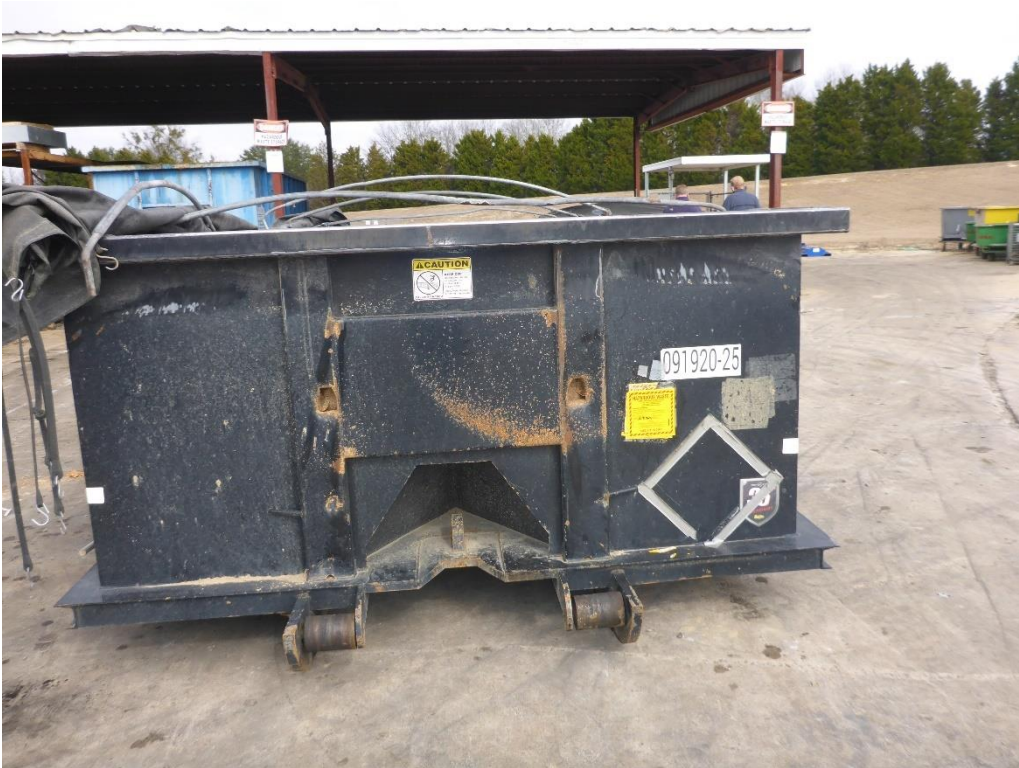
**Photo 35:** Roll-off container staged to receive supersacks of D008 hazardous waste baghouse dust. The container was labeled D008 hazardous waste solid (contains copper, lead and zinc) and identified with the UN3077. The container was dated 02/09/2021.

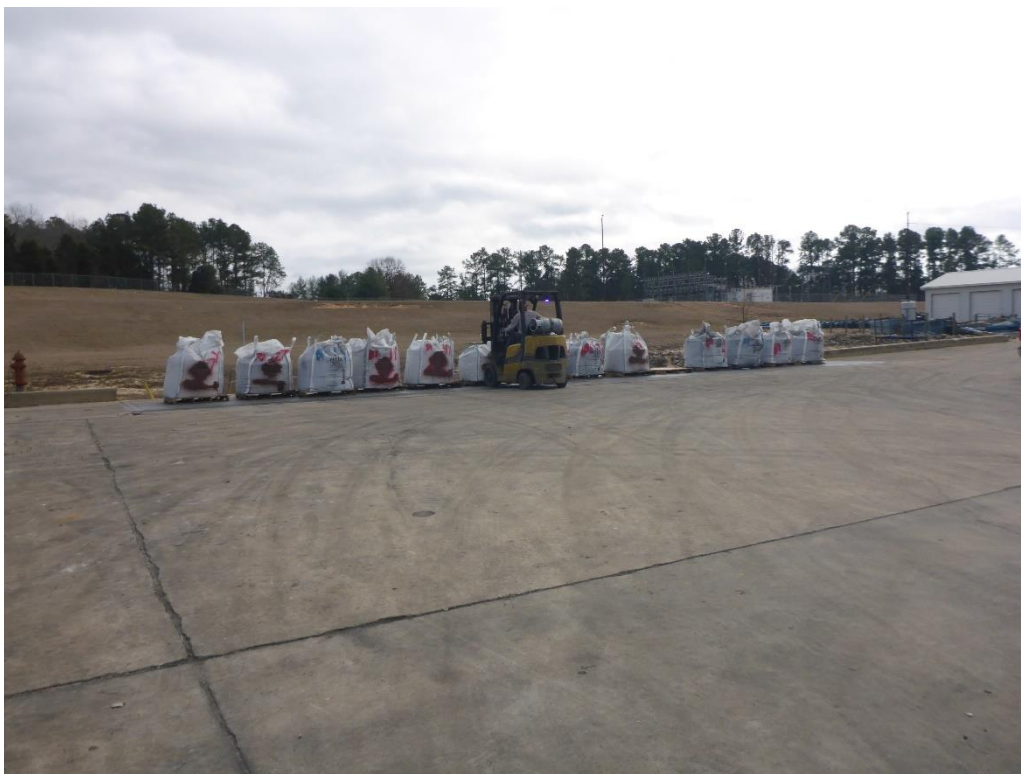
**Photo 36:** Supersacks of D008 hazardous waste baghouse dust staged on the scale for weighing before being placed into open roll-off container for storage and shipment.
