**Class I and II Well Inspection Form**  
**US Environmental Protection Agency – Region 4**  
**Underground Injection Control Program**  
61 Forsyth Street SW, MC 9T25, Atlanta, Georgia, 30303  
Phone: (404)562-9424

Well Name & #: *St. Regis Paper Company #12-3* \_\_\_\_\_  
Well Type (see table): *Enhanced Recovery (EOR)* \_\_\_\_\_ State Permit: API # *0911320072* \_\_\_\_\_  
Latitude (°N): *30.833611* °N \_\_\_\_\_ Longitude (°W): *-87.095556* °W \_\_\_\_\_ Elevation (ft): *NA* \_\_\_\_\_  
Injection Method (check applicable): ☐ Casing Injector; ☒ Tubing & Packer; ☐ Cemented Injection Tubing

**Site Photographs**  
**St. Regis Paper Company #12-3:**  
September 13, 2022

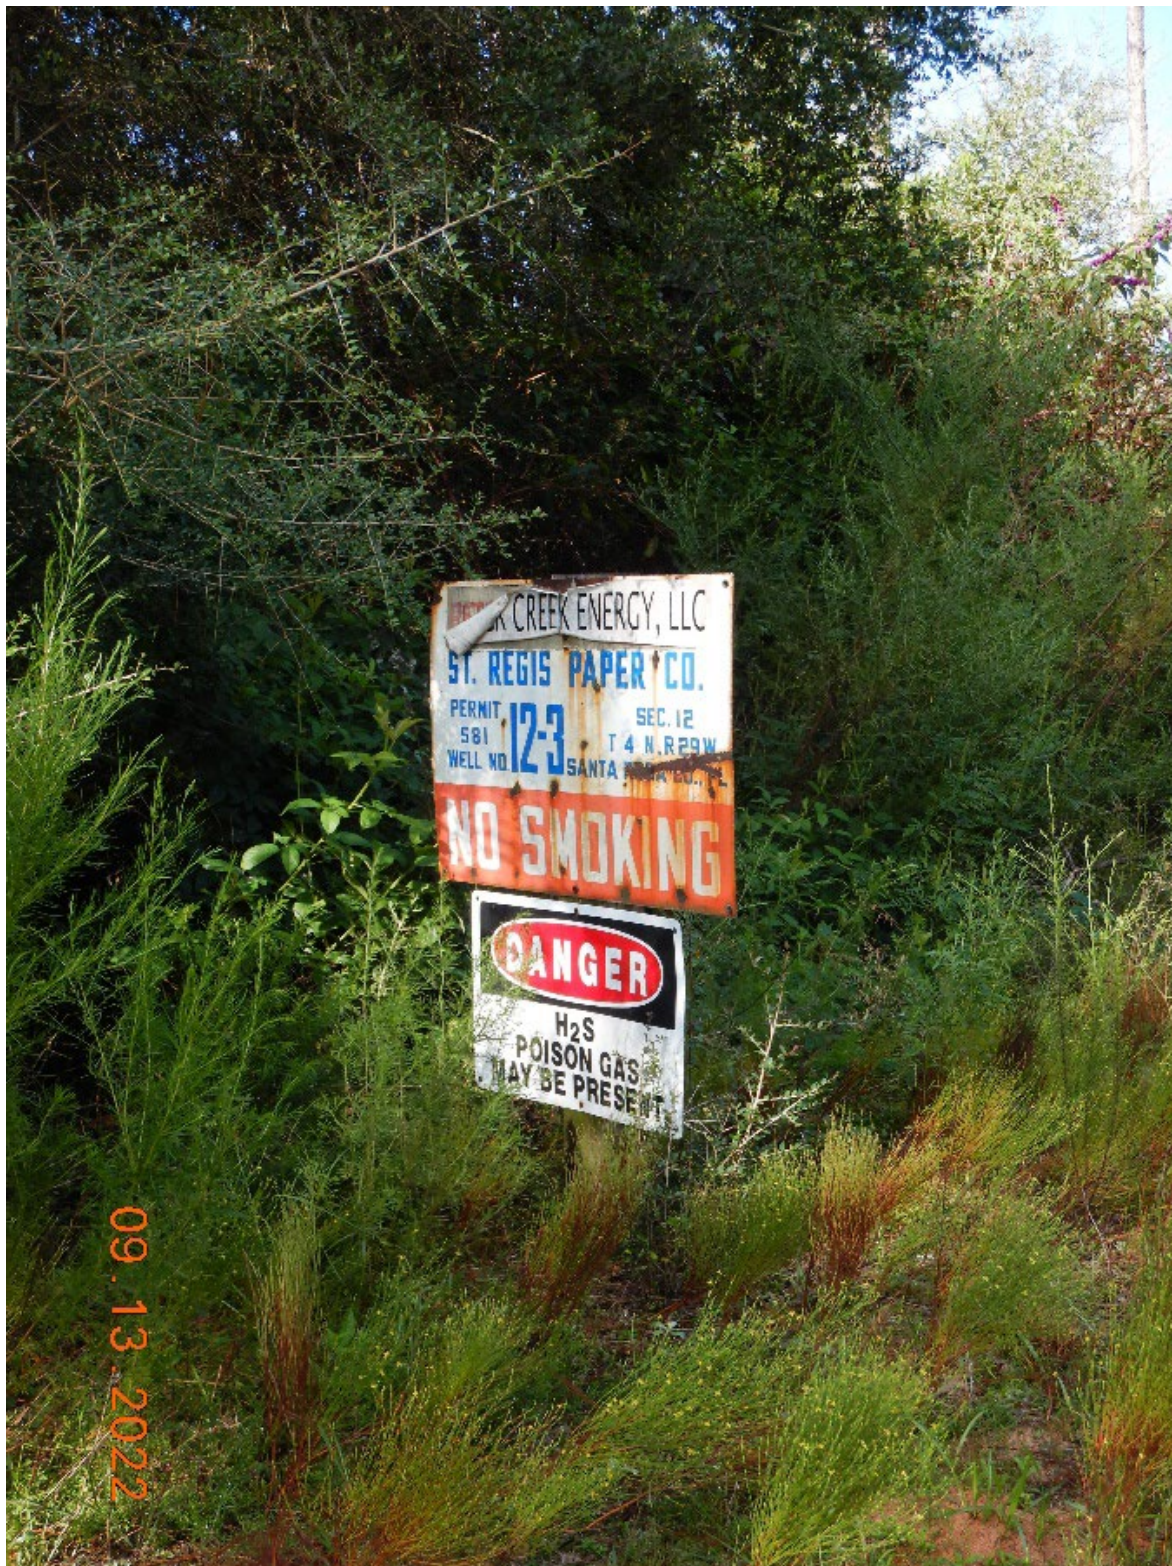
Description: *Looking west, St. Regis Paper Company #12-3 sign alongside access road.* \_\_\_\_\_

**Photograph 1:** Looking west, St. Regis Paper Company #12-3 sign alongside access road.

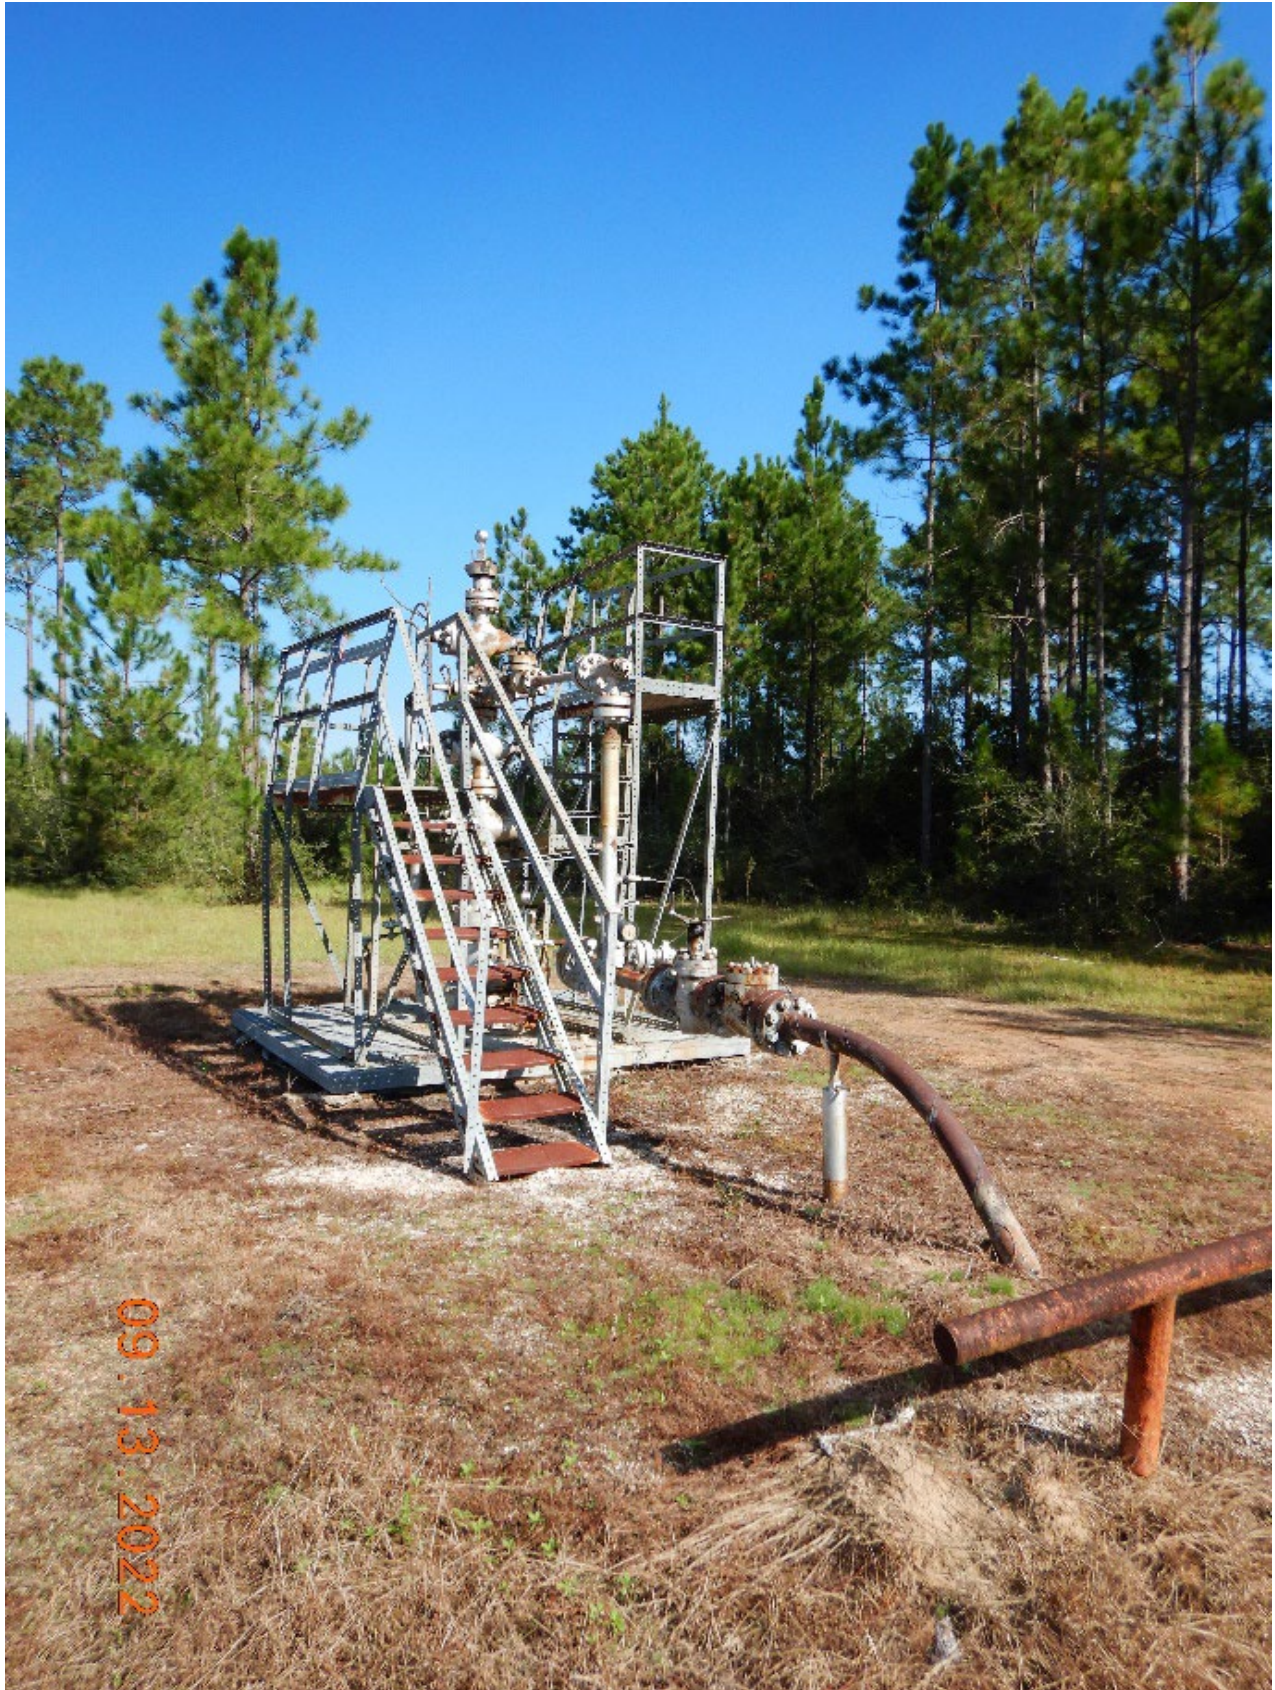
Notes & Comments (include discrepancies from database values): \_\_\_\_\_  
*The well status is active. Injection pressure was at 1,600 psi. The site was clean and well-maintained. There was no evidence of leaks or excessive corrosion.*  
*Perfs (see well schematics):*  
*Perfs at 15976'-16066'*  
*2SPF Total 184 shots*  
*12- Sep-76*

Description: *Looking west, site overview showing well head, pressure gauges, valves, and as stairway.* \_\_\_\_\_

**Photograph 2:** Looking west, site overview showing well head, pressure gauges, valves, and as stairway.

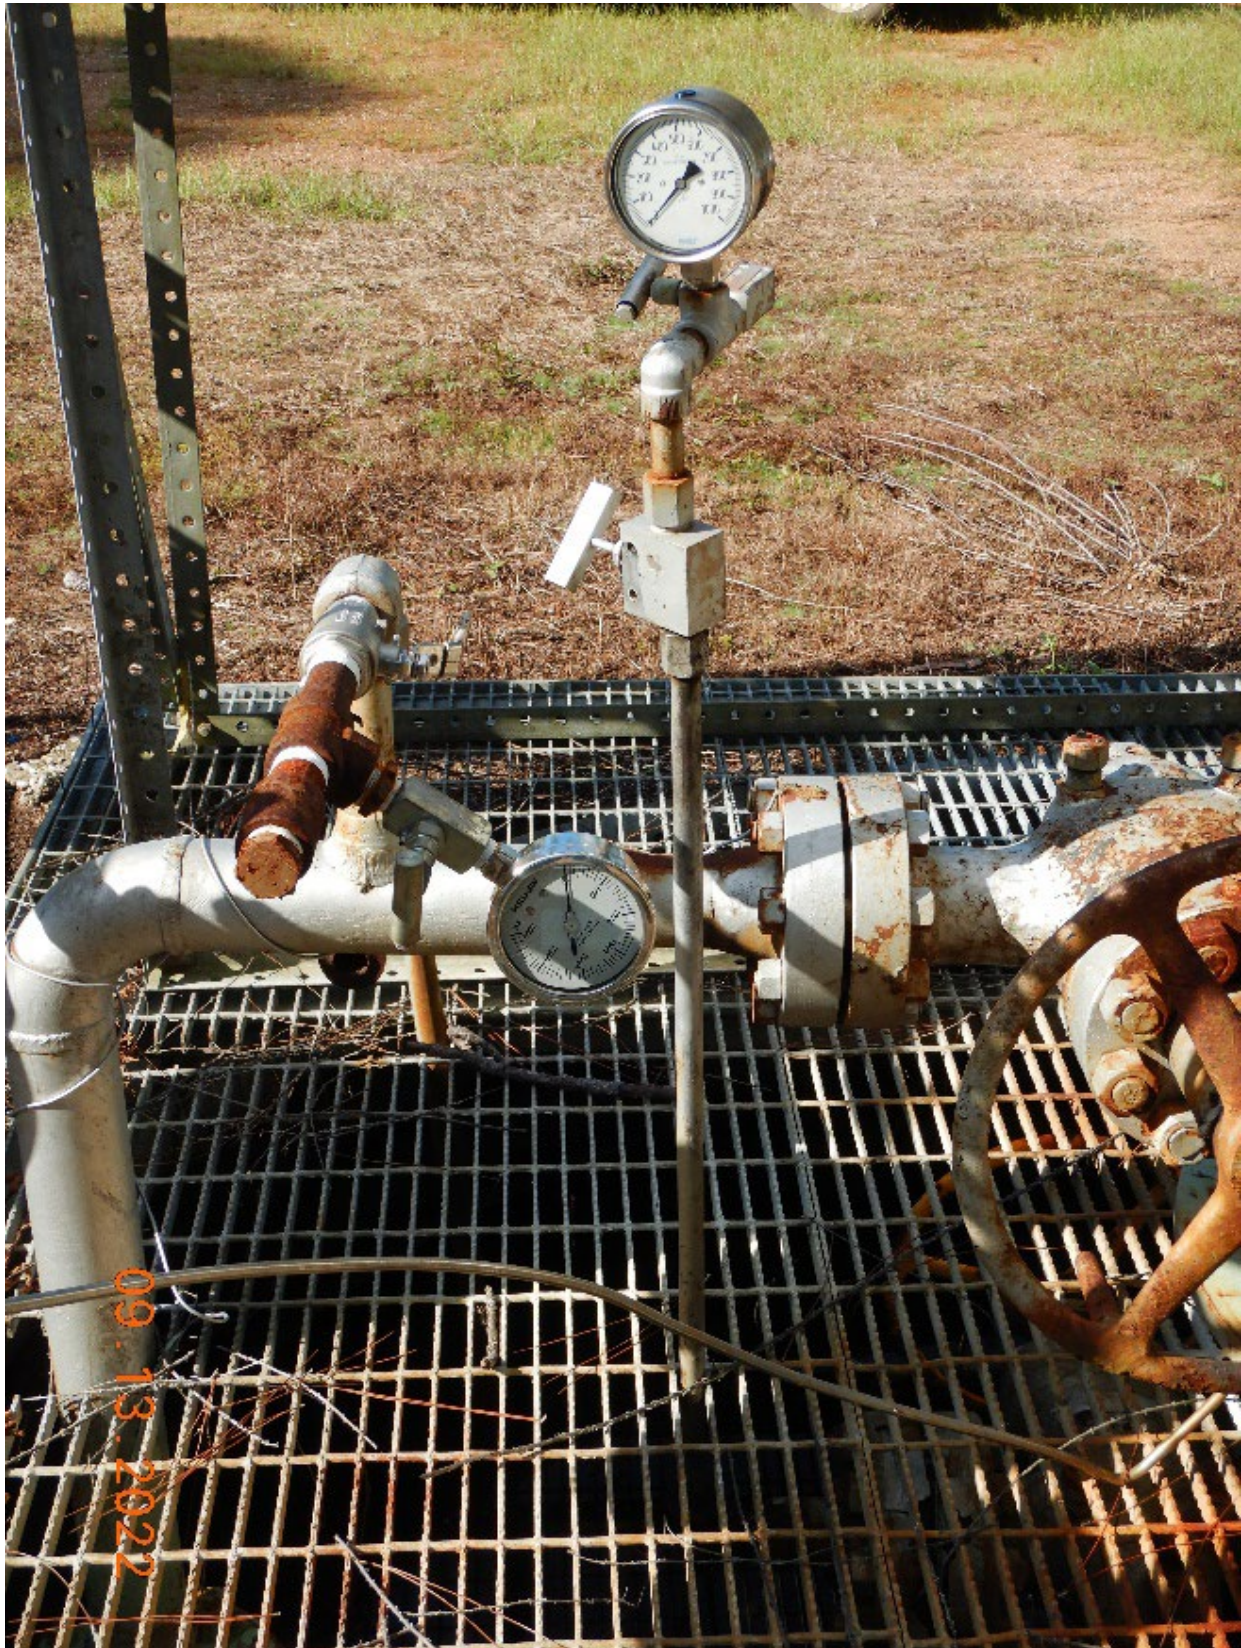
Description: *Looking south, closeup view of surface pressure gauge reading 0 psi.* \_\_\_\_\_

**Photograph 3:** Looking south, closeup view of surface pressure gauge reading 0 psi.

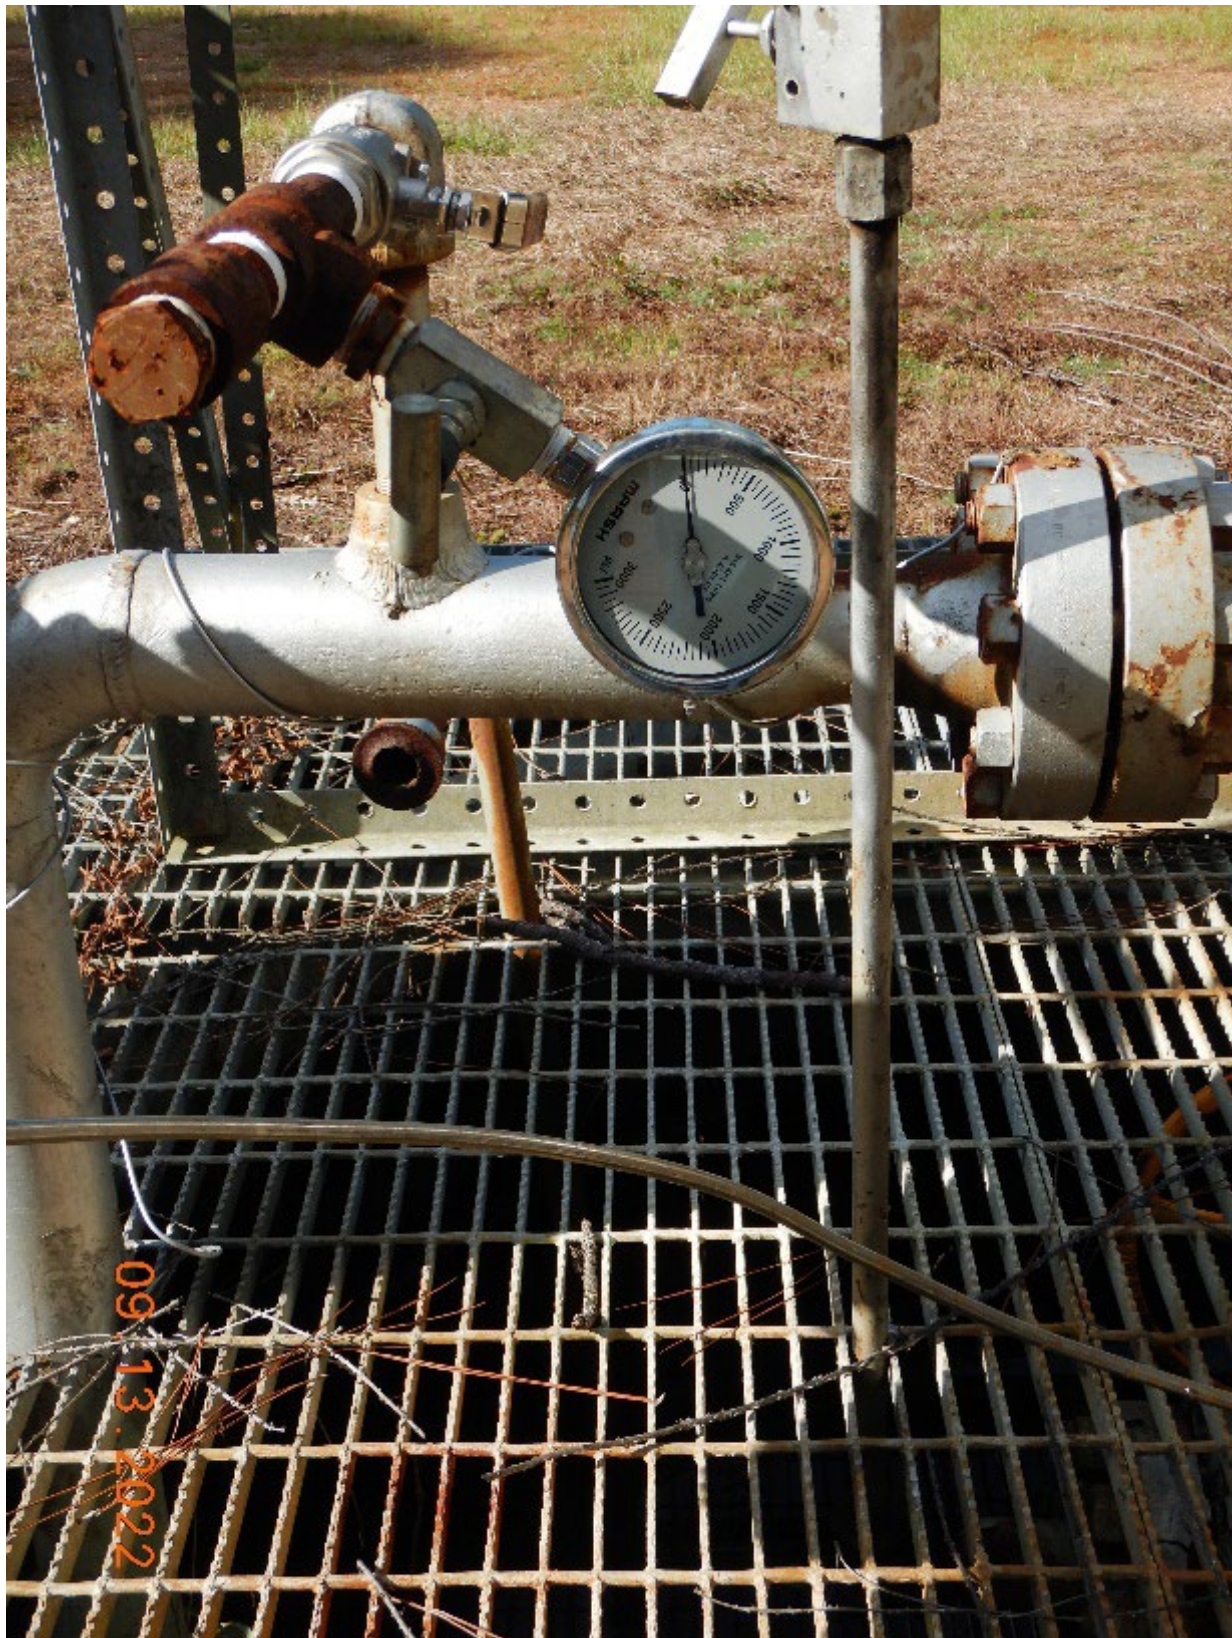
Description: *Looking south, closeup view of production casing pressure gauge reading 0 psi.* \_\_\_\_\_

**Photograph 4:** Looking south, closeup view of production casing pressure gauge reading 0 psi.

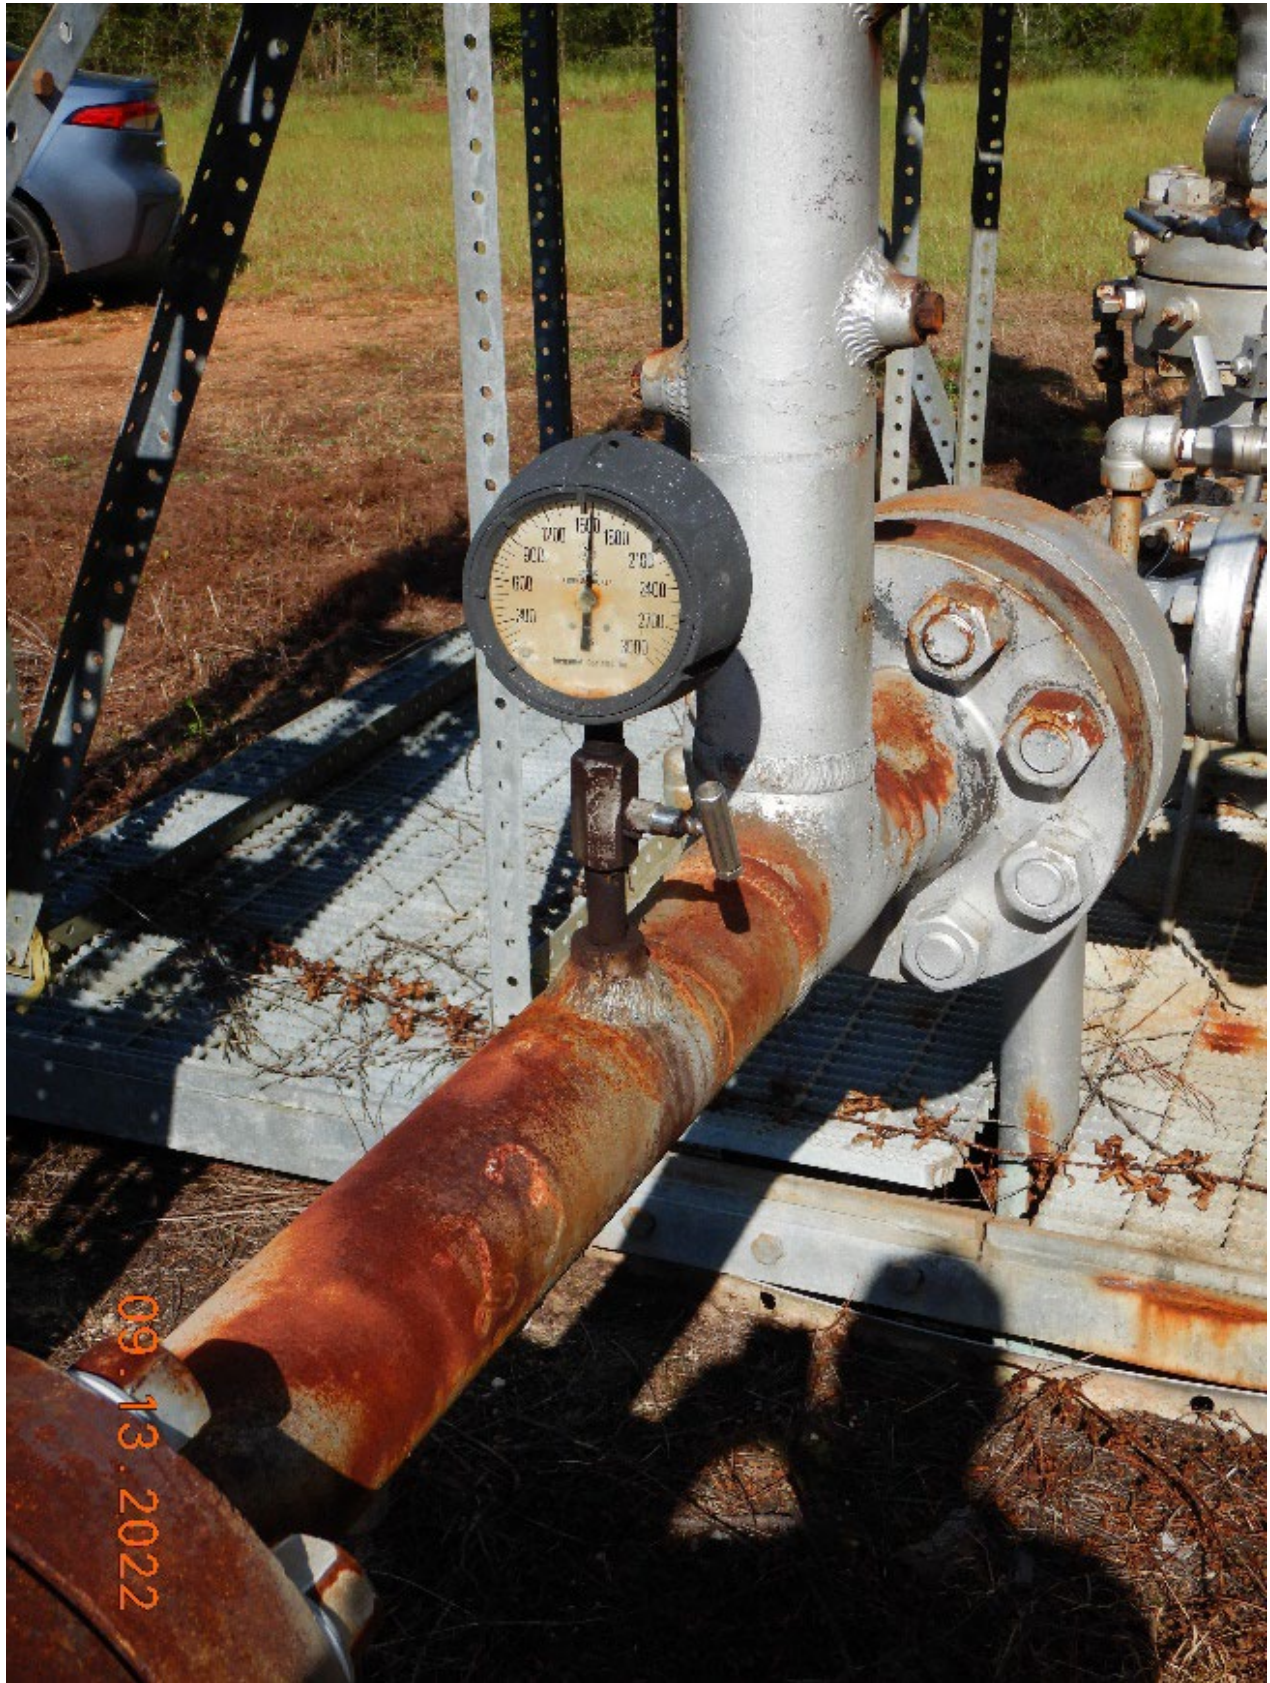
Description: *Looking west, closeup view of line pressure gauge reading 1,600 psi.* \_\_\_\_\_

**Photograph 5:** Looking west, closeup view of line pressure gauge reading 1,600 psi.

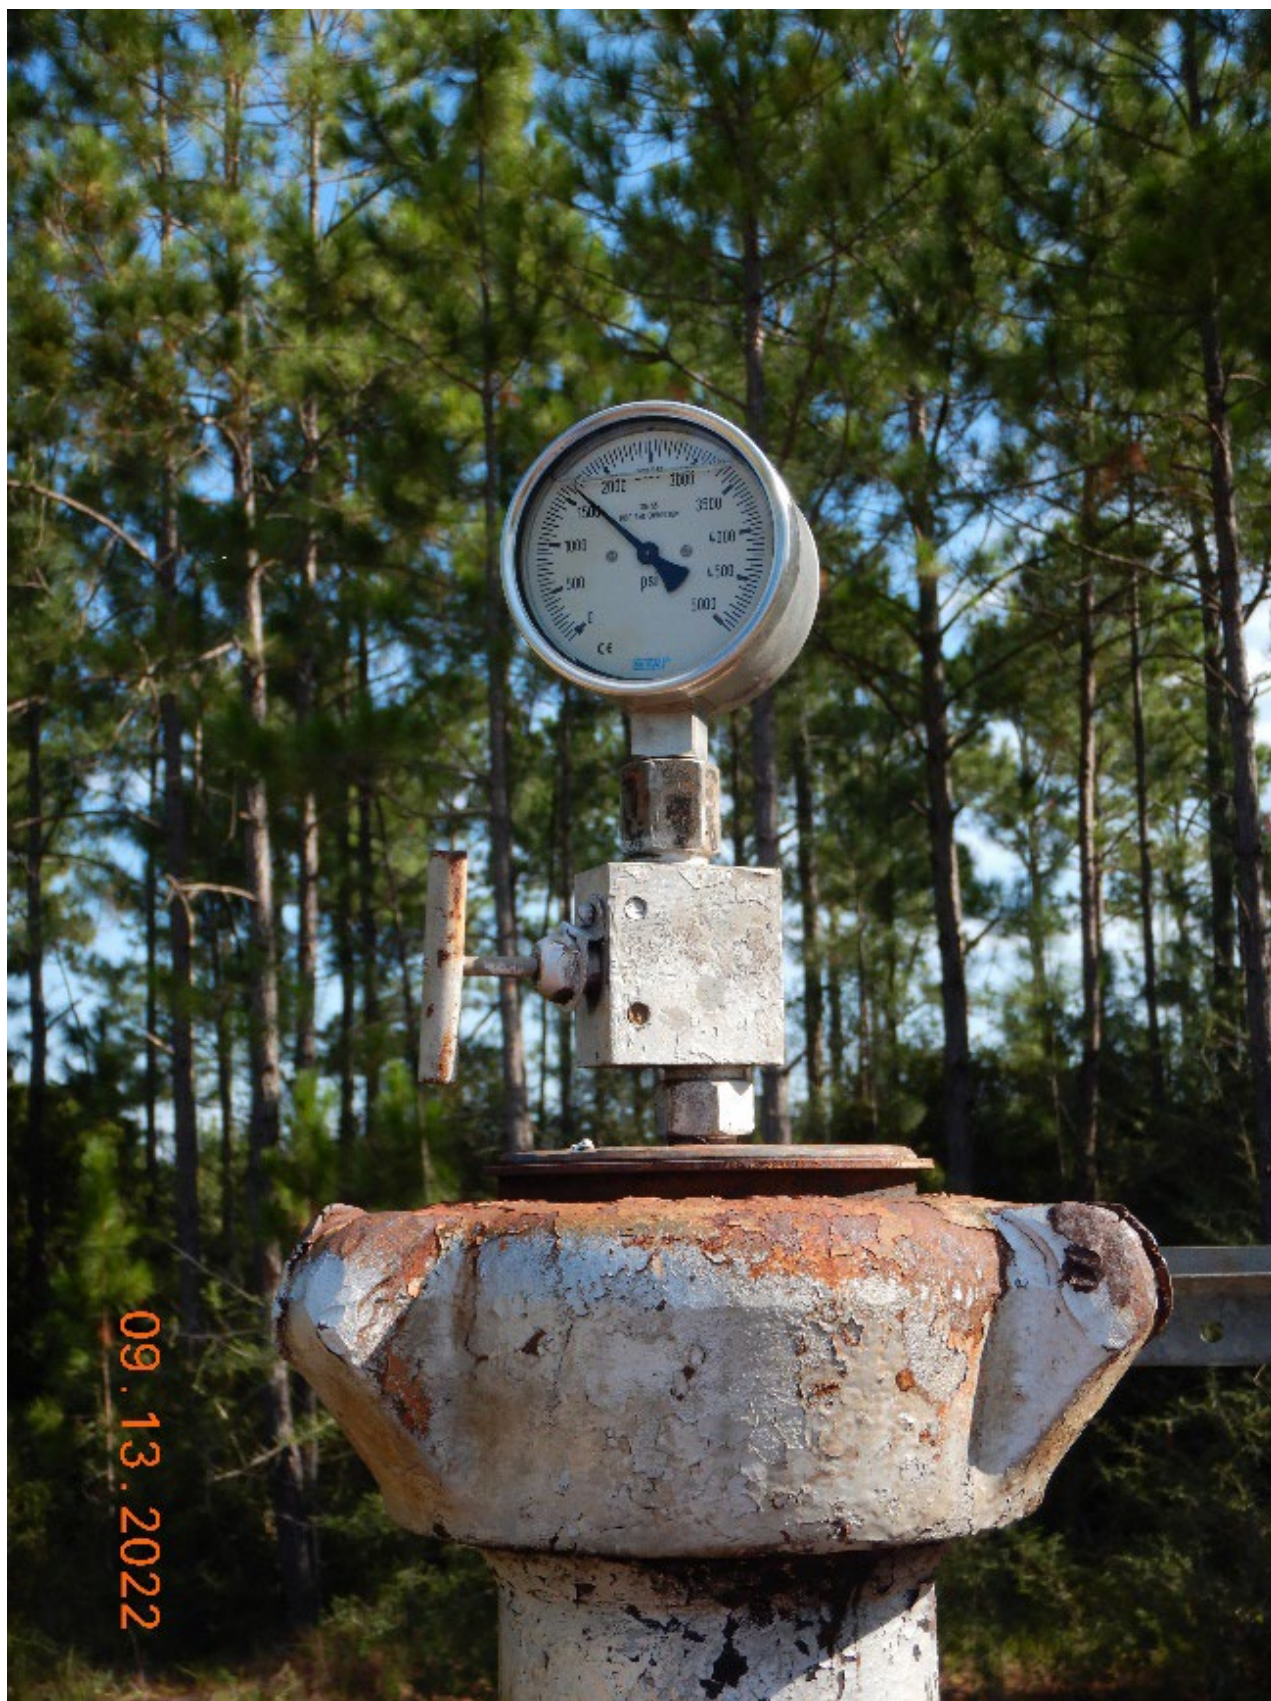
Description: *Looking north, closeup view of internal pressure gauge reading 1,600 psi.* \_\_\_\_\_

**Photograph 6:** Looking north, closeup view of internal pressure gauge reading 1,600 psi.
