## Region 6 - Enforcement & Compliance Assurance Division

### INSPECTION REPORT

EPA Region 6 inspectors Dr. Sarah Frey and Mr. Justin Chen and TCEQ inspector Rachel Cunningham (“inspection team”) arrived at the International Paper Company (“IP”) Orange Mill (“Mill” or “facility”) at 1:00 pm on Tuesday, February 18, 2020 for an announced inspection. We met with Frank Fraccastoro, Environmental, Health, and Safety Manager (“EHS”) at the security desk. At the Opening Conference, we presented our credentials to IP Orange Mill Manager Mike Culbertson. Mill representatives attending included Frank Fraccastoro/EHS Manager, Oren Ruth Jr./Maintenance Manager, Keith Love/Power Business Unit Manager, Colby Nelms/Kiln Area Process Manager, Kelly Winnon/Power Subject Matter Expert (“SME”), Troy Widdell/Fiber SME, Ashish Jain/Environmental Engineer, Andrew Carlquist/Safety Engineer, and Stephen Greer/Environmental Engineer. We informed them that this was an EPA inspection to determine compliance with the facility’s Title V Air Permit and the Clean Air Act (“CAA”) New Source Performance Standards (“NSPS”) and National Emissions Standards for Hazardous Air Pollutants (“NESHAP”). The scope of the

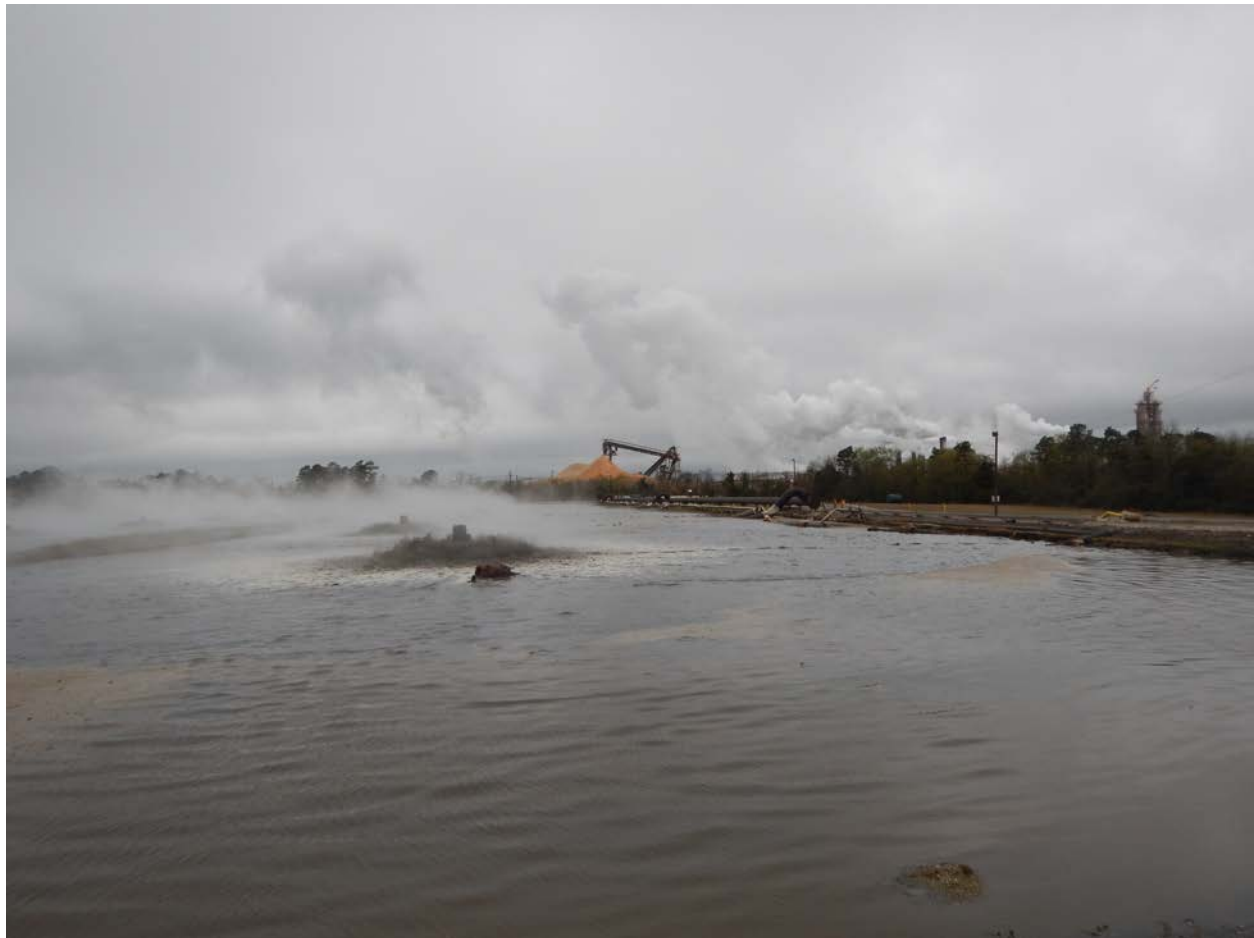
Photo No. 1

Description: Zone 1 of aeration stabilization basin (ASB) of wastewater treatment system. Pulping condensates are discharged under the surface prior to the first aerator, shown here.

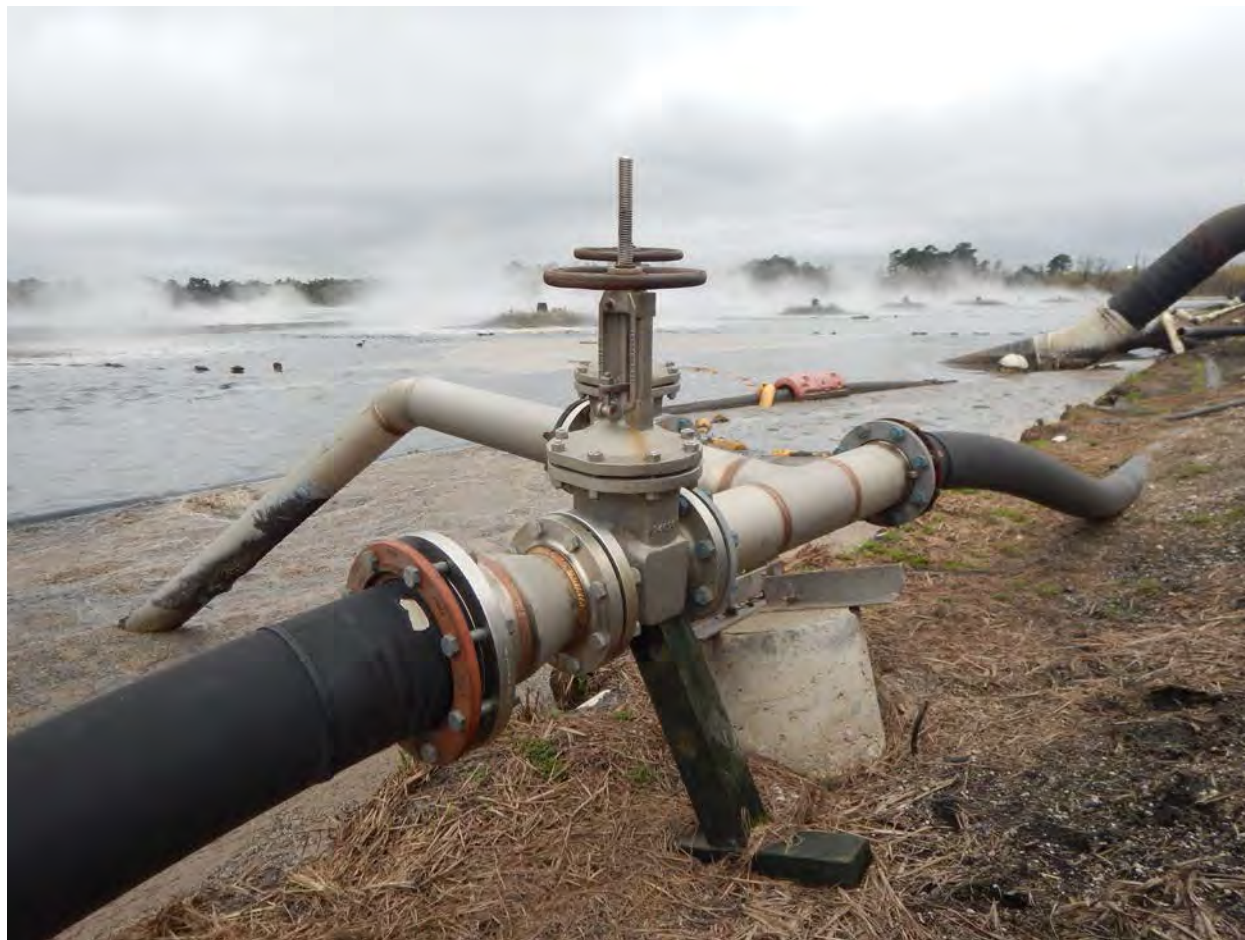
Photo No. 2

Description: Hardpipe leading to Zone 1 of aeration stabilization basin (ASB) of wastewater treatment system. Pulping condensates flow through rubber piping and is discharged under the water surface.

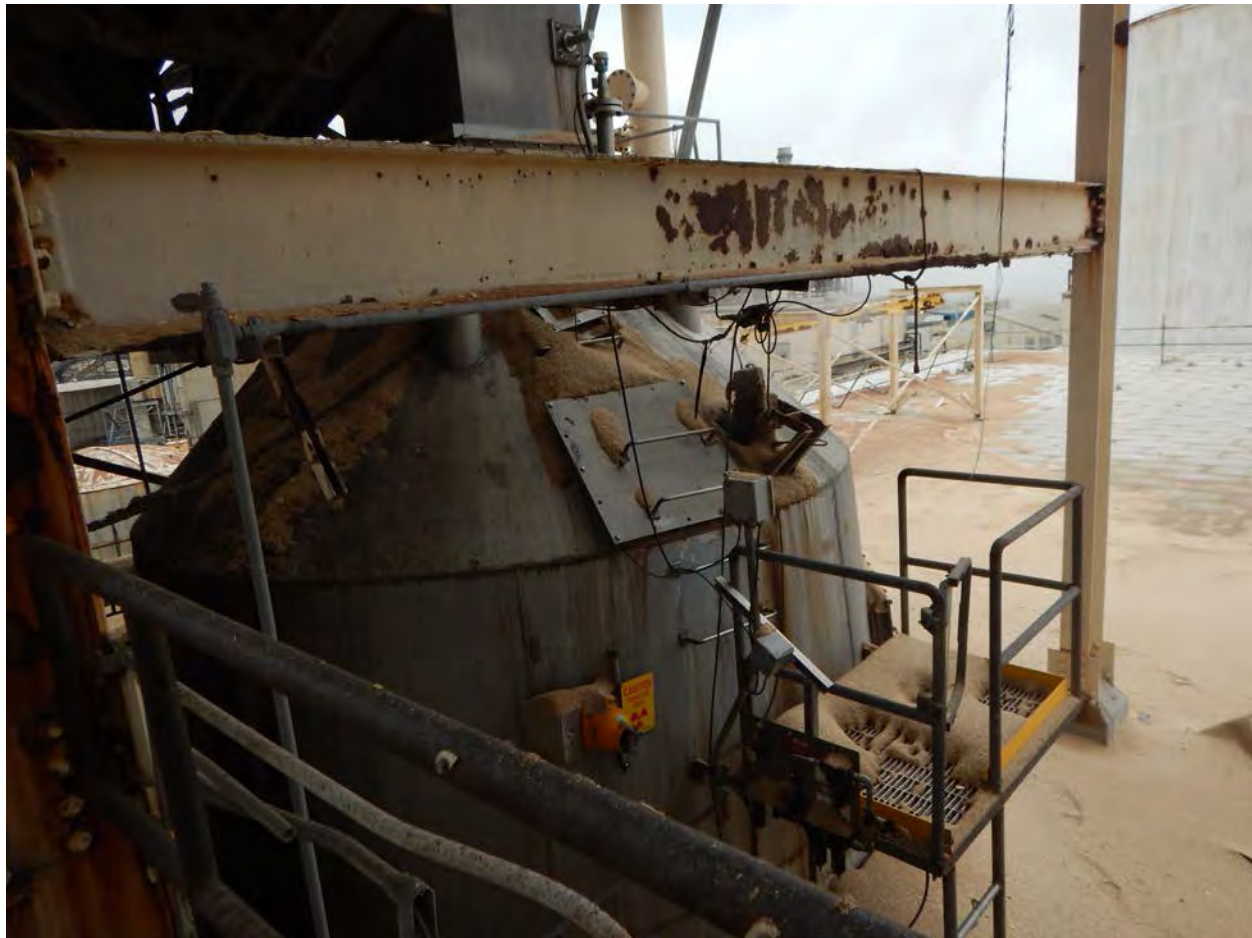
Photo No. 3

Description: A-line Chip bin. Visible emissions observed.

5) Visible emissions, defects, or indicators of historical leaks were observed by the inspection team, including at the A-Line chip bin, steaming vessel, and BSW; the Chemiwasher; and the #4 Reject Refiner. Per §63.443(c), specified equipment must be enclosed and vented into a closed-vent system and routed to a control device to prevent the release of HAPs to the atmosphere. According to the March 31, 2000 EPA Guidance "Questions and Answers for the Pulp and Paper NESHAP, Second Volume", if the steam entering the chip bin is not fresh steam, then it is considered a chip steamer and may need to be controlled.

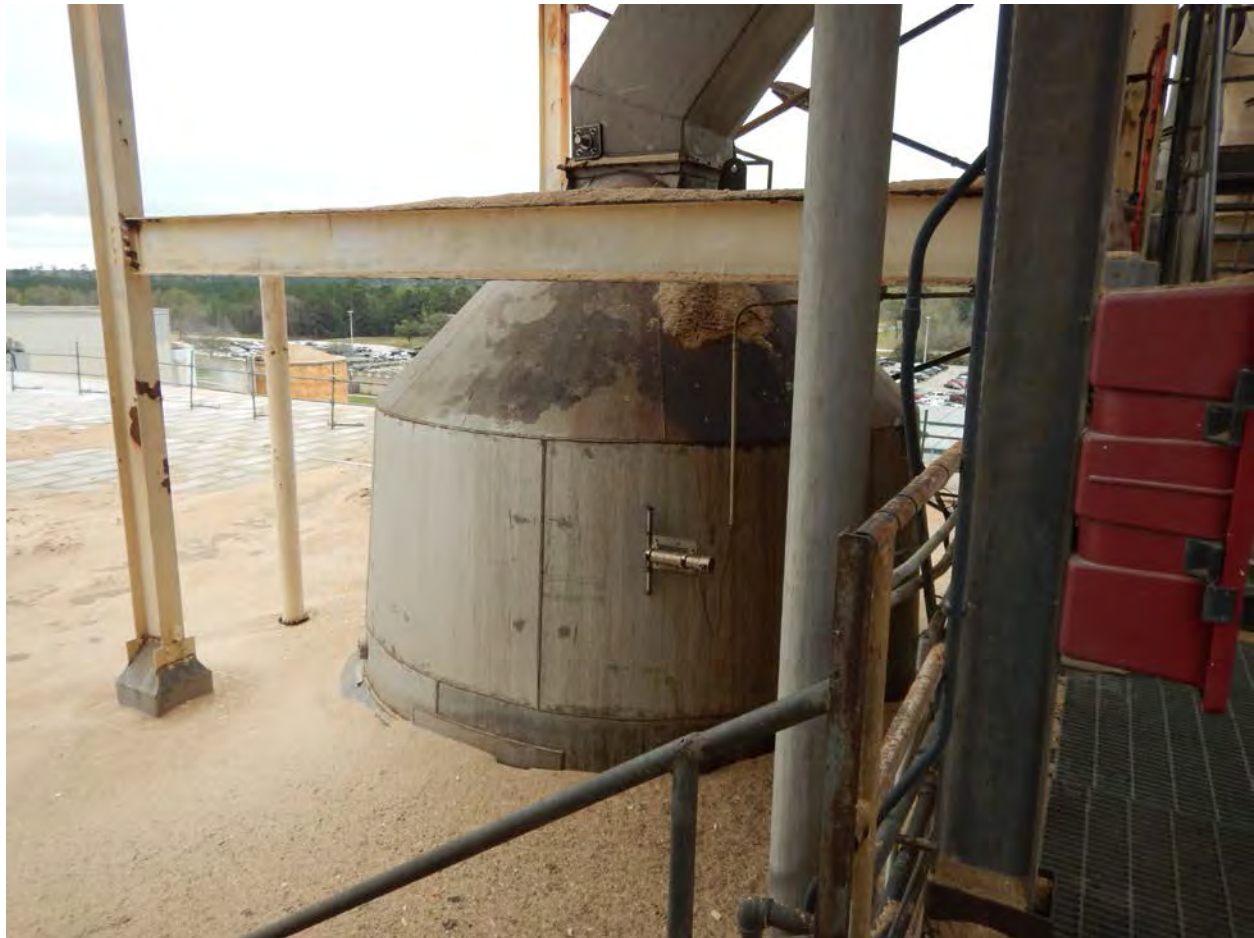
Photo No. 4

Description: B-line chip bin. No visible emissions observed.

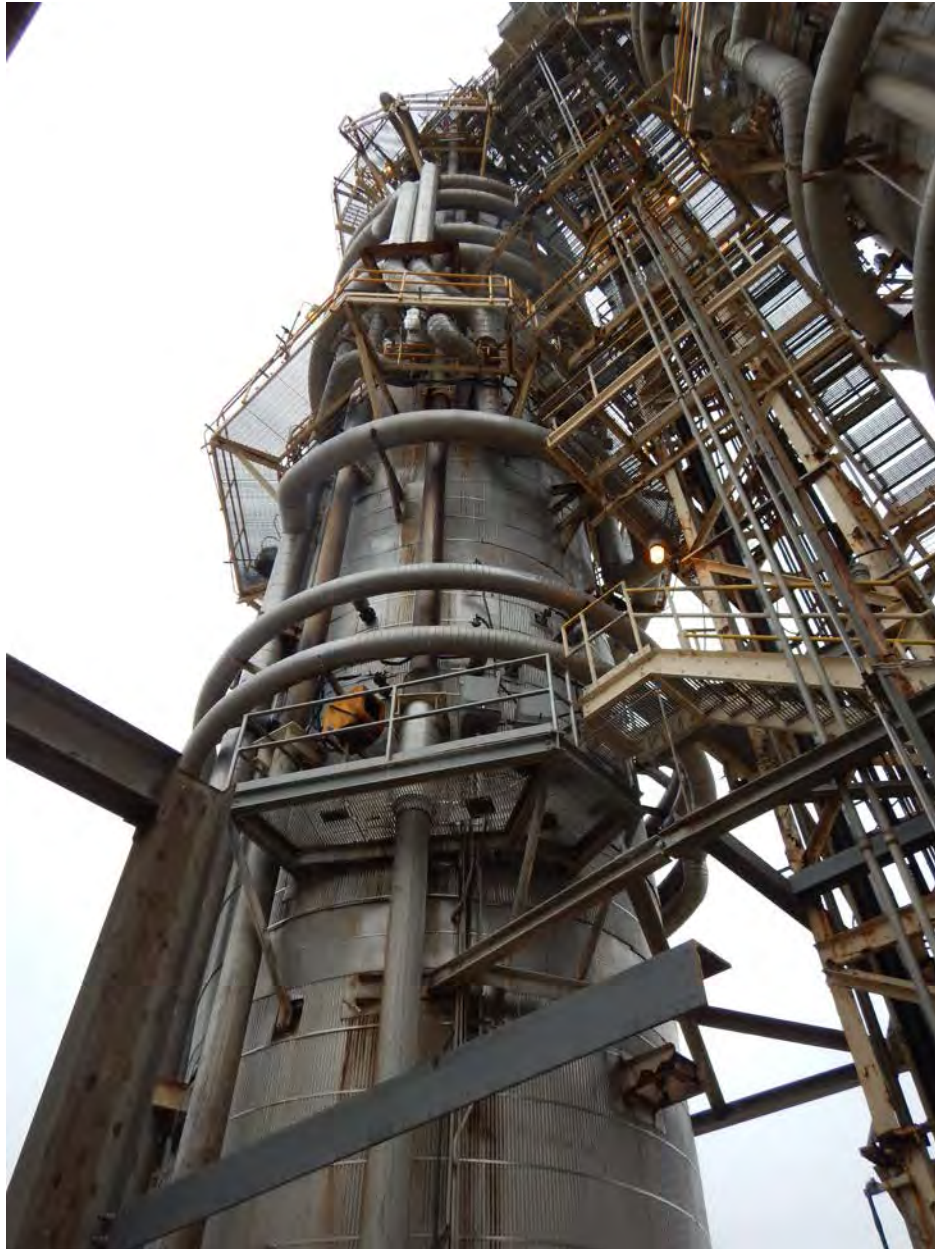
Photo No. 5

Description: B-line continuous digester.

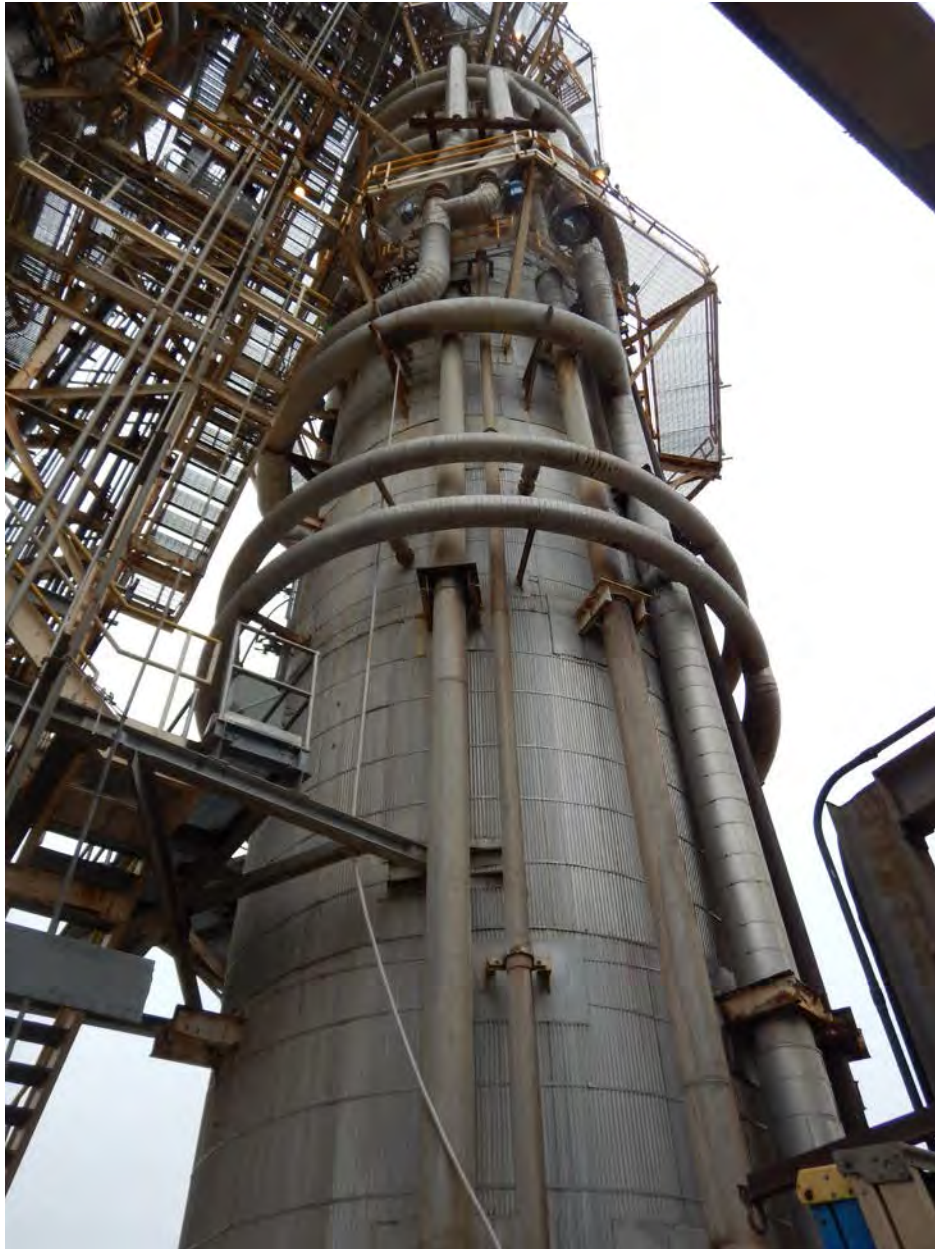
Photo No. 6

Description: A-line continuous digester.

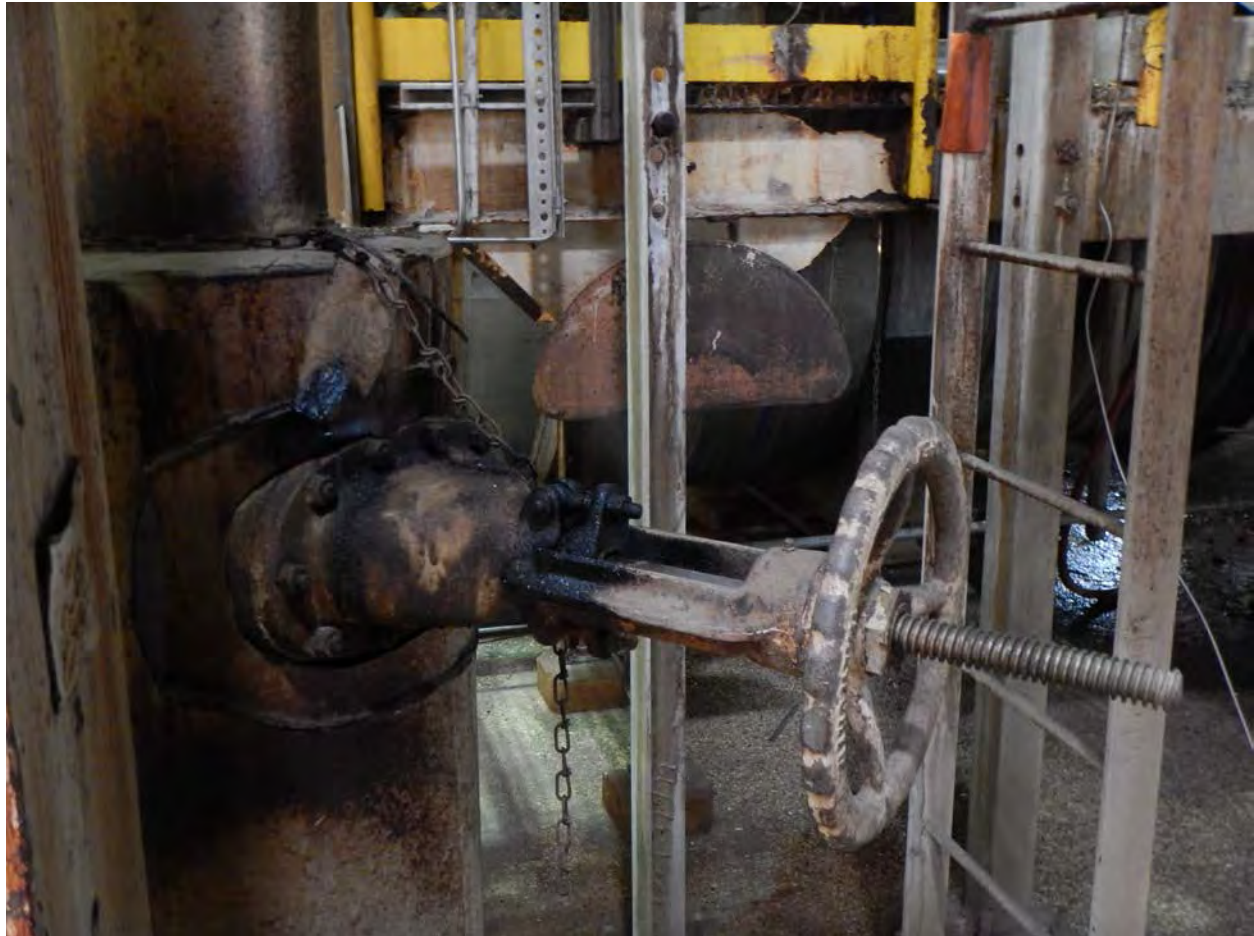
Photo No. 7

Description: Visible emissions emitting from A-line condensate flash tank return line to steaming vessel.

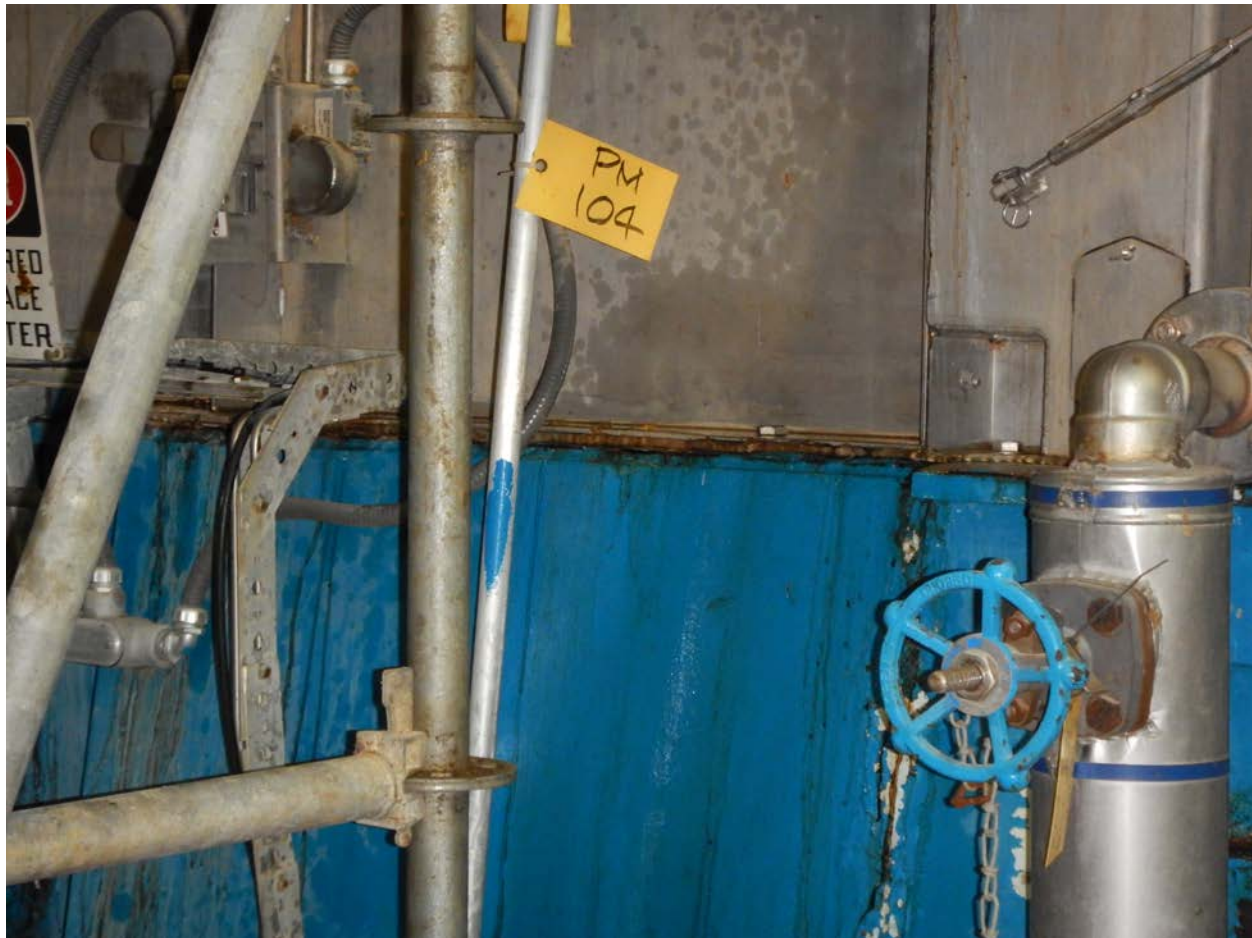
Photo No. 8

3) The Mill may have incomplete or missing LDAR inspections. When reviewing LDAR monthly inspection records, there were a handful of instances of incomplete monitoring or missing records. The February 2017 and October 2018 inspections were incomplete for some components on Figures 7 and 17. In addition, a pattern of repeating leaks appeared at the Brownstock Washers.

Description: Liquid leaks observed at the A-line Brownstock Washer (BSW).

6) The Mill may not be adequately repairing leaks identified during monthly LDAR Inspections. 35 months of inspection records were reviewed. Table 2 indicates the number of months that some components were discovered to be leaking. Per §63.453(k)(6)(i) and (ii), the first attempt of repair must occur within 5 days and the final repair must be complete within 15 days of discovery.

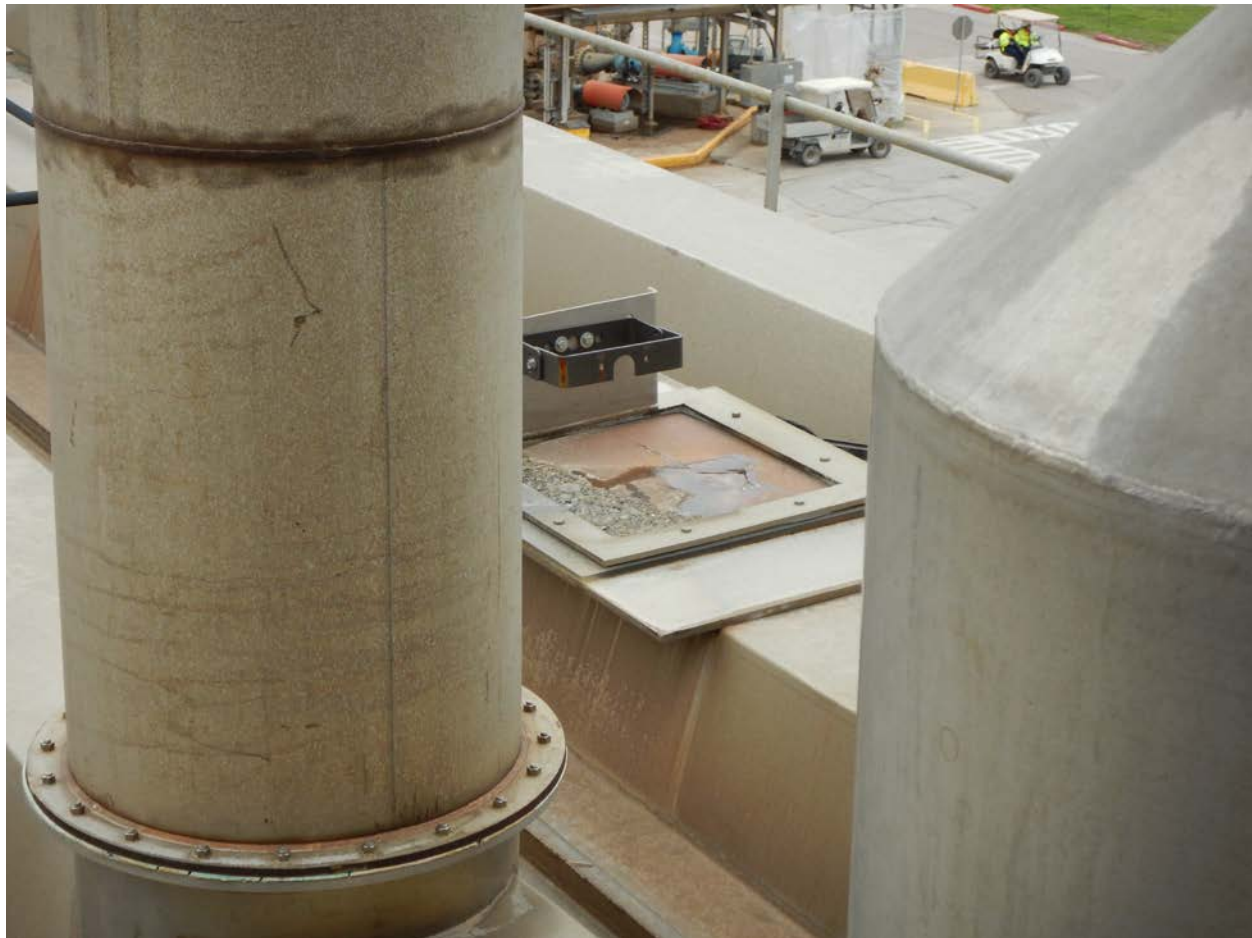
Photo No. 9

Next, we viewed the horizontal Chemiwasher and its blowers. We observed visible emissions coming from the air inlet piping, which is tied to the NCG header (Video 2). We observed a hole at the top of the Chemiwasher hood near the entrance roll (Photo 9). From the top of the hood, we observed a large liquid leak near the entrance roll (Photo 10). We observed visible emissions from the east and west sides of the roof, as well as the edges of the entrance and exit rolls (Video 3). We observed visible emissions from the sight glass at the entrance of the washer and a door at the midpoint of the washer body.

Description: Top of horizontal Chemiwasher hood. Broken panel, visible liquid and vapor emissions.

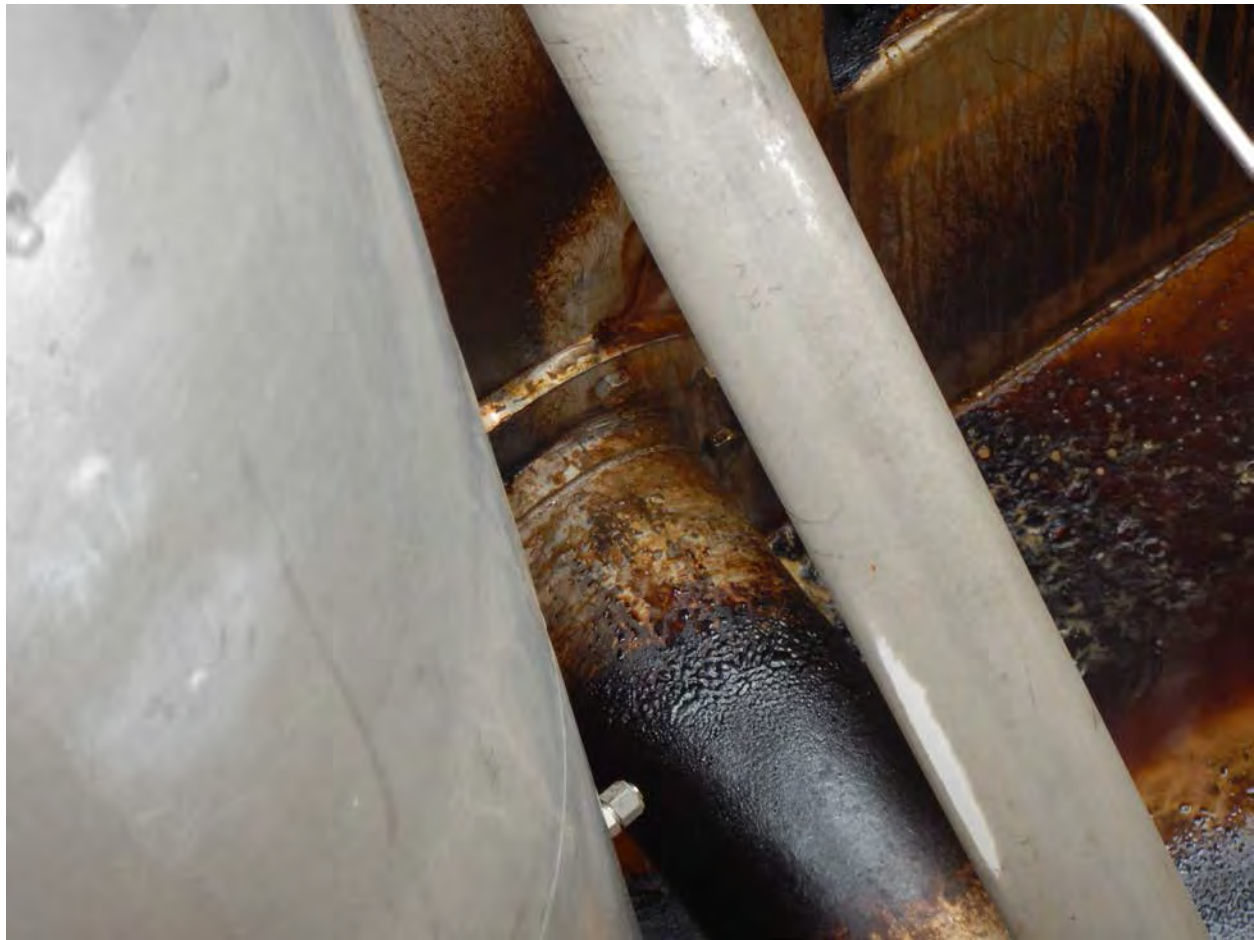
Photo No. 10

Description: Large water and black liquor leak towards first stage pulp washing (close to entrance roll) on horizontal Chemiwasher.

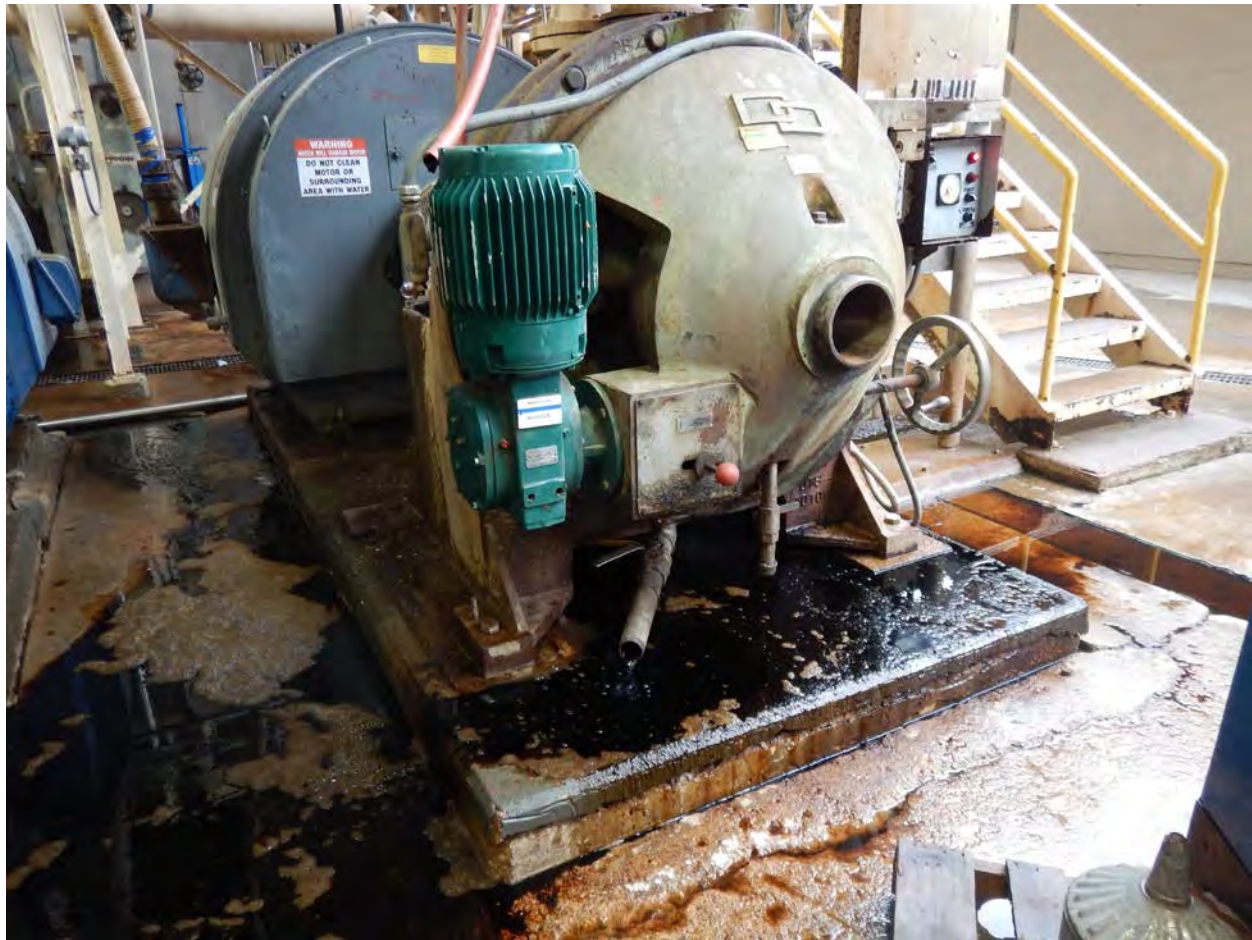
Photo No. 11

We viewed the HVLC/Chemiwasher collection tank and the #4 reject refiner. We observed BL discharging from the #4 reject refiner (Photo 11). Mr. Waddell stated that the refiner was out of service and the BL would flow into the drains which route to the Strong Waste Pond. We viewed the Reject Tank 506-010-005 and observed visible emissions at the top. We viewed the A and B high pressure feeders and were told that the A-line high pressure feeder is due to be replaced soon. We viewed the blow

Description: Black liquor leak from #4 Reject Refiner.
