## **RCRA Inspection Report**

Safety-Kleen Systems Inc.  
5217 Augusta Road, Highway 21  
Garden City, Georgia 31408  
EPA ID # GAD000776781

August 26, 2021, 9:00 a.m.

**Attachment A**

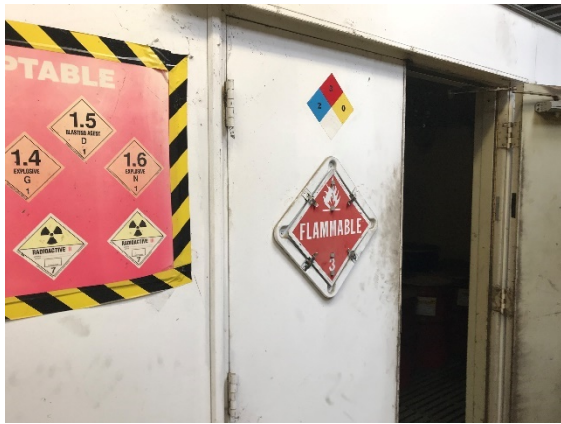
The inspection began in the Container Storage Area No. 3. This area is located inside the warehouse (Picture-1). There were 6 35-gallon drums of solvent sludge and 2 55-gallon drums of solvent sludge and a 5-gallon drum containing spill kits inside the storage area at the time of inspection, which did not exceed the permitted capacity of 2,040 gallons of hazardous waste (Picture-2). The drums were observed to be closed, labeled, and dated. The hazard indication on the containers were observed to be "Combustible Liquid". The earliest accumulation start date was observed to be 1/21/2021. "No Smoking" signs were posted on the sides, as well as on the door of the Container Storage Area No. 3.

*Picture 1: Signage at Flammable Container Storage Area #3 (Main)*

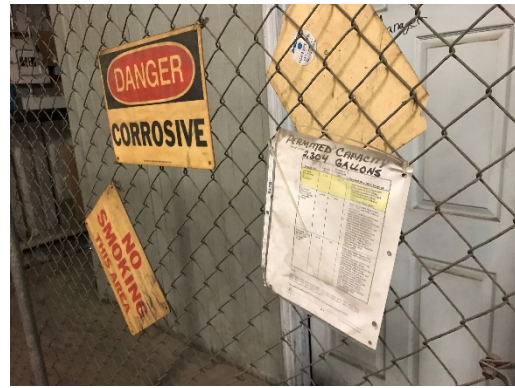
The Container Storage Area No. 1 was inspected next. Nonflammable permitted wastes are stored in this area (Picture-3). This area is permitted for the storage of 2,304 gallons of hazardous waste (Picture-4). At the time of inspection, the inspectors observed the following:

*Picture-4: Signages showing Permitted Storage Capacity, No Smoking and Corrosive*

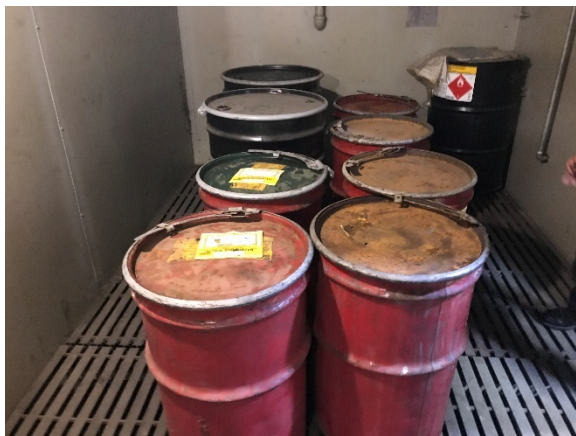
*Picture 2: 8 Hazardous Waste Containers inside Flammable Container Storage Area #3 (Main)*

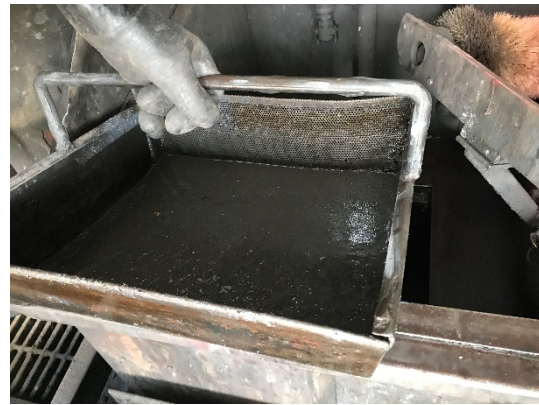
The operating return and fill unit was not in service at the time of inspection. There were no leaks or spills observed in the secondary containment of the Return and Fill Station. The inspectors observed that the tray containing sludge and debris (D001, D006, D008, D018, D039, and D040) had not been removed from the unit (Picture-5). The inspectors observed hazardous waste liquid (D001, D006, D008, D018, D039, and D040) in the sump (Picture-6). A drum was observed in the SAA in the Return and Fill Station closed, labeled, and had a hazard indication (Picture-7). According to Mr. Gordon the pump does not drain the sump in its entirety by pumping the spent hazardous waste solvent into the permitted hazardous waste tank. The Return and Fill Station was equipped with a spill kit and an eye wash station. "No Smoking" signs are posted in several locations at the Return and Fill Station.

*Picture 5: Hazardous Waste Sludge and Debris in the Tray, Return and Fill Area (D001, D006, D008, D018, D039 and D040)*

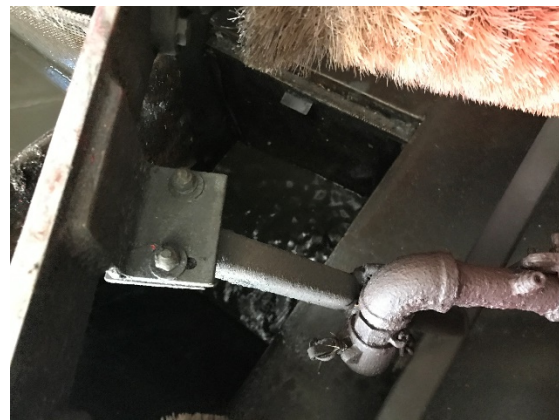
*Picture 6: Hazardous Waste Liquid (D001, D006, D008, D018, D039 and D040) in the Waste Sump of the Return and Fill Unit when not in service*

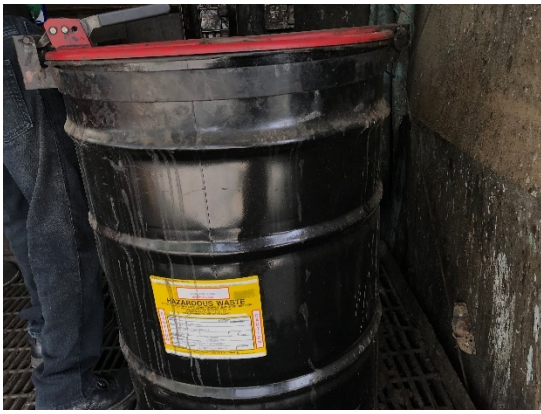
*Picture 7: 55-gallon SAA Drum in the Return and Fill Station*

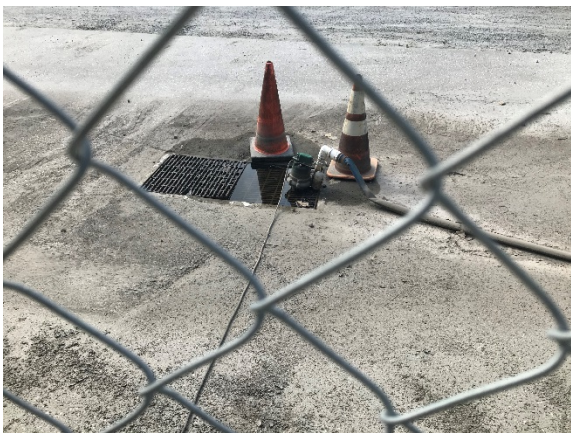
The inspectors observed a zero-discharge storm drain containing liquid located outside the Safety-Kleen property. The inspectors observed a pump near the drain connected to approximately a one-inch diameter pipe discharging into a stream behind the Safety-Kleen Property (Pictures-8, 9, and 10). The pump was not in service at the time of inspection. According to the Safety-Kleen personnel, the pump was operated during a rain event to pump the stormwater to the stream after testing. However, this could not be confirmed during the records review portion of the inspection

*Picture 8: A pump not in service used for pumping the storm water runoff from the tank farm and return and fill unit into an unnamed tributary of a creek.*

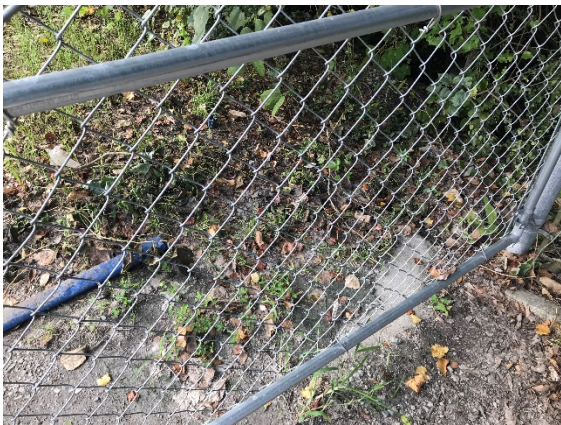
*Picture 9: A pipe connected to a pump for discharging storm water containing hazardous waste to an unnamed tributary of a creek*

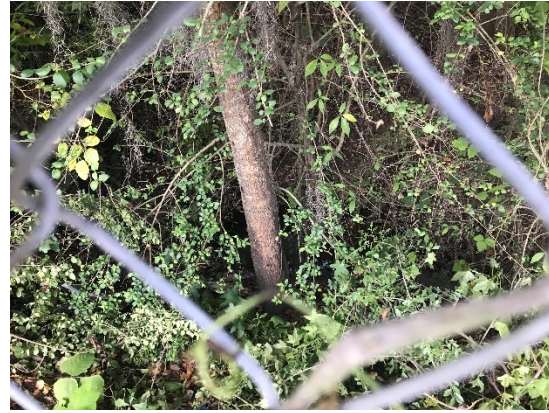
*Picture 10: Unnamed Creek located behind the SKS facility where storm water runoff from the SKS Tank Farm and Return and Fill Unit runoff is discharged via pump and a pipe.*

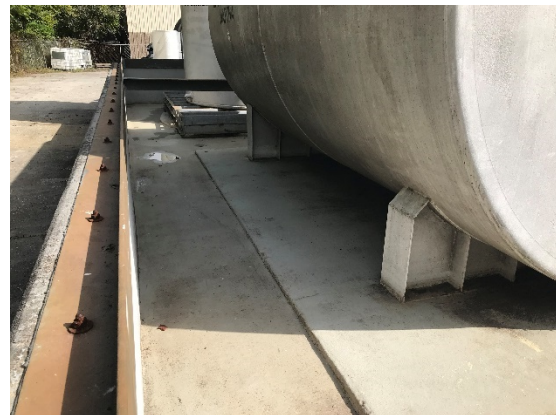
secondary containment. Tank No.1 is labeled with the words “Hazardous Waste” “Waste Petroleum Naptha” and a “No Smoking” sign (Picture-11). There were no leaks or spills observed in the secondary containment for the hazardous waste tank (Picture-12). The base of the tank appeared to be chipped. (Picture-13).

*Picture 12: No Leaks and Spills in Secondary Containment of Hazardous Waste Tank #1*

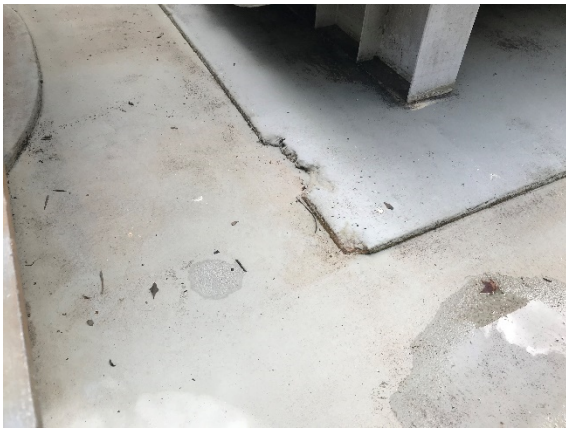
*Picture 13: The base of the 10,000-gallon hazardous waste tank is chipped.*

A review of the inspection logs appears to indicate that tank and the tank system inspections are performed daily; however, these inspections did not identify problems which includes not identifying the rust, corrosion, and cracks observed around the tank system and containment area during the inspection and the corrective actions taken to repair it. The facility's formal external inspection conducted on 09/16/2020 for Tank No. 1 by Clean Harbors Inspection Services also appeared to indicate that the cracks in the containment should be cleaned and sealed. The other recommendation made in the report included areas with coating failure should be cleaned,

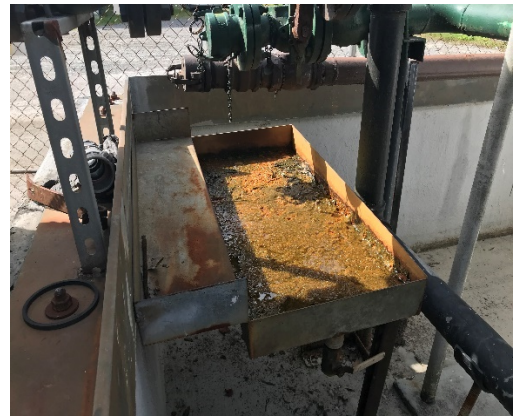
The inspectors observed signs of rust and paint peeling on the ancillary equipment associated with the tank and the tank system (Pictures-14 and 15). The inspectors observed a tray containing unknown residual material connected with the ancillary equipment associated with the tank (Picture-16). According to Mr. Gordon, the tray was used to capture rainwater.

*Picture 16: Unknown Residual Waste in a tray in Secondary Containment of Hazardous Waste Tank #1*

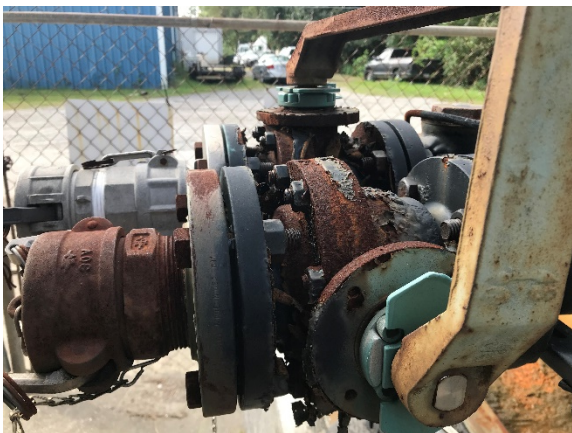
*Picture 14: Sign of Rust and Paint Peeling in Ancillary Equipment associated with Hazardous Waste Tank #1*

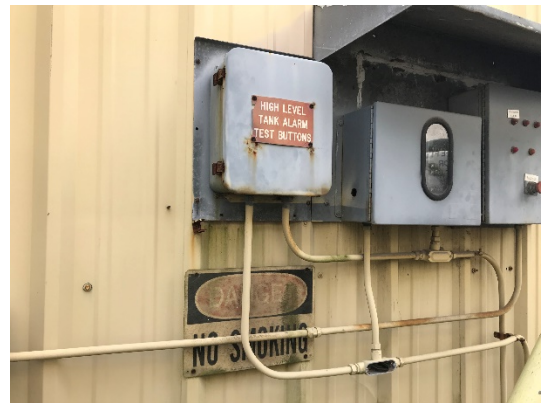
In response to an inquiry regarding testing frequency of the high-level alarm system, Mr. Gordon stated that the high-level alarm system on the hazardous waste tank was not in service (Pictures-17 and 18). Mr. Gordon discovered the problem with the alarm gauge on August 17, 2021 during the daily inspection of the tank and the tank system. The repair on the tank alarm was scheduled for September 3, 2021. On November 2, 2021, Mr. Williams provided a copy of the invoice by email indicating the service call and the repair of the alarm gauge sensor.

*Picture 17: High Level Tank Alarm was not in service for Hazardous Waste Tank #1 at the time of inspection*

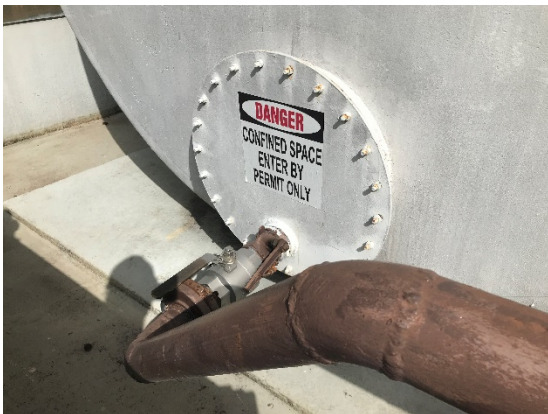
*Picture 15: Sign of Rust and Paint Peeling in Ancillary Equipment associated with Hazardous Waste Tank #1*

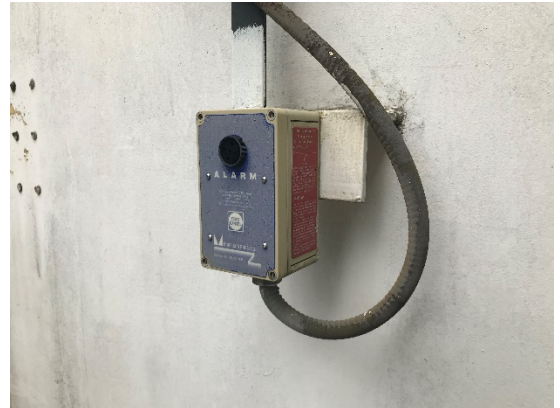
*Picture 18: High Level Tank Alarm Switch was disconnected for Hazardous Waste Tank #1*

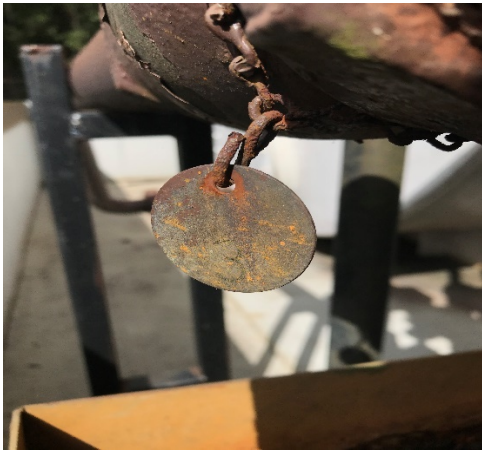
According to Mr. Groza, the spent solvent tank contains heavy liquid with low vapor pressure, therefore, a release would be visible in a liquid phase before it would be detectable as a vapor. Hence, the ancillary equipments are tagged and visually inspected and not subject to Leak Detection and Repair (LDAR) monitoring requirements. The inspectors observed various tags for the ancillary equipment including valves, pumps, and flanges associated with the tank and the tank system appeared to be weathered, missing and in the ground (Pictures-19, 20, 21, and 22). The Permit and the Permit Application require that all ancillary equipment associated with the tank and the tank systems are tagged and that the tags are always clear and visible.

*Picture 19: Tags associated with the Ancillary Equipment were not clear and visible*

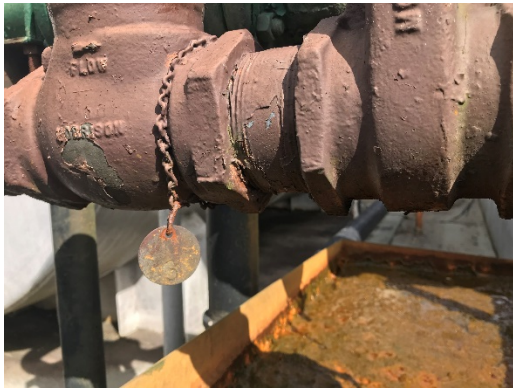
*Picture 20: Tags associated with the Ancillary Equipment were not clear and visible and Signs of Paint peeling (Tank #1)*

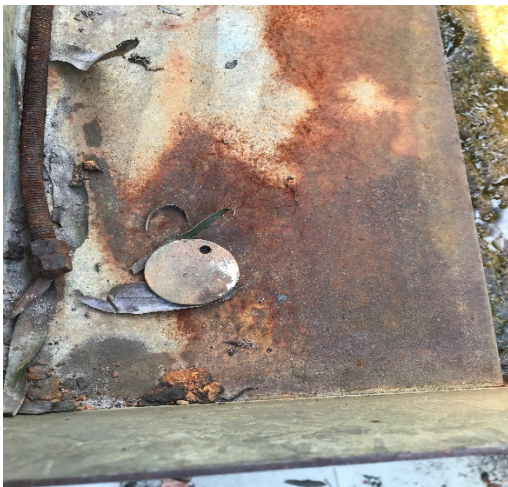
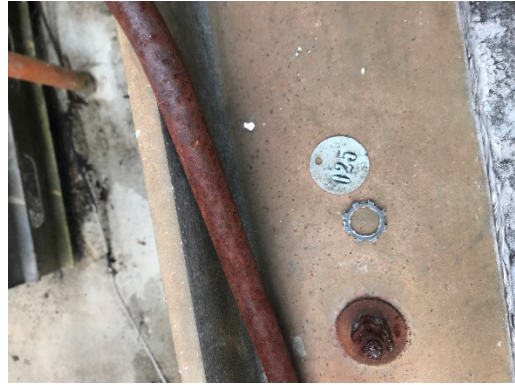
*Picture 22: Tags associated with the Ancillary Equipment observed in the ground and rusted ancillary piping associated (Tank #1)*

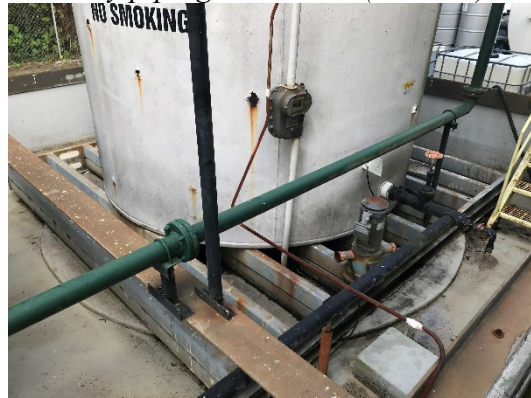
The adjoining tank is a vertical mount tank also in secondary containment; however, according to Mr. Gordon, the tank has never been in service (Picture-23). The inspectors observed that the ancillary equipment associated with the vertical mount tank appeared to be disconnected. The inspectors observed a third tank outside the secondary containment. Mr. Gordon stated that the tank was double-walled and was used for storing clean solvent (product). The tank was labelled with the words “Clean 150 Mineral Spirits 150” and a “No Smoking” sign (Picture-24). “No Smoking” signs are posted in several locations around the tank farm, including the chain link fence that surrounds the facility.

*Picture 23: Empty Vertical Mounted Tank in Secondary Containment no longer in service (Tank #2)*

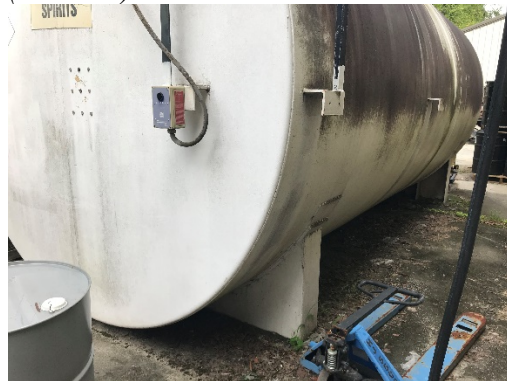
*Picture 24: Double walled, 10,000-gallon Clean Solvent Tank*

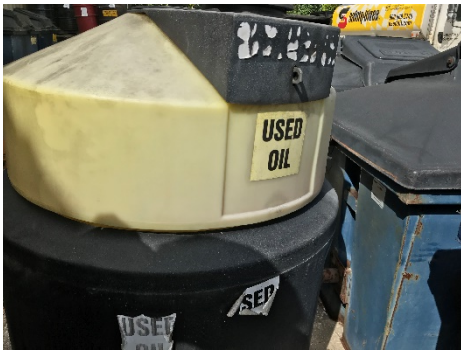
The inspectors observed 8 275-gallon bins of used oil filters and 3 165-gallon containers of used oil (Picture-25). Inspectors observed the used oil containers to be closed and labeled as “Used Oil”. There were no leaks or spills observed near the containers.

*Picture 25: Used Oil Container*
