INSPECTION REPORT

Inspection Entry Date/Time	11/08/2022 09:00 AM (ET)	Announced: Yes
Inspection Exit Date/Time	11/08/2022 11:15 AM (ET)	Access: Granted
Weather	Day 1 – Sunny and 45°F	
Media	Water	
Statute(s)/Program(s)	Clean Water Act, National Pollutant Discharge Elimination System (NPDES), Wastewater Treatment Plant (WWTP)	
Type of Inspection	CEI - Compliance Evaluation Inspection	
Confidential Business Information (CBI)	No CBI is included in this report and the facility did not make a CBI claim on any of the information provided.	
Permittee Name		
Scioto County Commissioners Minford Area WWTP		
Facility or Site Name		
Minford Area WWTP		
Facility/Site Physical Address		
East of SR 335, south of County Road 12 and north of the Scioto County Airport		
City, State, Zip Code		
Minford, Ohio		
County/Borough/Parish		
Scioto County		
Facility GPS Coordinates

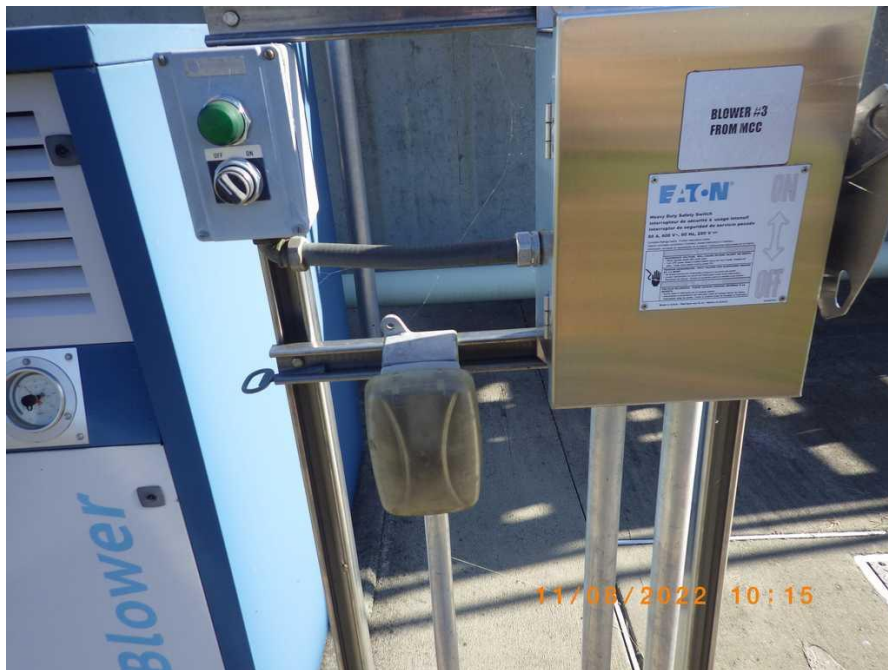
Control panel	RIMG2890.JPG	
11/08/2022 10:10 AM	Photographer: Andi Hodaj	
Aerobic digesters	No CBI	No PII
Control panel for one of the blowers at the aerobic digesters. Camera looking east.

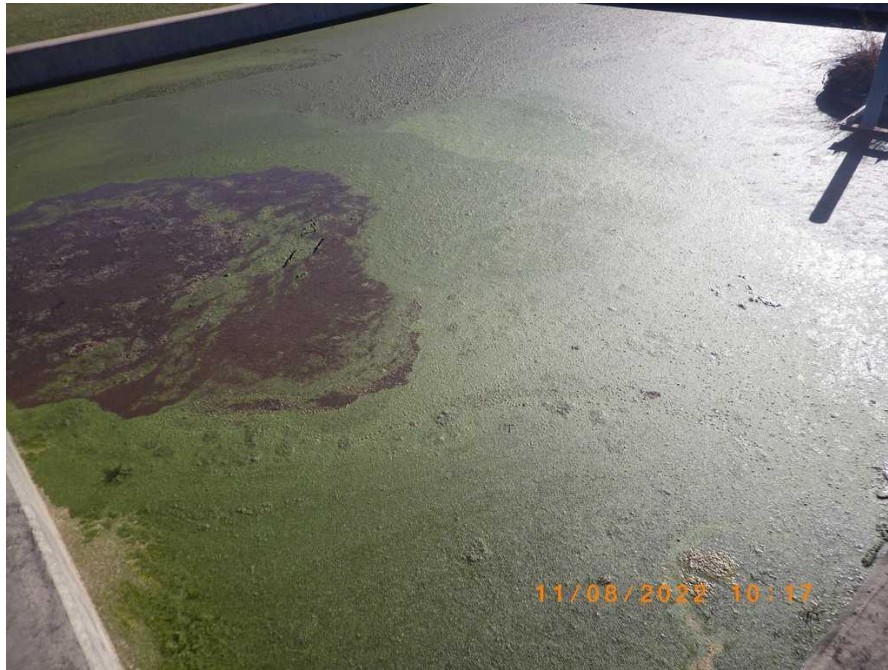
Location: Aerobic digesters		
Observation #: AH2-OB-005	Date: 11/08/2022	Weather: Sunny and 45°F
<p>EPA observed the two aerobic digesters. The aerobic digesters had a layer of green algae covering approximately 80% and 50% of the surface area, respectively. The operator stated that the blowers for the aerobic digesters, normally operate 24 hours a day, 7 days a week. However, the blowers were not operating at the time of the inspection. The operator stated that that was due to decanting going on at that time.</p>		
Photos		
<ol style="list-style-type: none">1. RIMG2890.JPG2. RIMG2891.JPG3. RIMG2892.JPG

AOC:
 The aerobic digesters had a layer of green algae covering approximately 80% and 50% of the surface area, respectively. The operator stated that the blowers for the aerobic digesters, normally operate twenty-four hours, seven days a week. However, the blowers were not operating at the time of the inspection. The operator stated that that was due to decanting going on at that time.

North digester	RIMG2891.JPG	
11/08/2022 10:17 AM	Photographer: Andi Hodaj	
Aerobic digesters	No CBI	No PII
North aerobic digester has its surface covered in green algae. Camera looking north.

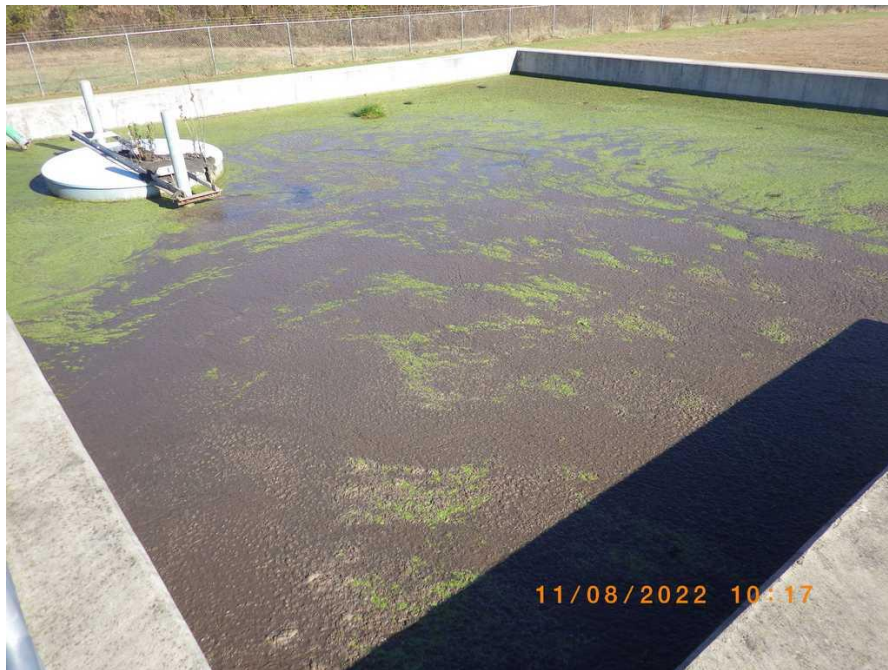
South digester	RIMG2892.JPG	
11/08/2022 10:17 AM	Photographer: Andi Hodaj	
Aerobic digesters	No CBI	No PII
The south aerobic digester has approximately 50% of its surface area covered in green algae. Camera looking south.

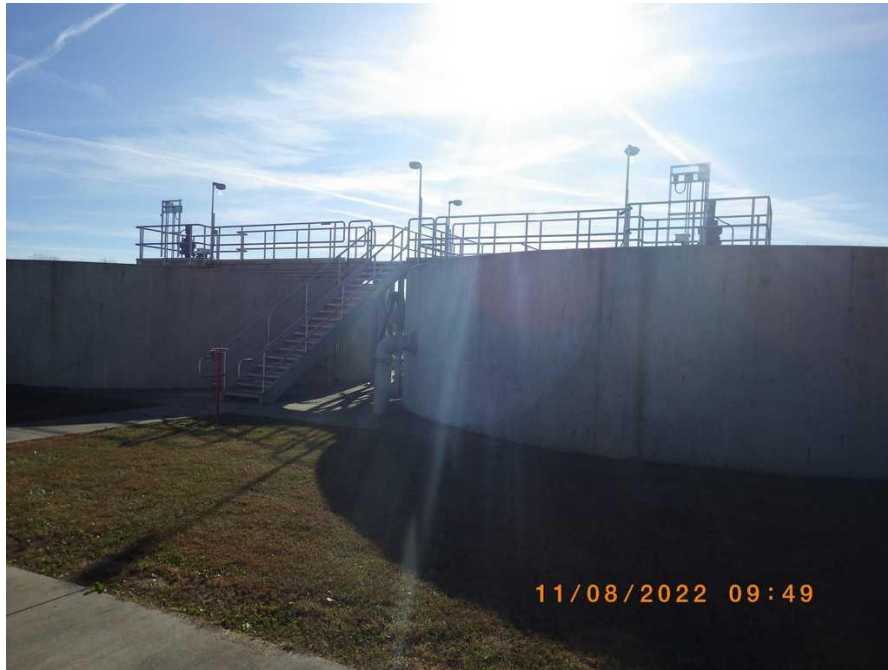
Clarifier Overview	RIMG2880.JPG	
11/08/2022 09:47 AM	Photographer: Andi Hodaj	
Clarifiers	No CBI	No PII
Overview of clarifier from the ground level. Camera looking northeast.

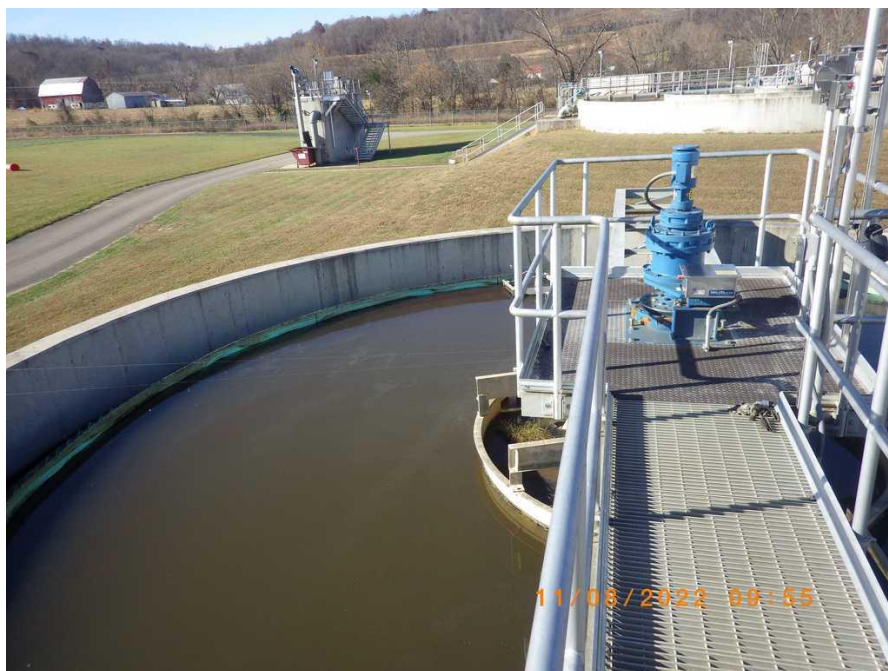
Observation #: AH2-OB-003	Date: 11/08/2022	Weather: Sunny and 45°F
<p>EPA observed a dark grey and light brown water in the clarifiers with some solids floating in them. The operator stated that sludge from the clarifiers is pumped to the oxidation tank every two hours and once per month or, once every two weeks to the aerobic digesters. EPA observed accumulated sludge at the splitter box that splits flow from the oxidation tank to the two clarifiers. The operator stated that he scoops the sludge out manually using a bucket.</p>		
Photos		
<ol style="list-style-type: none">1. RIMG2880.JPG2. RIMG2881.JPG3. RIMG2882.JPG4. RIMG2883.JPG5. RIMG2885.JPG6. RIMG2884.JPG

AOC:
 EPA observed a dark grey and light brown water in the clarifiers with some solids floating in them

West Clarifier	RIMG2881.JPG	
11/08/2022 09:55 AM	Photographer: Andi Hodaj	
Clarifiers	No CBI	No PII
Grey water in the west clarifier. Camera looking west.

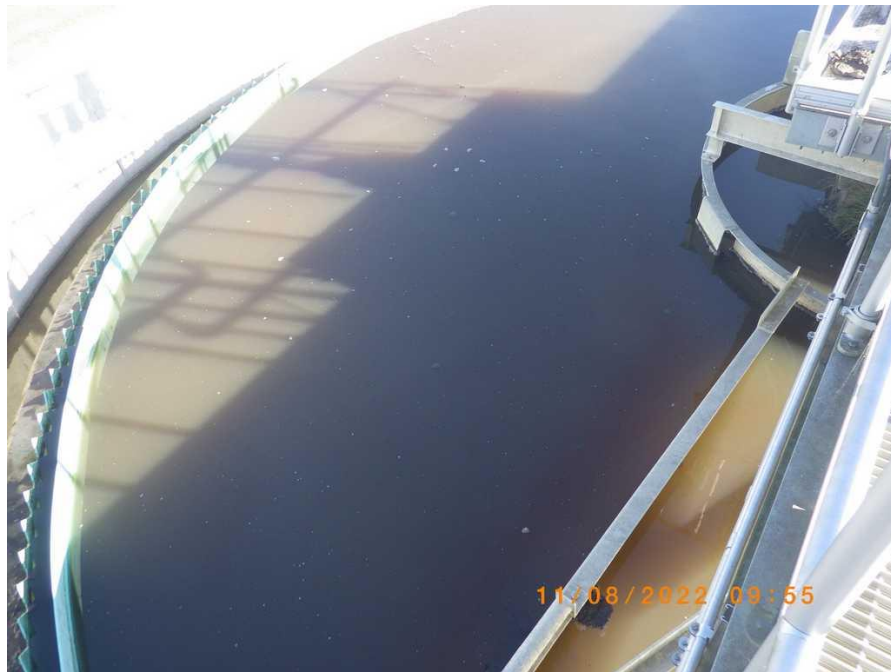
East Clarifier	RIMG2882.JPG	
11/08/2022 09:55 AM	Photographer: Andi Hodaj	
Clarifiers	No CBI	No PII
Grey water and solids floating in the east clarifier. Camera looking northeast.

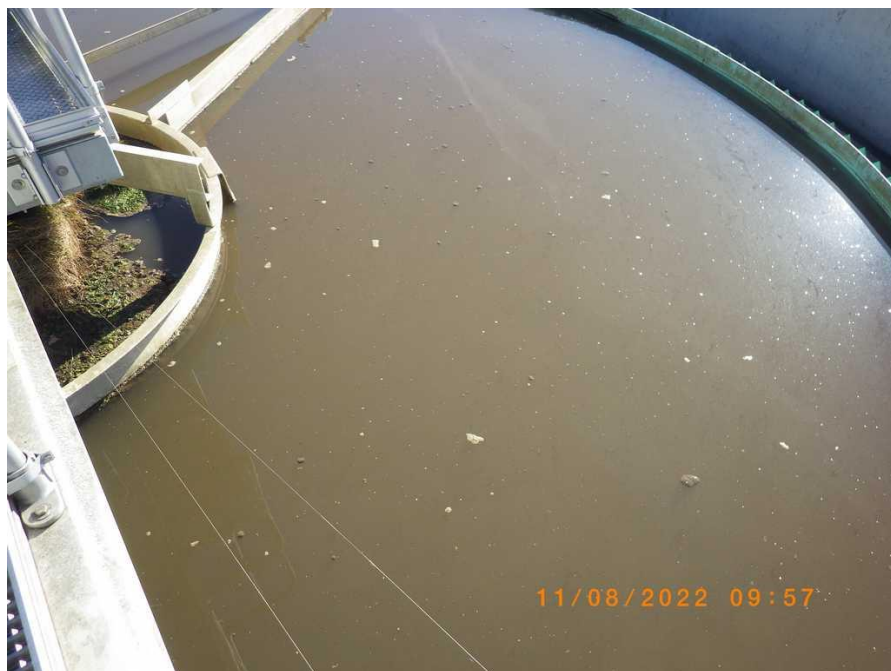
East Clarifier	RIMG2883.JPG	
11/08/2022 09:57 AM	Photographer: Andi Hodaj	
Clarifiers	No CBI	No PII
Grey water and solids floating in the east clarifier. Camera looking south.

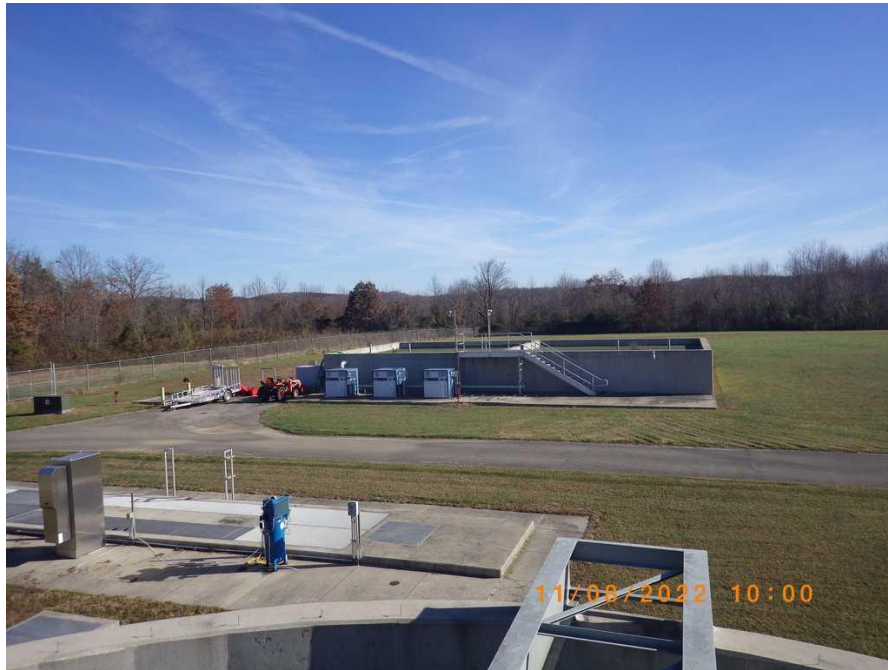
Final Tank and Aerobic Digesters	RIMG2885.JPG	
11/08/2022 10:00 AM	Photographer: Andi Hodaj	
Clarifiers	No CBI	No PII
View of the final tank, post aeration tank, UV channel and the aerobic digesters from the top of the clarifiers. Camera looking east.

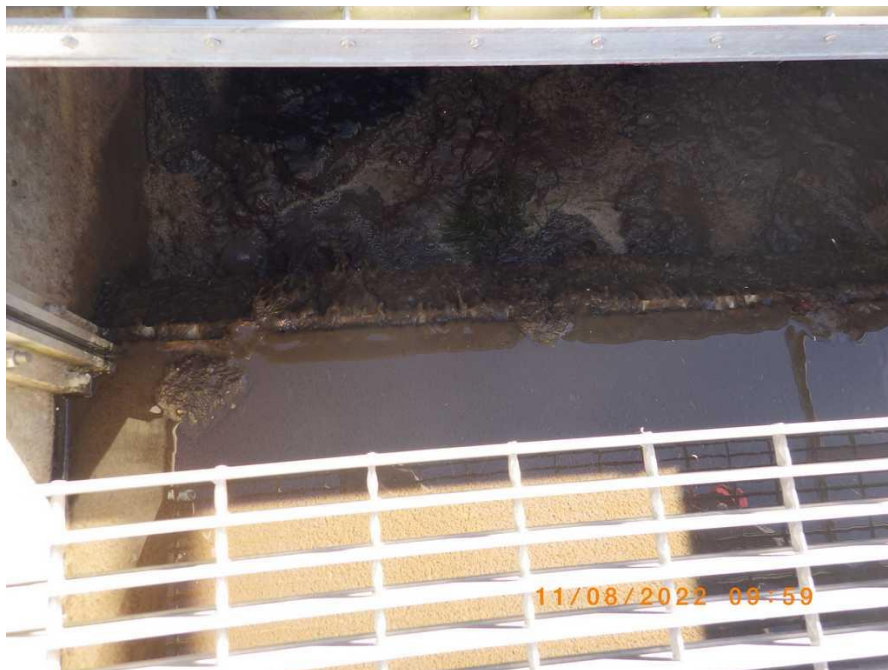
Splitter box	RIMG2884.JPG	
11/08/2022 09:59 AM	Photographer: Andi Hodaj	
Clarifiers	No CBI	No PII
Scum accumulated in the splitter box. Camera facing east.

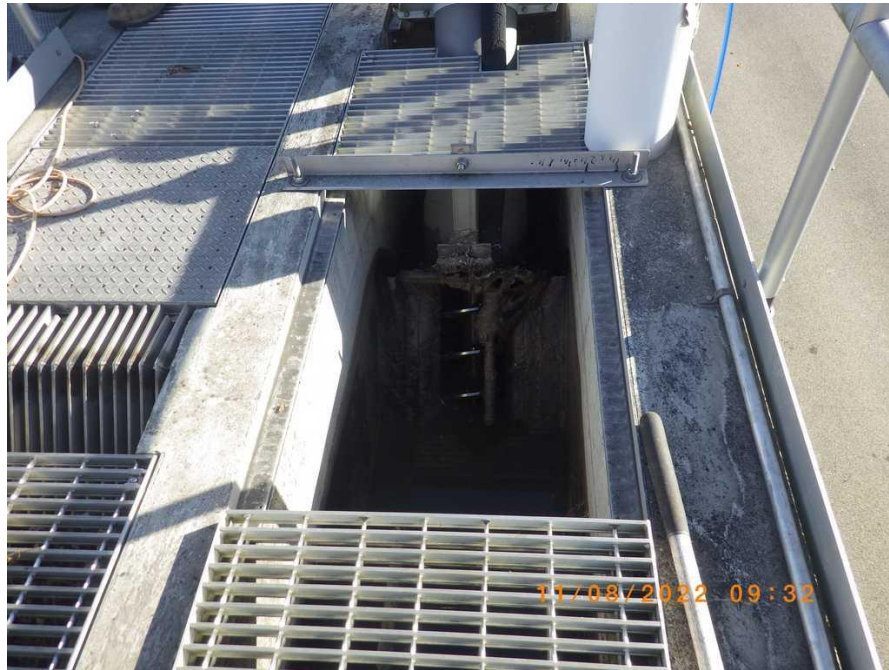
Location: Headworks		
Observation #: AH2-OB-001	Date: 11/08/2022	Weather: Sunny and 45°F
<p>EPA observed the headworks where there were two influent pipes, a spiral screen and a container where the screened solids are disposed, a refrigerated autosampler and the control panel for the spiral screen. EPA did not observe a thermometer in the autosampler and the autosampler lacked power at the time of the inspection.</p>		
<p>Photos</p> <ol style="list-style-type: none"> 1. RIMG2871.JPG 2. RIMG2872.JPG 3. RIMG2873.JPG 4. RIMG2874.JPG

Spiral Screen	RIMG2871.JPG	
11/08/2022 09:32 AM	Photographer: Andi Hodaj	
Headworks	No CBI	No PII
Spiral screen at Headworks. Camera looking north.

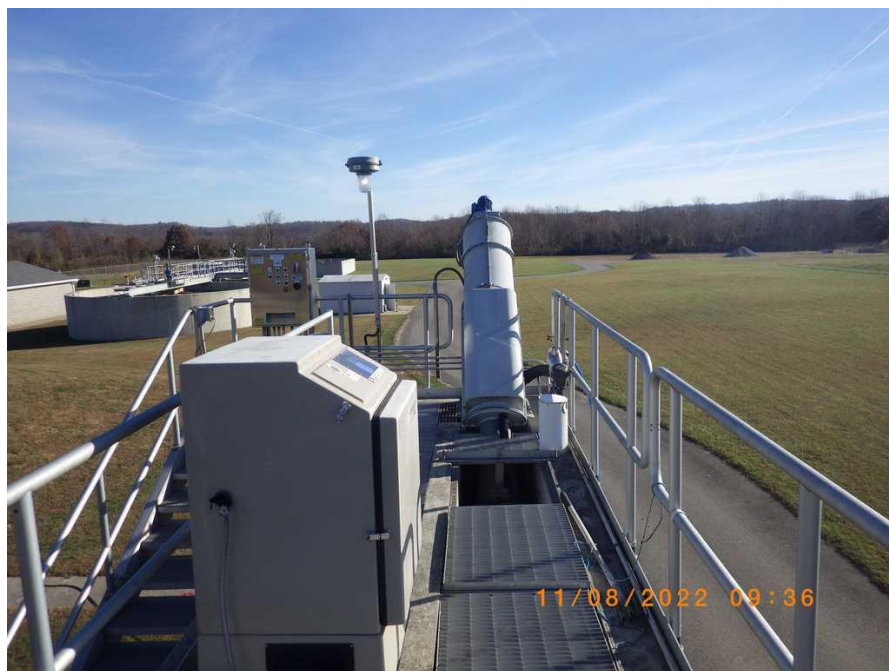
AOC:
 EPA did not observe a thermometer in the autosampler and the autosampler lacked power at the time of the inspection.

Headworks Overview	RIMG2872.JPG	
11/08/2022 09:36 AM	Photographer: Andi Hodaj	
Headworks	No CBI	No PII
General overview of Headworks with autosampler, spiral screen and the spiral screen control panel. Camera facing east.

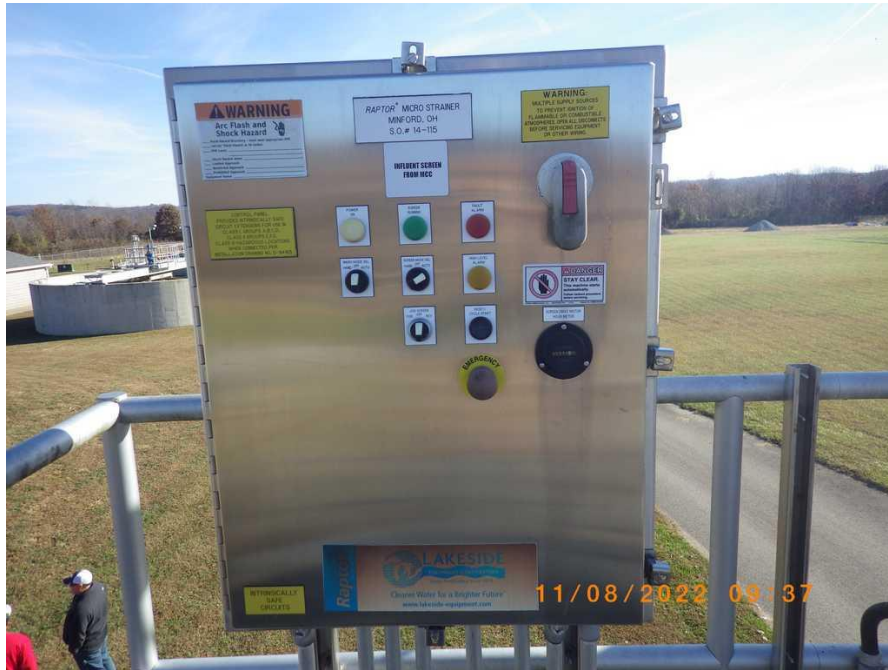
Spiral Screen Control Panel	RIMG2873.JPG	
11/08/2022 09:37 AM	Photographer: Andi Hodaj	
Headworks	No CBI	No PII
Control panel for the spiral screen. Camera facing east.

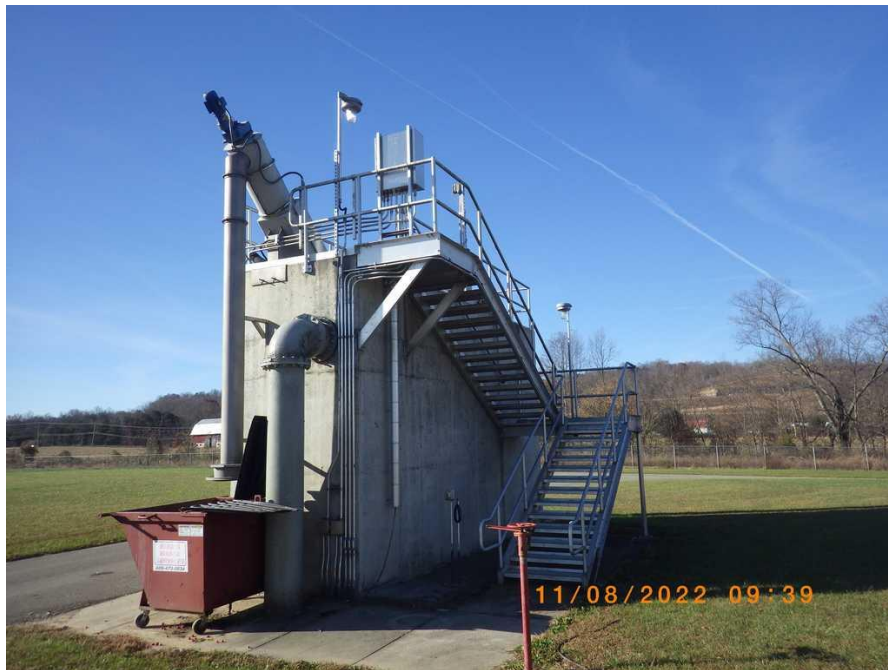
Headworks Overview	RIMG2874.JPG	
11/08/2022 09:39 AM	Photographer: Andi Hodaj	
Headworks	No CBI	No PII
Overview of Headworks from ground level. Camera looking west.

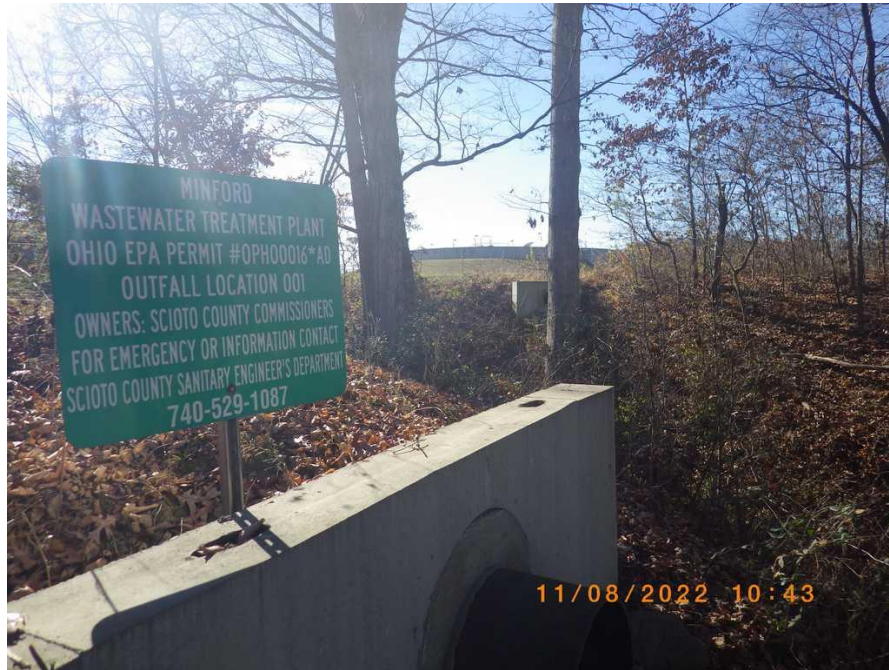
Location: Outfall 001		
Observation #: AH2-OB-006	Date: 11/08/2022	Weather: Sunny and 45°F
EPA observed outfall 001 and the outfall signage. The outfall signage was facing Long Run.		
Photos		
<ol style="list-style-type: none"> 1. RIMG2893.JPG 2. RIMG2894.JPG

Outfall Signage	RIMG2893.JPG	
11/08/2022 10:43 AM	Photographer: Andi Hodaj	
Outfall 001	No CBI	No PII
Outfall 001 signage facing Long Run. Camera looking southwest.

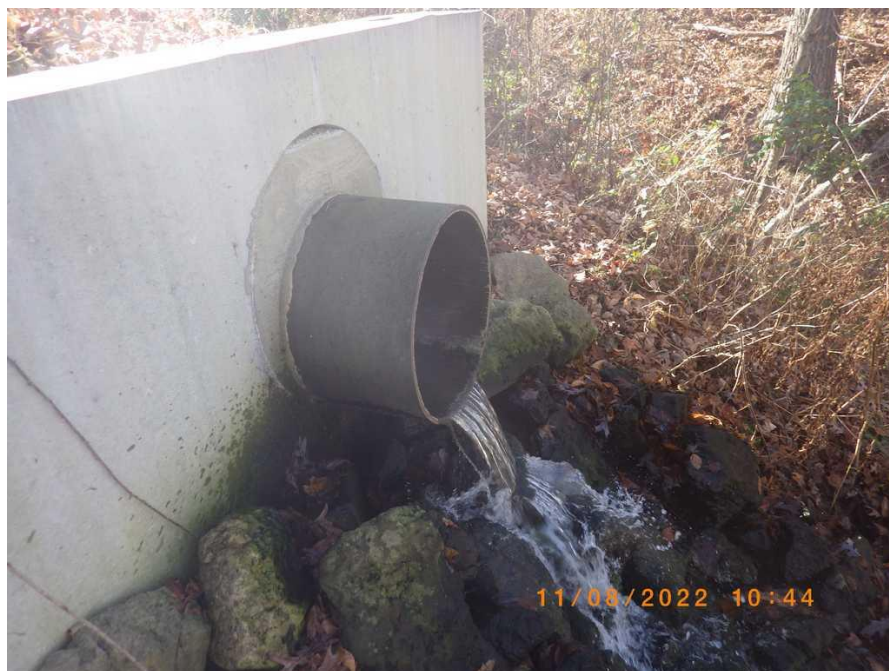
Outfall 001	RIMG2894.JPG	
11/08/2022 10:44 AM	Photographer: Andi Hodaj	
Outfall 001	No CBI	No PII
Outfall 001 discharging into Long Run. Camera looking southwest.

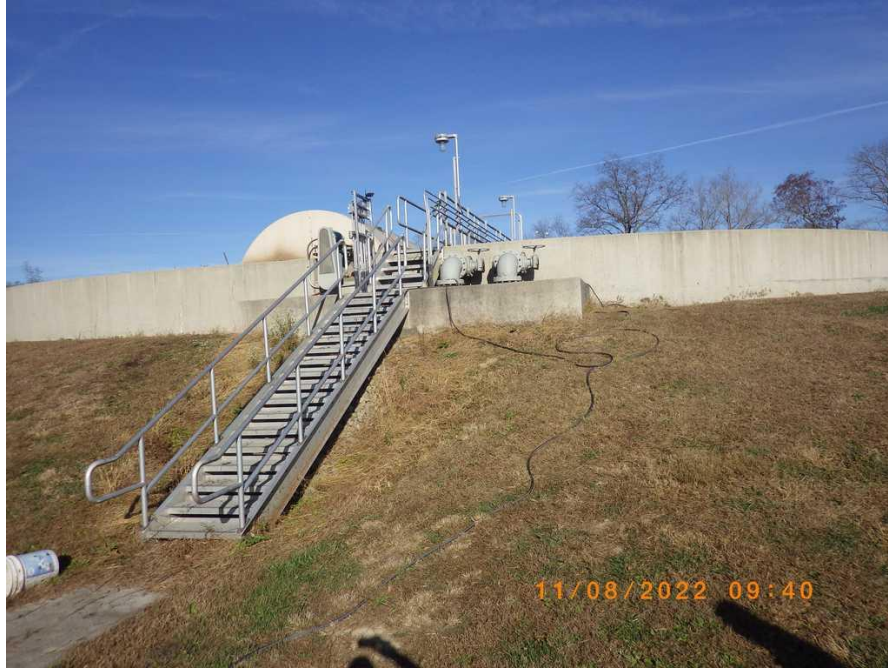
Oxidation Tank Overview	RIMG2875.JPG	
11/08/2022 09:40 AM	Photographer: Andi Hodaj	
Oxidation tank	No CBI	No PII
Overview of oxidation tank from ground level. Camera looking north.

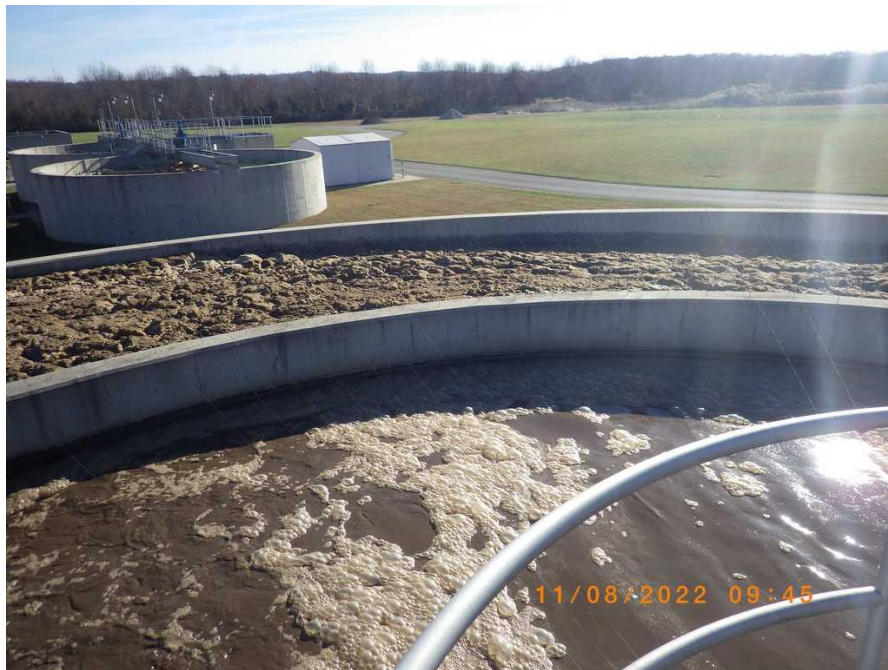
AOC:
 EPA observed two kinds of excessive foam in the oxidation tank. EPA observed thin, white to grey foam in the inner tank and pumice-like grey foam in the outer tank. Photos [RIMG2876.JPG](#), [RIMG2877.JPG](#), [RIMG2878.JPG](#) and [RIMG2879.JPG](#).

Oxidation Tank influent pipes	RIMG2877.JPG	
11/08/2022 09:43 AM	Photographer: Andi Hodaj	
Oxidation tank	No CBI	No PII
Two influent pipes into the oxidation tank. Camera looking south.

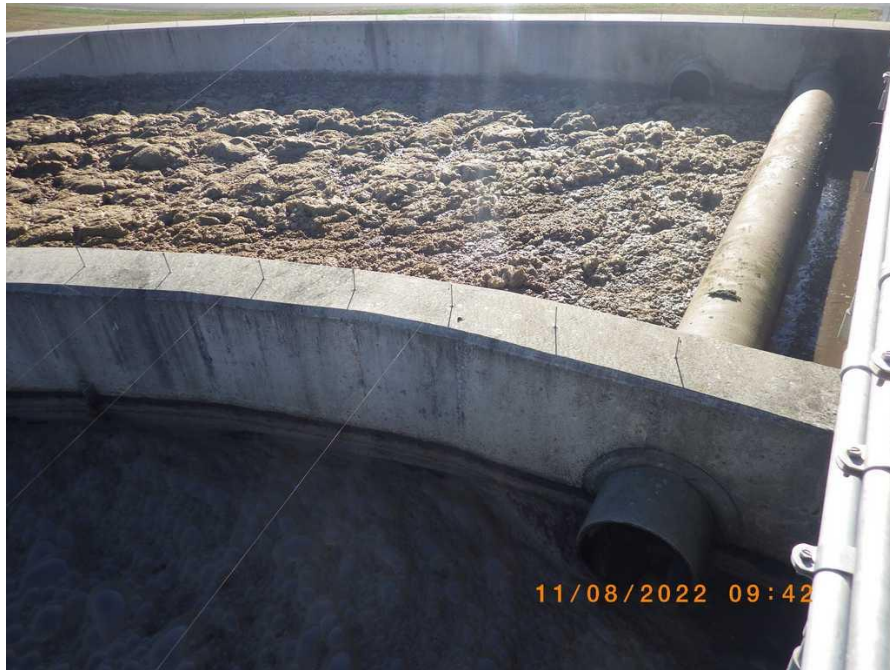
Scum in Oxidation Tank	RIMG2876.JPG	
11/08/2022 09:44 AM	Photographer: Andi Hodaj	
Oxidation tank	No CBI	No PII
Foam floating into the oxidation tank. Camera looking east.

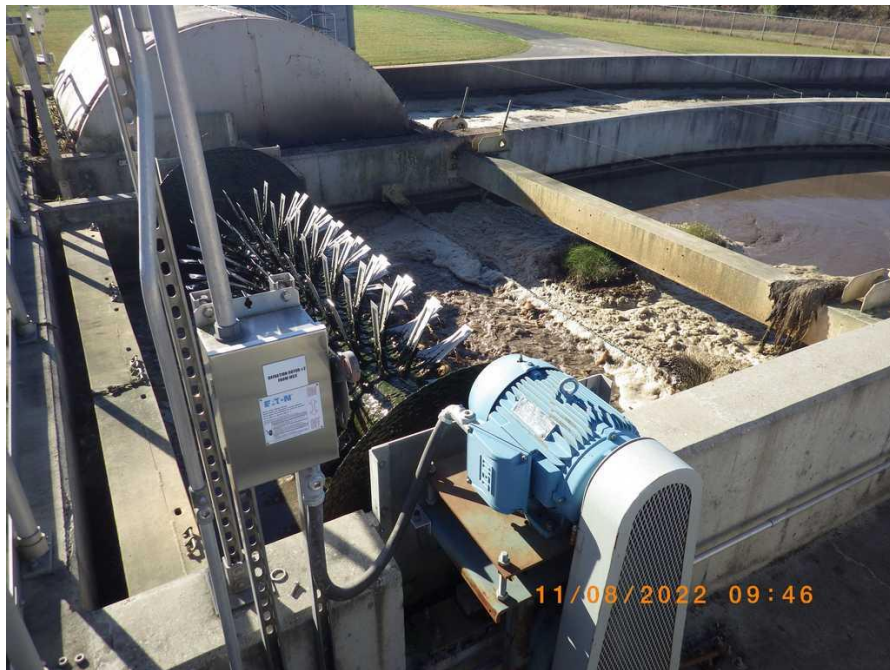
Replaced Rotor	RIMG2878.JPG	
11/08/2022 09:46 AM	Photographer: Danny Nguyen	
Oxidation tank	No CBI	No PII
Recently replaced rotor in oxidation tank. Camera looking south.

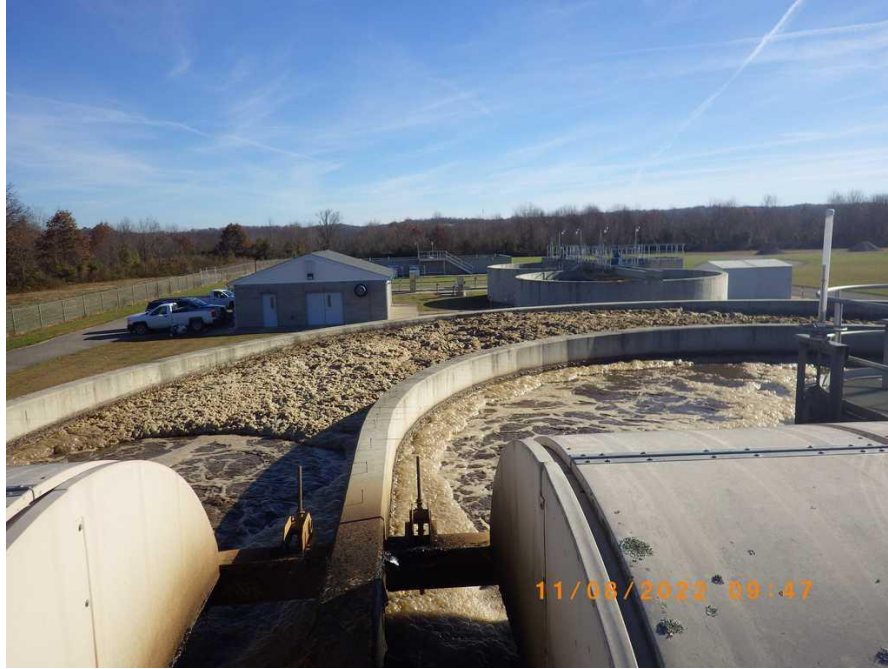
Oxidation Tank Overview	RIMG2879.JPG	
11/08/2022 09:47 AM	Photographer: Andi Hodaj	
Oxidation tank	No CBI	No PII
Foam floating in the oxidation tank. Camera looking east.

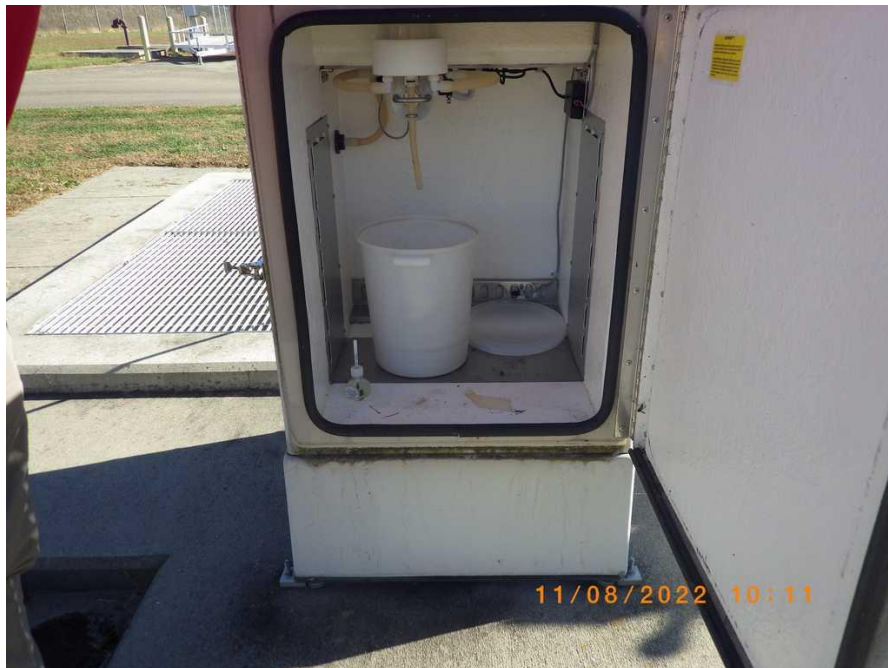
Autosampler	RIMG2889.JPG	
11/08/2022 10:07 AM	Photographer: Andi Hodaj	
Post-aeration tank and UV channel	No CBI	No PII
Effluent autosampler. Camera looking east.

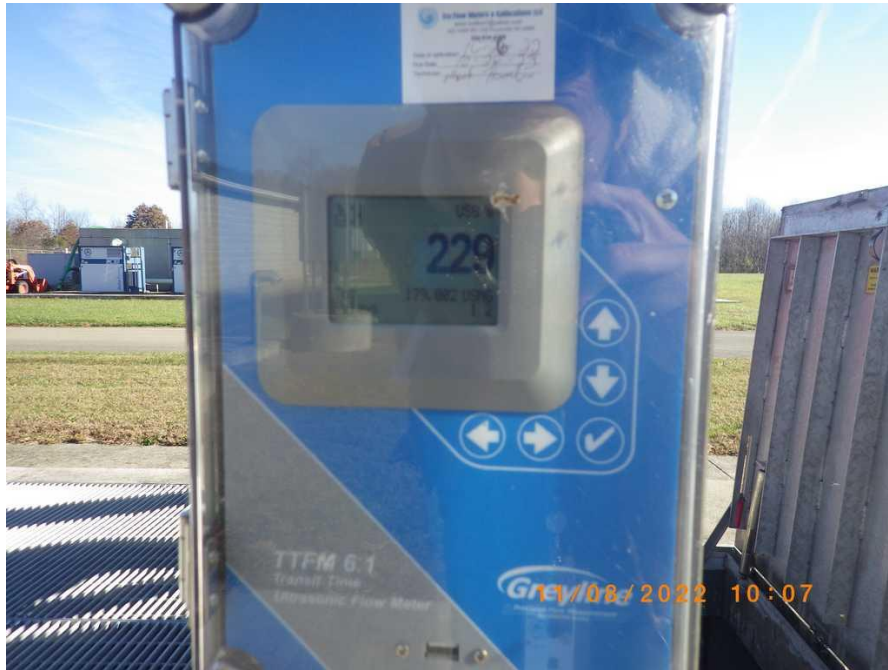
Location: Post-aeration tank and UV channel		
Observation #: AH2-OB-004	Date: 11/08/2022	Weather: Sunny and 45°F
<p>The post aeration tank and the UV disinfection were not operating at the time of the inspection. EPA observed the flowmeter in the final tank and the flowmeter panel with a calibration tag on it. The calibration tag showed the date of last calibration as October 6, 2022. EPA observed the effluent autosampler with a thermometer in it that showed 4°C. EPA observed the water in the final tank and it looked clear. The operator stated that the 24-hour composite sampling is done Tuesday to Wednesday and Thursday to Friday for samples required to be taken twice per week for both influent and effluent.</p>		
Photos		
<ol style="list-style-type: none">1. RIMG2889.JPG2. RIMG2886.JPG3. RIMG2888.JPG4. RIMG2887.JPG

Flow Meter datalogger	RIMG2886.JPG	
11/08/2022 10:07 AM	Photographer: Andi Hodaj	
Post-aeration tank and UV channel	No CBI	No PII
Flow meter datalogger and the calibration tag on it. Camera looking east.

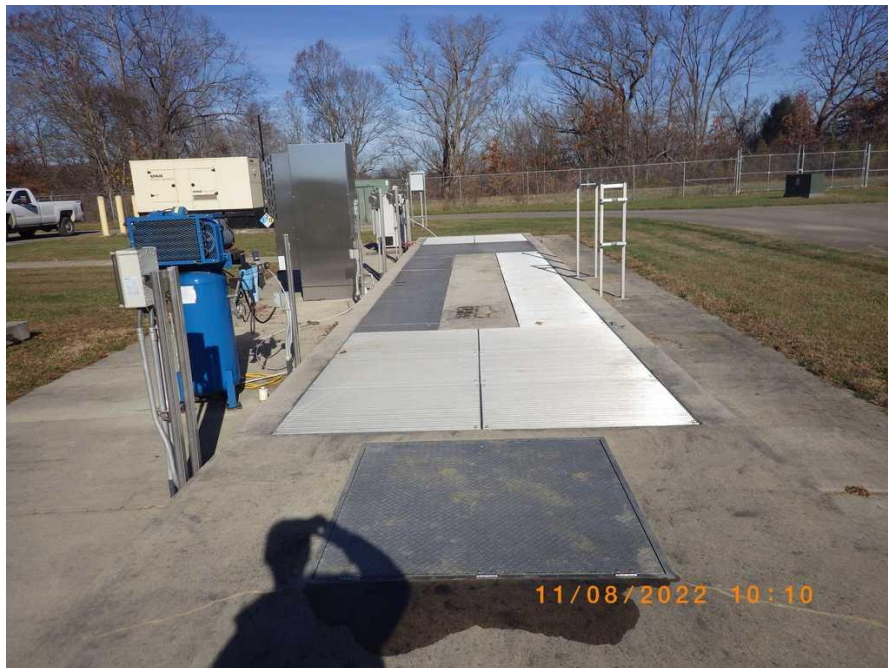
AOC:
 The post aeration tank was not operating at the time of the inspection.

Post Aeration and UV	RIMG2888.JPG	
11/08/2022 10:10 AM	Photographer: Andi Hodaj	
Post-aeration tank and UV channel	No CBI	No PII
Overview of post aeration, UV disinfection and final tank. Camera looking north.

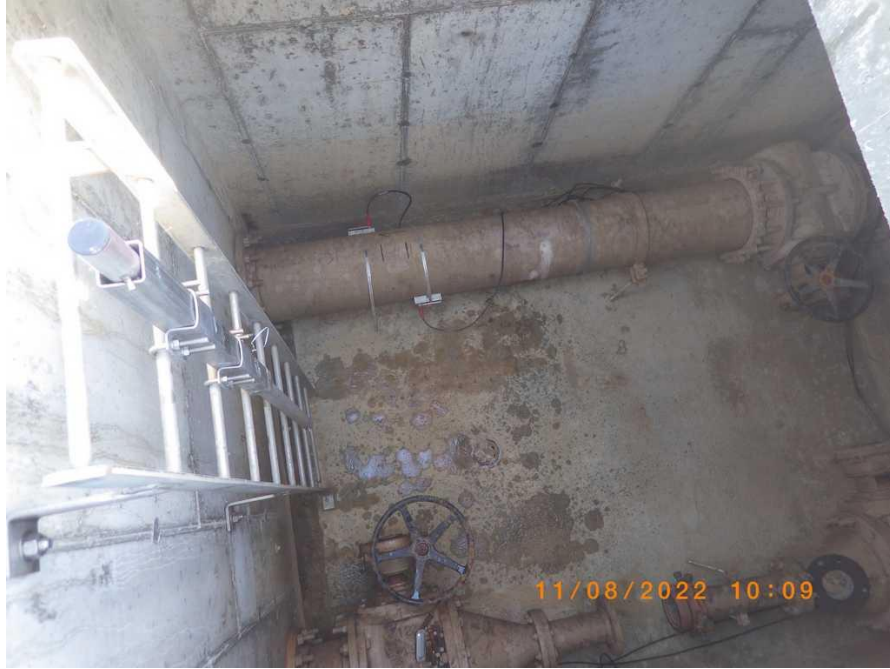
Flow sensor	RIMG2887.JPG	
11/08/2022 10:09 AM	Photographer: Andi Hodaj	
Post-aeration tank and UV channel	No CBI	No PII
Flow meter sensor in the final tank.
