## RCRA Compliance Evaluation Inspection Report

Clean Earth of Alabama, Inc.  
402 Webster Chapel Road  
Glencoe, Alabama 35905  
Etowah County

EPA ID/Permit No. ALD981020894

March 21, 2023, 8:30 a.m.

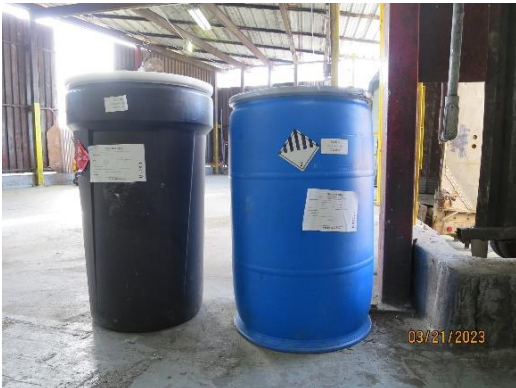
Photo #1 – Two SAA containers in Building #1.

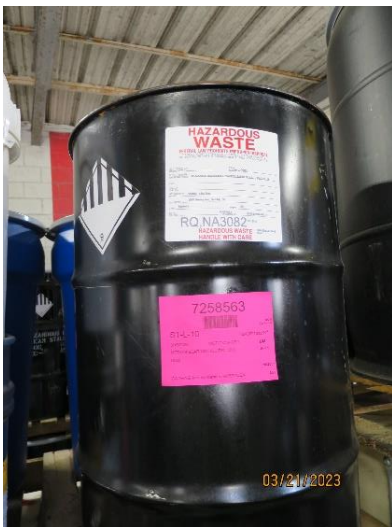
- Approximately 85 containers were missing an indication of the hazards of the contents. Of these 85 containers, some were labeled with a DOT class 9 Miscellaneous dangerous goods label, and some containers were marked with only a DOT class 3 flammable liquid label despite exhibiting the hazardous characteristics of both ignitability and toxicity. However, the containers were closed, marked with the words “Hazardous Waste,” and marked with a storage date less than one year (Photos #3-6);
- One 5-gallon container of “Hazardous Waste” flammable resin solution (D001, F003) was in poor condition, dented/damaged (Photo #7);

Photo #3 – Container missing an indication of the hazards.

**Pursuant to Permit Condition specified in Part III. Management in Containers, Section L. Management of Containers: 6) An appropriate hazardous waste label will be affixed to each container. The label will include, at a minimum, the date the container was received (or other information that provides a clear indication of the beginning date of the staging period for the container) and all appropriate EPA hazardous waste numbers associated with the hazardous waste in the container as specified in ADEM Admin. Code r. 335-14-2-.03 and 335-14-2-.04 (or other information that provides a clear indication of the type(s) of hazardous waste in the container and the hazard(s) associated with that waste).**

**Pursuant to ADEM Admin. Code r. 335-14-3-.01(5)(ii) [40 C.F.R. § 262.15(a)(5)(ii)], which is a condition of the SAA Permit Exemption, a generator must mark or label its containers with the following: (ii) an indication of the hazards of the contents (examples include, but are not limited to, the applicable hazardous waste characteristic(s) (i.e., ignitable, corrosive, reactive, toxic); hazard communication consistent with the Department of Transportation requirements at 49 C.F.R. part 172 subpart E (labeling) or subpart F (placarding); a hazard statement or pictogram consistent with the Occupational Safety and Health Administration Hazard Communication Standard at 29 C.F.R. 1910.1200; or a chemical hazard label consistent with the National Fire Protection Association code 704).**

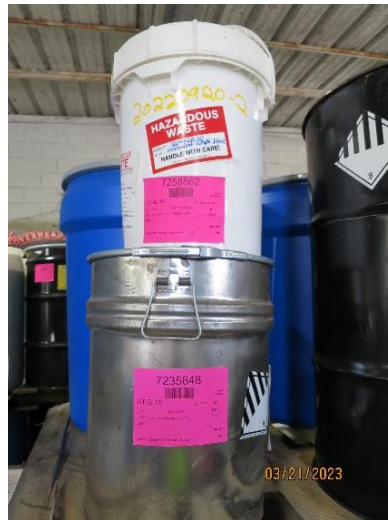
Photo #4 – Containers missing an indication of the hazards.

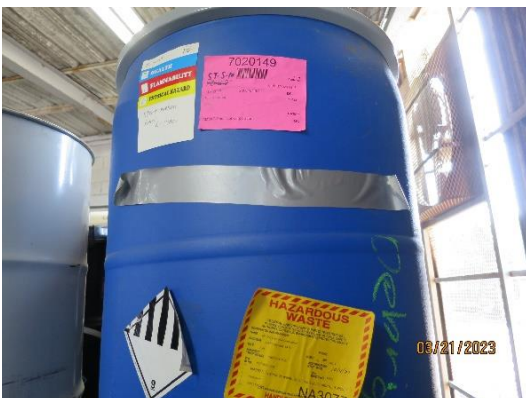
Photo #5 - Container missing an indication of the hazards.

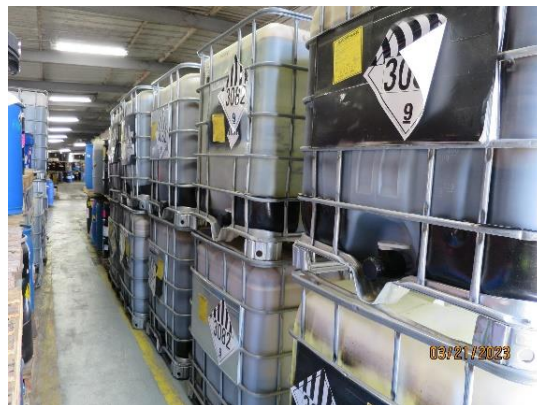
Photo # 6 – Containers missing an indication of the hazards.

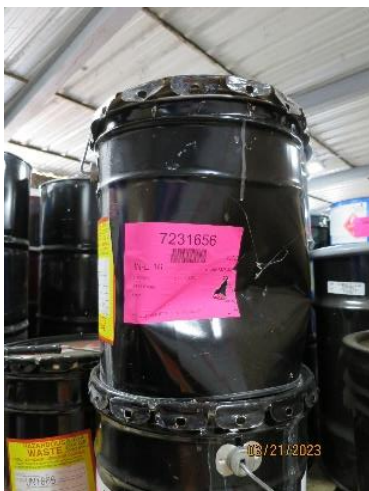
Photo #7 – A 5-gallon damaged container.

**Pursuant to Permit Condition specified in Part III. Management in Containers, Section J. Condition of Containers: If a container holding hazardous waste is not in good condition (e.g., severe rusting, apparent structural defects) or if it begins to leak, upon discovery the Permittee shall immediately transfer the hazardous waste from such container to a container that is in good condition or otherwise manage the waste in compliance with the conditions of ADEM Admin. Code r. 335-14-5-.09(2).**

**Pursuant to ADEM Admin. Code r. 335-14-3-.01(7)(a)1.(ii) [40 C.F.R. § 262.17(a)(1)(ii)], which is a condition of the LQG Permit Exemption, if a container holding hazardous waste is not in good condition, or if it begins to leak, the large quantity generator must immediately transfer the hazardous waste from this container to a container that is in good condition, or immediately manage the waste in some other way that complies with the conditions for exemption of this section.**

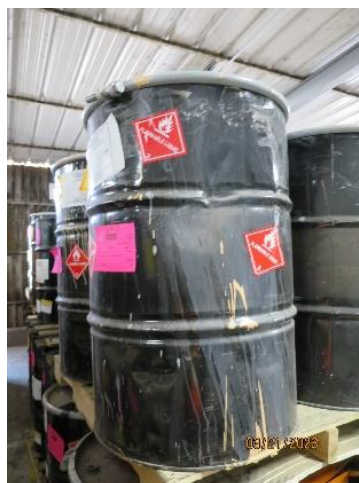
- One 55-gallon container of “Hazardous Waste” flammable liquid waste (D001, F003) was, in poor condition, dented/damaged (Photo #8);
- A pallet of 24 5-gallon containers was wrapped in plastic, with one “Hazardous Waste” label, marked with one storage date less than one year, and with one indication of the hazards of the contents affixed on the plastic wrap. *The inspectors informed the facility that each container must be marked individually with the words “Hazardous Waste,” with an indication of the hazards of the contents and marked with a storage date less than one year. The inspectors observed at least four additional pallets marked with one “Hazardous Waste” marking, dated with one accumulation start date, and one indication of the hazards of the contents on the plastic wrap during the inspection.*

Photo #8 - A 55-gallon damaged container.

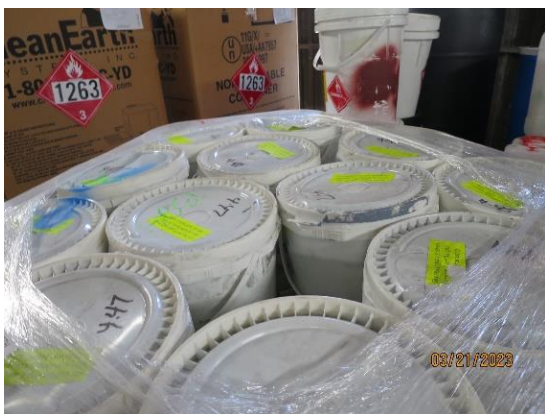
Photo #9 - 5-gallon containers were wrapped and secured with plastic.

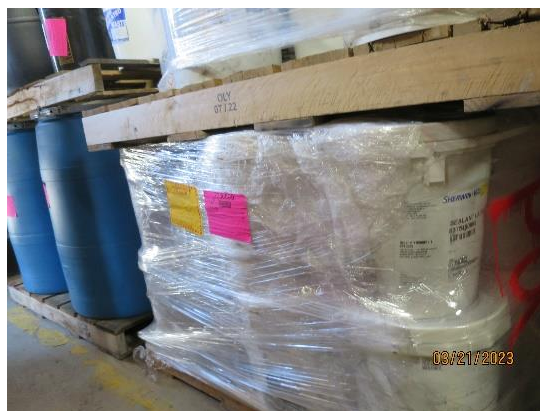
- Two pallets from Sherwin Williams, each containing 18 5-gallon containers, were wrapped in plastic film with one “Hazardous Waste” marked with a storage date less than one year, and one indication of the hazards of the contents was affixed on the plastic wrap.

Photo #10 – Two pallets of 5-gallon containers wrapped and secured with plastic.

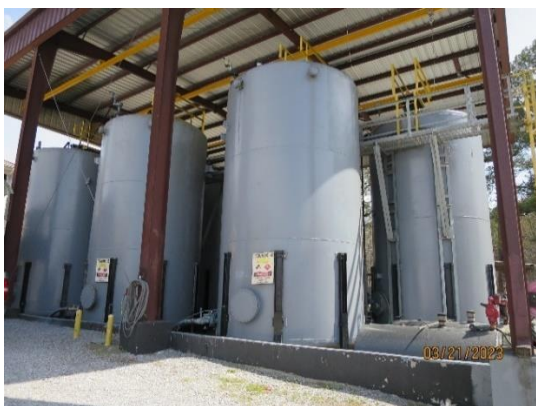
The Tank Storage Area is a permitted hazardous waste tank farm located outdoors to the rear of Building #1 (Photo #11). The Tank Storage Area is constructed with a metal roof. Each of the six hazardous waste tanks have a capacity of approximately 15,000-gallons, 56.78 cubic meters, and a maximum organic vapor pressure of 76.6 kPa (11.11 psi). Hazardous waste received by CEA

Photo #11 – Hazardous waste tank farm.

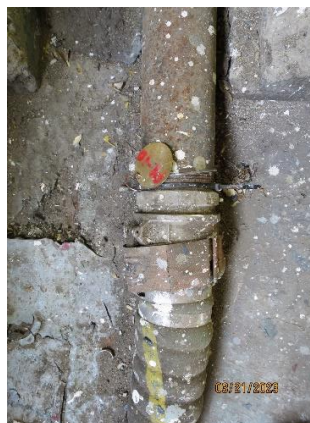
The secondary containment for the six 15,000-gallon storage tanks is sufficient to capture a release of 100% of one of the tanks plus the accumulated rainfall of a 25 year/24-hour rainfall event. The containment system surrounding the tank and tank ancillary equipment appeared in good condition. All piping connections are welded, visible, and located in coated concrete trenches that drain into the storage tank containment area. Plant personnel indicate that all pumps and piping are inspected daily for visible leaks. At the time of the inspection, there were no leaks or evidence of leaks from the piping or pumps. The inspectors observed one area of the trench had cracks or other defects (Photo #12). The piping appeared free of corrosion and all welds appeared to be intact.

Photo #12 – Cracked floor in the containment of ancillary equipment.

**Pursuant to Permit Condition specified in Part IV. Management in Tanks, Section H. Inspections: 1) The Permittee shall inspect each tank system (to include the ancillary equipment and secondary containment) and the area surrounding each tank as specified in Section 7 of the permit application and in accordance with the requirements of ADEM Admin. Code R. 335-14-5-.10(6).**

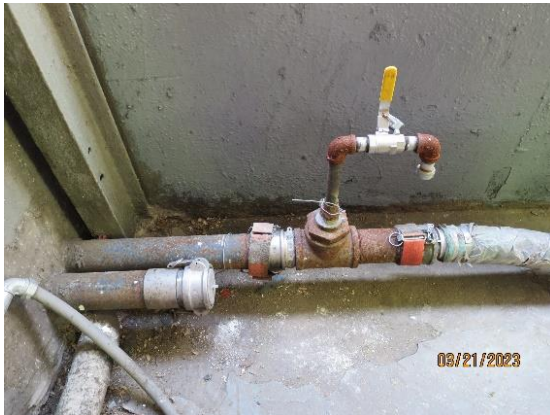
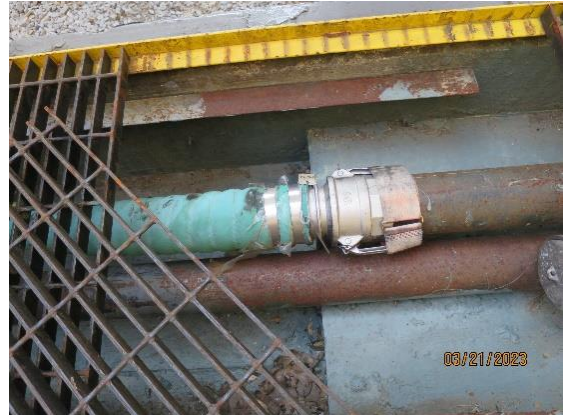
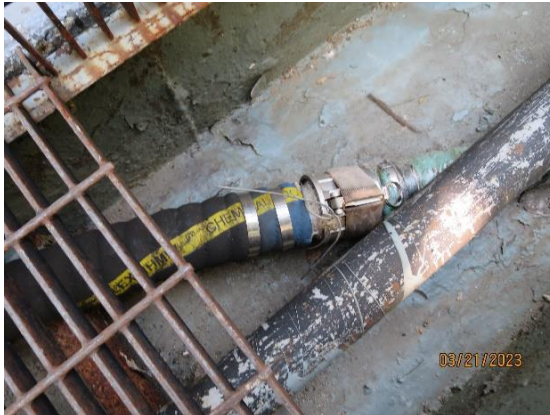
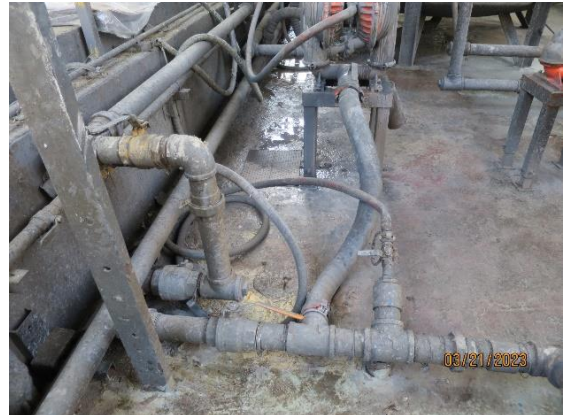
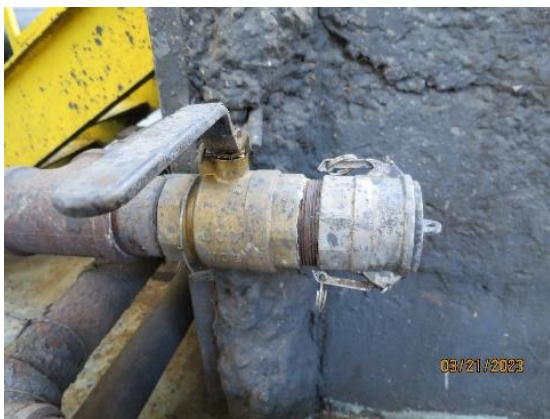
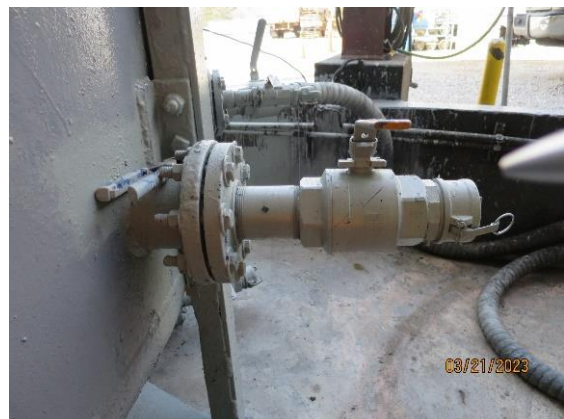
Pursuant to RCRA Hazardous Waste Facility Permit ALD981020894 and 40 C.F.R. Subpart BB requires that each tank system and associated ancillary equipment (flanges/pumps/end caps) used to manage hazardous waste be tagged for air leak monitoring. At the time of the inspection, the inspectors noticed that many of the tanks' ancillary equipments (flanges/connections/end caps) were not identified with a tag or tags were not clearly identifiable (Photos #13-20).

Photo #13 – ancillary equipment connections are not identified with a tag.

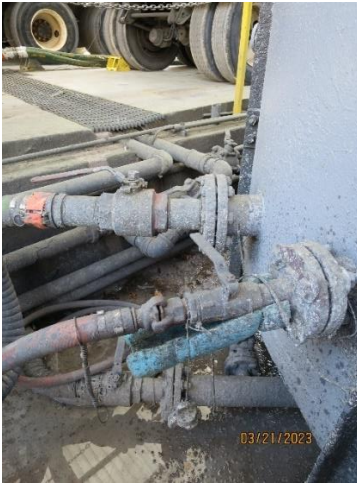
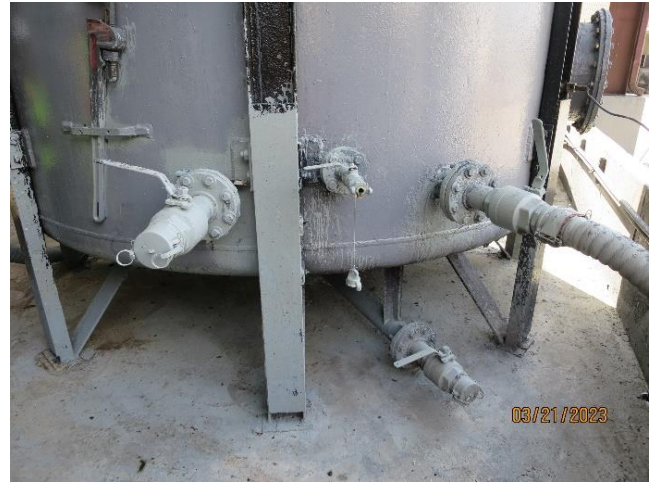
Photo #19 – ancillary equipment connections are not identified with a tag.

Photo #20 – ancillary equipment connections are not identified with a tag.

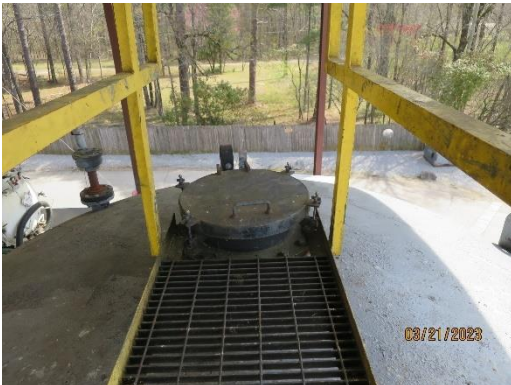
Photo #21 – ancillary equipment connections are not identified with a tag.

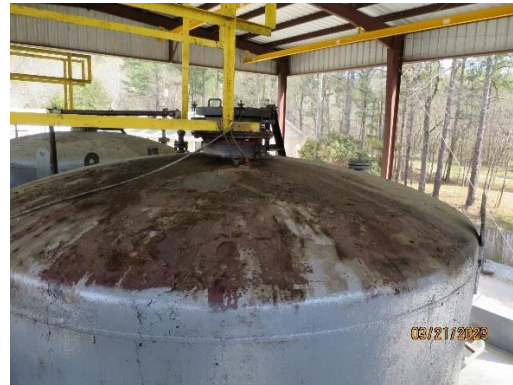
Tarin Tischler of EPA and Corey Holmes of ADEM climbed the exterior ladders of the tank farm to view the tops of the tanks. As required by Subpart CC, no visible cracks, holes, or gaps between each fixed roof's edge and tank walls were observed. All openings in the roof were secured in their closed positions. Each tank was fitted with an air pollution control device. The inspectors observed that tank #2 piping connections (Subpart BB) and process vents (Subpart CC) were not tagged or marked that it can be distinguished readily from other pieces of equipment (Photo #21). In addition, tank #2 had stains and corrosion on the top and appeared to have overflowed at some point (Photo #22).

Photo #22 – ancillary equipment connections are not identified with a tag.

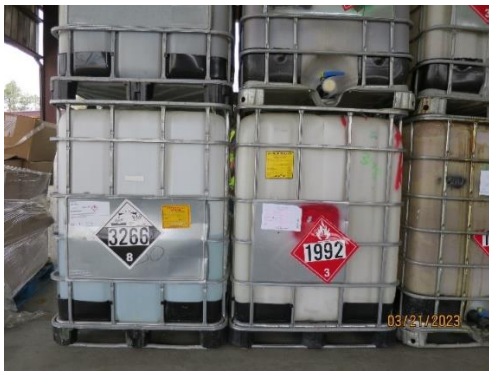
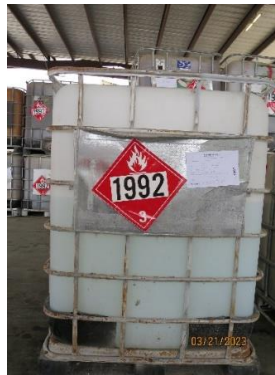
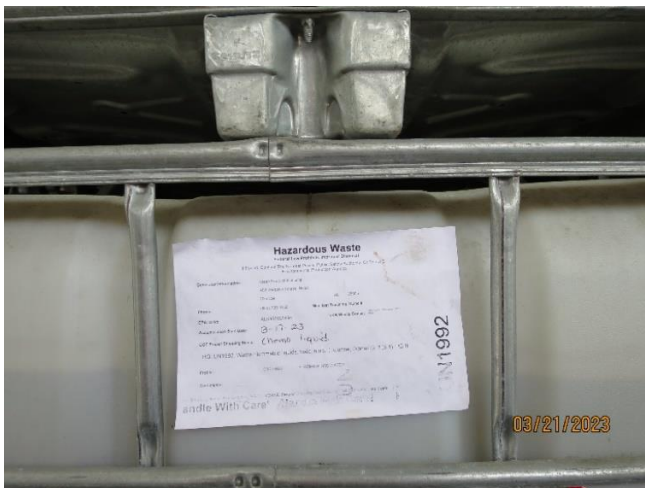
Inspectors observed numerous containers ranging from approximately five-gallon to approximately 275-gallons in capacity. Most of the containers were 55-gallons in capacity, stored on wooden pallets, and stacked two containers high. The inspectors observed approximately 12 containers were marked with DOT Class 9 miscellaneous dangerous goods label. In addition, there were 79 totes that were labeled as containing toluene and warfarin but were not marked with the applicable F and P waste codes and some were missing at least one indication of the hazards of the contents (Photos #25-27).

Photo #25 – Pharmaceutical waste totes missing applicable P waste code.

Photo #26 - Pharmaceutical waste tote missing applicable P waste codes.

Photo #27 – Pharmaceutical waste tote missing applicable P waste codes.

**Regarding the twelve containers and seventy-nine totes missing an indication of the hazards of the contents, pursuant to Permit Condition specified in Part III. Management in Containers, Section L. Management of Containers: 6) An appropriate hazardous waste label will be affixed to each container. The label will include, at a minimum, the date the container was received (or other information that provides a clear indication of the beginning date of the staging period for the container) and all appropriate EPA hazardous waste numbers associated with the hazardous waste in the container as specified in ADEM Admin. Code r. 335-14-2-.03 and 335-14-2-.04 (or other information that provides a clear indication of the type(s) of hazardous waste in the container and the hazard(s) associated with that waste).**

**Pursuant to RCRA Hazardous Waste Facility Permit ALD981020894, which incorporates ADEM Admin. Code r. 335-14-9-.05(1) [40 C.F.R. § 268.50(a)(2)(i)(C)], an owner/operator**

of a hazardous waste treatment, storage, or disposal facility that stores hazardous waste restricted from land disposal under subpart C of RCRA section 3004 in containers must clearly mark each container to identify its contents with an indication of the hazards of the contents.

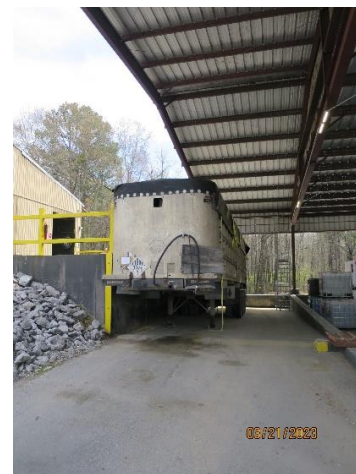
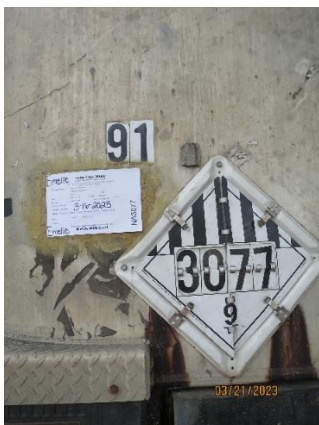
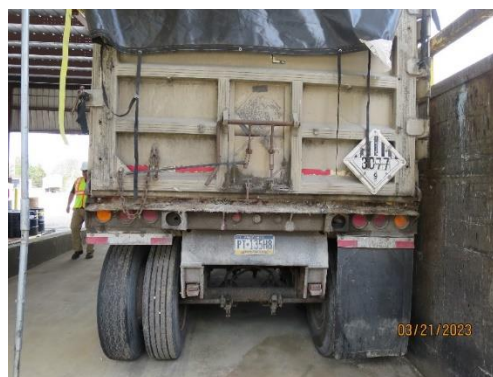
Photo #28 – Missing an indication of the hazards of the contents.

Photo #29 – Missing an indication of the hazards of the contents.

Photo #30 – Missing an indication of the hazards of the contents.

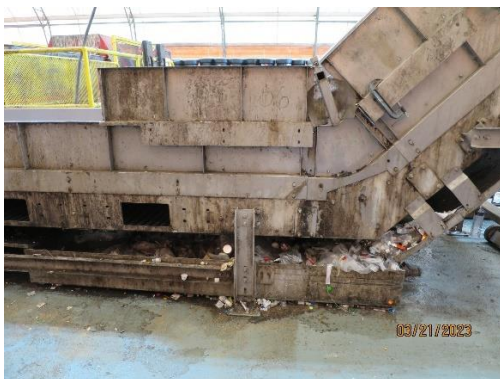
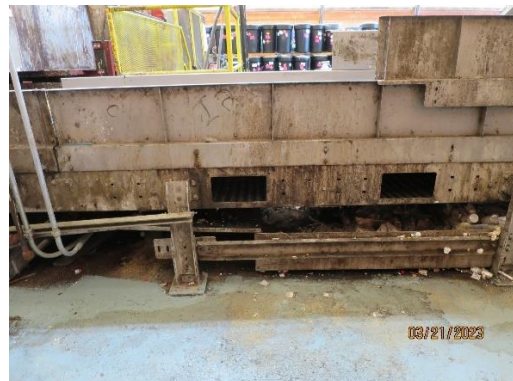
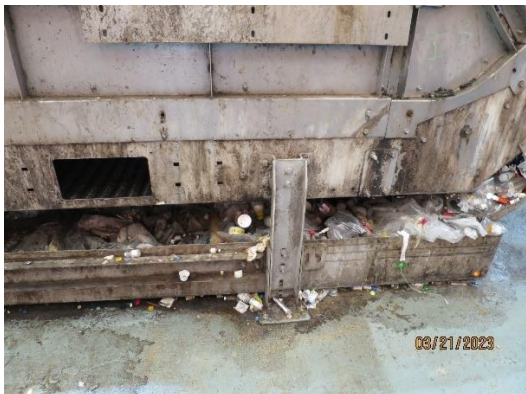
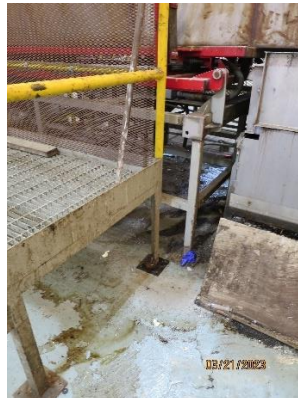
Photo #35 – Spilled pharmaceutical wastes under the shredding unit.

Photo #36 – Spilled pharmaceutical wastes under the shredding unit.

Photo #37 – Spilled pharmaceutical wastes under the shredding unit.

Photo #38 – Spilled pharmaceutical wastes under the shredding unit.

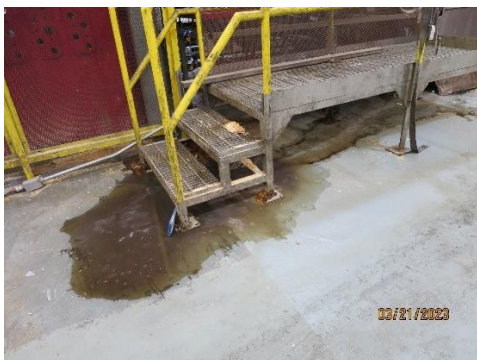
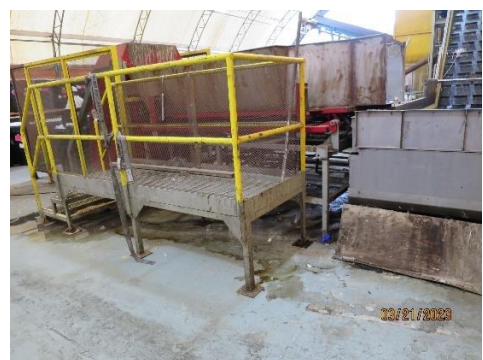
Photo #39 – Spilled liquid pharmaceutical waste near the shredding unit.

Photo #40 – Spilled liquid pharmaceutical waste Under the shredding unit.

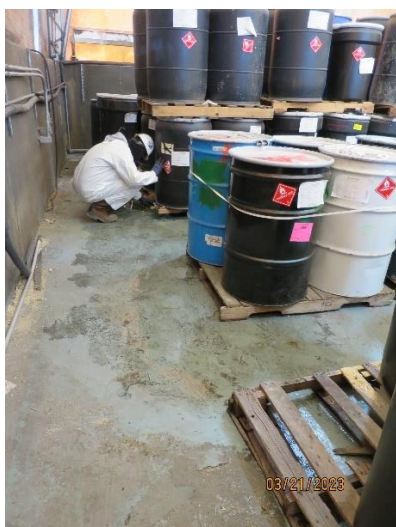
Photo #41 – Pharmaceutical waste containers leaking in staging/storage area – Building #2.

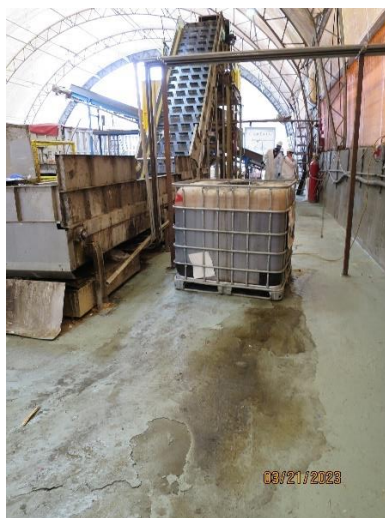
Photo #42 – Spilled liquid pharmaceutical waste From the shredding unit and SAA container.

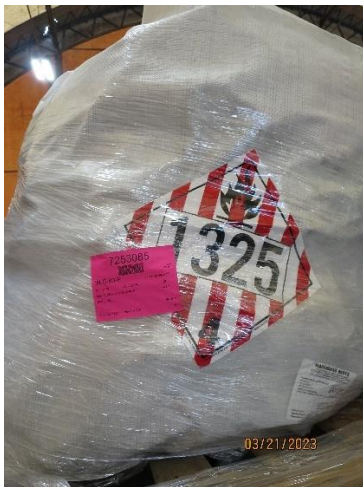
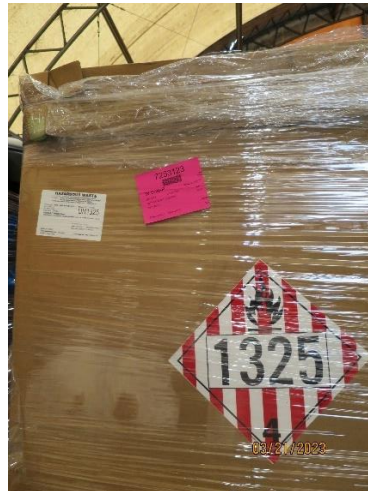
Photo #43 – Pharmaceutical hazardous waste not marked with a “Toxic” indication of the hazards of the contents.

Photo #44 – Pharmaceutical hazardous waste not marked with a “Toxic” indication of the hazards of the contents.

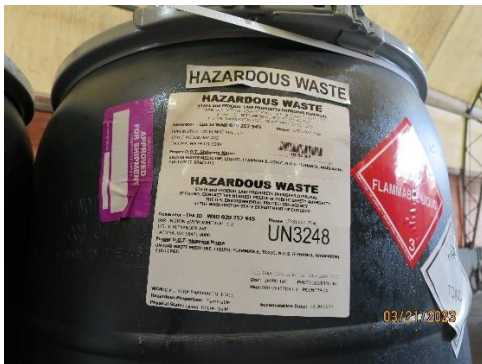
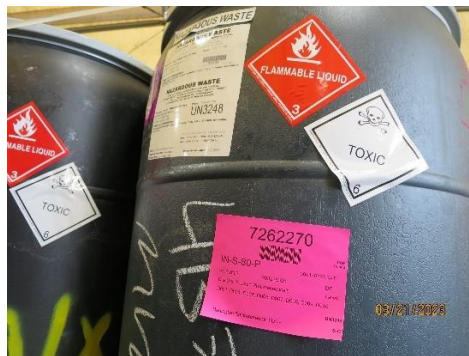
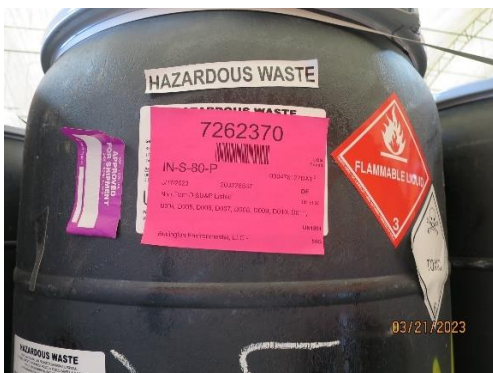
Photo #45 – Pharmaceutical wastes not identified with an appropriate EPA hazardous waste code.

Photo #46 – Pharmaceutical wastes not identified with an appropriate EPA hazardous waste code.

Photo #47 – Pharmaceutical wastes not identified with an appropriate EPA hazardous waste code.
