**Region 6 - Enforcement & Compliance Assurance Division**  
**INSPECTION REPORT**

| Company Name: | <b>Pharr, Billy W (B Pharr Operating, LLC)</b> | |
| Facility Name: | <b>Bo Gregory 2 SWD Tank Battery</b> | |

Appendix 1 – Photograph Log – 36 photos taken 10/08/2024.

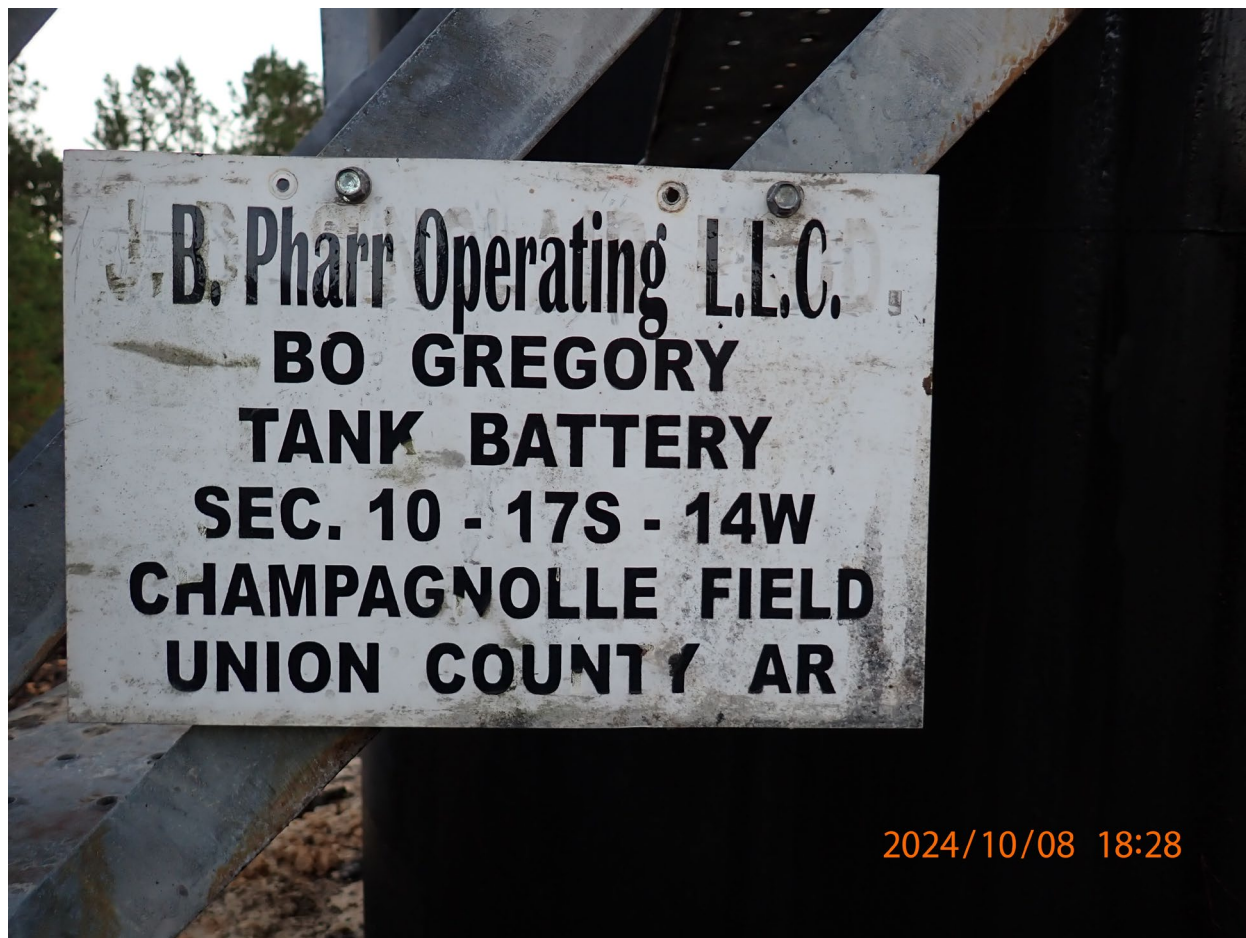
Photo No. 1

Description: Looking S-SE, this photo shows the signage at the facility.

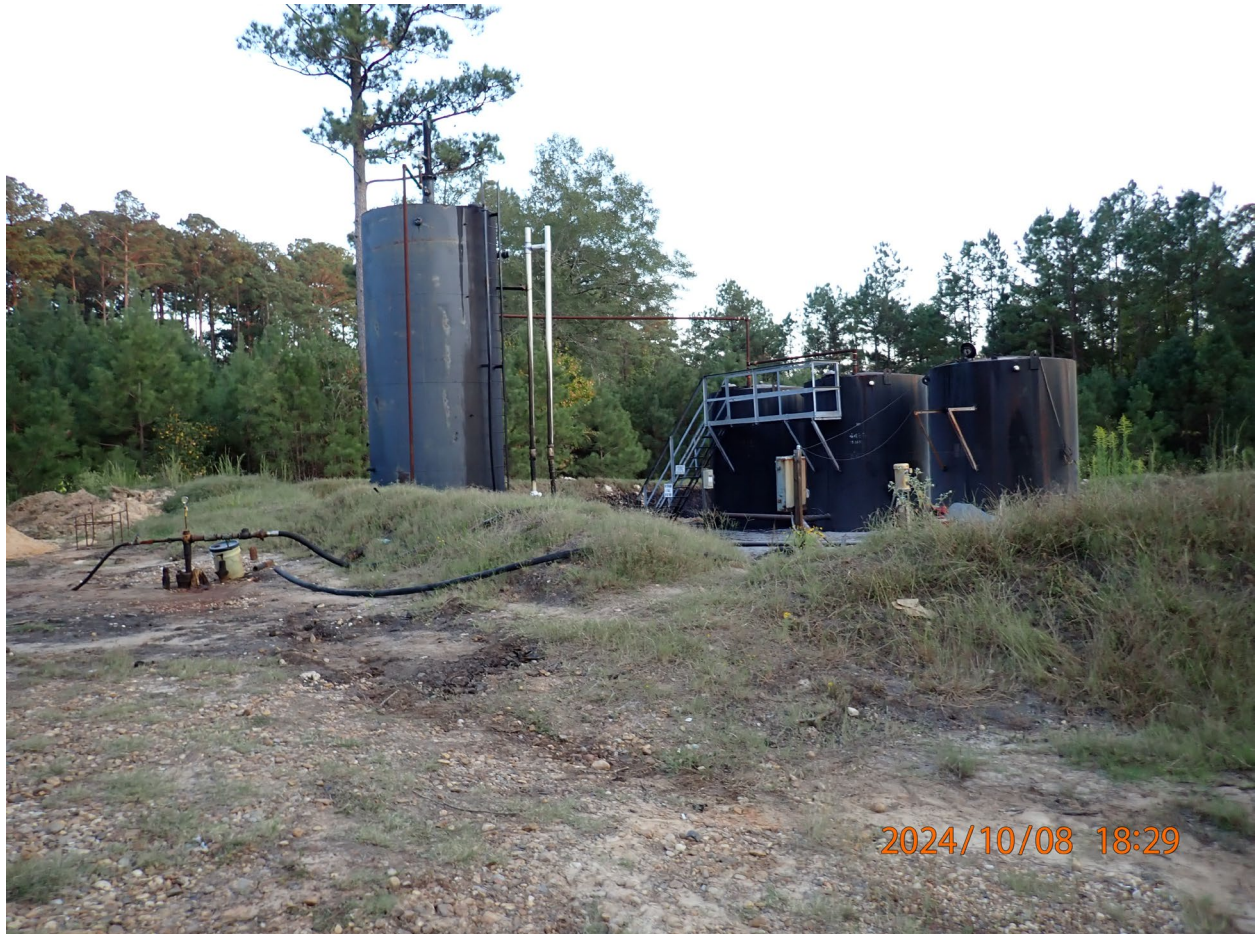
Photo No. 2

**Description:** Looking SW, this photo shows an overview of the Bo Gregory 2 SWD Tank Battery facility with one of two saltwater disposal (SWD) wells onsite.

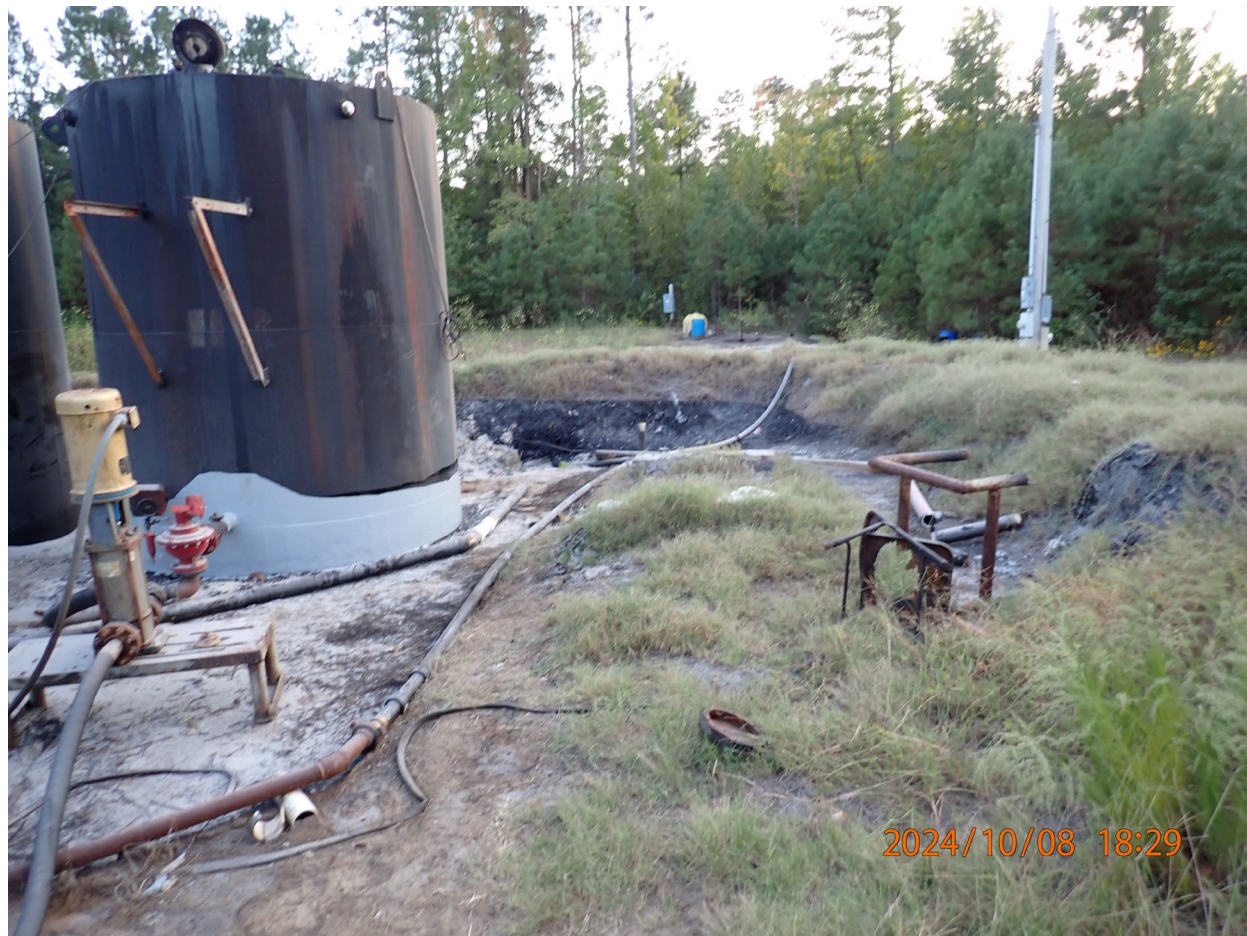
I observed loose oil inside secondary containment, see Photo No. 3 through No. 5, No. 7 and No. 8, and No. 12.

**Description:** Looking S-SE, this photo shows inside the tank battery with staining from crude oil on the berm levee.

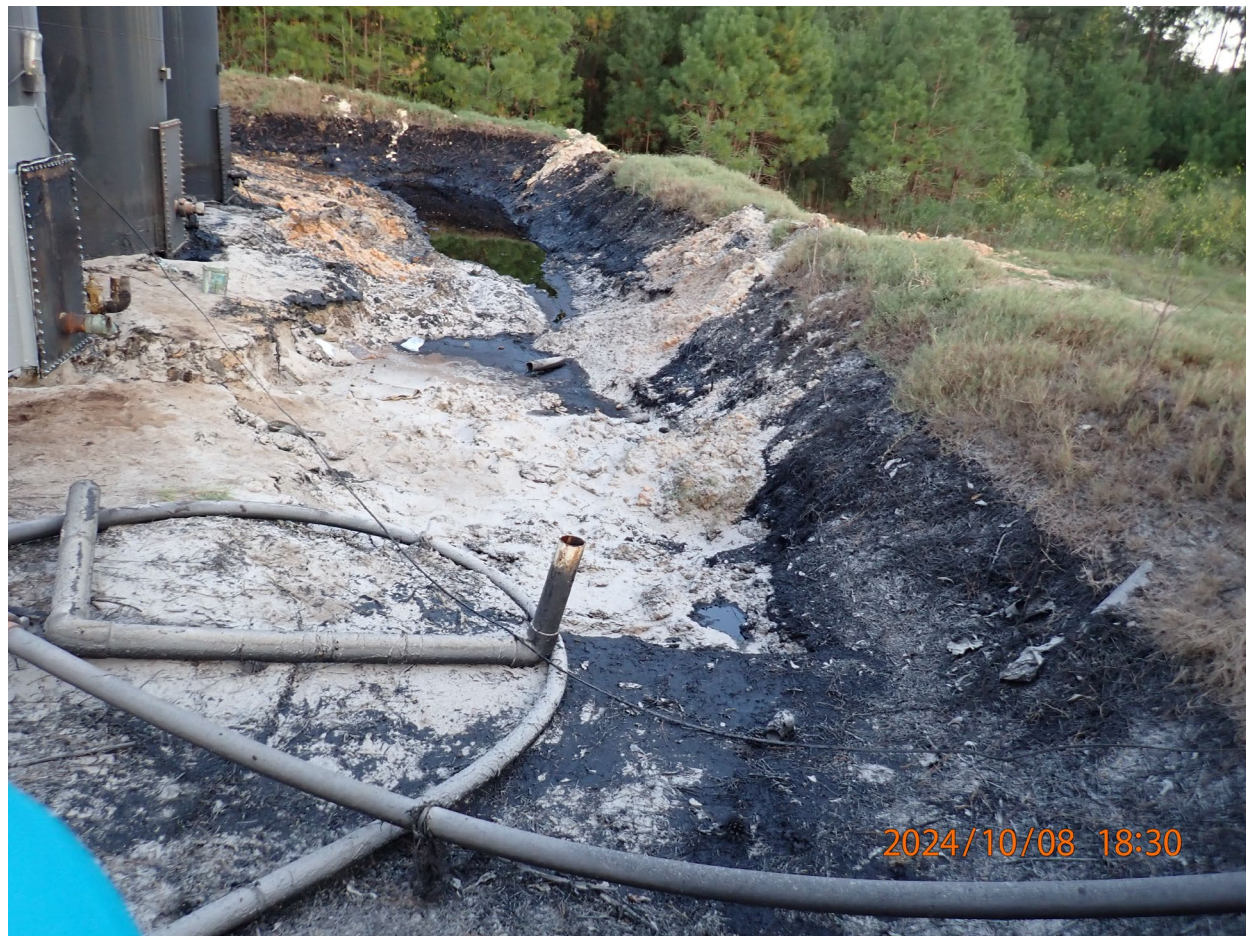
Photo No. 4

**Description:** Looking SW, this photo shows the backside of the tank battery with loose oil, oil staining, and sand from berm repairs.

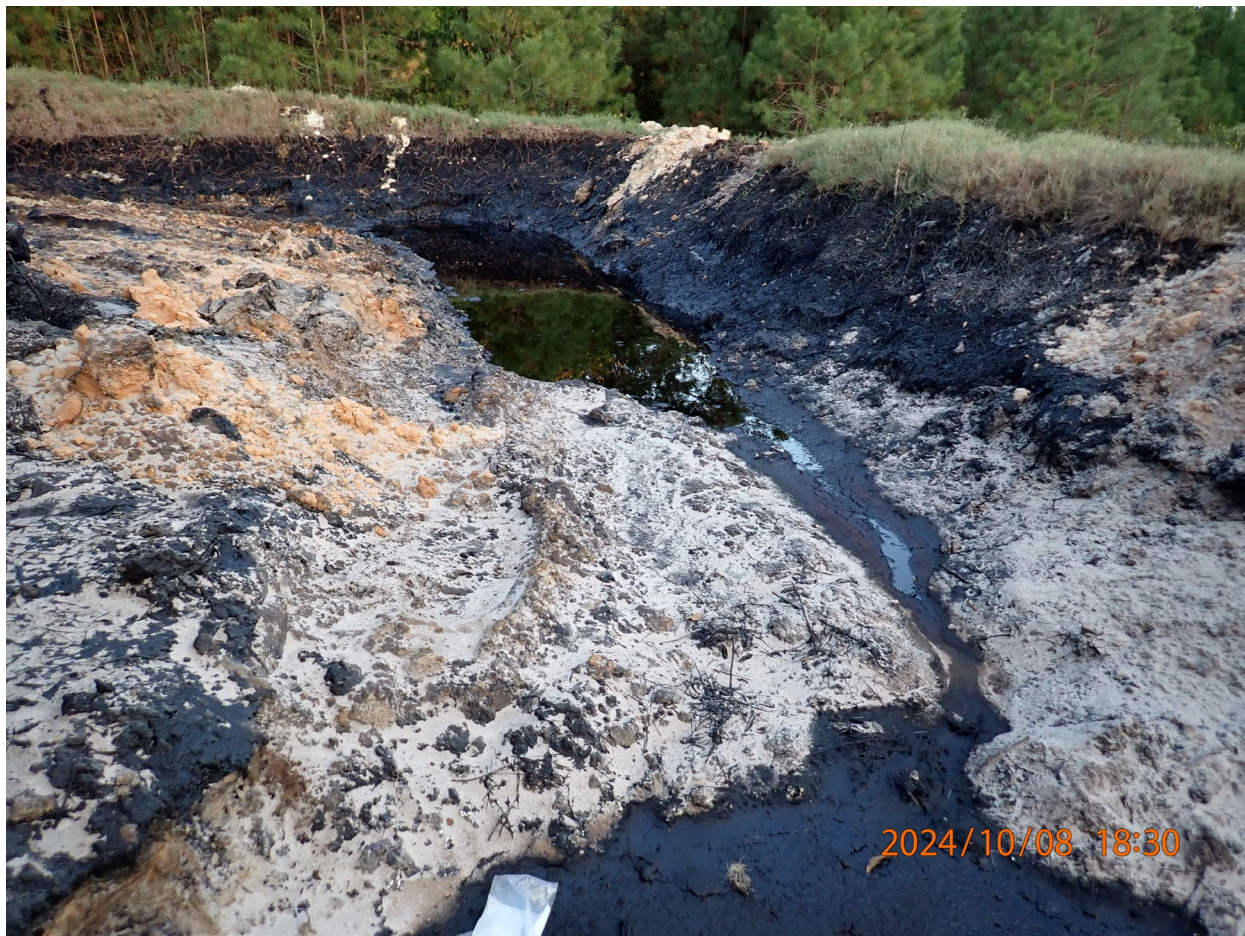
Photo No. 5

**Description:** Looking SW, this photo shows a closeup of the loose oil, oil staining, and sand within secondary containment.

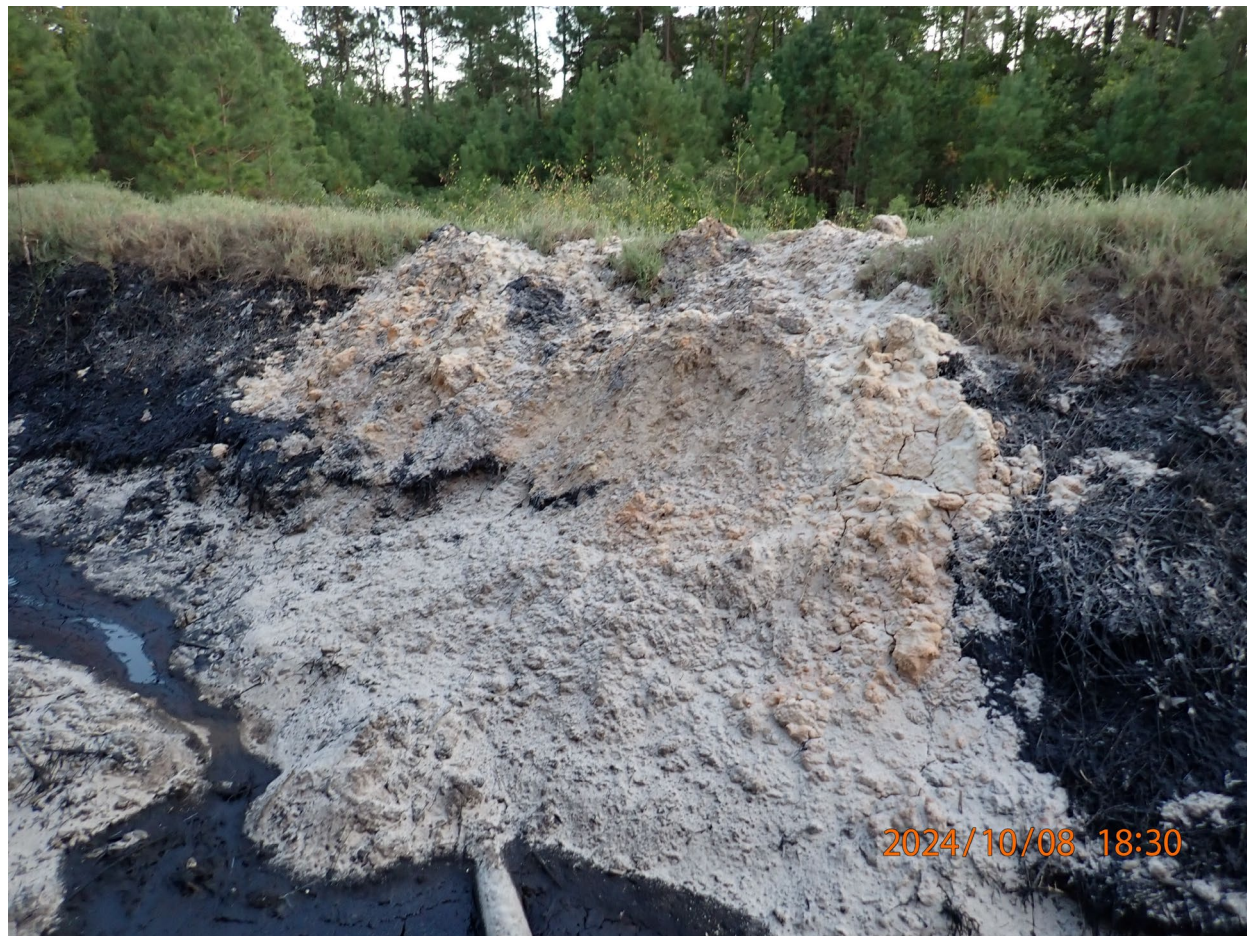
Photo No. 6

I observed disturbed areas of the secondary containment with evidence of repairs made to tanks, pumps, and the berm; see Photo No. 6, No. 9 and No. 10, No. 17, and No. 19.

**Description:** Looking S-SW, this photo shows a section of the berm that had been breached to replace the drainpipe through the berm.

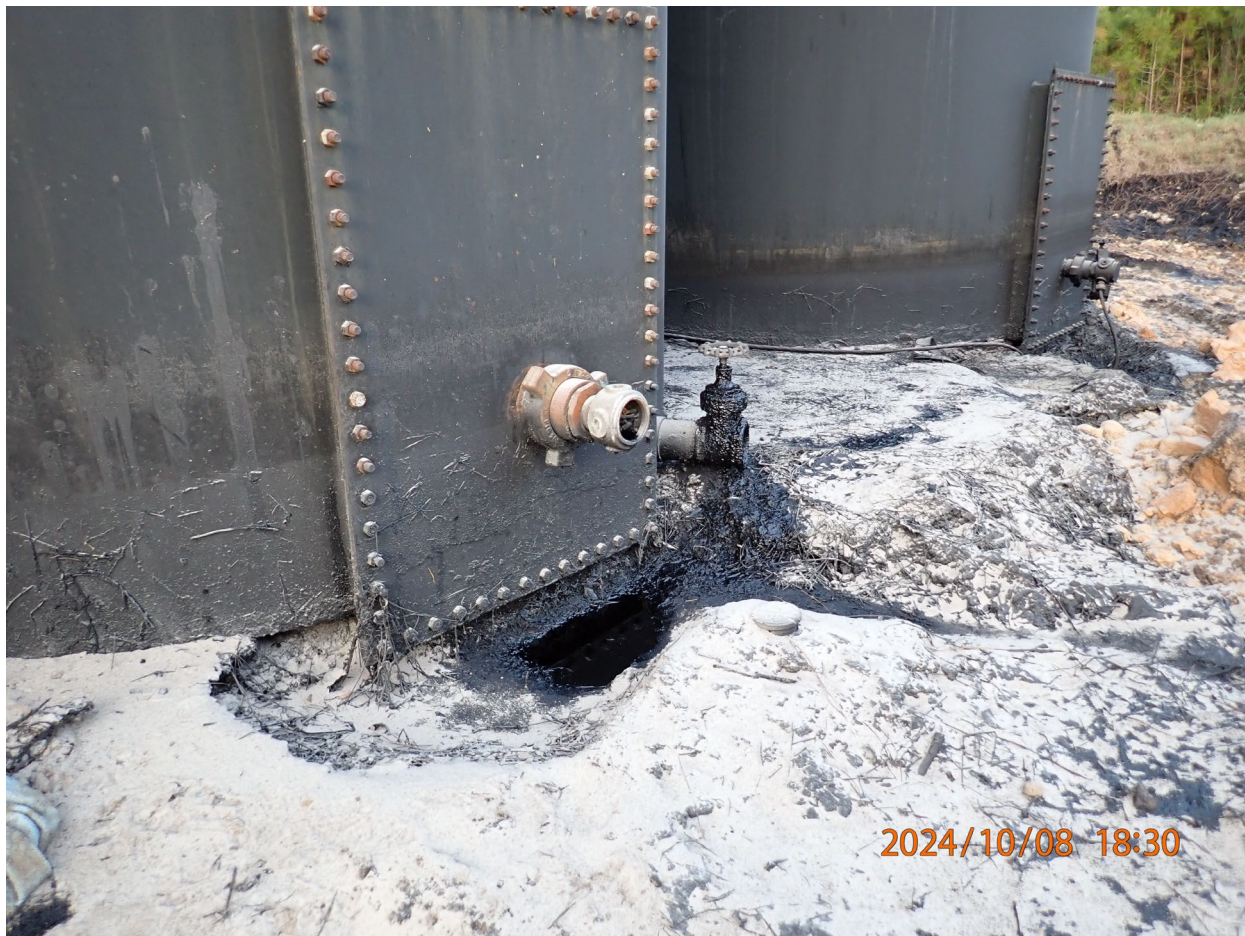
Photo No. 7

**Description:** Looking W, this photo shows an active leak of crude oil from a valve and a gap under the tank.

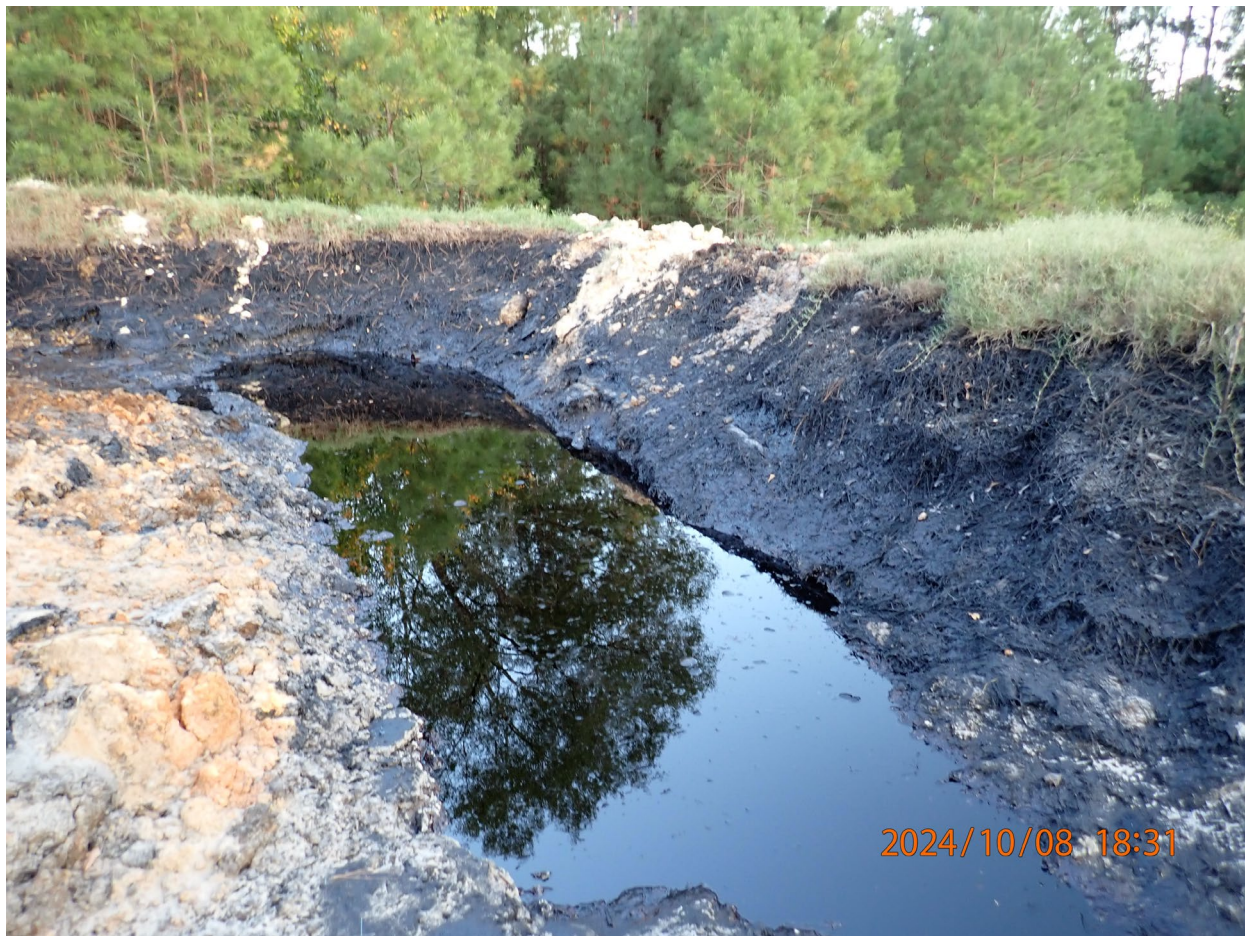
Photo No. 8

**Description:** Looking SW, this photo shows an overview of the loose oil pooled within the berm and the high-level mark from oil staining.

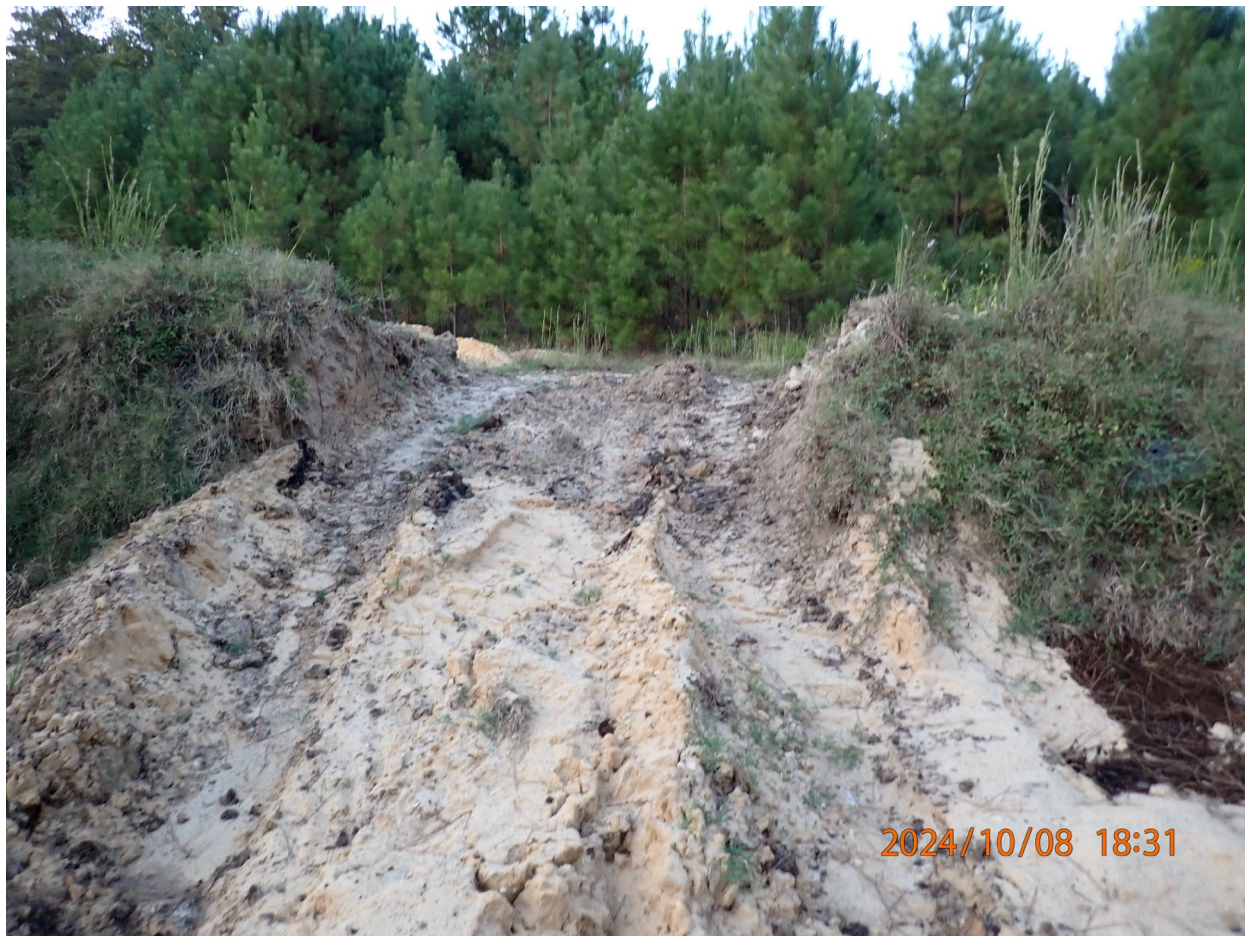
Photo No. 9

**Description:** Looking N-NW, this photo shows area at the front of the tank battery that had been breached to allow heavy equipment inside the berm.

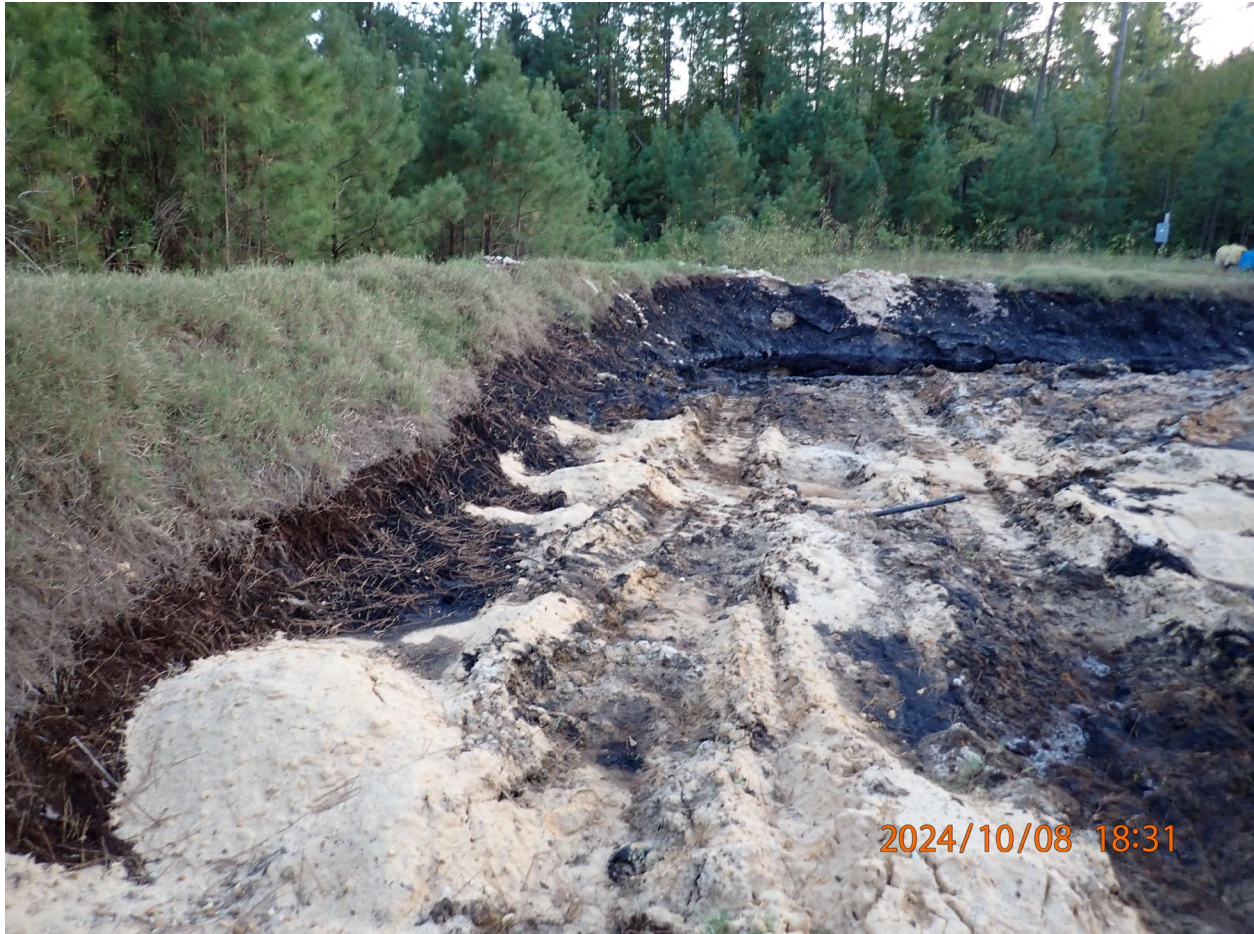
Photo No. 10

**Description:** Looking S, this photo shows heavy equipment tracking on the sand inside the secondary containment.

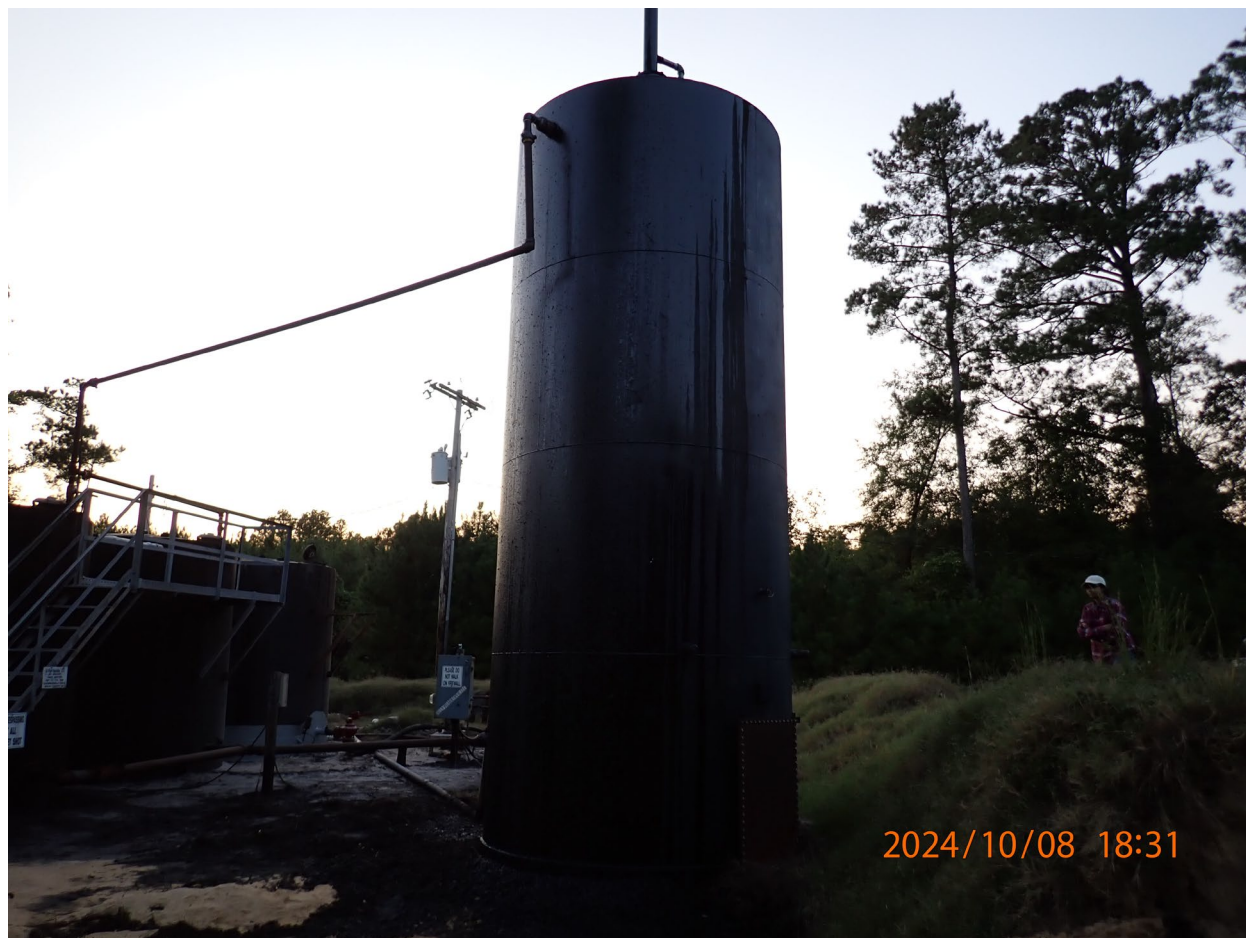
I observed two points of crude oil/saltwater release from the facility and associated SWD, see Photo No. 11 and No. 14.

**Description:** Looking E-NE, this photo shows the separator with evidence of overflow.

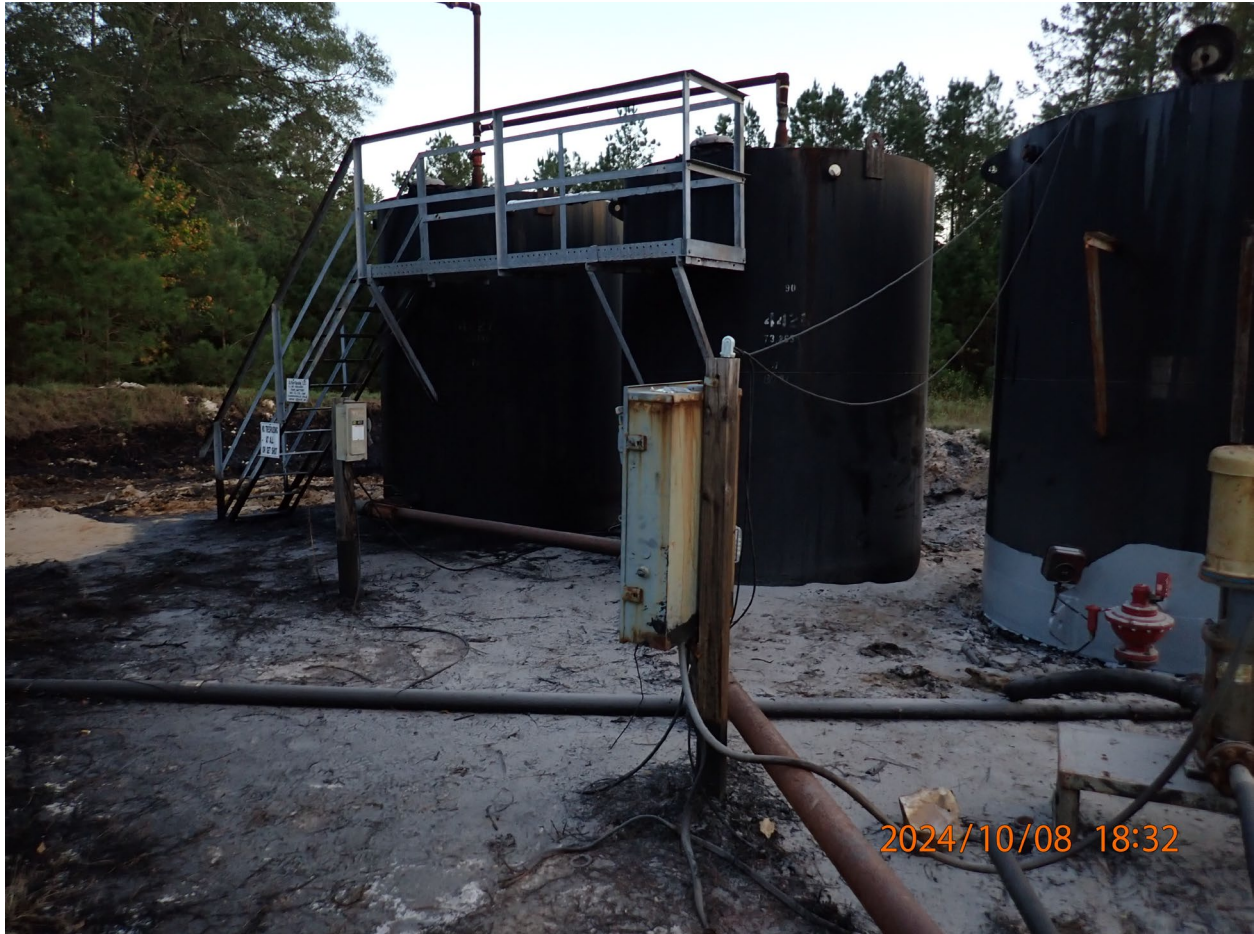
Photo No. 12

**Description:** Looking SW, this photo shows extensive oil staining inside the secondary containment.

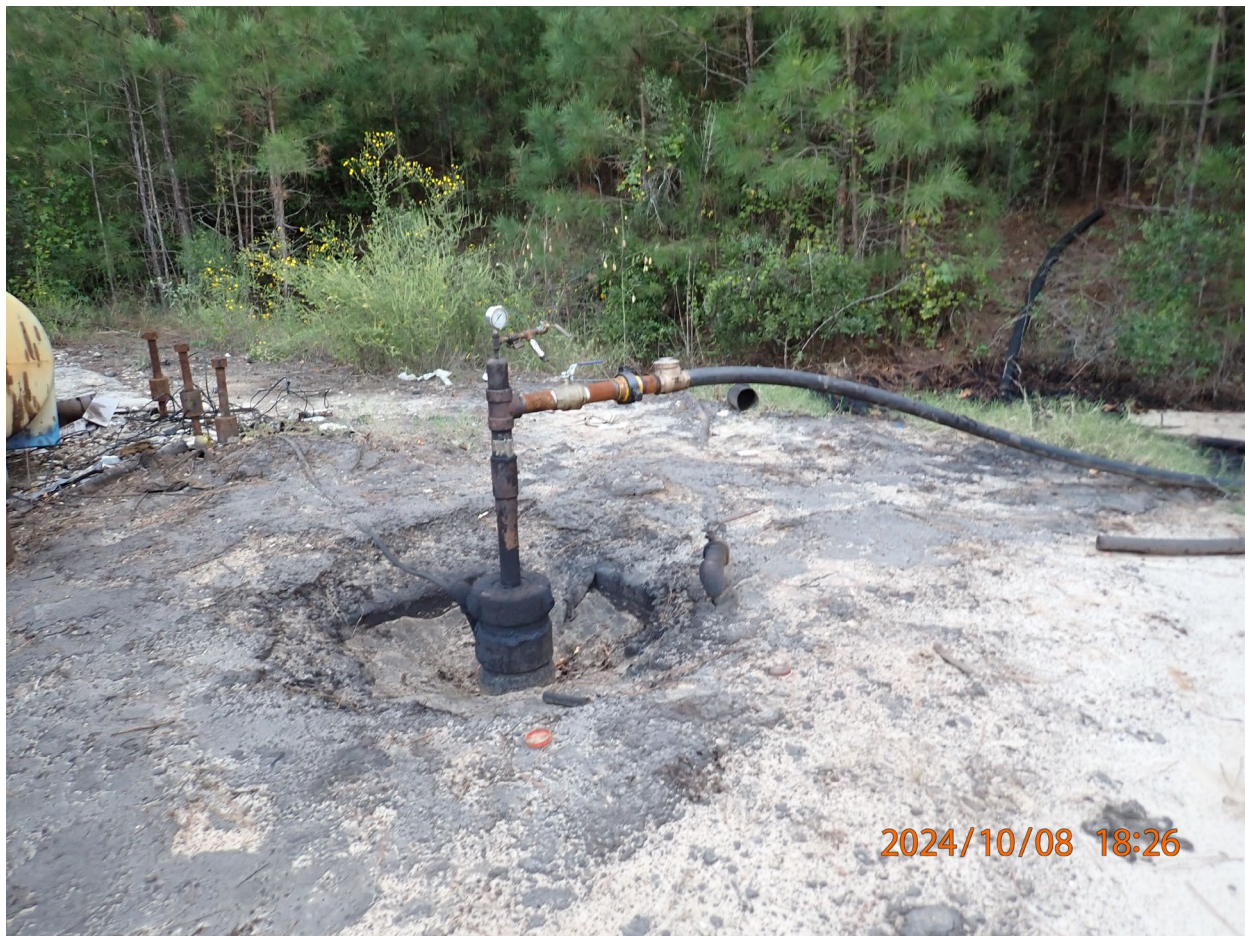
Photo No. 13

**Description:** Looking SE, this photo shows two of two SWD wells onsite.

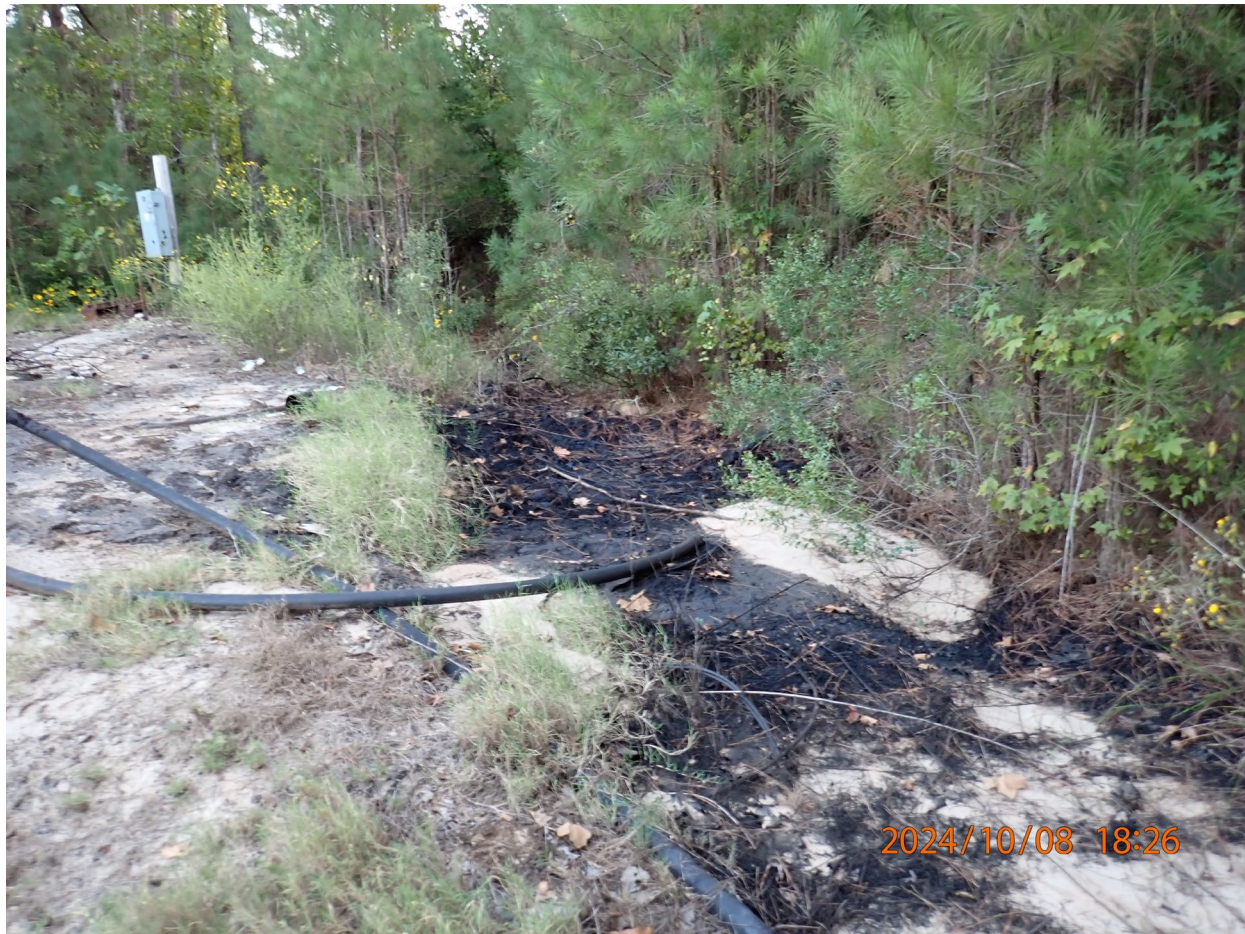
Photo No. 14

**Description:** Looking S, this photo shows one of two release points located at the site.

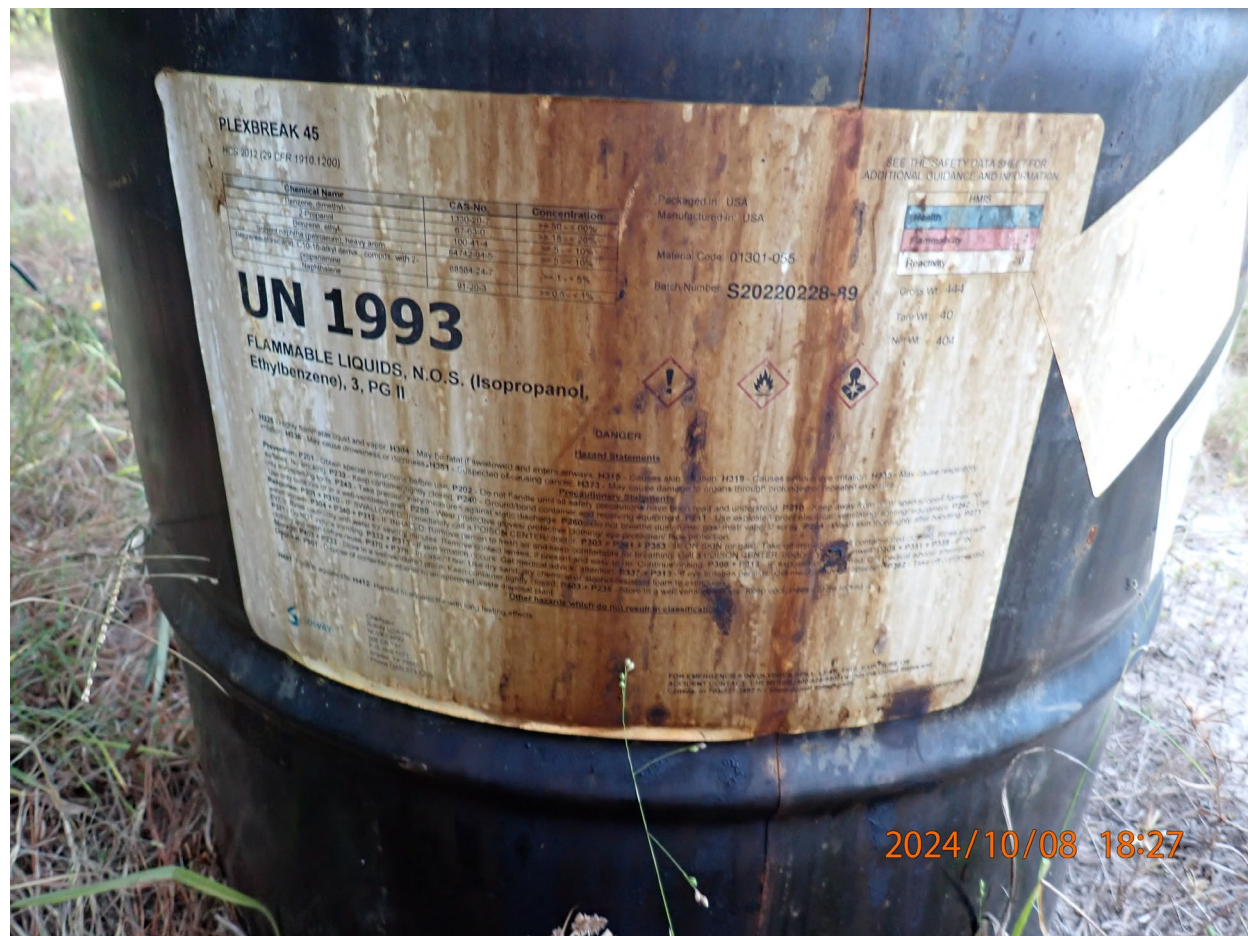
I observed a labeled barrel containing toxic material outside secondary containment, see Photo No. 15 and No. 16.

Description: Looking N-NW, this photo shows a barrel labeled with "Plexbreak 45 (UN 1993)," which contained fluid during the inspection.

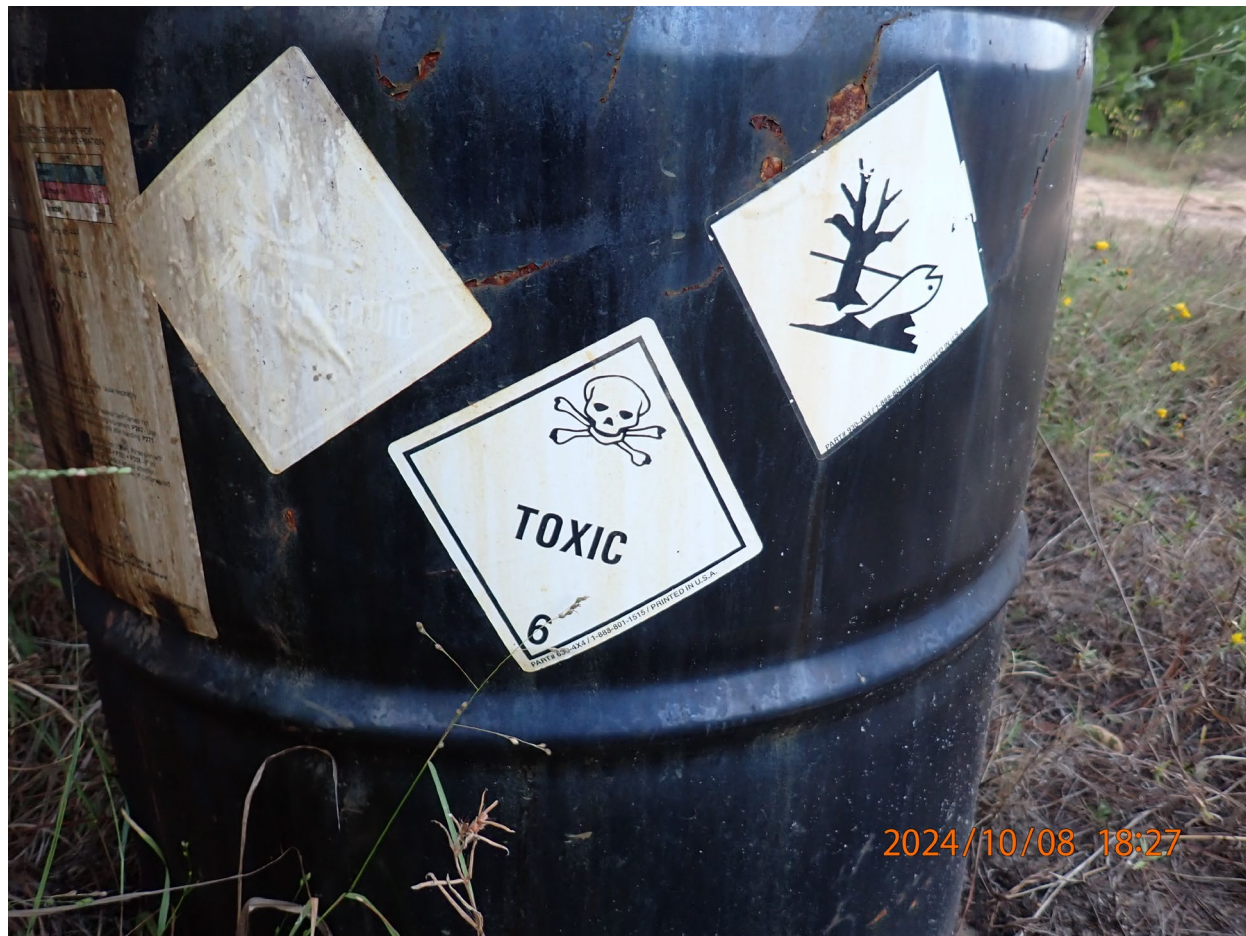
Photo No. 16

Description: Looking N-NE, this photo shows an additional view of the barrel in Photo No. 15.

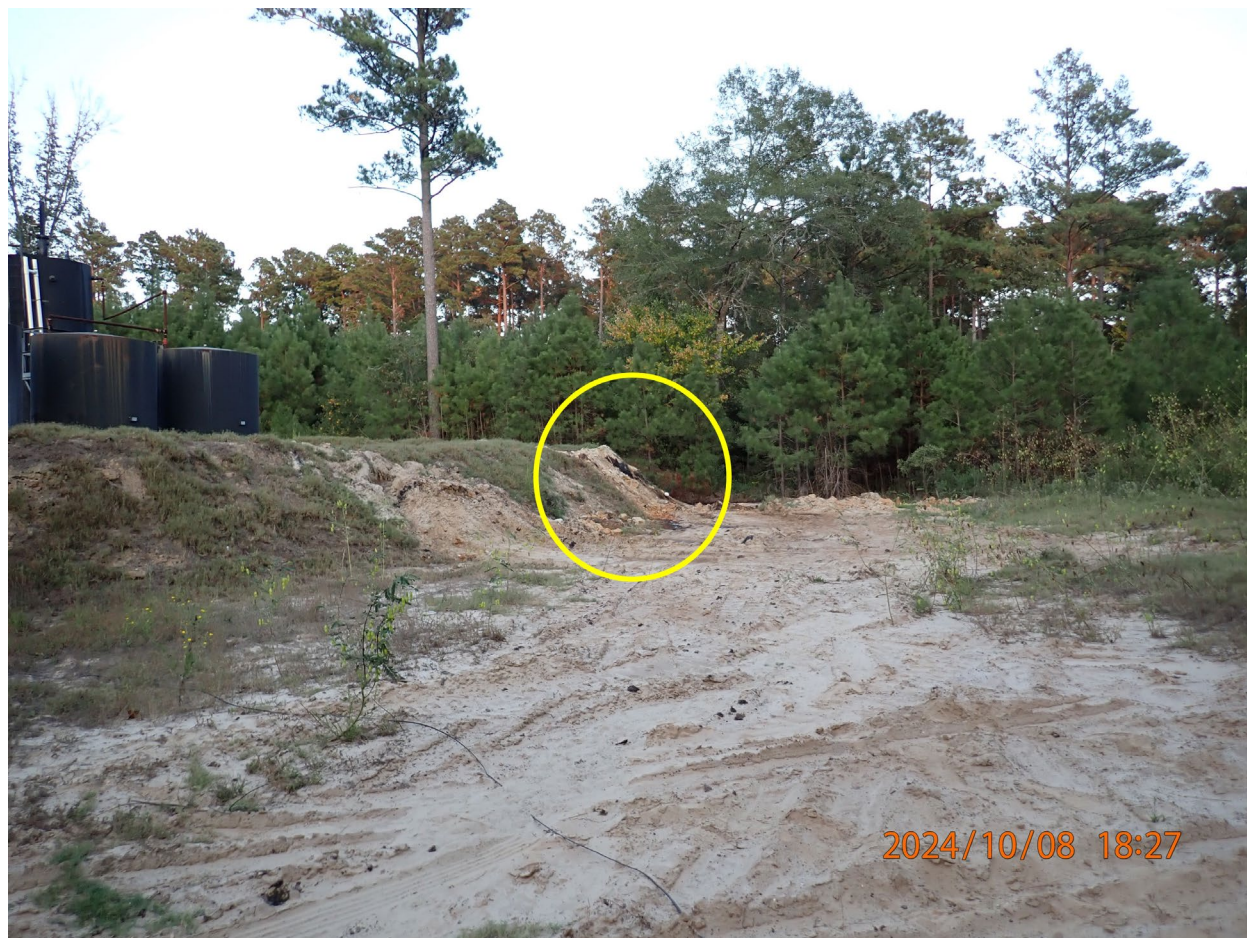
Photo No. 17

**Description:** Looking W-SW, this photo shows disturbed soil around the containment berm; oil staining is highlighted.

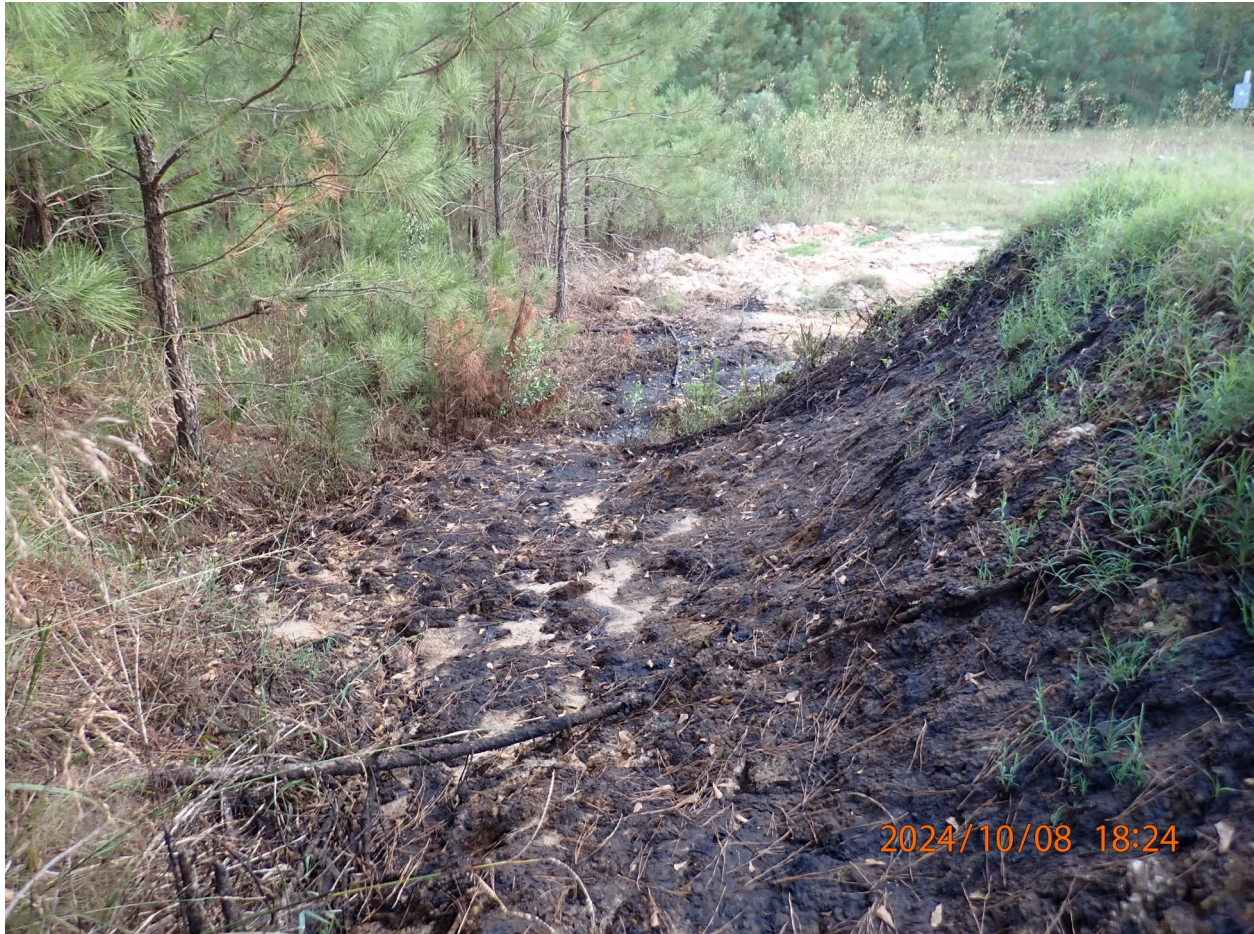
I observed the flowpath of the release of crude oil/saltwater, see Photo No. 18 through No. 30. Directional arrows have been added for clarity.

**Description:** Looking S-SE, this photo shows oil staining from an overflow that occurred from the secondary containment.

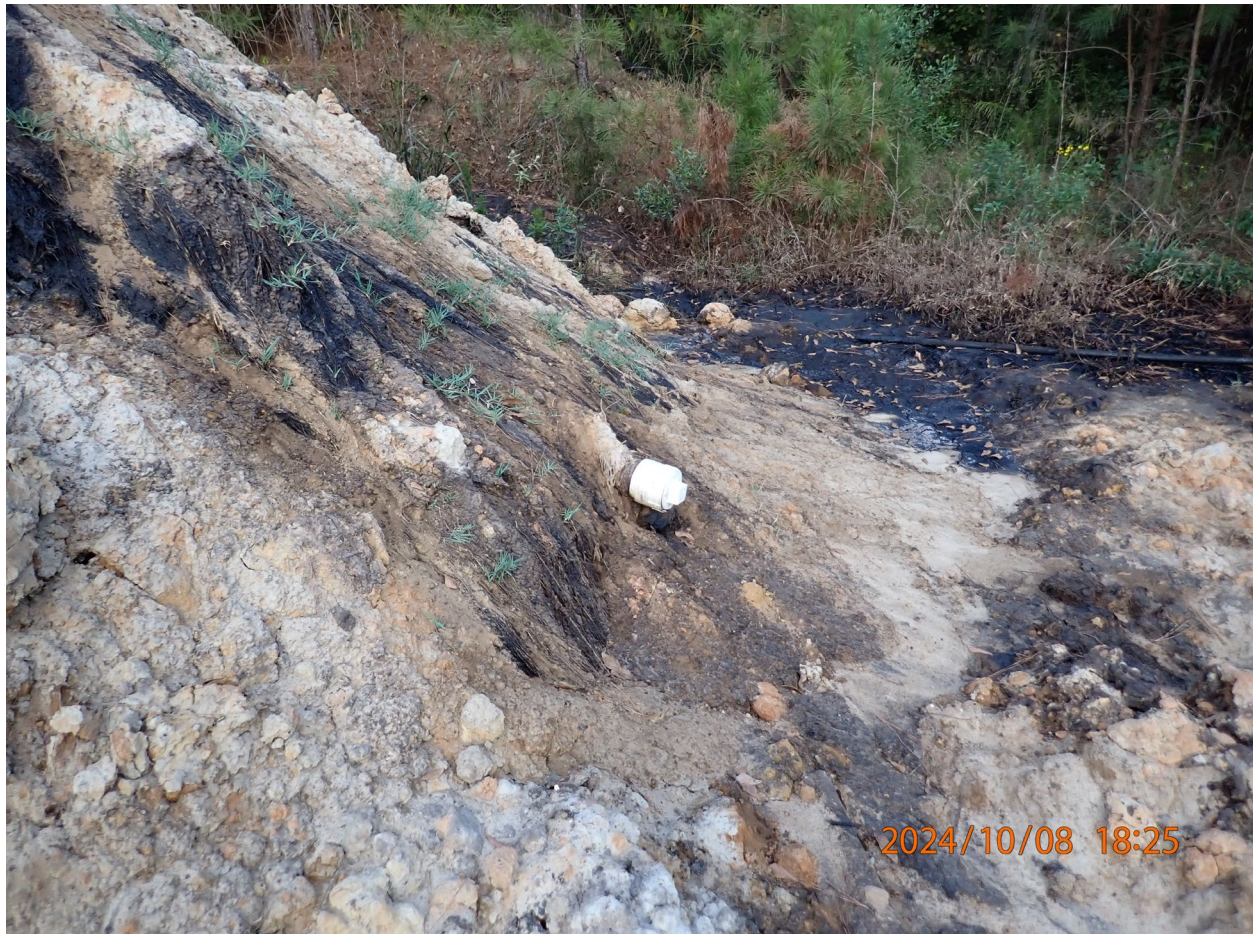
Photo No. 19

**Description:** Looking W-SW, this photo shows evidence of overflow and replaced drainpipe from the secondary containment.
