**Region 6 - Enforcement & Compliance Assurance Division**  
**INSPECTION REPORT**

| Company Name: | <b>Pharr, Billy W (B Pharr Operating, LLC)</b> | |
| Facility Name: | <b>Bo Gregory 2 SWD Tank Battery</b> | |

Appendix 1 – Photograph Log – 36 photos taken 10/08/2024.

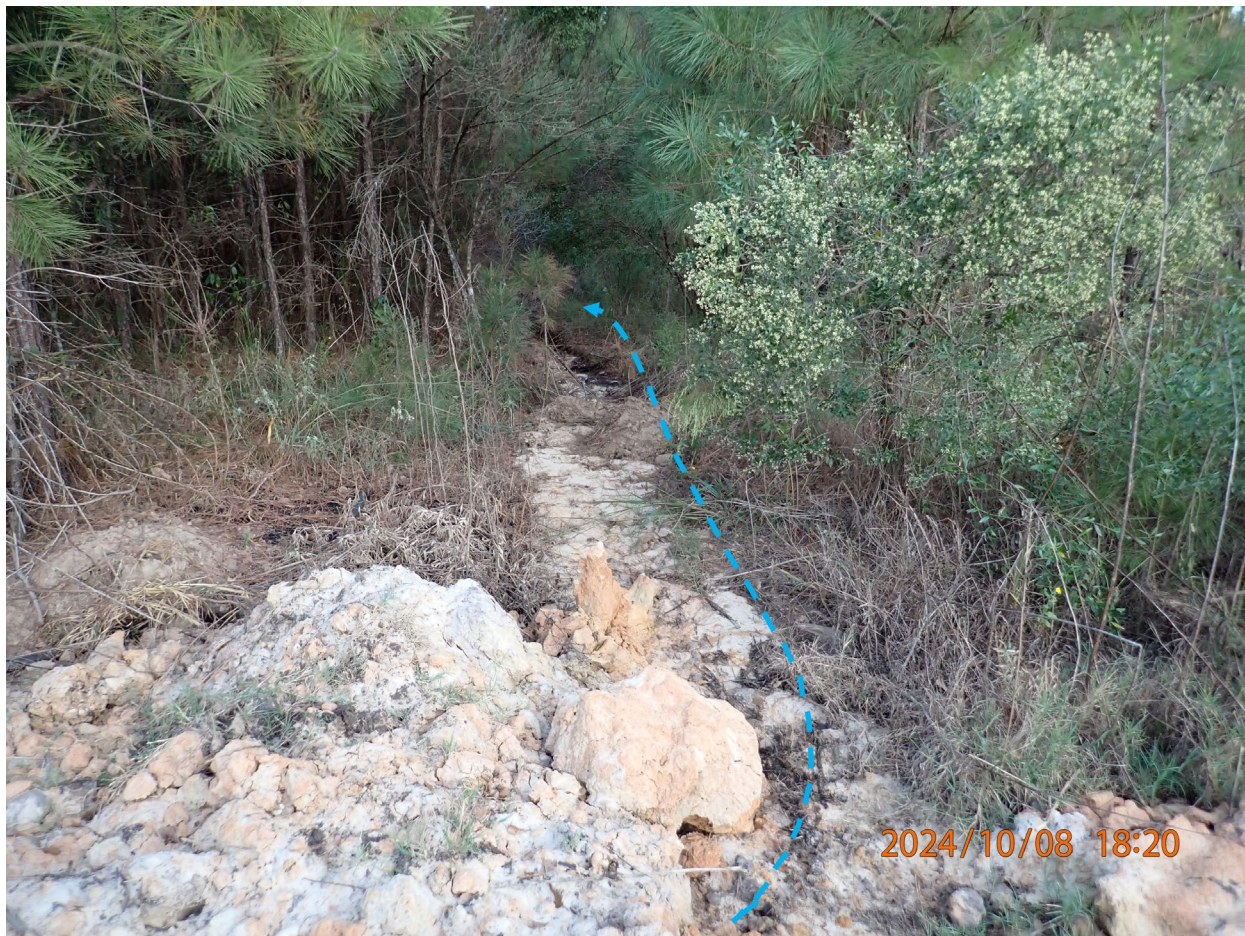
Photo No. 20

I observed the flowpath of the release of crude oil/saltwater, see Photo No. 18 through No. 30. Directional arrows have been added for clarity.

**Description:** Looking SW, this photo shows the beginning of the flowpath for the overflow that occurred at the secondary containment; flowpath has been highlighted for clarity.

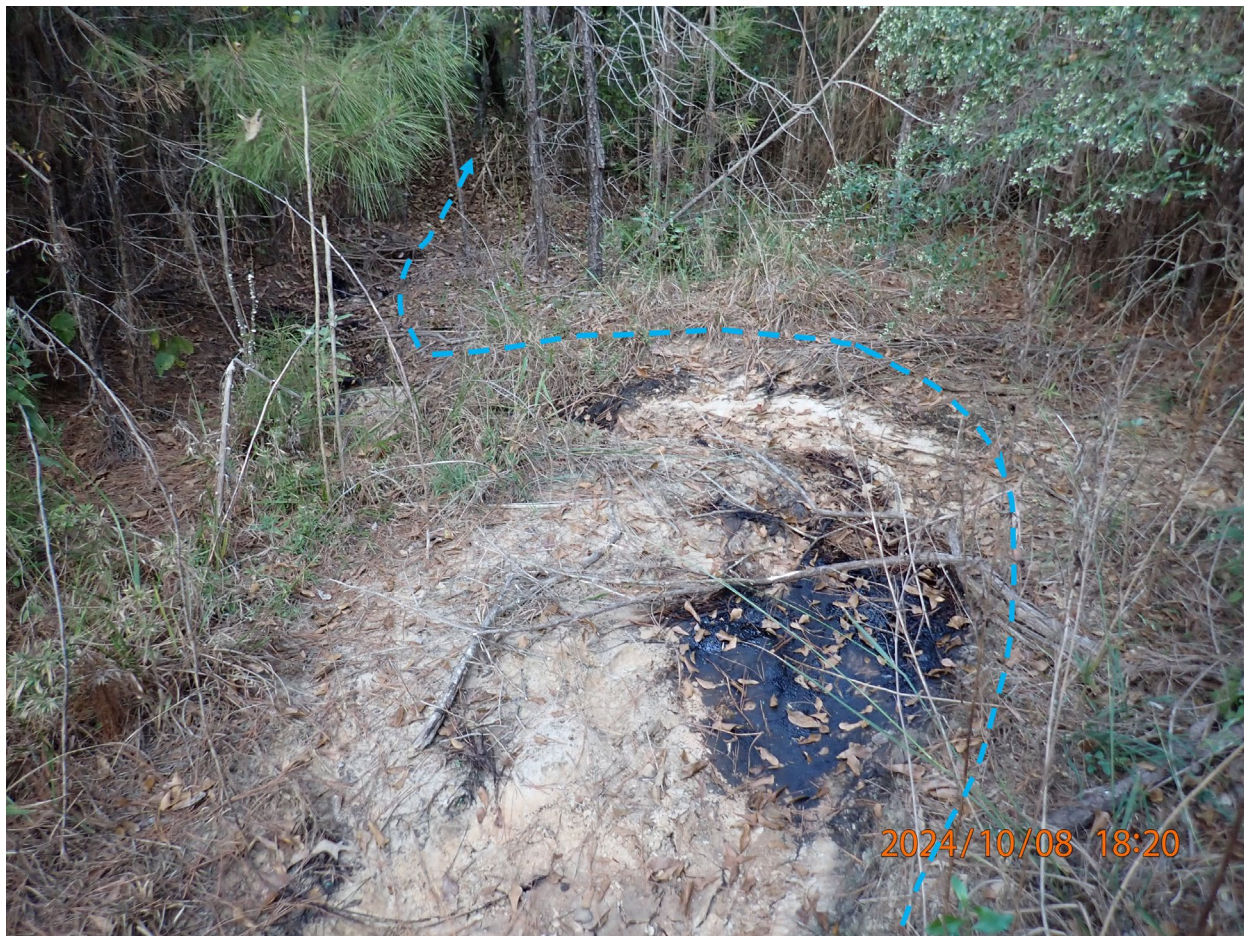
Photo No. 21

**Description:** Looking N-NW, this photo shows the continuation of the flowpath from the overflow from the secondary containment; flowpath has been highlighted for clarity.

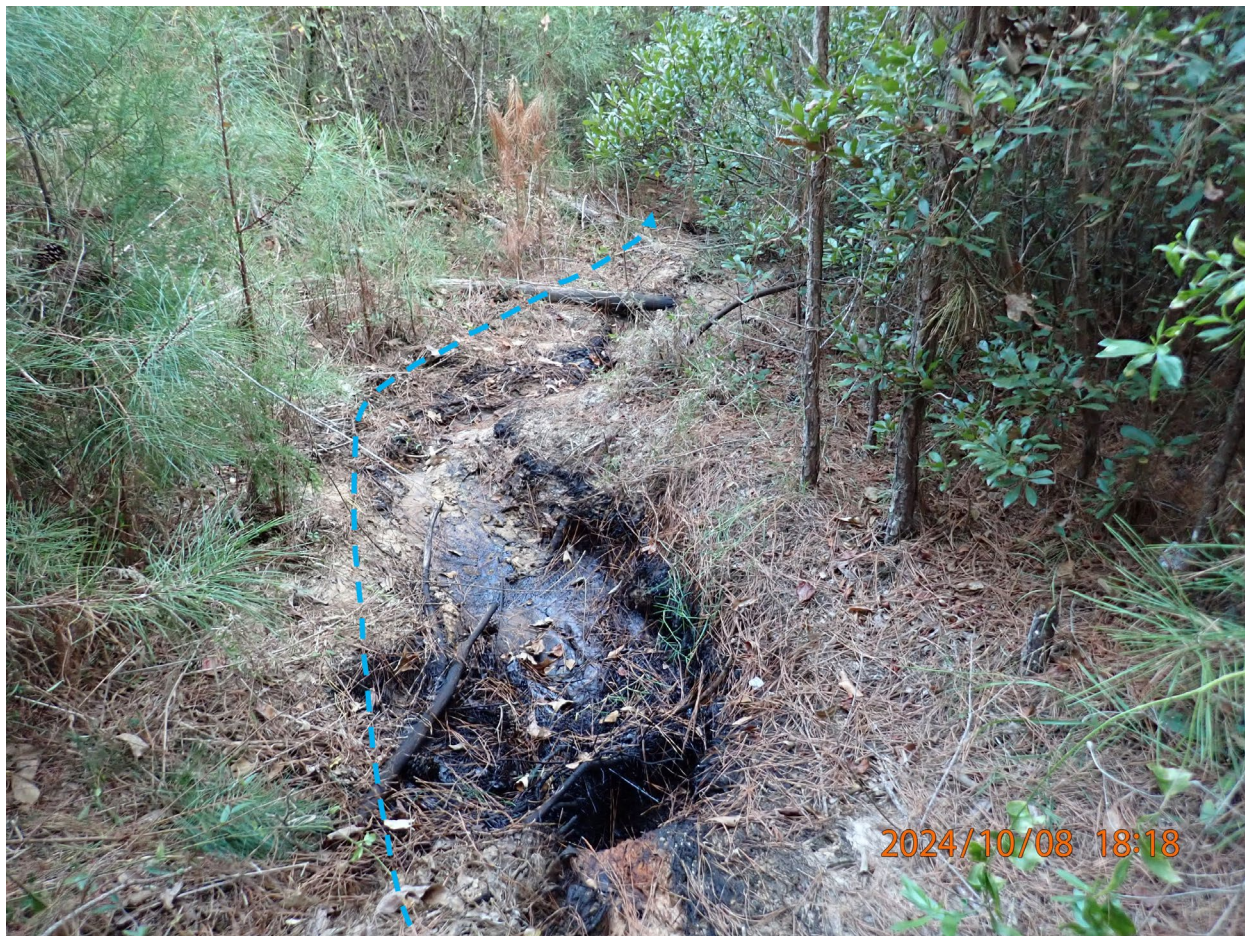
Photo No. 22

**Description:** Looking S-SW, this photo shows the continuation of the flowpath from the overflow from the secondary containment; flowpath has been highlighted for clarity.

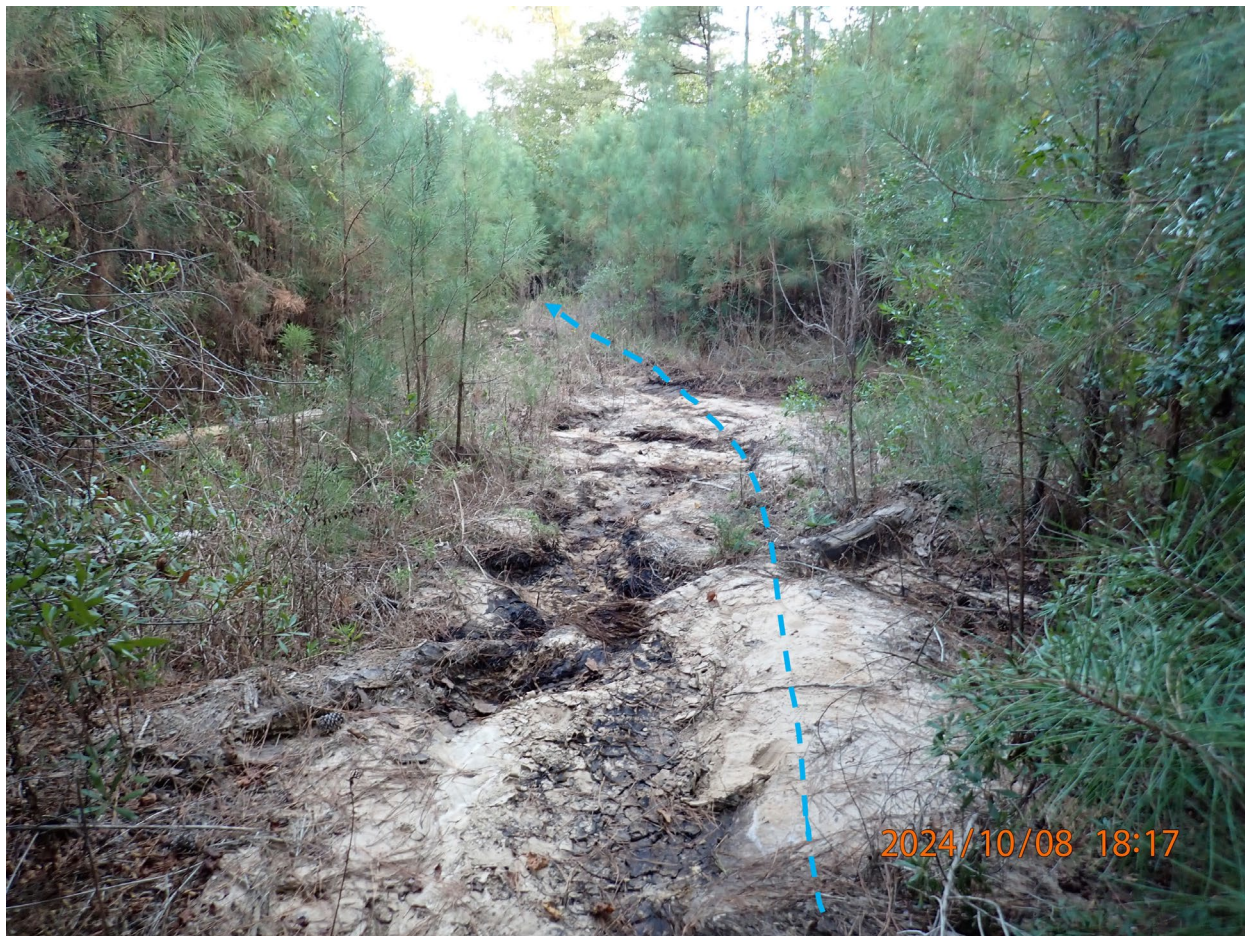
Photo No. 23

**Description:** Looking S, this photo shows the continuation of the flowpath from the overflow from the secondary containment; flowpath has been highlighted for clarity.

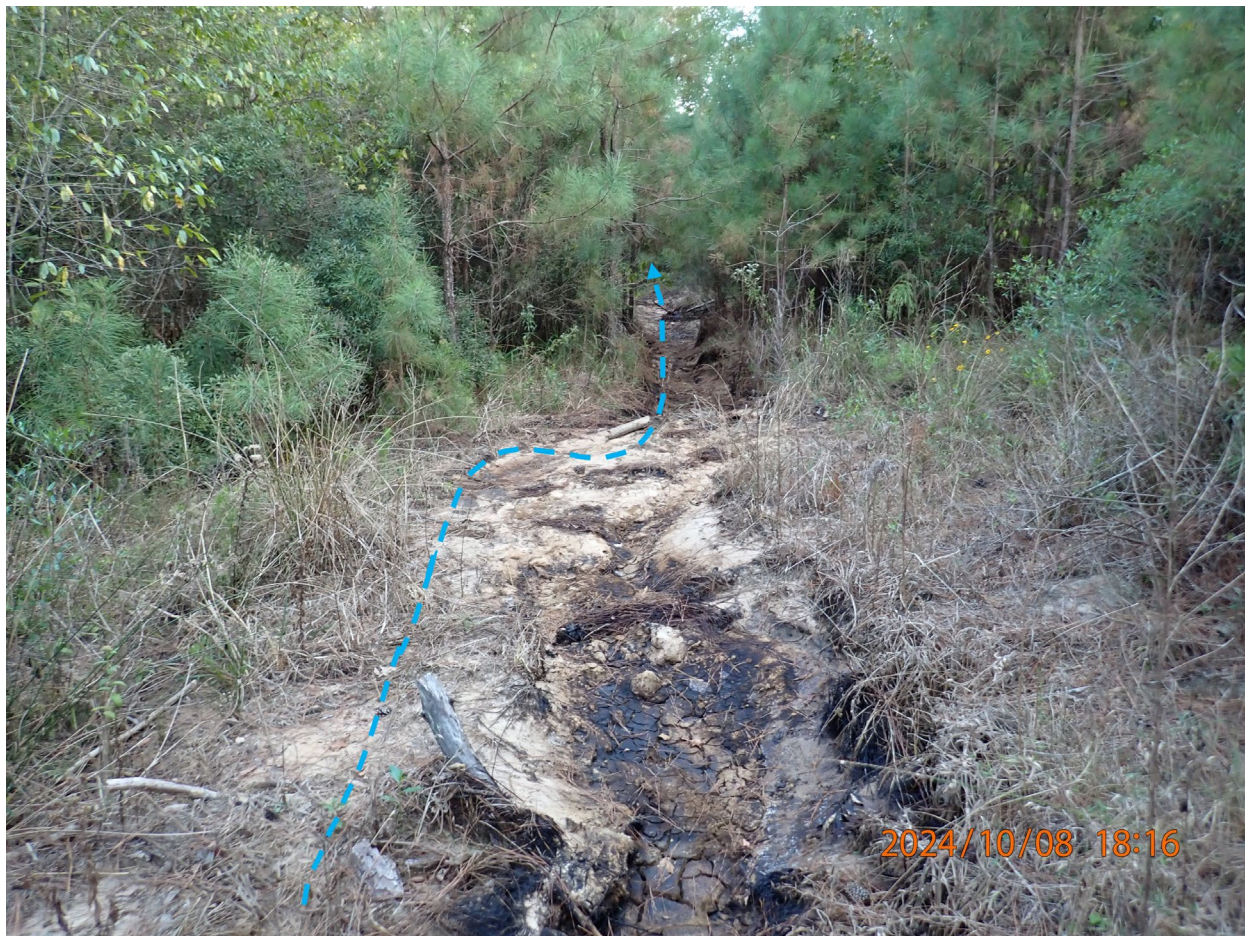
Photo No. 24

**Description:** Looking S-SW, this photo shows the continuation of the flowpath from the overflow from the secondary containment; flowpath has been highlighted for clarity.

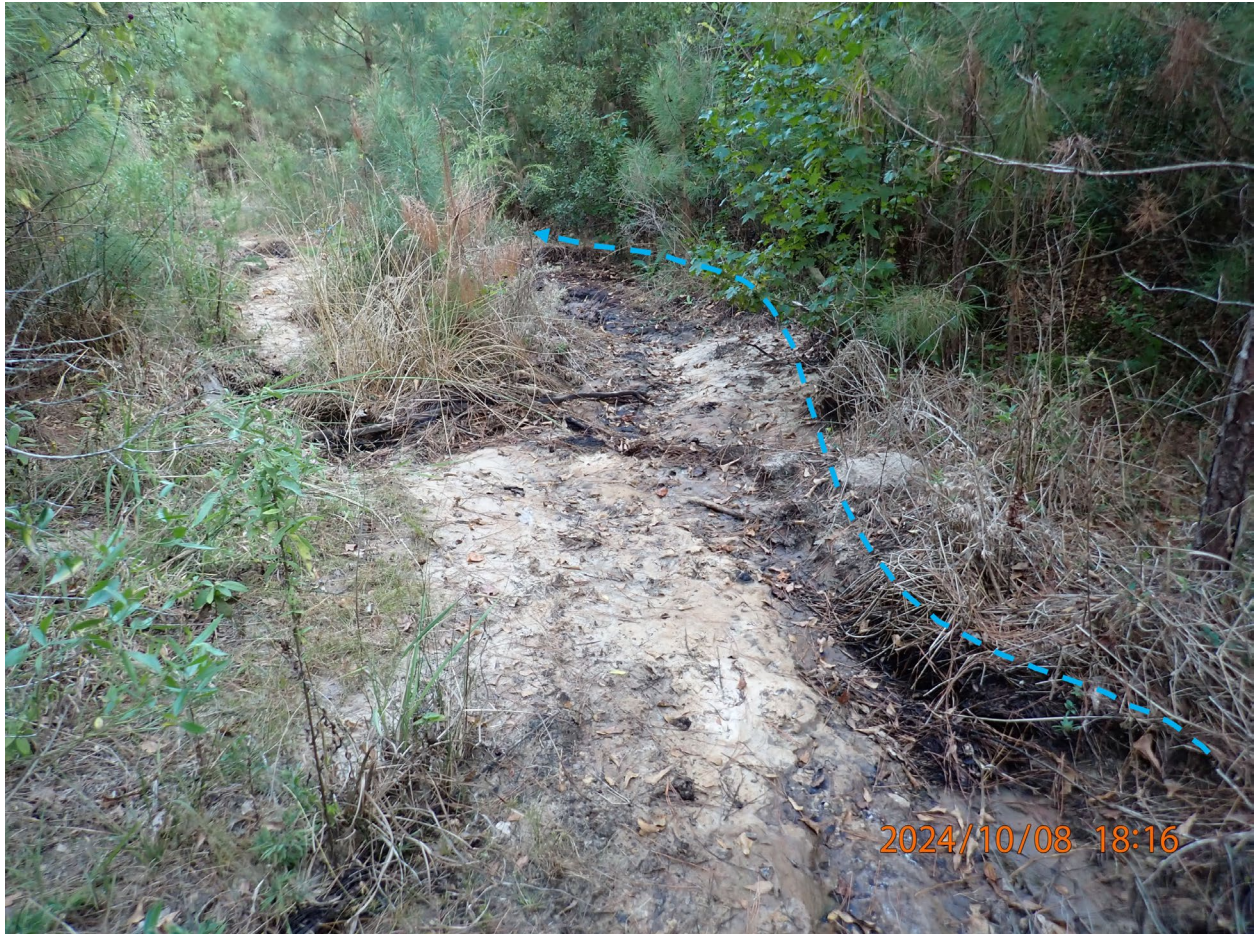
Photo No. 25

**Description:** Looking S-SW, this photo shows the continuation of the flowpath from the overflow from the secondary containment; flowpath has been highlighted for clarity.

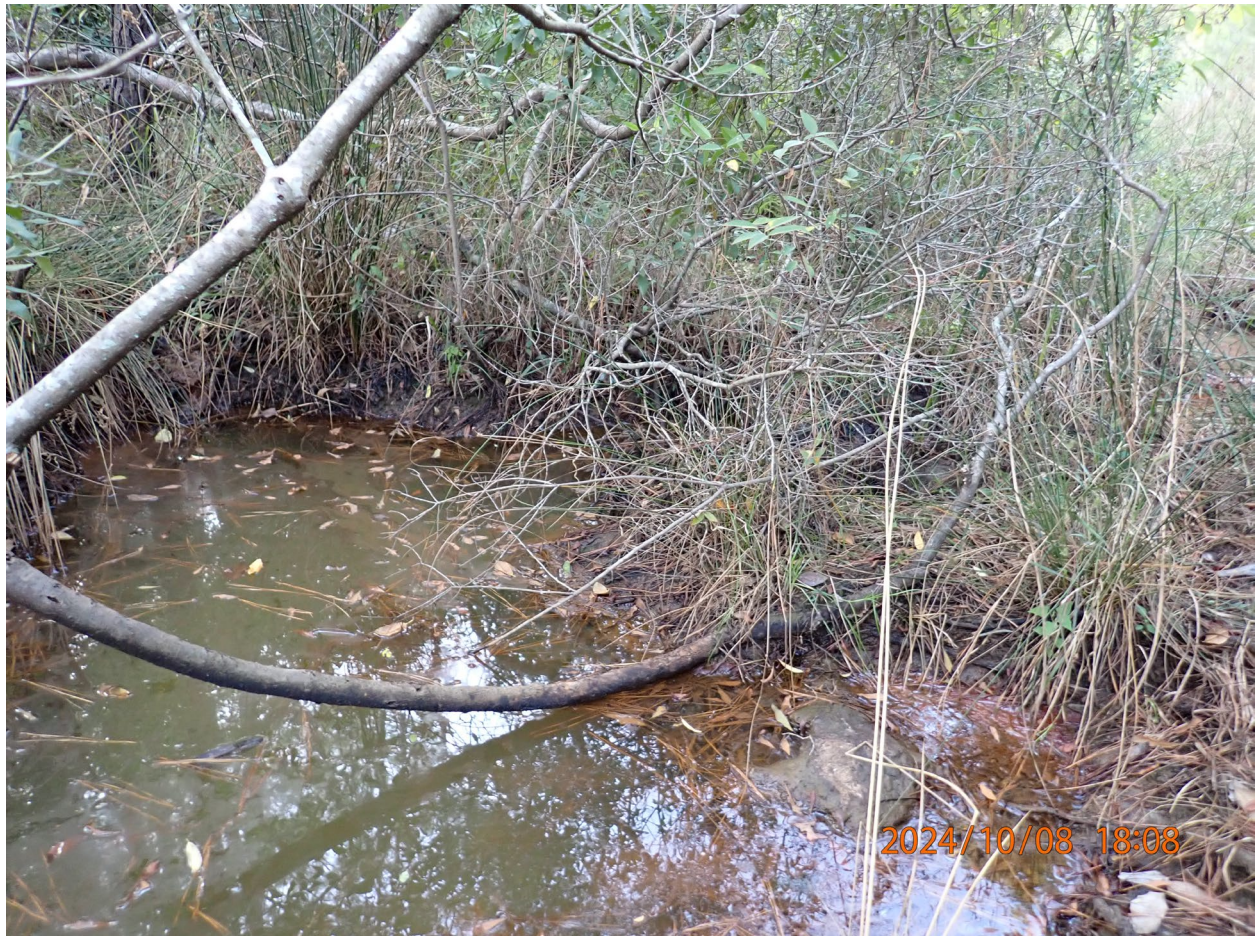
**Description:** Looking NE, this photo shows the area upstream of the TDS reading in Photo No. 31. Note reddish staining and petroleum sheen caused by a saltwater/crude oil discharge (bottom right).
