## **RCRA Inspection Report**

Ford Motor Company–KY Truck Plant      KYD053351227  
3001 Chamberlain Lane  
Louisville, Jefferson County, Kentucky 40241

October 18, 2022

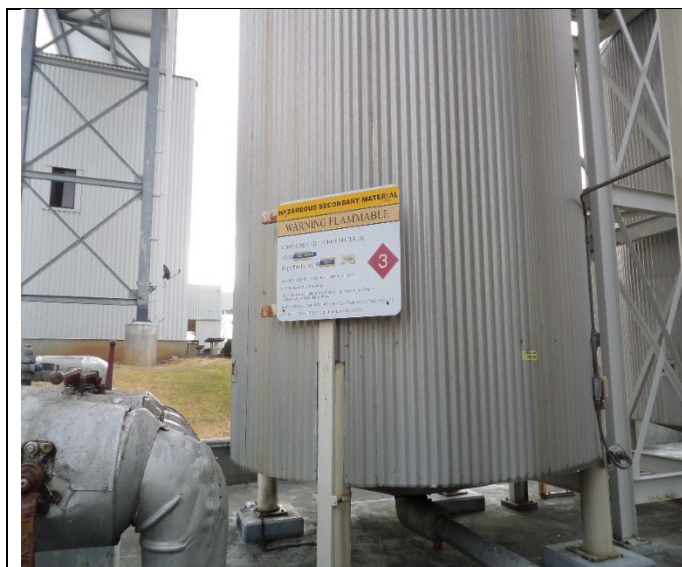
Mike Grossman, MPS and Nolan Pellman, Gage Products Company met inspectors at the outdoor tank farm. The inspectors observed a tank farm with two approximately 9,800-gallon vertical tanks marked as tank number three and tank number four. The tanks were on a sealed concrete pad and surrounded by 12 to 18-inch concrete secondary containment berm. Each tank was raised above the concrete pad by four welded steel support legs mounted on four elevated concrete footings. Tank number three accumulates purge solvent from the SUV paint line and tank number four accumulates purge solvent from the truck paint line. The inspectors observed that the concrete containment was dry, appeared clean, and in good condition. The inspectors observed each tank labeled with the words "hazardous secondary materials, warning flammable". The words "used purge material" were also marked on each tank (Photographs 1 and 2). Tank number one and number two accumulate wastewater.

Outdoor Tank Farm. HSM Tank #3 waste paint and solvent from SUV paint line. Photograph 1 taken at 9:59 a.m.

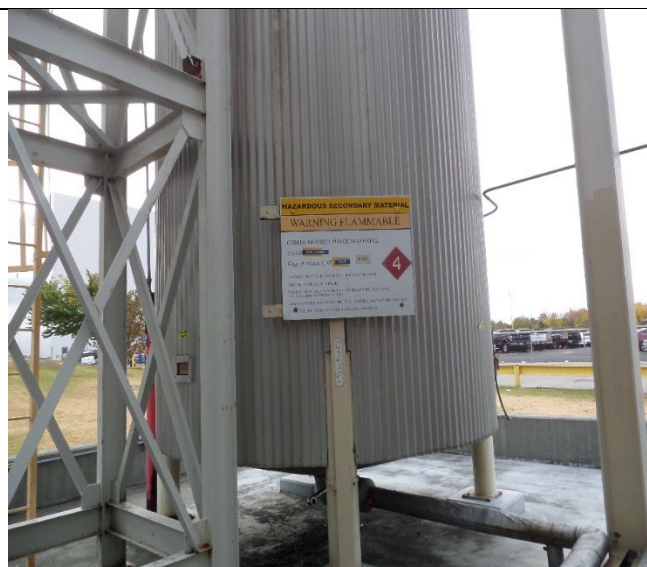
Outdoor Tank Farm. HSM Tank #4 waste paint and solvent from super duty truck paint line. Photograph 2 taken at 9:59 a.m.

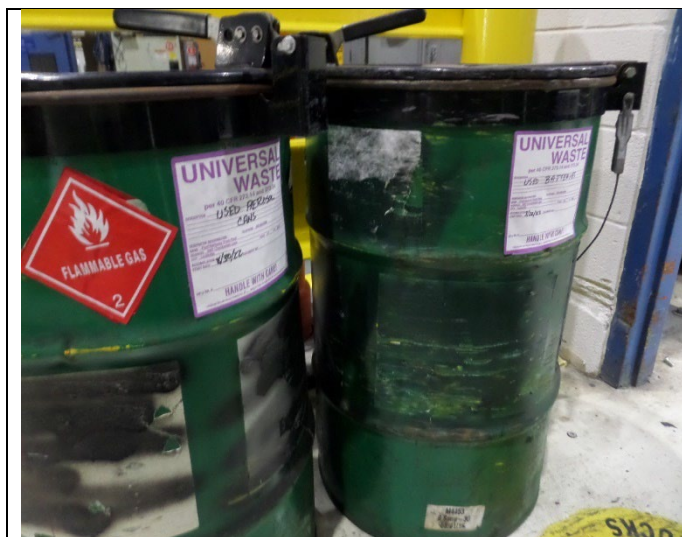
The inspectors observed two 20 to 30-gallon containers accumulating waste aerosol cans and waste batteries. The containers were closed, labeled with the words "universal waste", and

marked with the date March 22, 2022, and August 30, 2022. The container of aerosol cans was labeled with a flammable hazard indicator (Photograph 3).

Paint Building. Maintenance Area. Container of universal waste aerosol cans and batteries. Photograph 3 taken at 10:32 a.m.

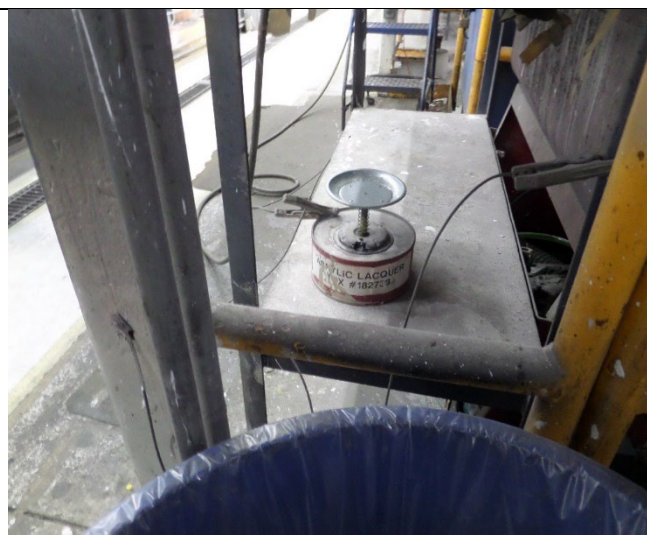
Minor repairs are performed on the trucks. The inspectors observed paper wipes contaminated with acrylic lacquer (MEK and acetone) in a large garbage container along with other accumulated trash. The contaminated wipes appear to be managed as nonhazardous waste and it appears a waste determination was not made on the contaminated wipes (Photographs 4 and 5).

Paint Building. Super Duty Truck Spot Repair. Container of acrylic lacquer used in spot repair. Photograph 4 taken at 10:40 a.m.

**Pursuant to 401 KAR 39:080 Section 1 [40 C.F.R. § 262.11], a person who generates a solid waste, as defined in 40 C.F.R. § 261.2, must make an accurate determination as to whether that waste is a hazardous waste in order to ensure wastes are properly managed according to applicable RCRA regulations articulated in 401 KAR 39:080 Section 1 [40 C.F.R. § 262.11].**

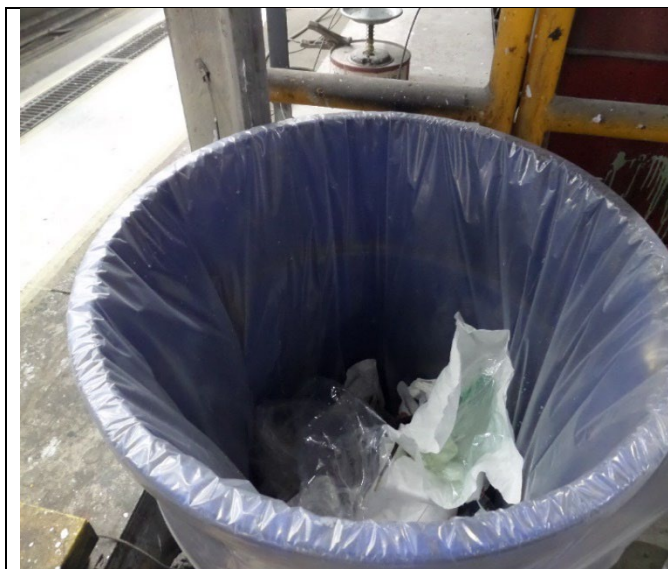
Paint Building. Super Duty Truck Spot Repair. Container of contaminated wipes (acrylic lacquer) accumulated with other trash. Photograph 5 taken at 10:40 a.m.

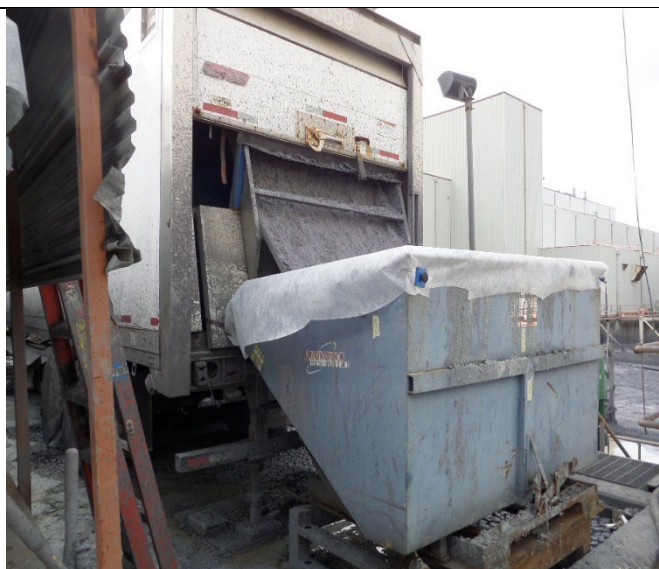
The inspectors also observed a release of waste solids to the concrete containment system under the belt press and under a container accumulating waste solids. The inspectors requested that the facility respond to the release of waste solids (Photograph 6).

WWTP. Belt Press used to dewater solids. Observed waste solids in containment area. Photograph 6 taken at 10:49 a.m.

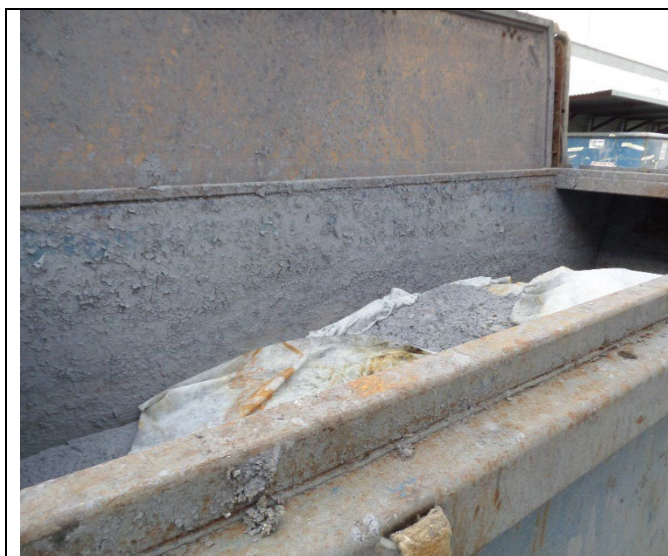
This area is managed by ABEDNGO, a contractor for Ford. ABEDNGO manages and maintains the chemistry of the wastewater in the solids collection pit and operates the belt press. The inspectors observed a 30 to 40-cubic yard container accumulating waste solids from the belt press dewatering operation (Photograph 7).

WWTP. Container accumulating waste solids. Photograph 7 taken at 10:50 a.m.

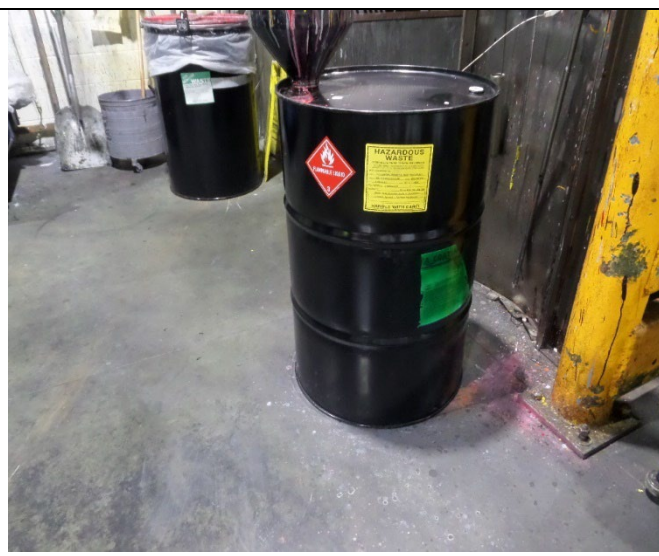
Empty product containers are washed in this booth and the containers are reused. The inspectors observed one 55-gallon container accumulating waste rags, paint chips, gloves and filters that was closed and labeled with the words “nonhazardous waste”. The inspectors observed one 55-gallon container accumulating waste butanol and xylene (D001, D018, D035, F003) in the Part Washer Booth SAA. The container was closed, labeled with words “hazardous waste”, and labeled with a hazard indicator (Photograph 8).

Paint Building. Paint Mix Room. Part wash booth used to wash empty product containers. Photograph 8 taken at 11:00 a.m.

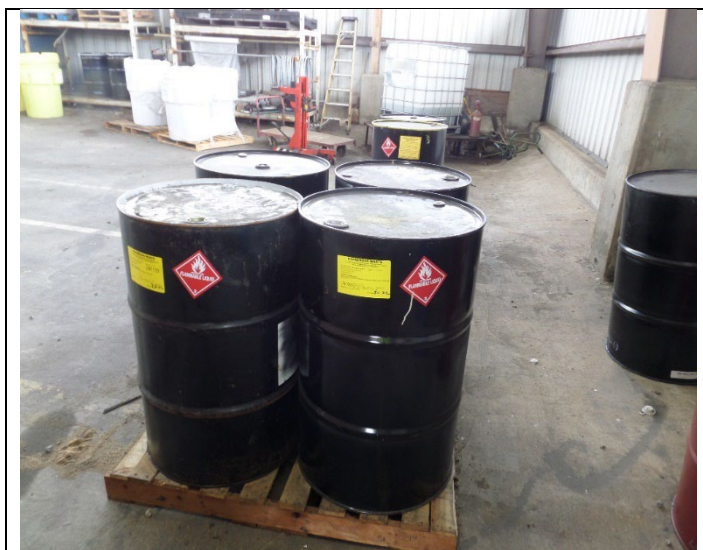
Michael Hall is the hazmat operator for this area. Containers of hazardous waste are stored in this area for 90-days or less, prior to offsite shipment to a destination facility. The inspectors observed one 55-gallon container accumulating waste solvent (toluene) and five 55-gallon containers accumulating waste paint and solvent (n-butanol and xylene) on wooden pallets. The containers were closed, in good condition, with aisle space, labeled with the words “hazardous waste”, each marked with an accumulation start date in September 2022, or October 2022, and labeled with hazard indicators (Photograph 9).

Central Accumulation Area. Observed six 55-gallon containers of waste paint and solvent. Photograph 9 taken at 11:26 a.m.
