## **RCRA Inspection Report**

Safety-Kleen Systems, Inc. (SKS)  
3536 Fite Road  
Millington, Tennessee 38053  
EPA ID No.: TND000614321

**COMPLIANCE EVALUATION INSPECTION**

**October 26, 2022**

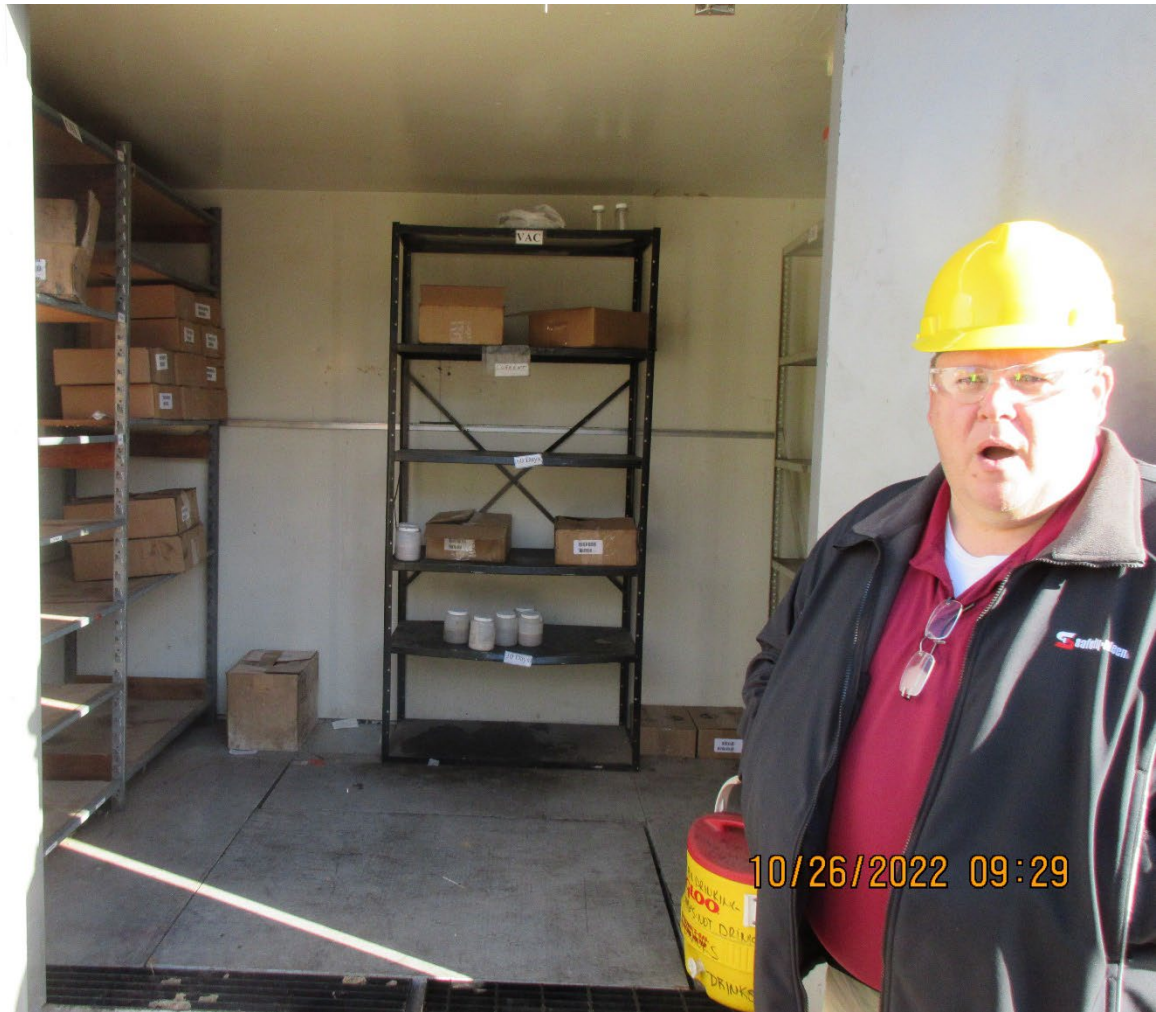
Samples of materials picked up from customers are maintained in a metal shed measuring approximately 10-feet by 8-feet (Photo 1). The inspection team observed the area where samples collected from customers are accumulated and maintained for 90 days before they are bulked and shipped offsite.

Photo 1 – Sample Return Area

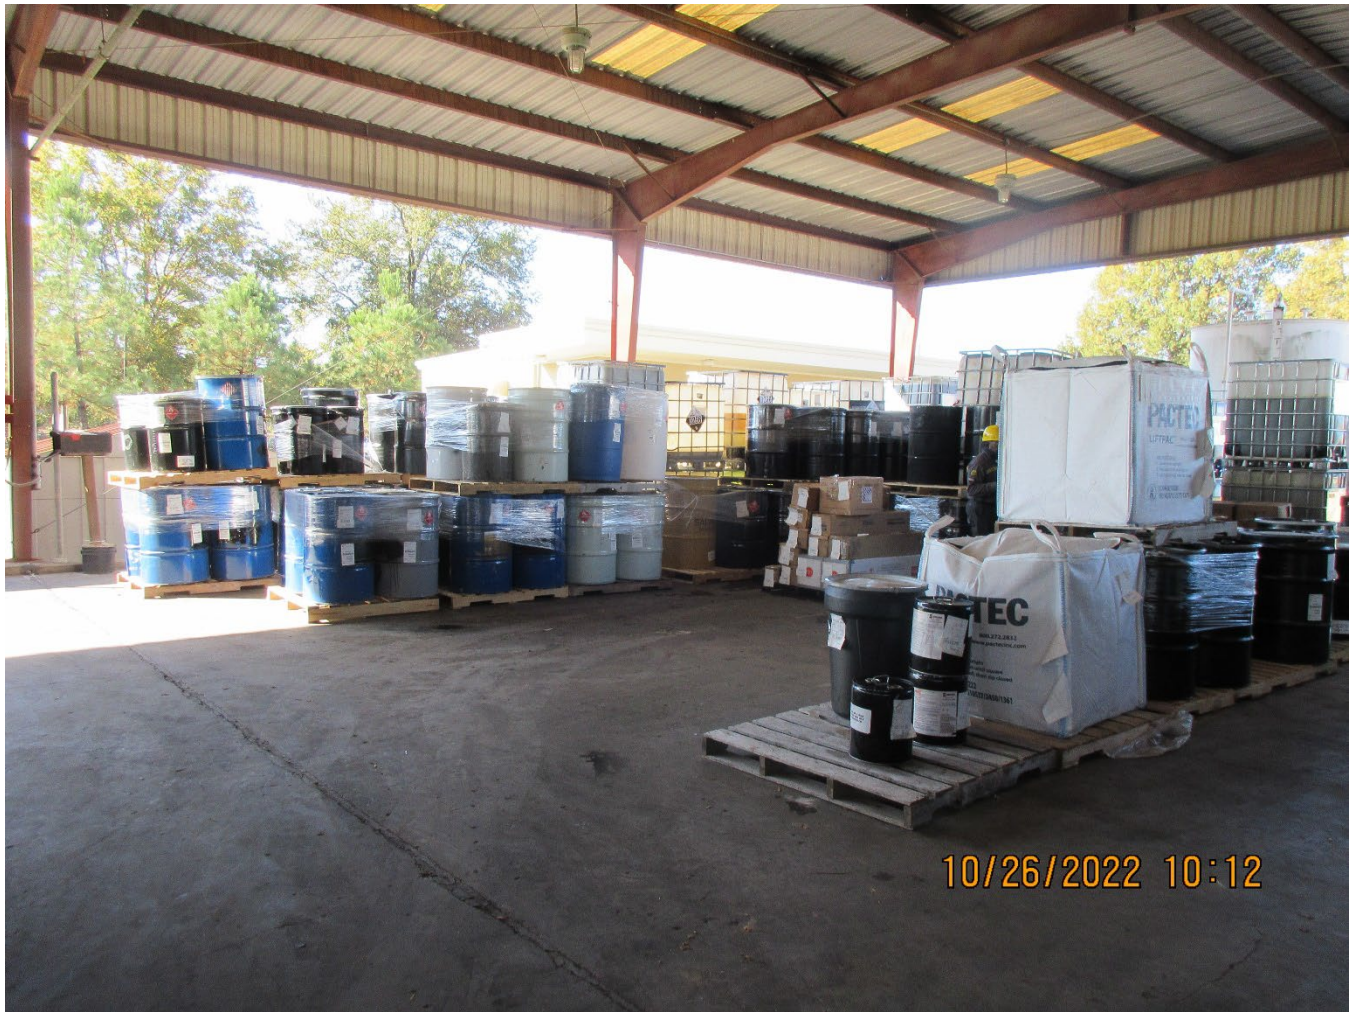
The inspection team observed 55-gallon, 30-gallon, 5-gallon, cubic yard fiber bag and 275-gallon totes in a part of the facility's permitted storage area that the facility is managing as a 10-day transfer area (Photo 2). The volume of waste managed in this area was within the permitted storage capacity for this area. Each container observed in this area was properly labeled, closed, and in good condition. Each container in this area had been stored for less than 10-days.

Photo 2 – Container Storage Area used as 10-Day Transfer Area

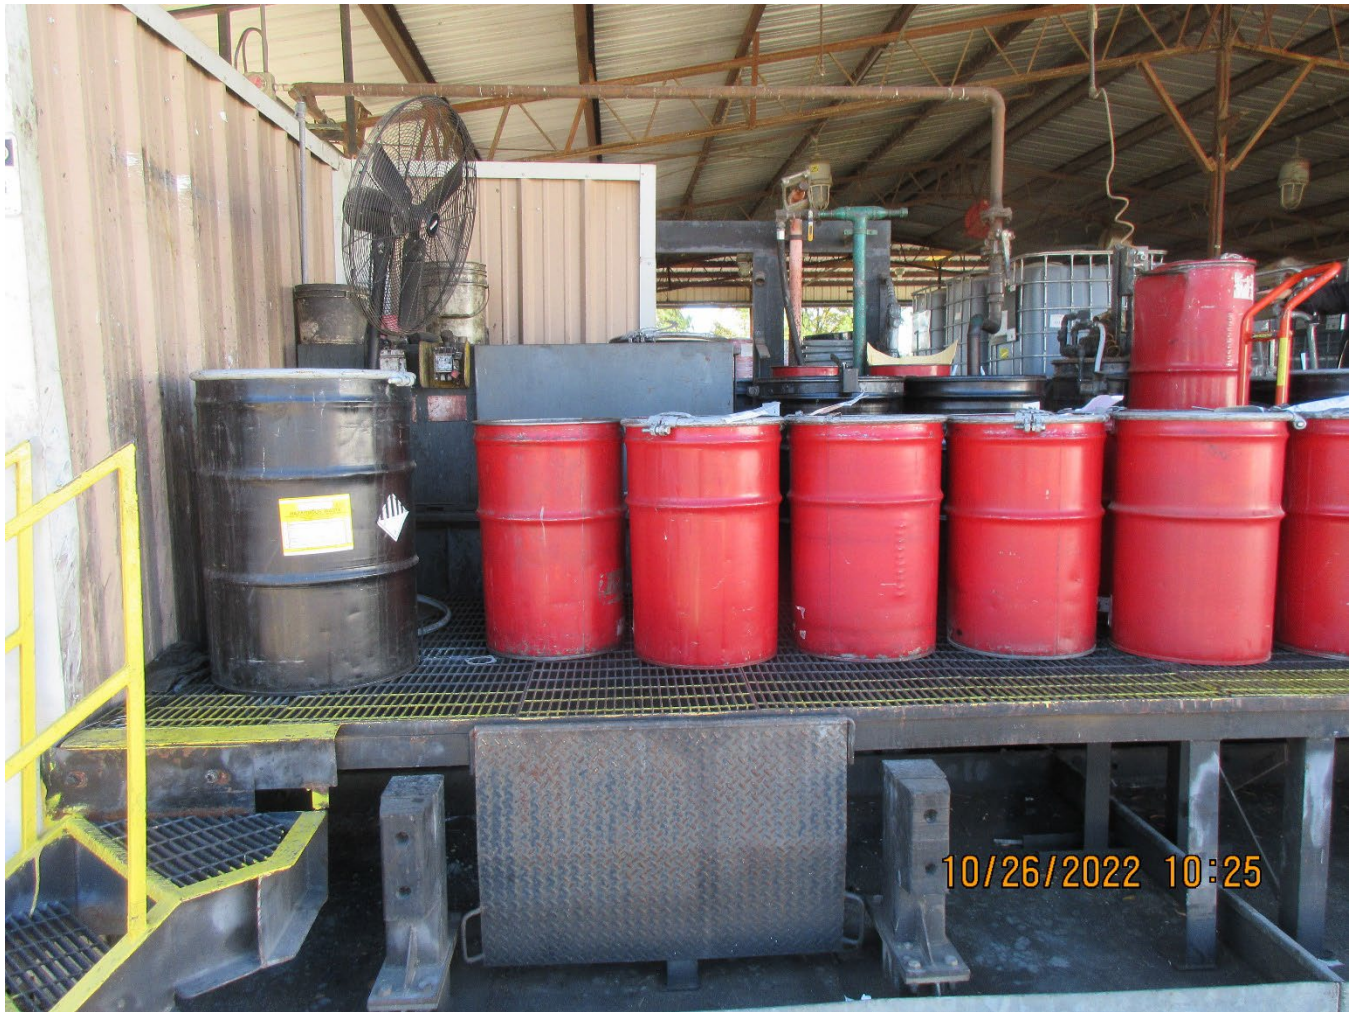
The inspection team inspected two permitted Return and Fill stations located on the north end of the facility's container storage building. The two stations are used to receive spent solvent containers picked up from customers utilizing parts washing machines provided to their customers (Photos 3 and 4). Timothy Hill stated that Safety-Kleen only provides limited amounts of low flash solvents to customers that request it. Hazardous waste codes assigned to wastes returned to the facility in 30-gallon containers are primarily codes for solvents the customer may use at its facility or metals which are the result of customer processes. The dump and fill stations were idle at the time of the inspection. More than twenty 30-gallon containers of hazardous waste collected from the facility's customers were observed on the permitted loading dock area on both sides of the Return and Fill stations (Photos 3 and 4). One 55-gallon container was observed within a satellite accumulation area (SAA) in this location for accumulation of contaminated rags, personnel protective equipment and filters. This container was in good condition, closed, and labeled with the words "Hazardous Waste."

Photo 3 – Northeast Return and Fill Station

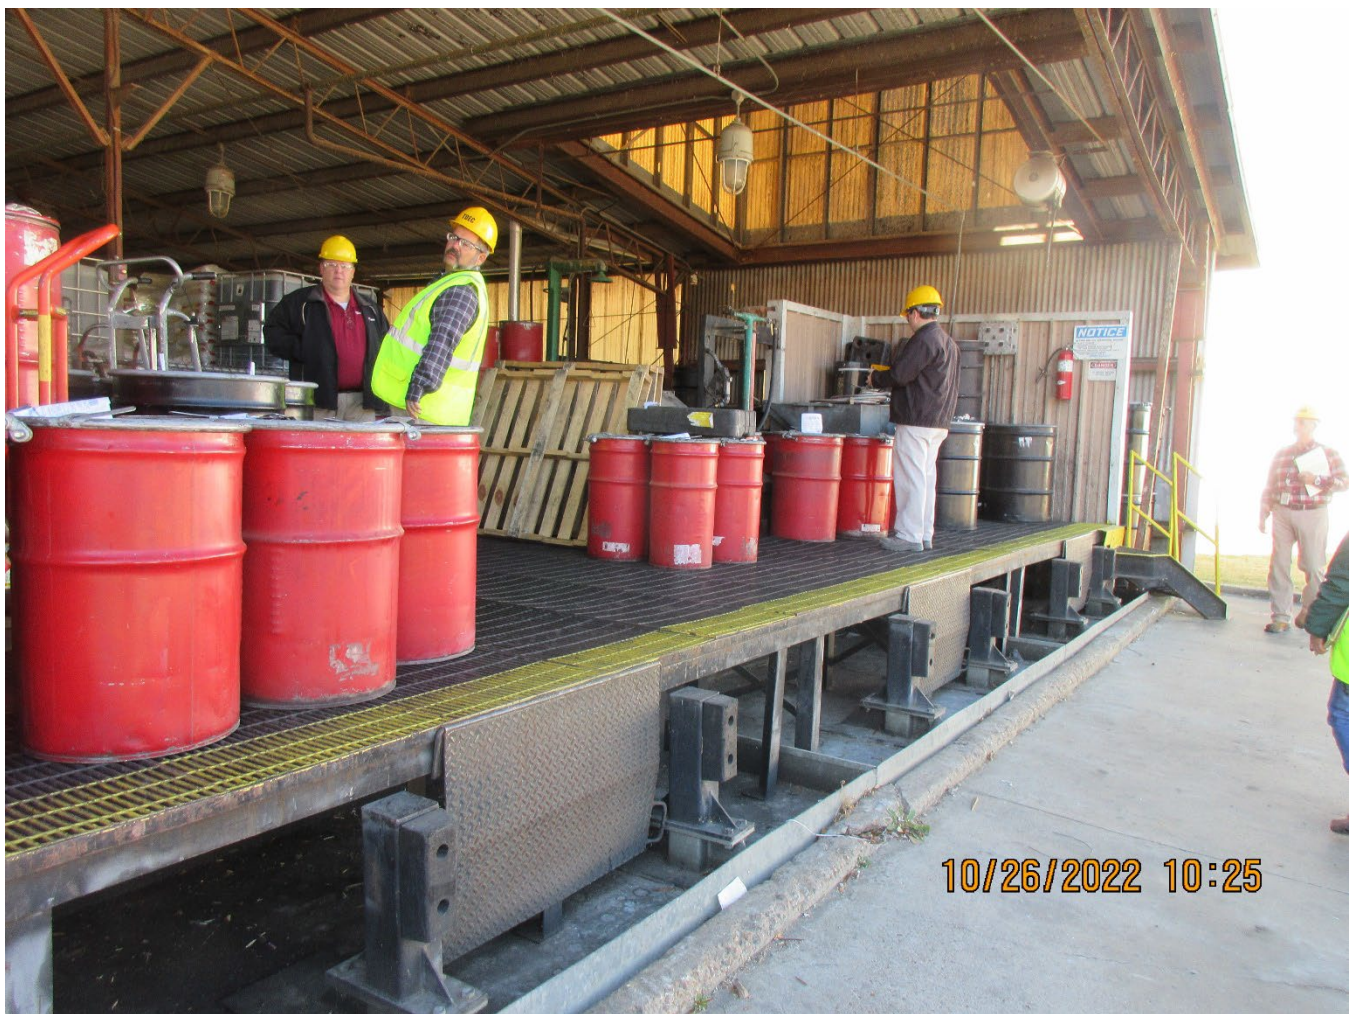
Photo 4 – Northwest Return and Fill Station

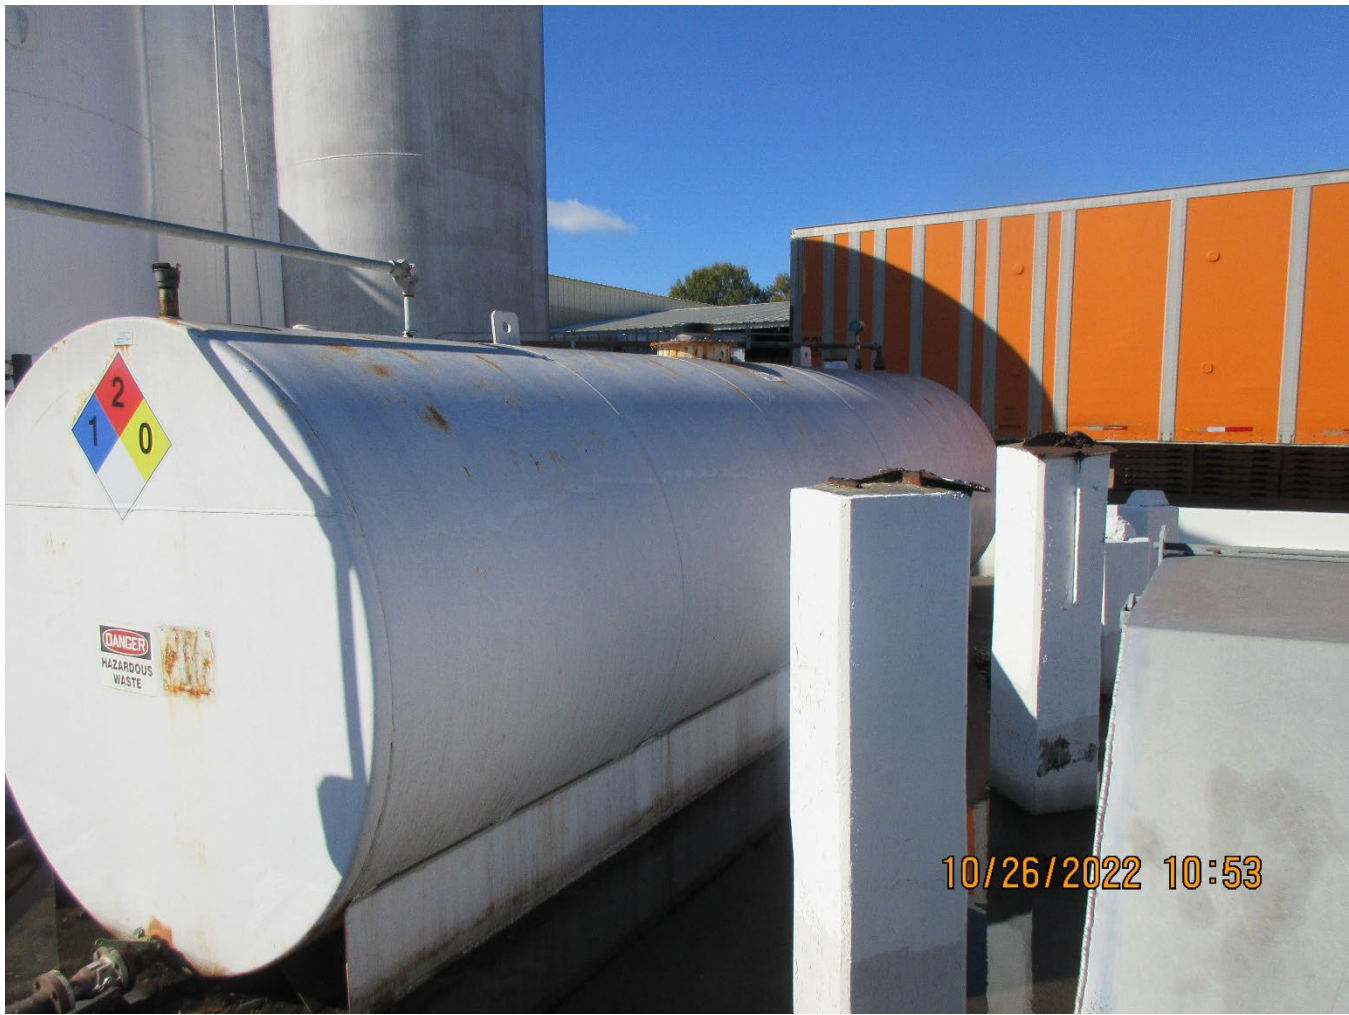
SKS operates five tanks in the tank farm. Tank 2 was being used to store solvent product. Tanks 1, 4, and 5 are used to store used oil and were properly labeled with the words "Used Oil." SKS utilized Tank 3 to store spent solvent (Photo 5). Tank 3 was labeled with the words "Hazardous Waste.," the secondary containment for the tank was free of cracks and gaps and at the time of the inspection.

Photo 5 – Hazardous Waste Storage Tank

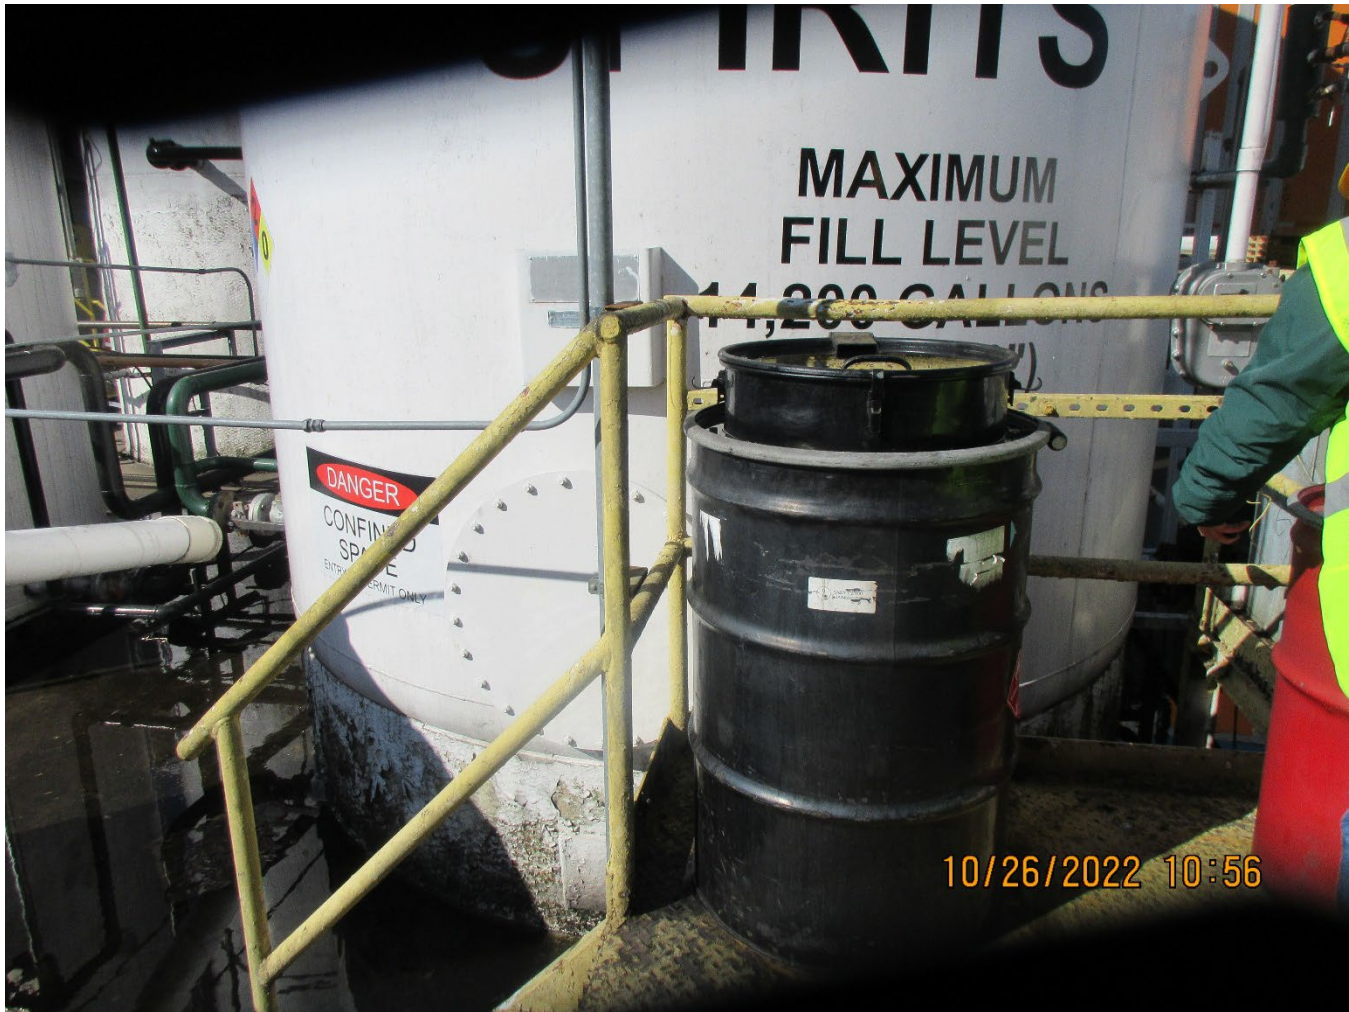
This area is used for loading outgoing solvent from the facility's hazardous waste storage tank. One 55-gallon container was observed within a SAA in this area for hazardous waste filters and PPE generated in this area (Photo 6). The container was closed and labeled with the words "Hazardous Waste" at the time of the inspection.

Photo 6 – 55-gallon drum located in SAA in truck loading area
