## **RCRA Inspection Report**

Milliken Chemical – Dewey Plant  
1440 Campton Road  
Inman, South Carolina 29349-0817

EPA ID No.: SCD069314045

June 9, 2021

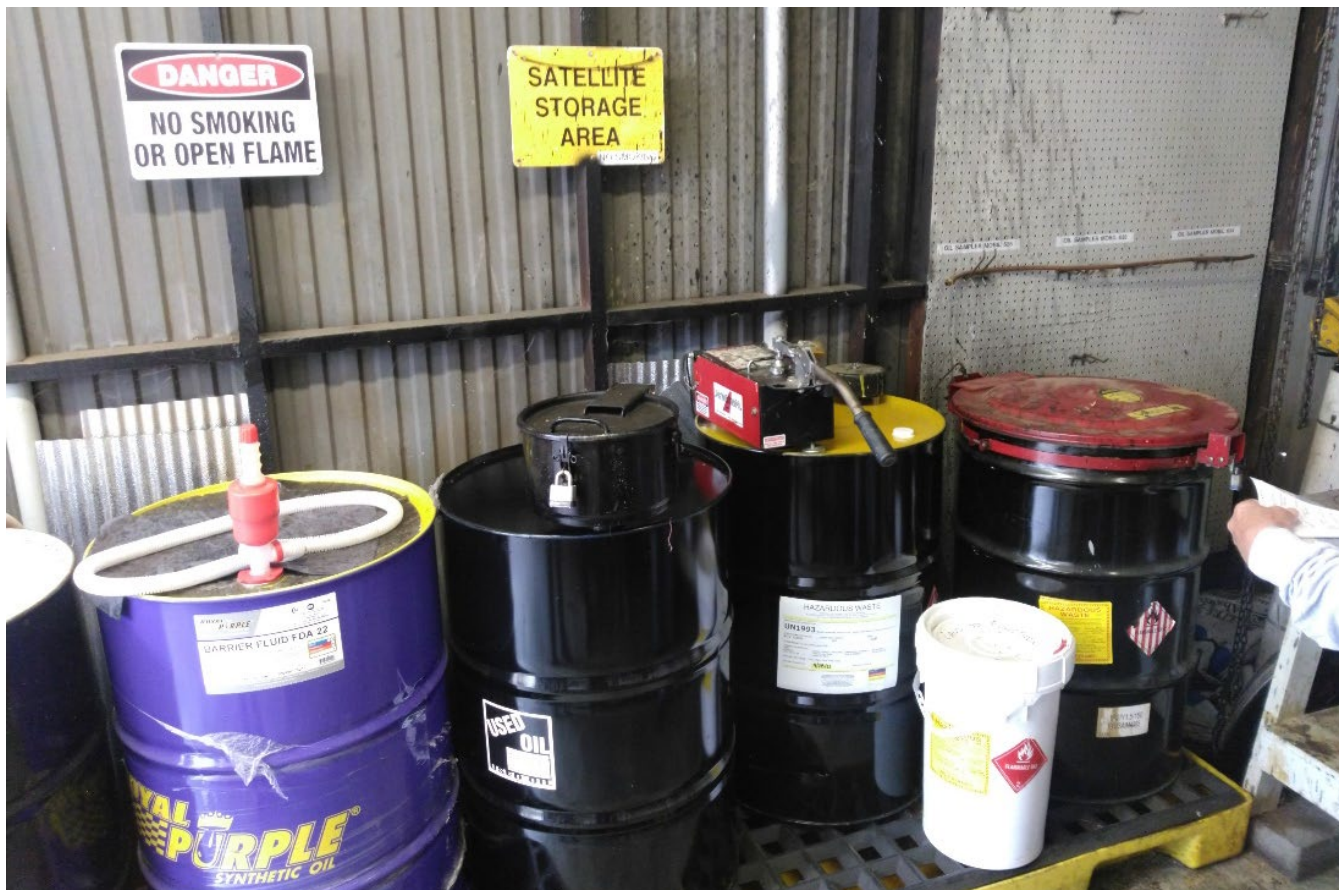
In the maintenance shop, the facility generates used oil, aerosol cans and shop rags. The satellite accumulation area (SAA) for solvent contaminated rags waste generated in the maintenance shop is in a shed outside the building. In the shed, the inspectors observed one 55-gallon container with shop contaminated rags (D001/F003), one 5-gallon container with aerosol cans (D001), one 55-gallon container with a can puncturing device to empty hazardous waste aerosol cans (D001) and one 55-gallon used oil container. The containers were on spill containment pallets, properly labeled, closed, and appeared to be in good condition (Photograph 1). The aerosol residue accumulation container was dated 4/28/21.

*Photograph 1: Maintenance Warehouse Oil Shed: 5-gallon with aerosol cans and one 55-gallon container with an aerosol can puncturer, one 55-gallon used oil container and one 55-gallon container of solvent contaminated shop rags.*

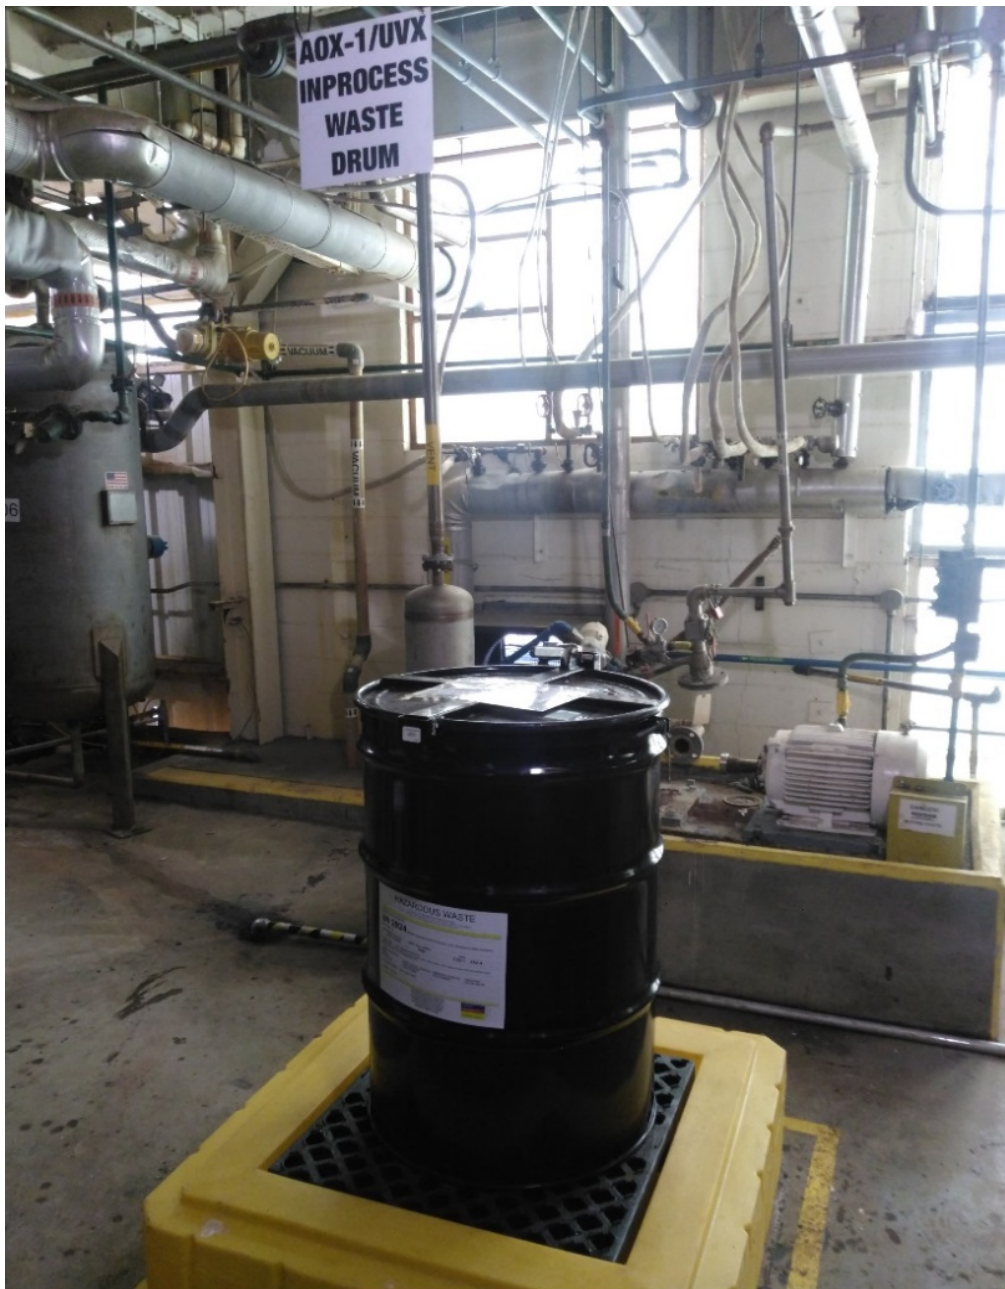
On the second floor of the Main Manufacturing building, the facility operates SAA #4. In the SAA, the inspectors observed one 55-gallon that contained sample residues (D001) from the manufacture of polyurethane protection products marketed as Milliguard®. The container was on a spill containment pallet, properly labeled, closed, and appeared to be in good condition (Photograph 2).

*Photograph 2: AOX and UVX sample residues accumulation container in SAA #4 located on the 2nd floor of the main production building.*

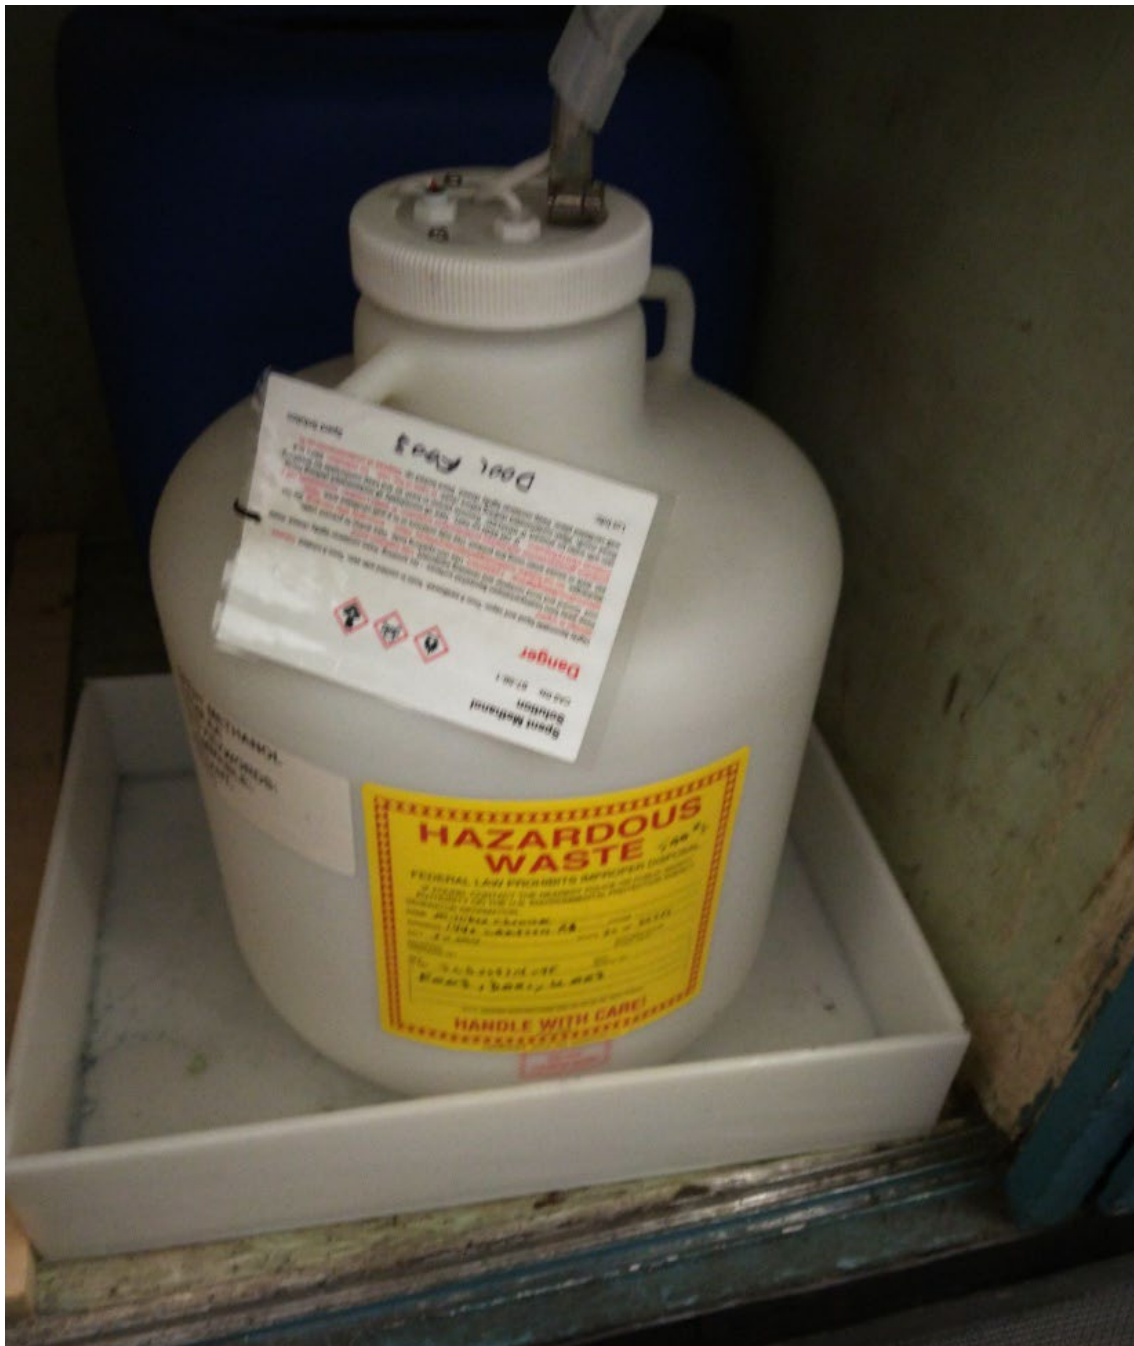
| <b>SAA ID</b> | <b>Waste Stream</b> | <b>Comment</b> |
|---|---|---|
| 2 | Spent methanol from atomic absorption (AA) unit - D001, F003, U003 | 5-gallon container connected to the AA unit with a hose (Photograph 3) |

*Photograph 3: SAA 2 with 5-gallon container connected to the AA unit with a hose collecting spent methanol from atomic absorption unit - D001, F003, U003*

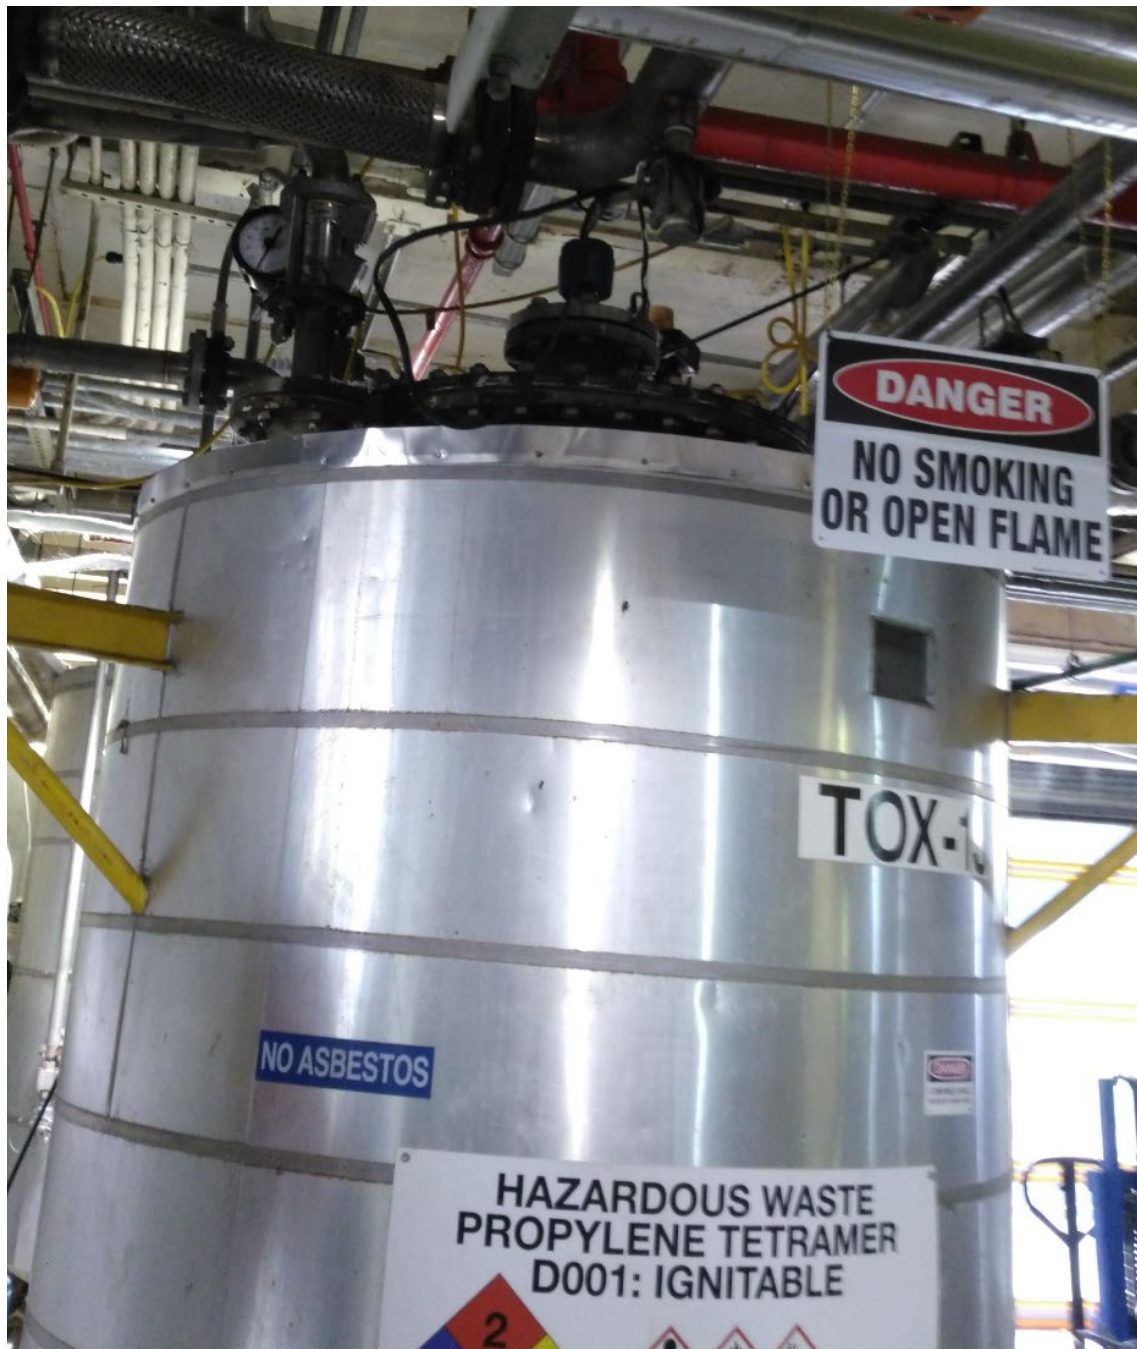
Across from the container CAA, Milliken operates a 500-gallon aboveground tank where it stores hazardous wastes (D001) from tank TSL-04 in the hydride production area. Mr. Parvez indicated that the tank, identified as TOX-13, has been in service since July 2020. In addition, Mr. Parvez indicated that the tank is in heavy liquid service. The inspectors did not observe any gaps between the tank's openings and closure devices. The tank was properly identified and dated 5/12/21 (Photograph 5).

*Photograph 5: Aboveground hazardous waste storage tank in the main production building.*

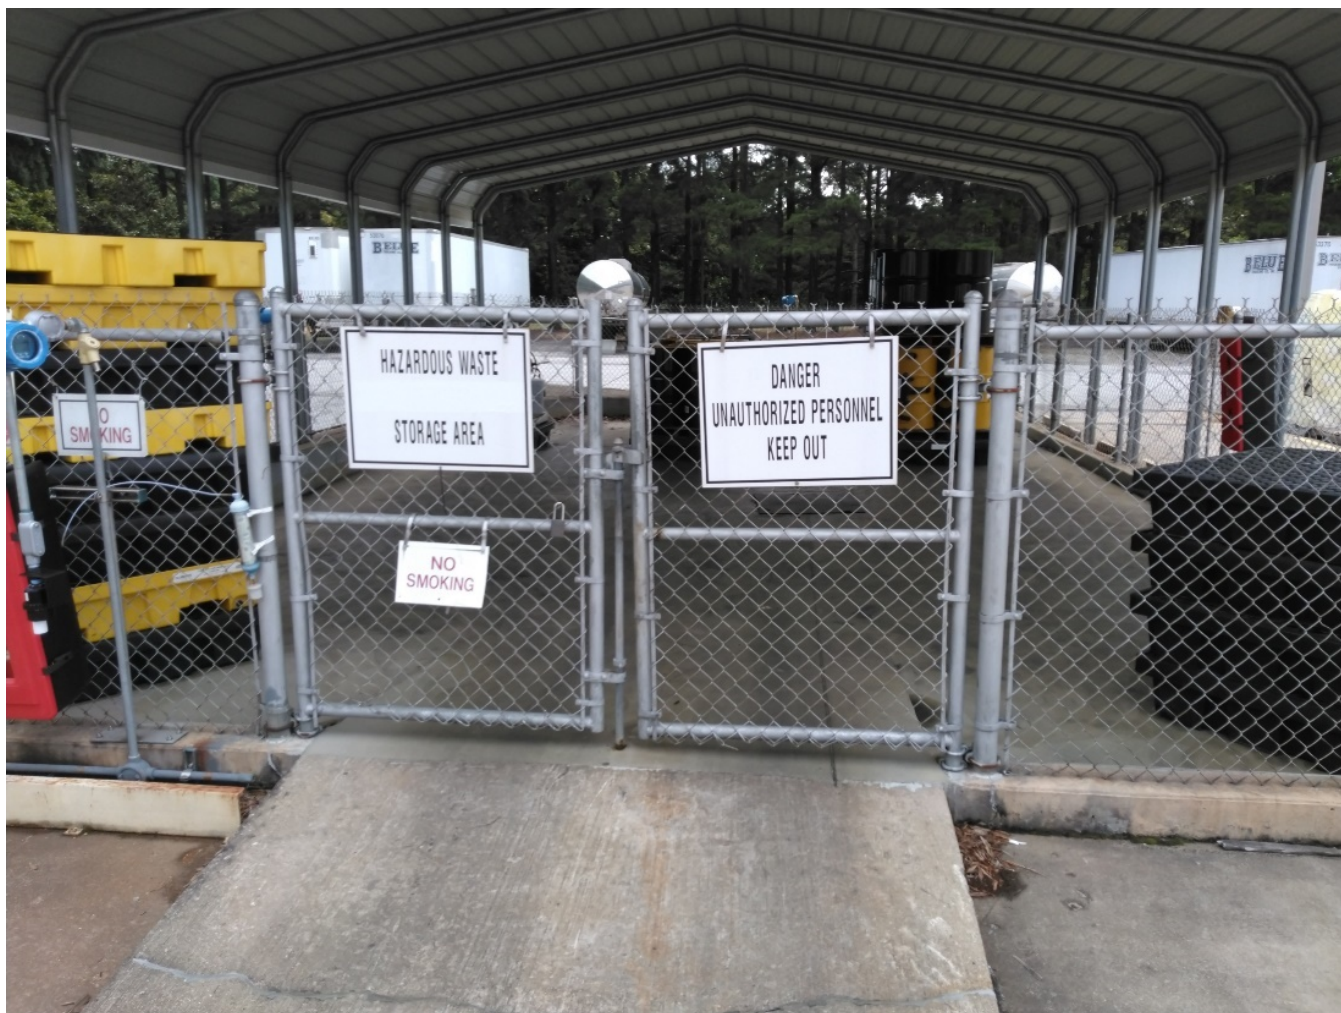
At the time of the inspection, the storage pad had the required signage, spill kits and fire extinguishers. In the pad, the inspectors observed 34, 55-gallon containers (including 13 containers labeled as “pending analysis”) and five 5-gallon containers. All containers were on spill containment pallets, properly labeled, dated, and appeared to be in good condition. (Photographs 6 and 7). The oldest accumulation start date observed during the inspection was 05/13/21.

*Photograph 6: Access gate to the hazardous waste storage pad.*

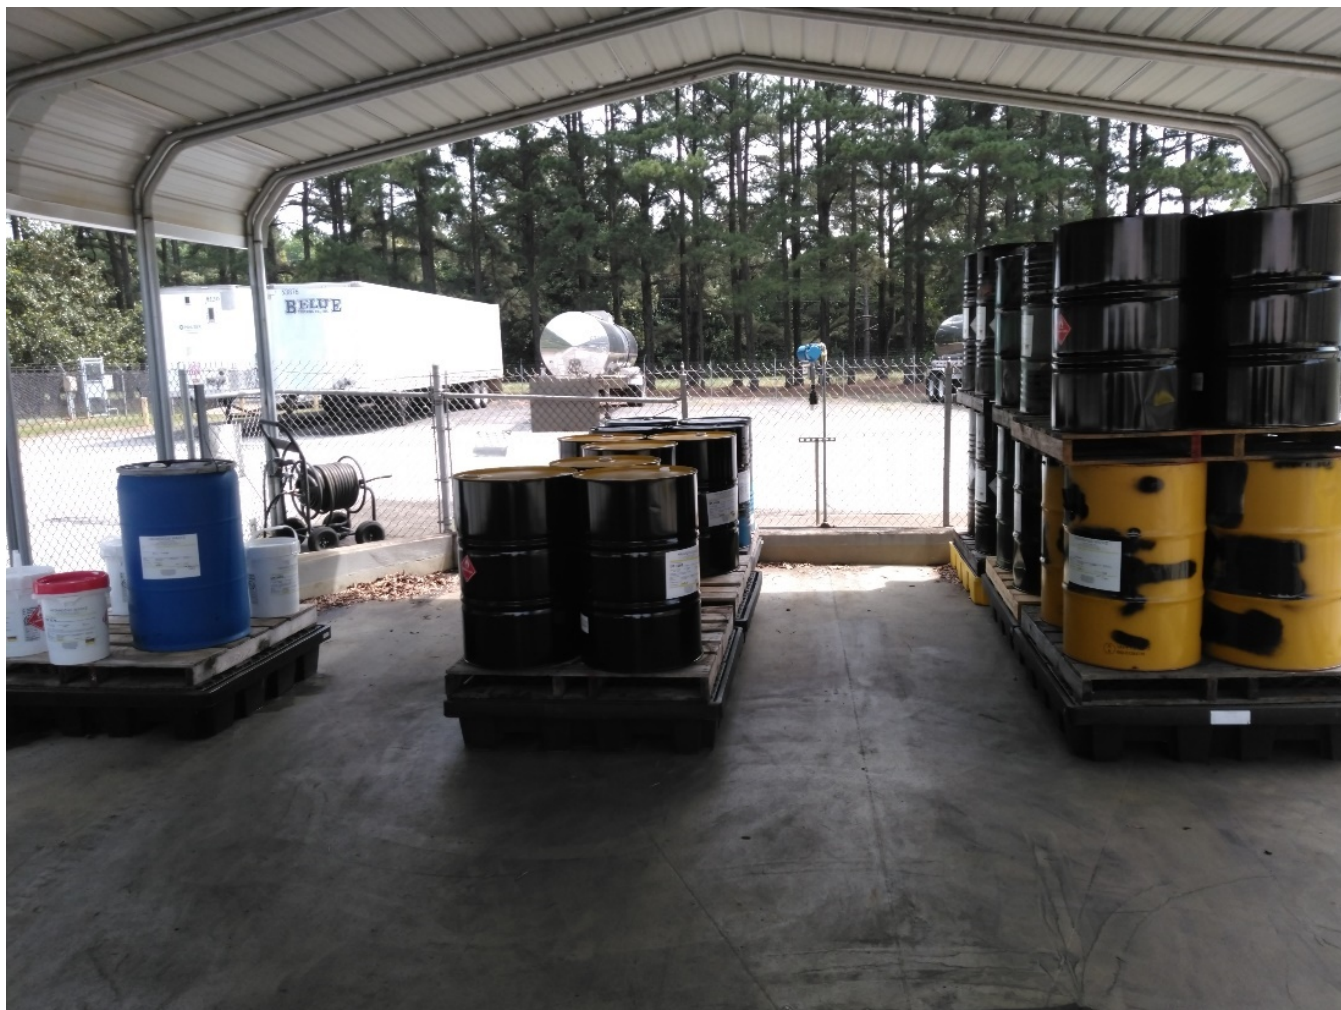
*Photograph 7: General view of the containers in the hazardous waste storage pad.*

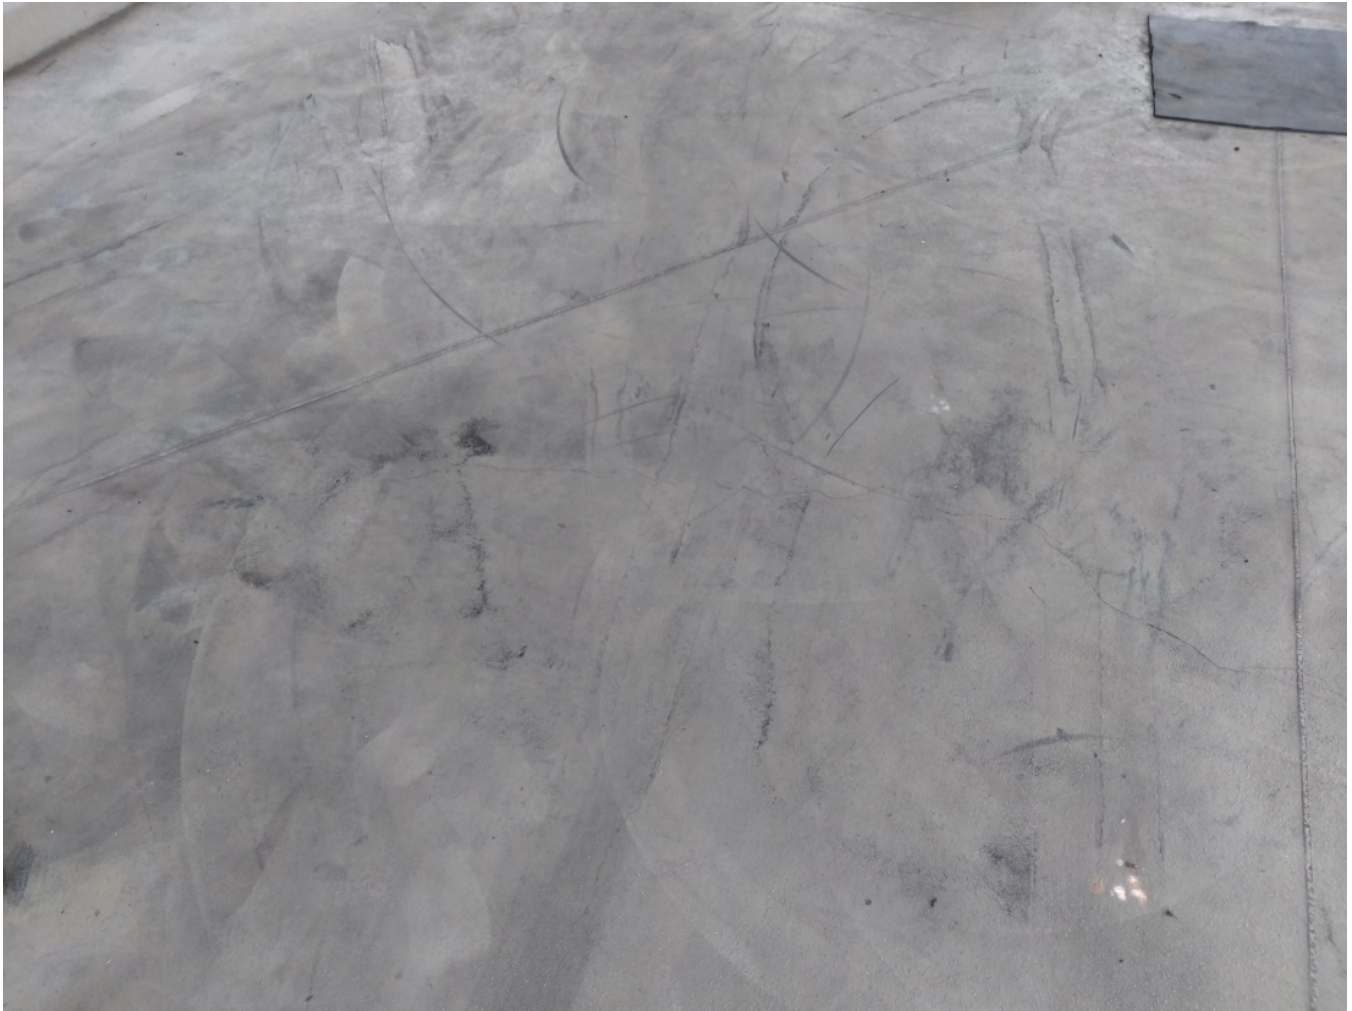
The storage pad concrete floor is sloped towards a blind sump in the center of the unit. Although there was no evidence of releases, the inspectors observed several hairline cracks and some nicked areas on the concrete floor (Photograph 8). Following the inspection, Milliken coated the floor with a sealant (Photograph 9).

*Photograph 8: View of hairline cracks observed in the concrete floor of the hazardous waste storage pad*

**Pursuant to Permit Condition III.F, Milliken shall maintain the containment system free of cracks in accordance with R.61-79.264.175 [40 C.F.R. 264.175], and Section D of the approved Permit application.**

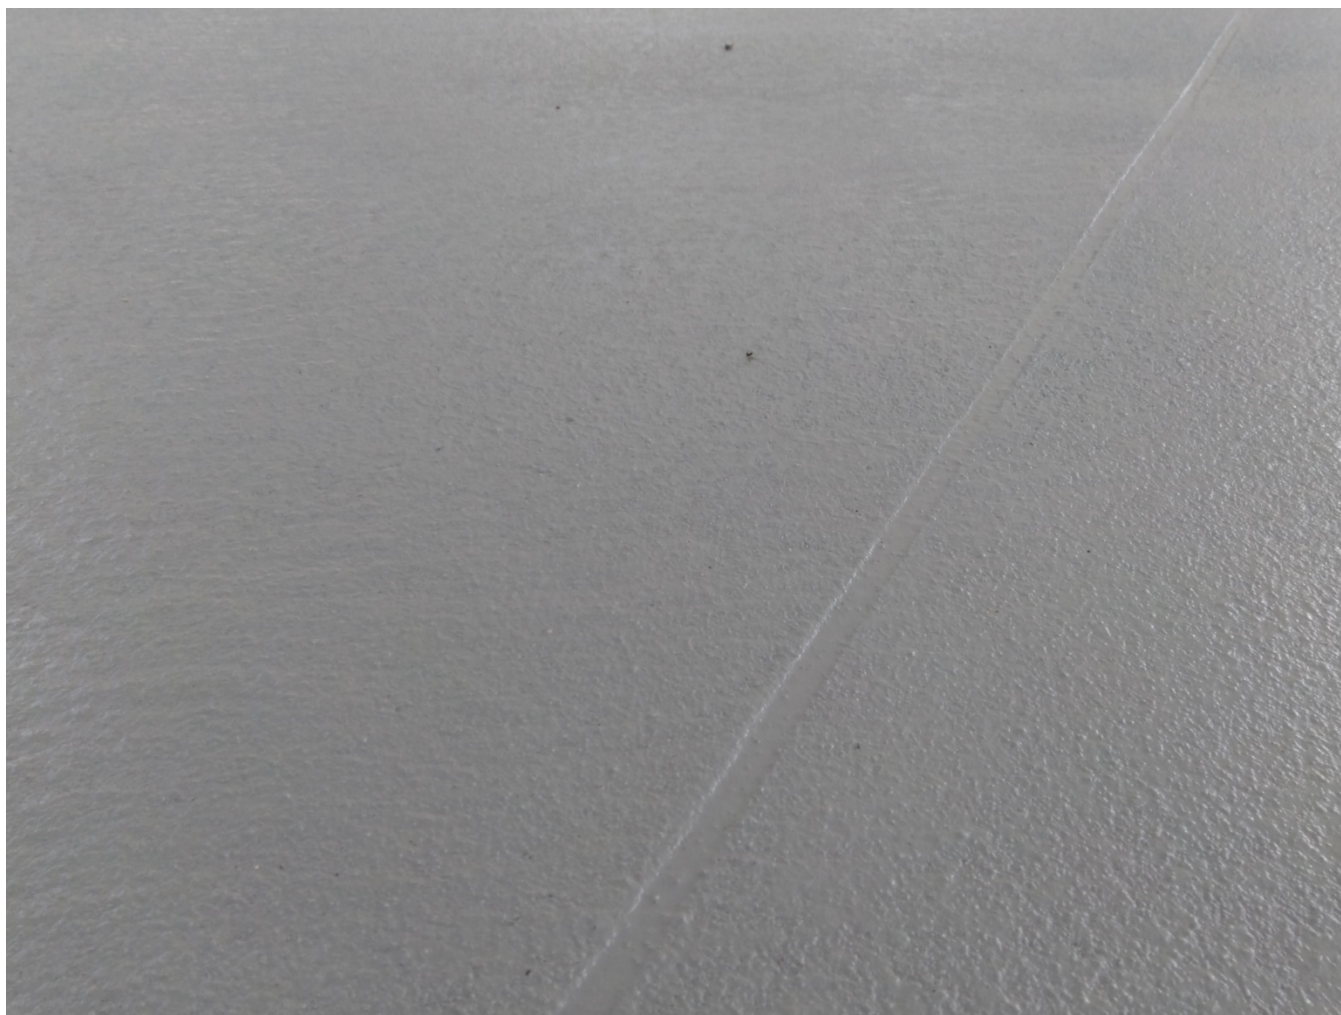
*Photograph 9: View of the hazardous waste storage pad's floor to document coating with sealant. Milliken took the photograph on June 21, 2021.*

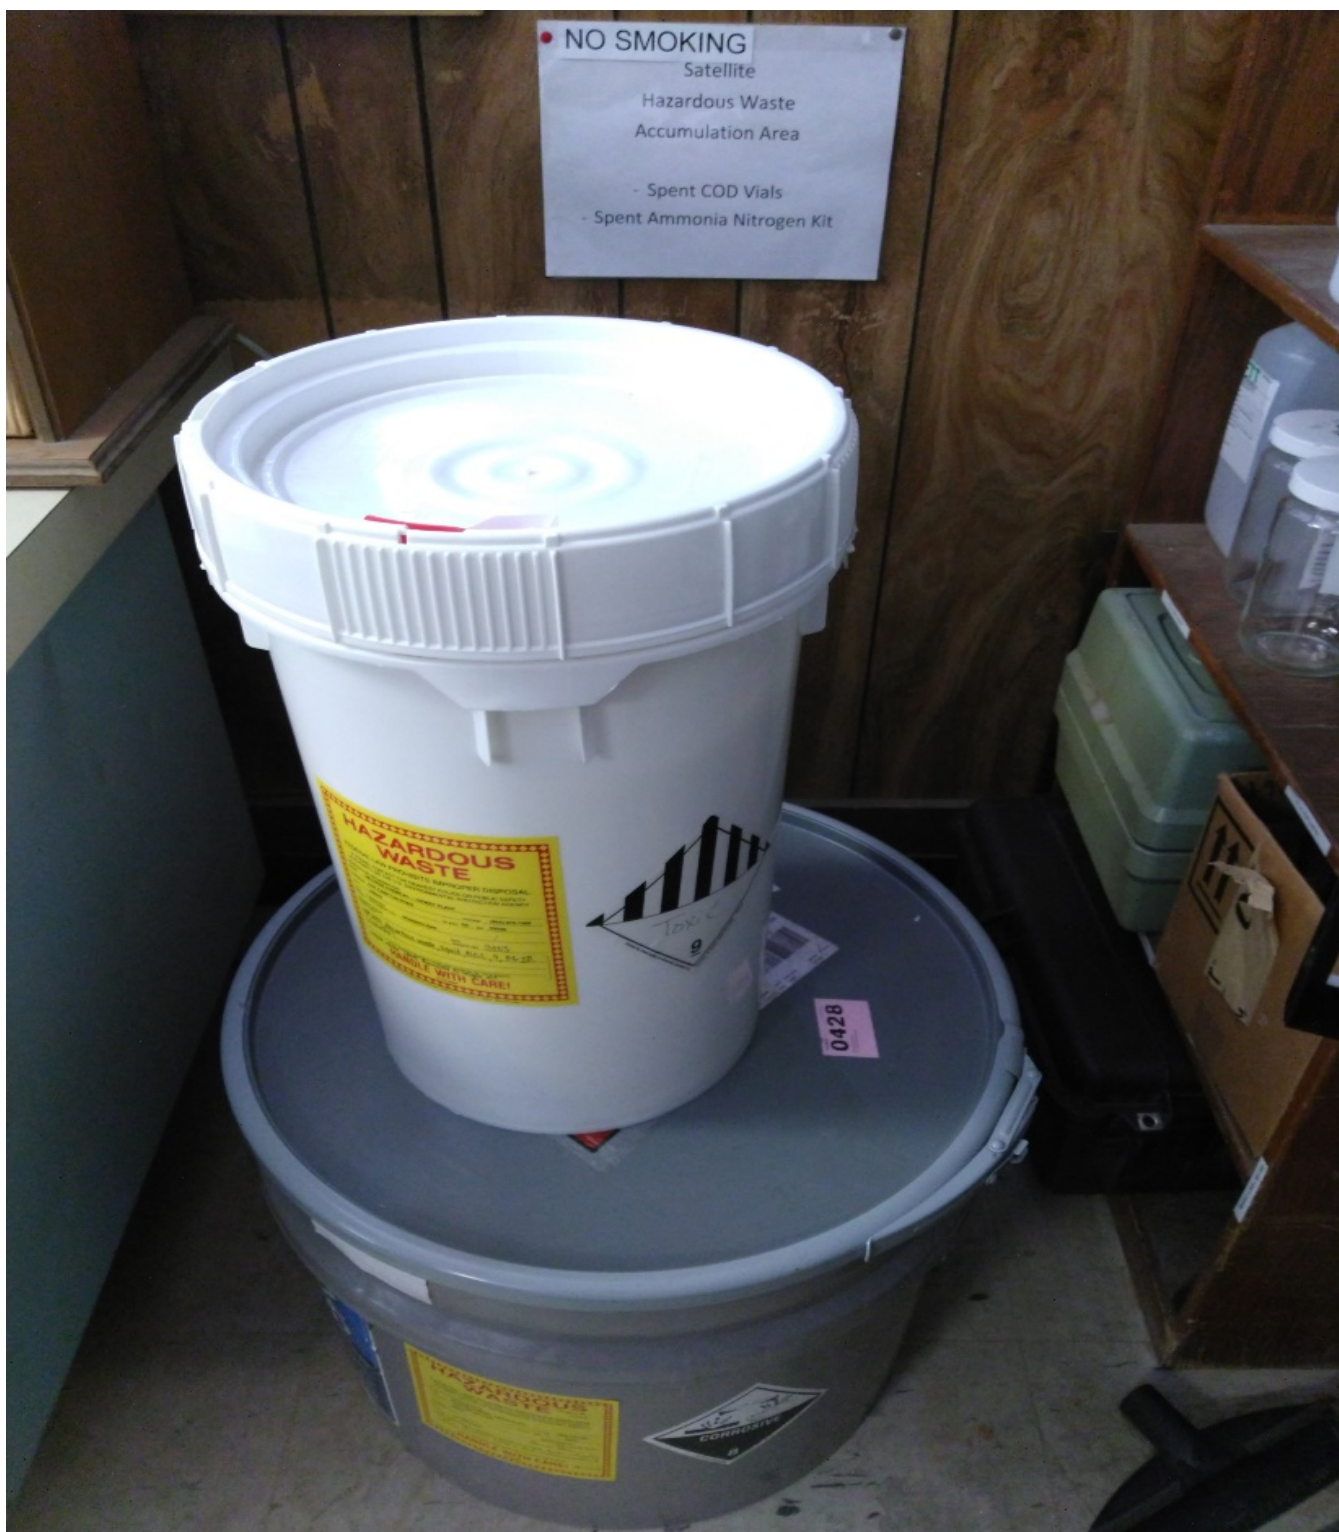
In the laboratory, Milliken generates spent chemical oxygen demand (COD) test vials and spent ammonium nitrogen test kits. At the time the inspection, the inspectors observed one 15-gallon container with spent COD vials (D009) and one 5-gallon container with ammonium nitrogen test kits (D003). Both containers were properly labeled, closed, and appeared to be in good condition. (Photograph 10)

*Photograph 10: Hazardous waste containers in the wastewater laboratory's SAA.*
