### INSPECTION REPORT

| Media Program: | Water | |
| Regulatory Program(s) | NPDES Stormwater/CWA 402 | |
| Facility Name: | Texas Health Forney Hospital | |

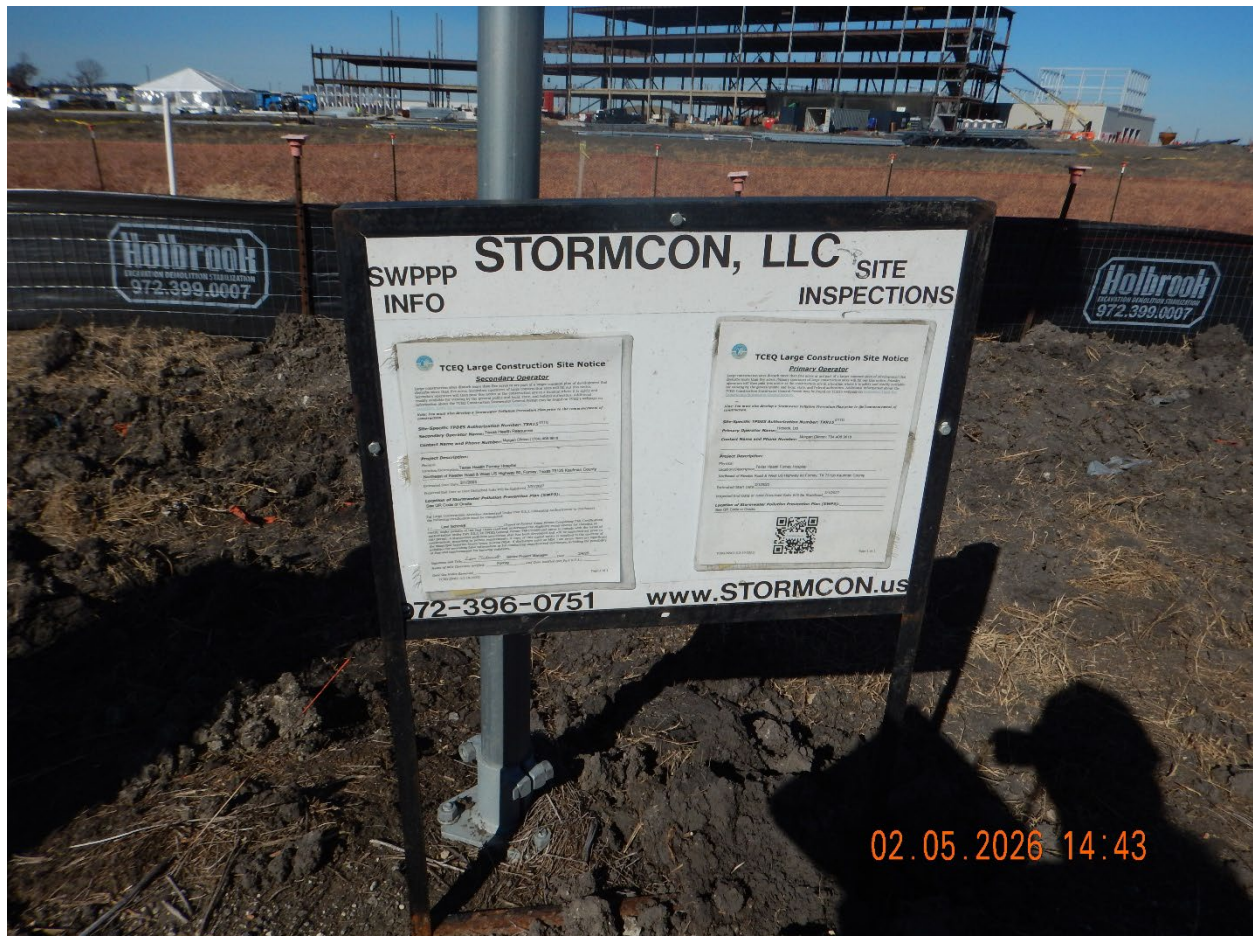
Photo no. 1

- The Construction Site Notice (CSN) was posted near the construction entrance off West US Hwy 80 (**Appendix 1, Photo 1**).
- The site map and Stormwater Pollution Prevention Plan (SWPPP) were observed inside the construction trailer (**Appendix 1, Photo 2-3**).

- Silt fence was installed along the perimeter of the site (**Appendix 1, Photos 1, 4-5**). The silt fence was observed in effective operating condition.

Description: The Construction Site Notice (CSN) posted near the entrance off West US Hwy 80. Also pictured behind the CSN is silt fence installed along the southern perimeter of the site. The silt fence was observed in effective operating condition.

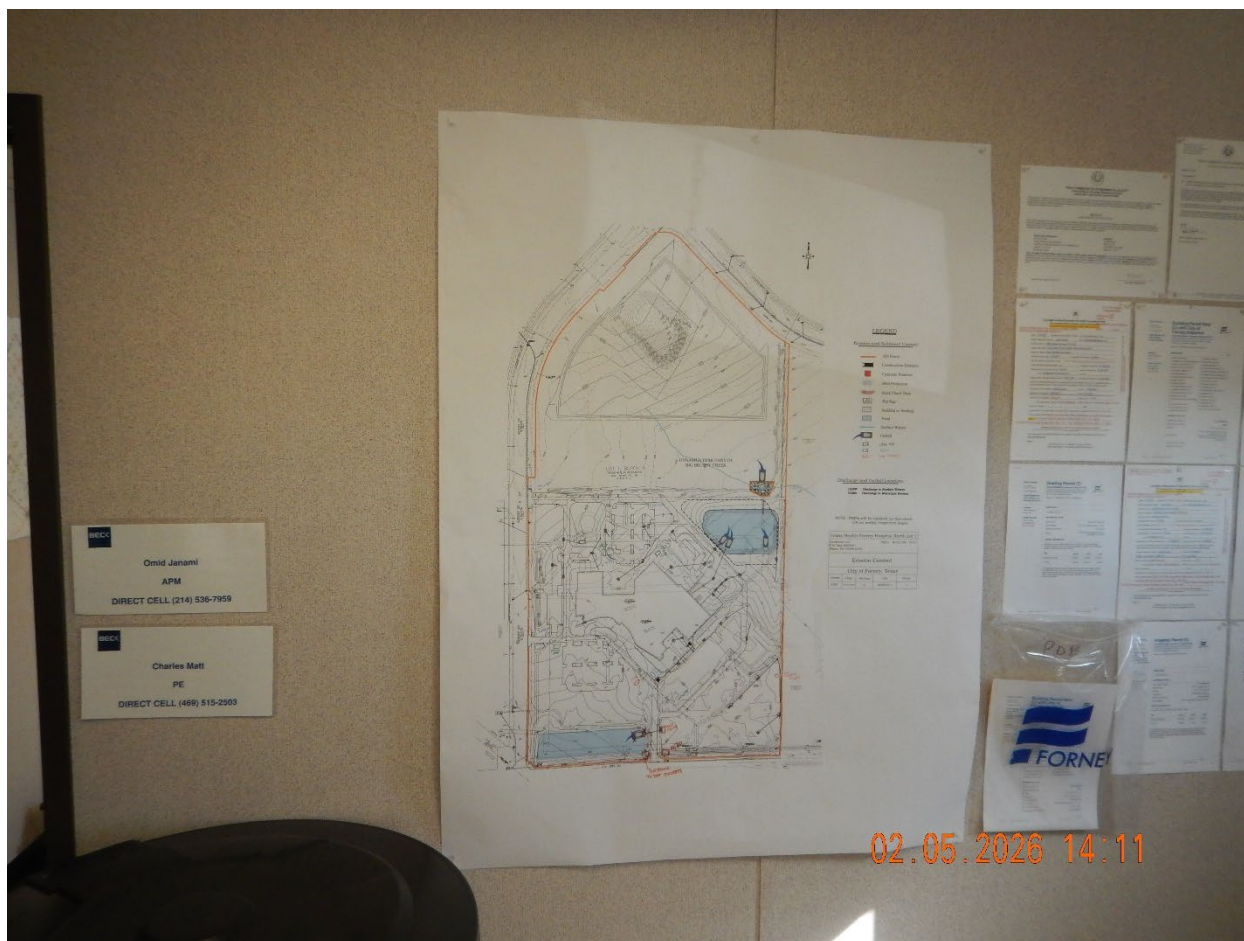
Photo no. 2

Description: The up-to-date site map in the construction trailer.

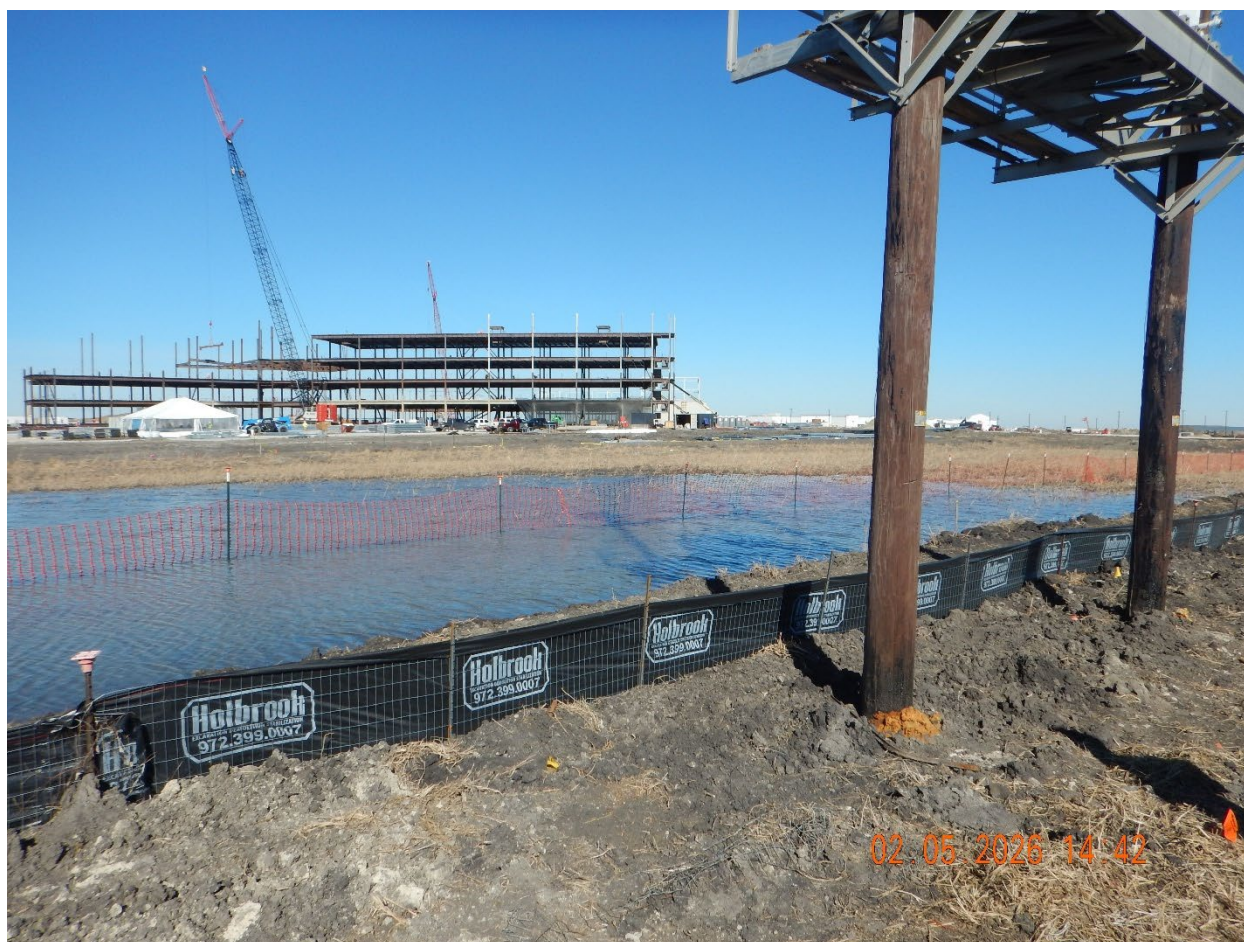
Photo no. 4

- Two (2) retention structures were observed on-site. Near the southwest perimeter of the site was a retention pond (**Appendix 1, Photo 4**) that collects surface water. Near the northeastern perimeter of the site was a dry sedimentation basin that receives water from the on-site inlets (**Appendix 1, Photo 7**).

Description: Silt fence installed along the southerner perimeter of the site. Also pictured is the retention pond that collects surface water from the site.

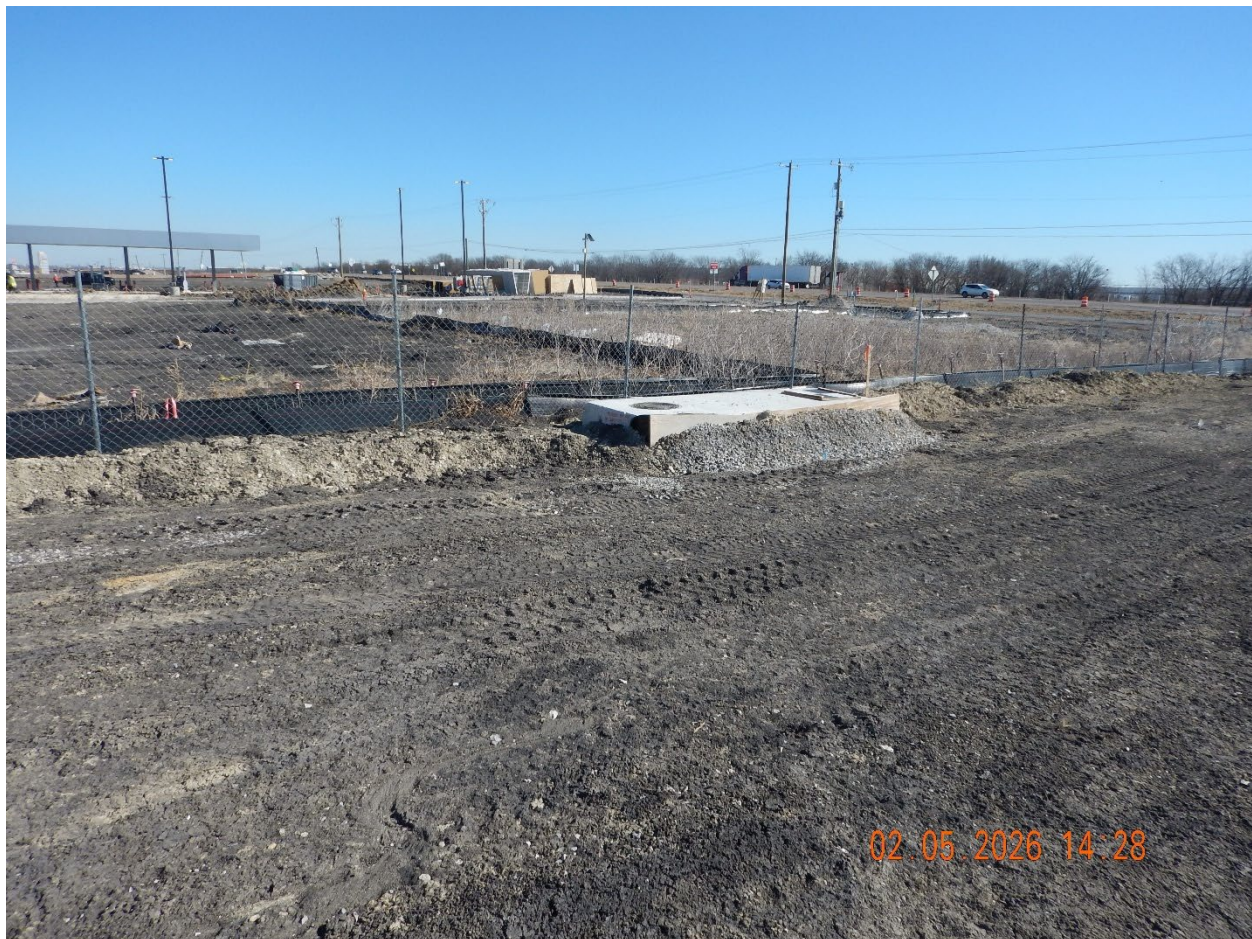
Photo no. 5

- The inlets throughout the site had BMPs installed (**Appendix 1, Photo 5**). The BMPs observed were in effective operating condition.
- Two (2) fuel storage tanks were observed on-site (**Appendix 1, Photo 6**). Both containers were plugged with no evidence of leakage.

Description: A curb inlet with filter fabric and a board blocking sediment from entering the inlet. Also pictured is silt fence along the eastern perimeter of the site.

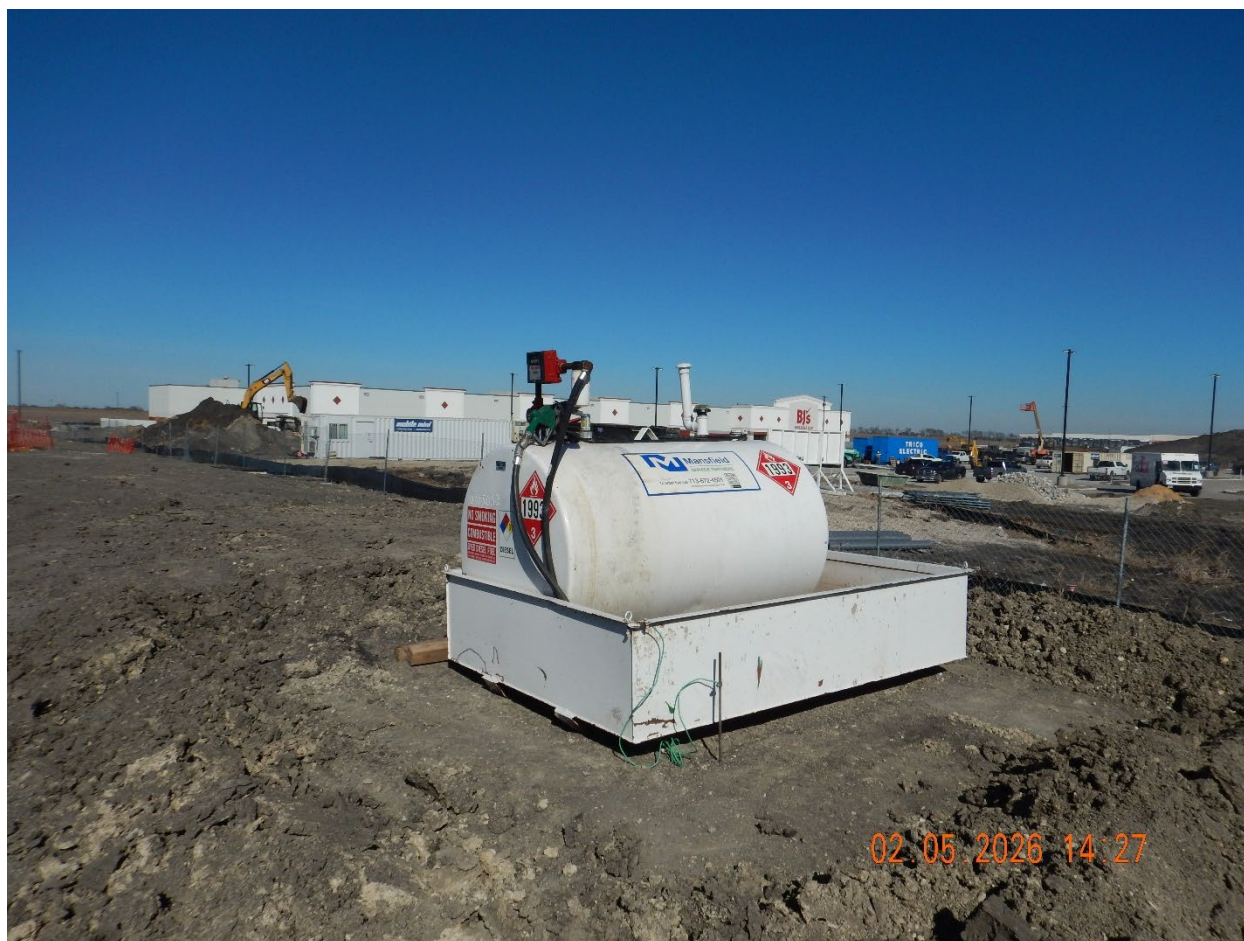
Photo no. 6

Description: One (1) of the two (2) fuel storage tanks observed on-site. The container was plugged with no evidence of leakage.

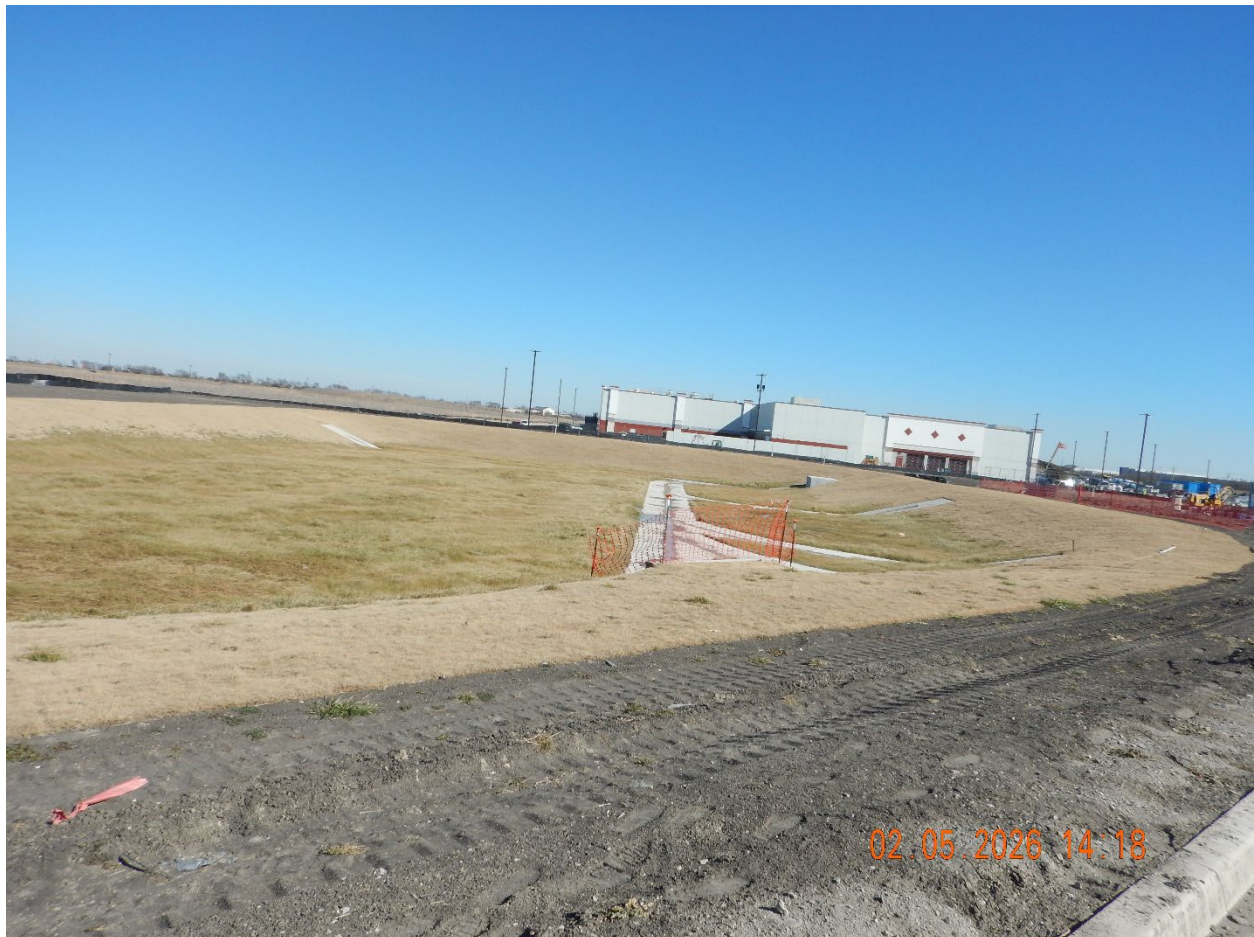
Photo no. 7

Description: The dry sedimentation basin located near the northeastern area of the site. The inlets on-site are tied into this basin.

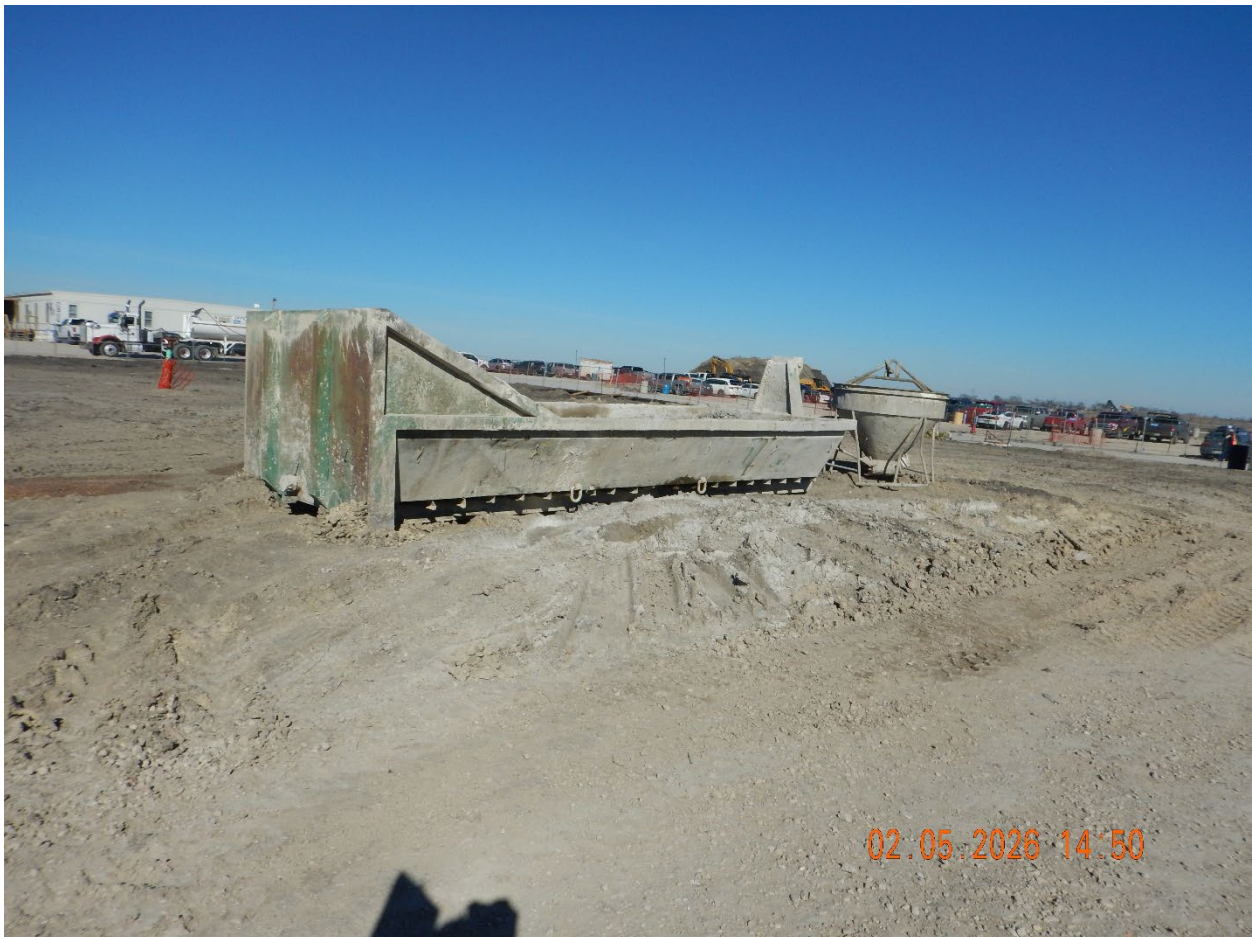
Photo no. 8

- One (1) concrete washout was observed on-site (**Appendix 1, Photo 8**). An Area of Concern (AOC) was identified as described in Section III of this report with photos included in Appendix 1.

Description: The prefabricated metal roll-off concrete washout bin located on-site.

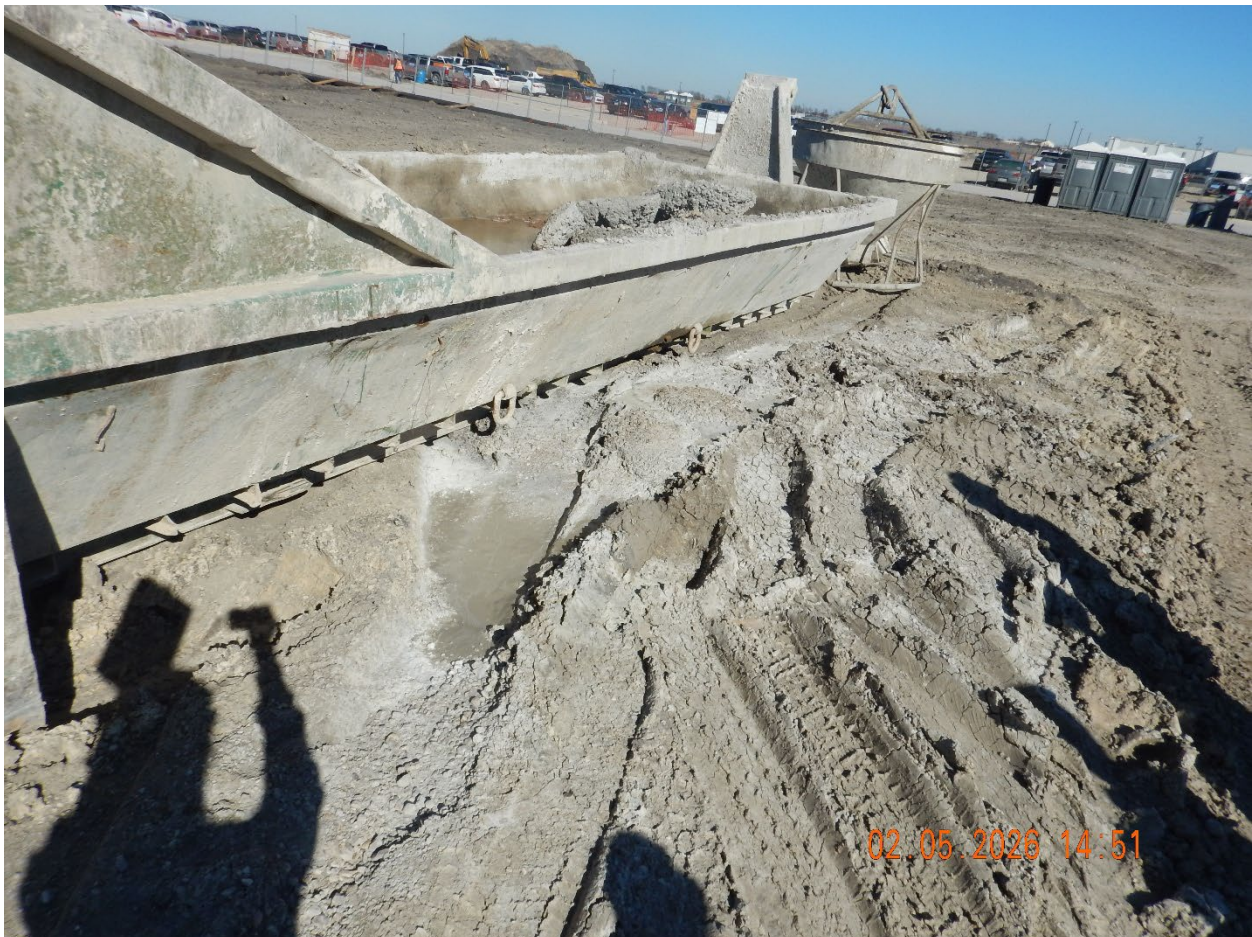
Photo no. 9

- TCEQ General Permit No. TXR150000 Part V, Section C; Part VI(B): Concrete washout liquid/waste was observed on the ground near the prefabricated metal roll-off concrete washout bin (**Appendix 1, Photos 8-9**). The waste was cleaned and photo evidence was emailed by Madeleine Forde shortly after the inspection ended on February 5, 2026 (**Appendix 2, Photo 1**).

Description: Concrete washout liquid/waste on the ground near the prefabricated metal roll-off concrete washout bin.

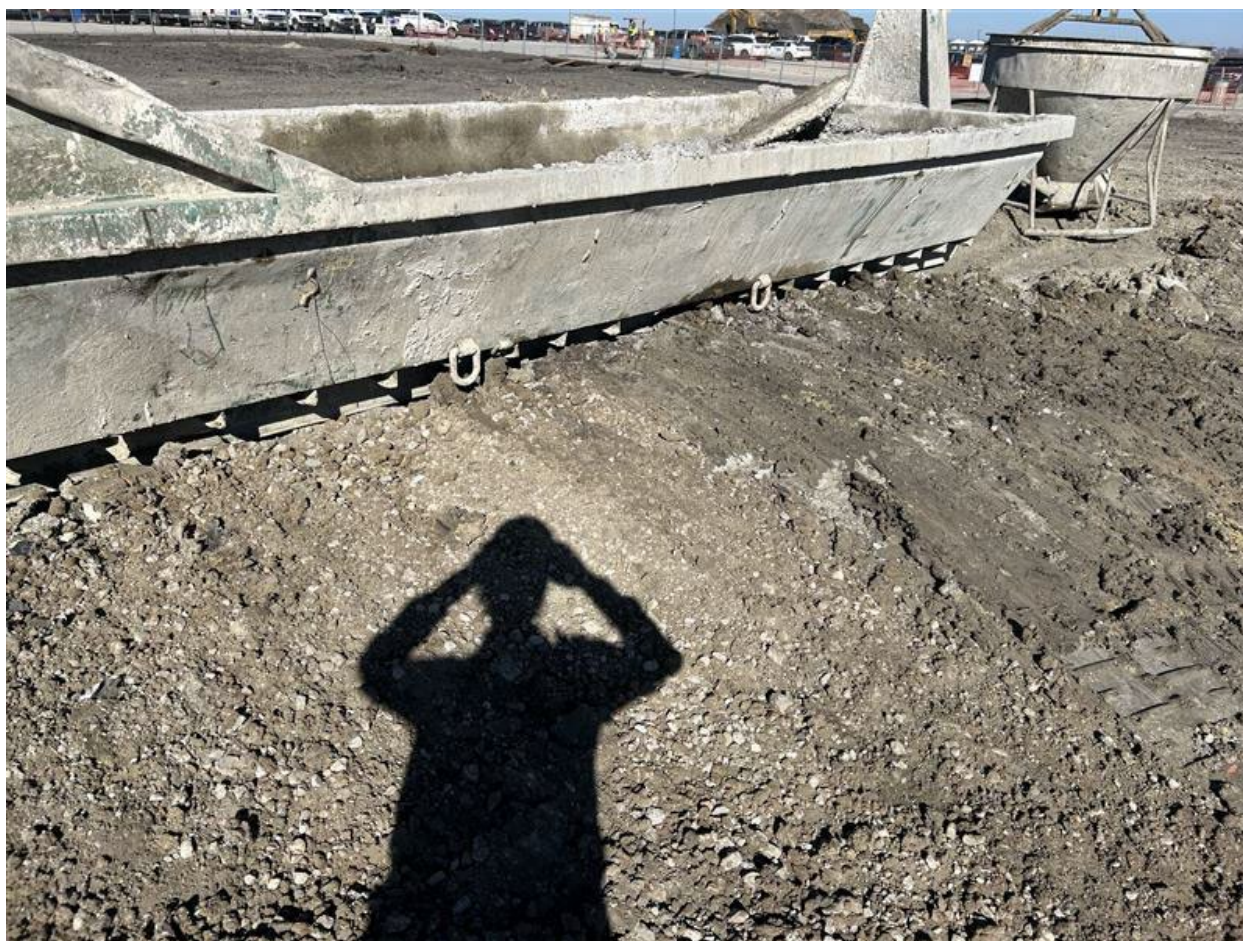
Photo no. 1

Description: Photo taken by a HCBeck representative illustrating that the concrete washout waste had been cleaned up.

- On February 5, 2026, a digital copy of the SWPPP, CSN, site map, inspection reports, and photos of the corrected AOC were emailed by Madeleine Forde. I completed a detailed review of the documentation provided and no concerns were identified.
