## **RCRA Inspection Report**

U.S. Department of Veterans Affairs  
Atlanta VA Health Care System  
1670 Clairmont Road  
Decatur, Georgia 30033  
DeKalb County

EPA ID No.: GA7360015450

July 14, 2021, at 9:00 a.m.

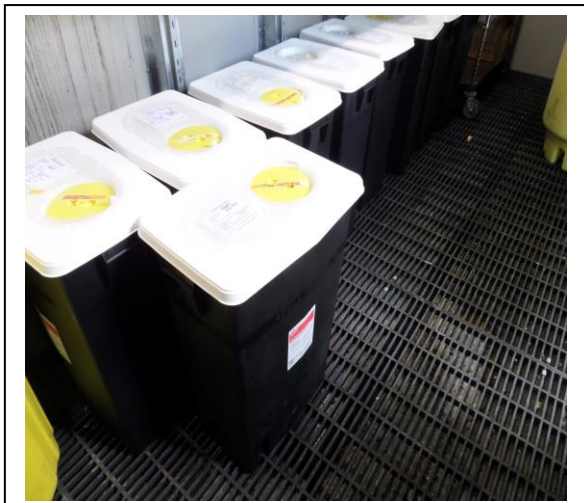
The inspectors observed nine 18-gallon containers accumulating hazardous waste solvents and corrosives. The containers were closed, in good condition with aisle space, labeled with the words hazardous waste and marked with dates in June or July 2021. The inspectors observed the containers were not labeled or marked indicating the hazards of the container contents (Photograph 1). At the time of the CEI, the facility placed new labels on each container and marked each label indicating the corrosive hazard of the container contents (Photographs 15 and 16).

Atlanta VA Health Care System (Atlanta VA). Central Accumulation Area (CAA 90-Day). The inspectors did not observe a hazard indicator on the containers. Photograph 1 taken at 10:19 a.m.

**Pursuant to Ga. Comp. R. and Regs. 391-3-11-.08(1) [40 C.F.R. § 262.17(a)(5)(i)(B)], which is a condition of the LQG Permit Exemption, a large quantity generator must mark or label its containers with the following: an indication of the hazards of the contents (examples include, but are not limited to, the applicable hazardous waste characteristic(s) (i.e., ignitable, corrosive, reactive, toxic); hazard communication consistent with the Department of Transportation requirements at 49 CFR part 172 subpart E (labeling) or subpart F (placarding); a hazard statement or pictogram consistent with the Occupational Safety and Health Administration Hazard Communication Standard at 29 CFR 1910.1200; or a chemical hazard label consistent with the National Fire Protection Association code 704).**

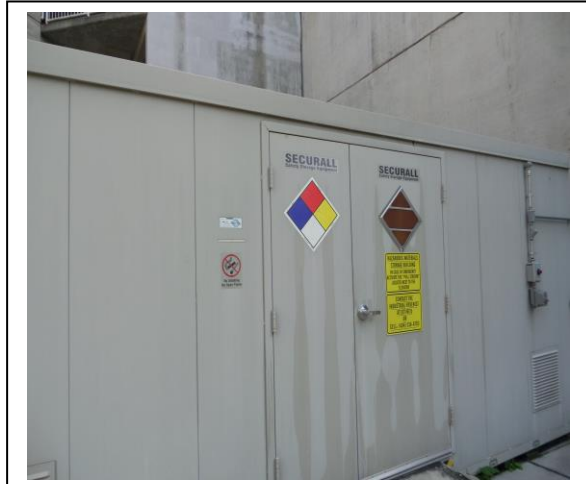
The CAA 90-Day is located outdoors between Parking Deck F and Parking Deck E. Hazardous waste is accumulated in containers for 90-days or less. The CAA is a 1,050 square foot portable steel shed constructed with double steel doors. The shed is constructed with a steel secondary containment system and covered with a grated steel floor. The inspectors observed an overhead wet chemical fire suppression system. The inspectors observed signs on the doors with the words, “No Smoking” and “Hazardous Materials Storage Building, contact the Industrial Hygienist at Ext 206115 or (404) 538-6703 (GEMS)” (Photograph 2).

Atlanta VA. 2 CAA 90-Day. The inspectors observed signs posted on CAA. Photograph 2 taken at 10:22 a.m.

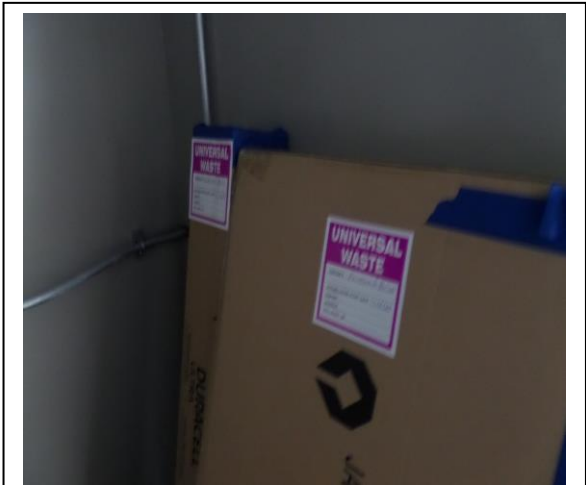
Atlanta VA. Universal Waste Shed. The facility labeled and dated the containers. Photograph 4 taken at 10:35 a.m.

The inspectors observed 23 containers accumulating four-foot waste lamps and two containers accumulating U-shaped waste lamps that were closed and in good condition. Twenty-one containers were labeled with the words universal waste and marked with the dates October 2, 2020 or October 20, 2020. The inspectors observed two containers of waste lamps were not marked or labeled with the words universal waste and not marked with a date (Photograph 3). The inspectors observed three five-gallon containers accumulating waste batteries that were not marked or labeled with the words universal waste and not marked with a date (Photograph 5 and 6). At the time of the CEI, the facility labeled the two containers of waste lamps and the three containers of waste batteries with the words universal waste and marked the containers with the date October 2, 2020 (Photographs 4 and 7).

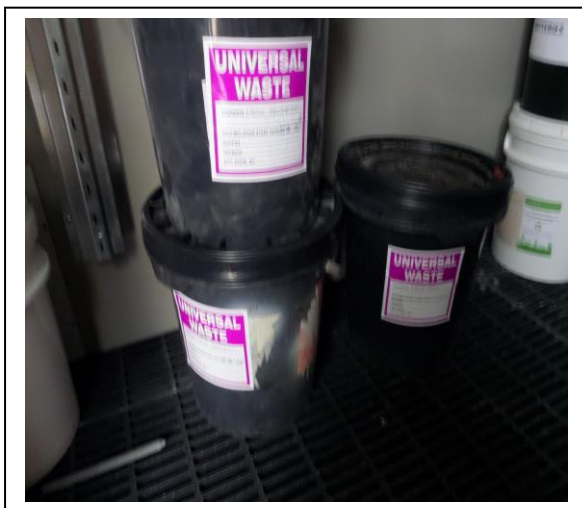
Atlanta VA. Universal Waste Shed. The facility labeled & dated the containers. Photograph 7 taken at 10:42 a.m.

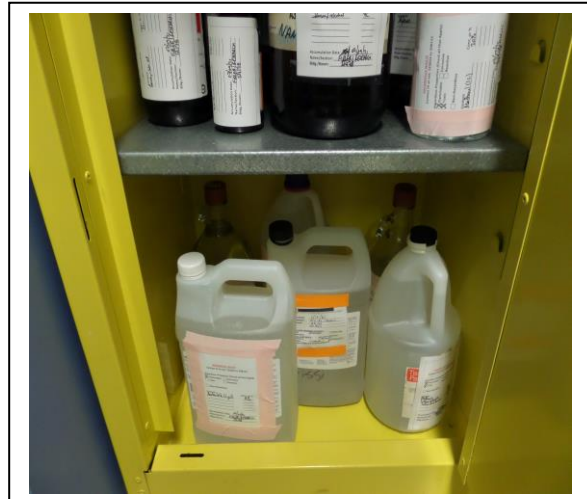
Located next to the metal shelf the inspectors observed a yellow fire cabinet accumulating four four-liter containers, two one-quart containers, three one-gallon containers, three small bottles and three two-liter containers of assorted waste solvents (methanol, xylene, isopropyl alcohol, acetonitrile). The containers were closed, in good condition with aisle space, labeled with the words hazardous waste, marked with dates in July 2021, and labeled with an indication of the hazards of the container contents (Photograph 8).

Atlanta VA. Research Laboratory Room 5A-178 90-Day Area. The inspectors observed labeled and dated containers accumulating waste solvent. Photograph 8 taken at 10:58 a.m.

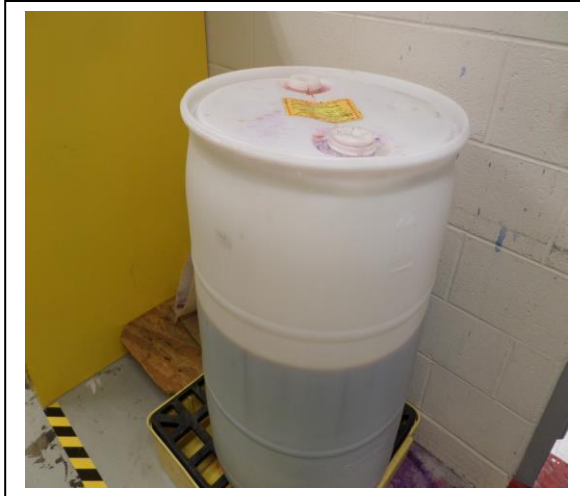
Hazardous waste generated in the histology, cytology, hematology, and microbiology laboratories is transferred from the SAA to a 90-Day or Less Accumulation Area located in Room 2B-176. Each laboratory has a supervisor. The inspectors observed a 55-gallon container accumulating spent solvents and water. The container was closed, in good condition with aisle space, labeled with the words hazardous waste, marked with date June 20, 2021, and labeled with an indication of the hazards of the container contents (Photograph 10 and 11). The hazardous waste label on the top of the container was beginning to deteriorate.

Atlanta VA. Clinical Laboratory Room 2B-176 90-Day Area. The inspectors observed the container accumulating waste solvents. Photograph 10 taken at 11:16 a.m.

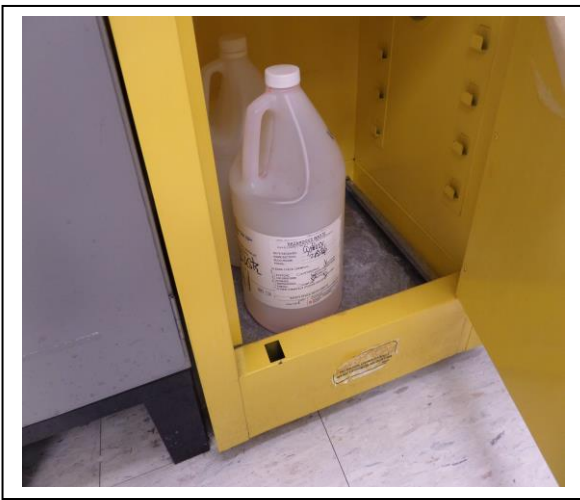
emptied from the instrument approximately once a week and accumulated in a container. The inspectors observed a SAA with a yellow fire cabinet accumulating an empty one-gallon container labeled with the words hazardous waste. The container was closed, in good condition with aisle space. The container was not labeled or marked with an indication of the hazards of the container contents (Photograph 12). A container accumulating hazardous must be labeled or marked with an indication of the hazards of the container contents.

Atlanta VA. Cytology Laboratory Room 2B-186. Satellite Accumulation Area. The inspectors observed the container is used to accumulate spent solvents. The container is empty. Photograph 12 taken at 11:35 a.m.

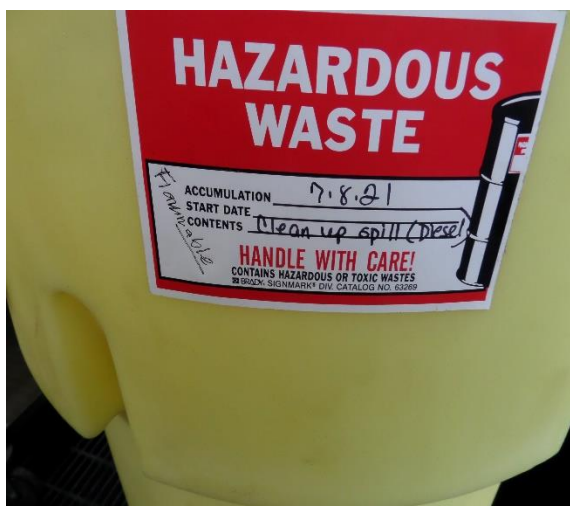
Atlanta VA. CAA 90-Day. The facility marked a hazard indicator on the container. Photograph 17 taken at 2:57 p.m.

The inspectors observed a yellow overpack container accumulating “clean up spill diesel”. The container was closed, in good condition with aisle space, labeled with the words hazardous waste and marked with the date July 8, 2021. The inspectors observed the container was not labeled or marked indicating the hazards of the container contents. At the time of the CEI, the facility marked the container with the word “Flammable” (Photograph 17). The inspectors observed spill
