INSPECTION REPORT

| Type of Inspection | Compliance Evaluation Inspection (CEI) | |
| Permittee Name | City of New Iberia | |
| Facility or Site Name | Sucrose Drive Treatment Plant | |

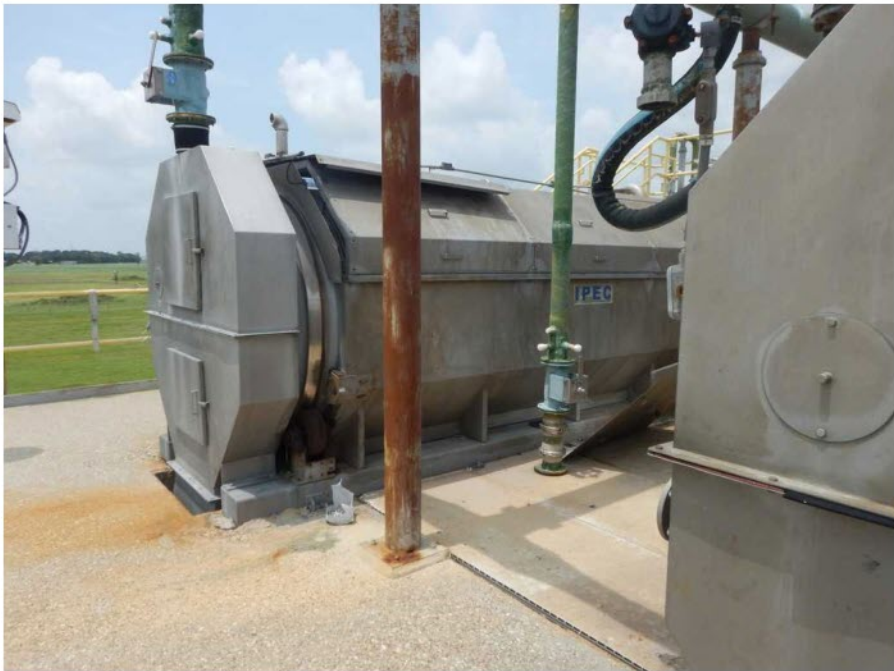
| Drum Screen | | | Drum Screen.JPG |

| Location: 1. Headworks | | |
|---|---|---|
| At the headworks, the drum screens have been inoperative for an indeterminate amount of time. They have temporarily been replaced by a manually cleaned bar screen, which catches most trash but is not as effective as the drum screens. According to the facility, funding has been secured for new drum screens and bids are currently being reviewed. | | |

| Photograph of one of the facility's drum screens, which were not in working order at the time of inspection. | | | |

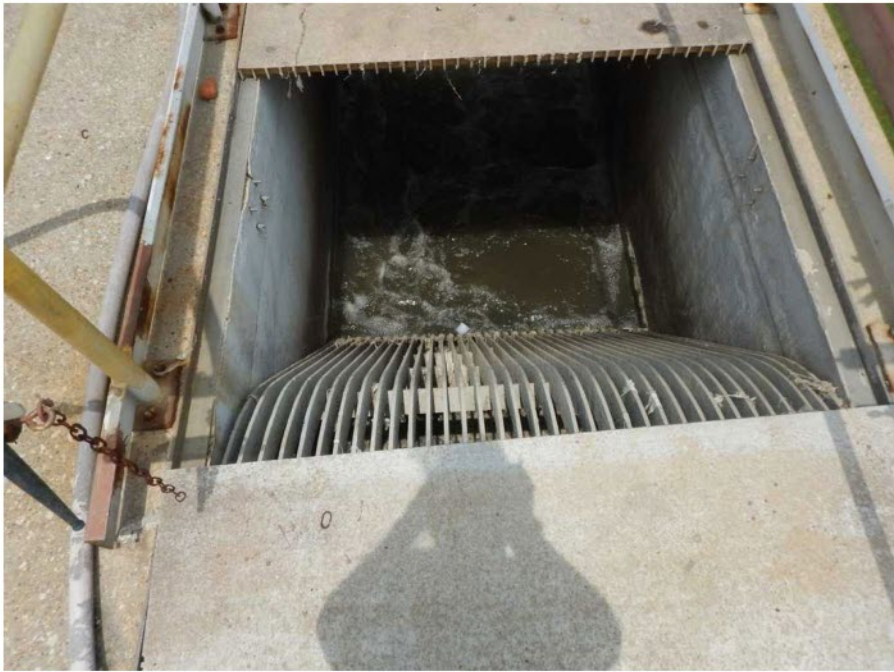
| Bar Screen | | | Bar Screen.JPG |

| Photograph of the manually cleaned bar screen that is a temporary replacement for the drum screens that were not operational at the time of inspection. | | | |

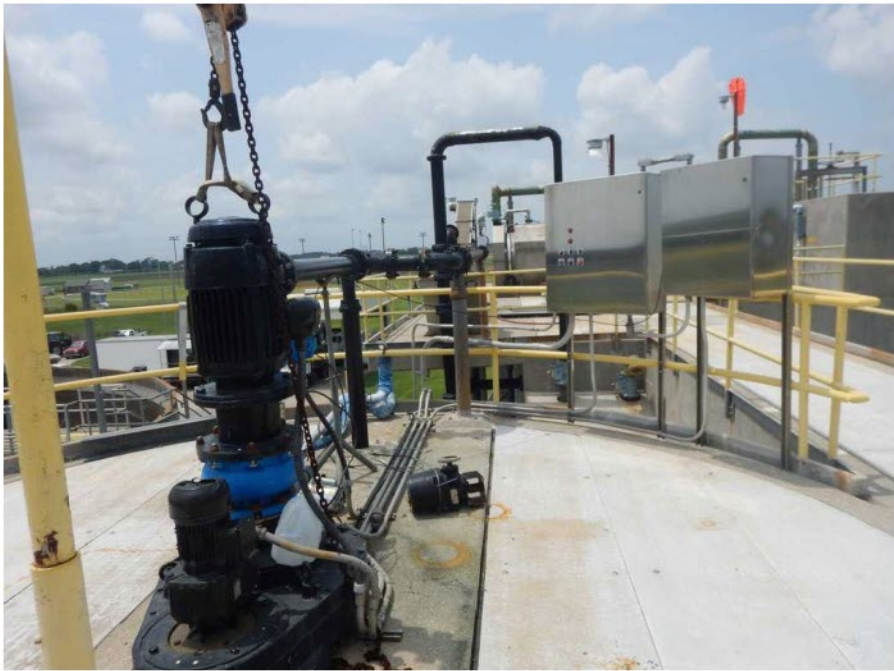
| Grit Pump Control Panel | | | Grit Chamber Control Panel.JPG |

| Location: 2. Treatment System | | |
|---|---|---|
| <p>The facility's grit pump had been down for a year, but was repaired the week before our inspection. While the pump was down, the centrifuge was still in operation, so grit was moved and pumped with a vacuum truck once a week.</p> | | |

| Photograph of the control panel which operates the facility's recently repaired grit pump. | | | |

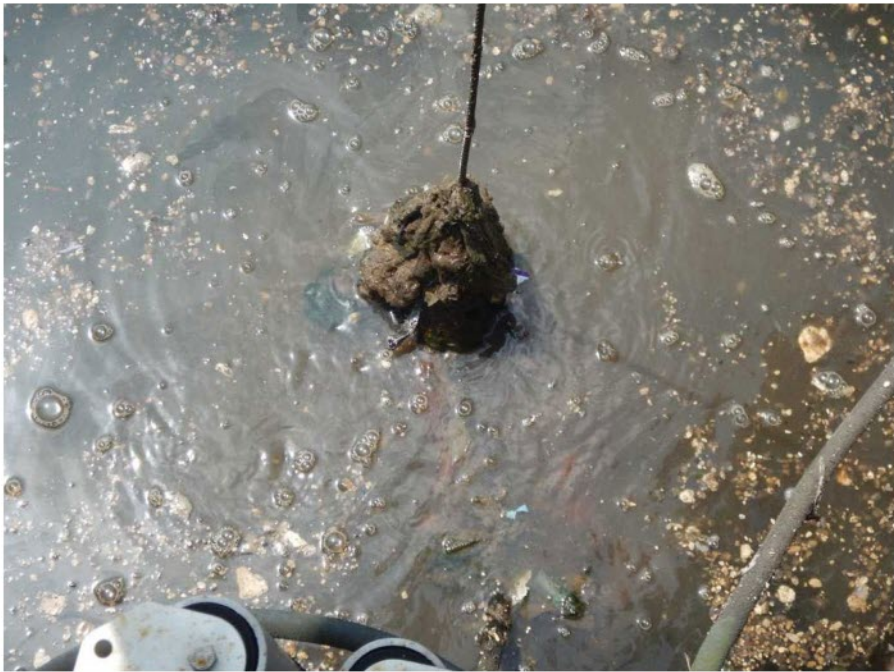
| Midge Fly Larvae | | | Midge Fly Larvae.JPG |

| Location: 2. Treatment System | | |
|---|---|---|
| <p>Midge fly larvae, also known as blood worms, were present in small numbers in the SBRs at the time of inspection. Facility personnel noted that the larvae increase in number during the summer.</p> | | |

| Photograph of midge fly larvae, also known as blood worms, attached to a rope in one of the facility's sequence batch reactors. | | | |

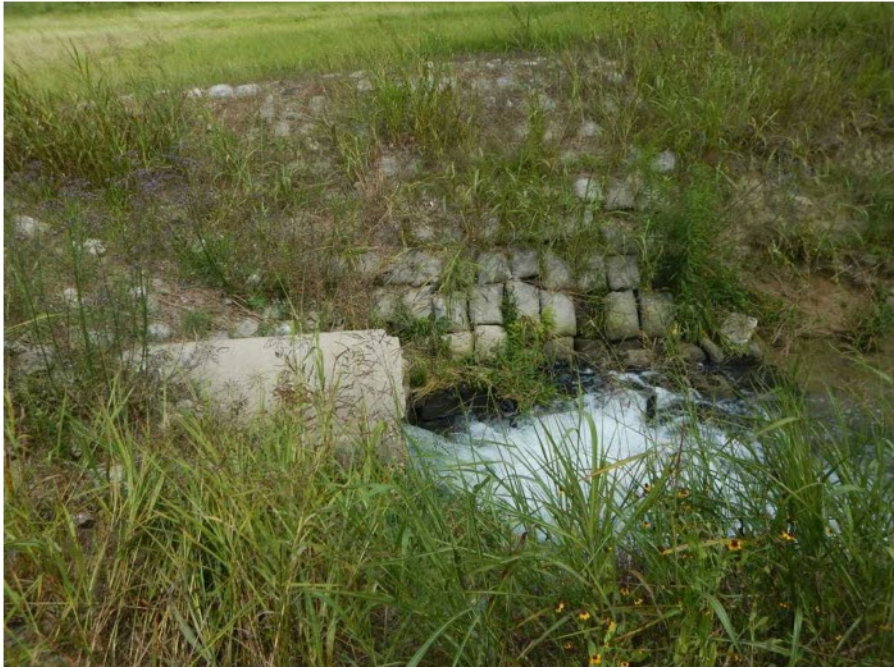
| Outfall | | | Outfall.JPG |

| Photograph of the facility's outfall through which all treated wastewater is discharged. | | | |

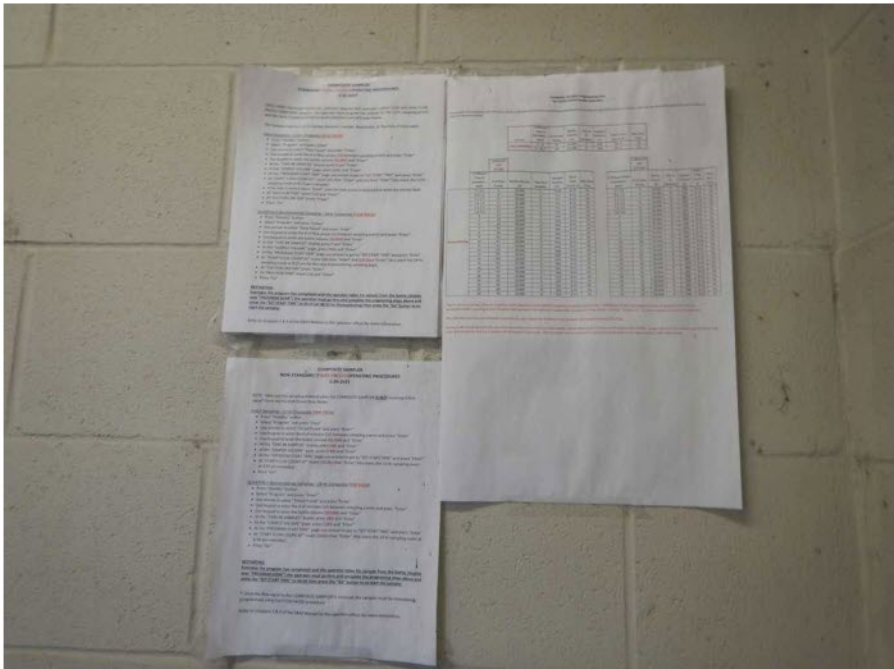
| Composite Sample Info | | | Composite Sample Info.JPG |

| Location: 4. Discharge | | |
|---|---|---|
| <p>New Iberia's permit requires flow-weighted composite samples. The composite samples were not being flow weighted properly at the time of inspection. The flow weight was being manually calculated based on the plant's flow from the previous day rather than being synced to real-time flow data.</p> | | |

| New Iberia’s permit requires 12-hour flow-weighted composite samples. The composite samples were not being flow weighted properly at the time of inspection. The flow weight was being manually calculated based on the plant’s flow from the previous day rather than being synced to real-time flow data. | |

| Photograph of the methods by which the volume is calculated for flow-weighted composite samples collected from the facility's discharge. | | | |
