# NPDES Compliance Inspection Report

## Moclips River Estates WWTP Taholah, Washington

**Permit #: WA0026603**

**Inspection Date: February 9, 2021**

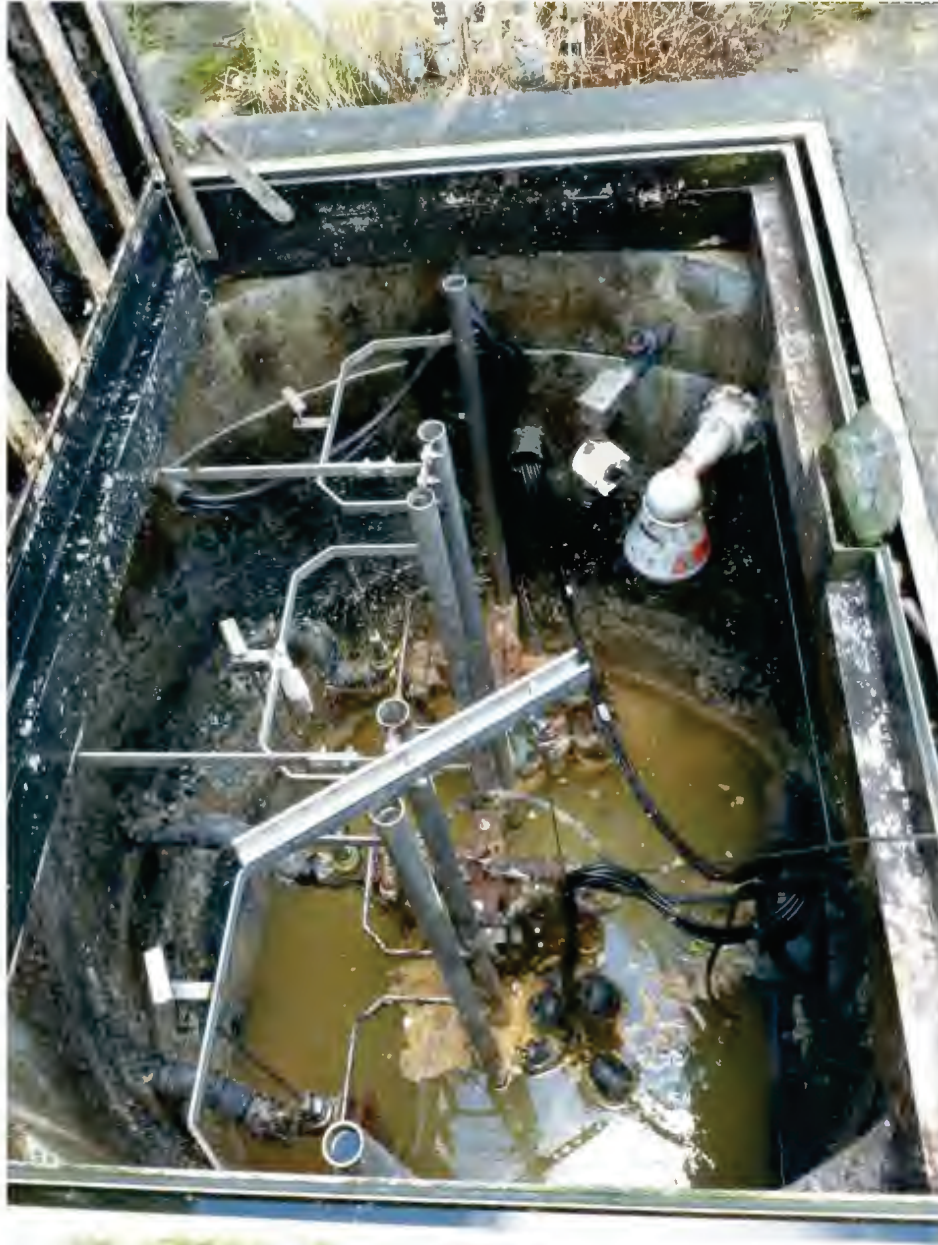
**Photo 1 / P1000650 – Lift Station**

I started the site inspection with Mr. Hinchén leading me to the headworks. Wastewater is gravity fed to the lift station (**Photo 1**) from the tribal housing area. Once the waste reaches the lift station, it passes through a bar screen to remove large solids. The screenings are removed as needed and shipped off-site for disposal. The influent sample is drawn from the lift station. After passing the bar screen, the waste is pumped to a splitter box (**Photo 2**) through an underground piping system. The Facility operates two bioreactors. Using the splitter box, Mr. Hinchén can decide which of the bioreactors receives wastewater. Each [REDACTED] consists of an anoxic compartment, an aeration compartment, and a clarifier. The bioreactors are covered with deck planks (**Photo 3**) which prevented me from closely observing the processes. From the splitter box, the wastewater enters the anoxic compartment of one of the bioreactors. The anoxic compartment uses low revolutions per minute (RPM) agitation to encourage the sewage to mix with activated sludge. From the anoxic compartment, the wastewater overflows into the aeration compartment which uses fine bubble aeration diffusers to ensure adequate aeration. The wastewater flows into the clarifier at the bottom of the chamber. As the wastewater rises, a sludge blanket is formed which acts as additional filtration to filter out small particles. Excess sludge is pumped to a sludge tank (**Photo 4**). Excess sludge is removed and trucked to another WWTP for disposal. Once the wastewater has completed the anoxic/aeration/clarifying treatment cycle, it flows through a series of microscreen filtration drums (**Photo 5**) to remove any remaining fine particles. The wastewater passes through ultraviolet (UV) disinfection (**Photos 6 & 7**) as the final step in the treatment process. Effluent sampling is conducted on the outlet side of the UV system. Once the effluent passes UV disinfection, it is pumped to the outfall. I did not observe the actual outfall.
