## RCRA Compliance Branch INSPECTION REPORT

| <b>Facility or Site Name:</b> | RSM Electron Power Inc | |

The purpose of the inspection was to perform a Resource Conservation and Recovery Act (RCRA) comprehensive evaluation inspection (CEI) at this facility. The inspection was conducted by EPA RCRA inspector Areeba Khan.

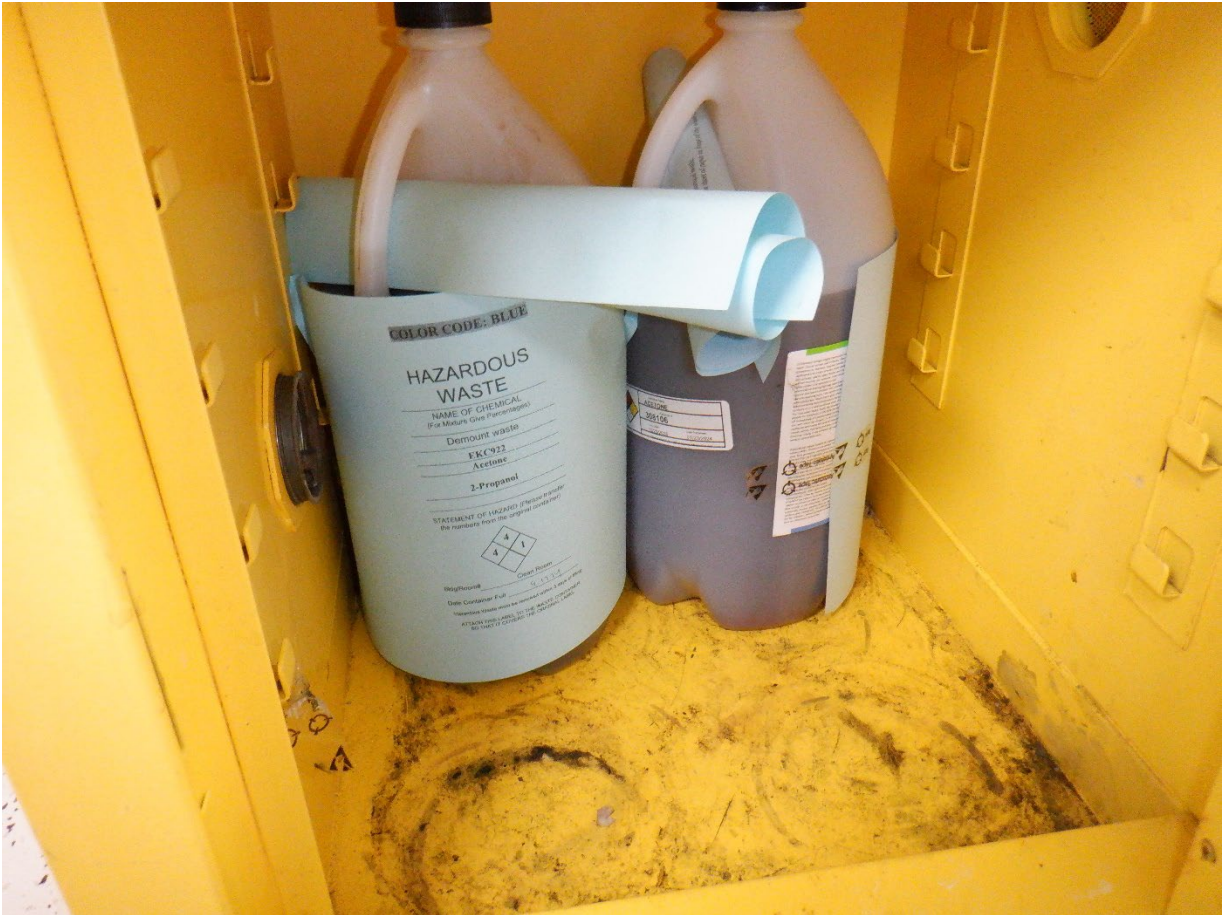
1. Ignitable cabinet (Shown in figures 1 and 2)
  - Inside the Cabinet
    - i. Two 1 gallon satellite accumulation container of acetone and propanal (hazardous waste) that were labeled and closed.

(Figure 1: Showing chemicals inside of the ignitable cabinet)

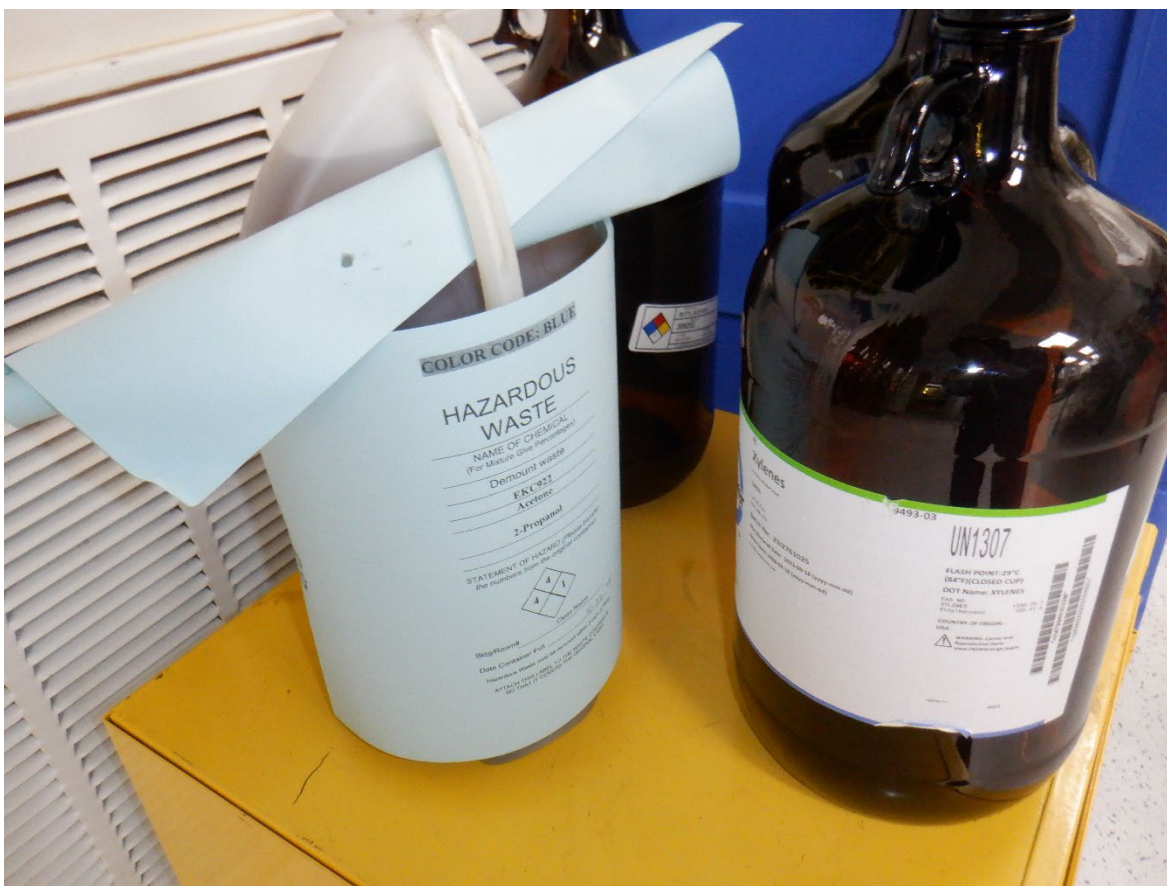
- On top of the Cabinet
  - i. One 1 gallon satellite accumulation container of acetone and propanal (hazardous waste) that was labeled and closed.
  - ii. Three 1 gallon satellite accumulation container of xylene (hazardous waste) that was labeled and closed.

(Figure 2: Showing chemicals on top of the ignitable cabinet)

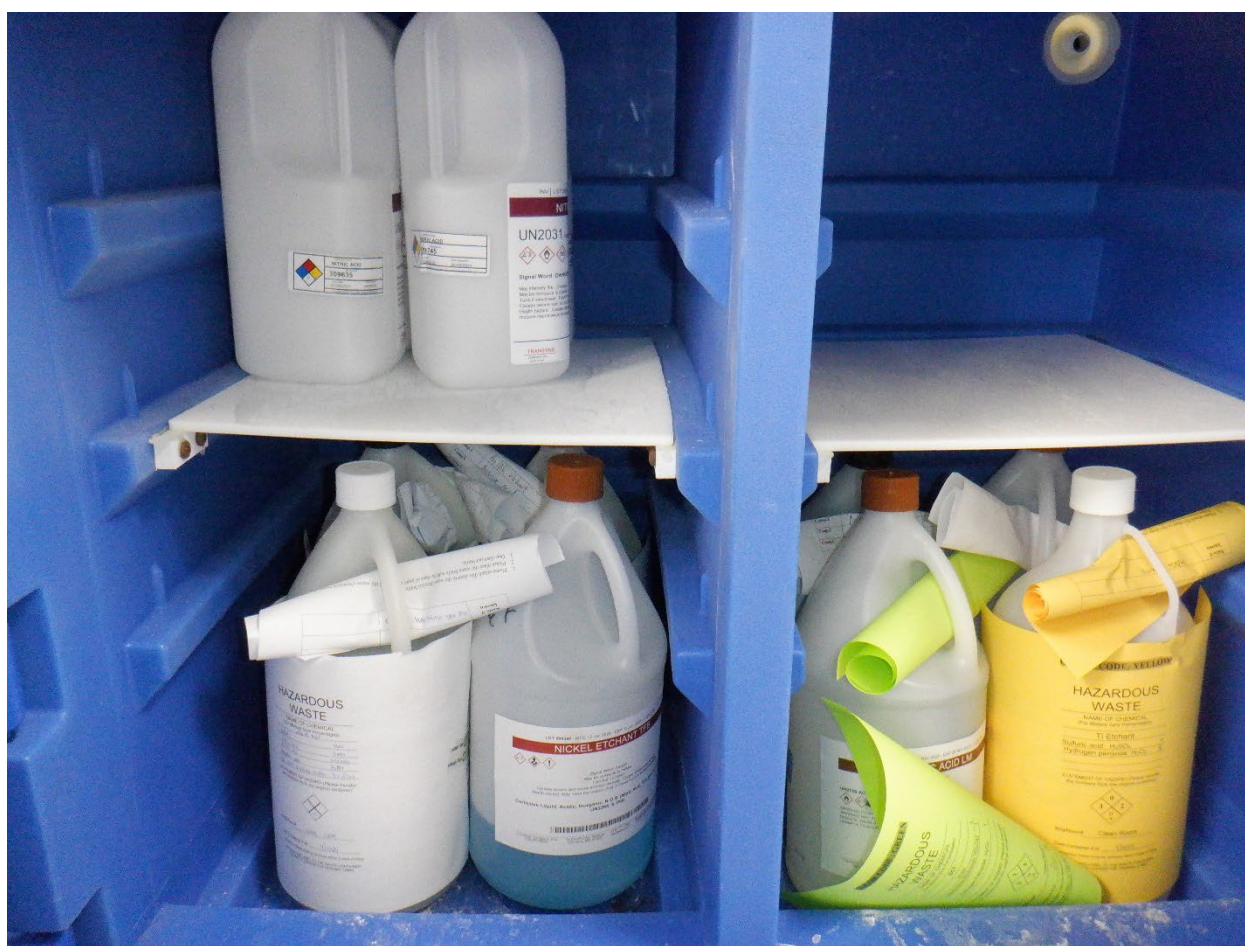
- One 1 gallon satellite accumulation container of sulfur peroxide (hazardous waste) that was labeled and closed.
- Three 1 gallon satellite accumulation container of nitric acid and acetic acid (hazardous waste) that was labeled and closed.
- One 1 gallon satellite accumulation container of amonium hydroxide and hydrogen peroxide (hazardous waste) that was labeled and closed.
- One 1 gallon satellite accumulation container of sulfuric acid and hydrogen peroxide (hazardous waste) that was labeled and closed.
- One 1 gallon satellite accumulation container of acetic acid (hazardous waste) that was labeled and closed.
- Four 1 liter satellite accumulation container of nitric acid (hazardous waste) that was labeled and closed.

- Two 1 gallon satellite accumulation container of hydrogen phosphorus (hazardous waste) that was labeled and closed.
- Three 1 gallon satellite accumulation container of hydrogen peroxide (hazardous waste) that was labeled and closed.
- One 1 gallon satellite accumulation container of sulfuric acid (hazardous waste) that was labeled and closed.
- One 1 gallon satellite accumulation container of hydrofluoric acid (hazardous waste) that was labeled and closed.

(Figure 3: Showing chemicals inside the acids cabinet)

- a. At the time of the inspection, there were incompatible wastes and materials placed near each other in the wafer fabricator area. The following acids were observed in the acid's cabinet and on top of the cabinet as shown in Figures 3 and 4:

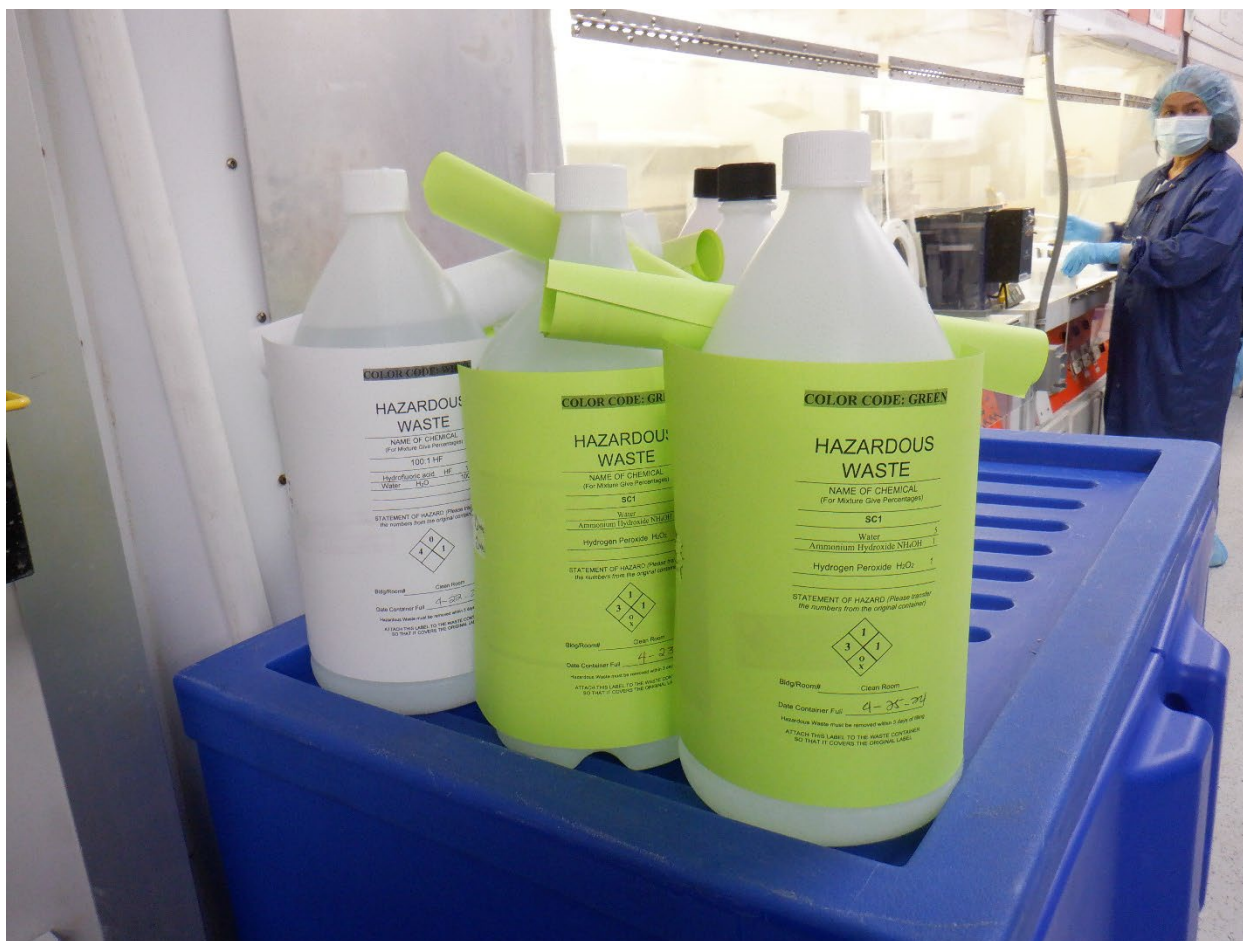
(Figure 4: Showing chemicals on top of the acids cabinet)

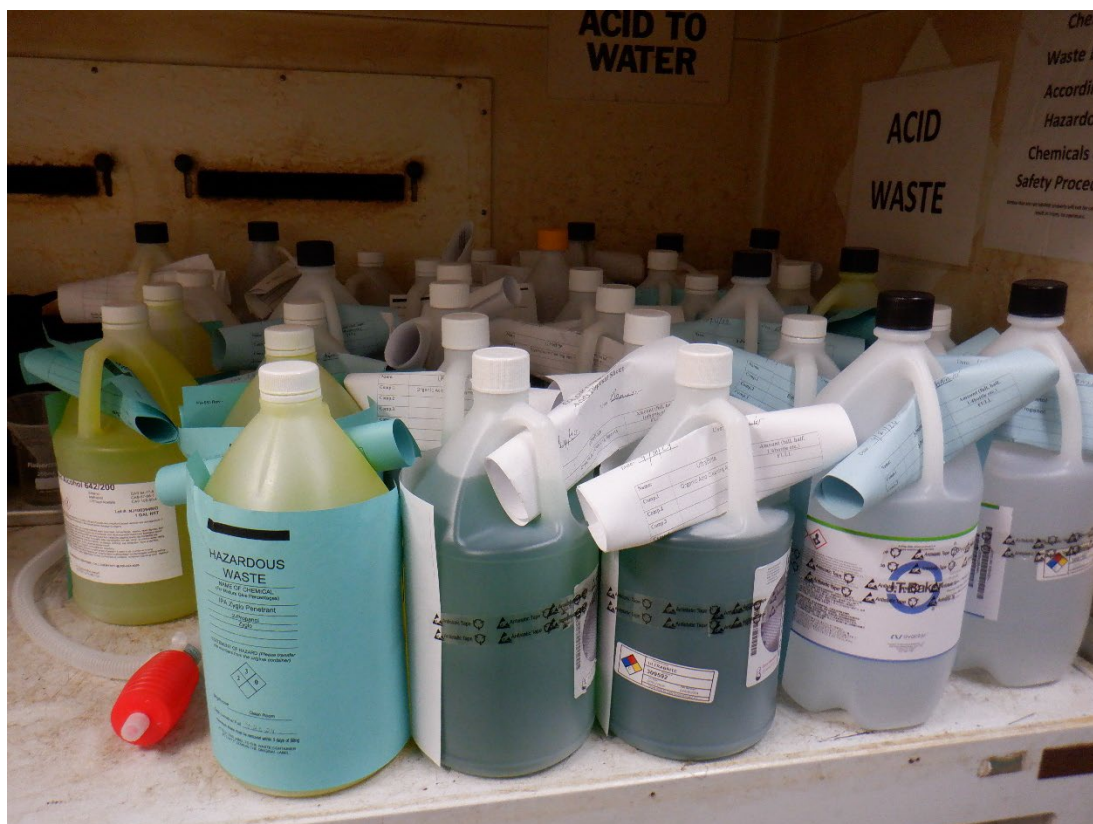
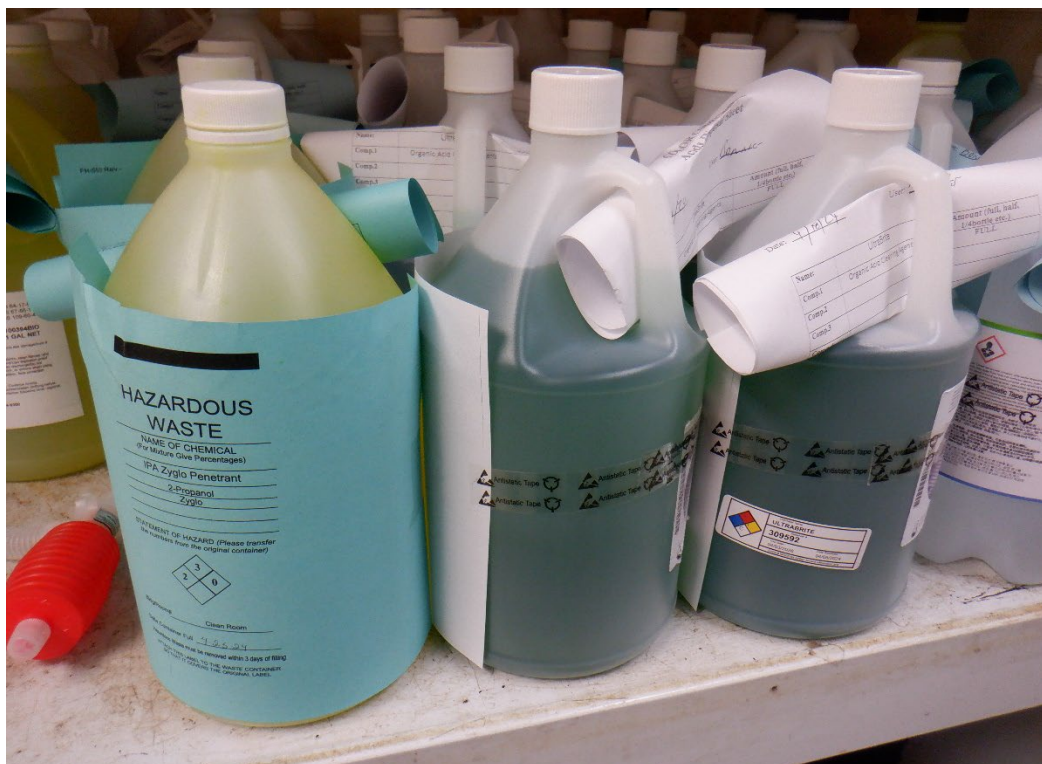
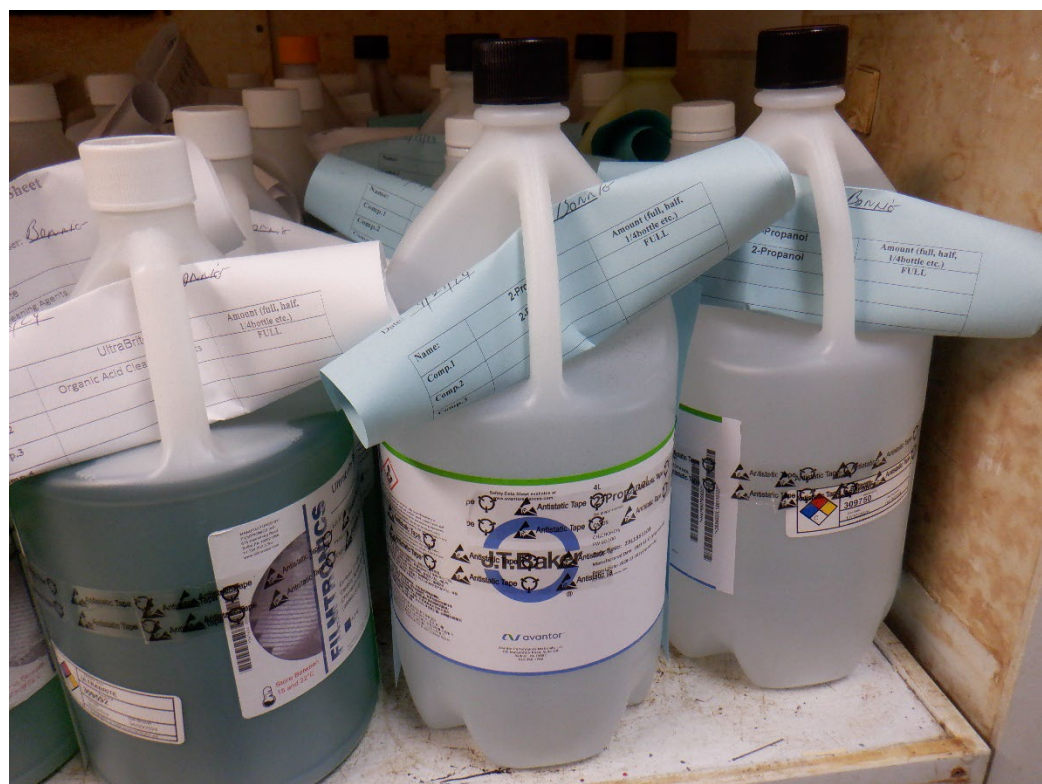
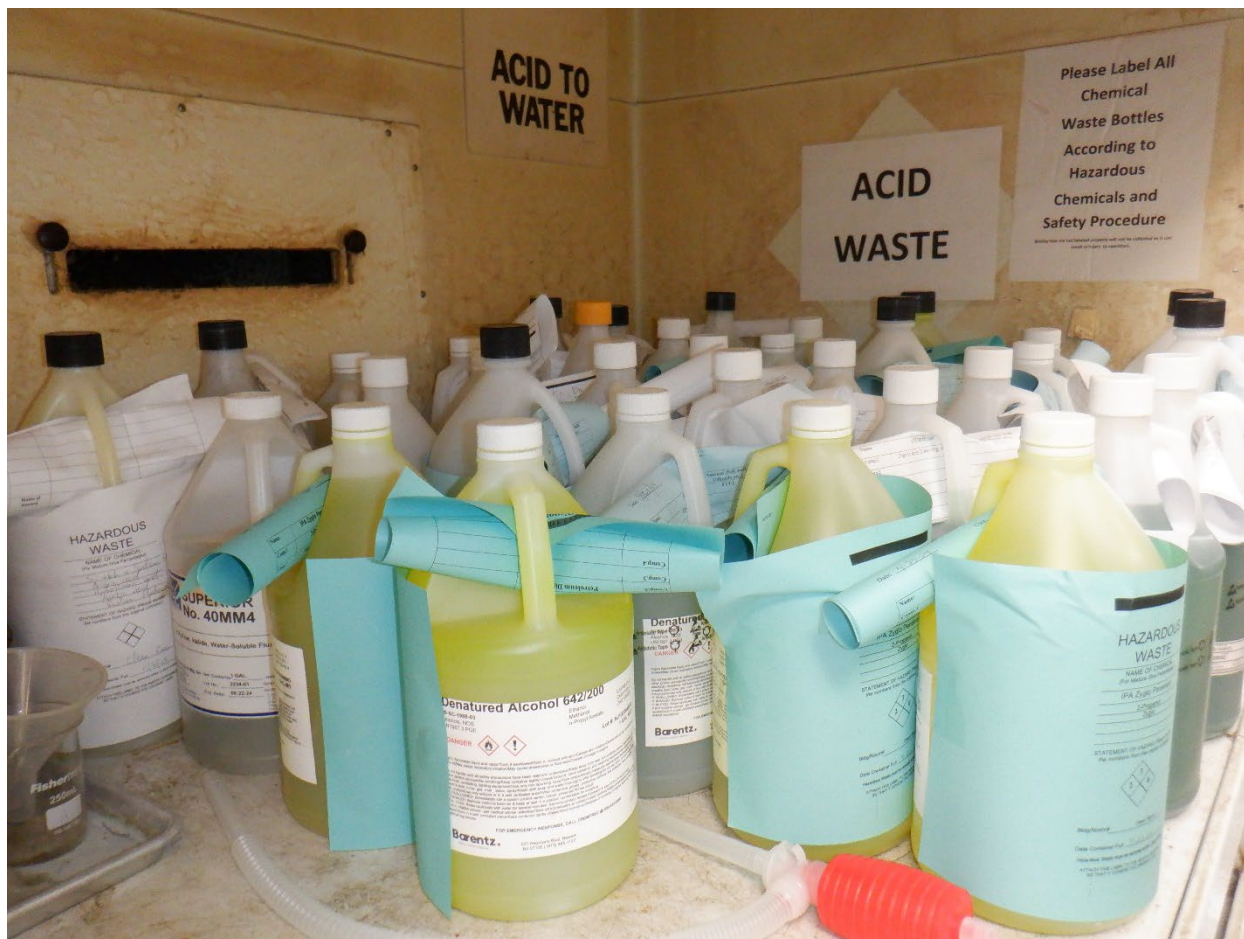
Mr. Reyes then showed me the chemical lab. The facility representative stated the chemical lab is where the facility does metal etching. There was a total of thirty five one gallon satellite accumulation containers of hazardous waste located all in one area underneath a hood as shown in figure 5, 6, 7 and 8. At the time of the inspection the following was observed:

(Figure 5: Showing Chemicals located in the Chemical Lab Area)

(Figure 6: Showing Chemicals located in the Chemical Lab Area)

(Figure 7: Showing Chemicals located in the Chemical Lab Area)

(Figure 8: Showing Chemicals located in the Chemical Lab Area)

- x. One 1 gallon satellite accumulation container of hydrofluoric acid (hazardous waste).
- b. At the time of the inspection, there were incompatible wastes and materials placed near each other in the chemical lab area. The following acids were observed underneath the hood as shown in Figure 5, 6, 7 and 8:

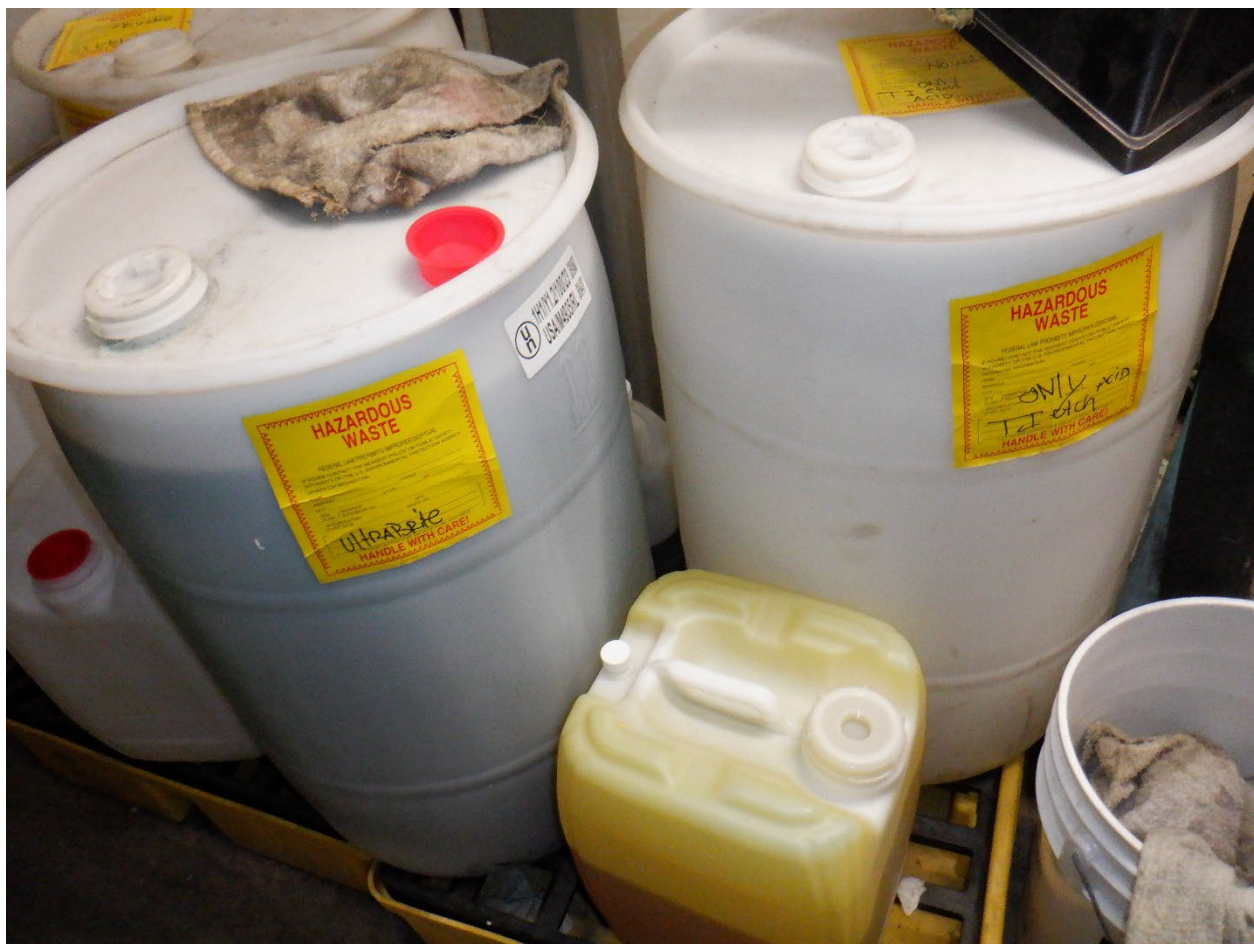
- One 30 gallon drum of ultra brite (hazardous waste) that was labeled, closed, and not dated.
- One 30 gallon drum of TI Etch (sulfuric peroxide) that was labeled, closed, and not dated.
- One 5 gallon container of acetic acid and nitric acid (hazardous waste) that was closed but was not labeled and did not have a date.
- One 30 gallon drum of SI Etch (sulfuric acid) that was labeled, closed, and not dated.

(Figure 9: Showing hazardous waste located in the Central Storage Area with no date)

3. Pursuant to 6 NYCRR § 372.2(a)(8)(ii), The date upon which each period of accumulation begins is clearly marked and visible for inspection on each container.

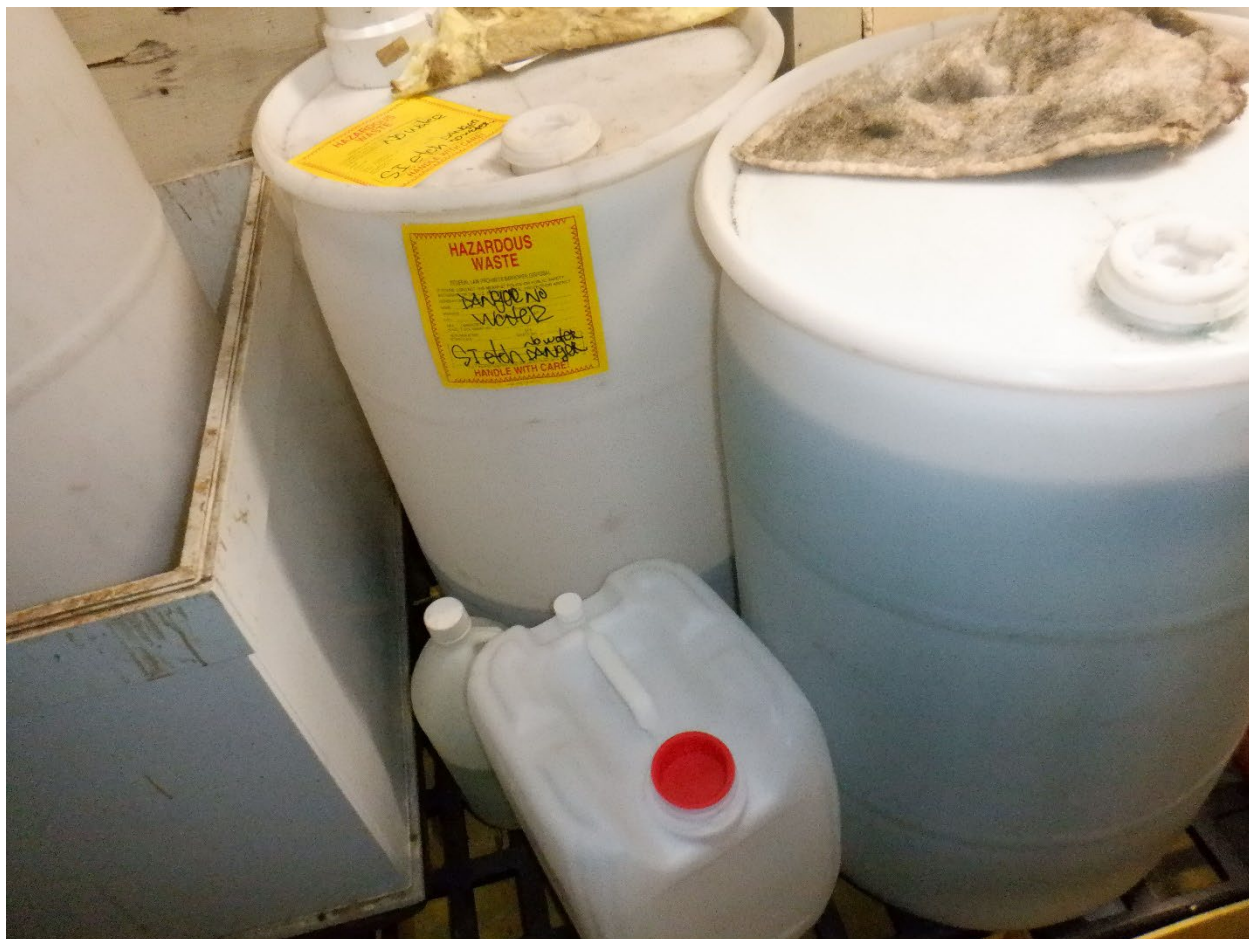
(Figure 10: Showing hazardous waste located in the Central Storage Area with no date and some with no labels)

2. Pursuant to 6 NYCRR § 373-3.9(d)(3): Each container is marked with the words "Hazardous Waste" and with other words to identify the contents.
  - a. At the time of the inspection, there was one 55 gallon hazardous waste (solvent waste) drum located in the central storage area that was not labeled with the words hazardous waste.

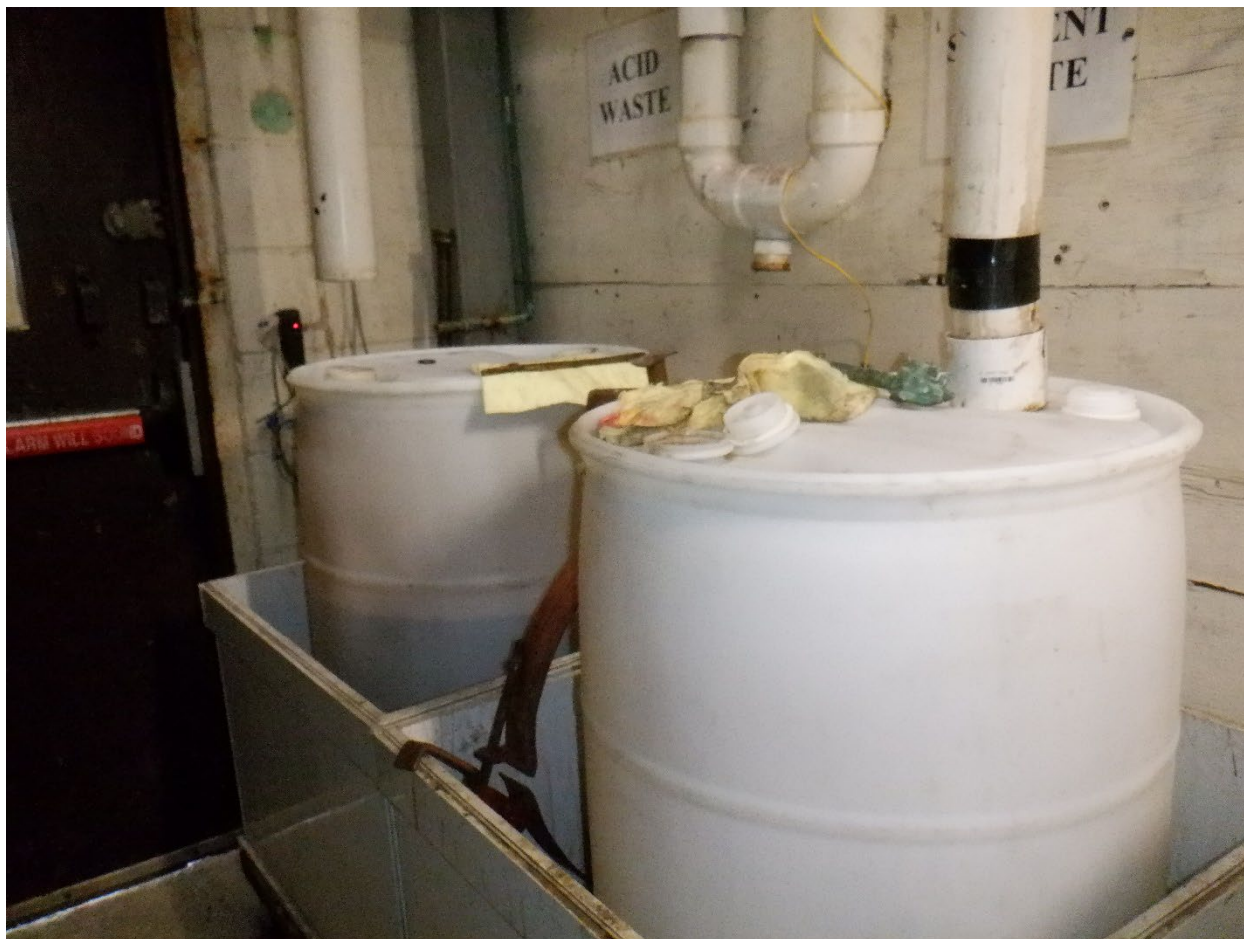
(Figure 11: Showing hazardous waste located in the Central Storage Area with that are open and not labeled with the words hazardous waste or have a date)

At the time of the inspection, there was one 55 gallon hazardous waste (solvent waste) drum located in the central storage area that was open.

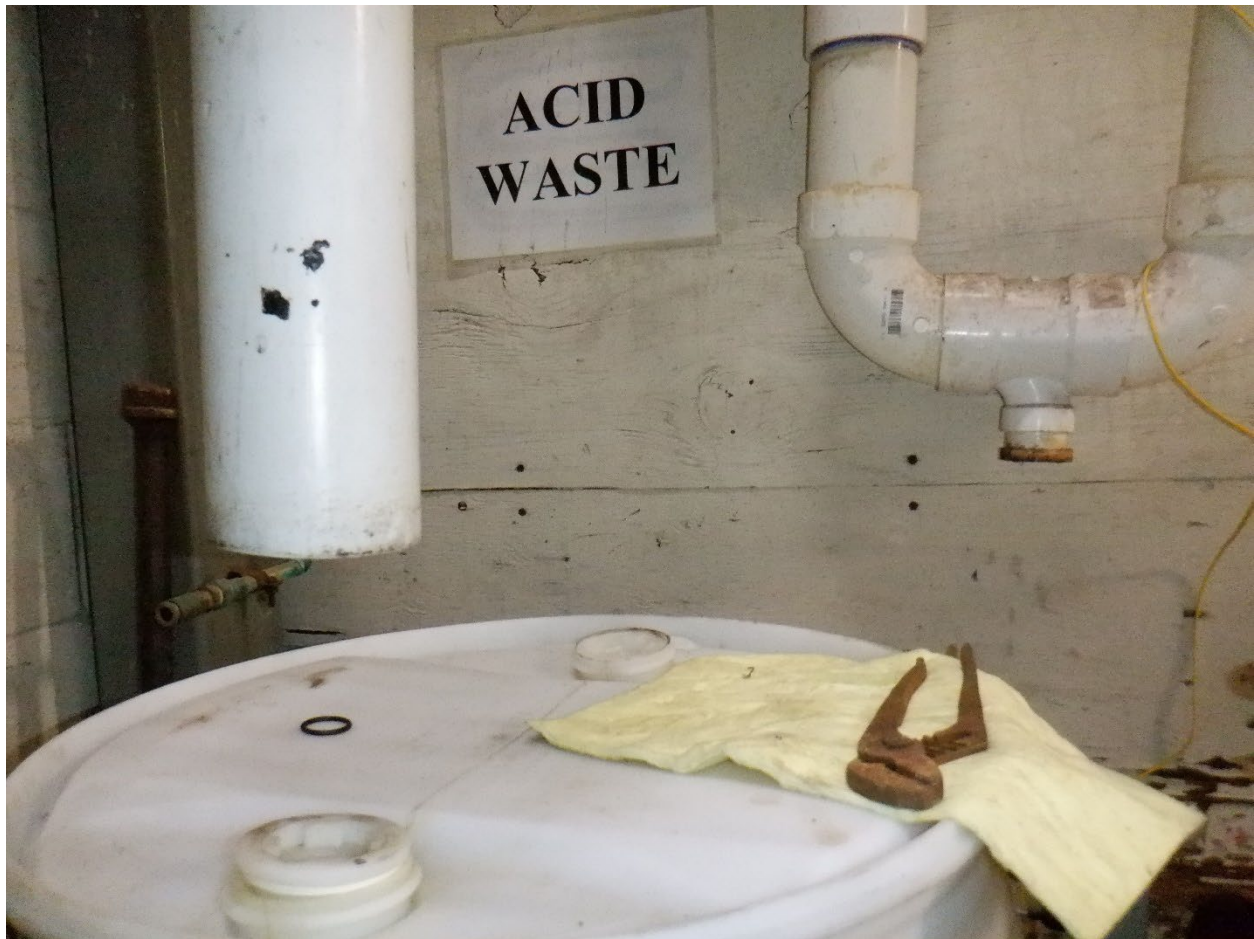
(Figure 12: Showing corrosion of the piping system above)

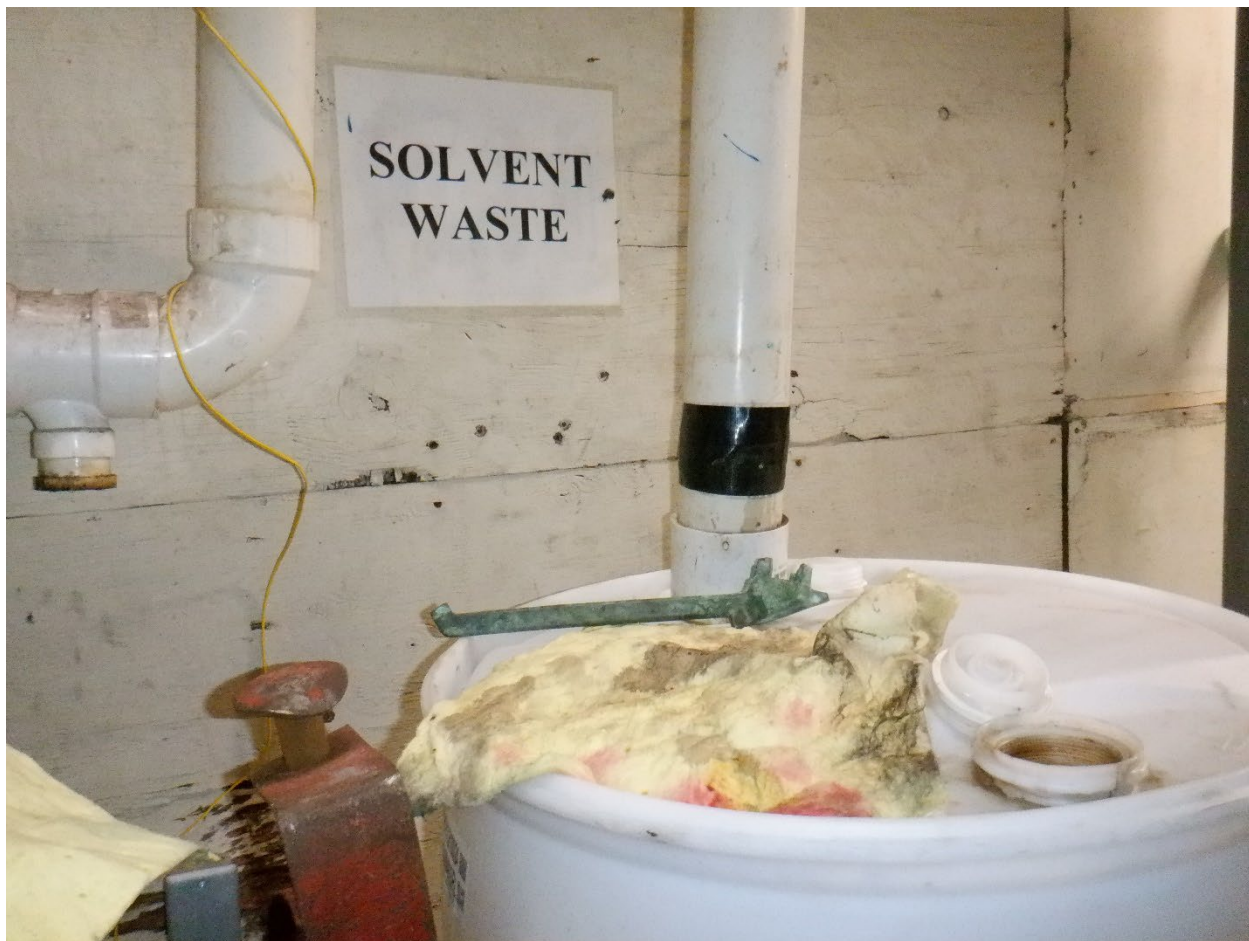
(Figure 13: Showing an open container and funnel into the other side of the drum)

1. Pursuant to 6 NYCRR § 373-3.9(d)(1), management of containers. (1) A container holding hazardous waste must always be closed during storage, except when it is necessary to add or remove waste.

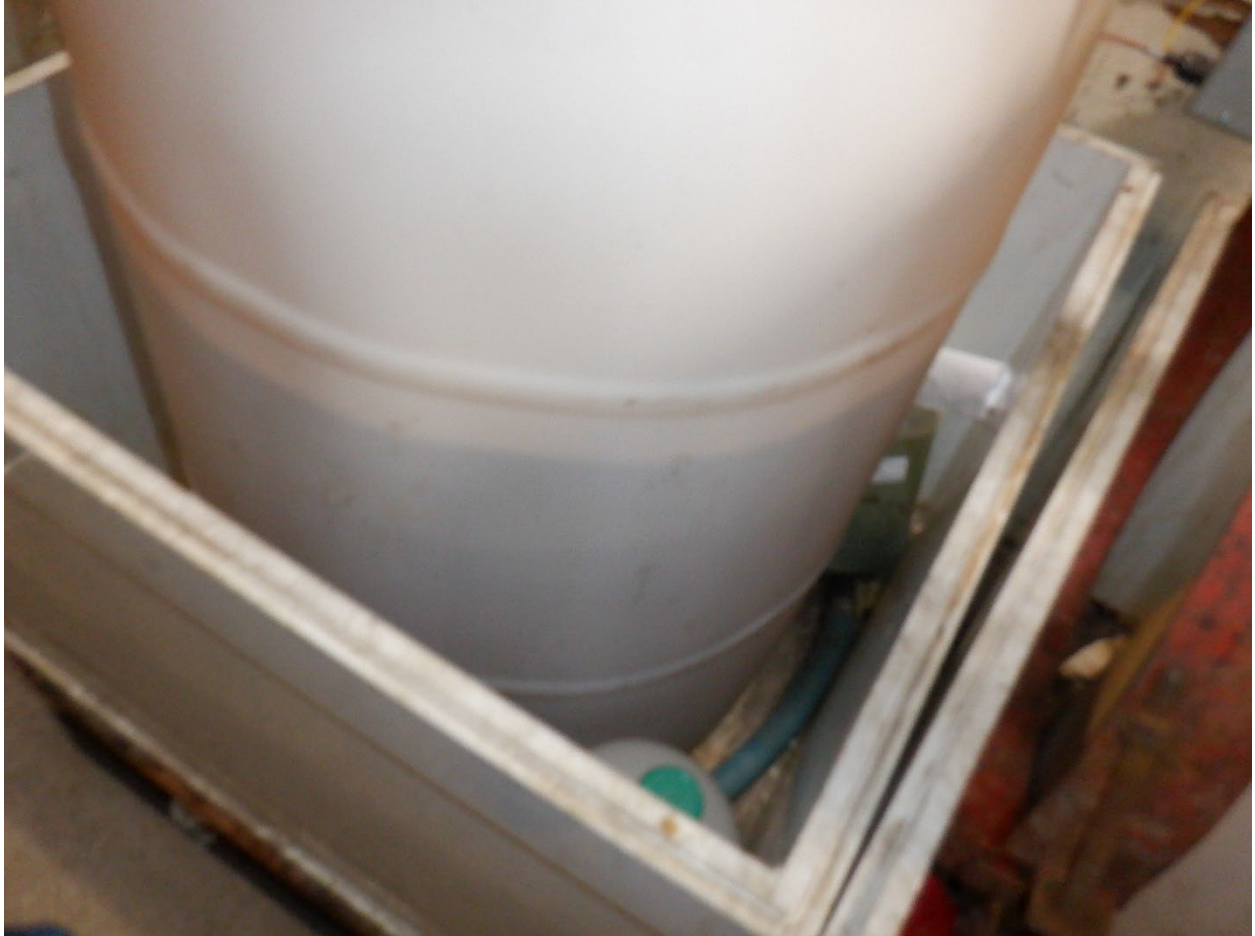
(Figure 14: Showing hazardous waste located inside the secondary containers with no label and date)

- e. At the time of the inspection, there were two 1 gallon drum of hazardous waste (phosphorous acid) drum located in the central storage area that was not labeled.

- e. At the time of the inspection, there were two 1 gallon drum of hazardous waste (phosphorous acid) drum located in the central storage area that was not dated.
