## Region 6 - Enforcement & Compliance Assurance Division

### INSPECTION REPORT

| Regulatory Program(s) | NPDES Stormwater/CWA 402 | |
| Facility Name: | Village at Gateway – Private – Commercial | |

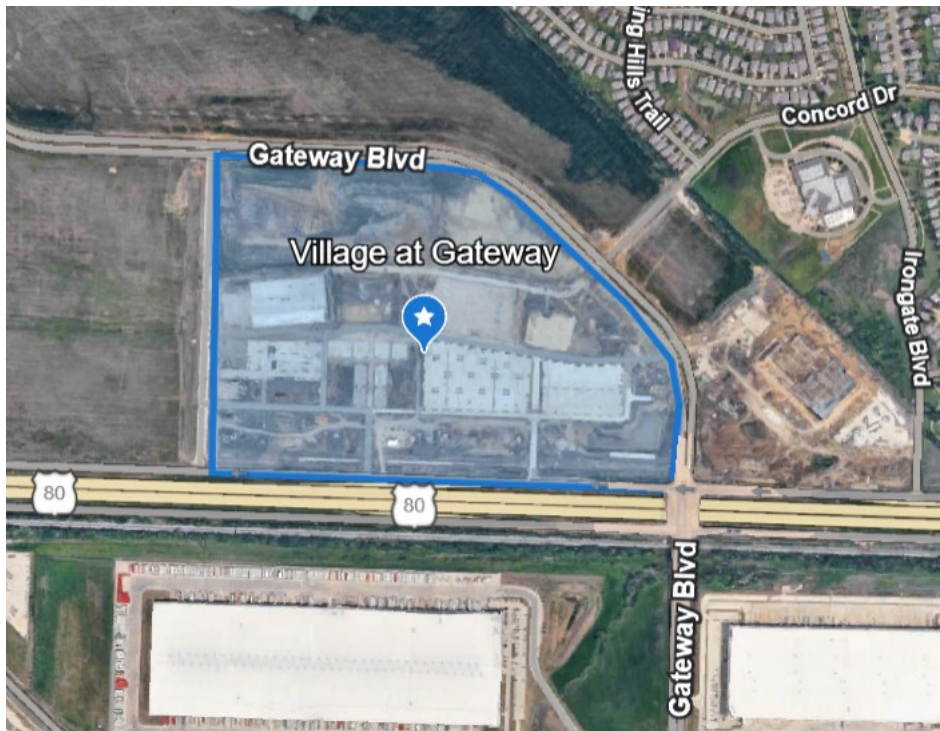
The Village at Gateway – Private is located near the northwest corner of West U.S. Highway 80 and Gateway Boulevard in Forney, Texas (denoted in **Aerial Image 1** below) with coordinates in the vicinity of Latitude 32°44'27.9"North, Longitude 96°24'57.8"West. The project totals 56.55 acres and discharges into Kings Creek (Segment #0818C) in the City of Forney’s Municipal Separate Storm Sewer System (MS4).

**Aerial Image 1:** The Village at Gateway – Private commercial construction site. The site is located within the approximate blue boundary lines depicted above (near the northwest corner of West U.S. Highway 80 and Gateway Boulevard in Forney, TX).

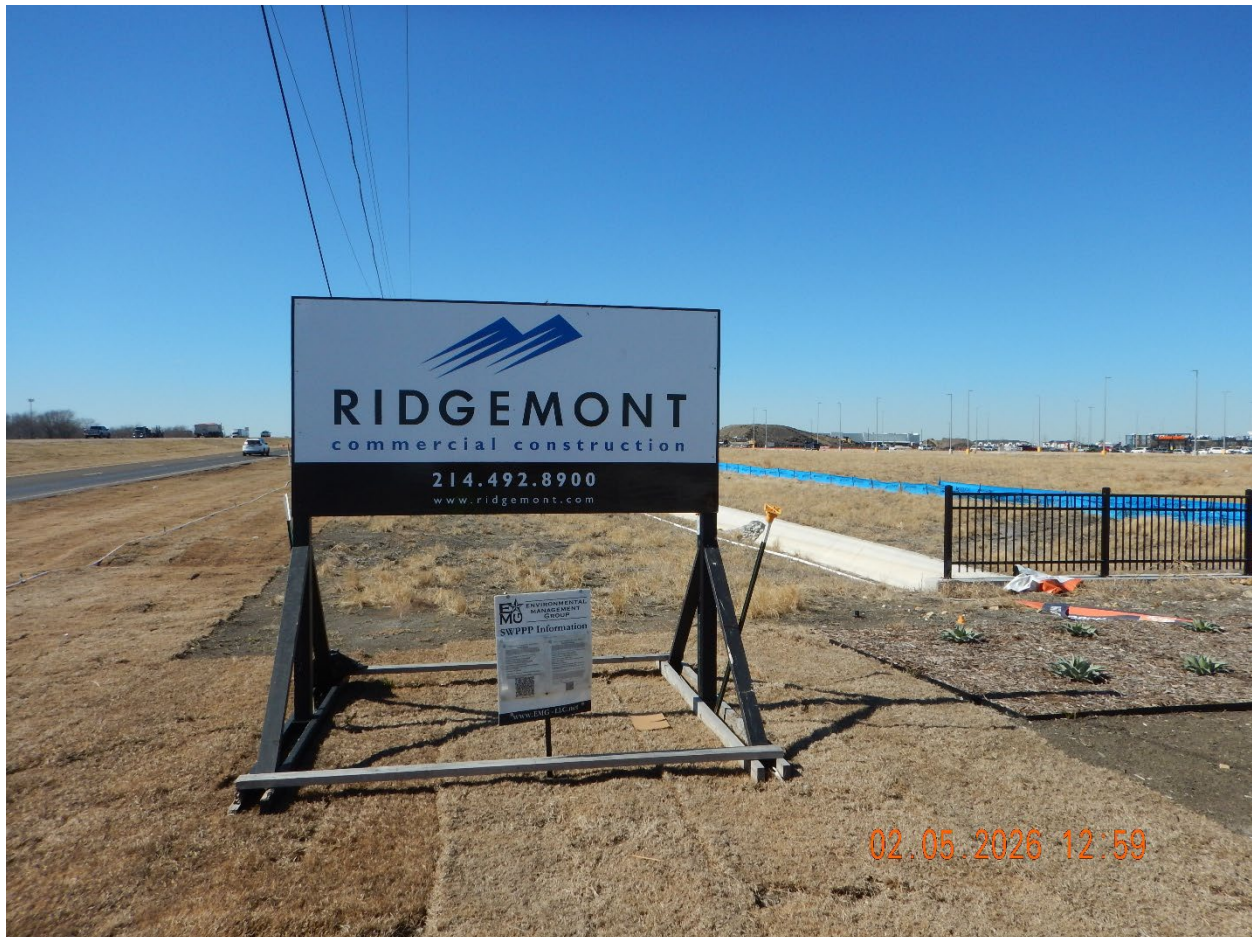
Photo no. 1

- The Construction Site Notice (CSN) was observed near the construction entrance off US Highway 80 (**Appendix 1, Photo 1**).
- The construction trailer was located near the entrance off US Highway 80 (Lot 8). The Stormwater Pollution Prevention Plant (SWPPP) was not available for review in the trailer at the time of inspection. However, Matthew Martin (Consultant) provided printed copies of the site maps at the beginning of the inspection and emailed a digital copy of the remaining SWPPP documentation at the conclusion of the inspection as described in Section IV of this report.

Description: The CSN posted near the construction entrance off US Highway 80.

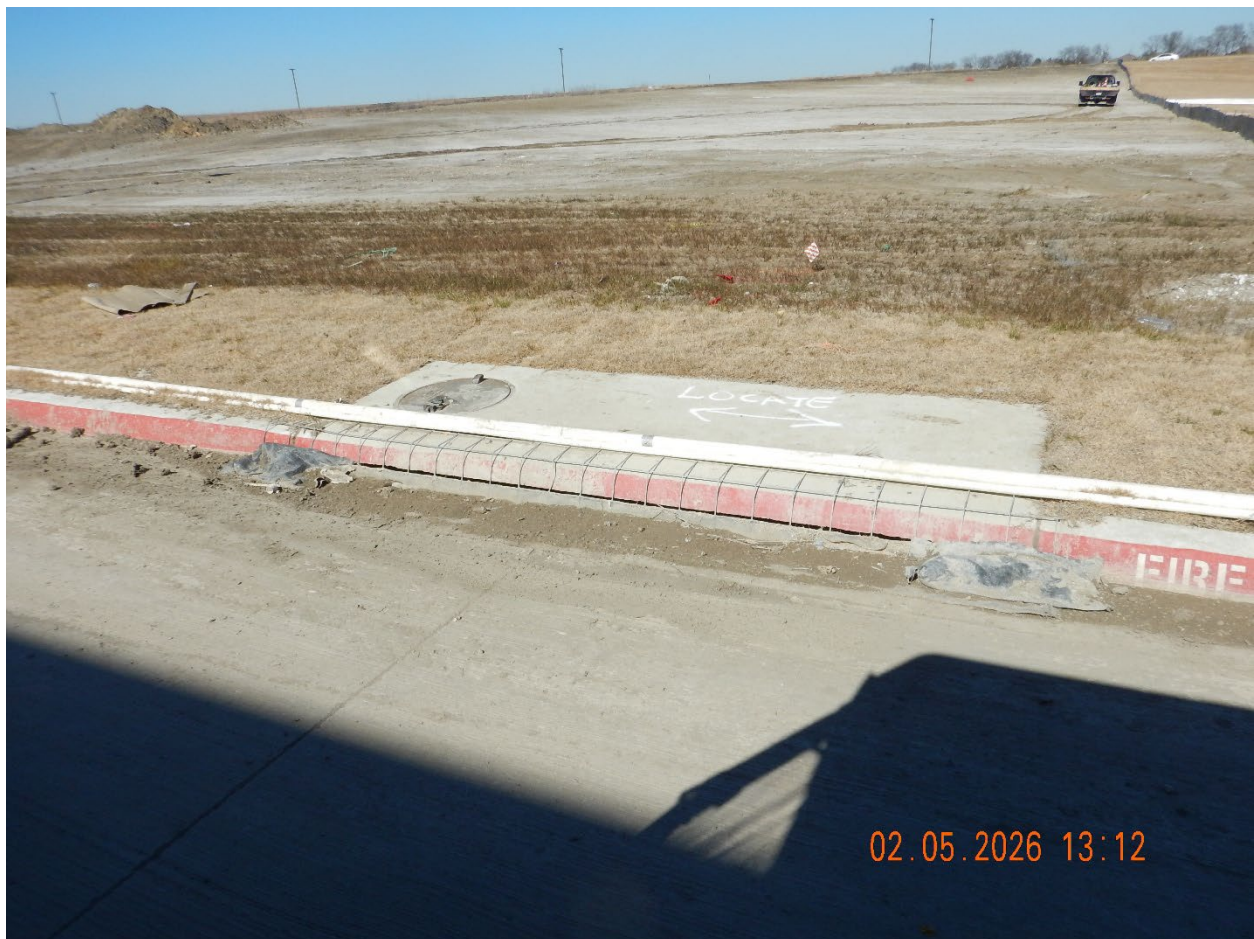
Photo no. 2

- The inlets throughout the site had BMPs installed. Some sediment buildup was present on the inlet protection along the northern perimeter of the site (**Appendix 1, Photo 2**). However, I observed a crew cleaning the inlets/inlet protection at the time of inspection.

Description: Inlet along the northern perimeter of the site. The inlet protection was covered with sediment. A crew was on-site actively cleaning the inlets/inlet protection during the inspection.

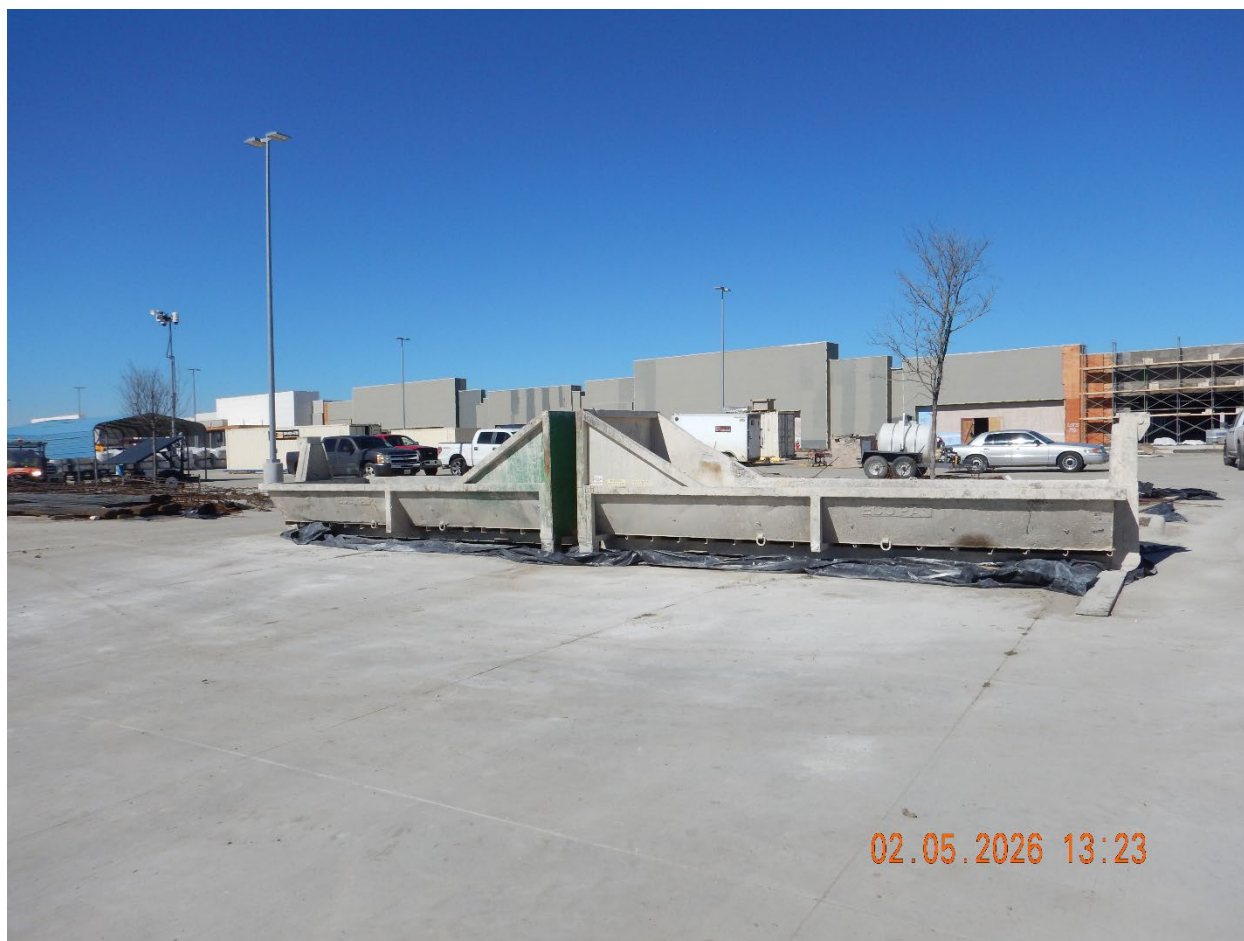
Photo no. 3

- Four (4) metal concrete washout roll-off containers were observed on-site with black liners underneath (**Appendix 1, Photo 3**). No spillage/leakage was observed near the containers.

Description: Two (2) of the four (4) metal concrete washout roll-off containers observed on-site with black liners underneath.

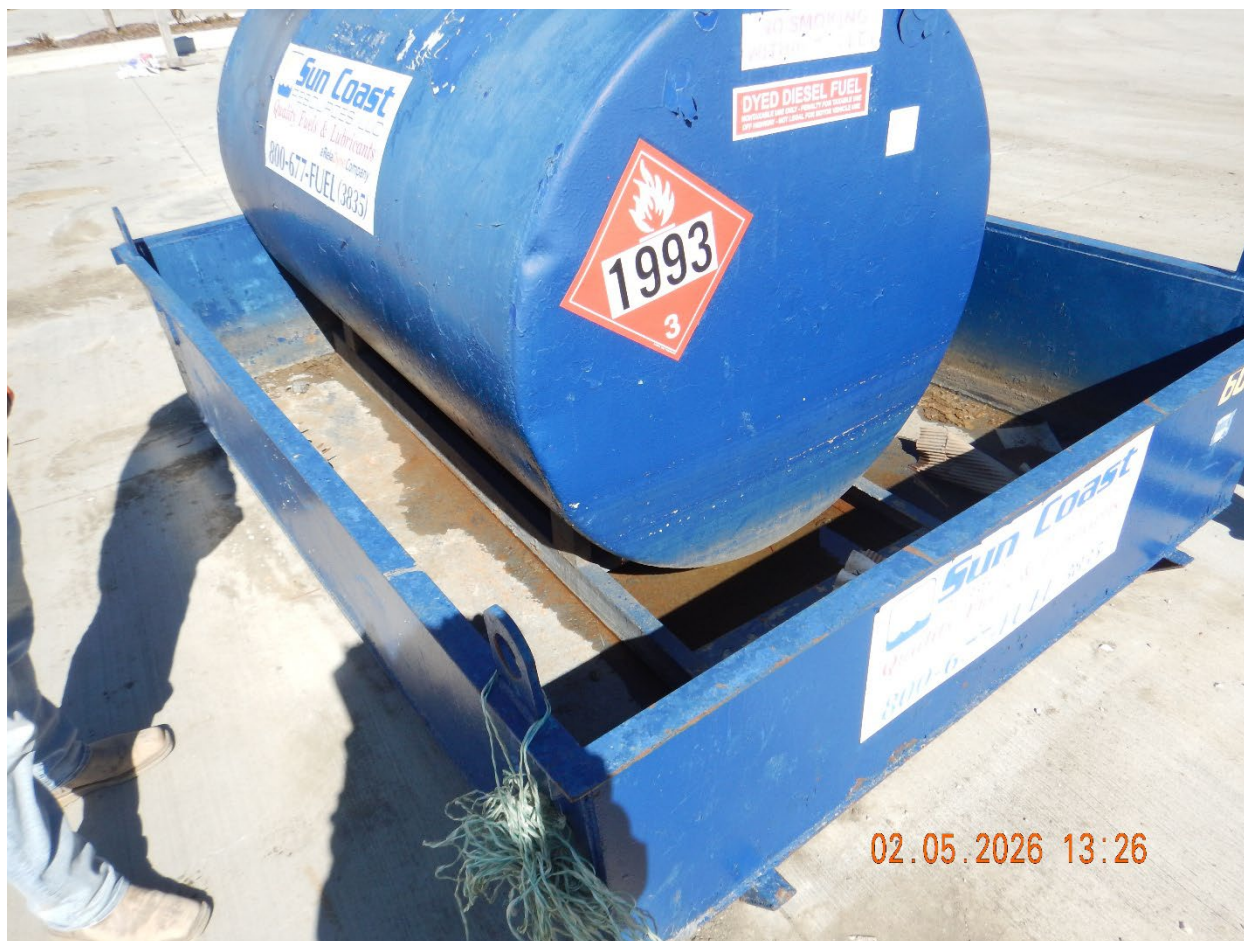
Photo no. 4

- I observed one (1) fuel storage tank on-site with no evidence of leakage (**Appendix 1, Photo 4**).
- Two (2) large commercial grade Quikrete mixers were observed near the buildings under construction in Lots 5/6 (**Appendix 1, Photo 5**). According to the site representatives, the concrete is discarded in eco-pans.

Description: Fuel storage tank observed in Lot 5 with no evidence of leakage.

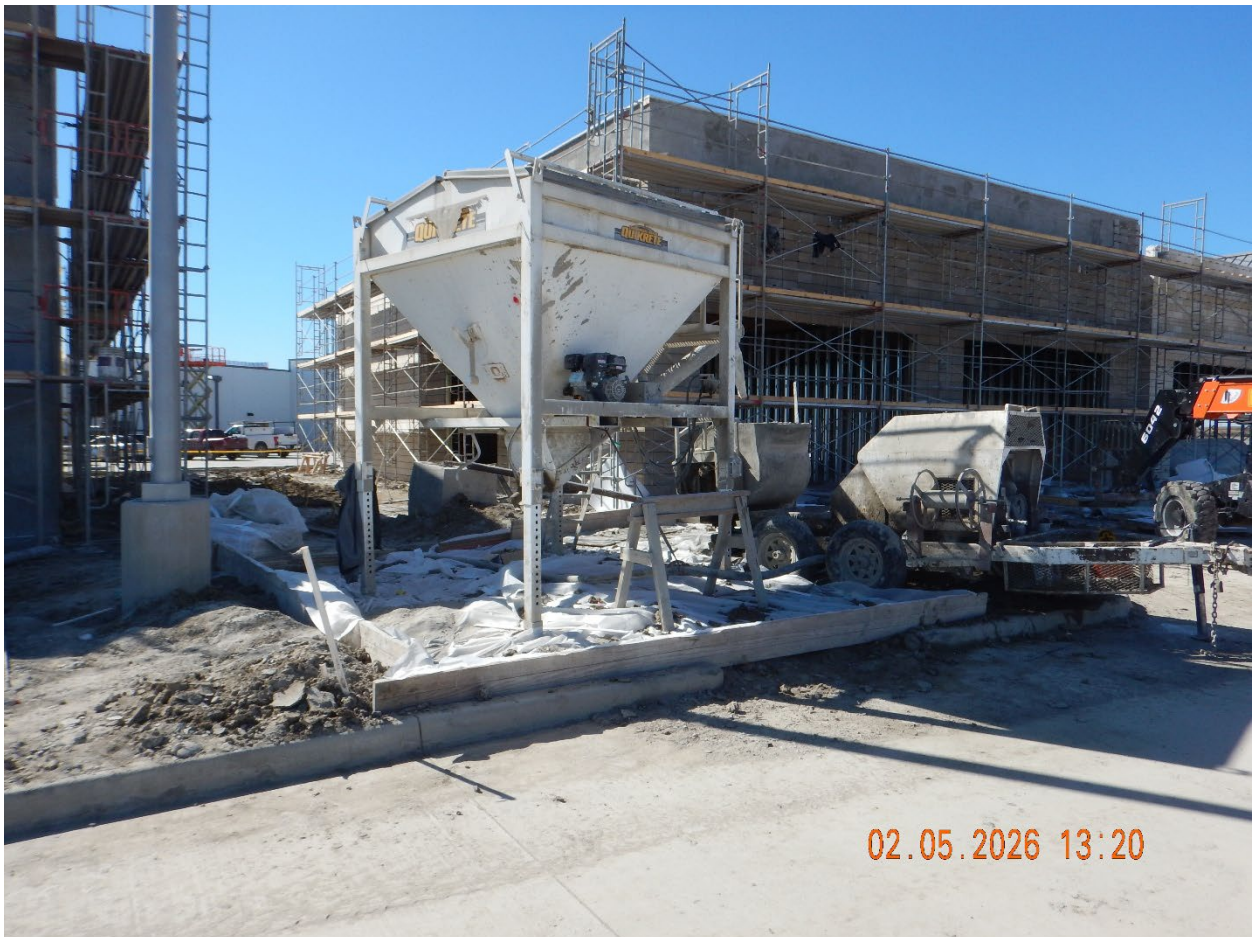
Photo no. 5

Description: One (1) of the two (2) large commercial-grade Quikrete mixers located between Retail 3 and Retail 4.

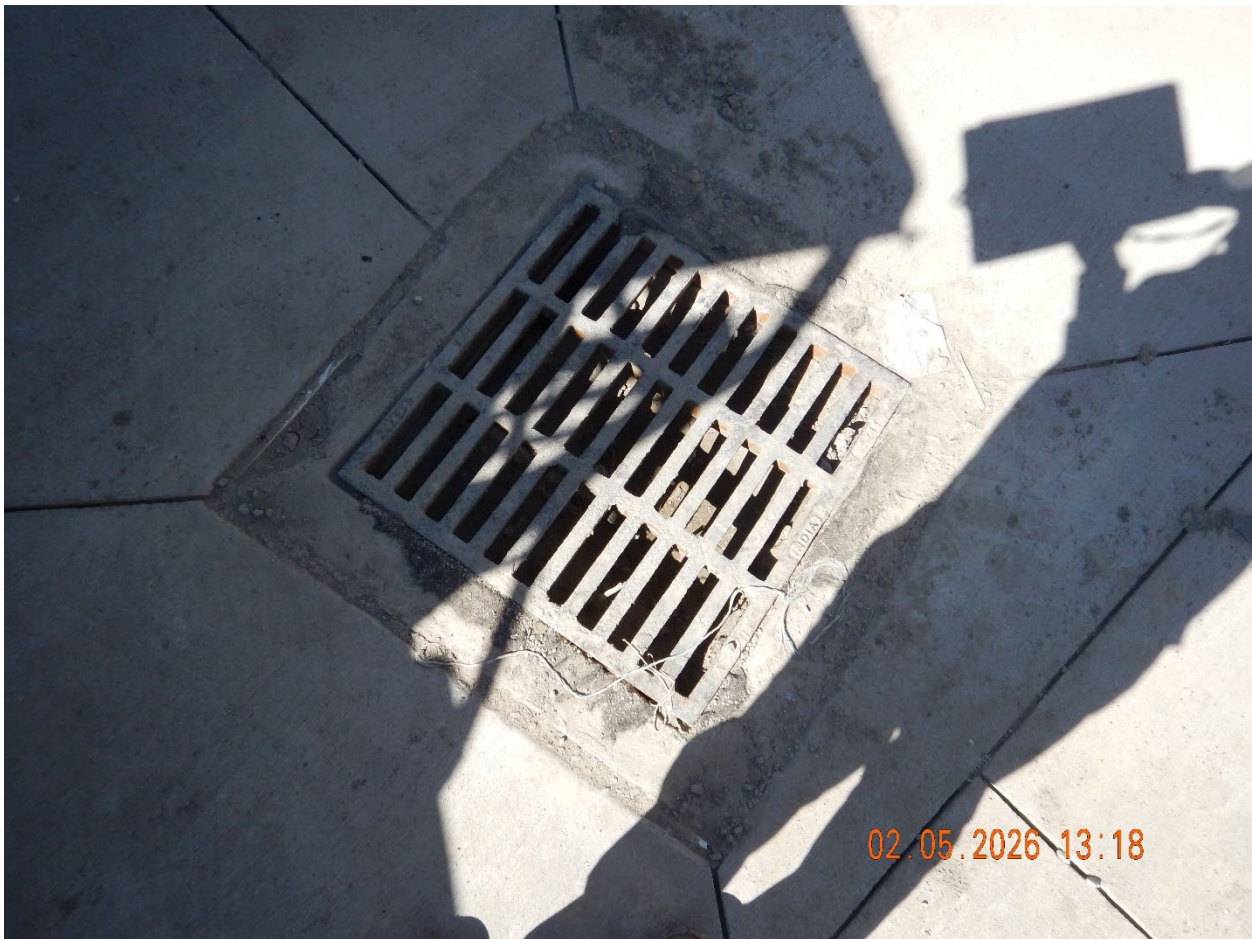
Photo no. 6

- TPDES General Permit No. TXR150000 Part III, Section F.6.(a) - Filter fabric was damaged in the grate inlet (Lot 6) (**Appendix 1, Photo 6**).
- TPDES General Permit No. TXR150000 Part IV, Section D.2 and D.4 - Blowable trash and construction debris was observed between Retail 3 and Retail 4 (**Appendix 1, Photo 7**).

Description: The grate inlet with damaged filter fabric located in Lot 6.

**Note: The AOCs were addressed by The Ridgemont Company on or around February 9, 2026, with photo evidence provided by Kirk Youngblood as illustrated in Appendix 2 of this report.**

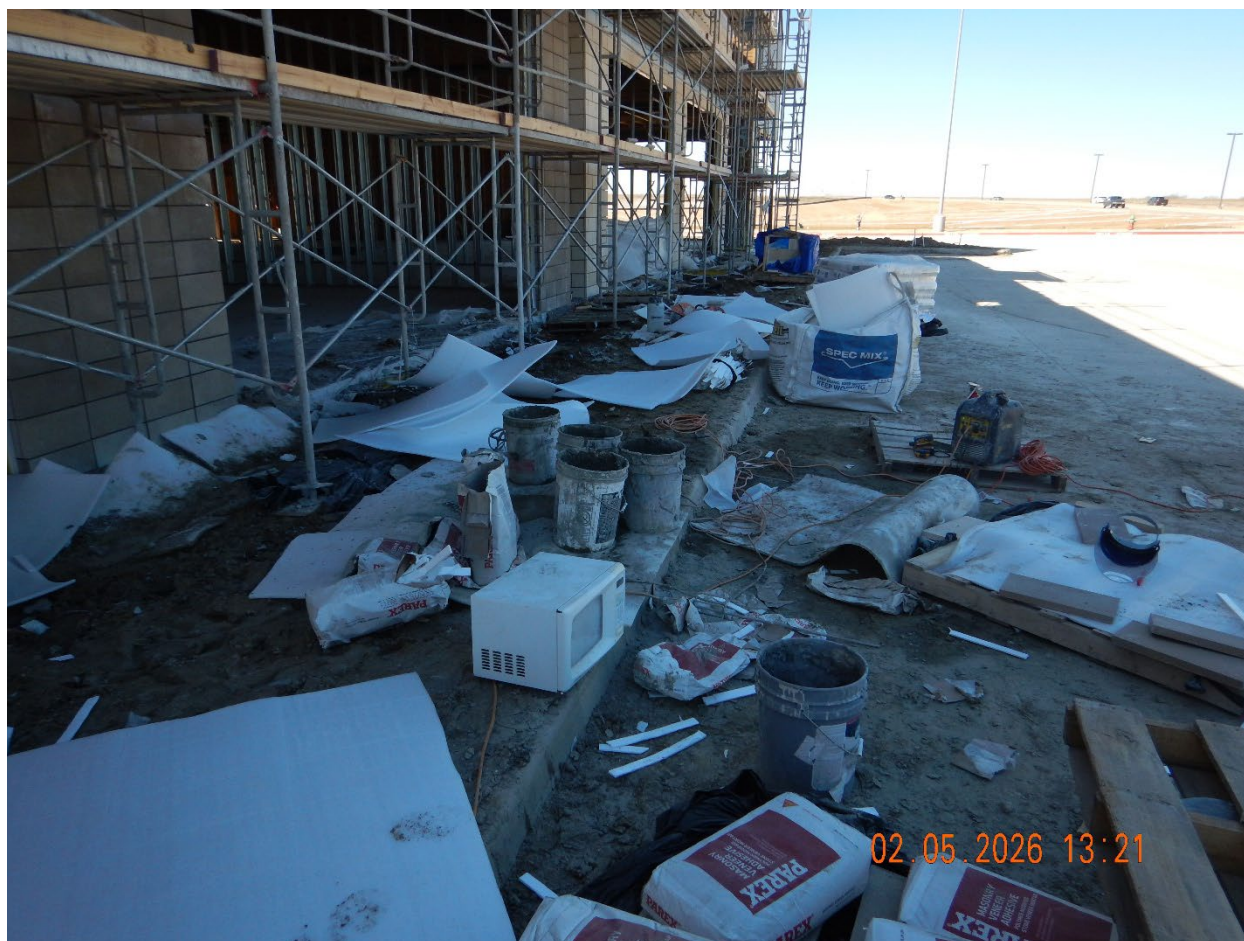
Photo no. 7

Description: Blowable trash and construction debris observed along Retail 3 and Retail 4.
