## **RCRA Inspection Report**

Process Barron Plant #1  
2770 Welborn Street  
Pelham, Alabama 35055  
Cullman County  
EPA ID Number: AL0000028811

**COMPLIANCE EVALUATION INSPECTION PHOTOGRAPHS**

**January 22, 2024**

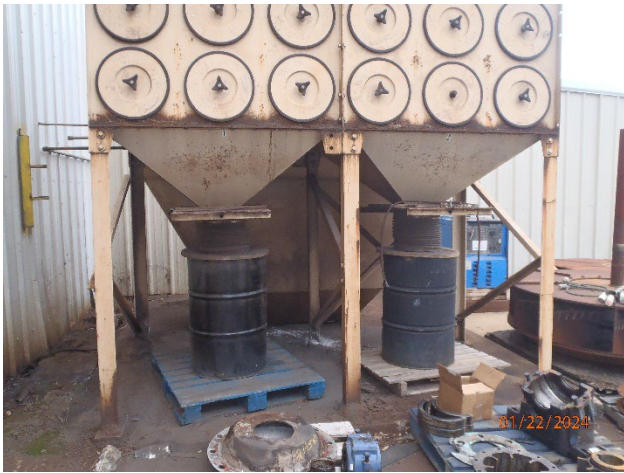
Mrs. Harrell and Mr. Stewart explained that there was an internal blast booth with external baghouses directly outside the door. At the time of the inspection, the inspectors observed two unmarked black 55-gallon drums underneath the baghouses (Picture 1). The inspectors explained to the facility that two 55-gallon containers with the same hazardous waste content side by side were a 90-day area. In addition, there was spent blast media on the ground around the drums (Pictures 2-3). Mrs. Harrell and Mr. Stewart confirmed that the spent blast media in the drums was disposed of as hazardous waste.

Picture 1 – Internal Blast Booth SAA drums not labeled

**Pursuant to ADEM Admin. Code r. 335-14-3-.01(6)(b)6.(i) [40 C.F.R. § 262.16(b)(6)(i)], which is a condition of the SQG Permit Exemption, a generator must mark or label its containers with the following: the words "Hazardous Waste"; an indication of the hazards of the contents; and the date upon which each period of accumulation begins clearly visible for inspection on each container.**

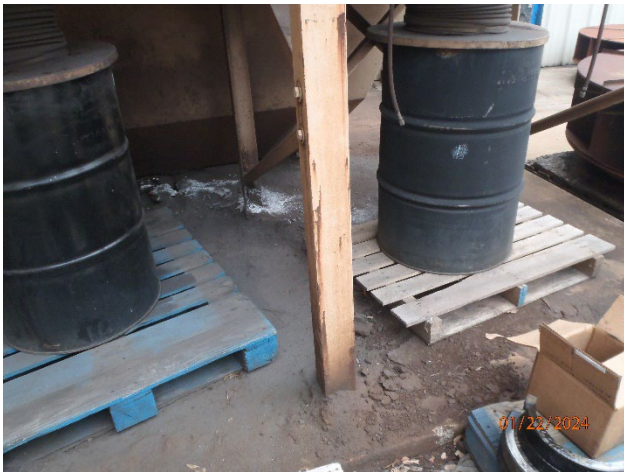
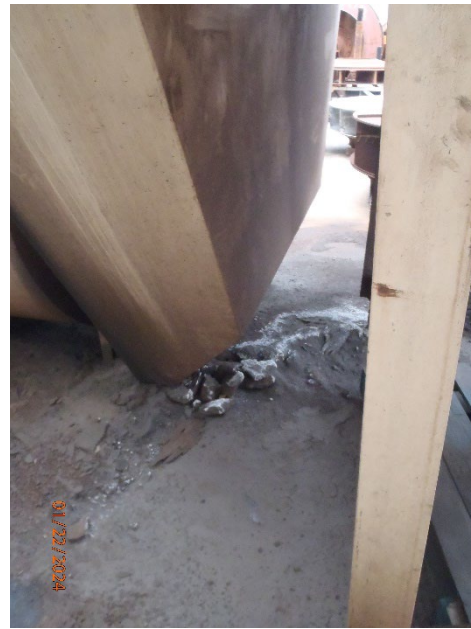
Picture 2 – Internal Blast Booth SAA –baghouse dust released to the ground

Picture 3 – Internal Blast Booth SAA –baghouse dust released to the ground

**Pursuant to ADEM Admin. Code r. 335-14-3-.01(6)(b)8.(i) [40 C.F.R. § 262.16(b)(8)(i)], which is a condition of the SQG Permit Exemption, a generator is required to maintain and operate its facility to minimize the possibility of a fire, explosion, or any unplanned sudden or non-sudden**

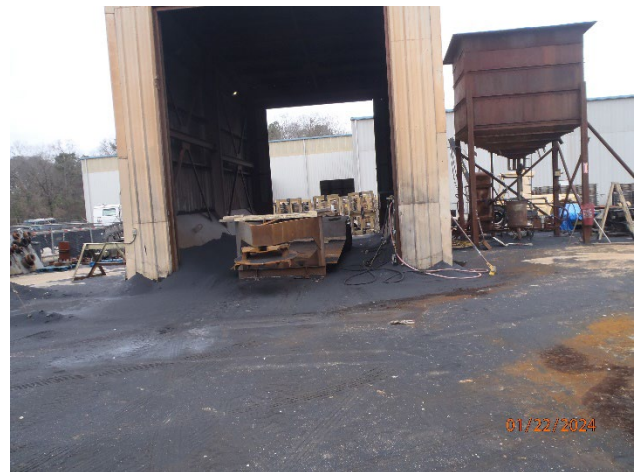
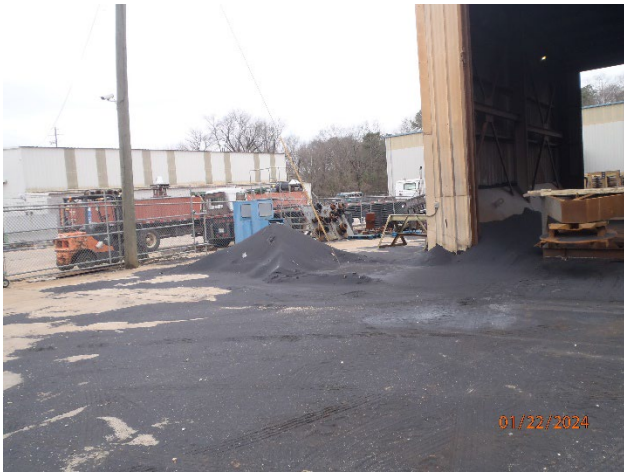
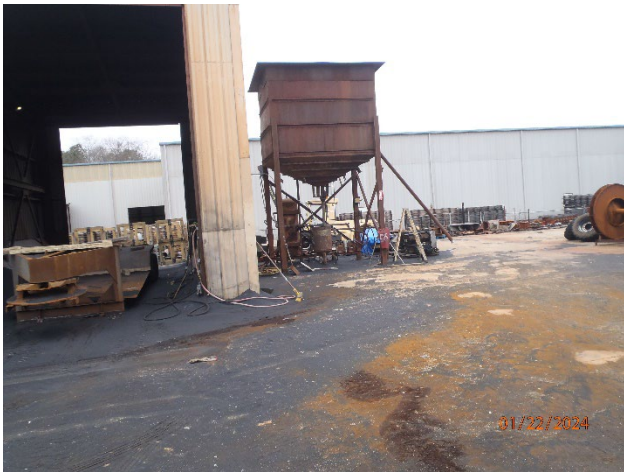
The facility has an External Blast Media booth that uses black beauty blast media to remove paint and rust from industrial fan parts. The media has been tested and the analytical results were non-hazardous. However, the booth was not fully enclosed and the spent blast media was allowed to release to the ground and into the stormwater drain behind the blast media booth (Pictures 4-10). The used black beauty media was scooped off the ground and placed into a red cubic yard roll-off for disposal at Big Sky Landfill.

Picture 4 – External Blast Media – non-hazardous black beauty media released to ground

Picture 5 – External Blast Media – non-hazardous black beauty media released to ground

Picture 6 – External Blast Media – non-hazardous black beauty media released to ground

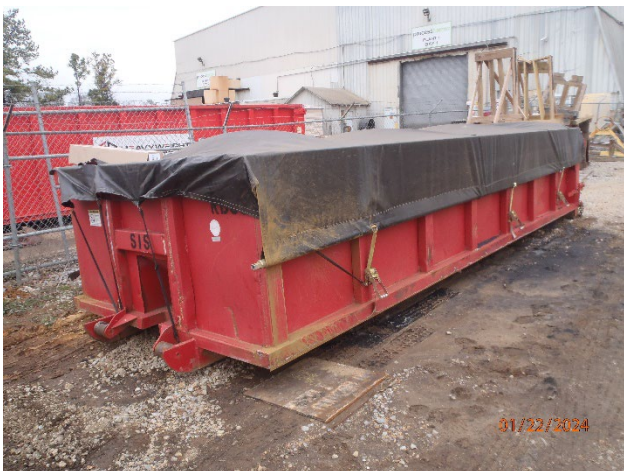
Picture 7 – External Blast Media – non-hazardous black beauty media waste roll-off

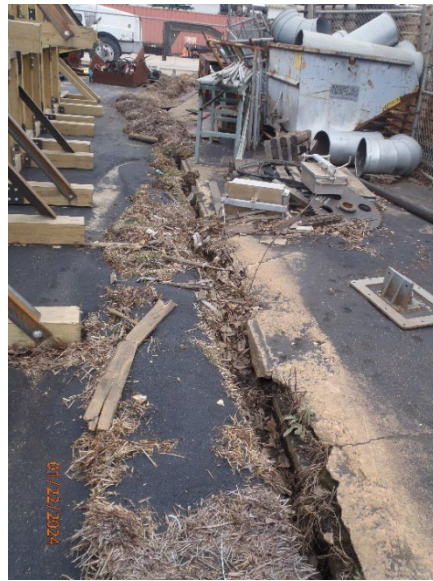
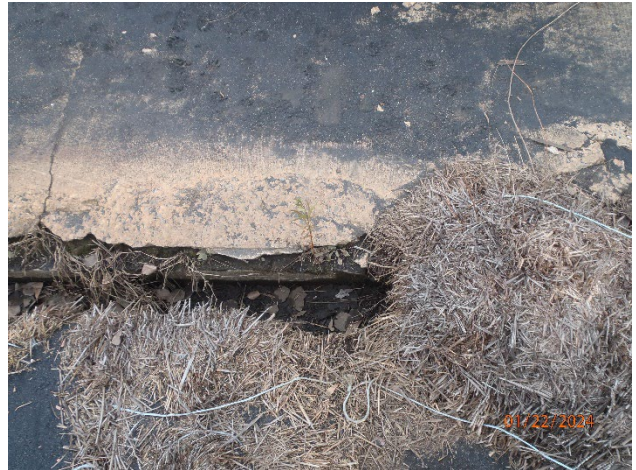
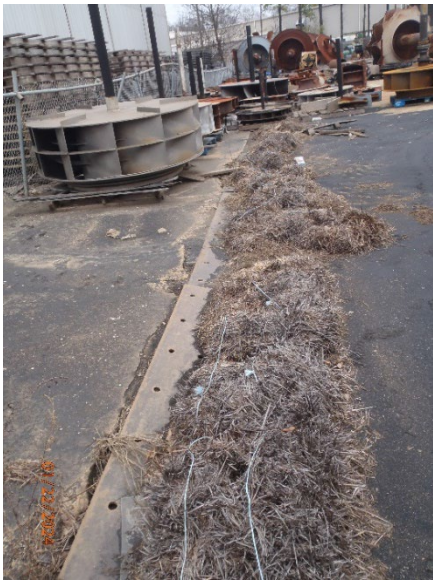
Picture 8 – External Blast Media – non-hazardous black beauty media released to storm water drain

Picture 9 – External Blast Media – non-hazardous black beauty media released to storm water drain

Picture 10 – External Blast Media – non-hazardous black beauty media released to storm water drain

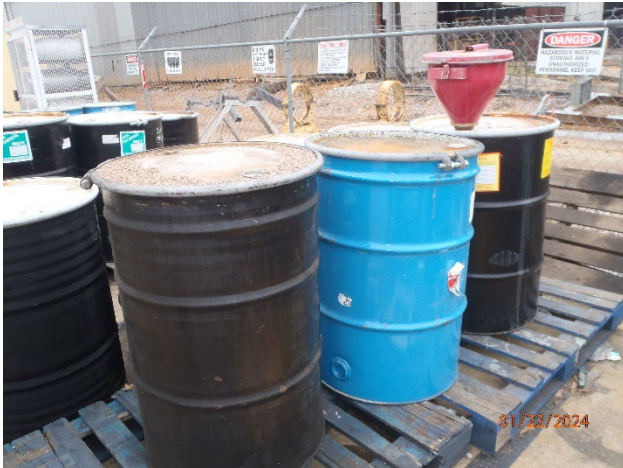
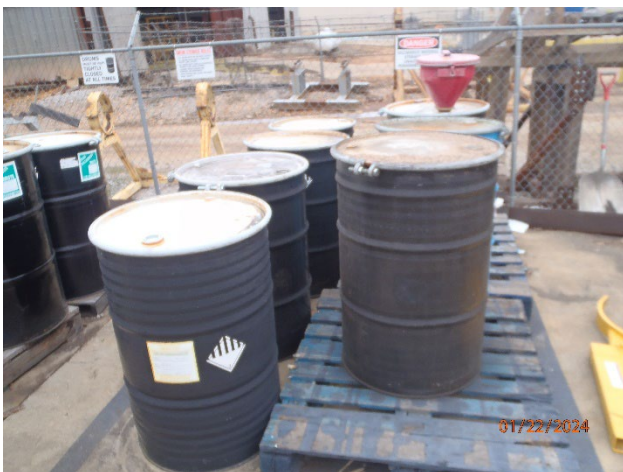
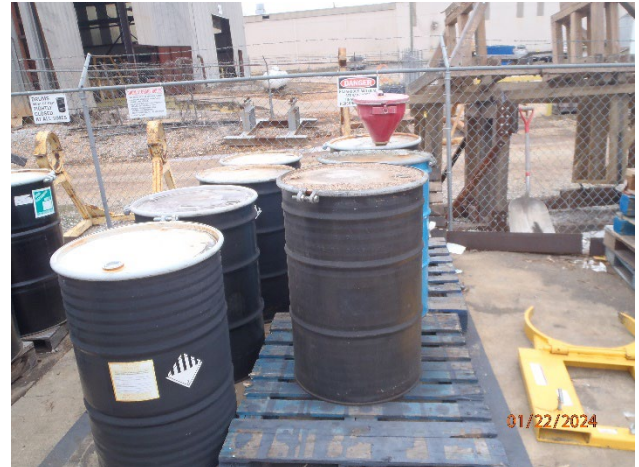
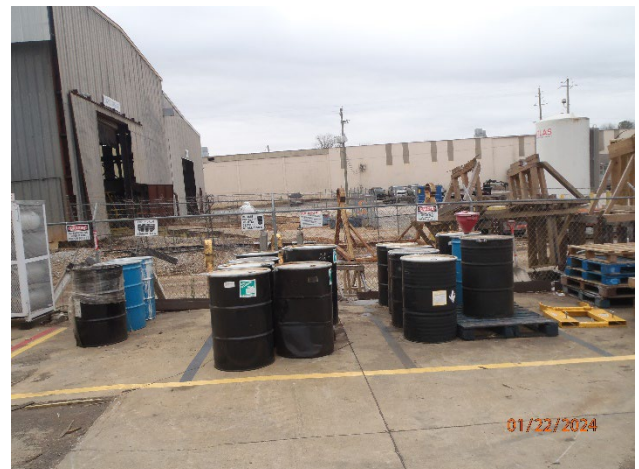
The less than 180-day hazardous waste central accumulation area (CAA) was located between the baghouses and the external blast media booth. The inspectors observed seven 55-gallon drums of hazardous waste sitting on pallets (Pictures 11-14). Five of the drums did not have start accumulations dates and two the drums were not labeled and did not have markings. In addition, one of the drums was a satellite accumulation area (SAA) drum that was not at or near the point of generation and not in control of the operator.

Picture 11 – 180-Day Hazardous Waste CAA with Paint Waste SAA

Picture 12 – 180-Day Hazardous Waste CAA

Picture 13 – 180-Day Hazardous Waste CAA

Picture 14 – 180-Day Hazardous Waste CAA

**Pursuant to ADEM Admin. Code r. 335-14-3-.01(6)(b)6.(i) [40 C.F.R. § 262.16(b)(6)(i)], which is a condition of the SQG Permit Exemption, a generator must mark or label its containers with the following: the words “Hazardous Waste”; an indication of the hazards of the contents; and the date upon which each period of accumulation begins clearly visible for inspection on each container.**

**Pursuant to ADEM Admin. Code r. 335-14-3-.01(5)(a) [40 C.F.R. § 262.15(a)], a generator may accumulate as much as 55 gallons of non-acute hazardous waste in containers at or near the point of generation where wastes initially accumulate, which is under the control of the operator of the process generating the waste, without a permit or without having interim status, as required by KRS 224.46-520(1) [Section 3005 of RCRA, 42 U.S.C. § 6925], and without complying with ADEM Admin. Code r. 335-14-3-.01(6) (b) or (7)(a) [40 C.F.R. § 262.16(b) or §262.17(a)], except as required in ADEM Admin. Code r. 335-14-3-.01(5)(a)7 and 8) [40 C.F.R. § 262.15(a)(7) and (8)], provided that the generator complies with the satellite accumulation area conditions listed in ADEM Admin. Code r. 335-14-3-.01(5)(a) [40 C.F.R. § 262.15(a)].**

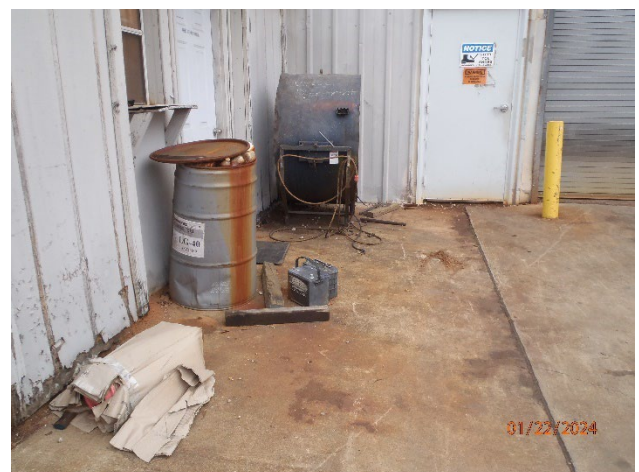
The EPA inspector observed two used lead acid batteries sitting outside the maintenance shed (Picture 15). When asked, Mr. Stewart stated the batteries would be returned to the vendor, Interstate Batteries.

Picture 15 – Used lead acid batteries

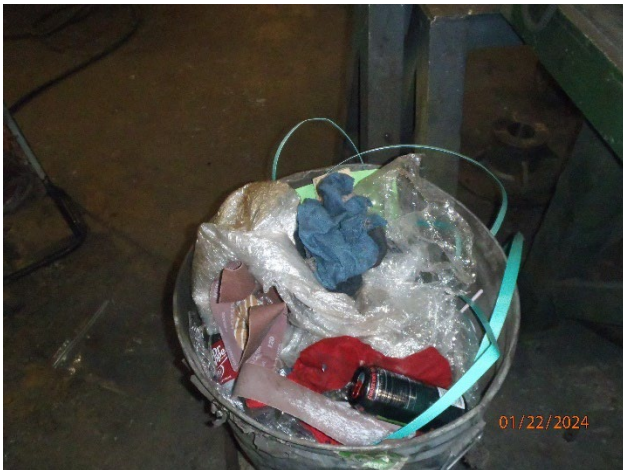
Back inside the facility, the inspectors toured the process and observed discarded rags in the garbage and various aerosol cans in use. Mrs. Harrell explained that the rags were supposed to be

collected in red fire cans for disposal by Safeway Industries. The used rags may have contained WD-40, oil and/or grease (Picture 16). At the time, the inspectors did not observe any rags being used with solvent.

Picture 16 – Paint Area trash with discarded rags

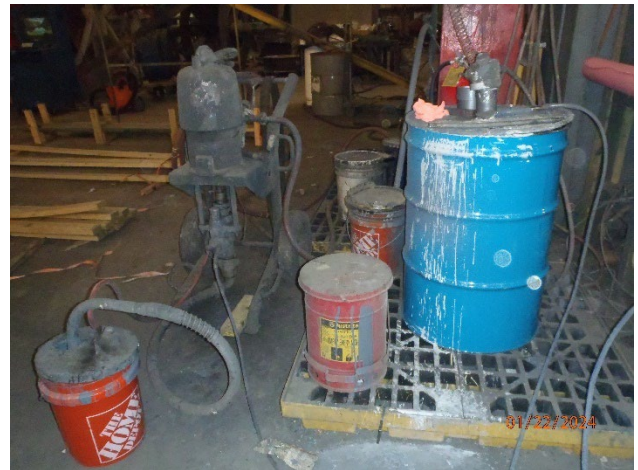
The Paint Area was in the rear of the facility. The area consisted of a paint booth with a prep area, a crane to move the rotors, and a large roll-off for trash. The Paint Technician explained that 5-gallon containers were used to collect the paint waste when the paint guns were purged (Picture 19). The inspectors observed that the solvent used in the paint booth was labeled as "Xylenes." Mr. Holmes explained that if the facility was using xylenes greater than 10% concentration, then the xylenes were hazardous waste. When Mr. Brent Pockrus looked up the safety data sheet for this product it was listed as 100% Xylenes. Mrs. Harrell explained that she previously advised the paint employees to place the spent personal protective equipment into the red cans until proper disposal could be determined.

Picture 19 – Paint Area

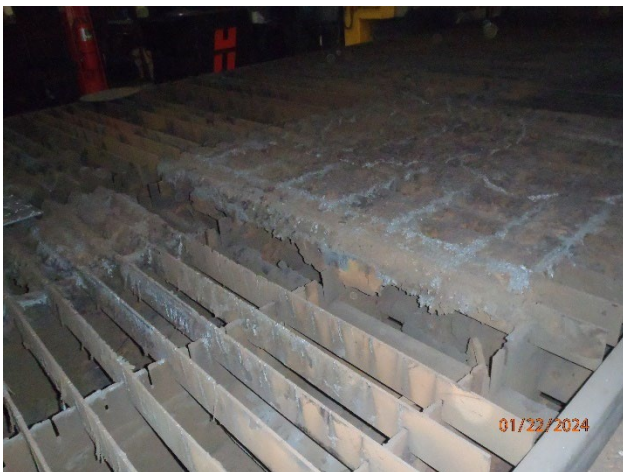
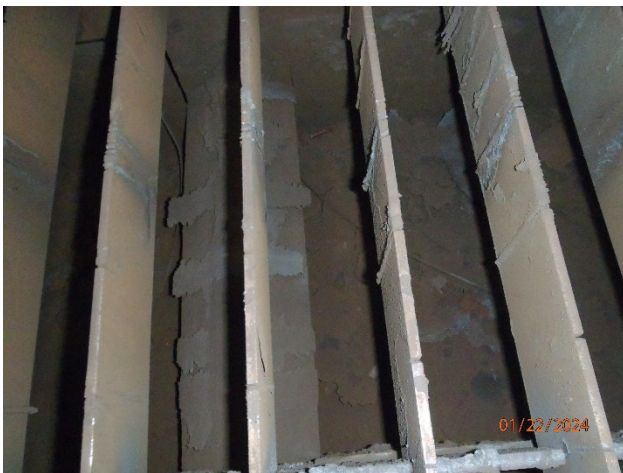
The Fabrication Area was visited next, and the inspectors observed the burn tables with slag attached. Mr. Stewart explained that the slag was non-hazardous and cleaned out during maintenance. During the inspection one of burn tables was down for repair (Pictures 17-18).

Picture 17 – Fabrication Area burn table with slag

Picture 18 – Fabrication Area burn table with slag

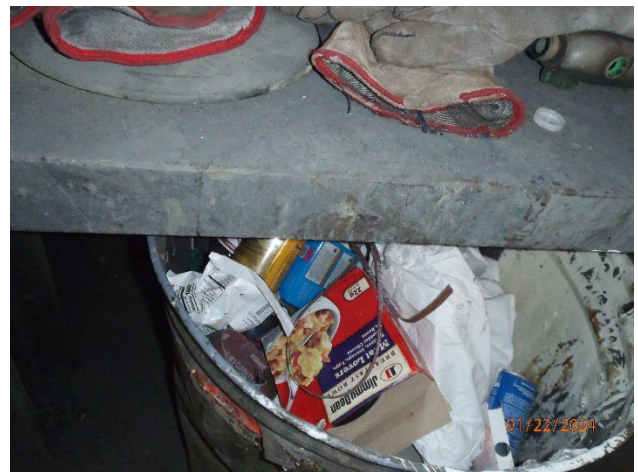
Mr. Holmes, ADEM inspector, explained that any personal protective equipment (gloves, Tyvek, respirator, filters), rags, containers, etc., that has been contaminated with the xylene and had to be discarded and disposed of as hazardous waste. At the time of the inspection, the inspectors observed Tyvek previously worn by the paint technician discarded in the garbage (Picture 20).

Picture 20 – Paint Area PPE debris discarded in garbage

**Pursuant to ADEM Admin. Code r. 335-14-3-.01(6)(b)7. [40 C.F.R. § 262.16(b)(7)], which incorporates ADEM Admin. Code r. 335-14-9-.01 [40 C.F.R. 268.7(a)(1)] and is a condition of the SQG Permit Exemption, a generator is required to comply with land disposal restrictions (LDR) for hazardous waste. *Process Barron Plant #1 was improperly disposing of discarded debris contaminated with xylene in the garbage.***

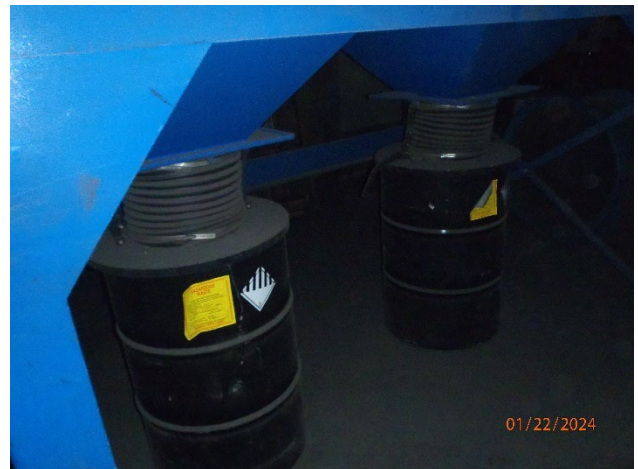
The Robovent baghouse was located outside the employee breakroom. At the time of the inspection, the inspectors observed two 55-gallon drum of hazardous waste that were closed and labeled (Pictures 21-22). However, the EPA inspector noticed that the labels were peeling off the drums, the two drums had the same content, and there were releases to the ground around the drums and underneath the baghouses (Pictures 23-24). It appeared to the EPA inspector that someone had tried to sweep up the area.

Picture 21 – Robovent Baghouse SAA drums

Picture 22 – Robovent Baghouse SAA drums

**Pursuant to ADEM Admin. Code r. 335-14-3-.01(6)(b)6.(i) [40 C.F.R. § 262.16(b)(6)(i)], which is a condition of the SQG Permit Exemption, a generator must mark or label its containers with the following: the words "Hazardous Waste"; an indication of the hazards of the contents; and the**

date upon which each period of accumulation begins clearly visible for inspection on each container.

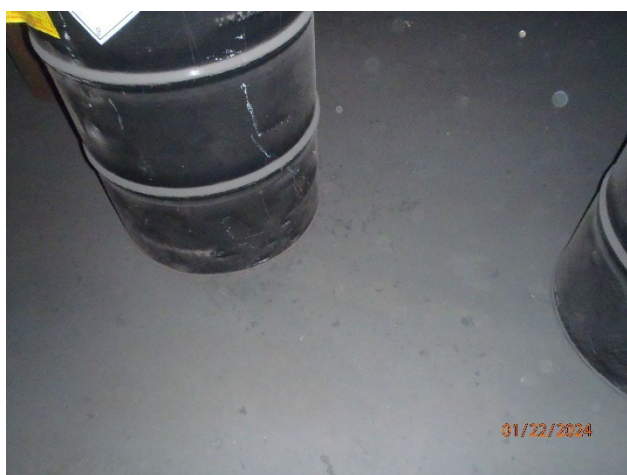
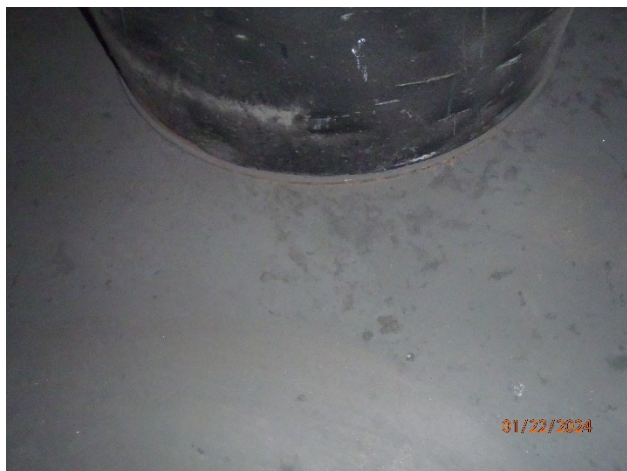
Picture 23 – Robovent Baghouse dust release to floor

Picture 24 – Robovent Baghouse dust release to floor

Pursuant to ADEM Admin. Code r. 335-14-3-.01(6)(b)8.(i) [40 C.F.R. § 262.16(b)(8)(i)], which is a condition of the SQG Permit Exemption, a generator is required to maintain and operate its facility to minimize the possibility of a fire, explosion, or any unplanned sudden or non-sudden release of hazardous waste or hazardous waste constituents to air, soil, or surface water which could threaten human health or the environment.
