INSPECTION REPORT

| Type of Inspection | Focused Compliance Inspection (FCI) | | | |
| Facility or Site Name | Jefferson Railport Terminal | | | |

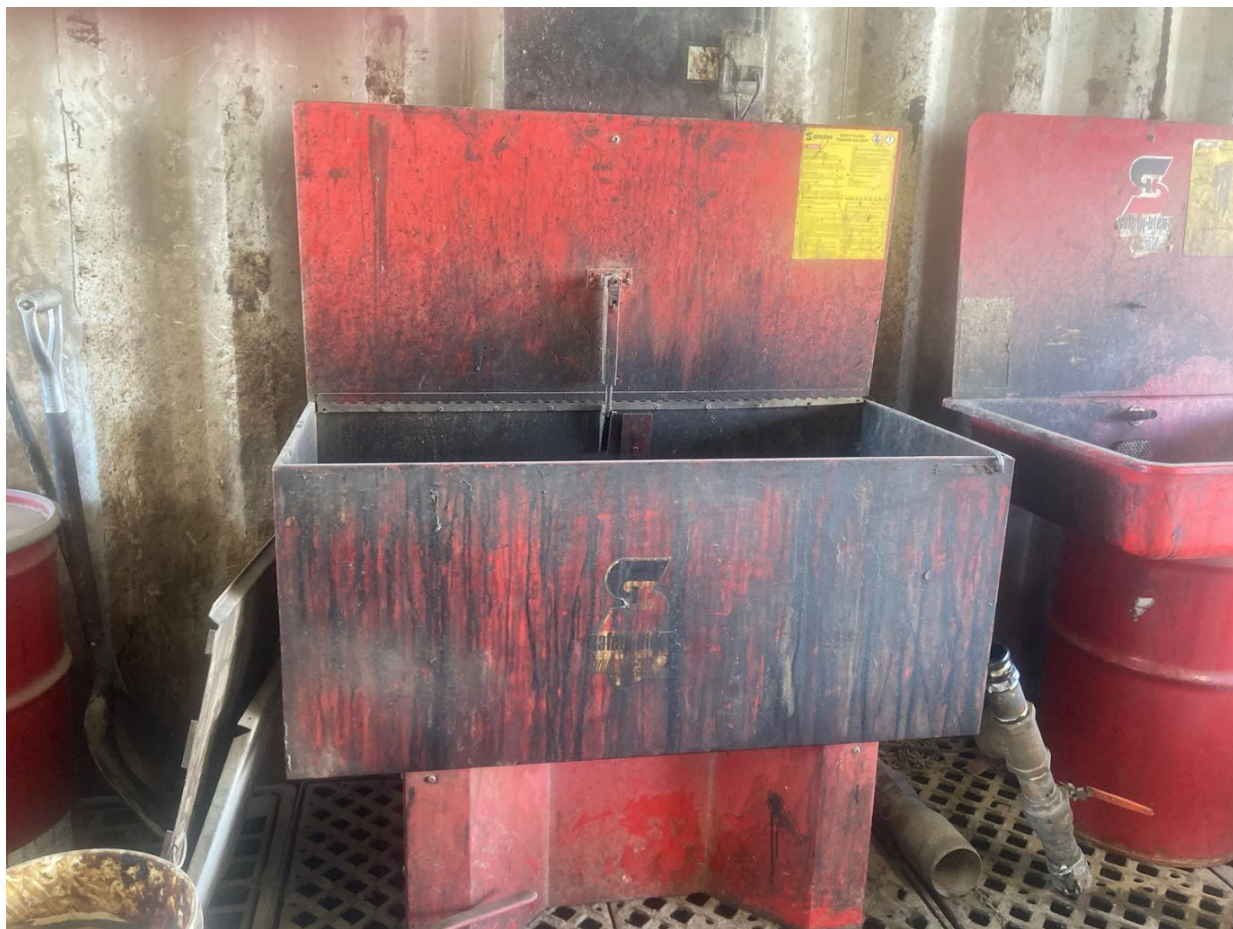
**Photo No. 1**

Description: View of a 100-gallon parts washer found in the drum storage area that had its lid left open at the time of the inspection.

The inspection team did not observe other AOCs at the time of the inspection. However, further EPA review may change or add to their potential AOCs. A closing conference was conducted at approximately 11:30 AM with JST personnel. The AOCs were communicated during the closing. Following the inspection, Mr. Istre sent two emails to the inspection team responding to the AOCs found during the inspection and providing any documents the inspection requested. On 11/6/2024, Mr. Istre sent a profile and manifest for treated wood from the railroad tracks (Appendix 2), an example waste profile and Bill of Lading (BOL) for oily waste (see Appendix 3), and an update on progress in email form (see Appendix 4). On 11/11/2024, Mr. Istre provided a picture of the aerosol drum found during the inspection with a new lid (Appendix 5). On 11/21/2024, Mr. Istre sent an email stating all of the drums found during the inspection were determined to contain usable product and provided several pictures including the lids of the parts washers closed and the drum storage area better organized (see Appendix 6).

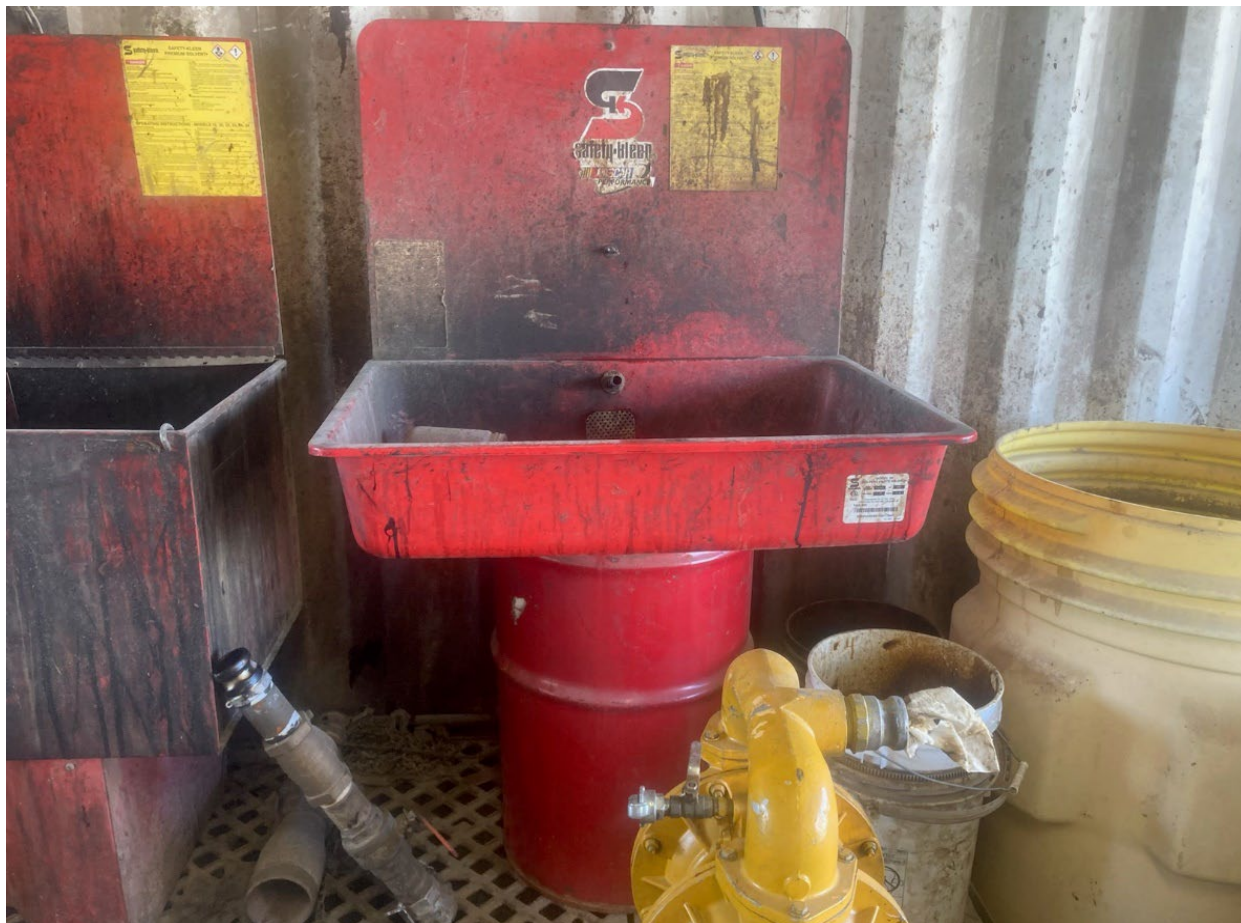
Photo No. 2

Description: View of a 55-gallon parts washer found in the drum storage area that had its lid left open at the time of the inspection.

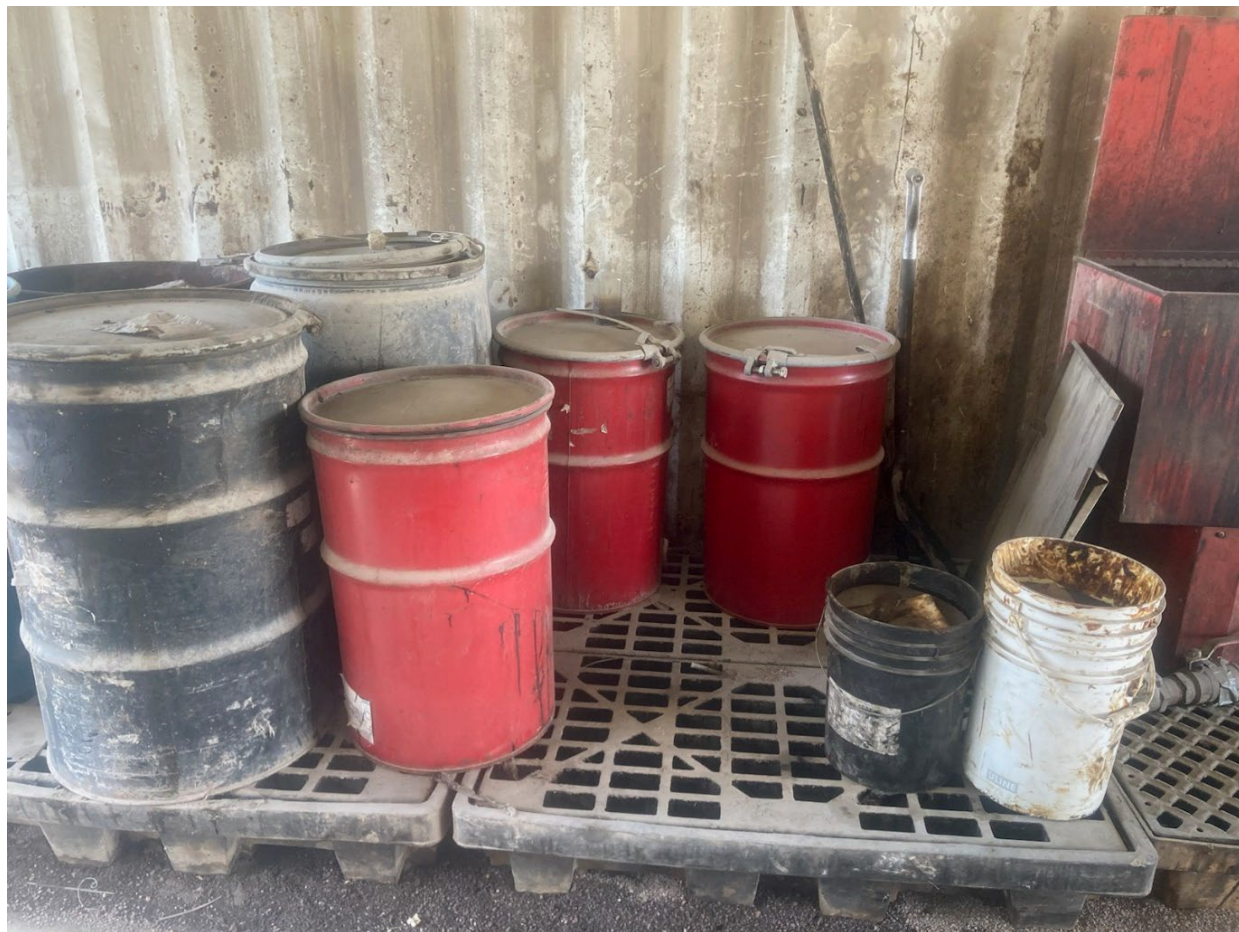
Photo No. 3

Description: View from left to right: two 55-gallon drums, three 35-gallon drums, and two 5-gallon containers found inside the drum storage area next to the parts washers. The containers were storing unknown materials at the time of the inspection.

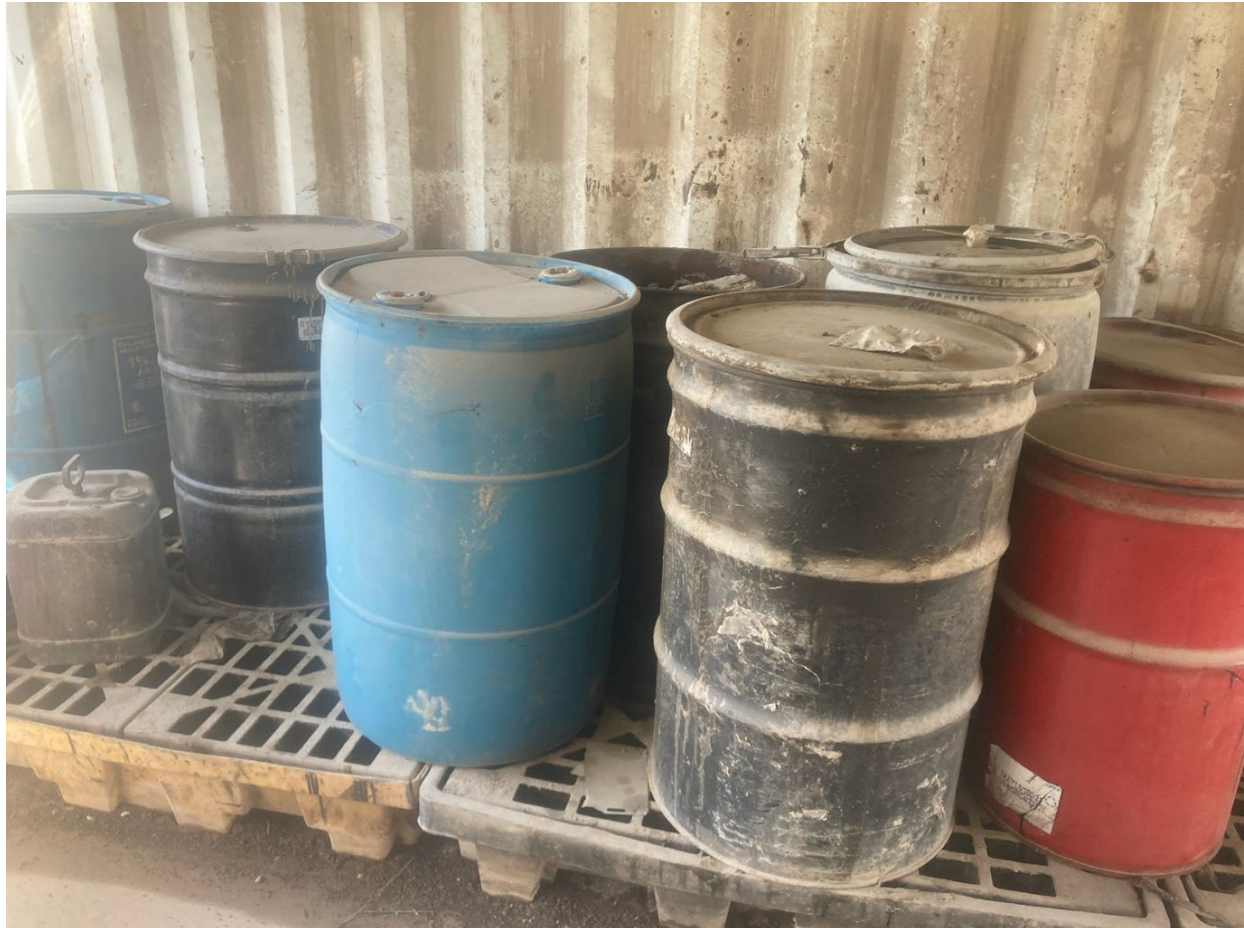
Photo No. 4

Description: View from left to right: one 5-gallon container, six 55-gallon drums, and two 35-gallon drums found inside the drum storage area next to the parts washer. The containers were storing unknown materials at the time of the inspection.

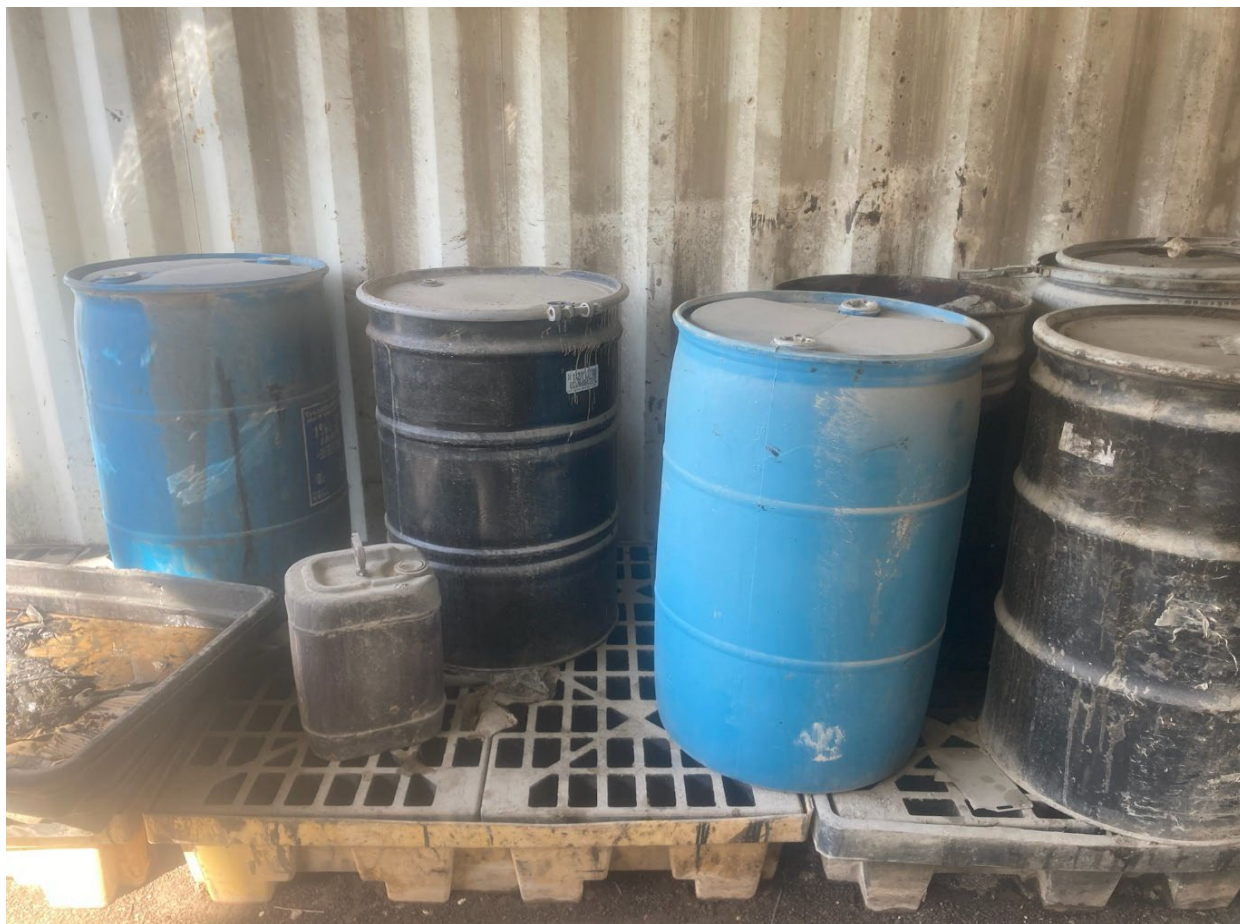
Photo No. 5

Description: Another view of the containers seen above in Photo 5.

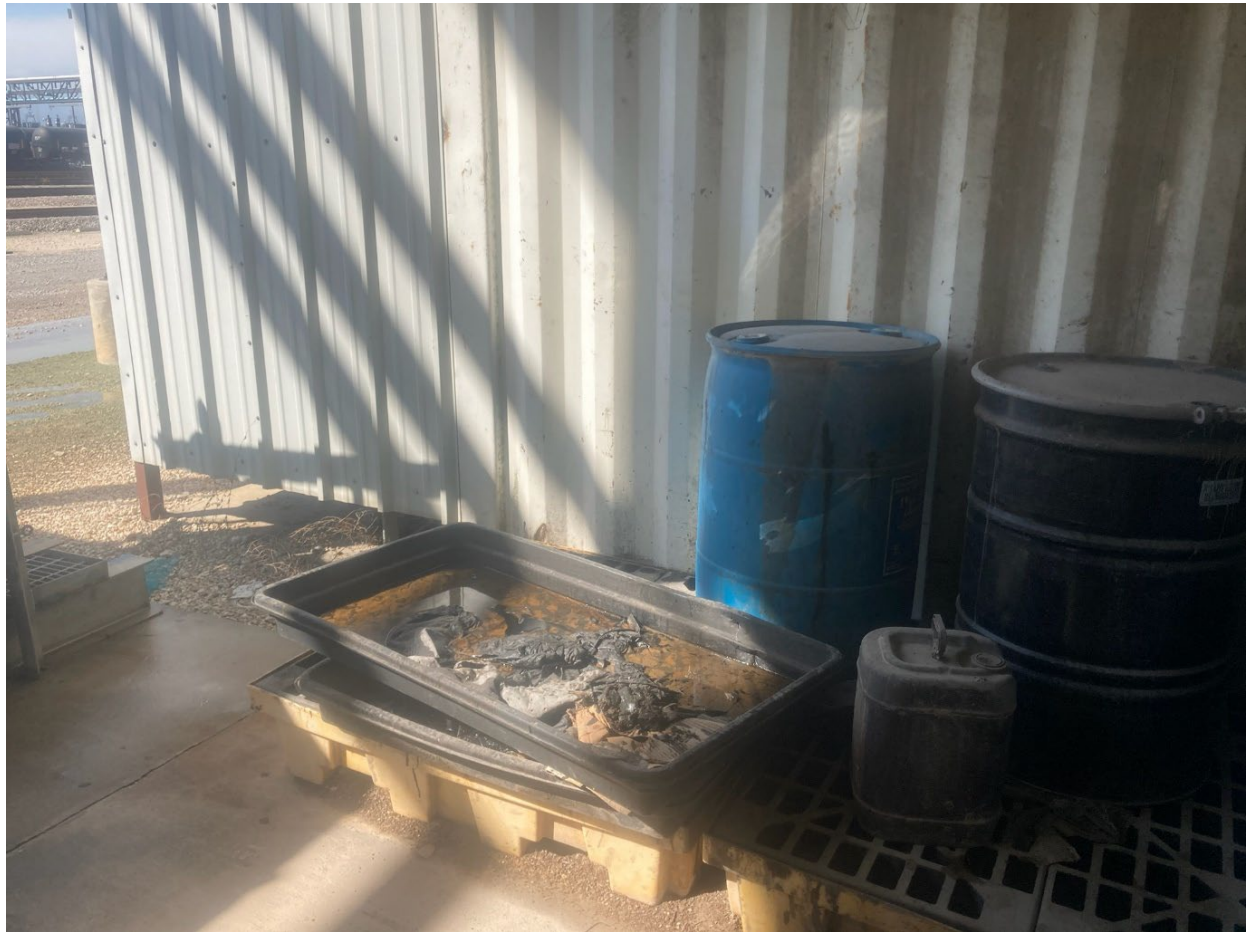
Photo No. 6

Description: View of drip pad that appeared to be storing oily rags and liquid inside the drum storage area.

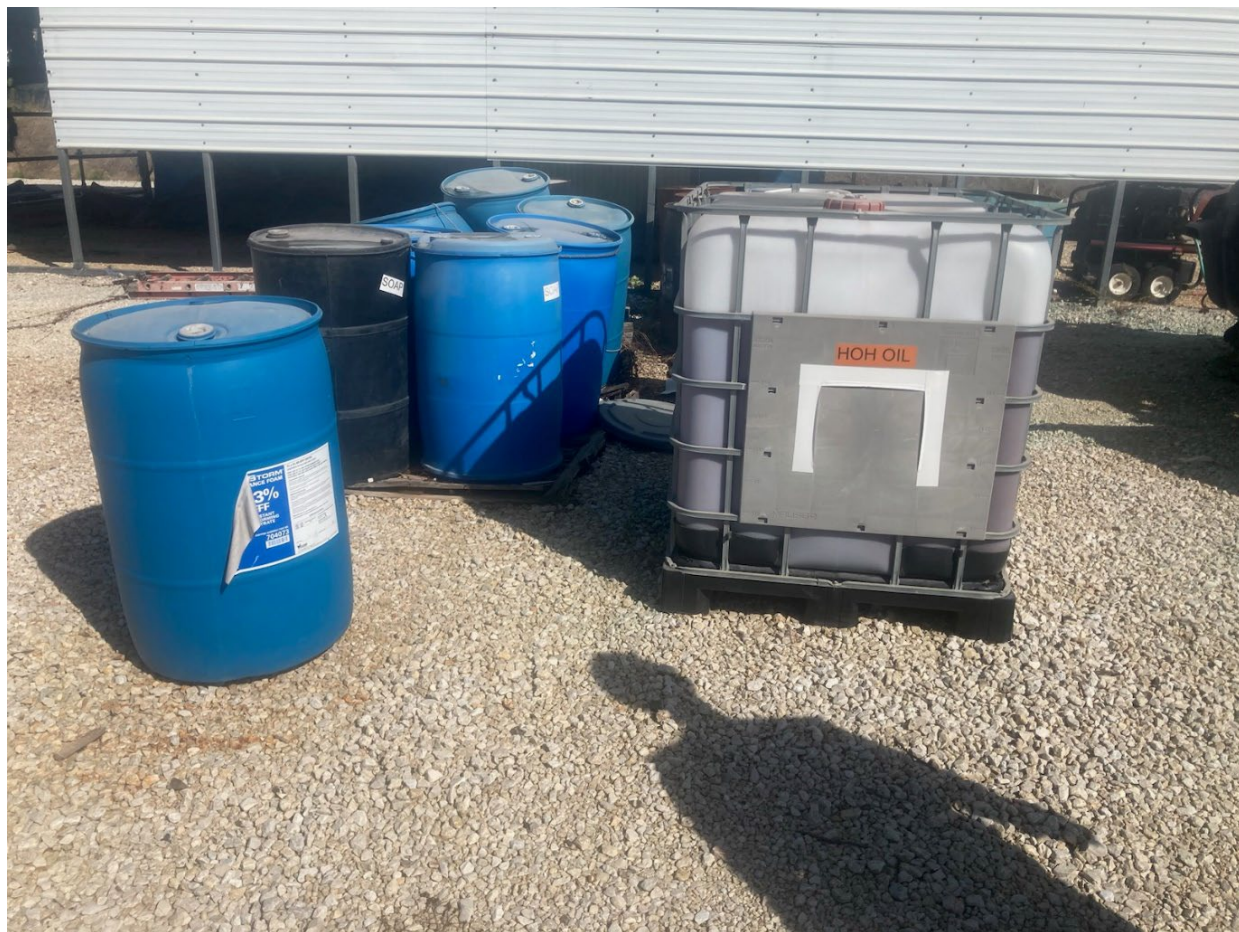
Photo No. 7

Description: View of a half-full tote containing HOH oil and seven 55-gallon drums containing unknown materials at the time of the inspection.

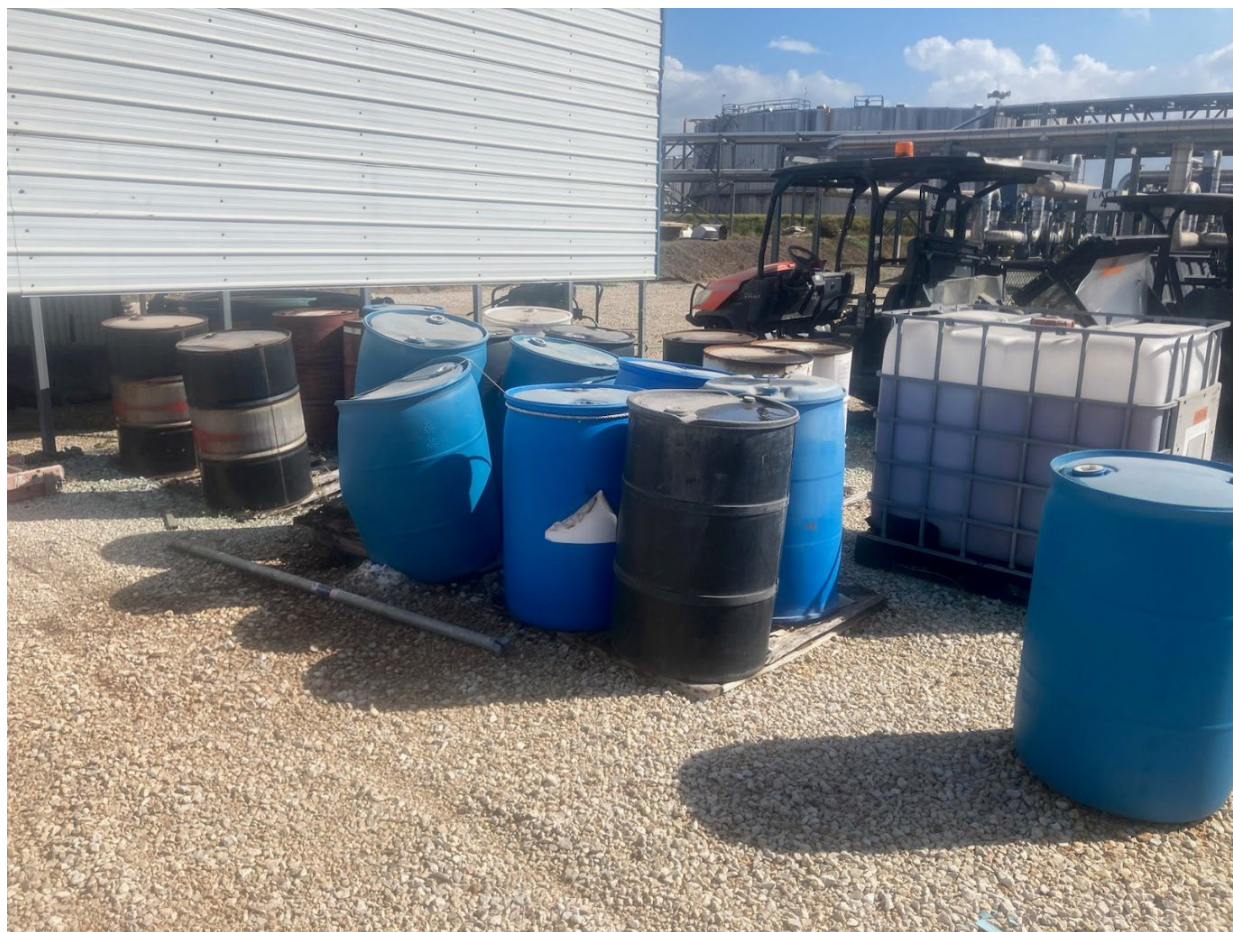
Photo No. 8

Description: Another view of nineteen 55-gallon drums containing unknown materials at the time of the inspection in the drum storage area.

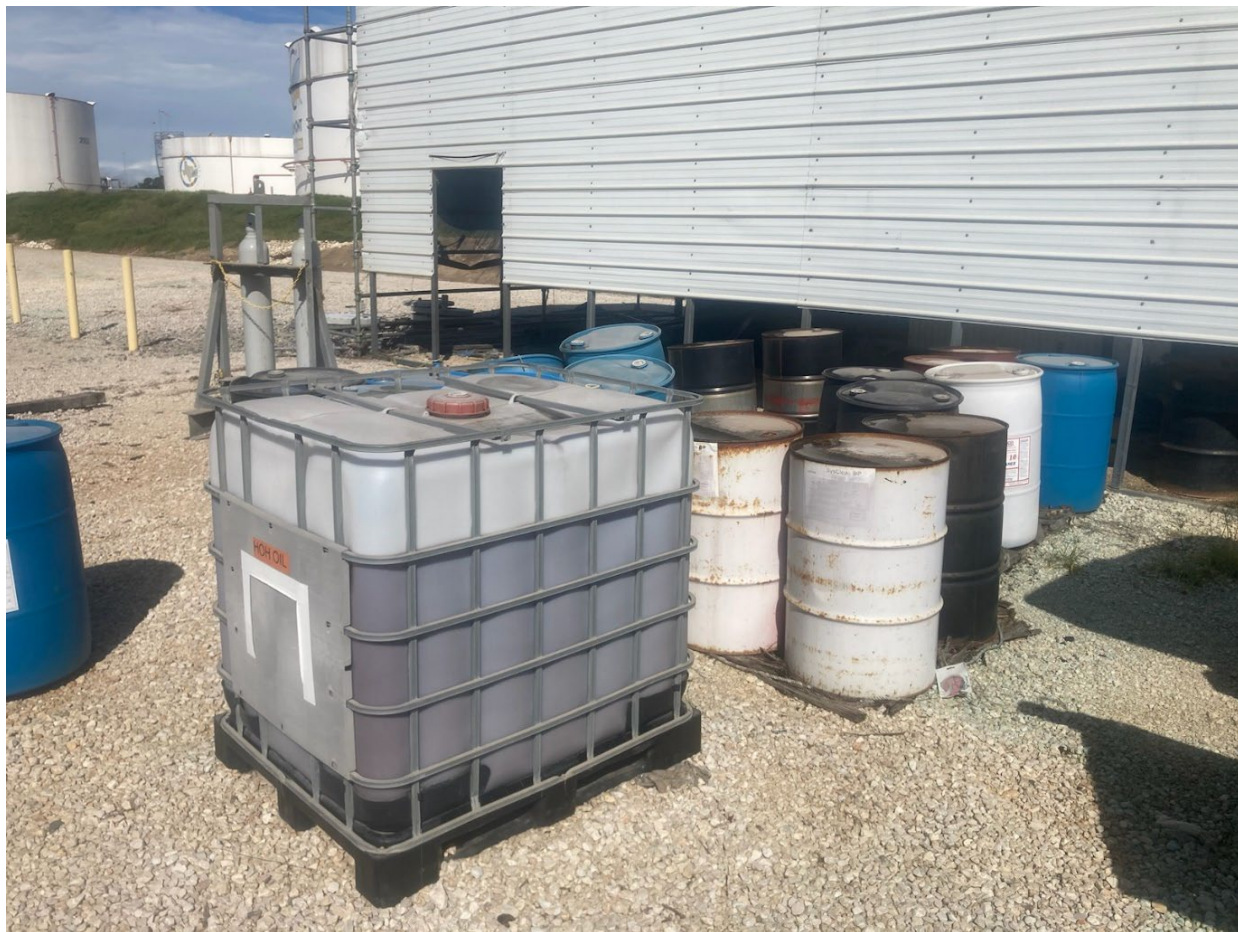
**Photo No. 9**

Description: Another view of nineteen 55-gallon drums containing unknown materials at the time of the inspection in the drum storage area.

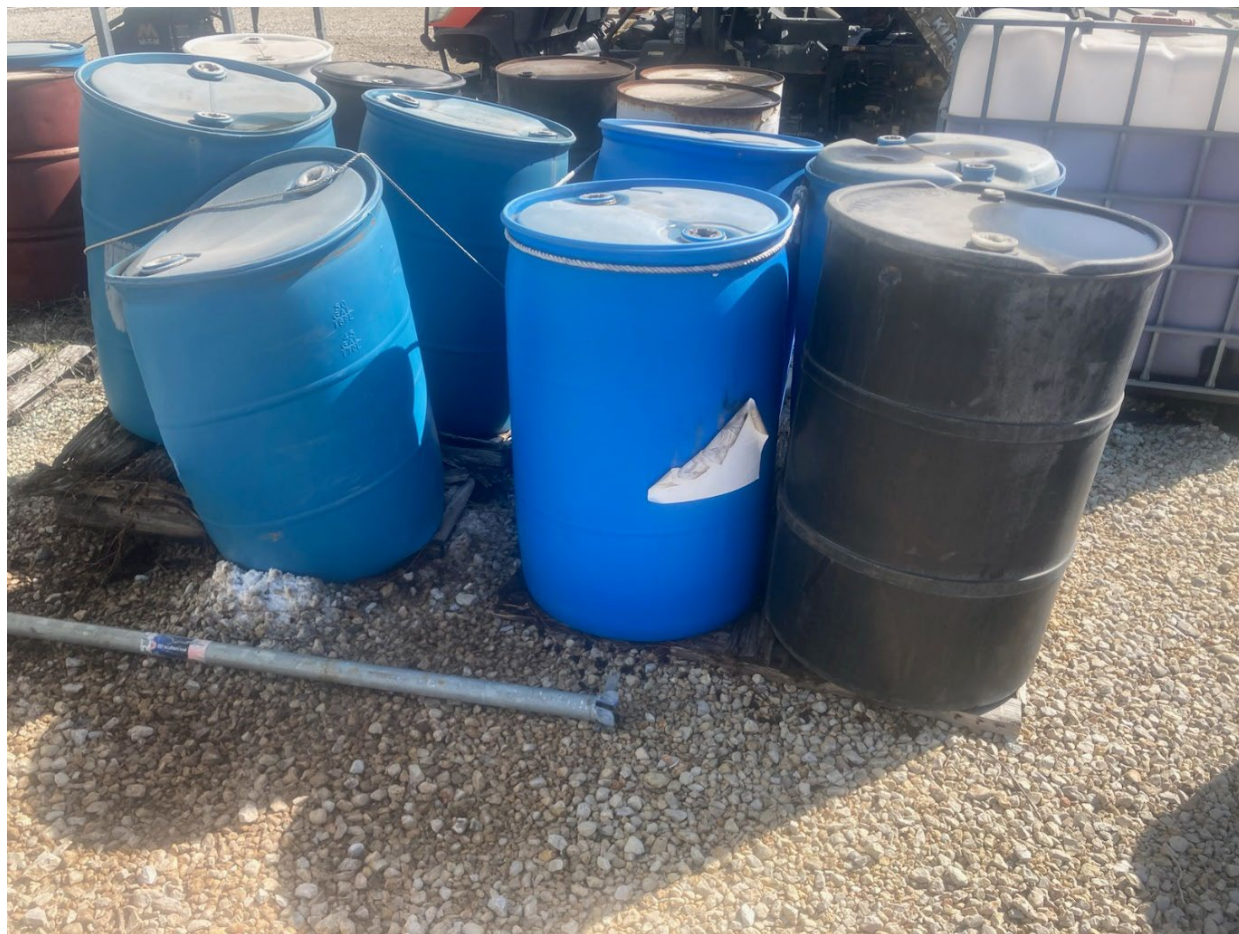
**Photo No. 10**

Description: View of one of the unidentified 55-gallon drums shown to be crushed.

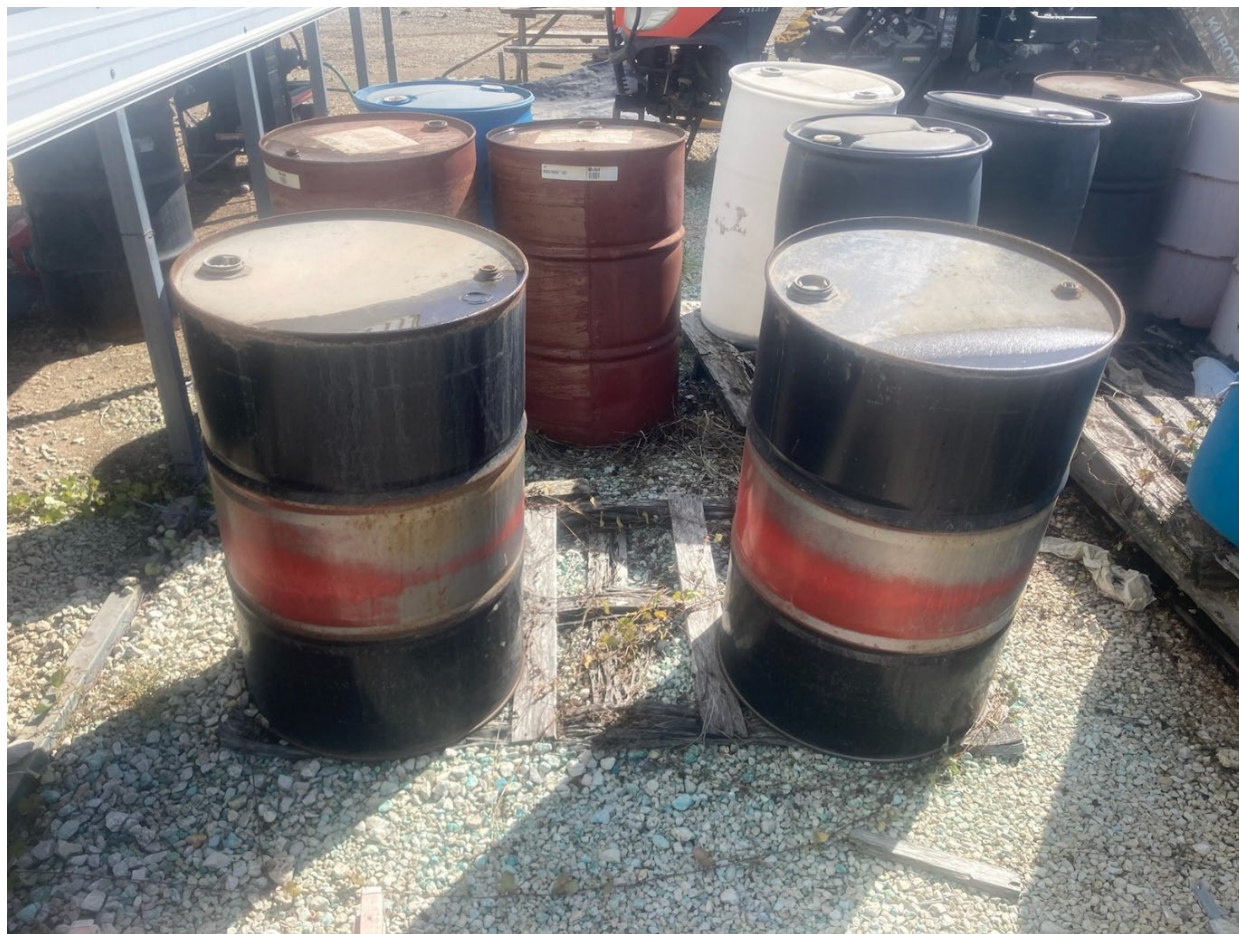
**Photo No. 11**

Description: Close-up view of the drums containing unknown materials shown to be stored on broken wooden pallets inside the drum storage area.

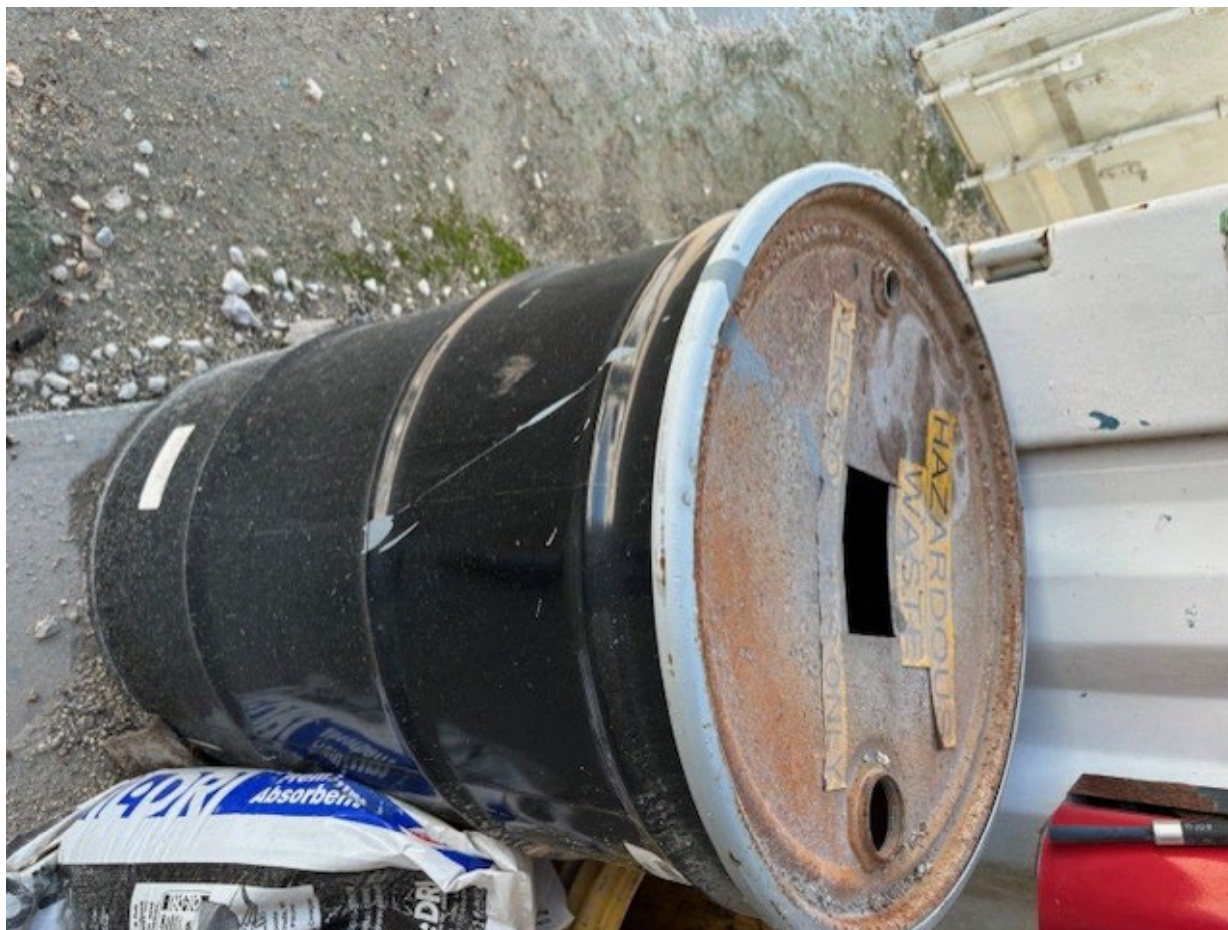
**Photo No. 12**

the drums or if the drums were storing waste materials at the time of the inspection [**AOC #1** – *JRT did not make a hazardous waste determination – 40 CFR 262.11*]. In front of the shed housing the parts washers, the inspection team observed one half-full 300-gallon tote storing HOH oil, a high-performance industrial lubricant, which is a usable product. The inspection team also found nineteen 55-gallon drums which were also not labeled and all contained material ranging from one-quarter full to full (see Appendix 1 – Photos 7 to 11). One of the 55-gallon drums was crushed (see Photo 10) and all the drums were stored on broken wooden pallets. JRT representatives were unsure what was being stored in the drums at the time of the inspection (see **AOC#1**). The inspection team also observed a 55-gallon drum accumulating unpunctured aerosol cans. JST stated they are managing the waste as universal waste and the hazardous waste label on the drum was not updated. The drum was closed but had a hole cut into the lid (see Appendix 1 – Photo 12).

Description: View of a 55-gallon drum storing unpunctured aerosol cans, approximately half-full, that had a hole cut into the lid of the container found inside the drum storage area.

Appendix 5. Aerosol Drum Photo with New Lid

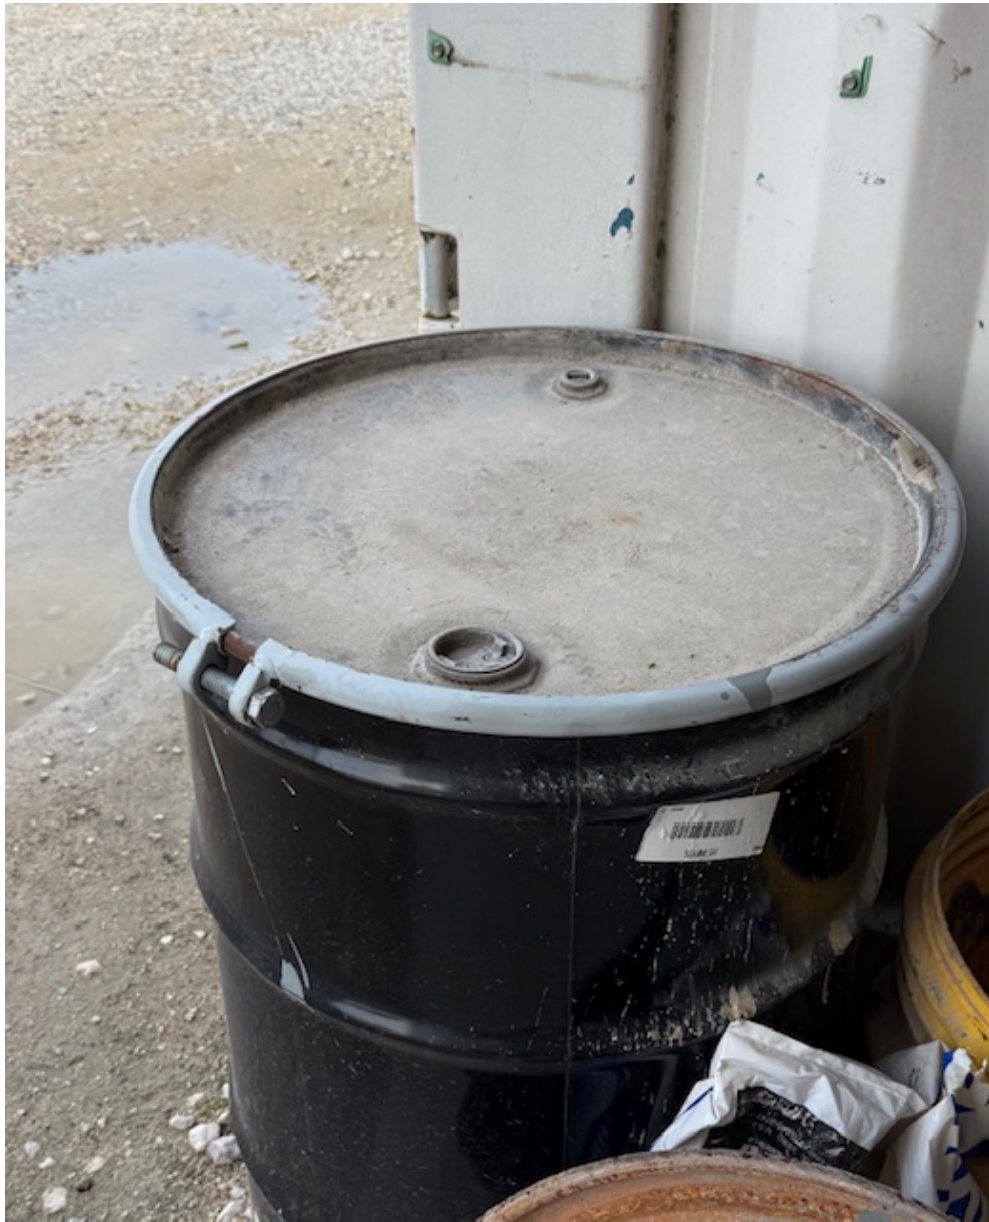
Image of aerosol can drum with new lid sent on 11/11/2024 by JRT.
