## Region 6 Compliance Assurance and Enforcement Division

### INSPECTION REPORT

| Company Name: | <b>Village of Fort Sumner</b> | | |
| Facility Name: | <b>Fort Sumner Municipal Water System</b> | | |

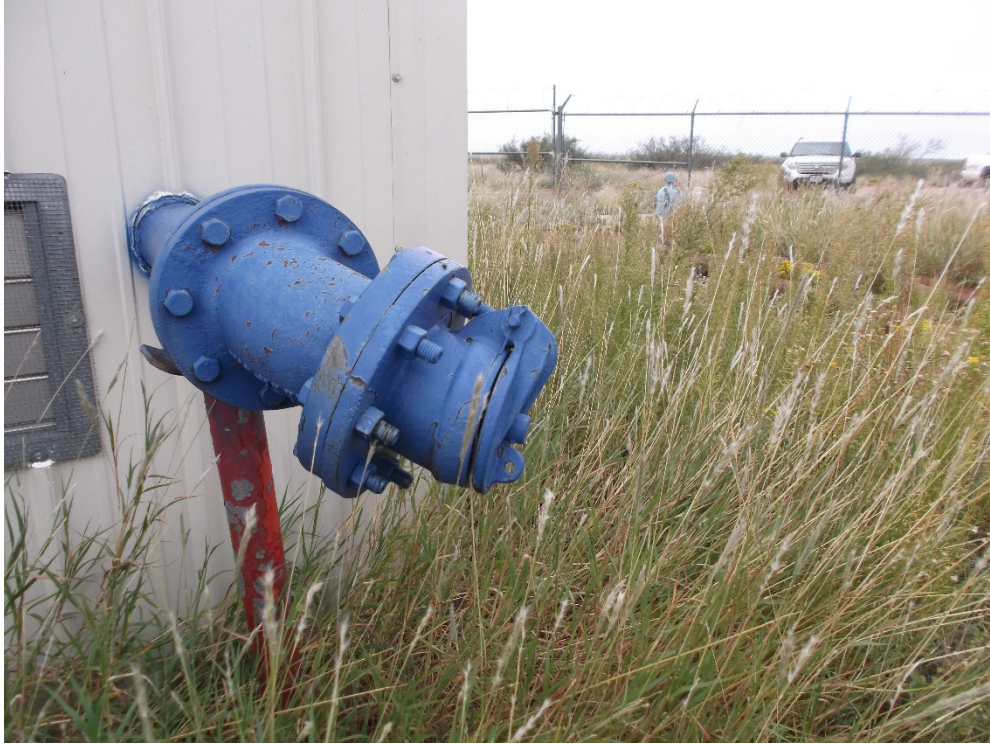
- a. Flow meter no longer in operation at Mac well
- b. Overflow valve for Mac well house, not seating properly and vegetation not managed. See photo #1 in Appendix 1.
- c. The raw water sample port is in-line with the chlorine injection location at the Mares and Grizzle wells. See photo #9 in Appendix 1.
- d. The flush line directly to the Grizzle well has no gasket or other protection for the flapper valve and is possibly misaligned. See photo #12 in Appendix 1.

Photo 1: Overflow valve for Mac Well, not seating properly and vegetation not managed

8. Monitoring of dead-ends for chlorine residuals is not being completed.
9. Overflow valve for Mac well is not seating properly and therefore open to intrusion.

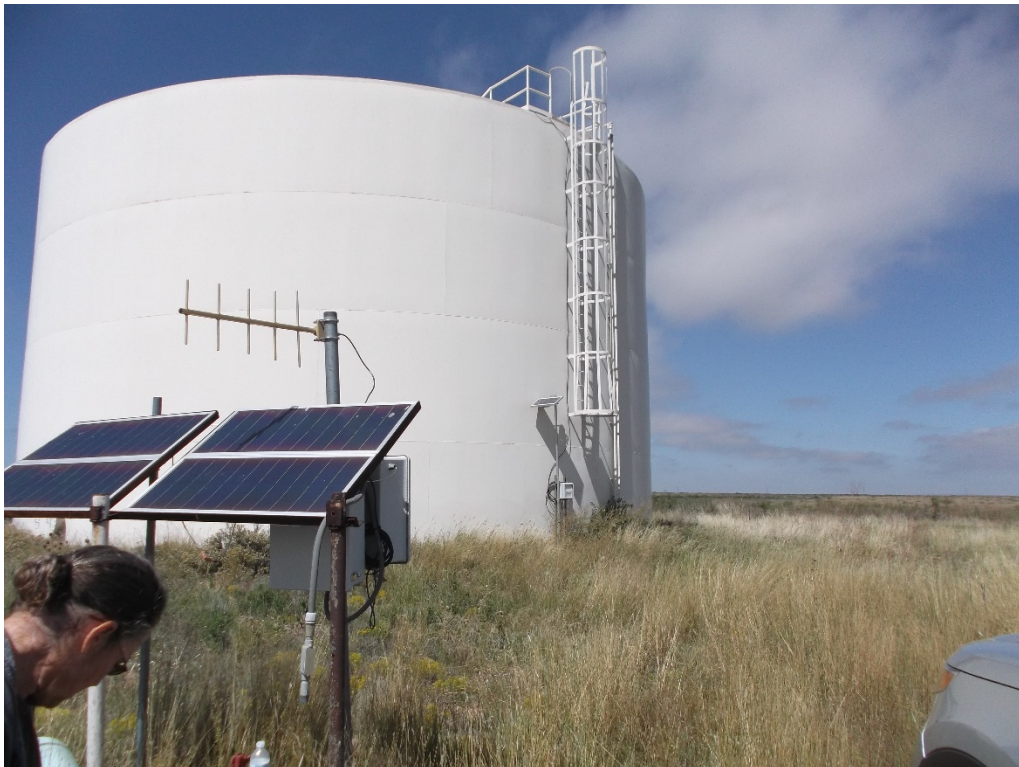
- a. Grizzle Tank area overrun with vegetation, making it difficult (and potentially hazardous) to observe problems and perform maintenance. See photo #2 and #3 in Appendix 1.
- b. The Grizzle tank overflow valve splashpad is nonexistent. Currently using small area of rock under pipe, allowing vegetation overgrowth. See Photo #4 in Appendix 1.

Photo 2. Grizzle Tank area overrun with vegetation, making it difficult (and potentially hazardous) to observe problems and perform maintenance

7. Lack of O&M was evident at all locations during the inspection, including vegetation management around wells, tanks, buildings, overflow valves, etc.

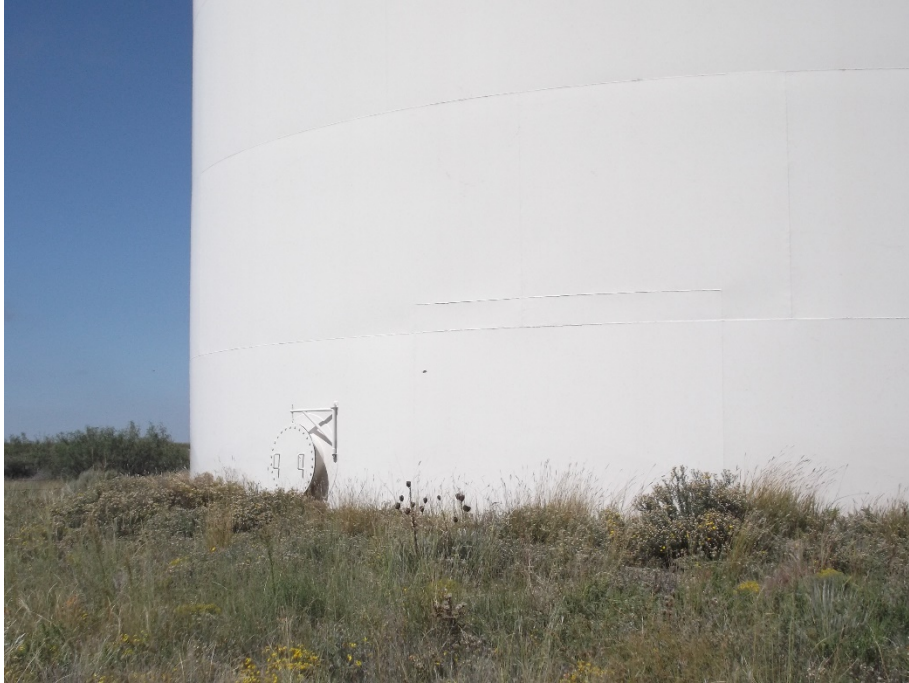
Photo 3. Grizzle Tank area overrun with vegetation, making it difficult (and potentially hazardous) to observe problems and perform maintenance

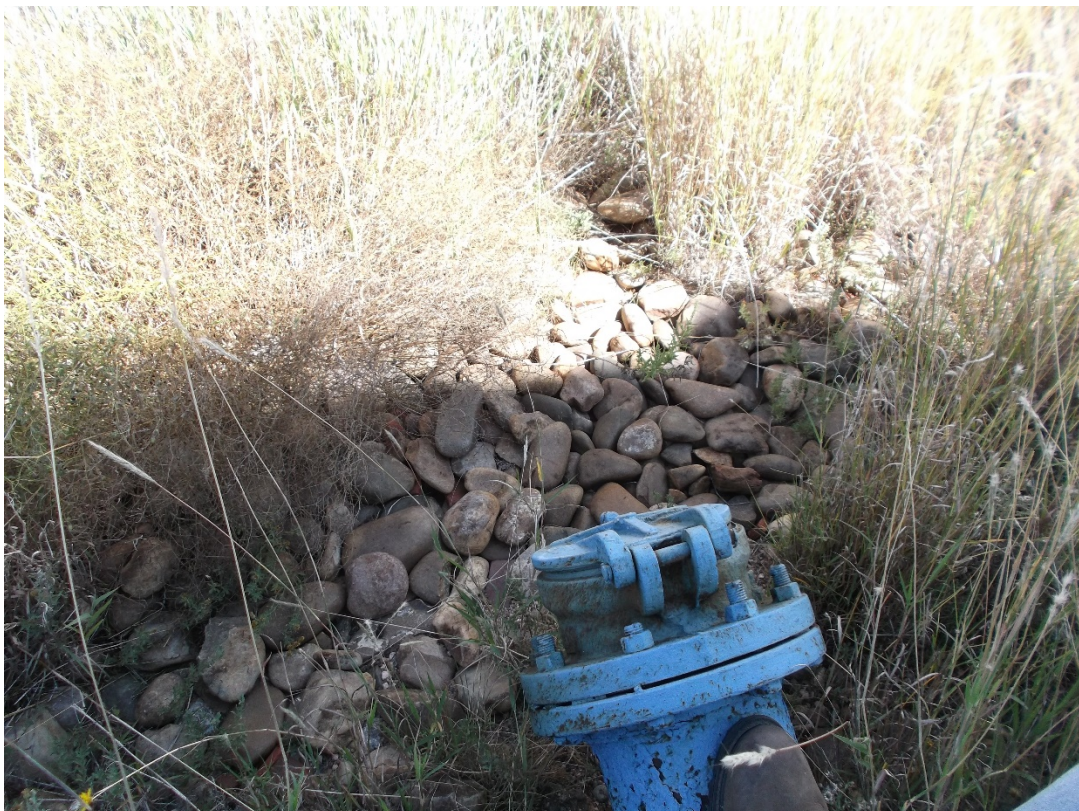
Photo 4. Grizzle Tank overflow valve.

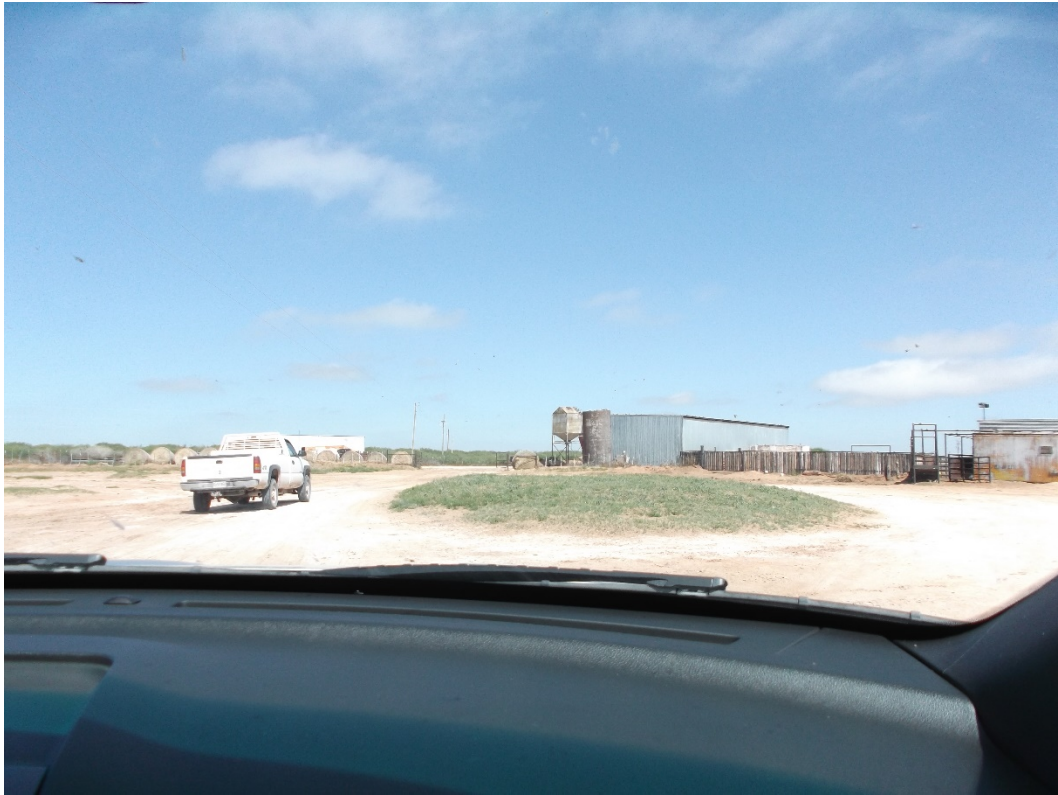
- b. Access to the Mares and Grizzle wells location required driving through multiple feedlot areas at a home site and gated area. See photo #5 in Appendix 1.

Photo 5. Driving through cattle feedlot to get to the Grizzle and Mares wells location

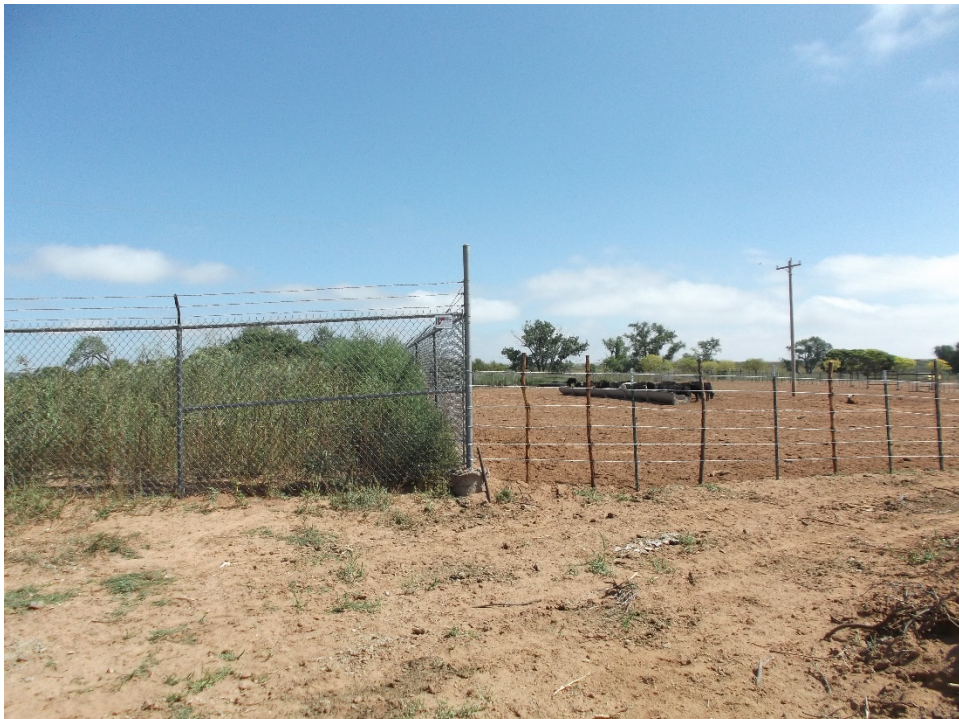
- c. A cattle feedlot is located next to the fenced area of Mares and Grizzle wells. See photo #6 and #7 in Appendix 1.
- d. The concrete pad surrounding the Mares and Grizzle wellheads is cracked at various locations. See photo #8 in Appendix 1.

Photo 6. Cattle feedlot next to fenced area of Mares and Grizzle wells.

4. The cattle feedlots next to the Mares and Grizzle wells may be a potential for contamination.
5. Possible manure pile at the north side of the Mares and Grizzle wells may be a potential for contamination.

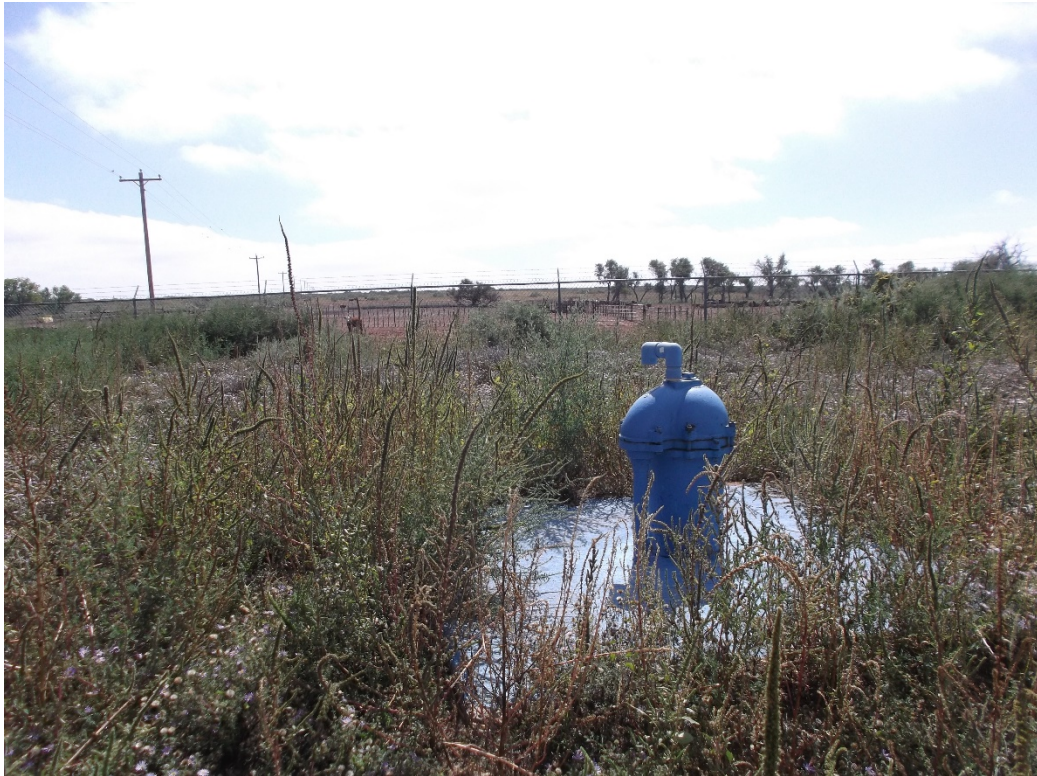
Photo 7. Cattle feedlot next to fenced area of Mares and Grizzle wells.

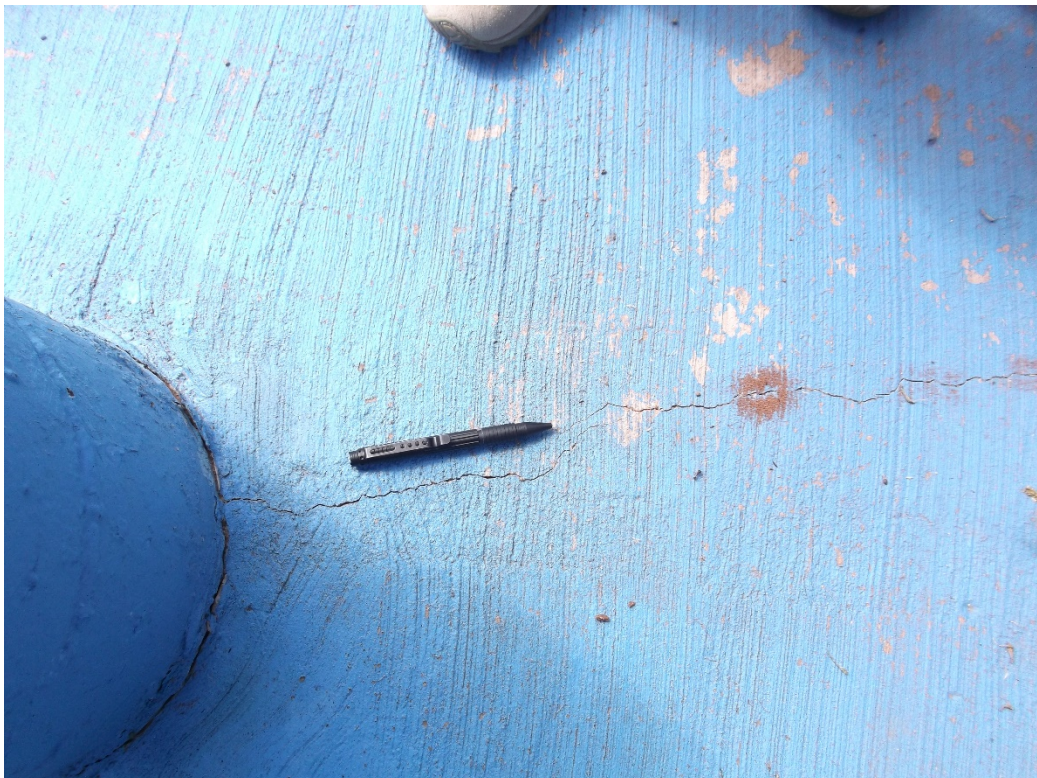
Photo 8. Concrete pad at Mares and Grizzle wells location

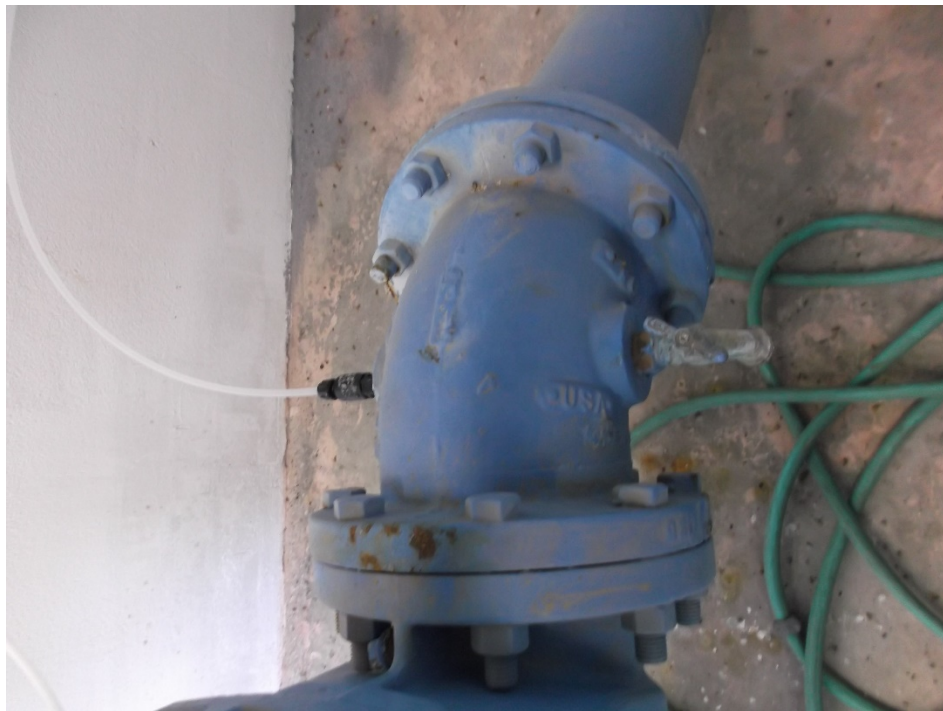
12. The raw water sample port is in-line with the chlorine injection location at the Mares and Grizzle wells. See photo #9 in Appendix 1.
13. The system has two Pressure Reducing Valves (PRV) located below ground level. Both exhibit corrosion, are subject to flooding (not at minimum height) and do not have properly screened vents. At least one PRV has open electrical lines. See Photo #15 in Appendix 1.

Photo #9. Raw water sample port in-line with the chlorine injection location.

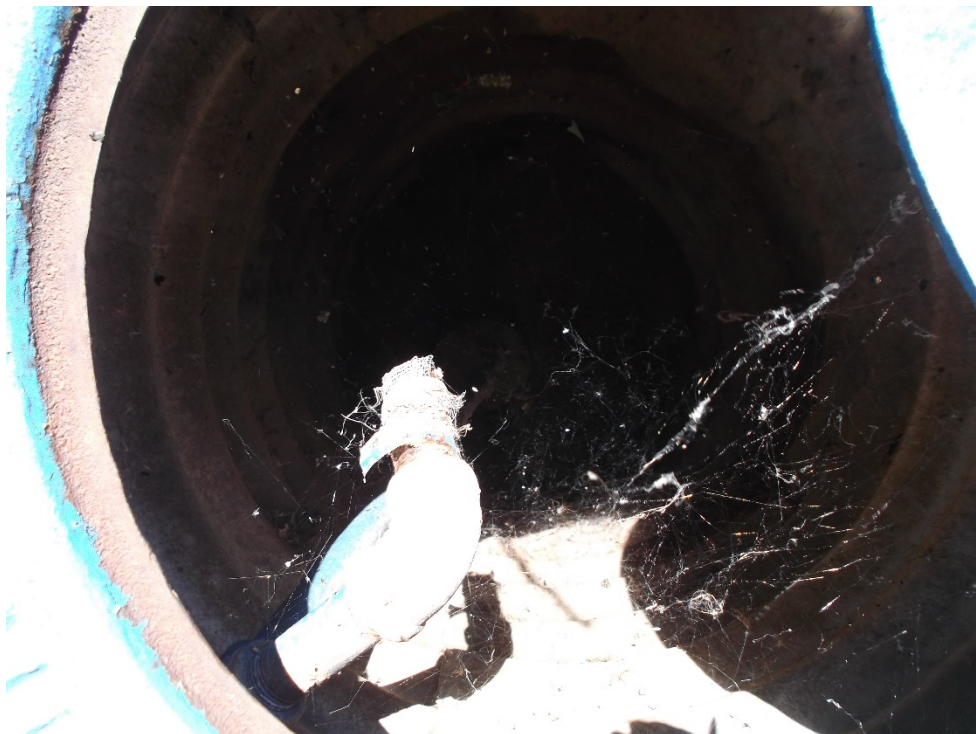
- e. Rodent holes were observed next to concrete pads at the Mares and Grizzle wells.
- f. The screen on the air relief valve for Grizzle well is ineffective. See photo #10 in Appendix 1.

Photo #10. Screen on the air relief valve for Grizzle well.

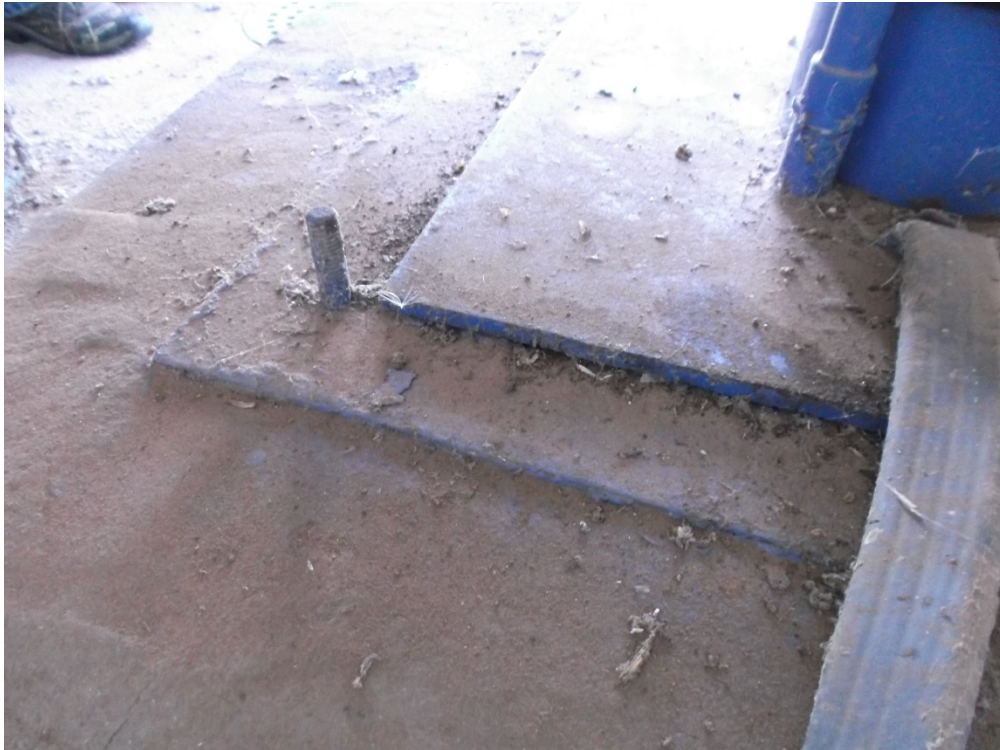
- g. There is a gap in the well plate at the Grizzle well. See photo #11 in Appendix 1.
- h. The first "customer" appears to be the cattle feedlot next to the Mares and Grizzle wells, with a frost-free hose bib. See photo # 13 in Appendix 1.

Photo #11. Gap in the well plate at the Grizzle well

10. Manganese adjustments for the Hach instrument has not been done. This may be an issue with false chlorine residual readings.
11. The gap in the well plate at the Grizzle well is a potential conduit for contamination.

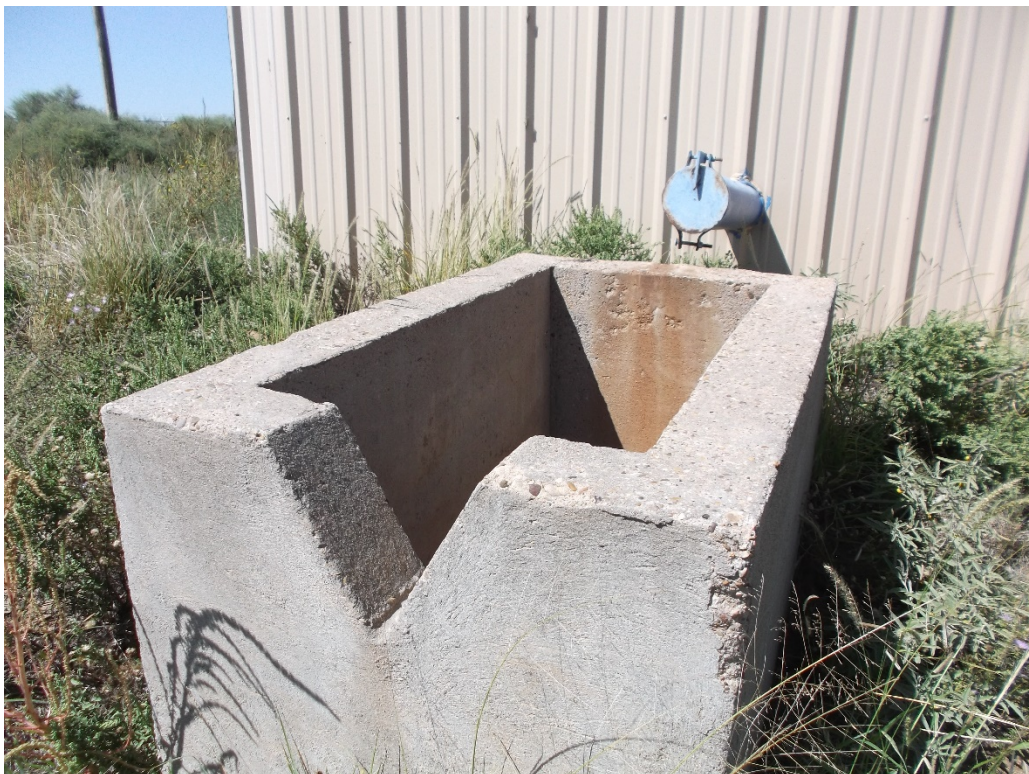
Photo #12. The flush line directly to the Grizzle well has no gasket or other protection for the flapper valve

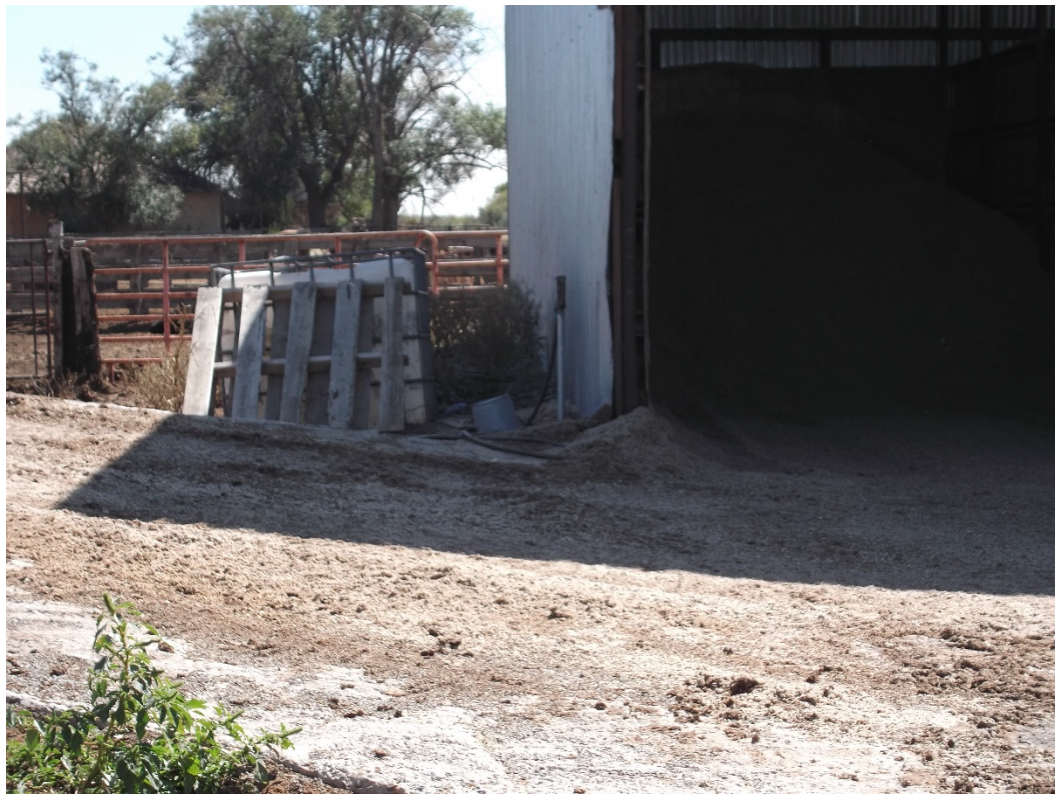
Photo #13. Frost-free spigot (hose bib) at cattle feedlot next to Mares and Grizzle wells – first “customer”

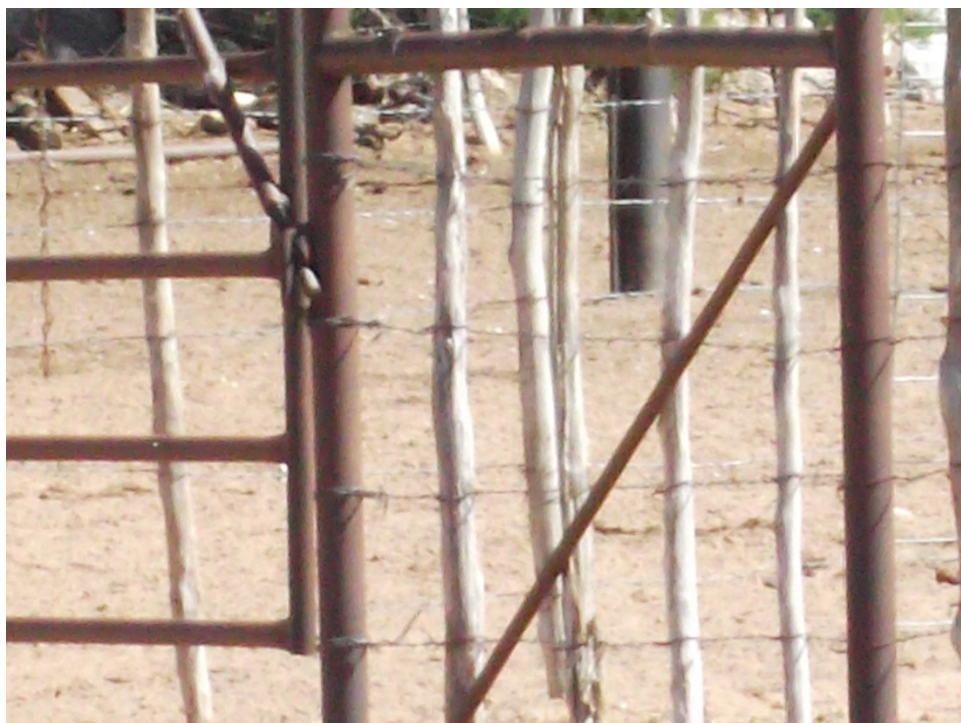
- 1. The Mares and Grizzle wells are currently offline due to positive total coliform bacteria.
- 2. There is a private well at the house, and inside a cattle lot. See Photo #14 in Appendix 1. Based on aerial measurements, the private well appears to be about 1,060 feet – or less than a quarter mile - from the Mares and Grizzle wells. This may be potential for contamination of the groundwater within the vicinity of the public water supply wells.
- 3. The first “customer” appears to be the cattle feedlot close by the Mares and Grizzle wells, with a frost-free hose bib next to a barn and cattle lot. See photo # 13 in Appendix 1. This is a potential contamination to the public water supply if it is a customer and there is no backflow prevention.

Photo #14. Private well located close to house, and inside cattle lot, next to the Mares and Grizzle wells.

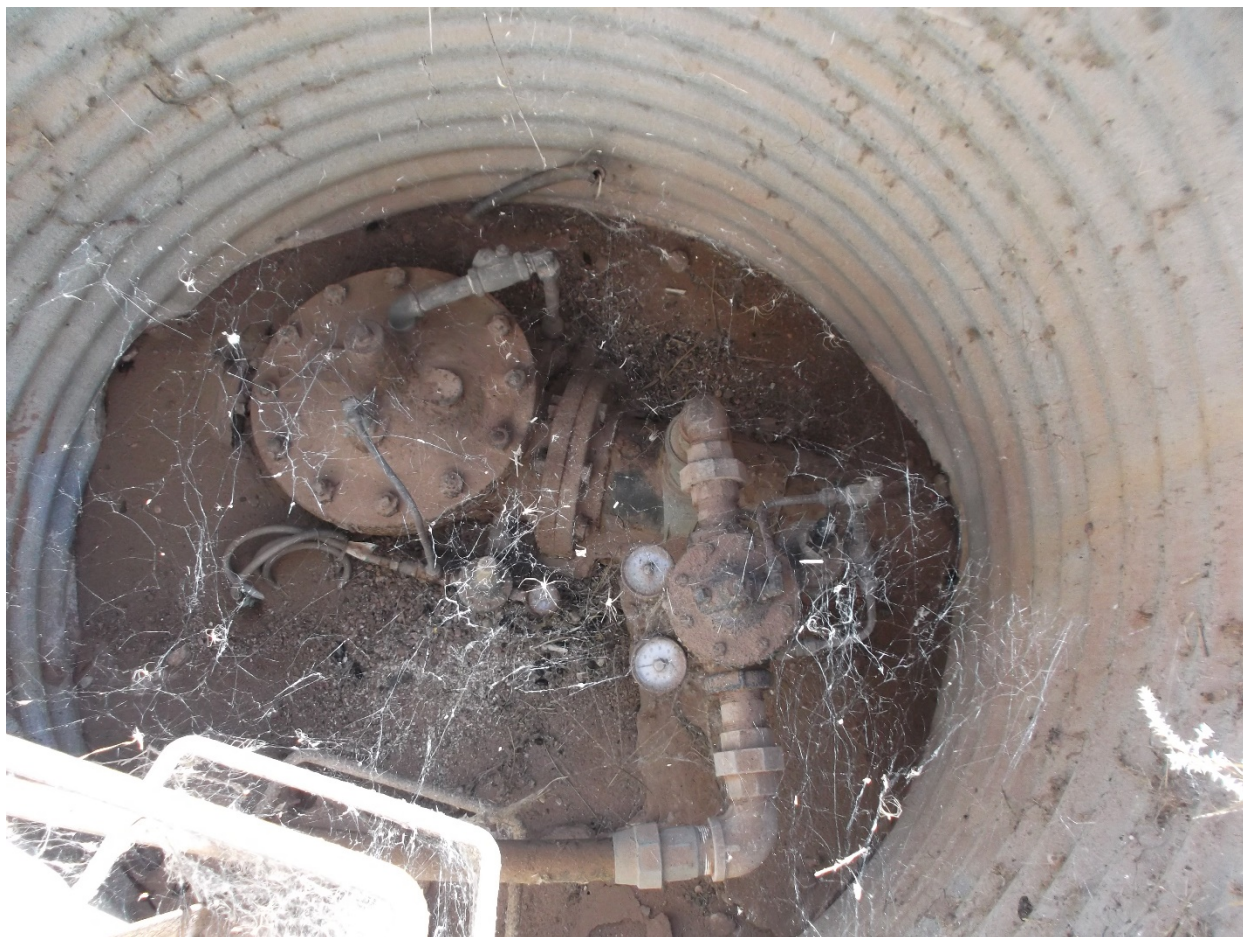
The system has two Pressure Reducing Valves (PRV) located below ground level. Both exhibit corrosion, are subject to flooding (not at minimum height) and do not have properly screened vents. At least one PRV has open electrical lines. See Photo #15 in Appendix 1.

Photo #15. (1 of 2) Pressure Reducing Valves. Some corrosion, electrical open, subject to flooding, no vent.
