## **RCRA Inspection Report**

SNF Flocryl, Inc.-Acrylate  
674 Chemical Plant Road  
Riceboro, Georgia 31323

March 12-13, 2024

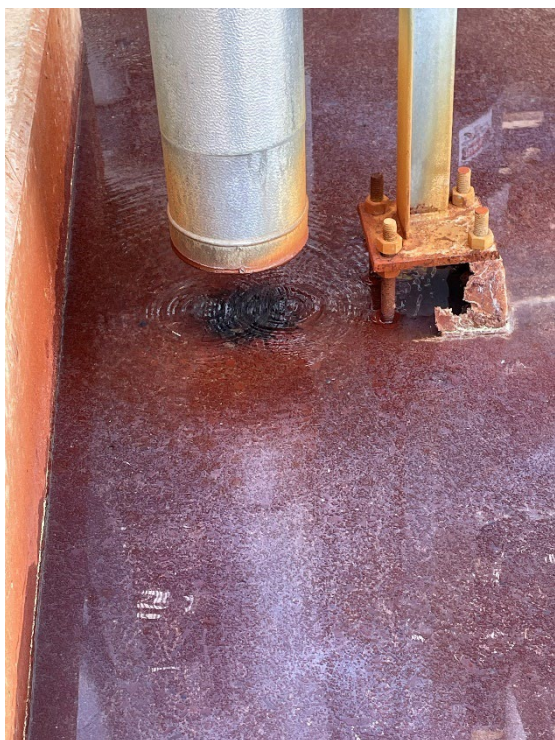
The inspectors observed the secondary containment for the process and waste vessels. The secondary containment was observed to be damaged and eroded by the condensate from T-345 (Figure 1).

Figure 1: IMG\_3244.jpg – Damage to secondary containment at T-345.

**Pursuant to Ga. Comp. R. and Regs. 391-3-11-.08(1) [40 C.F.R. § 262.17], which incorporates Ga. Comp. R. and Regs. 391-3-11-.10(1) [40 C.F.R. § 265.193(e)(1)(iii)] and is a condition of the LQG Permit Exemption, a generator managing hazardous waste in tanks must ensure that the secondary containment system is free of cracks and gaps.**

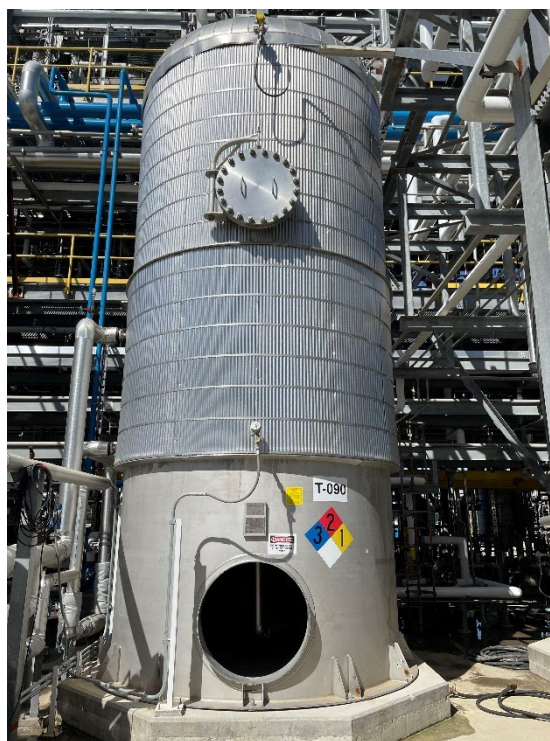
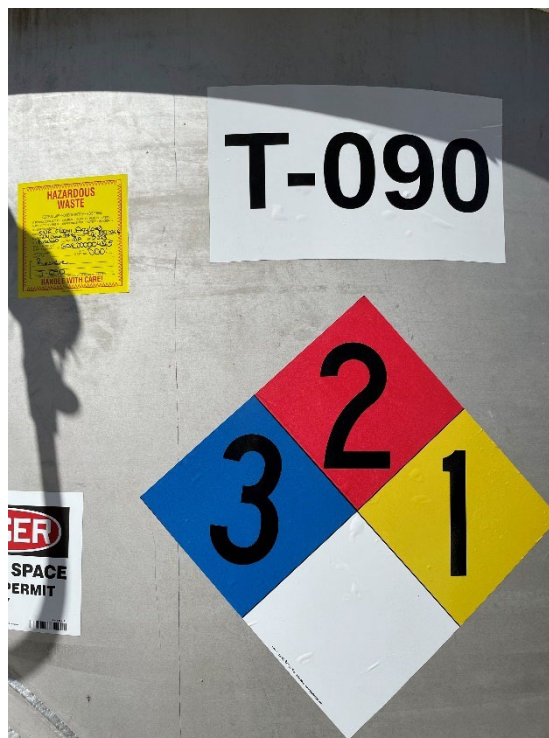
The inspectors observed the Hazardous Waste Tank T-090, labeled with the words "Hazardous Waste" and an indication of the hazard of the contents (Figures 2-4). The secondary containment that was damaged, as discussed above.

Figure 2: IMG\_3245.jpg – Hazardous Waste Tank T-090

Figure 3: IMG\_3246.jpg – Hazardous Waste Tank T-090

Figure 4: IMG\_3247.jpg – Hazardous Waste Tank T-090

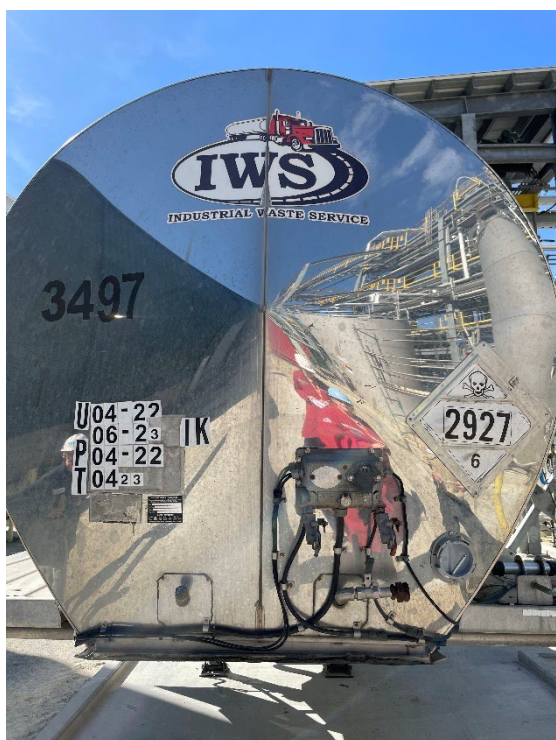
The inspectors observed a tanker container in the area of T-090 (Figure 5). The facility representative explained that this tanker container is used to ship the waste residues from T-090 (and other hazardous waste tanks onsite) off-site for disposal. At the time of the inspection, the facility representatives could not determine if there was waste present in the tanker container. However, they did explain that once waste is loaded into the tanker container a sample is taken from the tanker container to the North Plant Lab. At that time, the flashpoint of the waste is determined. If the flashpoint is below 140 degrees Fahrenheit (°F) then the waste is sent offsite as hazardous waste, if the flashpoint is above 140 °F then it is sent as nonhazardous waste on a uniform hazardous waste manifest (UHW). This is not the point of generation of the waste.

During the review of UHWM the inspectors observed that the TSD receiving the waste was routinely returning the tanker containers with a sizable heel present. The TSD was unable to remove all the material from the container, therefore the load was partially rejected or returned to the generator. Once the container arrives at SNF, the container is not managed in a CAA, dated or managed as hazardous waste until new waste is added to the tanker container. Once waste is added to the tanker, the waste is sampled to determine the flashpoint and the process begins again.

Figure 5: IMG\_3248.jpg – Tanker Truck used to store and ship hazardous waste.

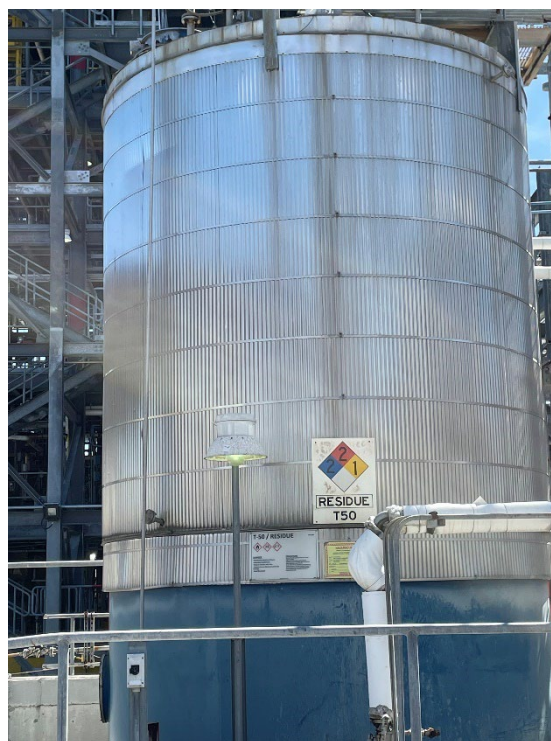
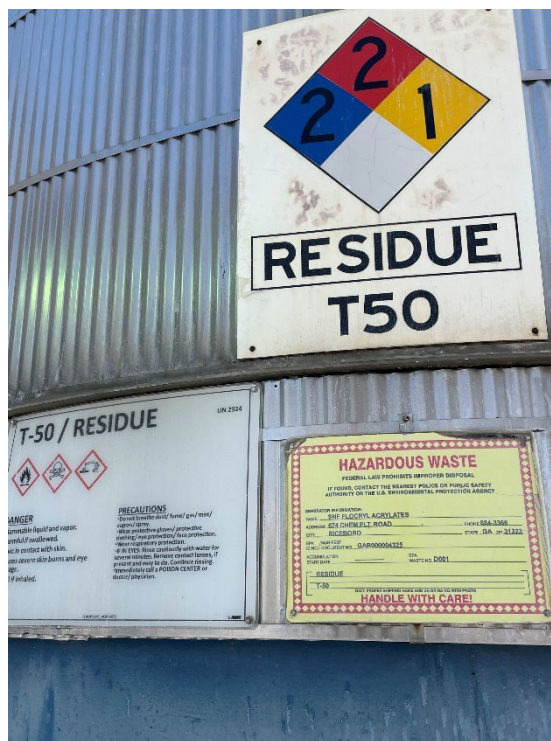
The inspectors observed the Hazardous Waste Tank T-50, to be labeled with the words “Hazardous Waste” and an indication of the hazard of the contents (Figure 6 and 10). LDAR tags 51415, 51416, and 51418 were observed. T-50 is a pressure vessel, details of the tank’s design and installation were provided.

Figure 6: IMG\_3249.jpg – Hazardous Waste Tank T50

Figure 10: IMG\_3253.jpg – T50

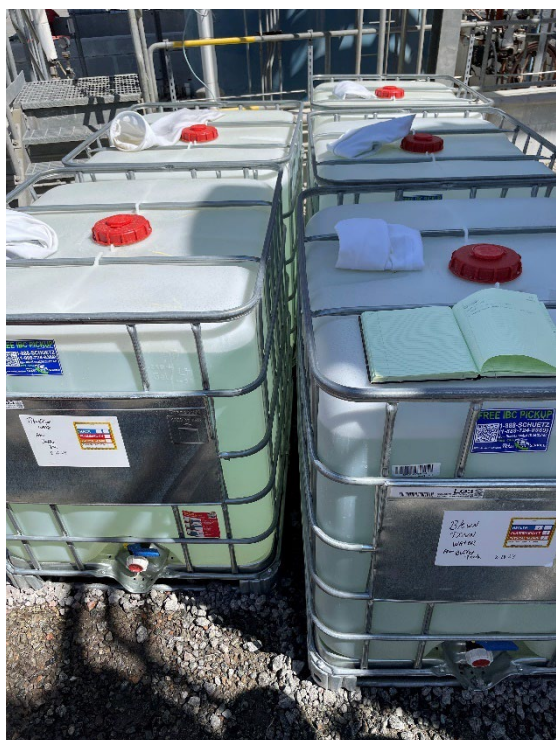
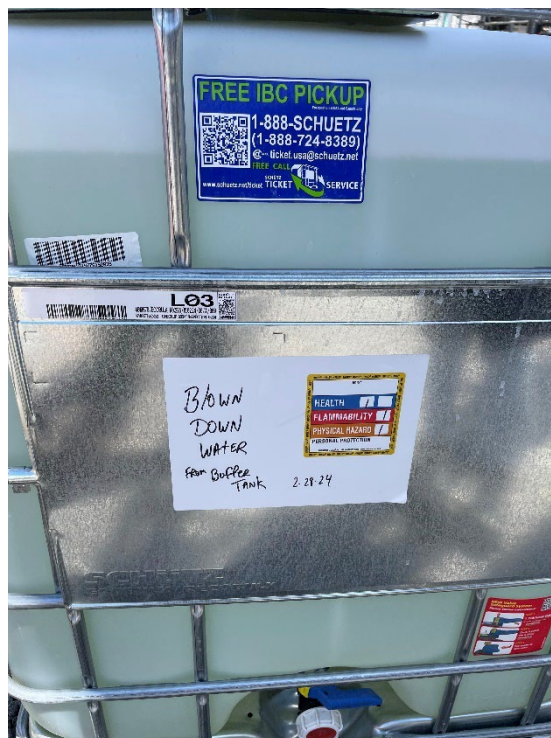
At the time of the inspection five (5) totes of Blow Down Wastewater were observed near the T-50 tank. A waste profile was requested for the totes. A PDF file of an email stated a flashpoint of greater than 150 and a pH of 8.72.

Figure 7: IMG\_3250.jpg – Blow down water in totes

Figure 8: IMG\_3251.jpg – Blow down water in totes

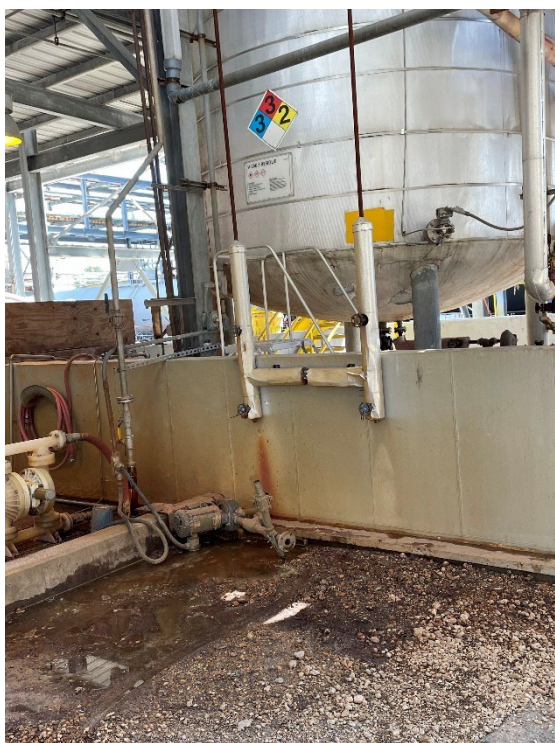
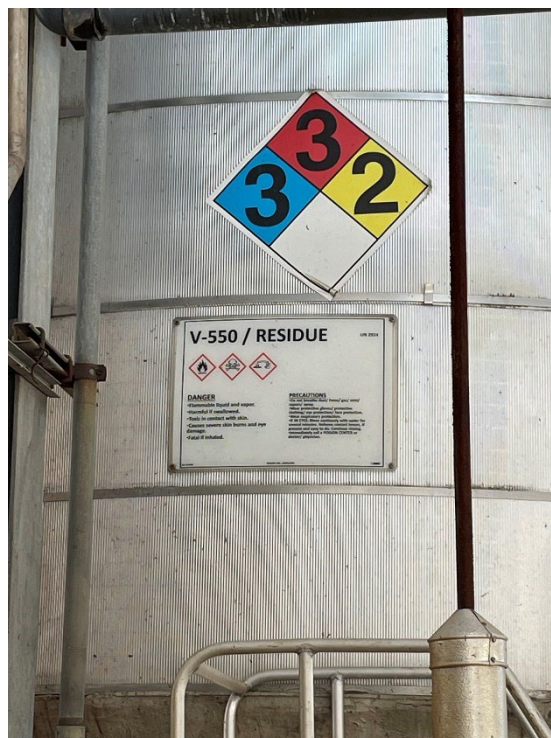
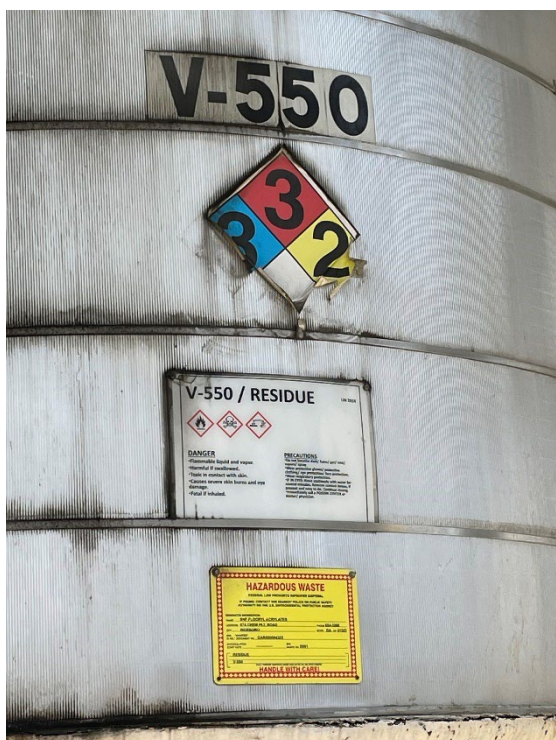
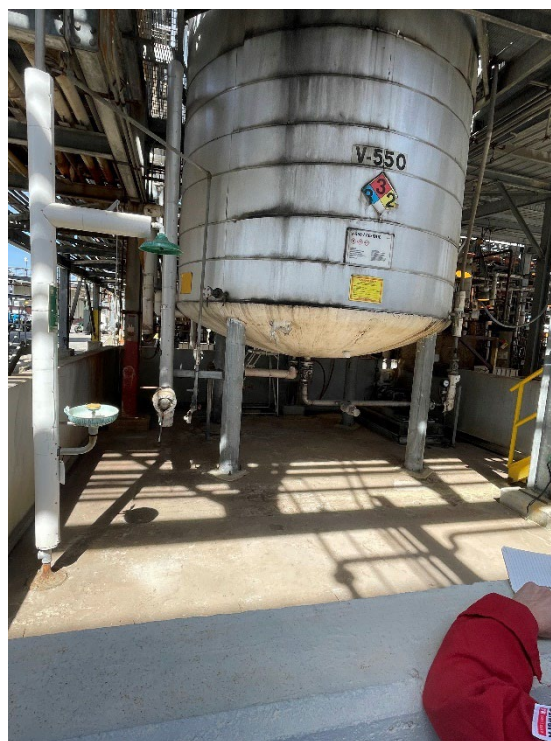
The inspectors observed the Hazardous Waste Tank V-550, to be labeled with the words “Hazardous Waste” and an indication of the hazard of the contents (Figures 11-14). The secondary containment serving V-550 had a wall moved. The inspectors observed, a large crack and gap in the secondary containment as seen in Figures 15 and 16.

Figure 11: IMG\_3254.jpg – Hazardous Waste Tank V-550

Figure 12: IMG\_3255.jpg – Hazardous Waste Tank V-550

Figure 13: IMG\_3256.jpg – Hazardous Waste Tank V-550

Figure 14: IMG\_3257.jpg – Hazardous Waste Tank V-550

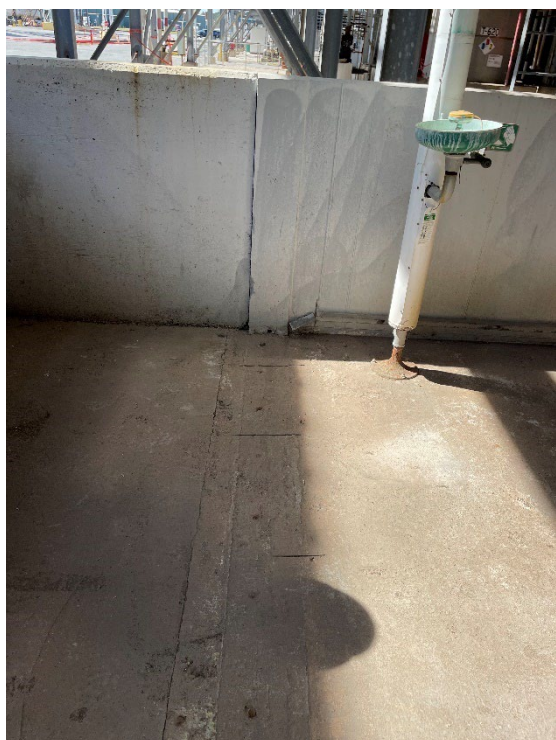
Figure 15: IMG\_3258.jpg - V-550 secondary containment

Figure 16: IMG\_3259.jpg - V-550 secondary containment

**Pursuant to Ga. Comp. R. and Regs. 391-3-11-.08(1) [40 C.F.R. § 262.17], which incorporates Ga. Comp. R. and Regs. 391-3-11-.10(1) [40 C.F.R. § 265.193(e)(1)(iii)] and is a condition of the LQG Permit Exemption, a generator managing hazardous waste in tanks must ensure that the secondary containment system is free of cracks and gaps.**

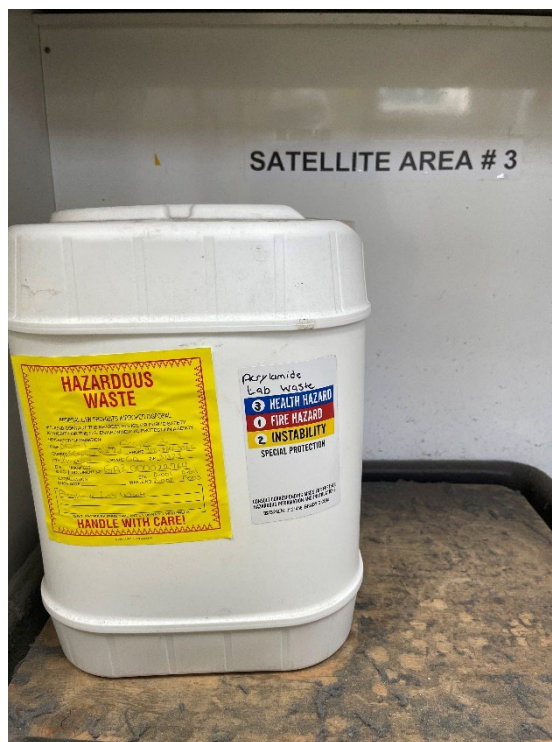
At the time of the inspection, the Acrylamide Lab SAA consisted of one (1) gallon jug of acrylamide lab waste (D001, D002, D011, F003). The container was closed and labeled with the words "Hazardous Waste" with an indication of the hazards of the contents. (Figure 28)

Figure 28: IMG\_3271.jpg – Acrylamide Lab Waste Container

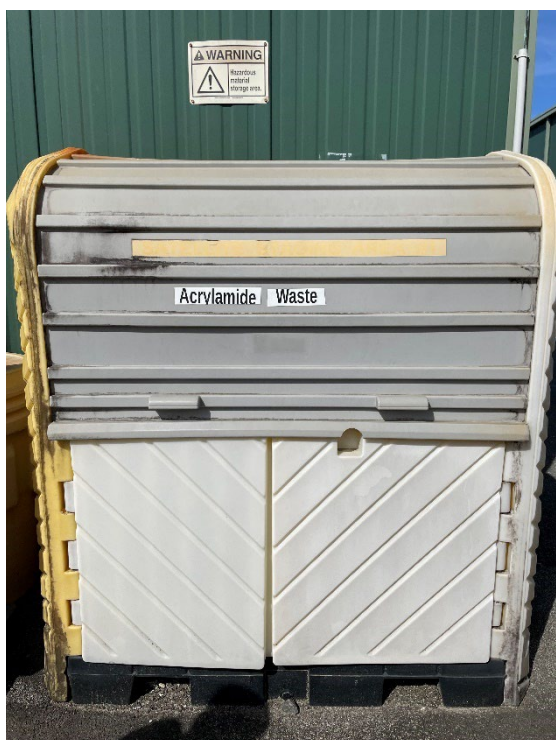
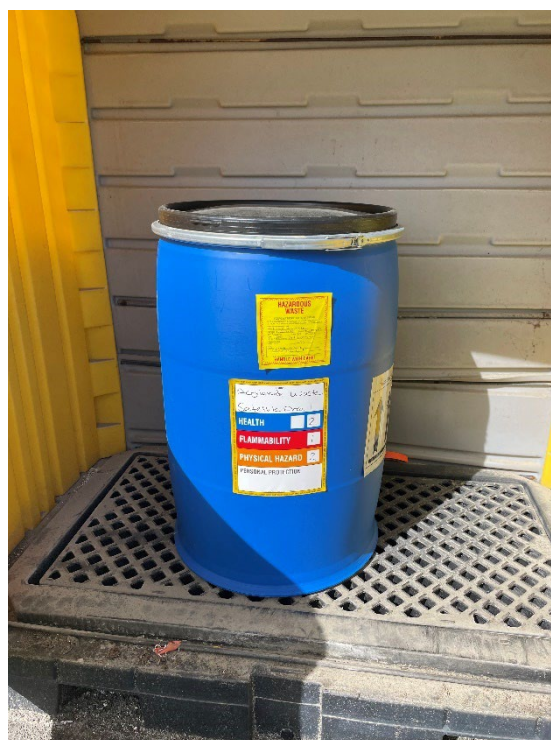
At the time of the inspection, the Acrylamide waste SAA consisted of one (1) 55-gallon drum of acrylamide waste. The container was closed and labeled with the words "Hazardous Waste" and an indication of the hazards of the contents (Figures 29 and 30).

The facility's use of HMIL/HMIS for labelling the indications of hazards of the contents is an area of concern.

Figure 29: IMG\_3272.jpg – Acrylamide SAA #1

Figure 30: IMG\_3273.jpg – Acrylamide Waste Container

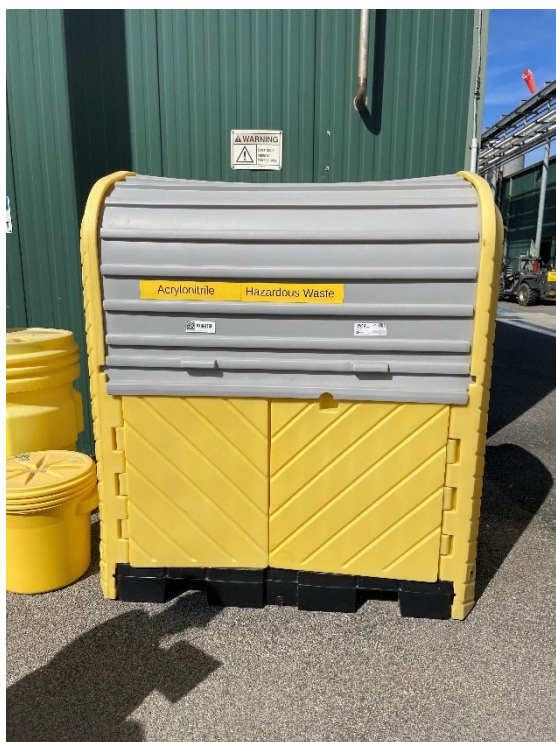
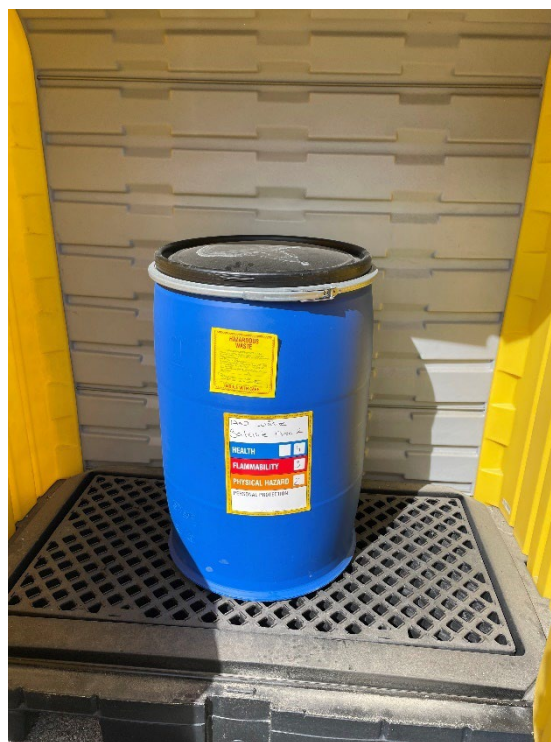
At the time of the inspection, the Acrylonitrile SAA consisted of one (1) 55-gallon drum of acrylamide waste. The container was closed and labeled with the words "Hazardous Waste" and an indication of the hazards of the contents (Figure 31 and 32).

Figure 31: IMG\_3274.jpg – Acrylonitrile SAA

Figure 32: IMG\_3275.jpg – Acrylonitrile Waste Container

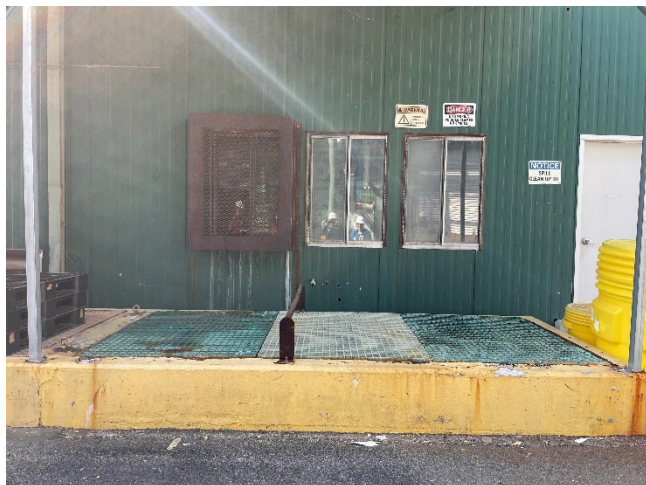
At the time of the inspection, the Acrylamide CAA did not contain any hazardous waste (Figure 33).

Figure 33: IMG\_3276.jpg – Acrylamide CAA

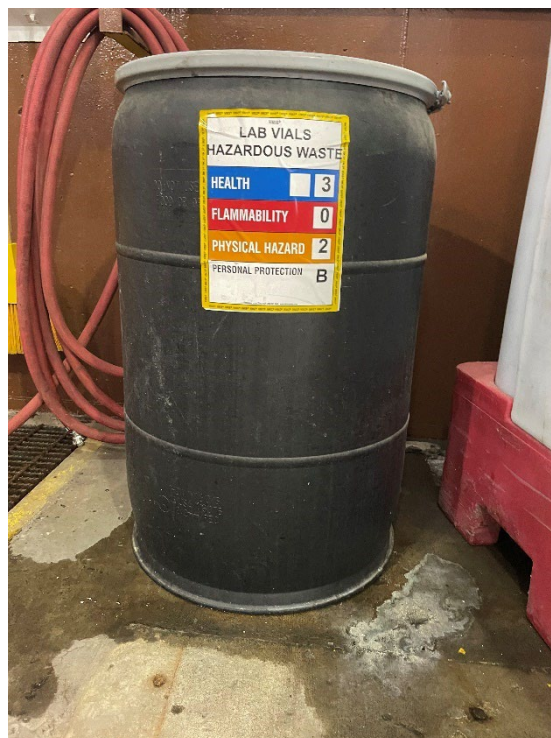
At the time of the inspection, the WWTP SAA consisted of one (1) 55-gallon drum of lab vial waste. The container was closed and labeled with the words “Hazardous Waste” and an indication of the hazards of the contents (Figure 34).

Figure 34: IMG\_3277.jpg – WWT Lab Vials Hazardous Waste Container in SAA

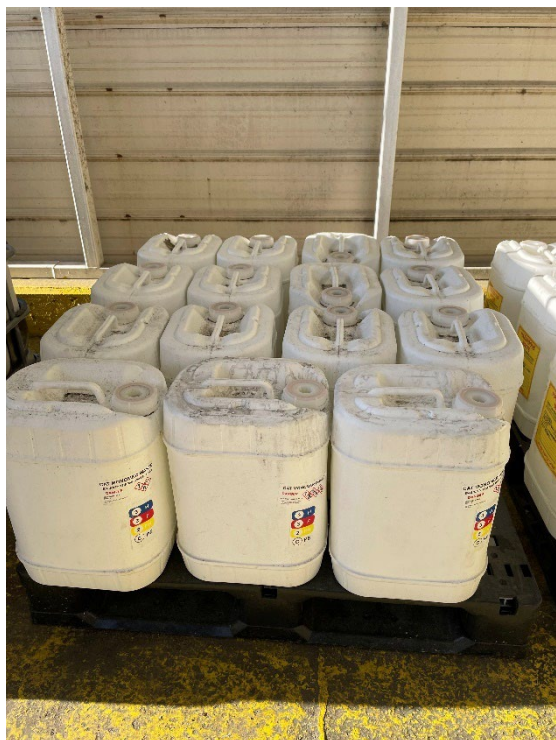
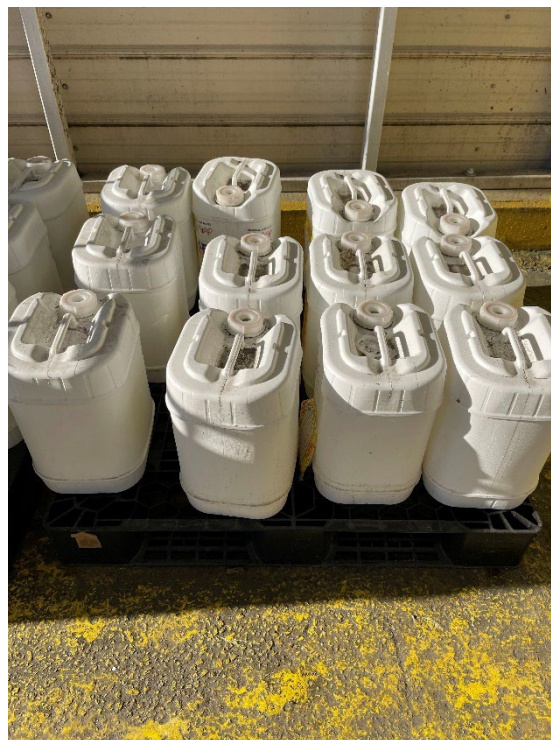
At the time of the inspection, the inspectors observed that the twenty (20) 5-gallons jugs of CAT Monomer Waste were stored on a palette without adequate aisle space. (Figures 39 and 40)

Figure 39: IMG\_3282.jpg – Containers of cat monomer, hazardous waste

Figure 40: IMG\_3283.jpg – Hazardous Waste stored without aisle space

**Pursuant to Ga. Comp. R. and Regs. 391-3-11-.08(1) [40 C.F.R. § 262.16(b)(8)(v)], and is a condition of the SQG Permit Exemption, a generator is required to maintain aisle space to allow the unobstructed movement of personnel, fire protection equipment, spill control equipment, and decontamination equipment to any area of facility operation in an emergency, unless aisle space is not needed for any of these purposes.**
