## **RCRA Inspection Report**

University of Kentucky  
355 Cooper Drive  
Lexington, Kentucky 40506-0490  
Fayette County  
EPA ID Number: KYD000830851

EPA RCRA CEI Photographs**

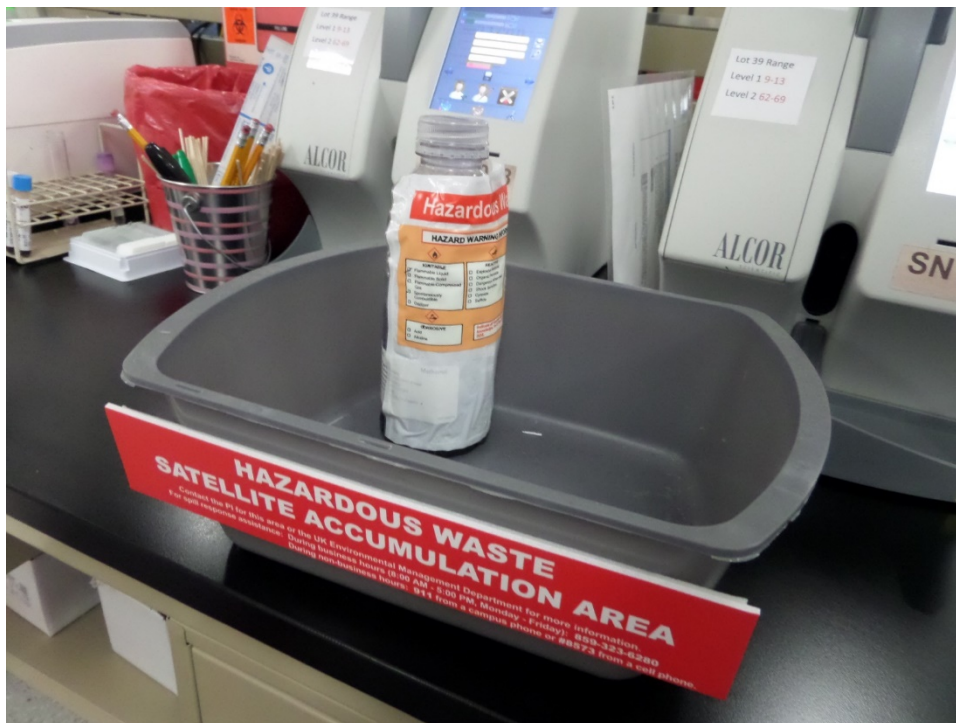
Next, the inspectors went to the Clinical Laboratory Department where they were assisted by Ms. Darlene Paskovich, UK Lab Safety Officer. In the Surgical Pathology Lab, the inspectors observed one SAA with a 16-ounce container that contained spent methanol used in slides and one SAA with six 1-gallon containers of expired reagents (Photographs 3 and 4).

*Photograph 3: Spent methanol accumulation container in the Surgical Pathology Lab of the Good Samaritan Hospital.*

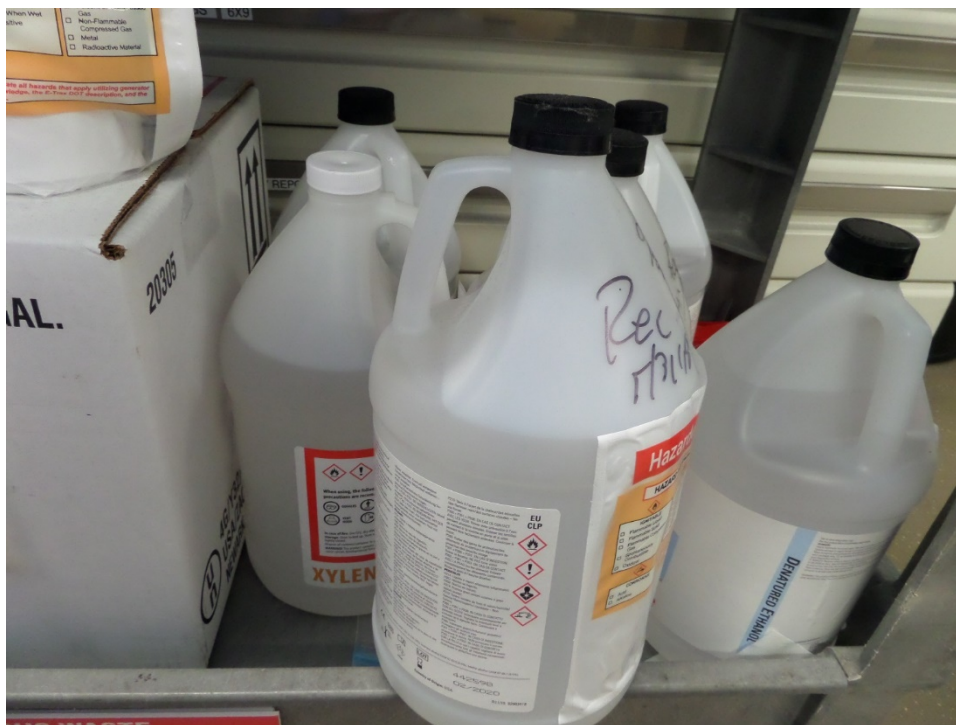
*Photograph 4: Expired reagents in the Surgical Pathology Lab of the Good Samaritan Hospital.*

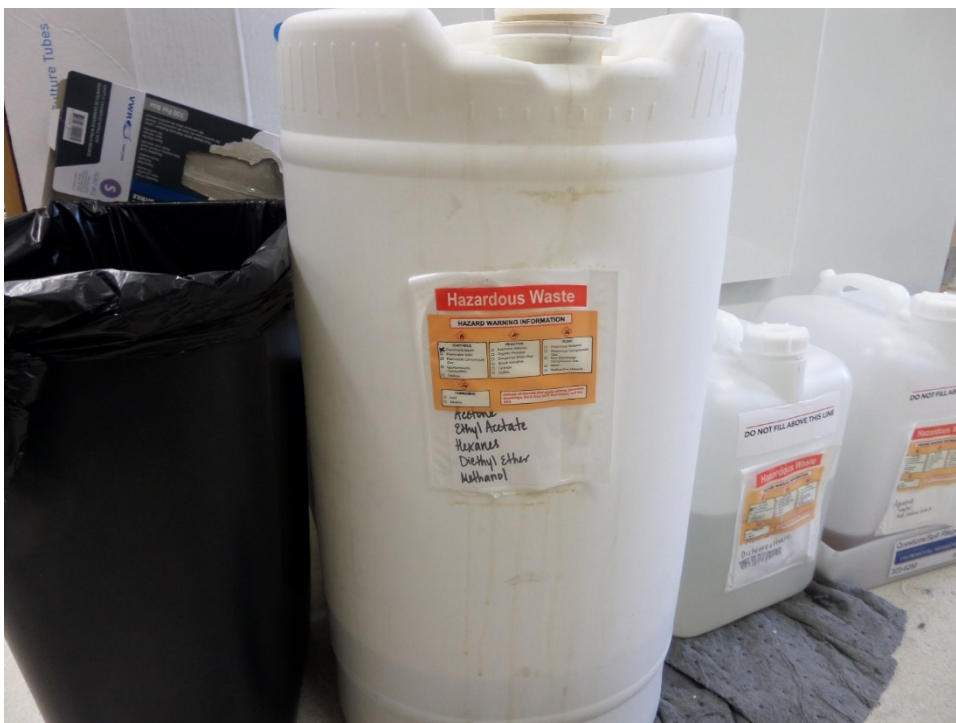
This building includes two floors of academic spaces and three floors of research laboratories. Kristie Moore, UK Safety Officer, assisted the inspectors while in the building. On the third floor, the inspectors observed a total of 14 SAAs in Rooms 306, 316, 326 and 376. The largest container observed had a 15-gallon capacity. Hazardous wastes observed in the SAAs included spent solvents from glassware cleaning activities, sample residues, spent staining solutions, chromatography residues, spent resins and instrumentation residues. All containers were properly labeled, closed, and appeared to be in good condition (Photographs 5 – 7 show some of the observed containers).

*Photograph 5: Hazardous waste containers in a SAA at the chemical laboratory section of Room 316 in the Lee T. Todd Building.*

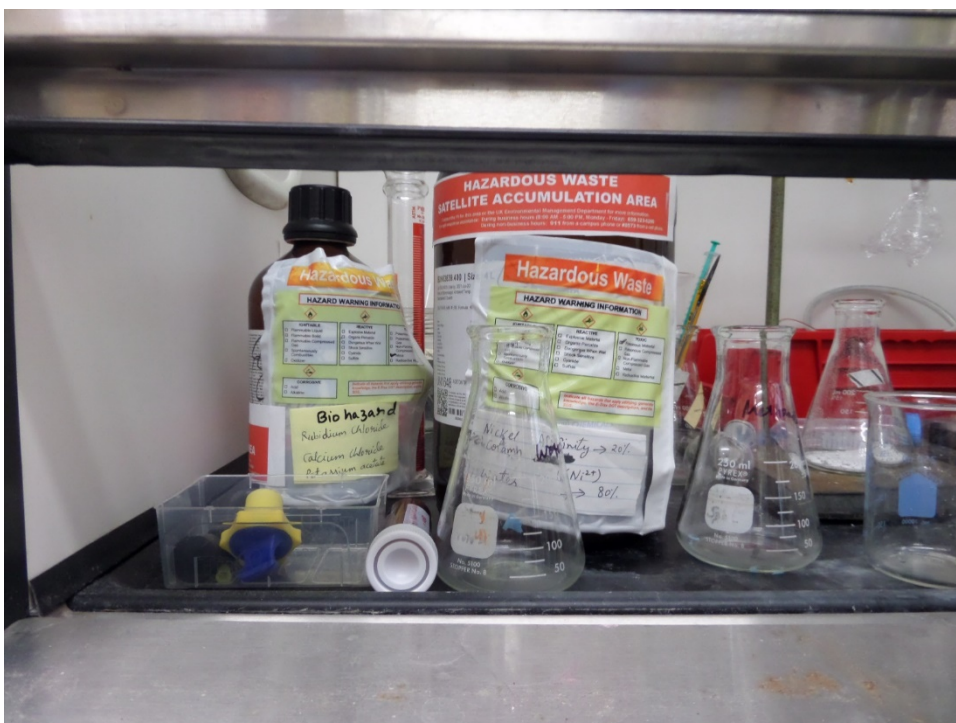
*Photograph 6: Hazardous waste containers in a SAA at the biology laboratory section of Room 316 in the Lee T. Todd Building.*

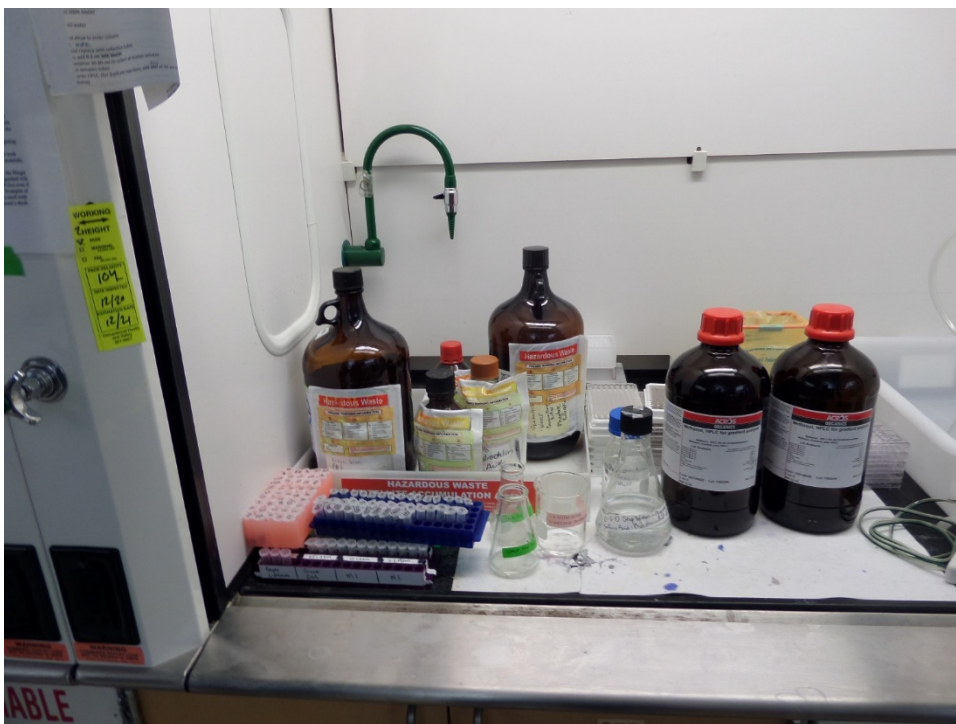
*Photograph 7: Hazardous waste containers in a SAA at the biology laboratory section of Room 376 in the Lee T. Todd Building.*

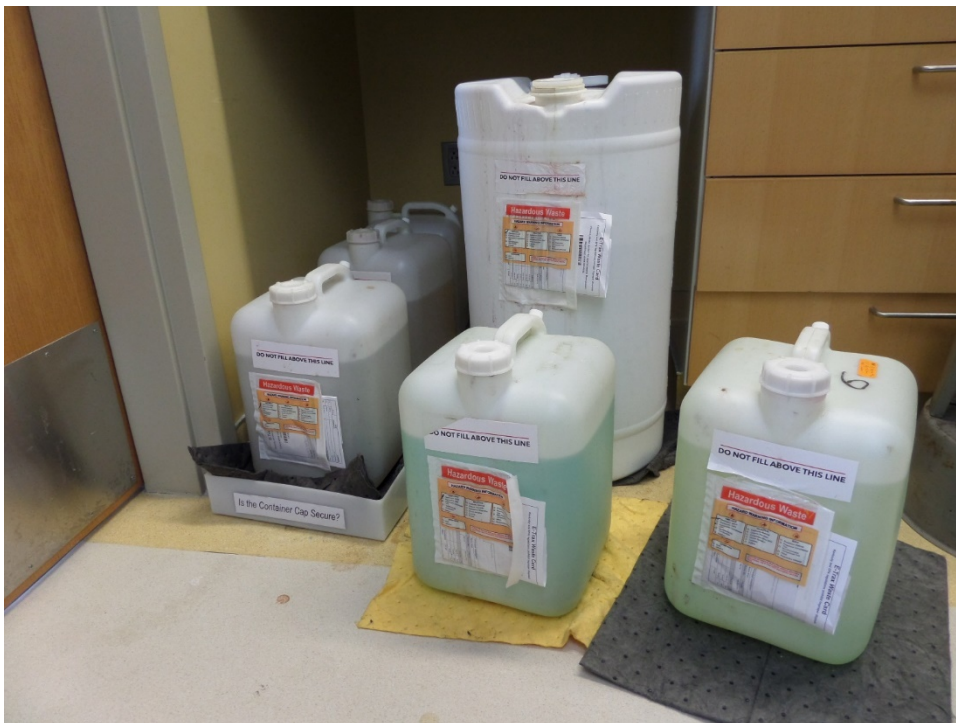
*Photograph 9: Hazardous waste containers in a SAA at the chemistry laboratory section of Room 406 in the Lee T. Todd Building.*

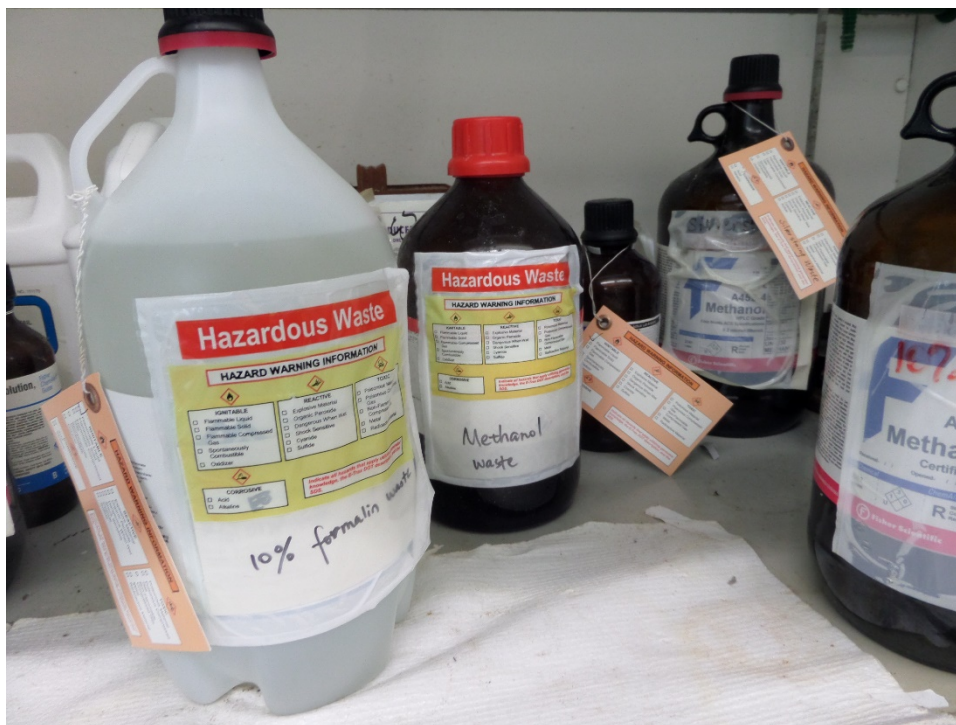
*Photograph 11: SAA in Room 106-Bench 14 at the BBSR Building.*

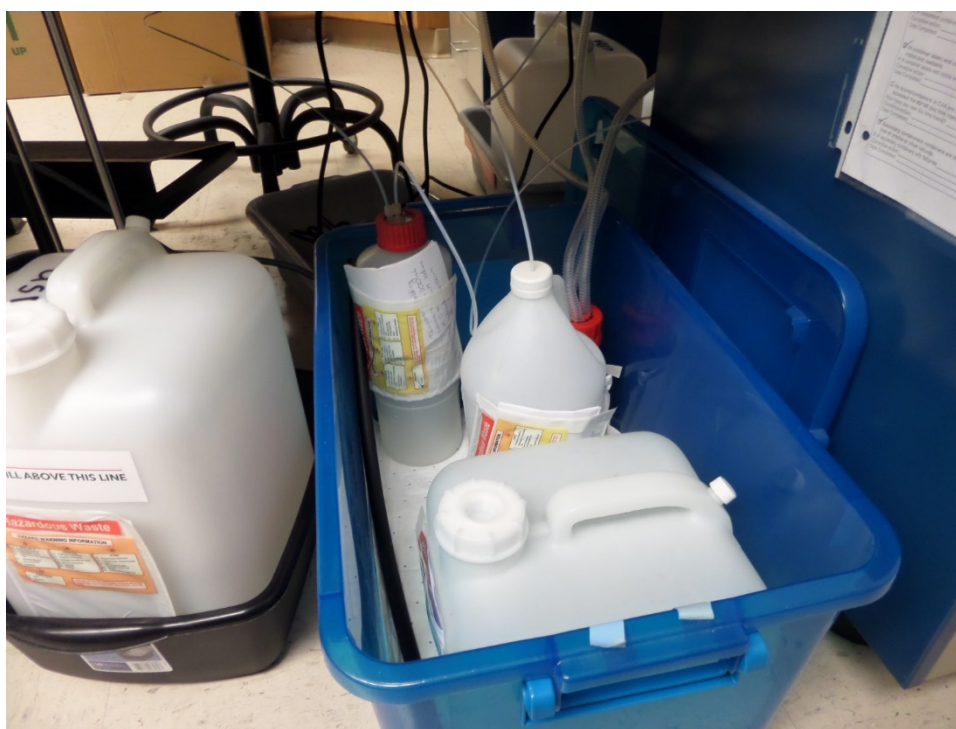
The USDA operates about 5,000 square feet of laboratory space on the building's second floor. In this area, the inspectors visited a total of nine SAAs in rooms 201, 203 and 221. Hazardous wastes observed in the SAAs included spent sodium hydroxide, spent sulfuric acid, sample residues, and spent solvents. All containers were properly labeled, closed, and appeared to be in good condition. No container with a capacity greater than 5-gallons was observed in the SAAs. (Photographs 12 and 13 show some of the observed containers).

*Photograph 12: Hazardous wastes accumulation containers observed in Room 221, operated by the USDA.*

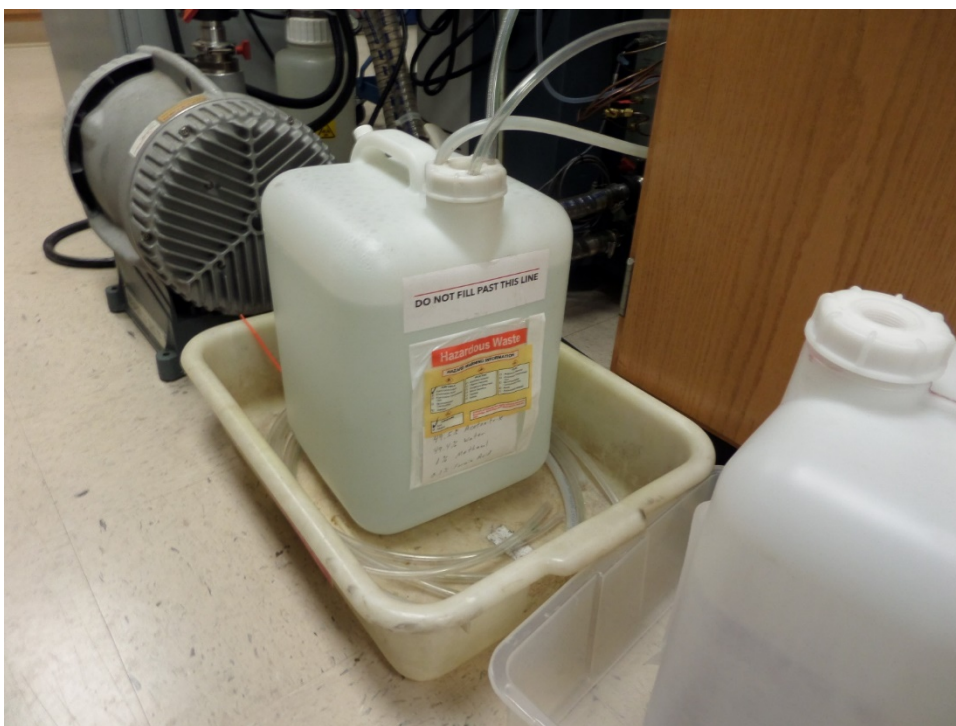
*Photograph 13: Hazardous wastes accumulation container observed in Room 201, operated by the USDA.*

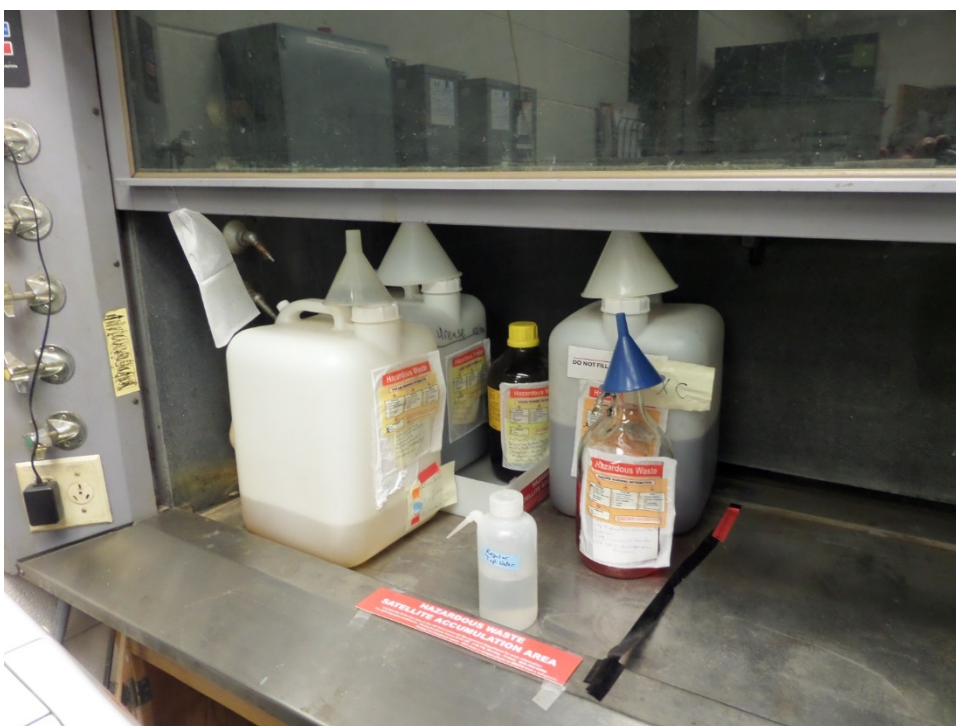
Next, the inspectors visited Room 205 (Animal Science – Molecular Biology Laboratory) and Room 107 (Soil Bio-Chemistry Laboratory), which are operated by the UK AG Department. No hazardous waste was observed in Room 205. In a vent hood in Room 107, the inspectors observed an SAA with three 5-gallon containers, one 1-gallon container and one 1-liter container. Hazardous wastes observed in the room included spent potash permanganate, reaction byproducts, spent methanol and spent stock solutions. The containers were properly labeled, closed, and appeared to be in good condition. (Photograph 14)

*Photograph 14: Hazardous waste accumulation containers in a vent hood in Room 107.*

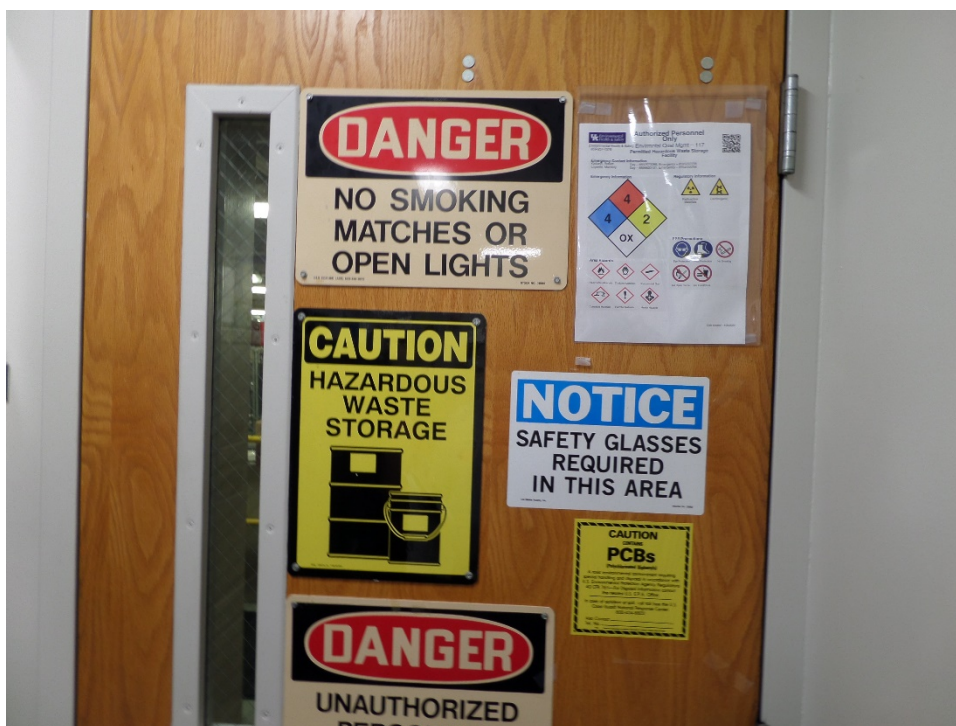
The EQMC has an electronic security system that includes access control doors and an alarm system with fire sensors, combustion gas sensors, CO<sub>2</sub> sensors and motion detectors. The facility has 11 distinct storage bays/rooms for management of waste stream according to compatibility. At the time of the inspection, the EQMC's floor appeared to be in good condition and properly sealed. All hazardous waste containers were properly labeled, dated, closed and in good condition. The oldest containers observed (two phosphorus trifluoride cylinders) were dated 9/15/2020. The following table includes a summary of the observations made at each storage room/bay in the EQMC and includes the storage capacity (in gallons and 55-gallon container equivalent) established in the permit for each area. (Photographs 15 – 20)

*Photograph 15: EQMC's access door to the hazardous waste storage area.*

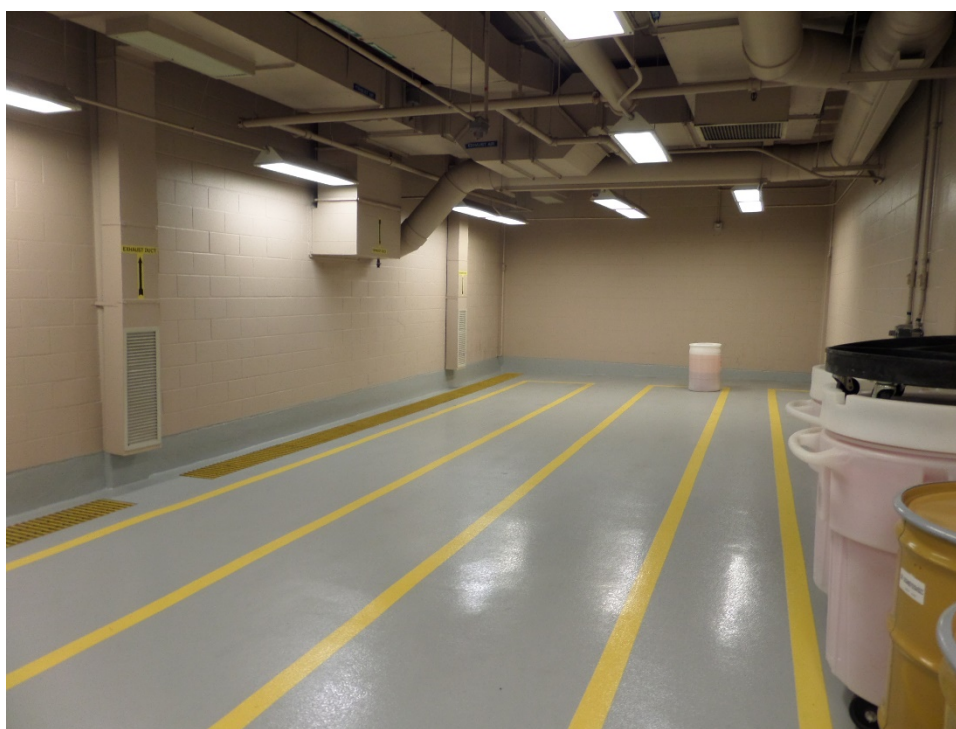
| Area Designation | Maximum Capacity (Equivalent in 55-gallon containers) | Inspection Observations |
|---|---|---|
| Flammables Storage Room 115 | 7150 Gallons (130) | Two 55-gallon containers of clinical laboratory waste, dated 6/24/2021<br>One 30-gallon container of laboratory waste, dated 6/28/2021 |

*Photograph 16: Partial view of the Flammables Storage Room 115.*

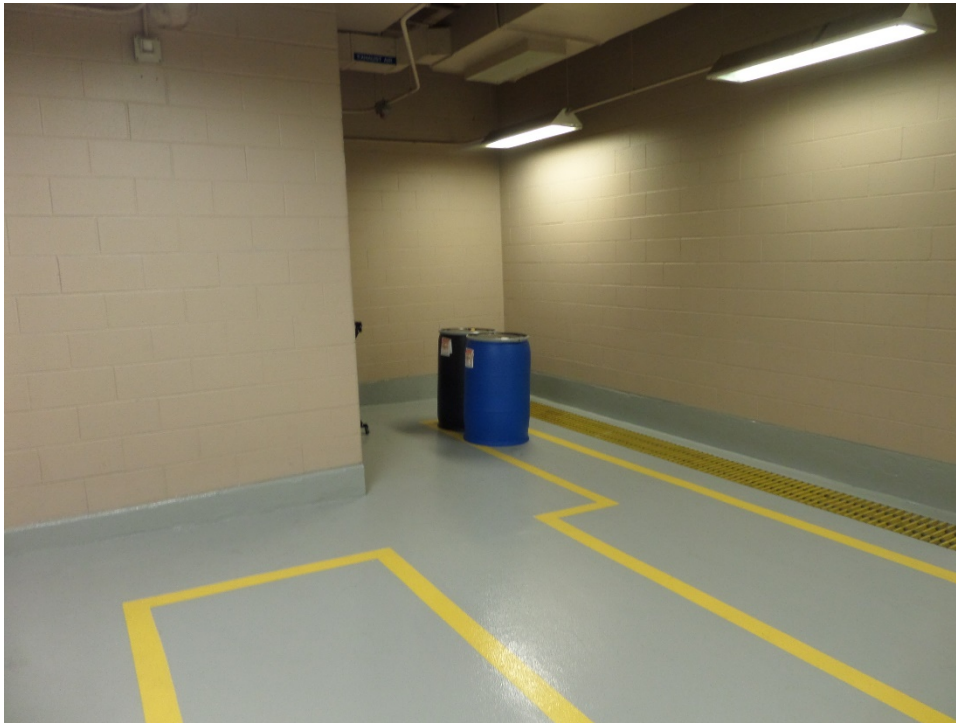
*Photograph 17: Partial view of the Flammables Storage Room 115.*

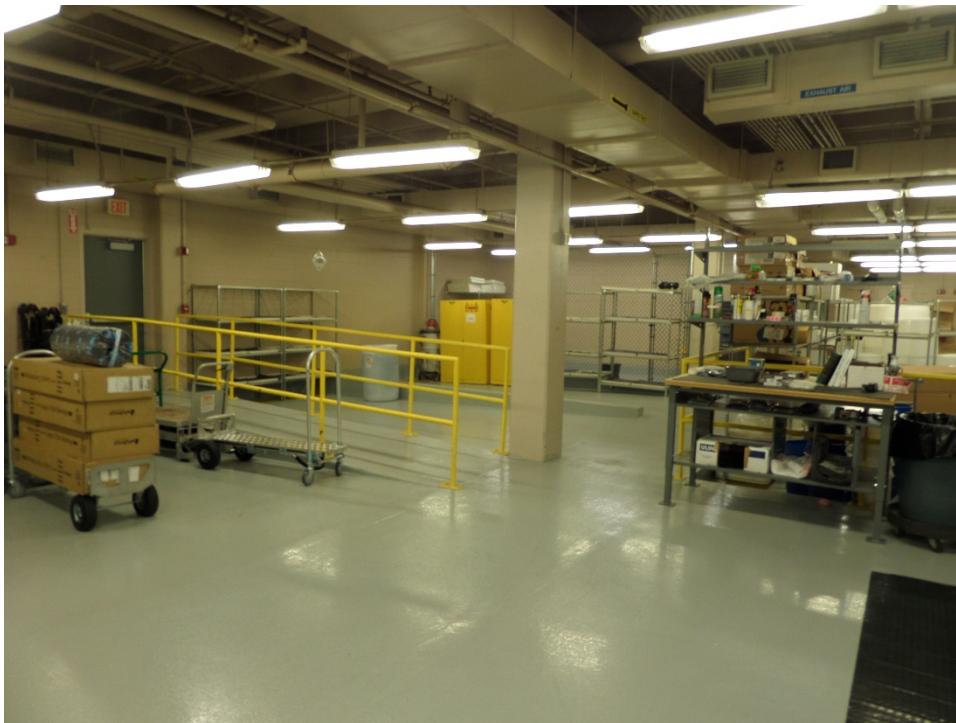
*Photograph 18: General of the EQMC's RCRA permitted area.*

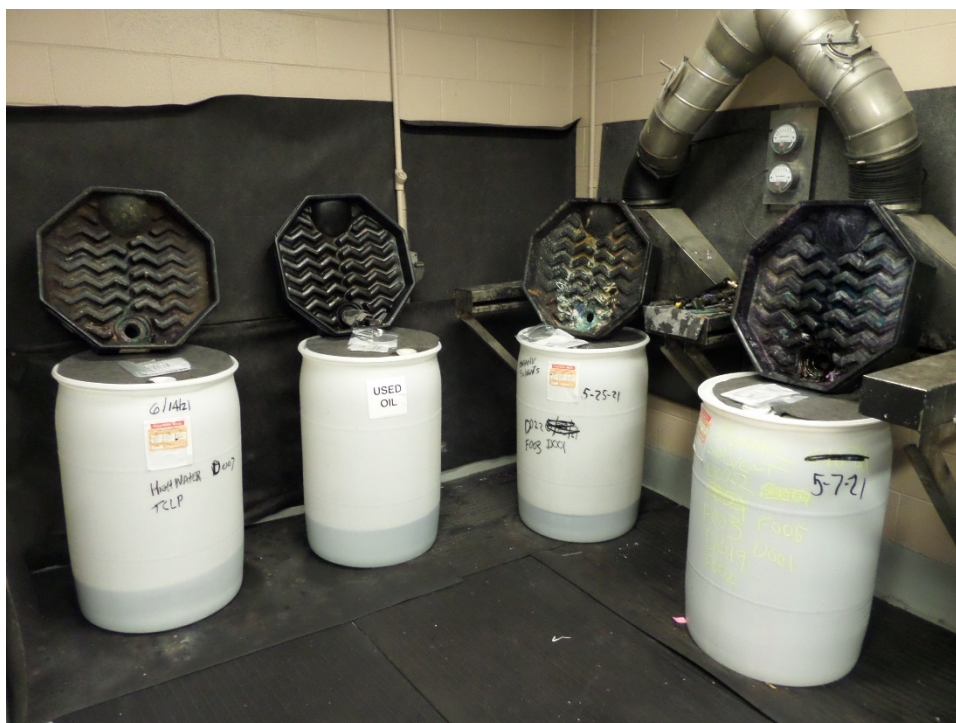
| Area Designation | Maximum Capacity (Equivalent in 55-gallon containers) | Inspection Observations |
|---|---|---|
| Bulking Room 120 | 500 Gallons (9.09) | Three 55-gallon containers of laboratory waste, oldest dated 5/7/2021. Dated with oldest date of waste added to the bulking container.<br>One 55-gallon used oil container (Photograph 20) |

Photograph 20: Consolidation containers in the Bulking Room 120.
