Resource Conservation and Recovery Act (RCRA)
 Compliance Evaluation Inspection

Facility Name:	Neolpharma, Inc. – Caguas		
EPA ID Number:	PRD090378225		
Date of Inspection:	August 9, 2023		
Generator Status in Record:	Large Quantity Generator (LQG)		
Generator Status at the time of inspection:	LQG		
RCRA Permitted:	No		
Basis for Inspection:	Core Program		
Corrective Action:	No		
Project ID	CEPD-RCRA-23-0433		
Potential EJ Concern	Yes. 8 EJ Indexes above the 80% USA Percentile. (See Appendix C)		
Potential Flood Prone Area	Yes. The Facility boundaries are within the 100-Year Flood Zone layer (See Appendix D)		
Facility Physical Location: (Municipality, PR, zip code)	99 Jardines St Caguas, PR 00725		
Geographical Coordinates:	18.240619, -66.017865		
Facility Owner:	Neolpharma Inc	787-286-4000	
	99 Jardines St Caguas, PR 00725		
Facility Operator:	Neolpharma Inc	787-286-4000	
	99 Jardines St Caguas, PR 00725		
NAICS:	325412; Pharmaceutical Preparation Manufacturing		
SIC:	2834; Pharmaceutical Preparations

Resource Conservation and Recovery Act
Neolpharma, Inc. – Caguas
PRD090378225

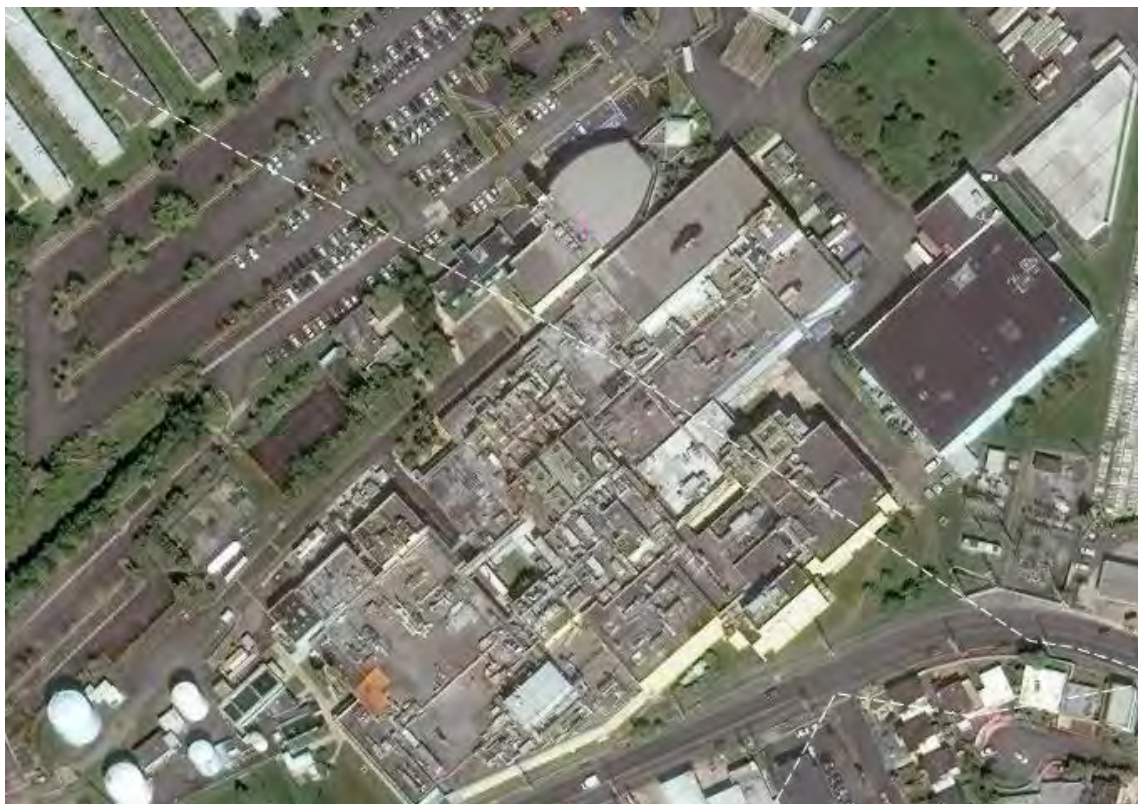
Figure 1: Neolpharma, Inc. Aerial Photograph

The Facility is located at 99 Jardines Street, Caguas, Puerto Rico, 00725. See aerial photograph (Figure 1) below for reference.

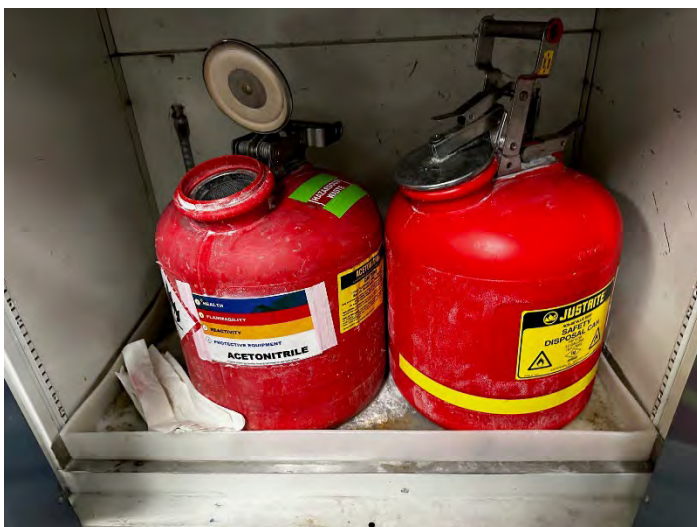
At the time of the inspection, the Analytical Laboratory #1 SAA had 2 (two) 5-gallon hazardous waste containers of acetonitrile and 2 (two) 5-gallon hazardous waste containers of methanol. One (1) of the containers' storing acetonitrile was found open (See Appendix A, Photograph 1). At that time, laboratory representatives were not adding or removing waste from the container.

Photograph 1: Open container of acetonitrile at the Analytical Laboratory #1 SAA.

REGULATORY, STATUTORY OR PERMIT REFERENCE	FIELD OBSERVATION
RCRA Subtitle C – Hazardous Waste	
40 CFR § Part 262.15(a)(4): A container holding hazardous waste must be closed at all times during accumulation, except: when adding, removing, or consolidating waste; or when temporary venting of a container is necessary.	At the time of the inspection, the Analytical Laboratory #1 SAA had an open container of acetonitrile. See Appendix A, Photograph 1.
40 CFR § Part 262.15(a)(6)(ii): A generator must remove the excess from the satellite accumulation area within three consecutive calendar days.	At the time of the inspection, the Raw Material Laboratory #4 SAA had a pyridine container dated August 3, 2023. The inspection was conducted on August 9, 2023. See Appendix A, Photograph 3.
40 CFR § Part 262.17(a)(1)(v): At least weekly, the large quantity generator must inspect central accumulation areas.	CAA #1 The following table summarizes weekly inspections that were not recorded in the checklist for calendar years

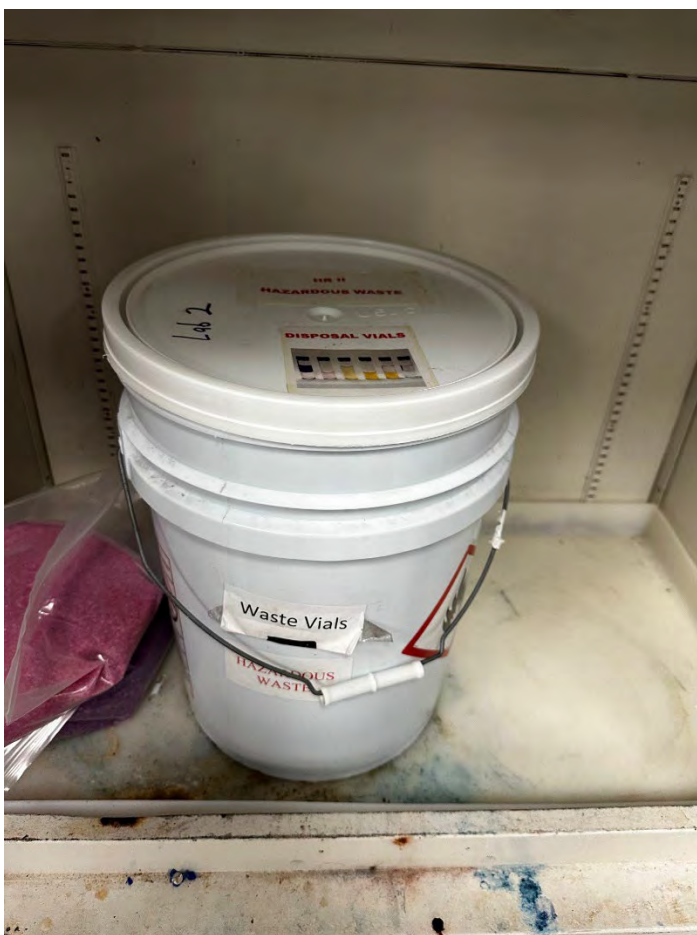
The Analytical Laboratory #2 SAA had a 5-gallon hazardous waste container of acetonitrile, a 5-gallon hazardous waste container of methanol and a bucket of waste vials generated from high performance liquid chromatography (HPLC) (See Appendix A, Photograph 2).

Photograph 2: Waste vials of HPLC at the Analytical Laboratory #2 SAA.

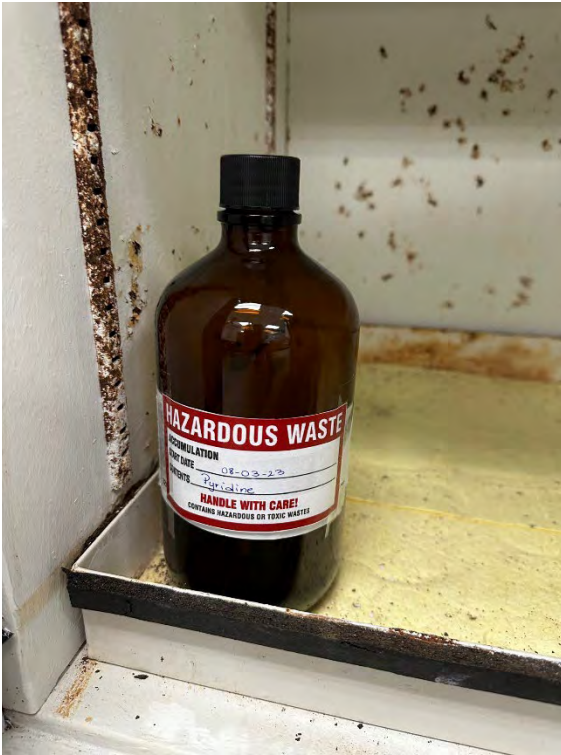
At the Raw Material Laboratory #4 SAA, there was a hazardous waste container of pyridine dated August 3, 2023 (See Appendix A, Photograph 3). Under RCRA, a generator must remove the excess from the SAA within three consecutive calendar days to a CAA or to an off-site designated facility. The SAA was also storing a 5-gallon hazardous waste container of acetonitrile and a 5-gallon hazardous waste container of methanol.

Photograph 3: Container of pyridine dated August 3, 2023 at the Raw Material Laboratory #4 SAA.

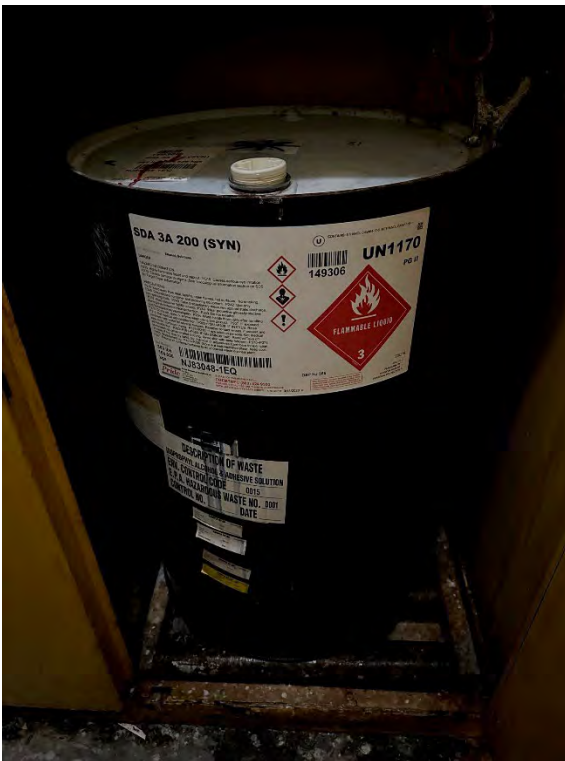
At the Manufacturing SAA, there was a 55-gallon drum of adhesive solution and contaminated isopropyl alcohol (IPA) (See Appendix A, Photograph 4).

Photograph 4: 55-gallon drum of adhesive and contaminated IPA at the Manufacturing SAA.

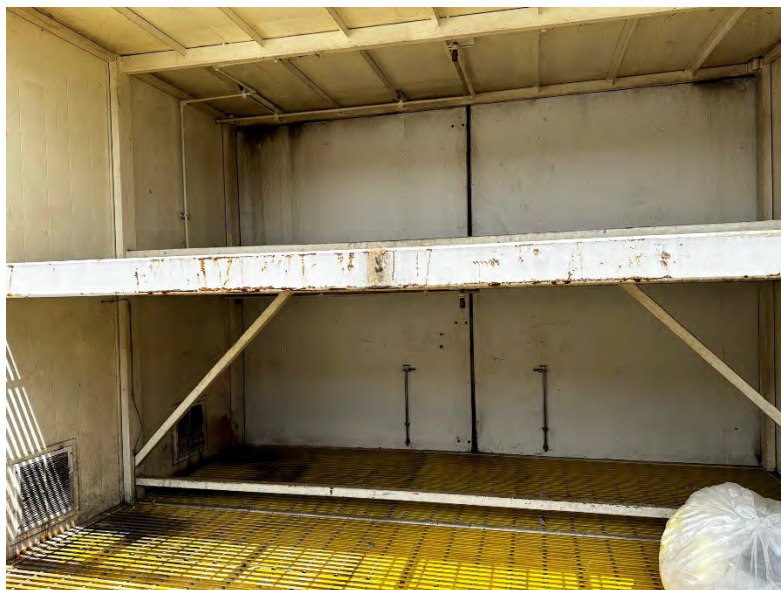
No hazardous waste was being stored due to a pickup several days prior to the inspection (See Appendix A, Photograph 5).

Photograph 5: Overview of CAA #1 with no hazardous waste.

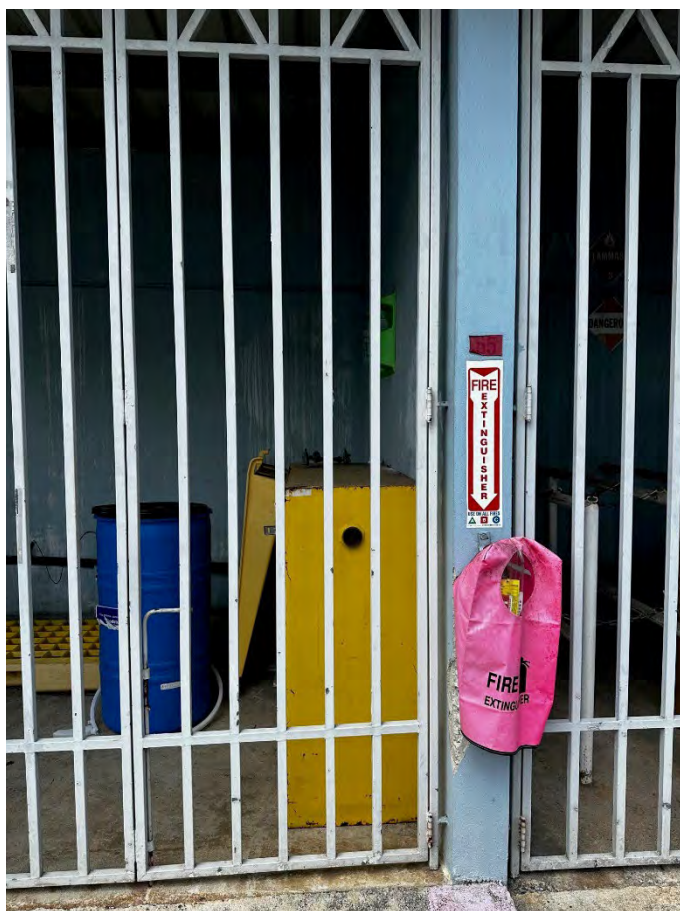
No hazardous waste was being stored due to a pickup several days prior to the inspection (See Appendix A, Photograph 6).

Photograph 6: Overview of CAA #2 with no hazardous waste.

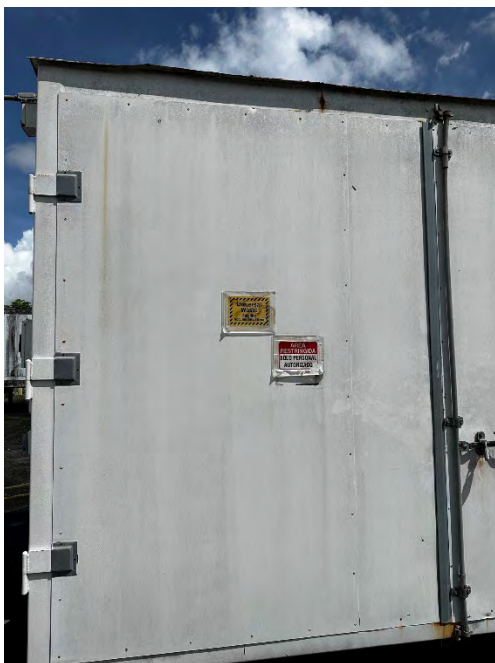
The Facility has a dedicated area solely for universal waste, specifically used fluorescent bulbs and batteries located within the premises in a shipping-type metal container (See Appendix A, Photograph 7). At the time of the inspection, 3 (three) batteries were being stored (See Appendix A, Photograph 8).

Photograph 7: UW Storage Area metal container.

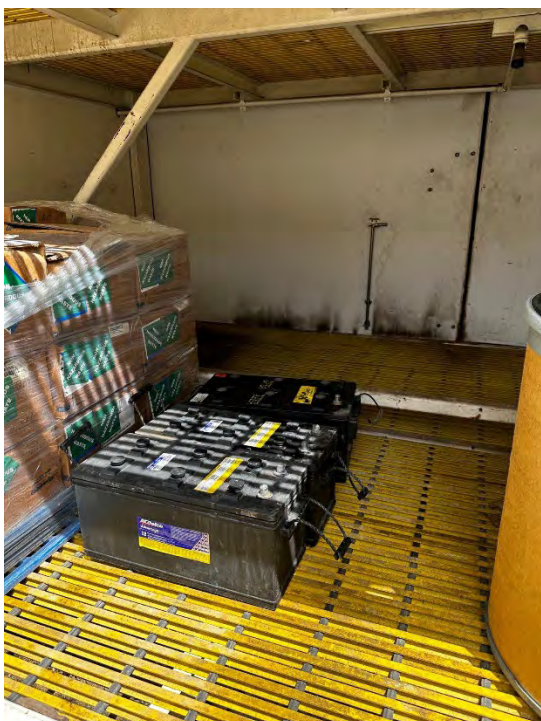
Photograph 8: UW batteries at the UW Storage Area.

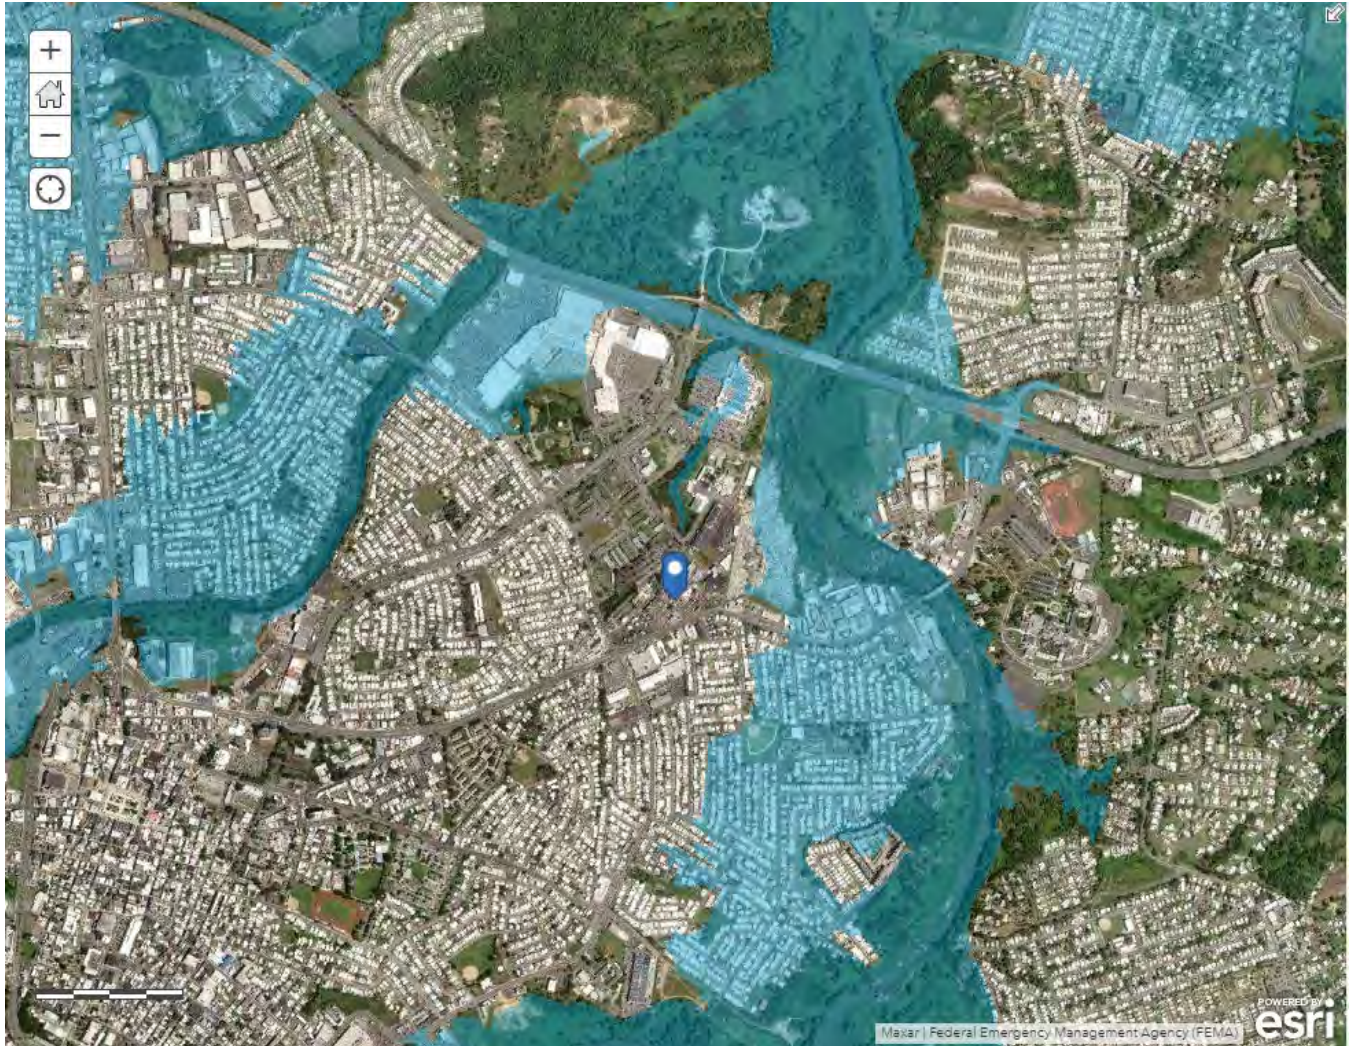
Federal Emergency Management Agency (FEMA) 100 Year Flood Zones and EPA's Region 2 Composite Flood Risk Layer

The Facility boundaries are within the 100-Year Flood Zones FEMA Layer.
