NEW ENGLAND REGIONAL LABORATORY  
NORTH CHELMSFORD, MA 01863

**Subject:** Inspection Report  
Compliance Sampling Inspection  
Tender Corporation d/b/a Adventure Ready Brands™

- A. Facility Name: Tender Corporation d/b/a Adventure Ready Brands™
- B. Facility Location: 944 Industrial Park Road, Littleton, NH 03561
- C. Facility Contact(s): John Gaulin, Chief Operating Officer  
[jgaulin@adventurereadybrands.com](mailto:jgaulin@adventurereadybrands.com) (800) 258- 4696,  
Patience Marsh, QAIRA Manager,  
Anastasia Keats, QC Manager
- D. National Pollutant Discharge Elimination System ("NPDES") ID Number: NHPIU0014

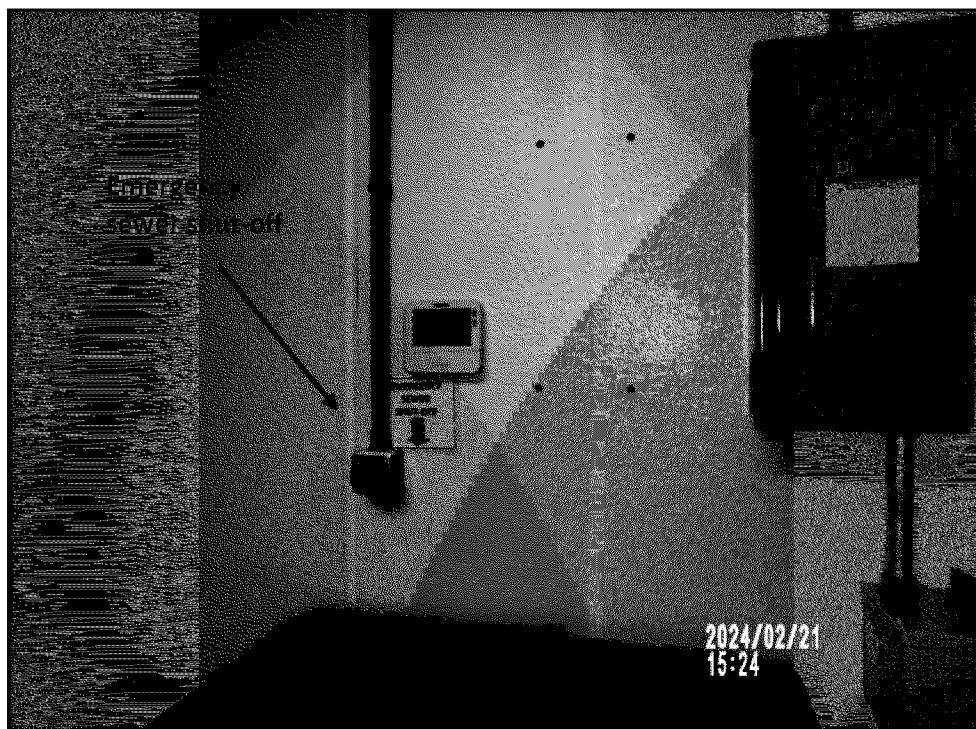
At the pretreatment system, the EPA Inspection Team observed the emergency stop for the automatic sump-pump (Photo 1) and the 300 and 1,000-gallon pharmaceutical mix tanks. The EPA Inspection Team observed two floor drains, one on the upper level, and one on the lower level beneath the tanks, both of which lead to the sump. Ms. Marsh and Ms. Keats showed the EPA Inspection Team the pH neutralization unit which is attached to the sump. They explained that a digital meter attached to the pretreatment system depicts flow and pH. The station also has a paper flow meter attached to the pretreatment system (Photo 2). The EPA Inspection Team observed a valve, labeled “Outfall 1”, where Mr. Gaulin said the facility samples treated wastewater is sampled (Photo 4).

**Photo 1:** Emergency shut off button located in the facility's pretreatment room.

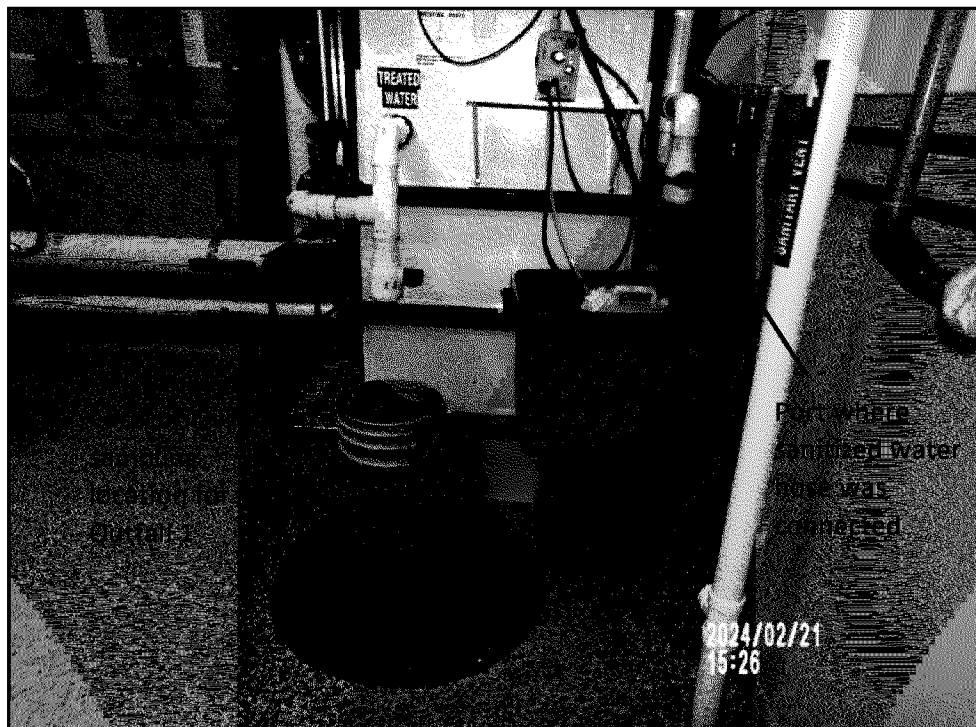
The EPA Inspection Team began sampling set up at approximately 14:34 at “Outfall 1”. To trigger the batch discharge from the pretreatment system Ms. Marsh fed a sanitized water line hose to a port in the “wastewater” pipeline (Photo 3). Samples were collected from the “Outfall 1” valve on the “Treated Water” pipeline. Prior to sample collection, the valve was opened and allowed to run for proximately 30 seconds into a catch bucket to purge the line. Grab and duplicate sample collection occurred at 15:00. Details of the sampling event can be found in Section VII: “Wastewater Sampling”.

**Photo 3.** The port where the sanitized water hose was connected to is located on the right-hand side, on the “Wastewater” pipe. The categorical sampling location for “Outfall 1” is located on the left over the catch bucket.
