## Clean Water Act Section 404: Site Visit/Case Development

| Site Name | Brian Arico Property | | | | |

CWA 404 Inspection  
Brian Arico Property  
Bog Hollow Road  
Wassaic, NY

April 16, 2021

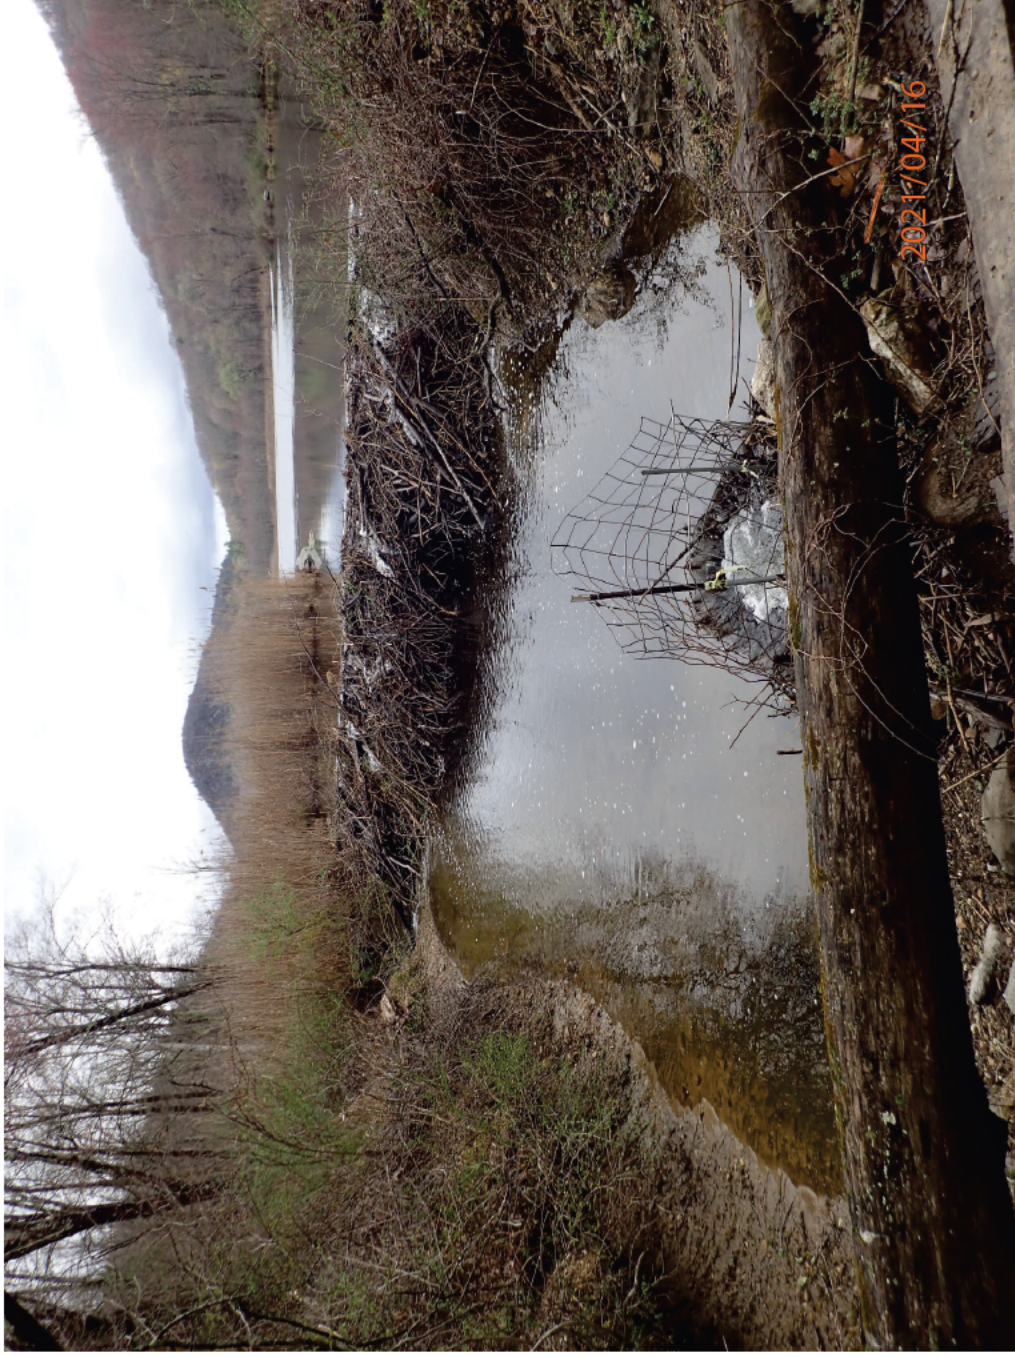
**Date:** 4/16/2016  
**Time:** 11:02 AM  
**Photographer:** SSA  
**Photo ID:** 1 – P4160132

Bog Hollow Creek looking  
upstream toward northern  
pond; photo taken from bridge

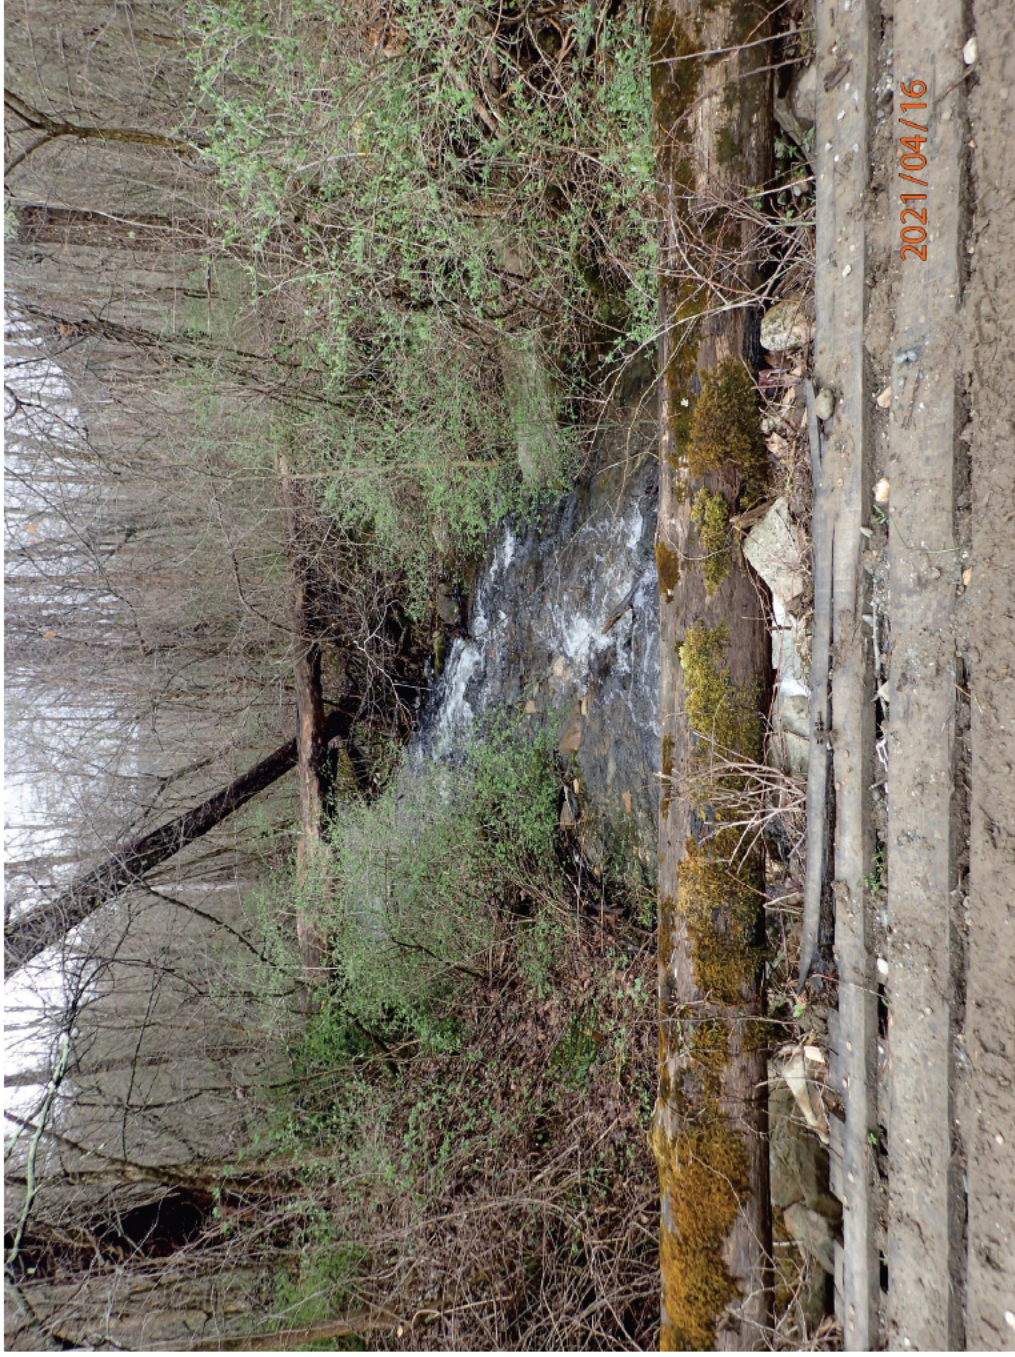
**Date:** 4/16/2016  
**Time:** 11:02 AM  
**Photographer:** SSA  
**Photo ID:** 2 – P4160133

Bog Hollow Creek looking downstream; photo taken from bridge

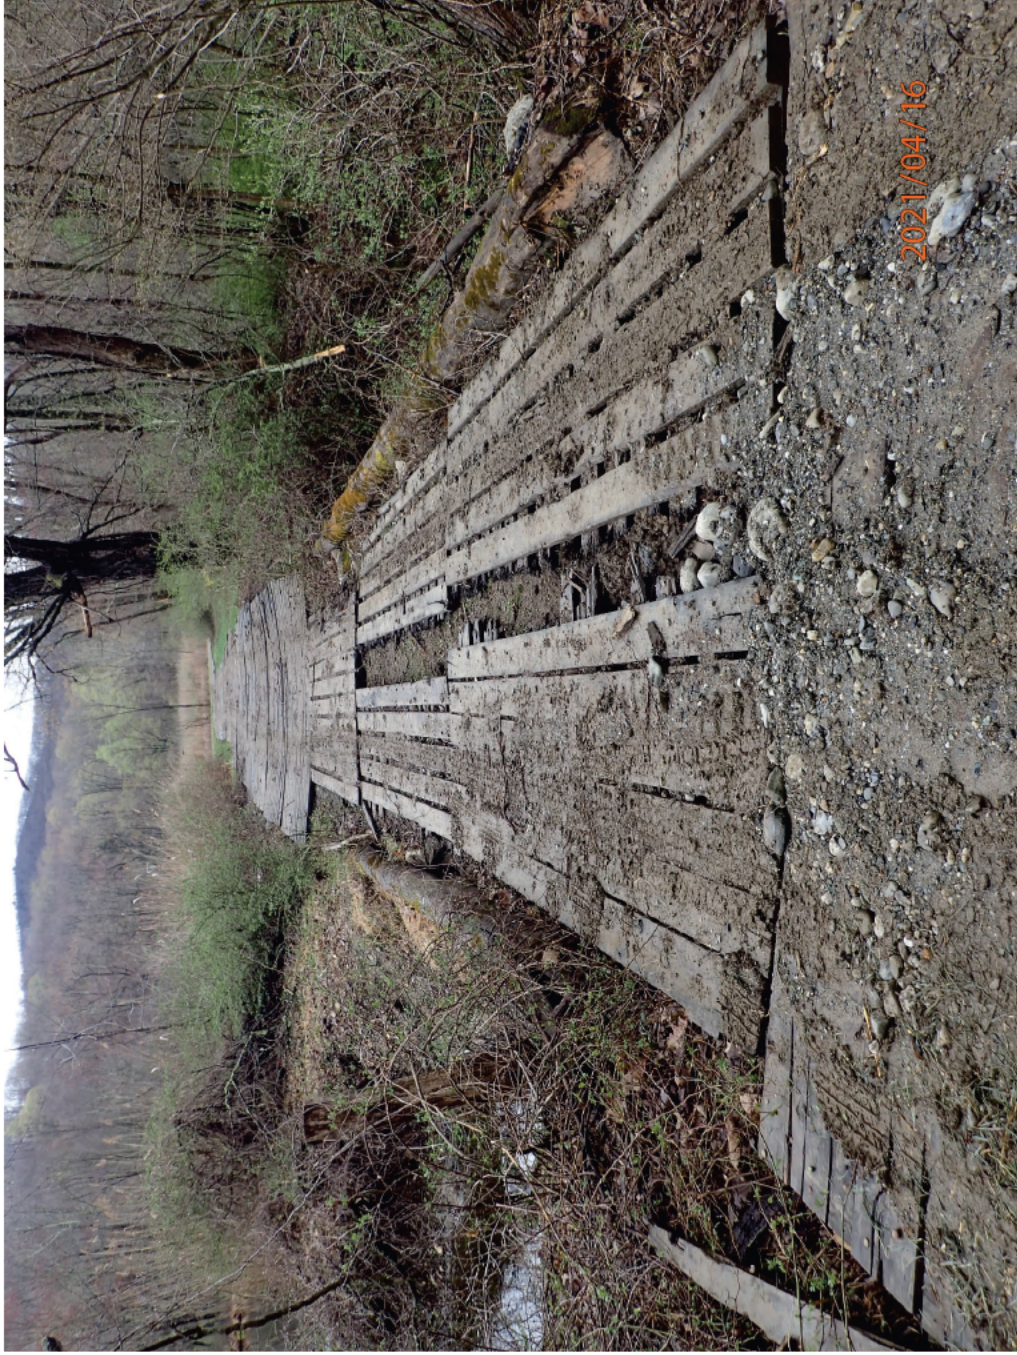
**Date:** 4/16/2016  
**Time:** 11:02 AM  
**Photographer:** SSA  
**Photo ID:** 3 – P4160134

**Description:**  
Bridge over Bog Hollow Creek

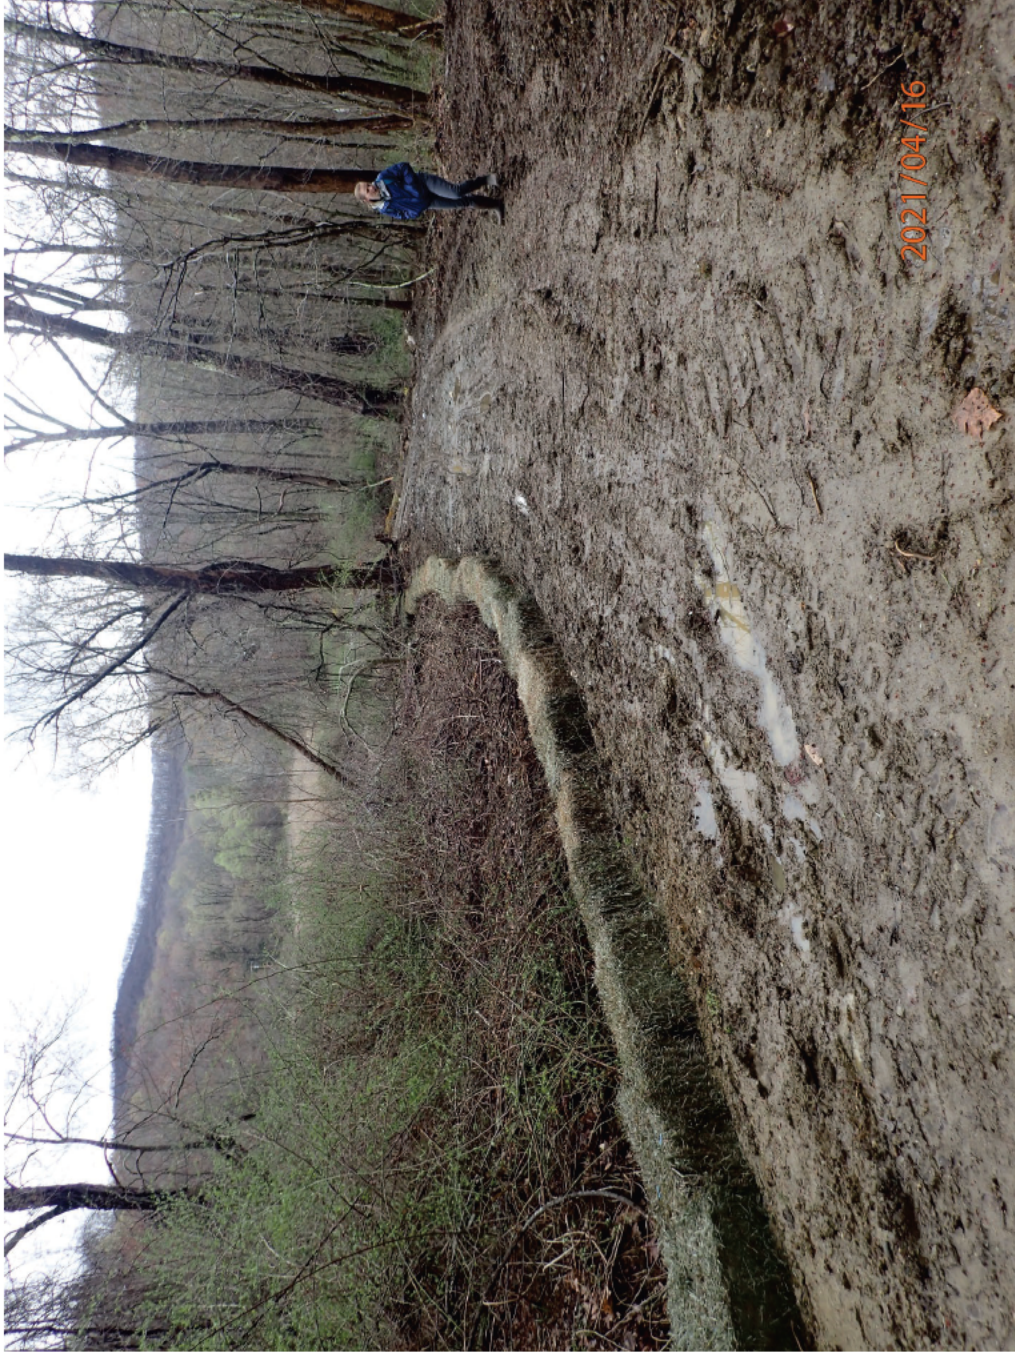
**Date:** 4/16/2016  
**Time:** 11:07 AM  
**Photographer:** SSA  
**Photo ID:** 4 – P4160135

**Description:**  
Fresh straw bales at edge of  
access road west of bridge

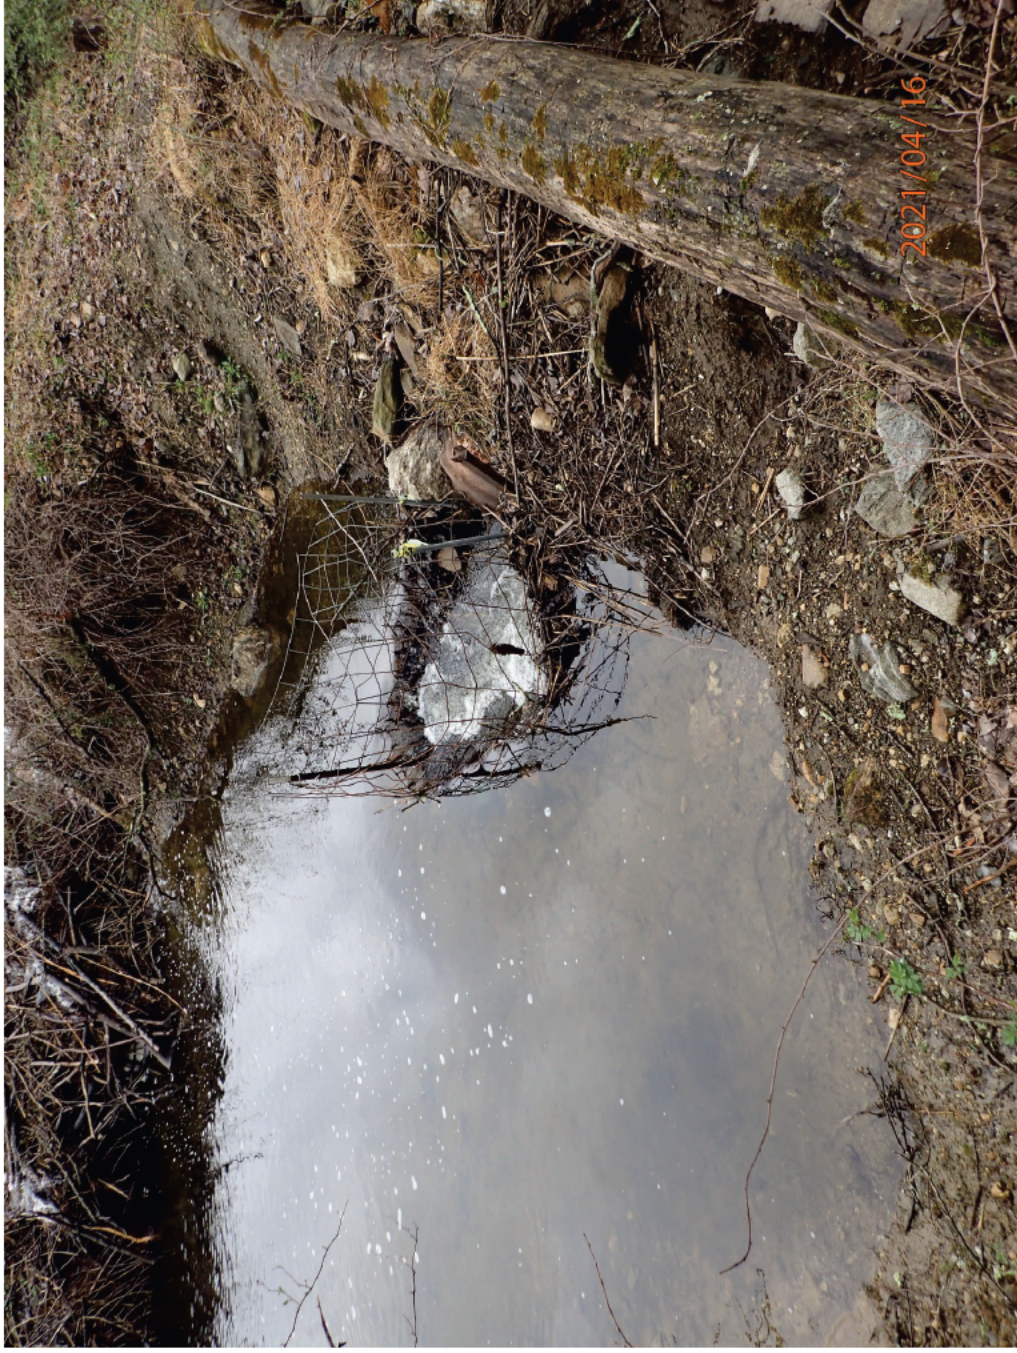
**Date:** 4/16/2016  
**Time:** 11:10 AM  
**Photographer:** SSA  
**Photo ID:** 6 – P4160137

**Description:**  
Upstream culvert; Bog Hollow  
Creek

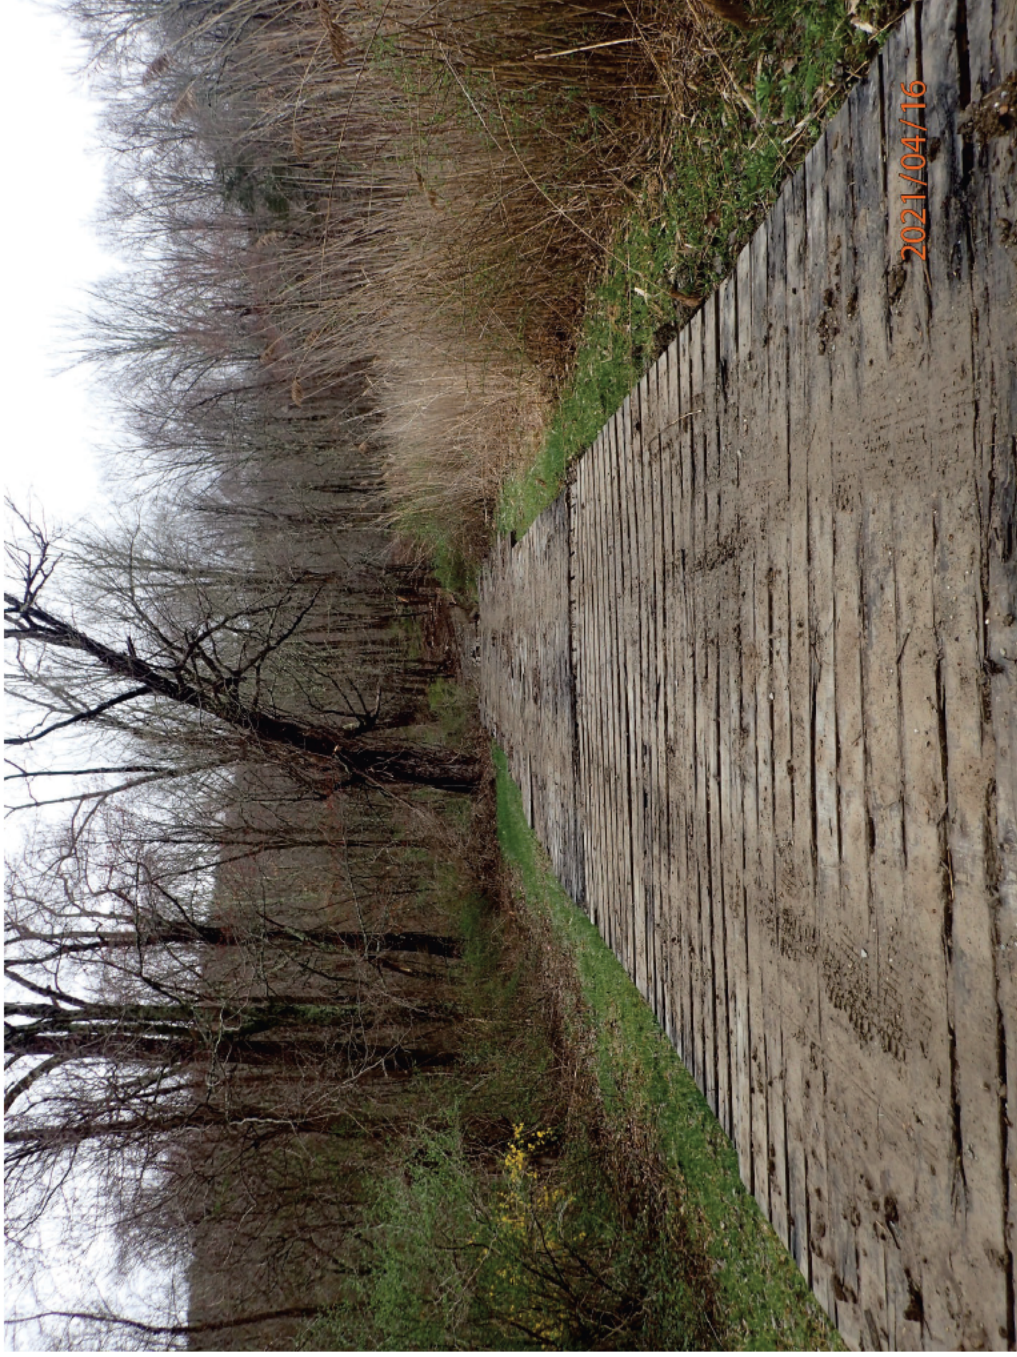
**Date:** 4/16/2016  
**Time:** 11:21 AM  
**Photographer:** SSA  
**Photo ID:** 7 – P4160138

**Description:**  
Timber mat access road; Photo taken facing west towards bridge (in background)

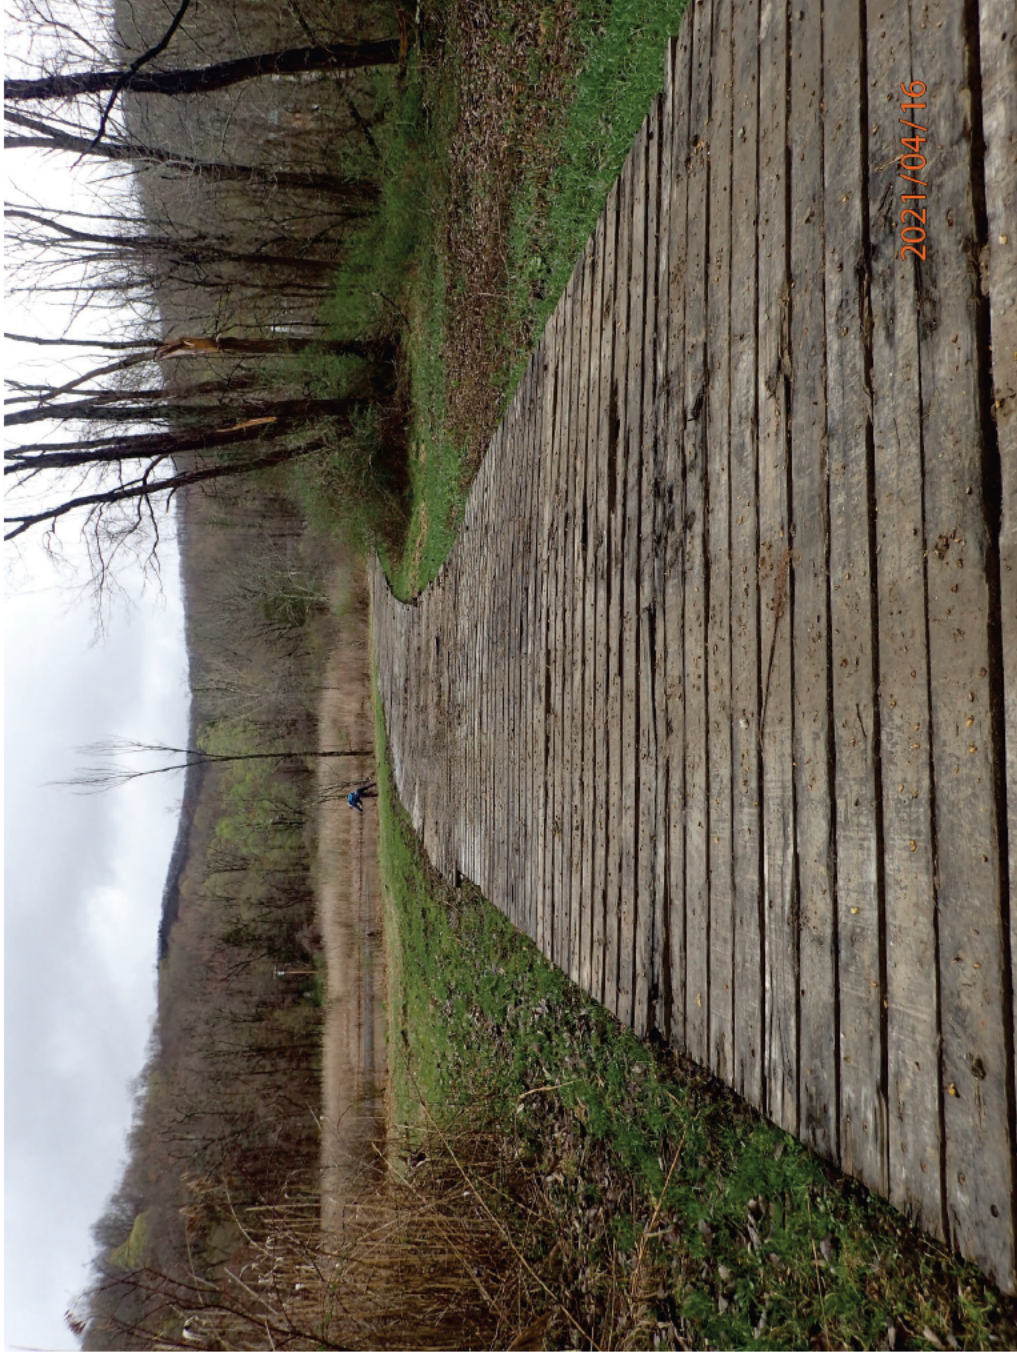
**Date:** 4/16/2016  
**Time:** 11:21 AM  
**Photographer:** SSA  
**Photo ID:** 8 – P4160139  
**Description:**  
Timber mat access road; Photo taken facing east towards Bog Hollow Road

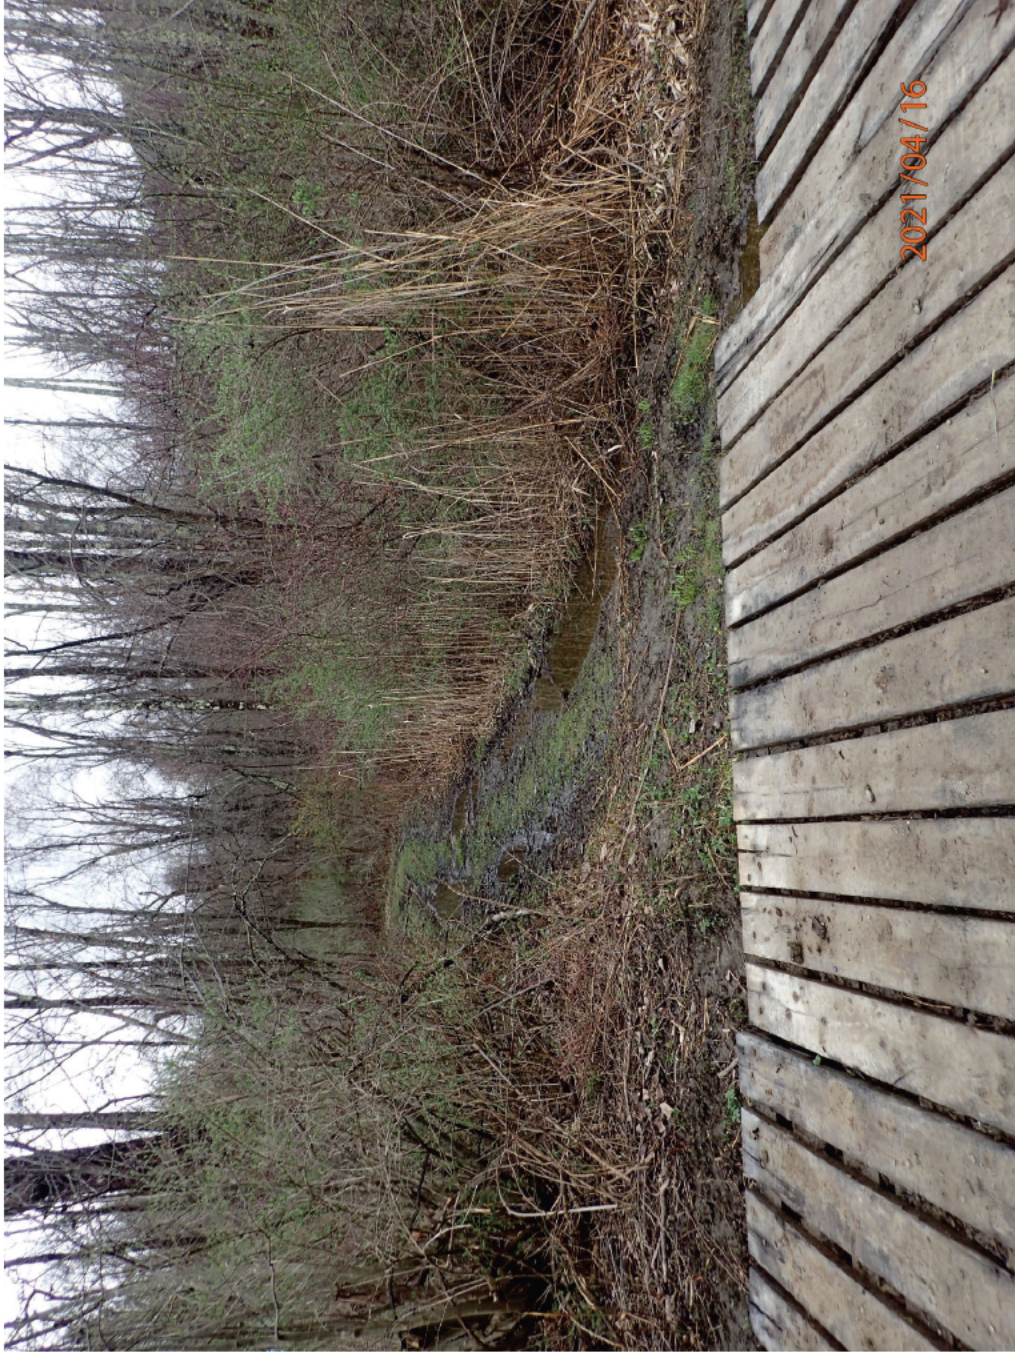
**Date:** 4/16/2016  
**Time:** 11:32 AM  
**Photographer:** SSA  
**Photo ID:** 9 – P4160140

Trail off of main timber mat  
access road

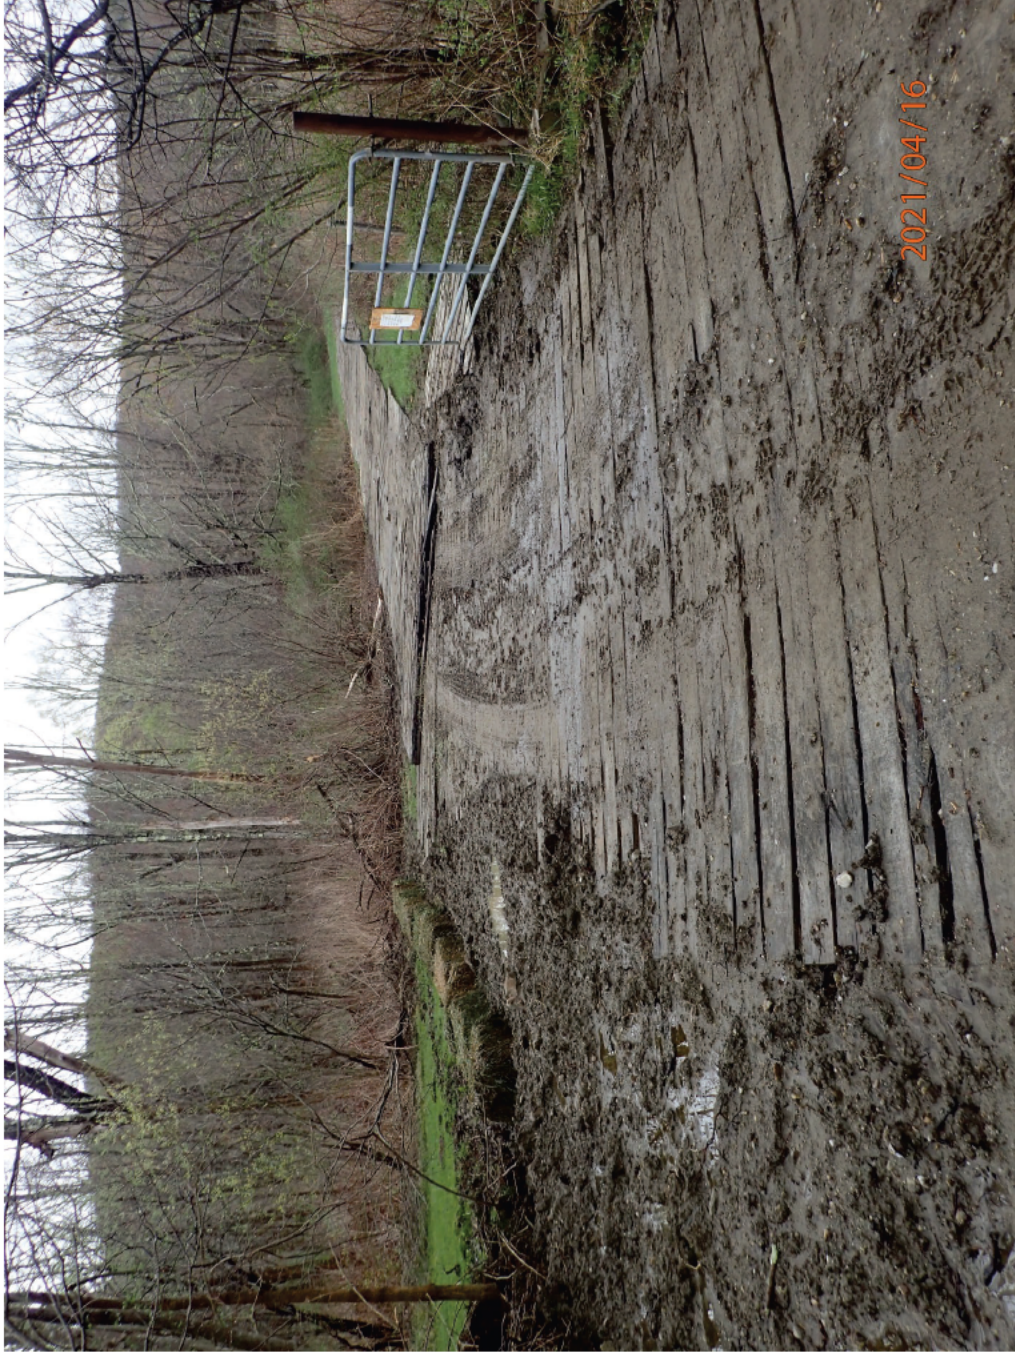
**Date:** 4/16/2016  
**Time:** 11:34 AM  
**Photographer:** SSA  
**Photo ID:** 10 -P4160141

| <p>EPA walked the length of the access road from the entrance at Bog Hollow Road to the bridge over Bog Hollow Brook and took photographs of the access road, areas adjacent to the access road, and stabilization/erosion control measures along the road. Timber matting had been placed on top of the 700+ feet of existing trail from the rock-stabilized entrance to the bridge. Presumed wetland areas were observed on the northern side of the access road near the northern pond. Vegetation on this side of the access road included common reed (<i>Phragmites australis</i>)(FACW) and <i>Alnus serrulata</i> (OBL). Vegetation on the southern side of the access road included Morrow's honeysuckle (<i>Lonicera morrowii</i>)(FACU), multiflora rose (<i>Rosa multiflora</i>), and yellow archangel (<i>Lamium galeobdolon</i>)(presumed UPL). Fresh straw bales had been placed along portions of the road. Grass had been planted in disturbed areas along the access road; however, some areas were still in need of stabilization.</p> | | | |

Soil disturbance adjacent to  
timber mat access road

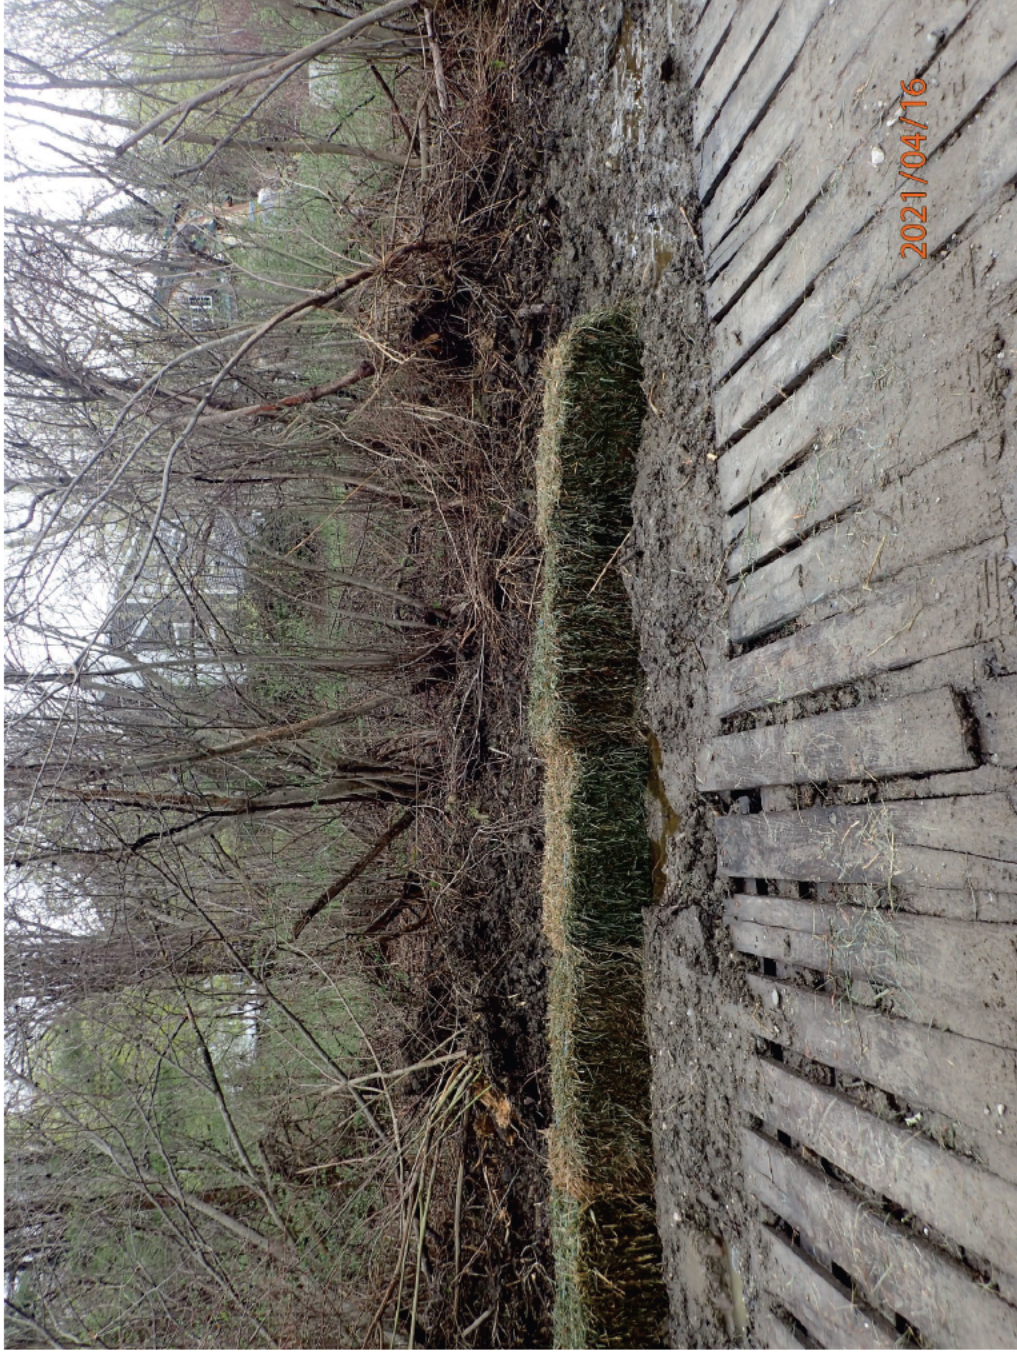
**Date:** 4/16/2016  
**Time:** 11:34 AM  
**Photographer:** SSA  
**Photo ID:** 11 -P4160142

Soil disturbance adjacent to  
timber mat access road

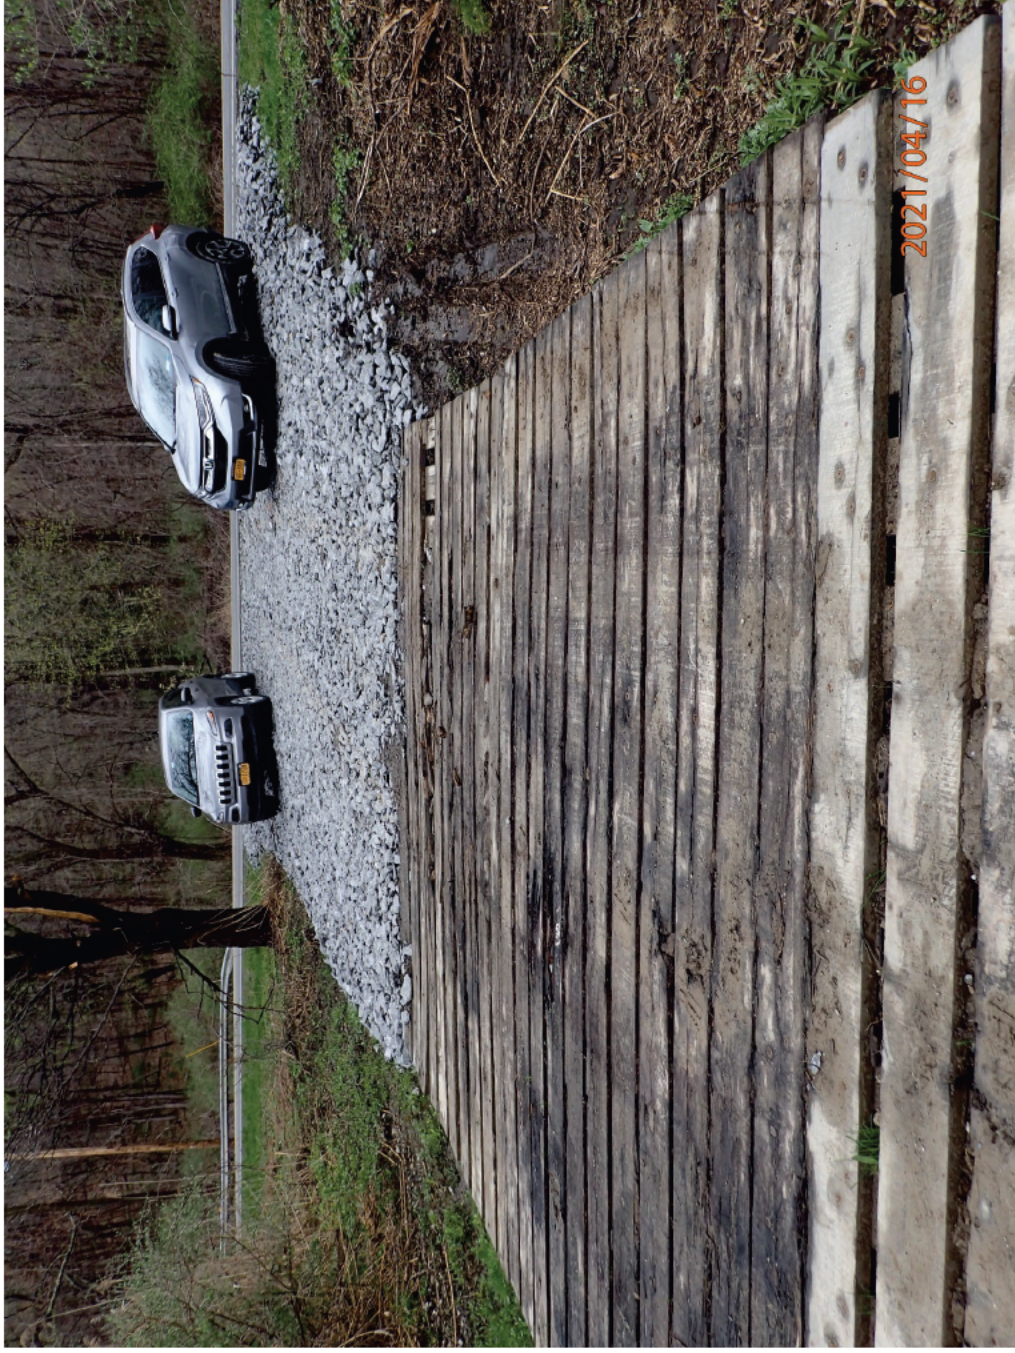
**Date:** 4/16/2016  
**Time:** 11:36 AM  
**Photographer:** SSA  
**Photo ID:** 12 -P4160143

| Purpose and Need for Discharge of Dredged and/or Fill Material<br>Material (rock and timber matting) had been brought to the site to create an access road. Cobble-sized rock had been placed at the entrance of the access road from Bog Hollow Rd. 700+ feet of timber matting had been placed on top of an existing path. | | | |

Rock placed at entrance of  
access road off of Bog Hollow  
Road for stabilization; timber  
mat access road in foreground
