## **RCRA Inspection Report**

Holcim (US) Inc./Geocycle LLC.  
8677 Hwy 45 Alternate South  
Artesia, Mississippi 39736  
EPA ID# MSD077655876  
562211 – Hazardous Waste Treatment and Disposal

March 11, 2021, 09:30 hours

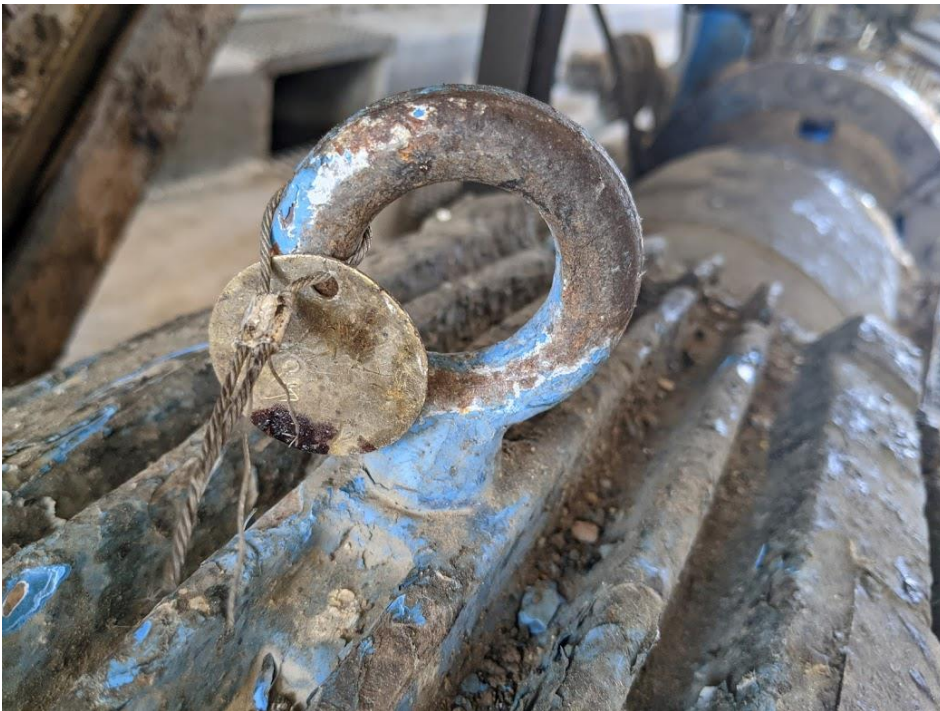
At the time of the inspection, the facility had two (2) operating unloading pumps and three more process pumps that transfer waste to the onsite treatment tanks. The treatment process takes approximately 48 hours. The tagging system for the pumps, valves, connectors, and other ancillary equipment were not all legible or present (Photographs 1-3).

Photograph 1 of 6: Illegible Tag on Ancillary Equipment Subject to Subpart BB

**Pursuant to the RCRA Permit, Part VI. Organic Air Emission Standards for Tanks, Containers, Miscellaneous Units, and Equipment [40 C.F.R. § 264.1050], which incorporates Section VI.A.2. Equipment Standards [40 C.F.R. § 264.1052 through 264.1058, 264.1060 through 264.1062, & 264.1064(b)], each piece of equipment subject to 40 C.F.R. Part 264 Subpart BB shall be tagged with a unique identification number.**

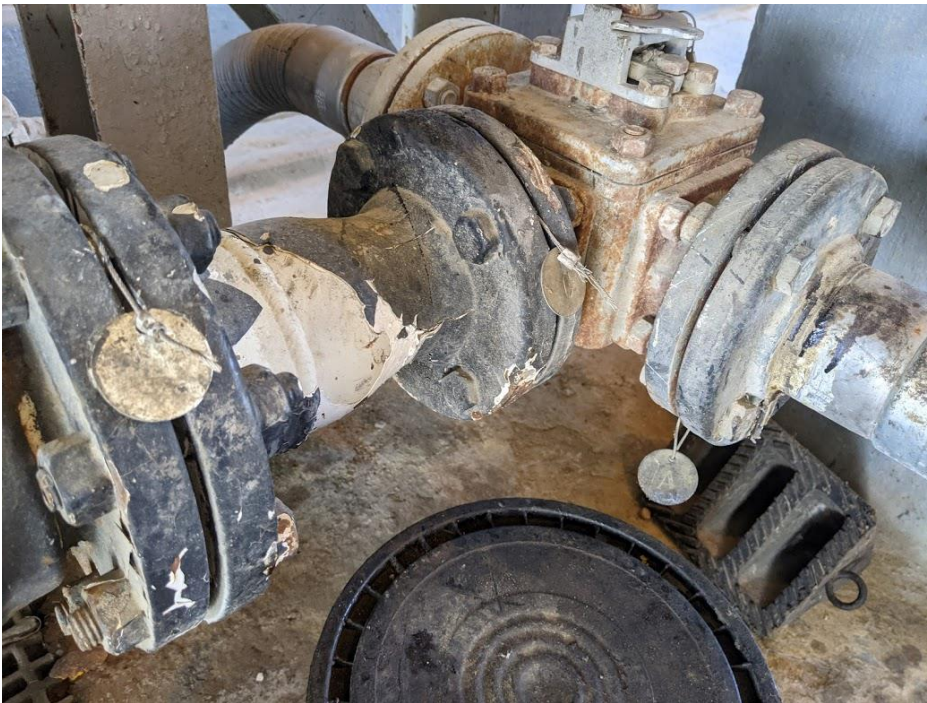
Photograph 2 of 6: Illegible Tags on Ancillary Equipment Subject to Subpart BB

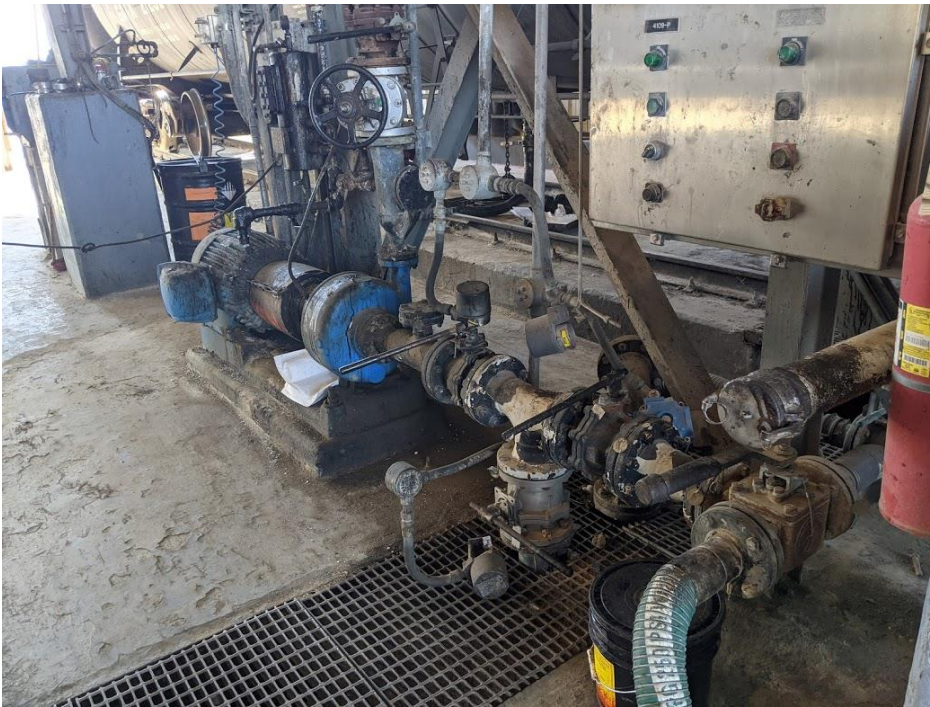
Photograph 3 of 6: Ancillary Equipment Managing Waste Subject to Subpart BB

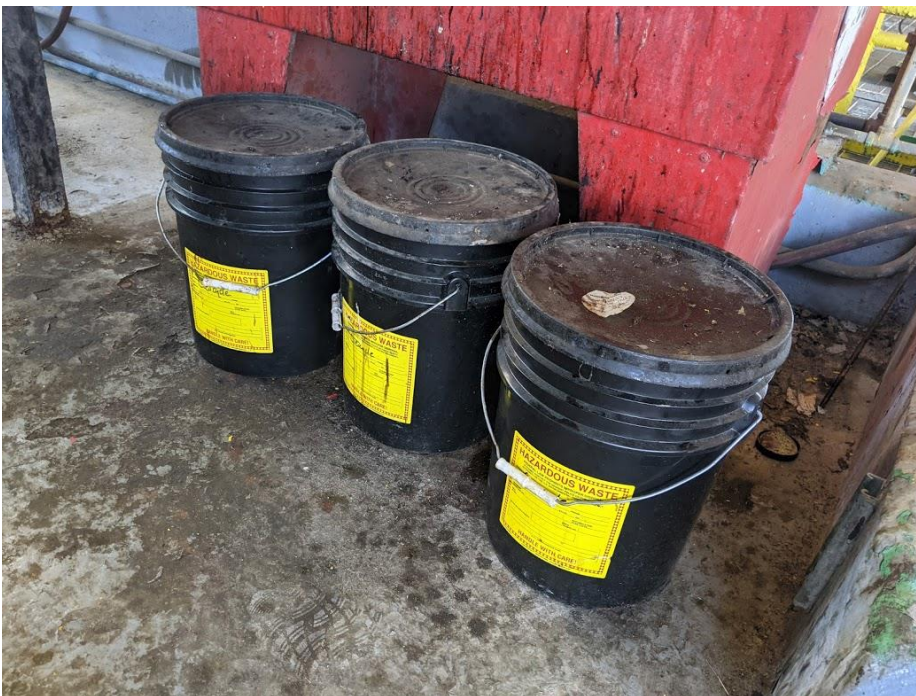
This area contains one SAA for accumulating retain samples. The inspectors observed three (3) 5-gallon containers of retain samples in this SAA. At the time of the inspection, the containers were not labeled with in indication of the hazards of its contents (Photograph 4).

Photograph 4 of 6: Three 5-gallon containers at the Retain Sample SAA Missing Characteristic Labels

**Pursuant to 11 Miss. Admin. Code Pt. 3, R. 1.3 [40 C.F.R. § 262.15(a)(5)(ii)], which is a condition of the SAA Permit Exemption, a generator is required to mark or label its containers with an indication of the hazards of the contents.**

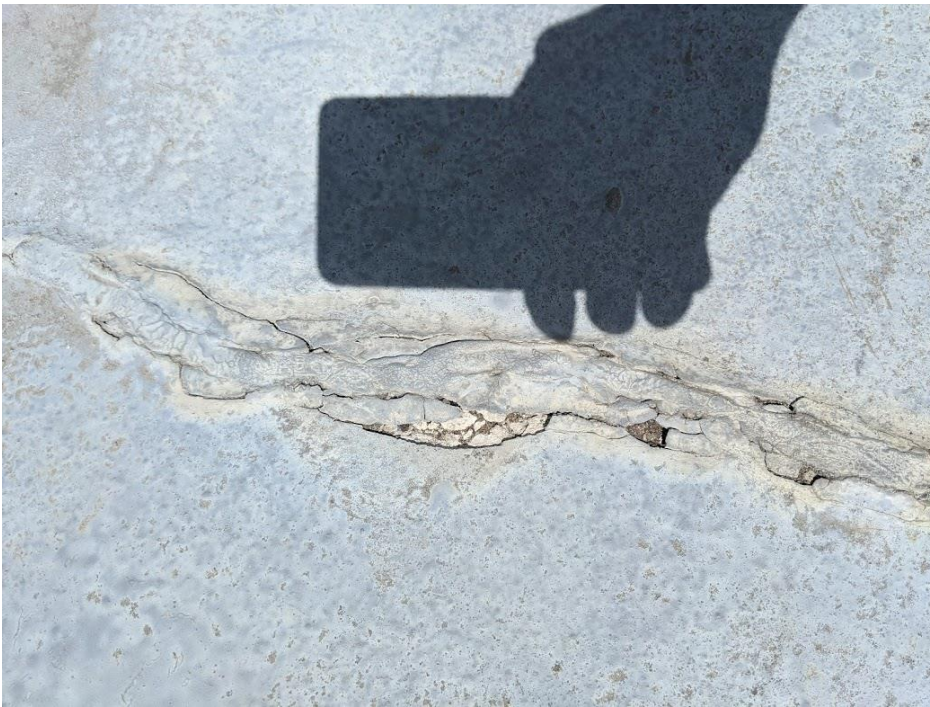
At the time of the inspection, there were 6 total fuel tanks. There was one (1) 90,000-gallon burn tank (#4106), one (1) 90,000-gallon blend tank (#4105) and four (4) 40,000-gallon fuel-blend tanks (#4101, #4102, #4103, #4104). At the time of the inspection, the secondary containment floor appeared to have cracks, gaps, and/or holes (Photographs 5 and 6).

Photograph 5 of 6: Cracks in Secondary Containment for Hazardous Waste Storage

**Pursuant to the RCRA Permit, Part IX. Tanks [40 C.F.R. § 264 Subpart J], which incorporates Section I.X.D.1. Design and Construction [40 C.F.R. § 264.193(e)(1)(iii)], a facility using a tank system for storing or treating hazardous waste must provide secondary containment with an external liner system that is free of cracks or gaps.**

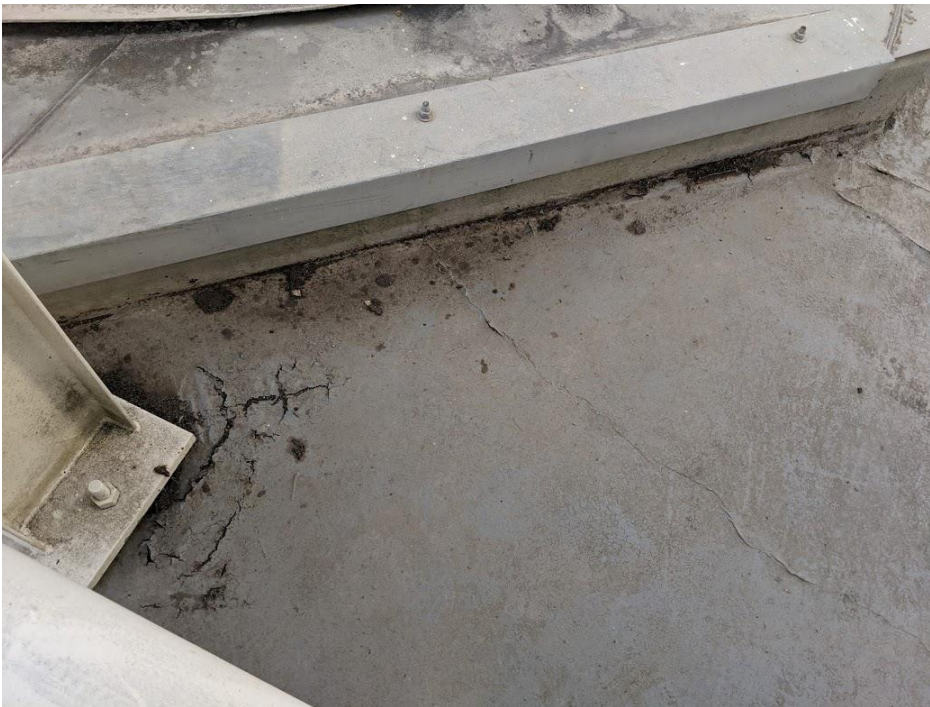
Photograph 6 of 6: Cracks in Secondary Containment for Hazardous Waste Storage
