Region 2 Enforcement & Compliance Assurance Division  
Air Compliance Branch  
CAA Inspection Report

Inspection Date: 11/7/2024  
Facility Name: Darling Ingredients  
Facility Address: 825 Wilson Ave Newark, NJ 07105  
ICIS-Air ID #: NJ0000003401305574  
EPA Lead Inspector: Katherine Marmanides (212)637-4063  
EPA Asst. Inspector: Victor Tu (212)637-3476  
Facility Contact: Matthew Appleby, o: (973)474-5908 c: (201)240-1679, MAppleby@darlingii.com  
State Inspector(s): State inspector name, title, phone number.  
Other Inspector(s): Other inspector name, title, phone number.

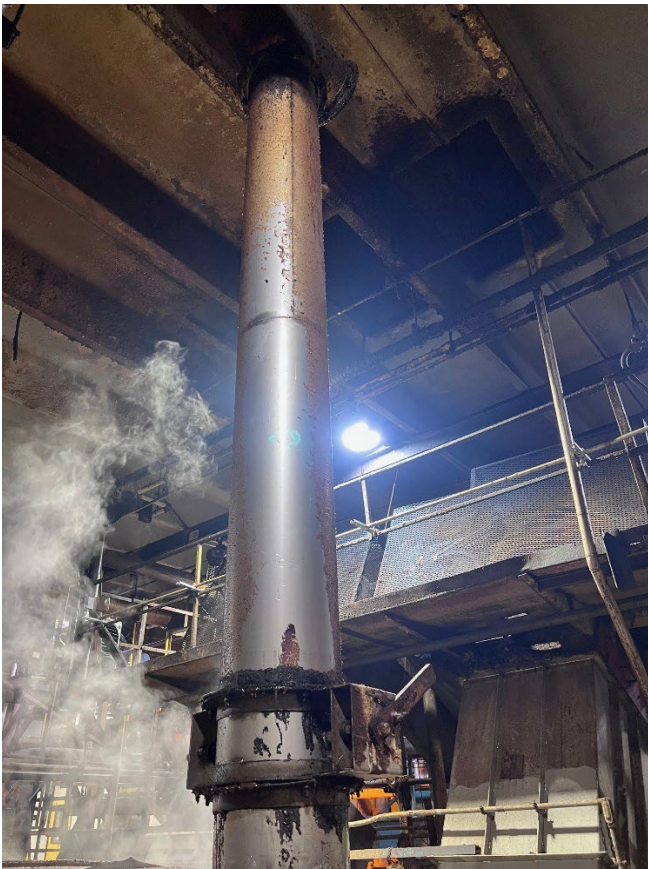
(Figure #3 – hood)

After Mr. Ashir and Mr. Medic walked us through everything in the control room, we went back into the rendering room. There is a hood in the rendering room which has a fan and draws all the rendering room air through it (see figure #3). It collects vapor and gases that go through a scrubber and venturi. Mr. Medic said that the hood oversees the entire rendering process room. The PID read as high as 1.950 PPM around the roto shear. The hood is located directly above a roto shear (see figure #4 & figure #5). There were sections of the floor that were covered with slippery & foamy residual material.
