**Region 6 - Enforcement & Compliance Assurance Division**  
**INSPECTION REPORT**

| Inspection Date(s): | 10/01/2025 | |
| Facility Name: | [REDACTED] | |

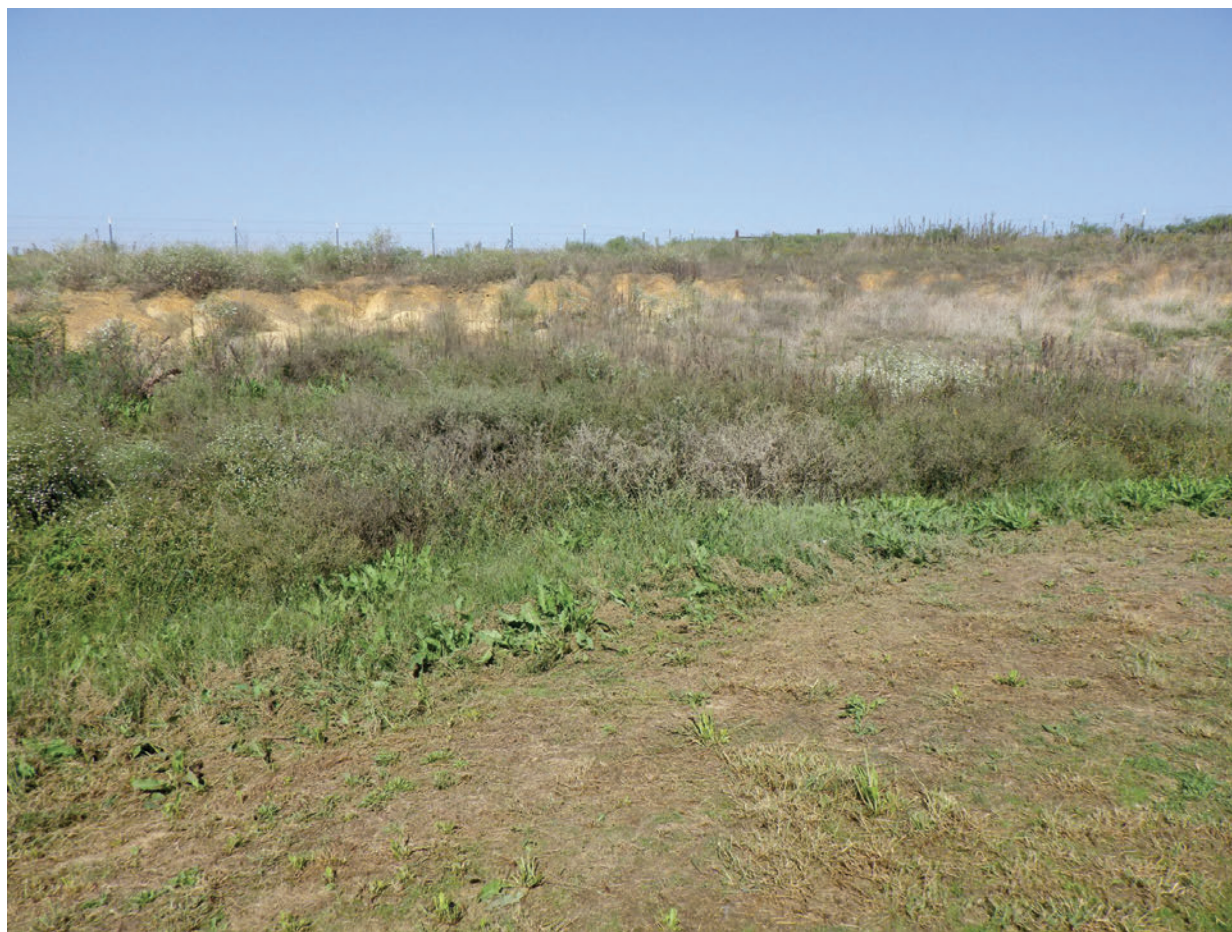
Photo No. 1

- The facility demonstrates good housekeeping practices.
- No cracks or run-off were observed from the litter barn.
- Good, vegetated buffers were observed around the perimeter of the property (Photo 1, Appendix 1).
- There were no signs of track-out at the entrance of any of the chicken houses.
- Chicken parts were observed outside containment (Photo 2, Appendix 1).

| Description: | A 7–8-foot berm was observed on the northwest corner of the facility. | | |

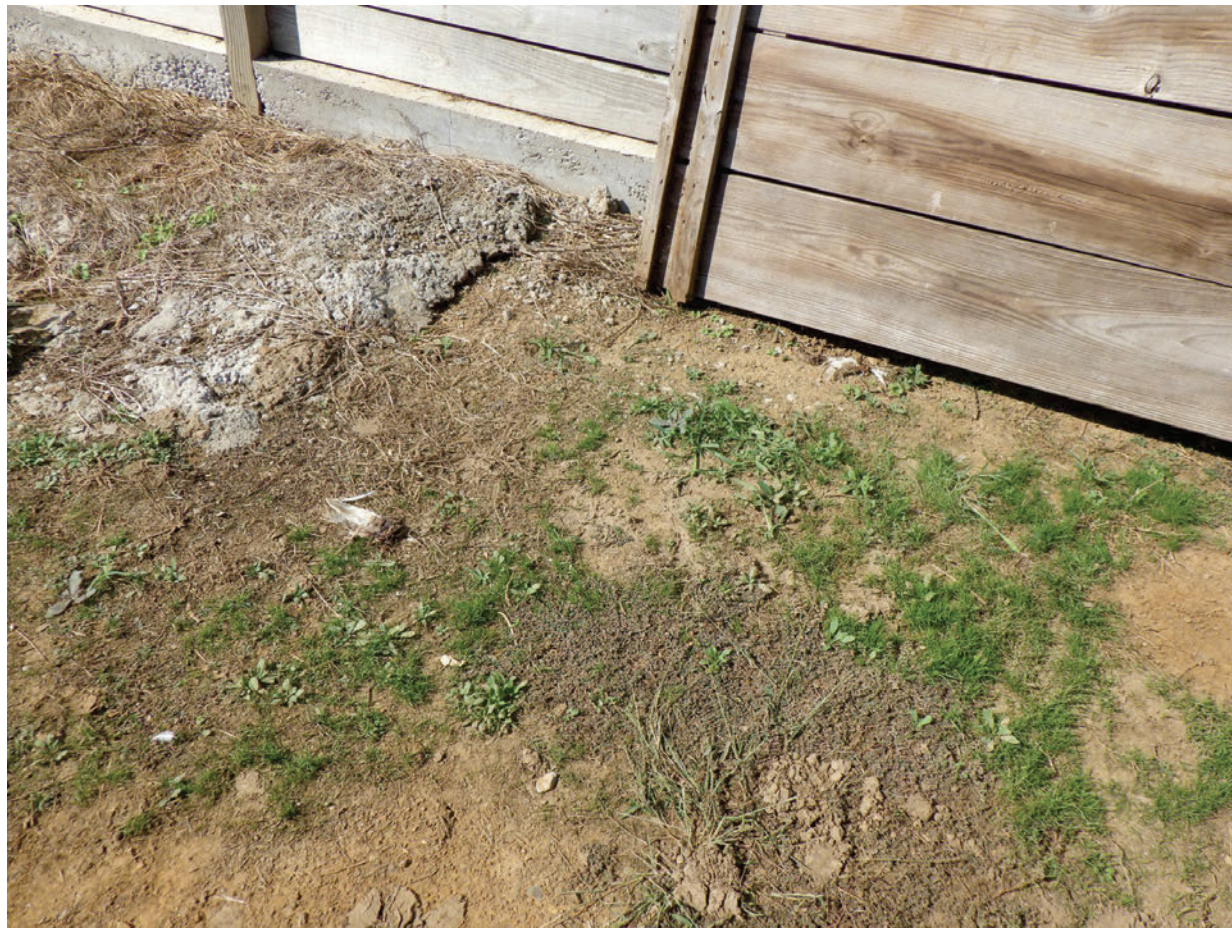
Photo No. 2

The exposed mortality outside the litter barn is at risk of being washed away by rainfall, potentially contaminating nearby water bodies such as [REDACTED], which is currently impaired for Benthic Macroinvertebrates Bioassessments & Dissolved Oxygen (DO) (Appendix 1, Photo 1) (40 CFR §122.23(b)(7)).

| Description: | A mortality/chicken parts were observed outside containment. | | |
